HISTORIC AND DESIGN REVIEW COMMISSION

HDRC CASE NO: 2016-016
ADDRESS: 304 E TRAVIS ST
LEGAL DESCRIPTION: NCB 415 BLK 18 LOT A-7, A- 8, A-9, P-100, P-101 & P-102
ZONING: D HE
CITY COUNCIL DIST.: 1
LANDMARK: St Anthony Hotel
APPLICANT: Brandon Raney
OWNER: BCL St. Anthony ML, LP
TYPE OF WORK: Tax Certification
REQUEST:

RE: St. Anthony Hotel Tax Certification Application

St. Anthony Hotel
Scope Summary of Exterior Rehabilitation

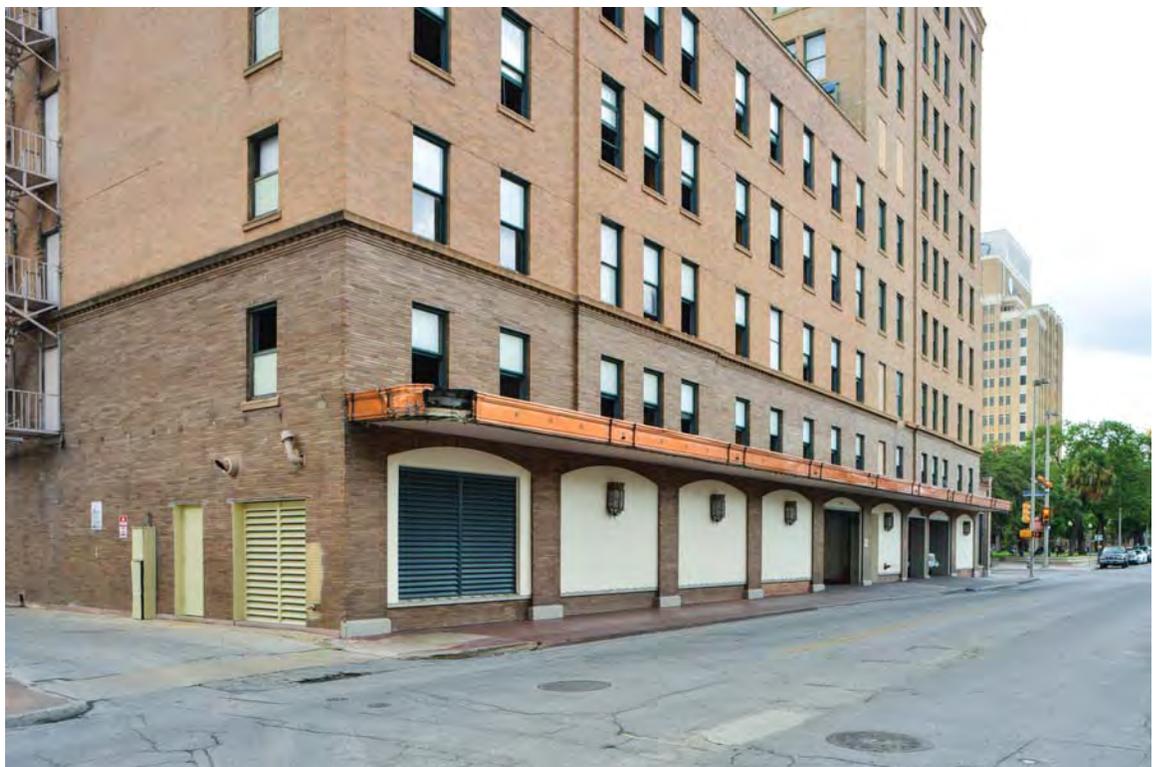
SAH-003

Name: Saint Anthony Hotel, 300 East Travis Street, San Antonio, Texas
View: Jefferson Street facade, looking northwest
Description: Damaged Jefferson Street canopy and deteriorated wood windows in garage
Date: September 2012

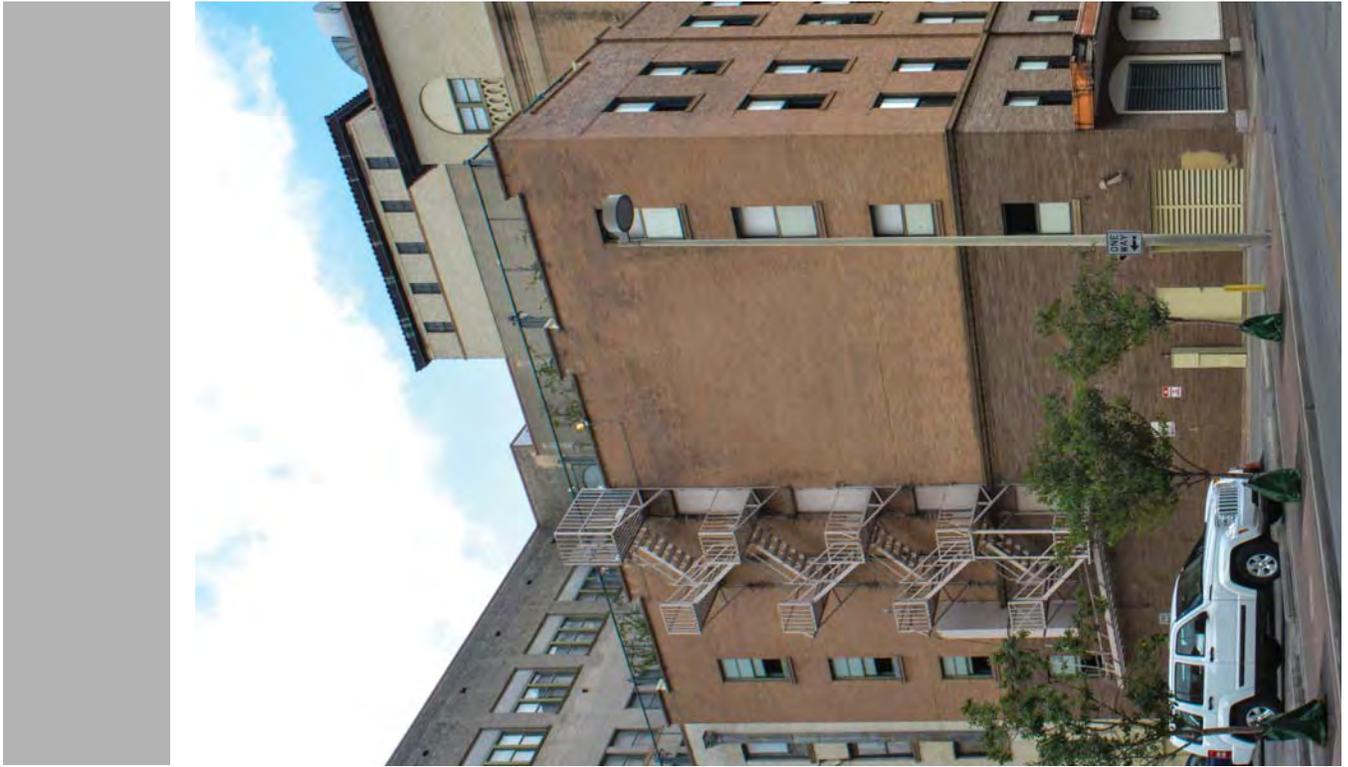
SAH-004

Name: Saint Anthony Hotel, 300 East Travis Street, San Antonio, Texas
View: South facade of garage from Jefferson Street looking northwest
Description: Exterior fire escape from sixth floor pool terrace and stained masonry
Date: September 2012

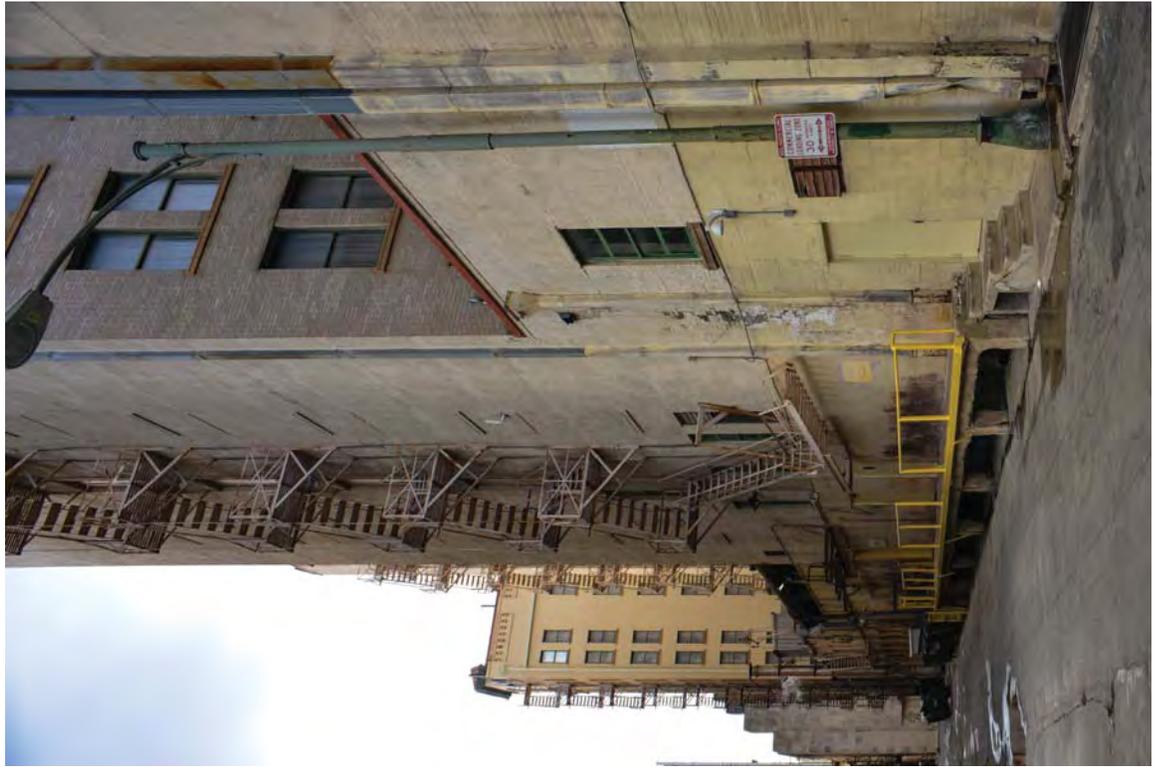
SAH-006

Name: Saint Anthony Hotel, 300 East Travis Street, San Antonio, Texas
View: South facade of Tower 3 from Jefferson Street at alley, looking west
Description: Exterior fire escape, stained masonry, and deteriorated concrete loading dock
Date: September 2012

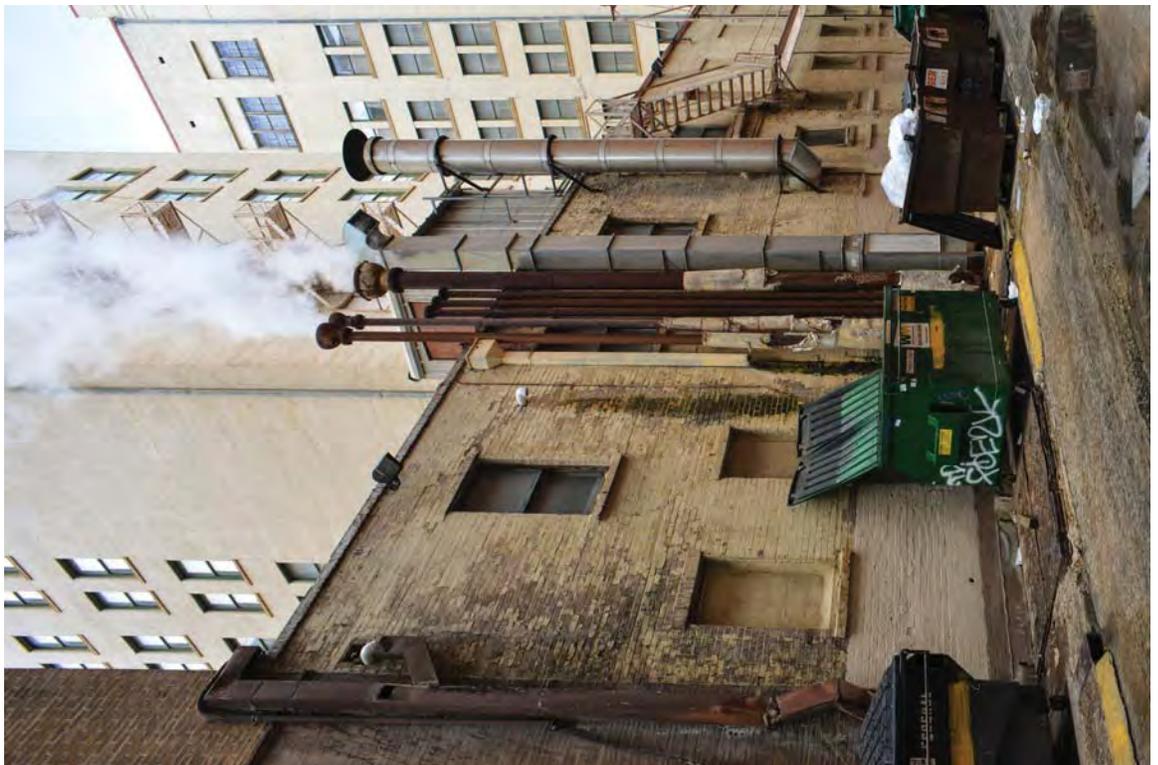
SAH-007

Name: Saint Anthony Hotel, 300 East Travis Street, San Antonio, Texas
View: South facade between Tower 1 & 2 at alley, looking east-northeast
Description: Stained and dirty brick masonry, damaged downspouts, and mechanical piping
Date: September 2012

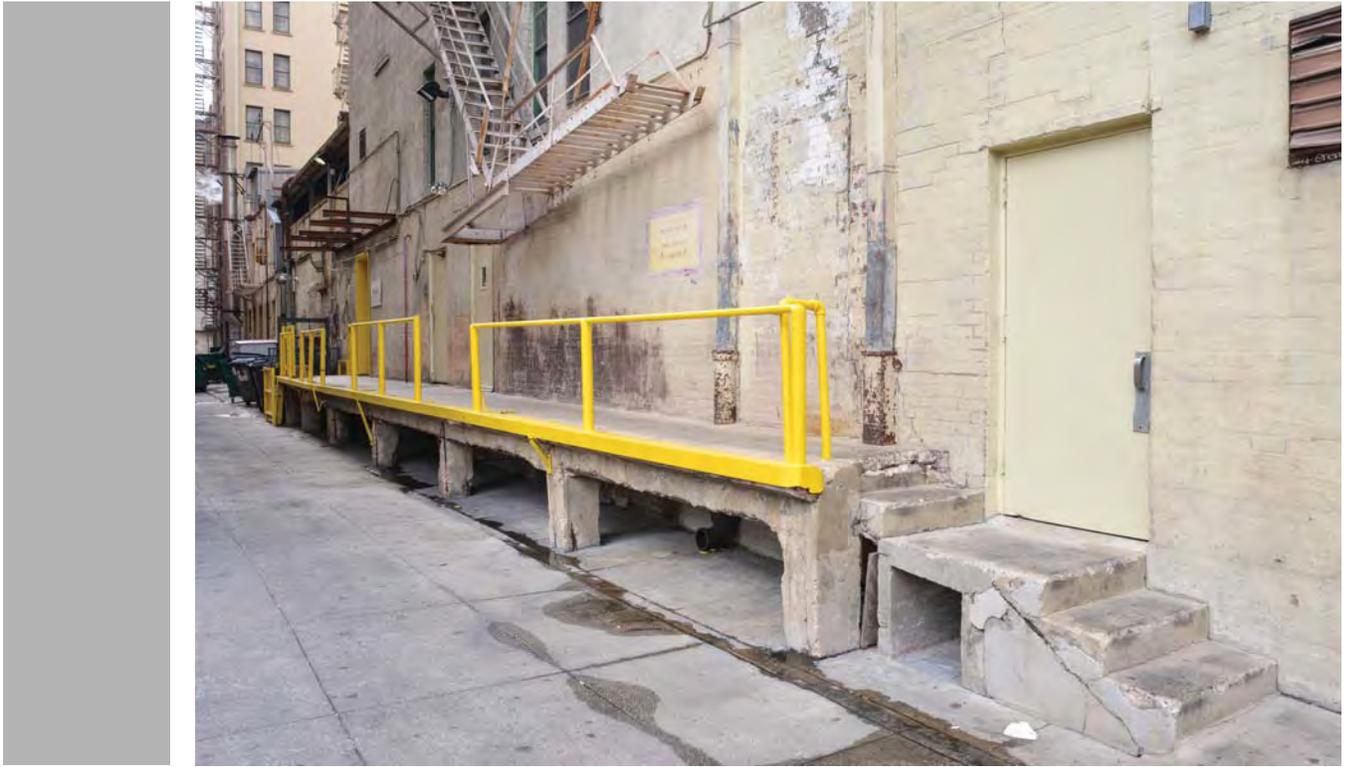
SAH-008

Name: Saint Anthony Hotel, 300 East Travis Street, San Antonio, Texas
View: South facade of Tower 3 at alley, looking west-northwest
Description: Deteriorated concrete loading dock and stairs & dirty and stained masonry
Date: September 2012

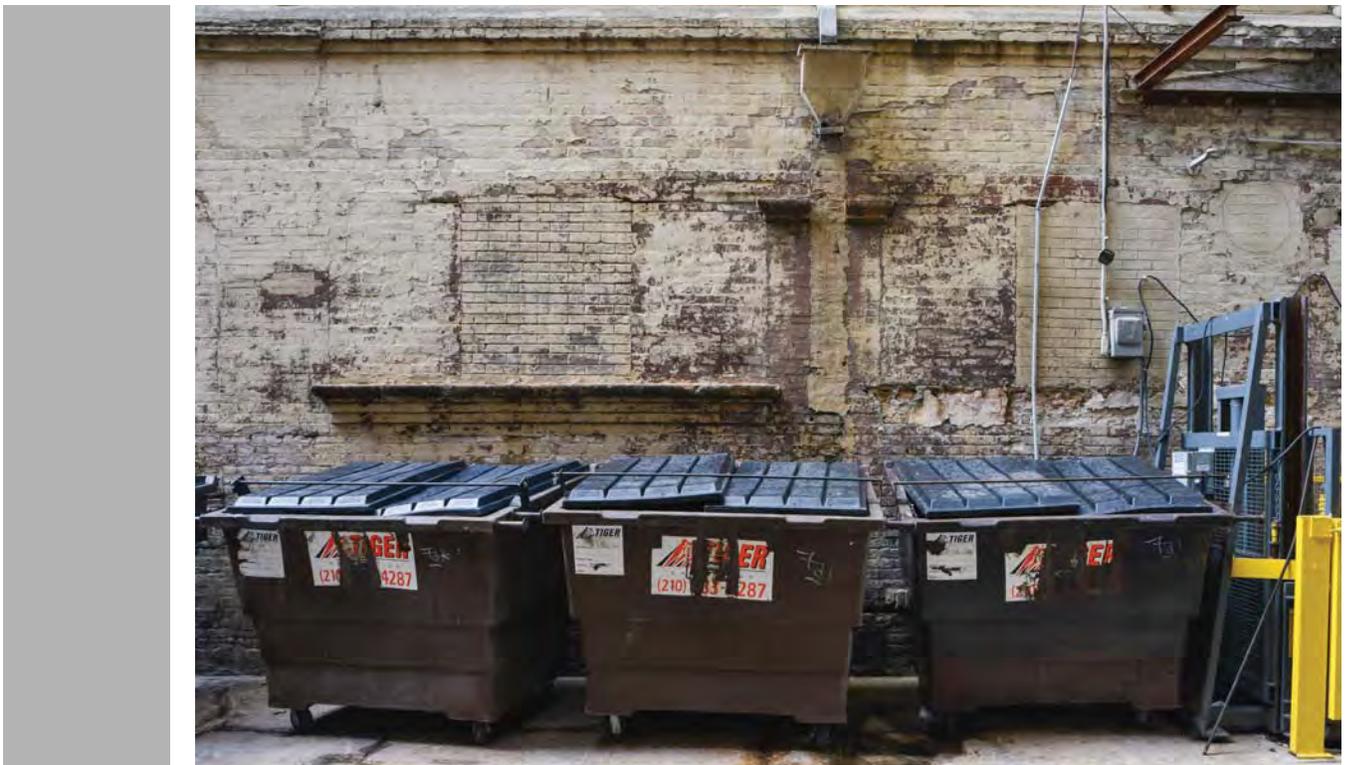
SAH-009

Name: Saint Anthony Hotel, 300 East Travis Street, San Antonio, Texas
View: South facade of Tower 2 at alley, looking north
Description: Dirty and stained masonry with damage due to dumpsters
Date: September 2012

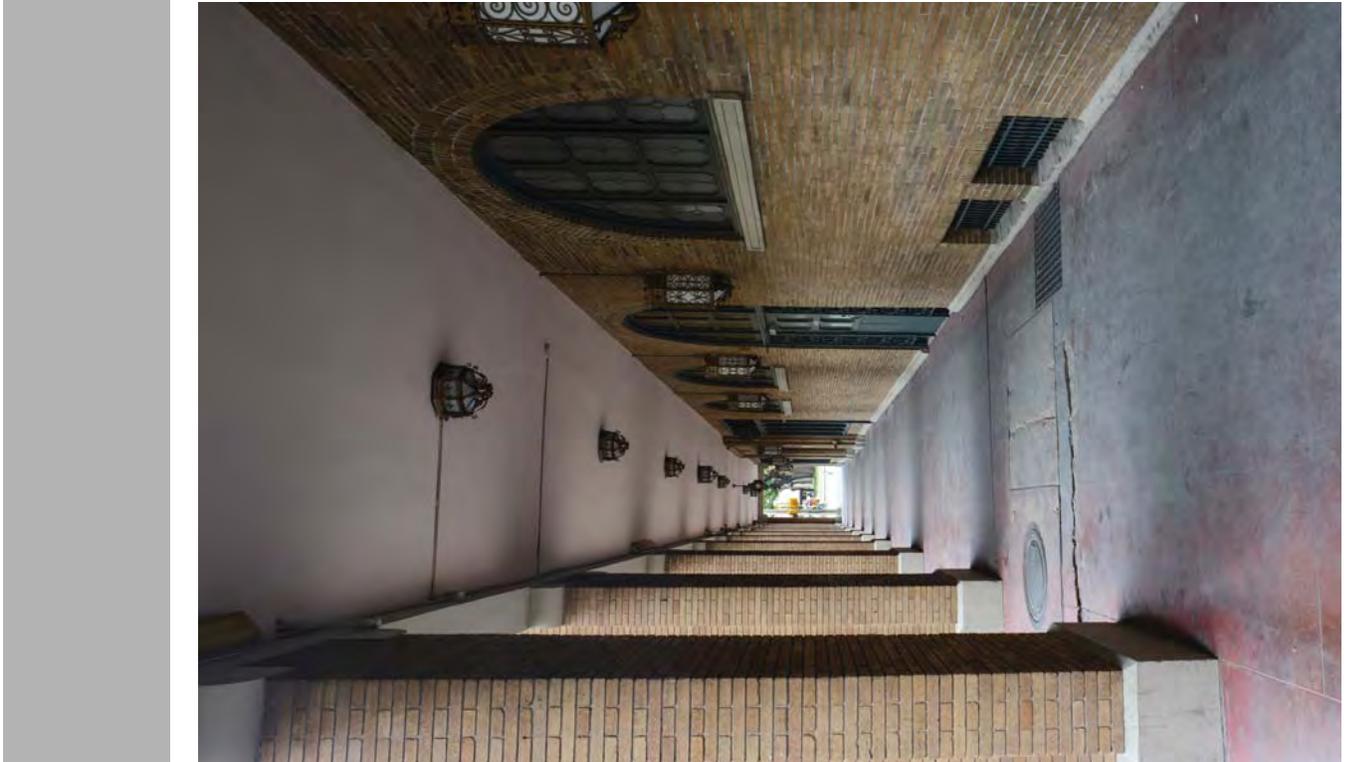
SAH-019

Name: Saint Anthony Hotel, 300 East Travis Street, San Antonio, Texas
View: West facade of west arcade looking north
Description: Cast stone, brick masonry, and concrete requiring cleaning and repair
Date: September 2012

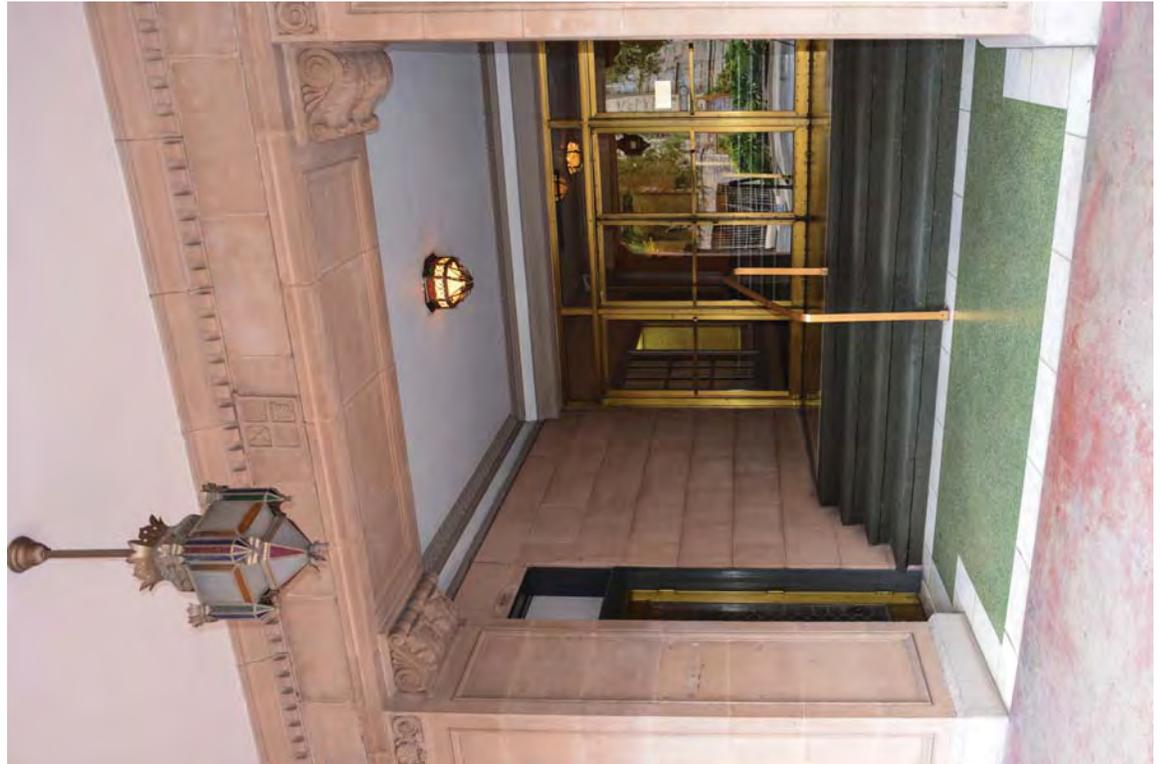
SAH-022

Name: Saint Anthony Hotel, 300 East Travis Street, San Antonio, Texas
View: Navarro Street entrance, looking east
Description: Non-historic door and glazing system to be replaced
Date: September 2012

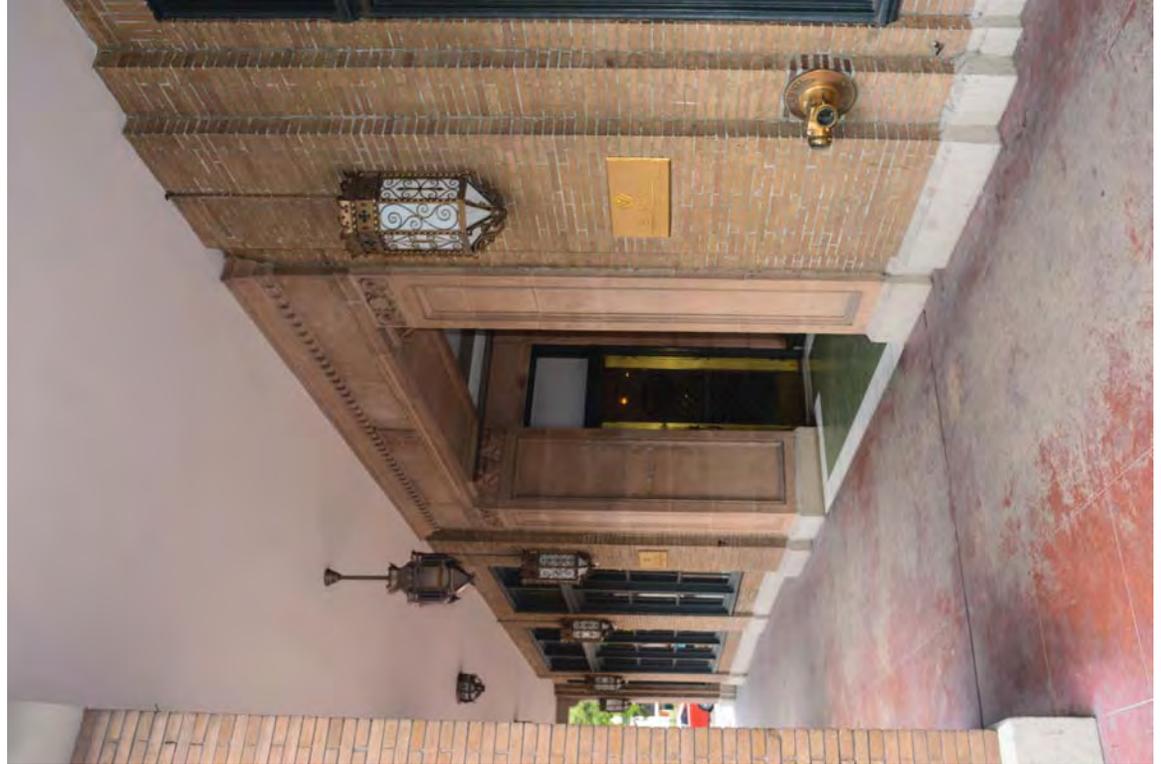
Photograph No.
SAH-023

Name: Saint Anthony Hotel, 300 East Travis Street, San Antonio, Texas
View: Navarro Street entrance, looking northeast
Description: Cast stone and brick masonry requiring general cleaning and repair
Date: September 2012

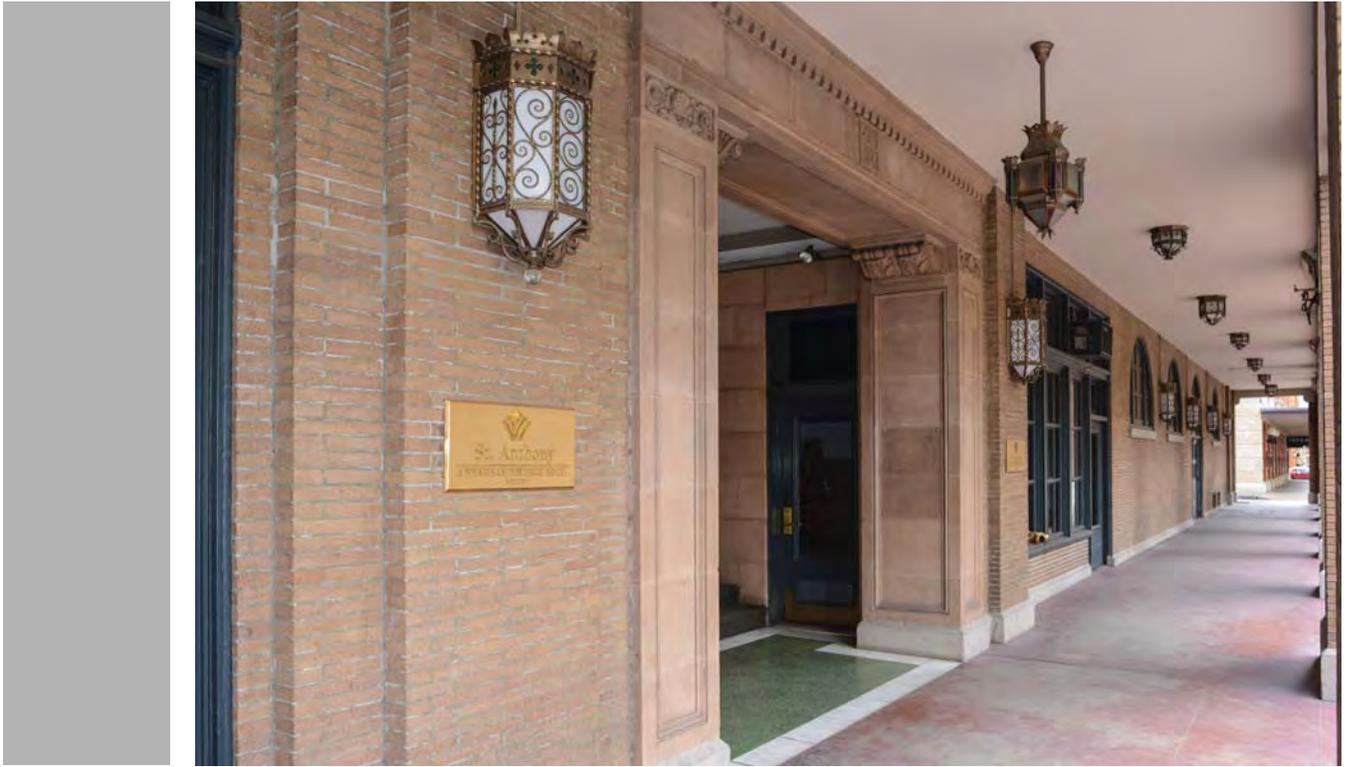
Name: Saint Anthony Hotel, 300 East Travis Street, San Antonio, Texas
View: Navarro Street entrance and arcade, looking southeast
Description: Cast stone and brick masonry requiring general cleaning and repair
Date: September 2012

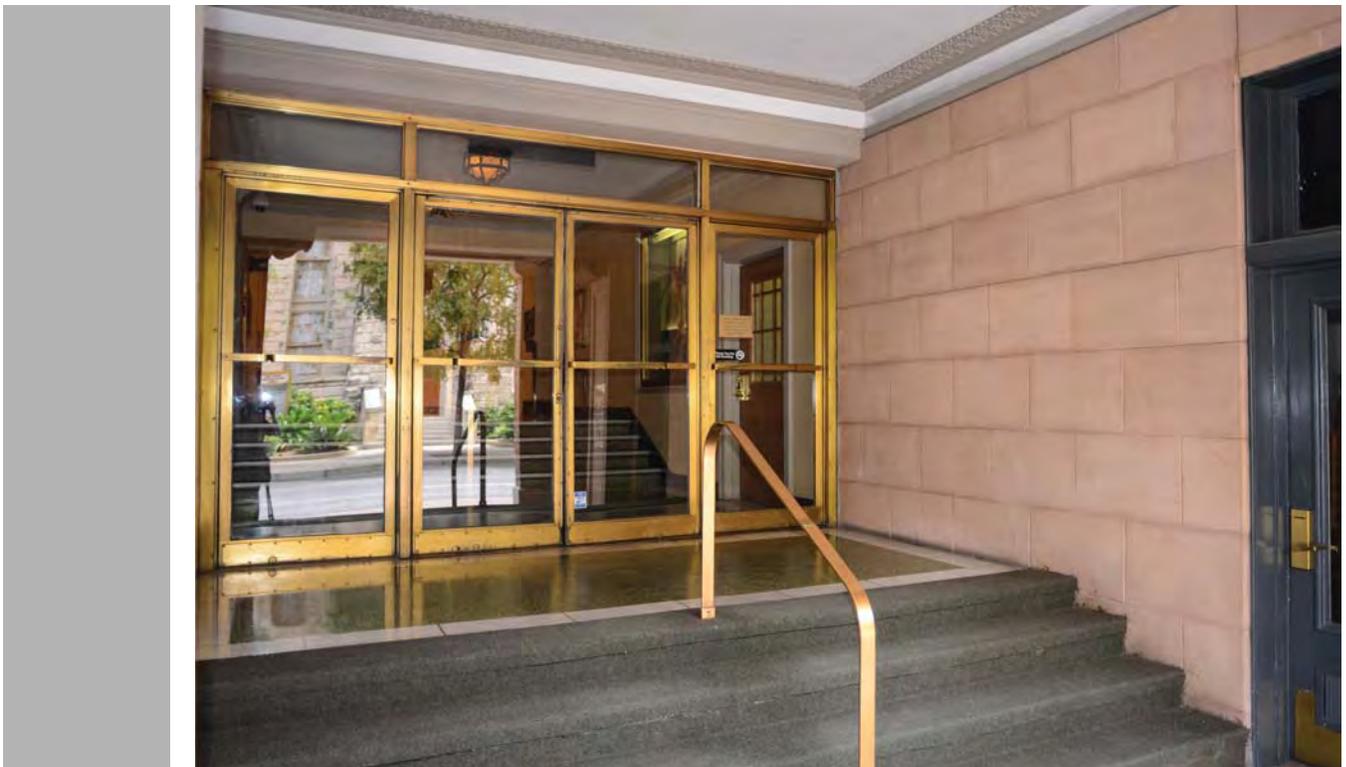
Name: Saint Anthony Hotel, 300 East Travis Street, San Antonio, Texas
View: Navarro Street entrance, looking east
Description: Non-historic door and glazing system to be replaced
Date: September 2012

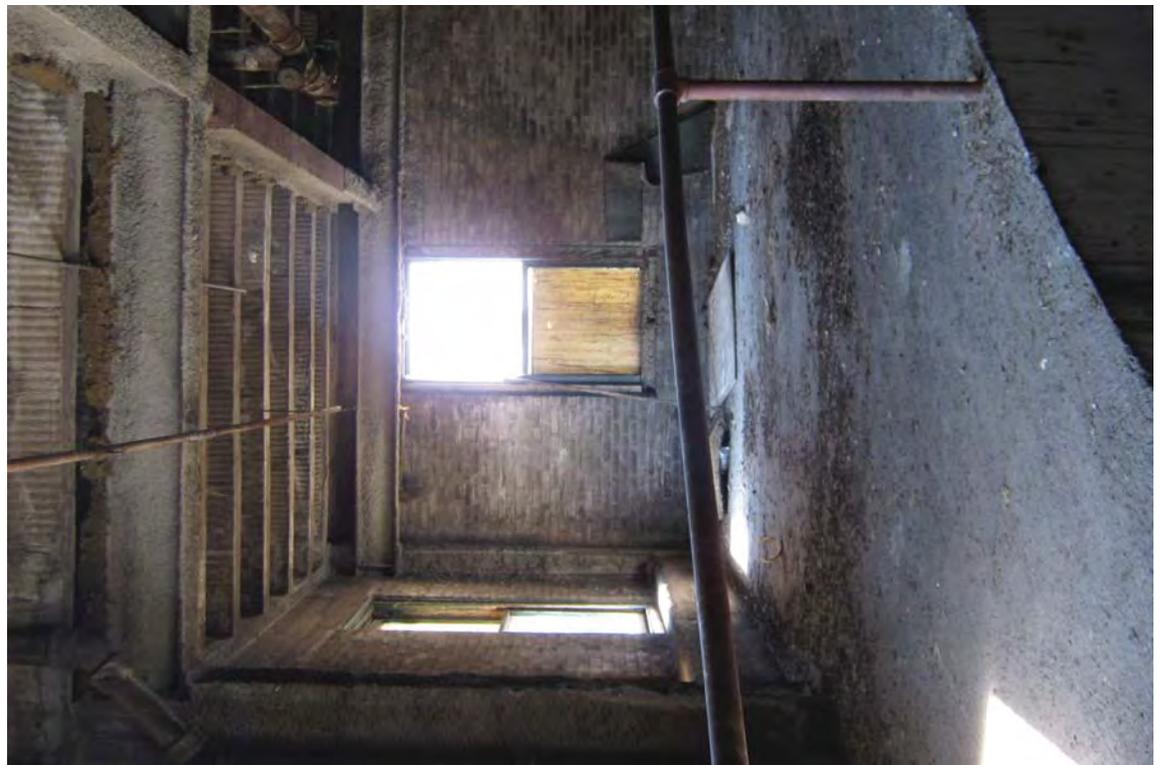
Name: Saint Anthony Hotel, 300 East Travis Street, San Antonio, Texas
View: Typical interior view of parking garage
Description: Concrete & masonry cleaning, window sash replacement required
Date: September 2012

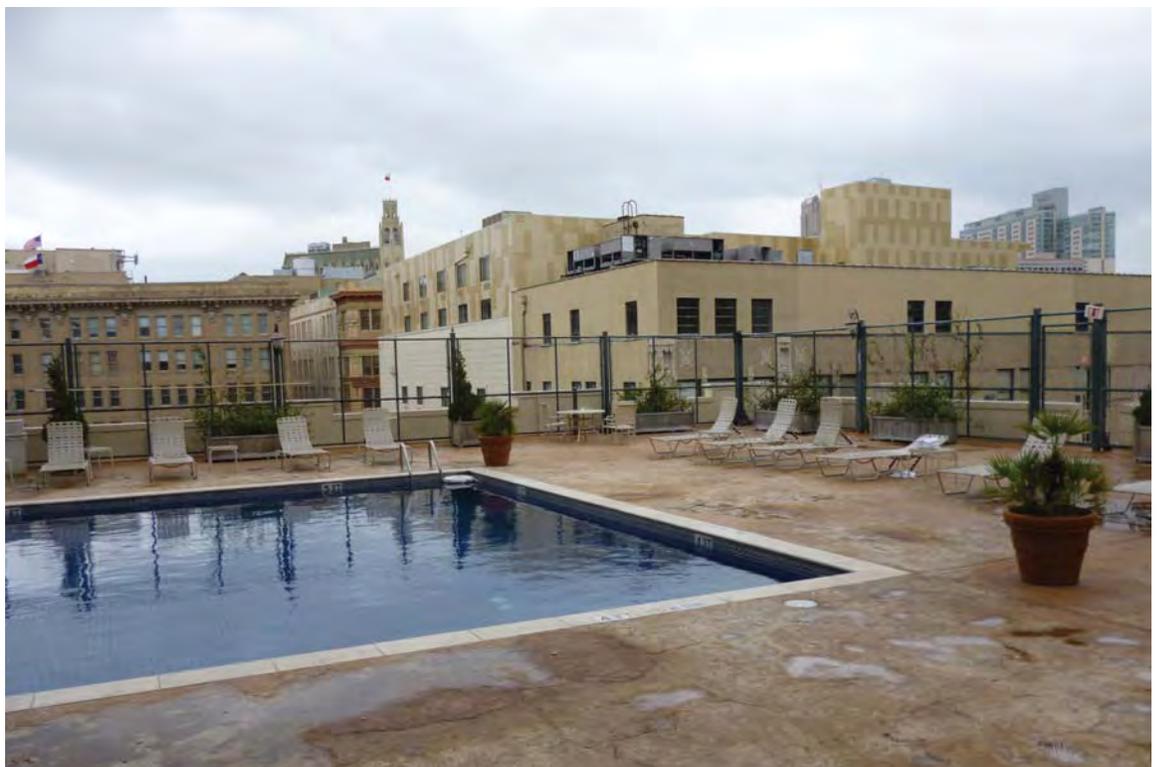
Name: Saint Anthony Hotel, 300 East Travis Street, San Antonio, Texas
View: Sixth floor pool terrace, looking east-southeast
Description: Cracked and spawling decking material & inappropriate fencing
Date: September 2012

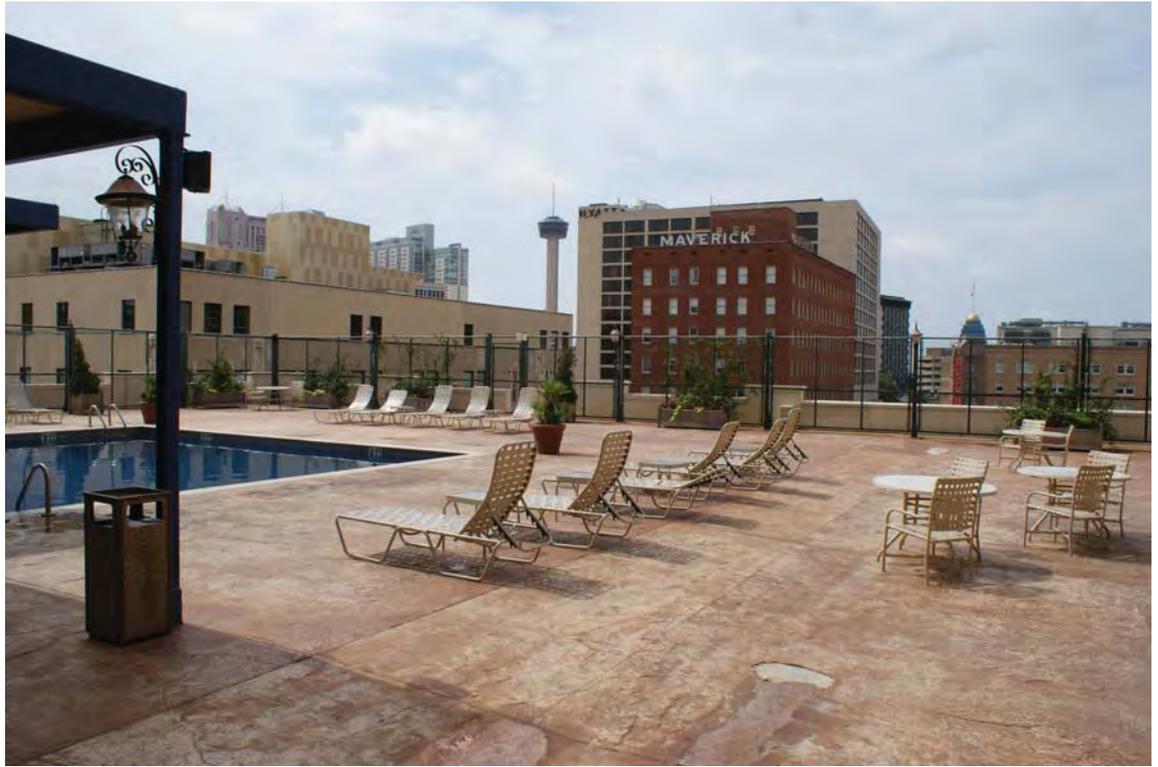
Name: Saint Anthony Hotel, 300 East Travis Street, San Antonio, Texas
View: Sixth floor pool terrace, looking southeast toward Tower of the Am.
Description: Cracked and spawling decking material & inappropriate fencing
Date: September 2012

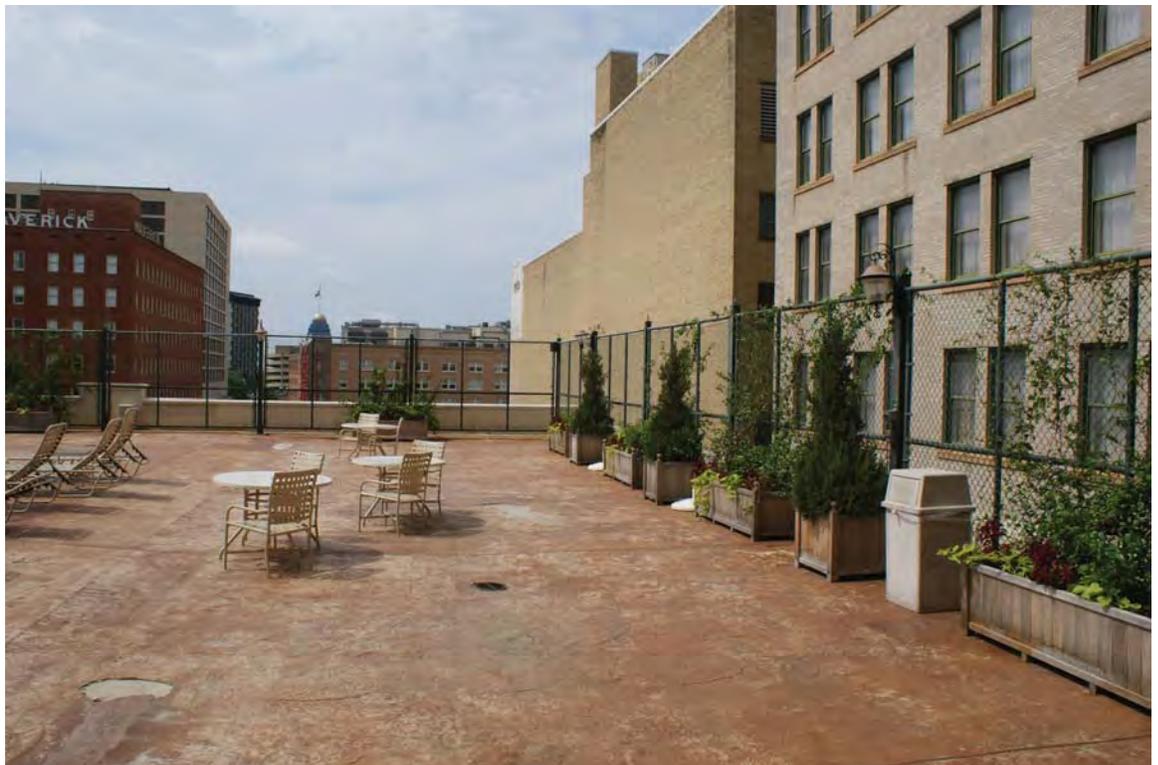
Name: Saint Anthony Hotel, 300 East Travis Street, San Antonio, Texas
View: Sixth floor pool terrace, looking south toward Casino Club Bldg.
Description: Cracked and spawling decking material & inappropriate fencing
Date: September 2012

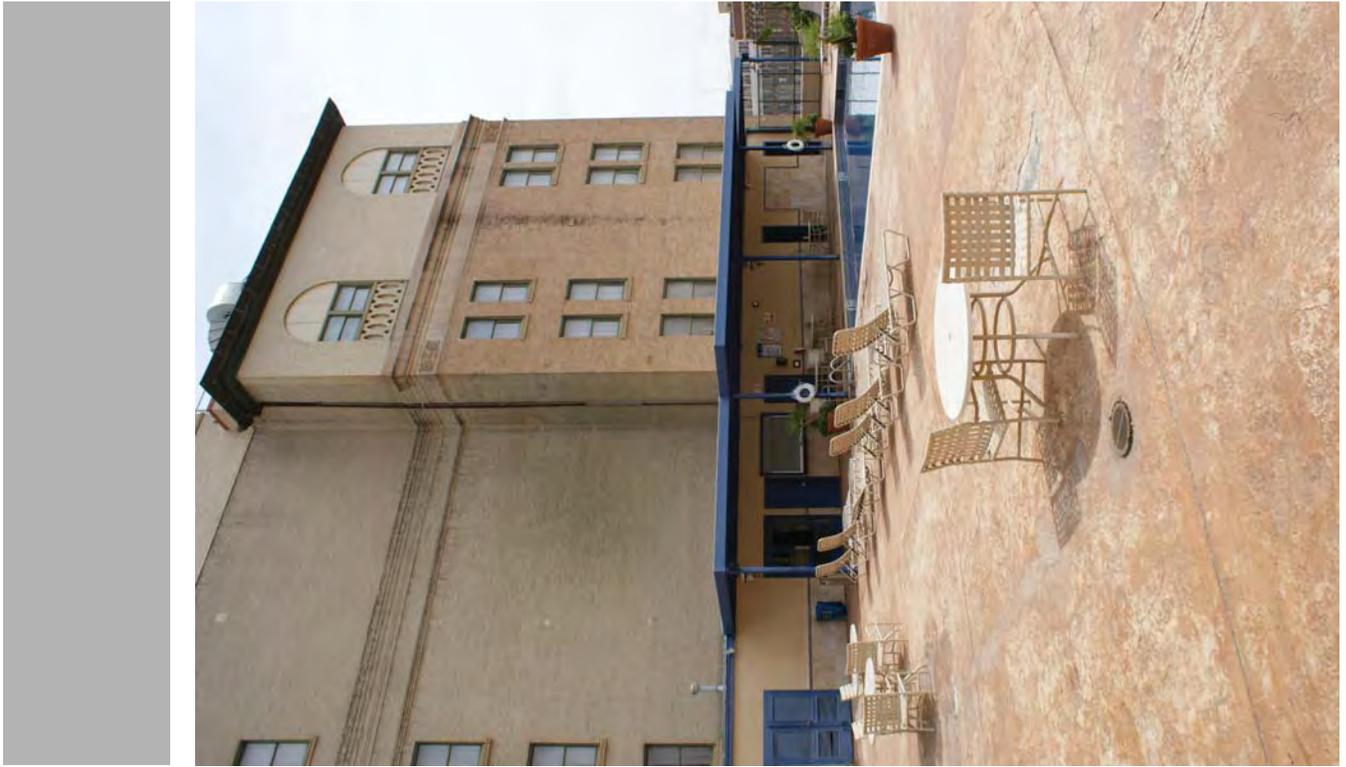
Name: Saint Anthony Hotel, 300 East Travis Street, San Antonio, Texas
View: Sixth floor pool terrace, looking northeast toward Tower 4
Description: Cracked and spawling decking material & stained and dirty masonry
Date: September 2012

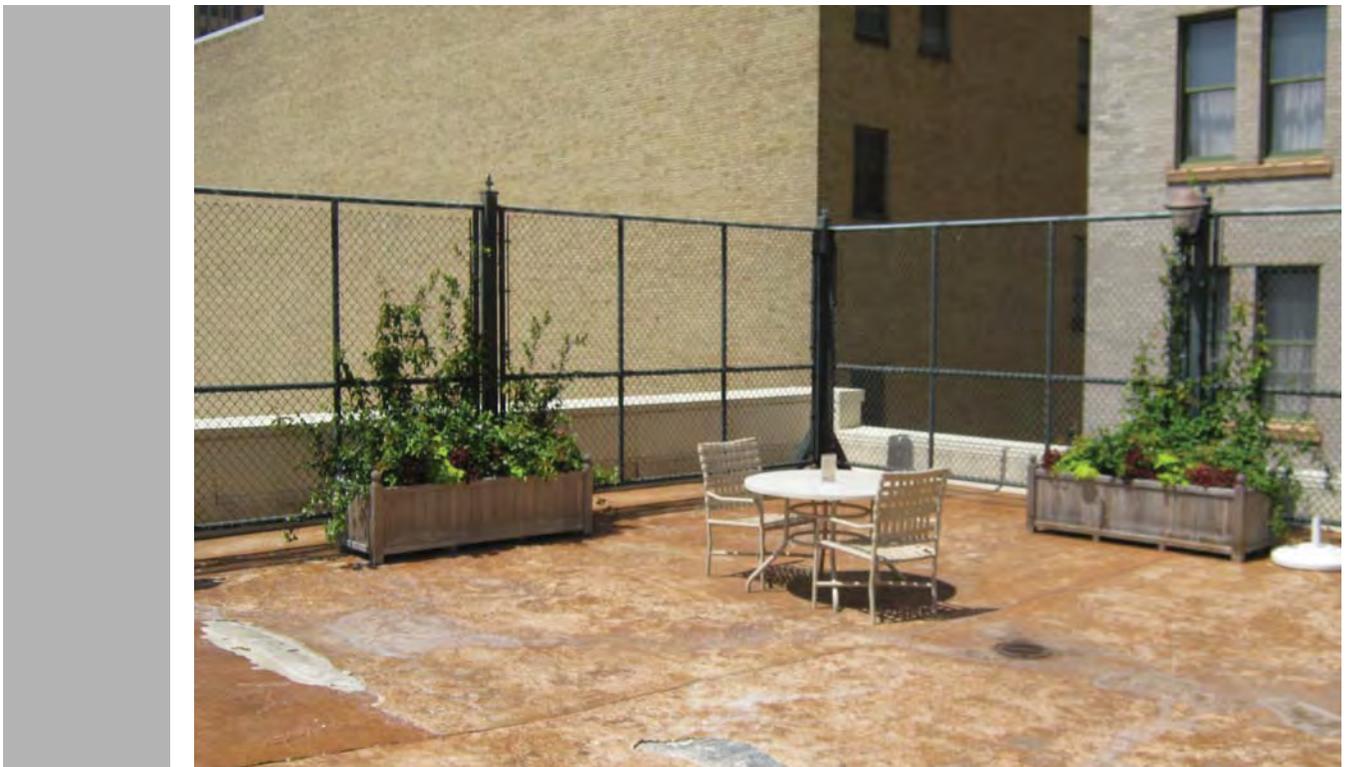
Name: Saint Anthony Hotel, 300 East Travis Street, San Antonio, Texas
View: Sixth floor pool terrace, looking southwest toward terrace corner
Description: Cracked and spawling decking material & inappropriate scaled fencing
Date: September 2012

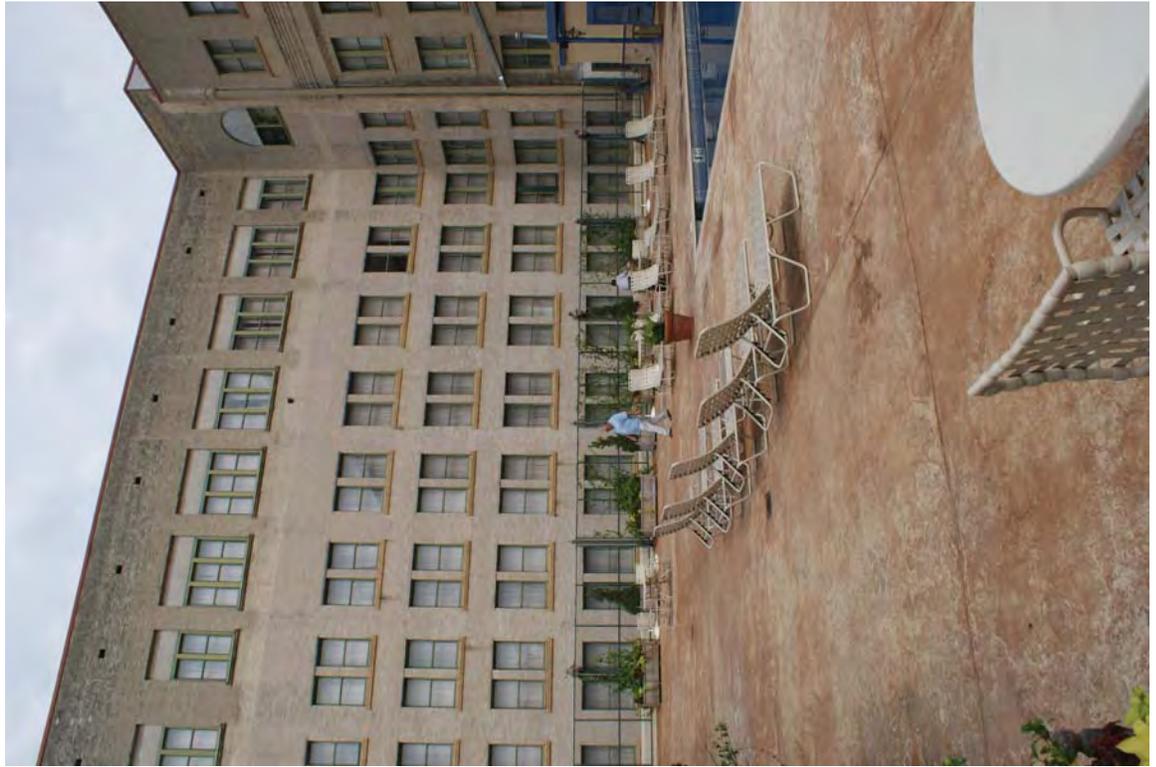
Name: Saint Anthony Hotel, 300 East Travis Street, San Antonio, Texas
View: Sixth floor pool terrace, looking west-northwest toward Tower 3
Description: Atmospheric and mineral stained masonry
Date: September 2012

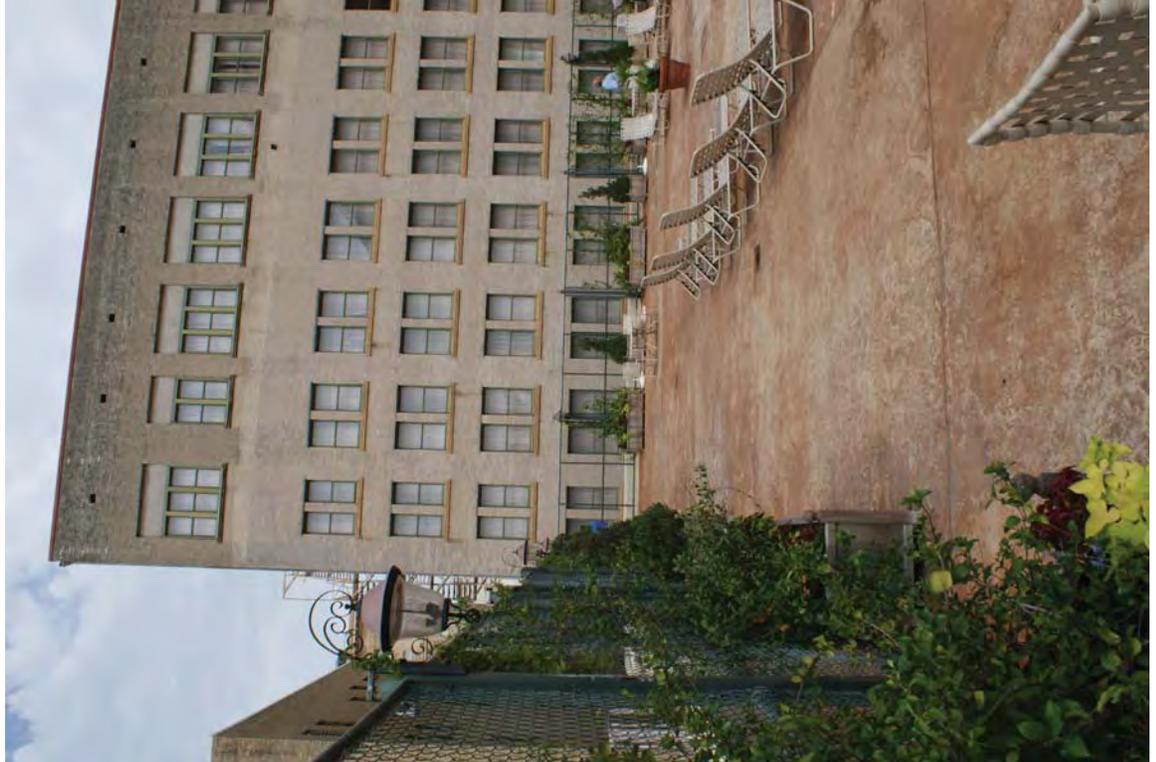
Name: Saint Anthony Hotel, 300 East Travis Street, San Antonio, Texas
View: Sixth floor pool terrace, looking west toward Tower 3
Description: Atmospheric and mineral stained masonry; inappropriate fencing
Date: September 2012

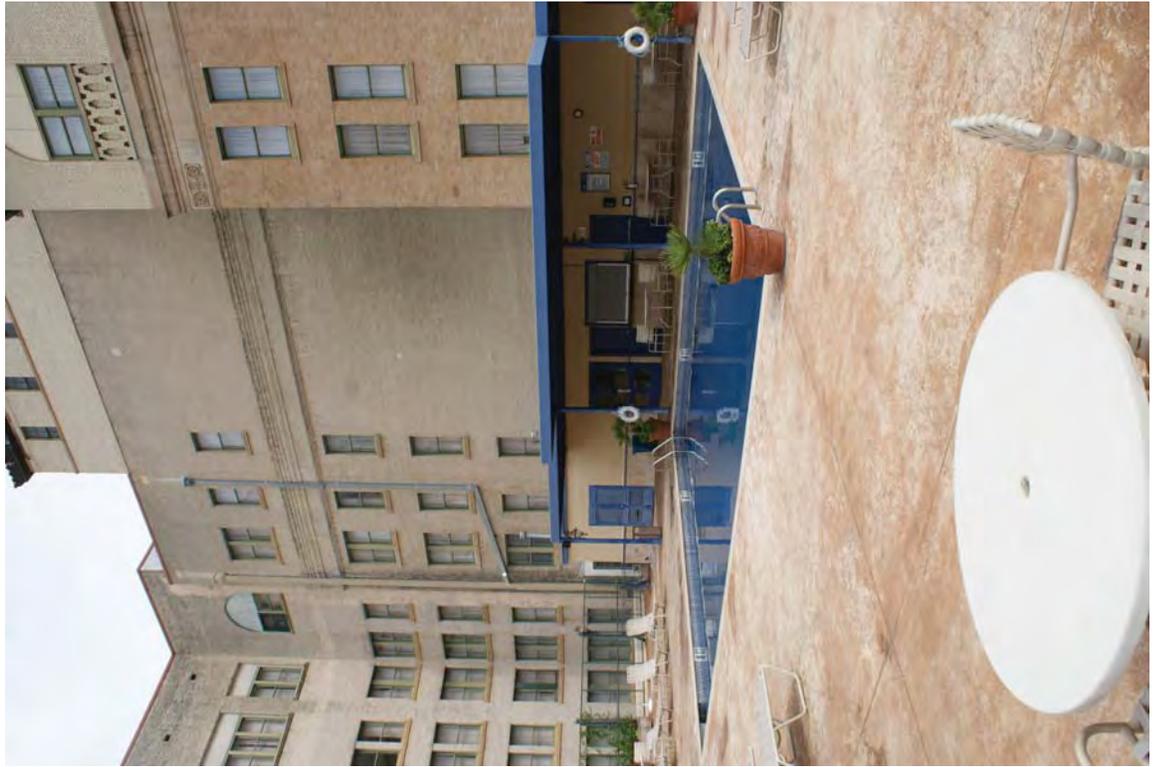
Name: Saint Anthony Hotel, 300 East Travis Street, San Antonio, Texas
View: Sixth floor pool terrace, looking north-northwest toward Tower 4
Description: Atmospheric and mineral stained masonry; pool concession addition
Date: September 2012

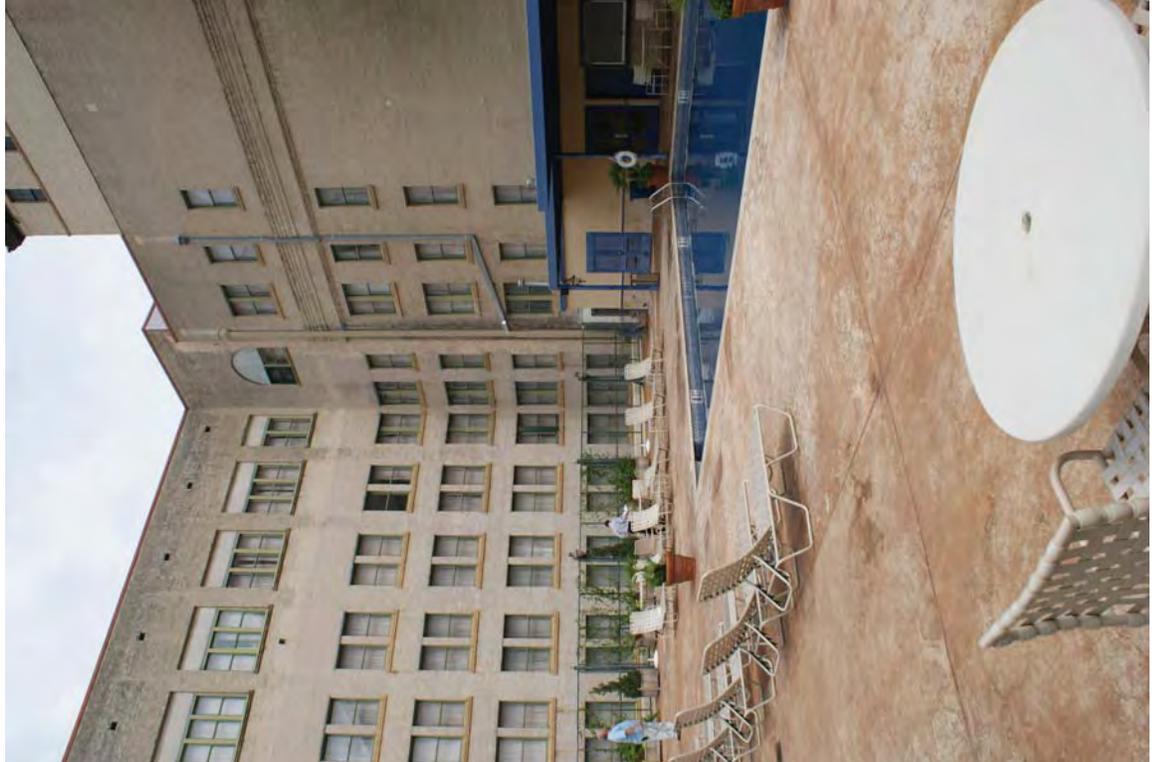
Name: Saint Anthony Hotel, 300 East Travis Street, San Antonio, Texas
View: Sixth floor pool terrace, looking northwest toward Towers 3 & 4
Description: Atmospheric and mineral stained masonry; pool concession addition
Date: September 2012

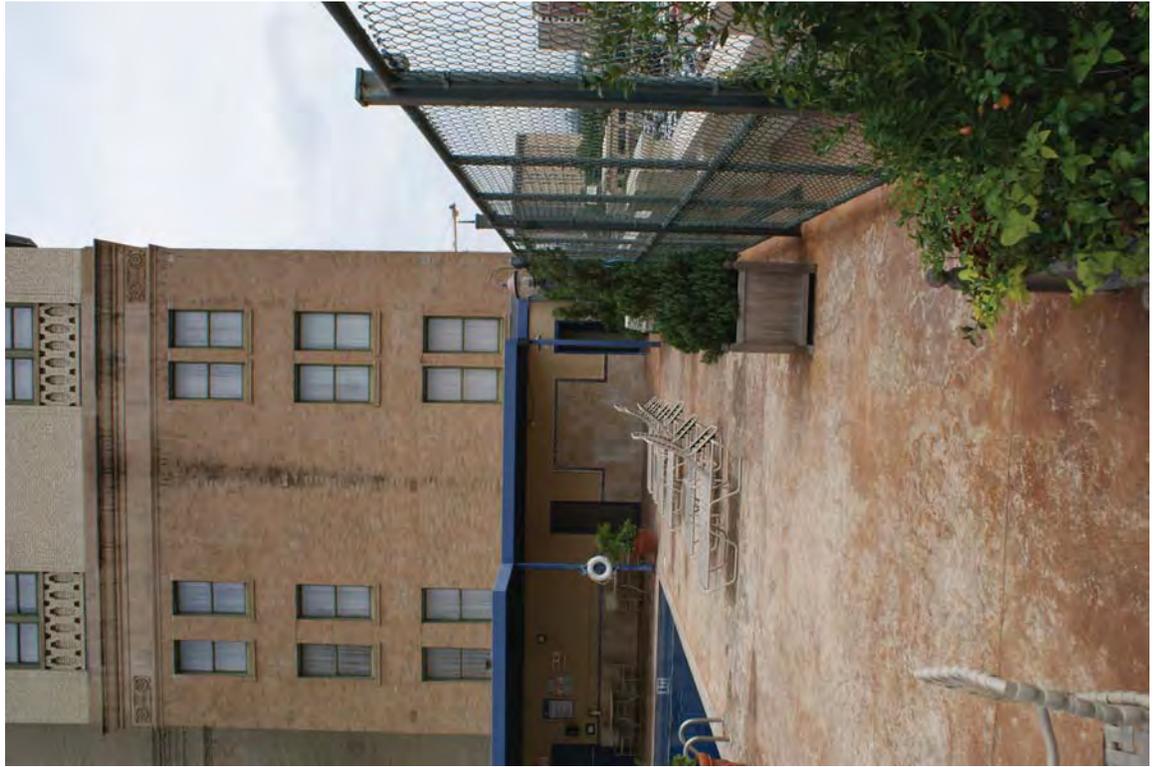
Name: Saint Anthony Hotel, 300 East Travis Street, San Antonio, Texas
View: Sixth floor pool terrace, looking north at Tower 4 south facade
Description: Atmospheric and mineral stained masonry; pool concession addition
Date: September 2012

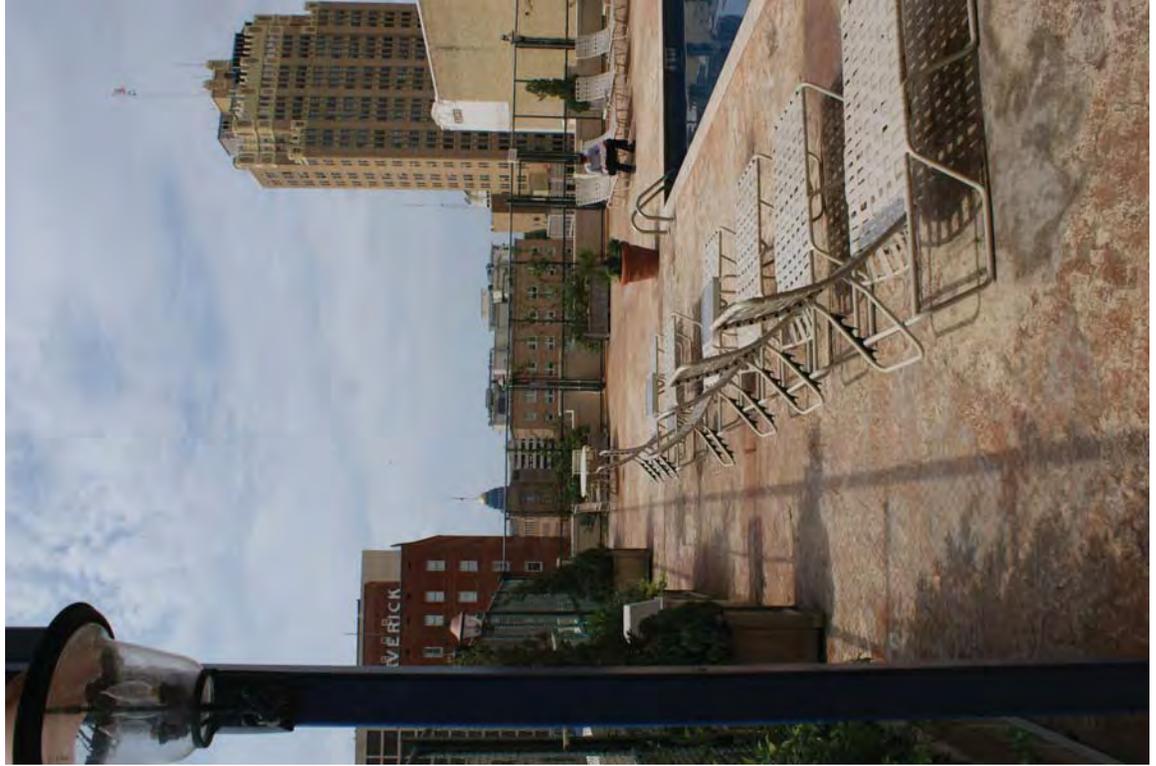
Name: Saint Anthony Hotel, 300 East Travis Street, San Antonio, Texas
View: Sixth floor pool terrace, looking south toward Maverick Bldg.
Description: Light fixtures & perimeter fencing with inappropriate scale & materials
Date: September 2012
