HISTORIC AND DESIGN REVIEW COMMISSION

HDRC CASE NO: 2016-016
ADDRESS: 304 E TRAVIS ST
LEGAL DESCRIPTION: NCB 415 BLK 18 LOT A-7, A- 8, A-9, P-100, P-101 & P-102
ZONING: D HE
CITY COUNCIL DIST.: 1
LANDMARK: St Anthony Hotel
APPLICANT: Brandon Raney
OWNER: BCL St. Anthony ML, LP
TYPE OF WORK: Tax Certification
REQUEST:

RE: St. Anthony Hotel Tax Certification Application

St. Anthony Hotel
Scope Summary of Exterior Rehabilitation

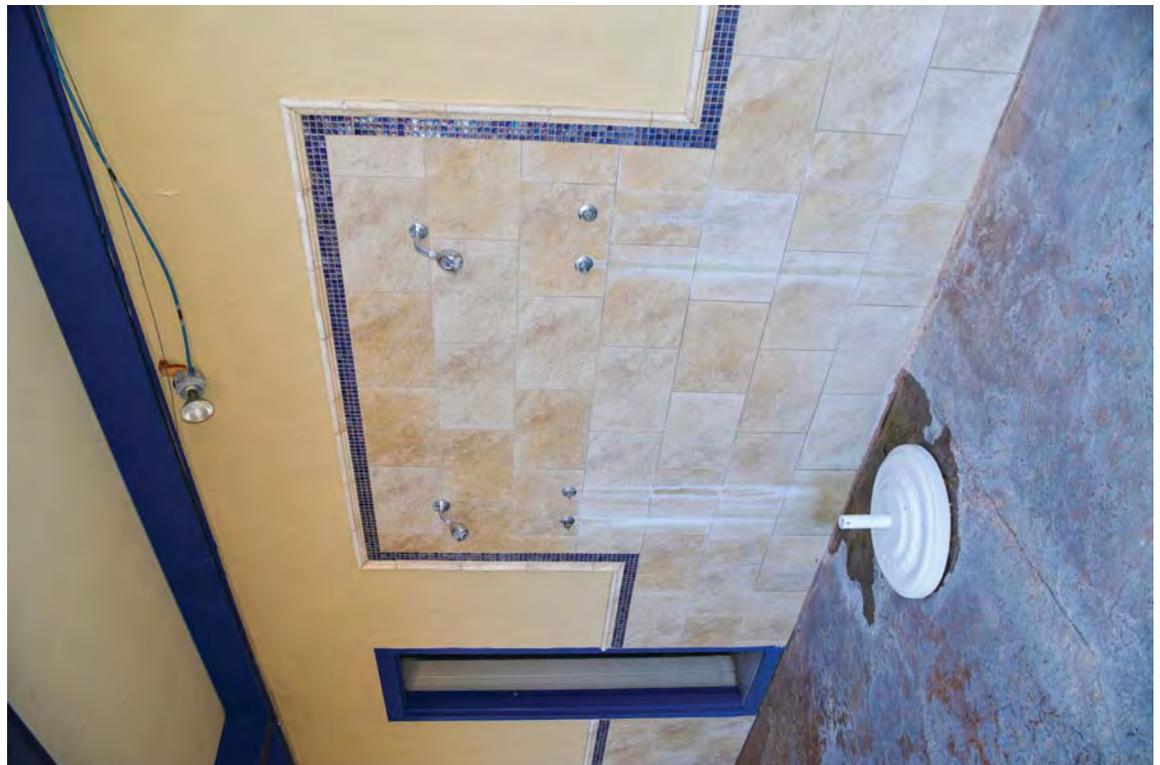
Name: Saint Anthony Hotel, 300 East Travis Street, San Antonio, Texas
View: Sixth floor pool terrace, looking northwest at Tower 4 south facade
Description: Exterior showers with mineral stained tile & cracked pool terrace deck
Date: September 2012

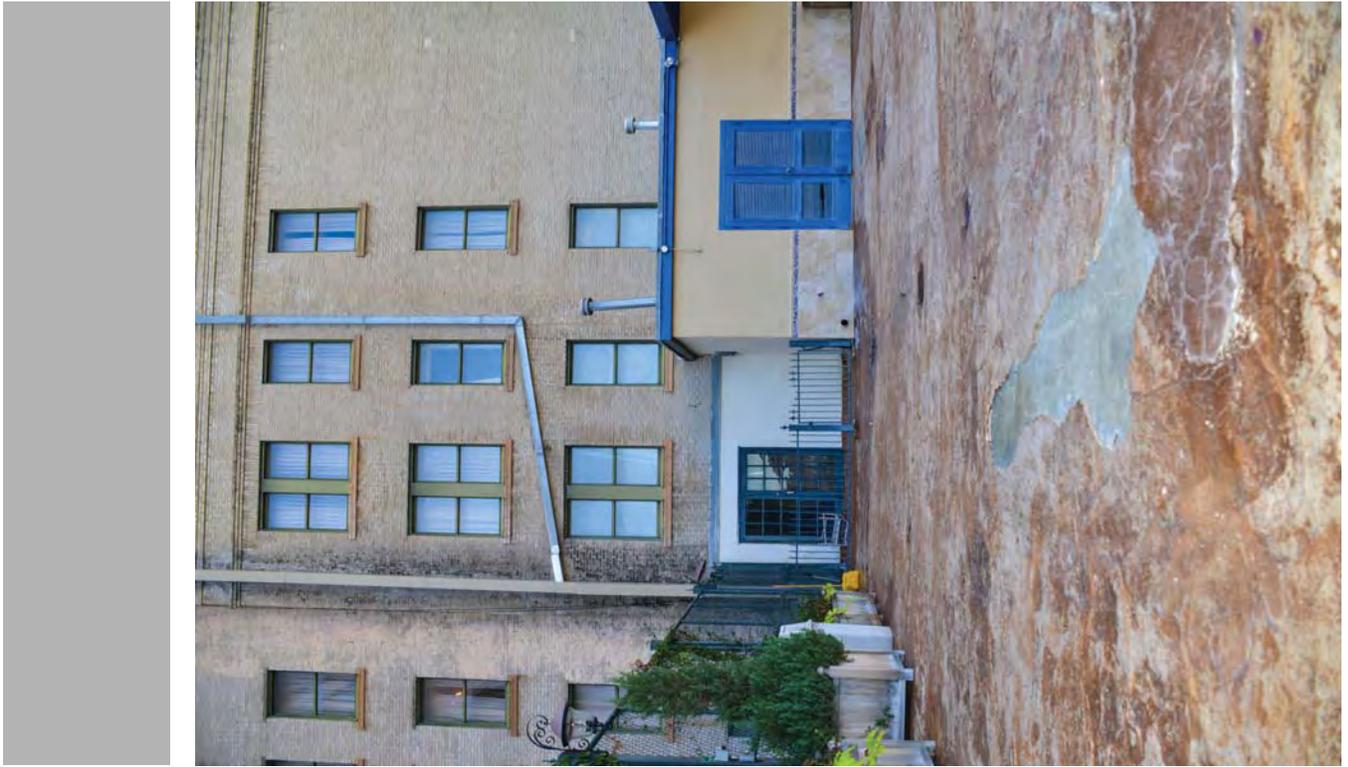
Name: Saint Anthony Hotel, 300 East Travis Street, San Antonio, Texas
View: Sixth floor pool terrace, looking north at Tower 4 south facade
Description: Mold and mineral stained masonry; cracked pool terrace
Date: September 2012

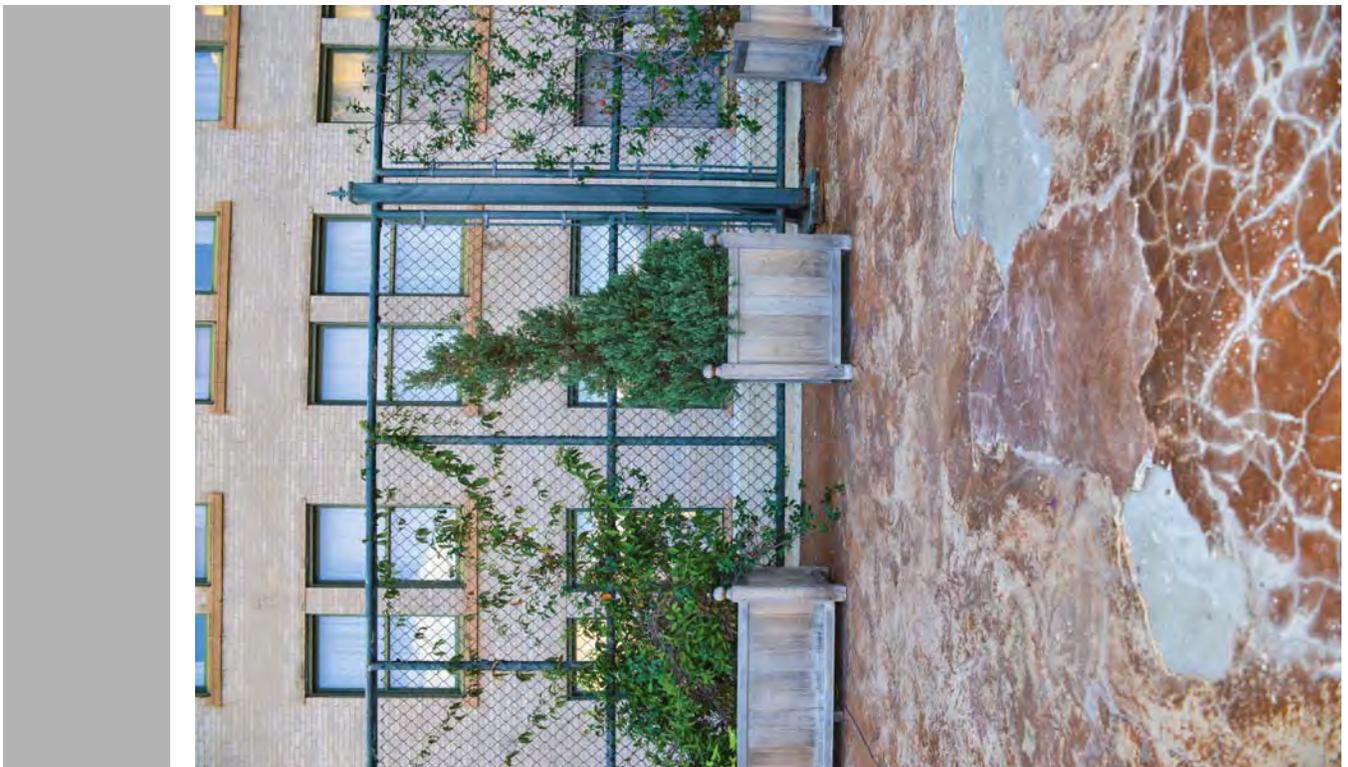
Name: Saint Anthony Hotel, 300 East Travis Street, San Antonio, Texas
View: Sixth floor pool terrace, looking west at Tower 3 east facade
Description: Cracked and spawling decking material & inappropriate scaled fencing
Date: September 2012

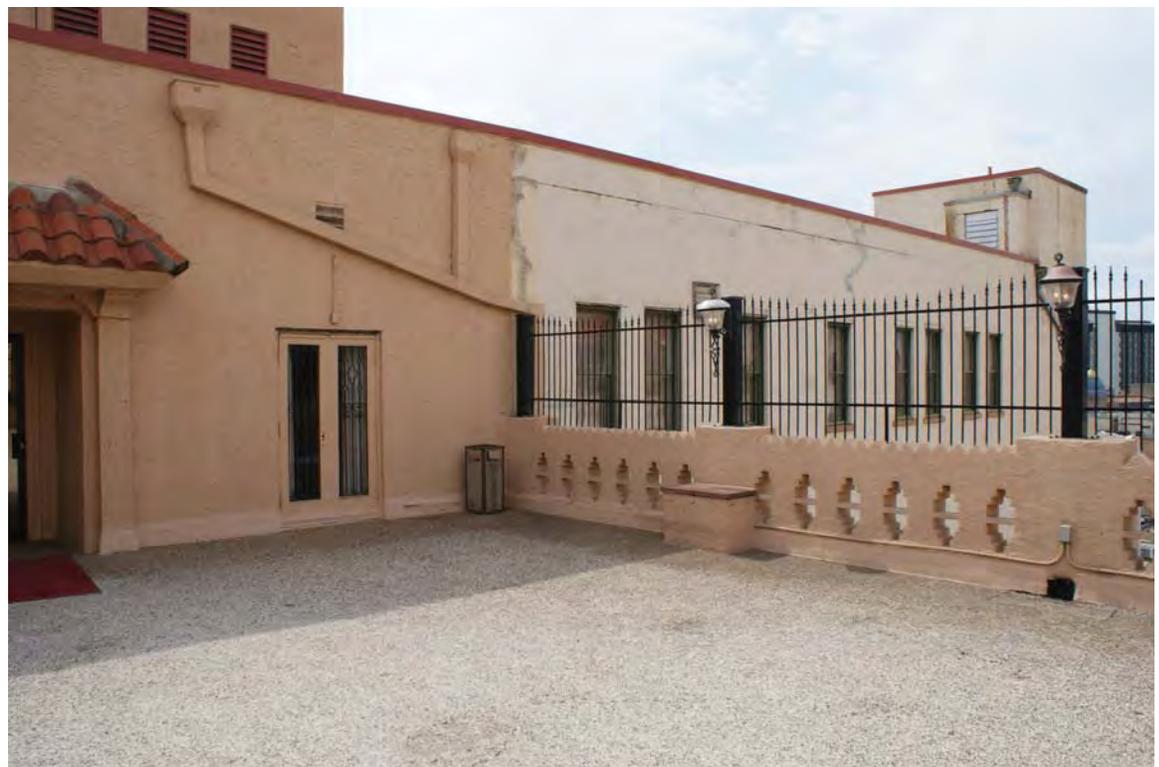
Name: Saint Anthony Hotel, 300 East Travis Street, San Antonio, Texas
View: Tenth floor Starlight Terrace, looking southeast at Tower 3 west facade
Description: Cracked and detaching masonry coating and stucco finish
Date: September 2012

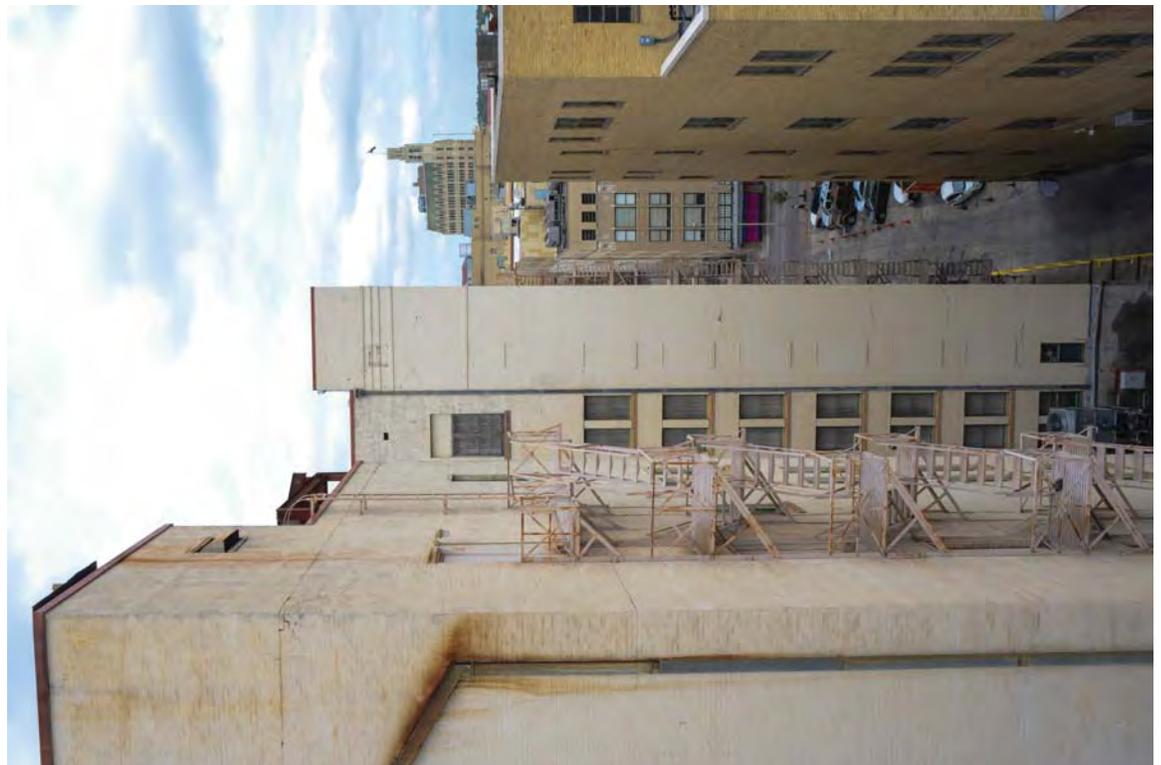
Name: Saint Anthony Hotel, 300 East Travis Street, San Antonio, Texas
View: Alley as seen from tenth floor Starlight Terrace, looking east
Description: Coated masonry with rust stains; Tower 2 fire escape
Date: September 2012

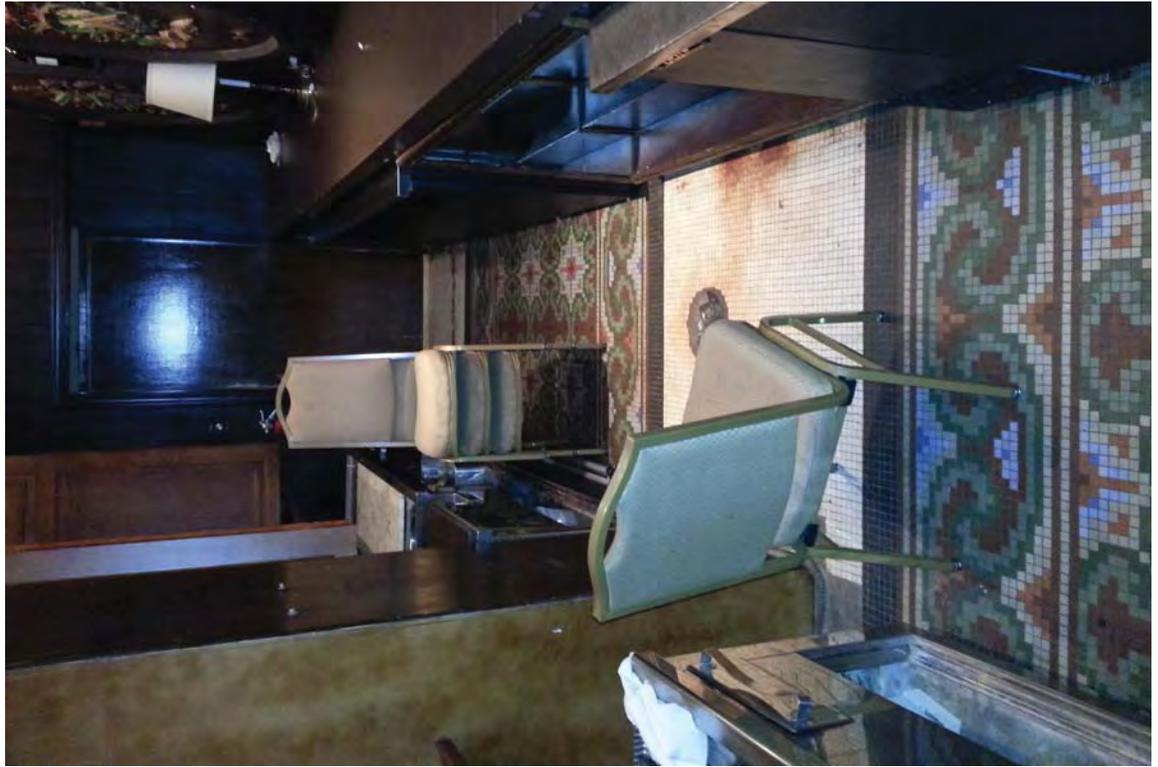
Name: Saint Anthony Hotel, 300 East Travis Street, San Antonio, Texas
View: First floor St. Anthony Club bar interior, looking south
Description: Historic tile flooring with dirt and mineral stains
Date: September 2012

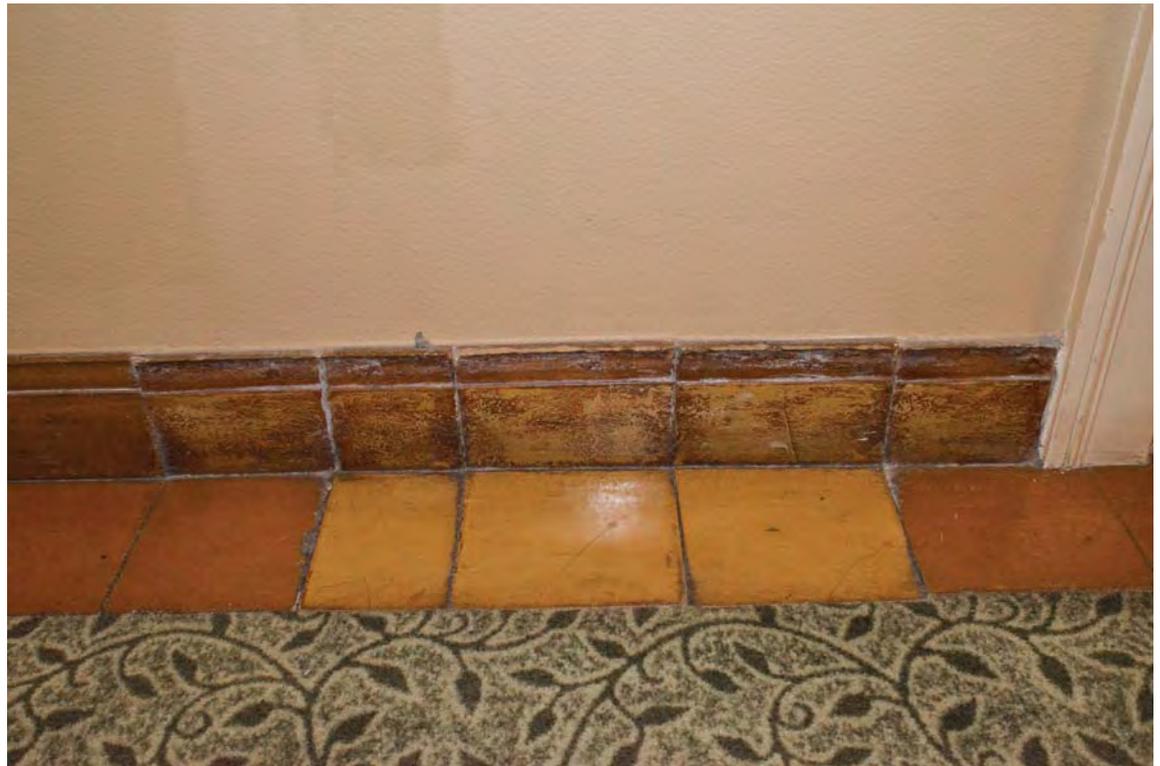
Name: Saint Anthony Hotel, 300 East Travis Street, San Antonio, Texas
View: Third floor corridor tile border and base detail
Description: Example of inconsistent replacement tiles at border and base
Date: September 2012

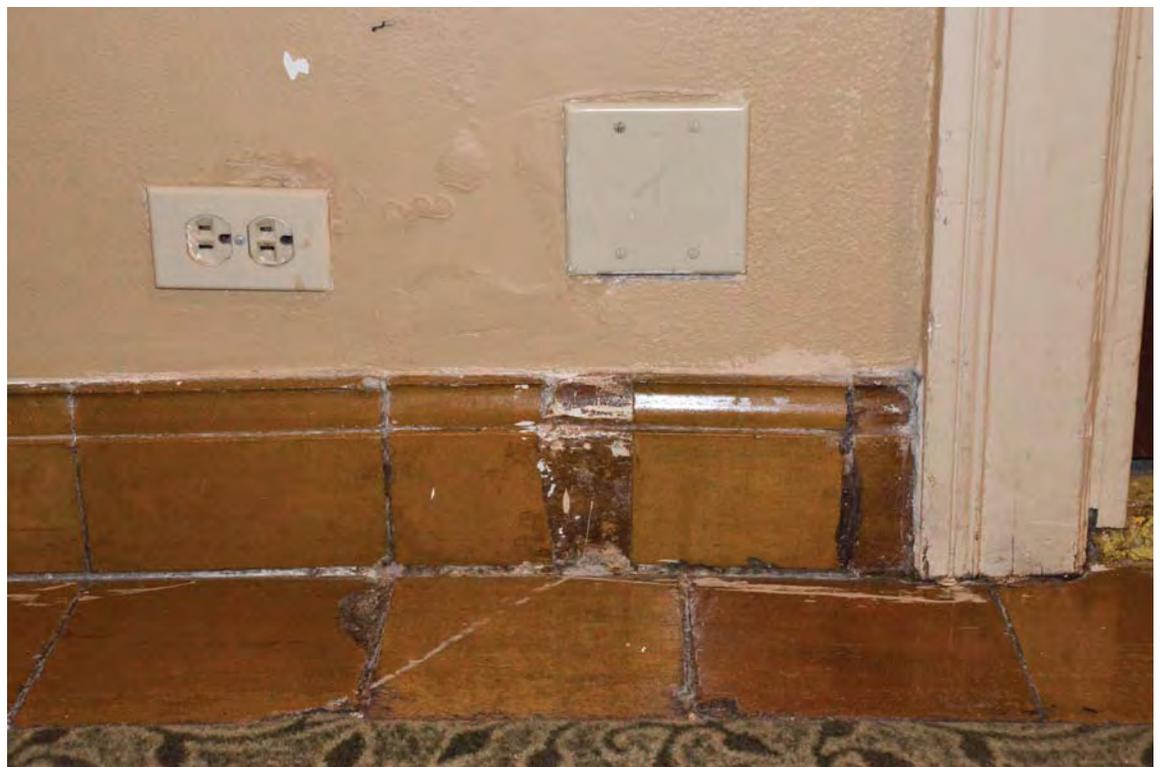
Name: Saint Anthony Hotel, 300 East Travis Street, San Antonio, Texas
View: Third floor corridor tile border and base detail
Description: Example of inept Dutchman repair of damaged tiles at border and base
Date: September 2012

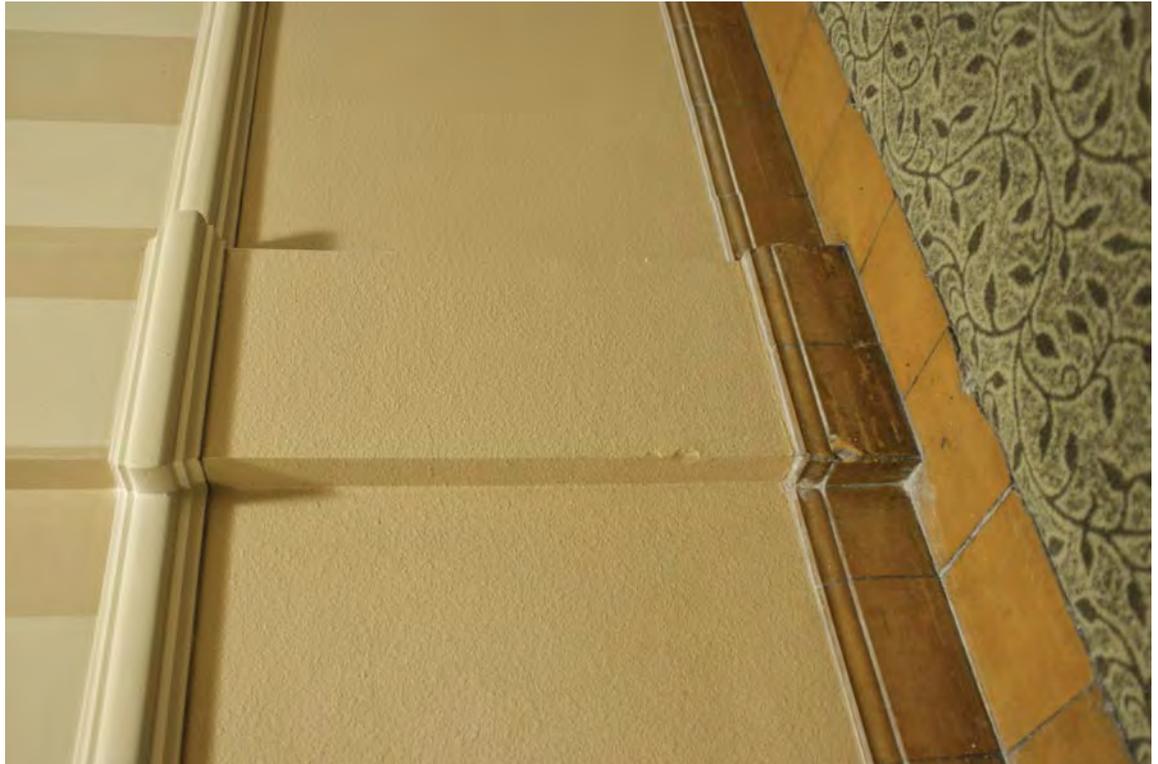
Name: Saint Anthony Hotel, 300 East Travis Street, San Antonio, Texas
View: Third floor corridor tile border and base detail
Description: Example of typical damage to tile base at projecting corners
Date: September 2012

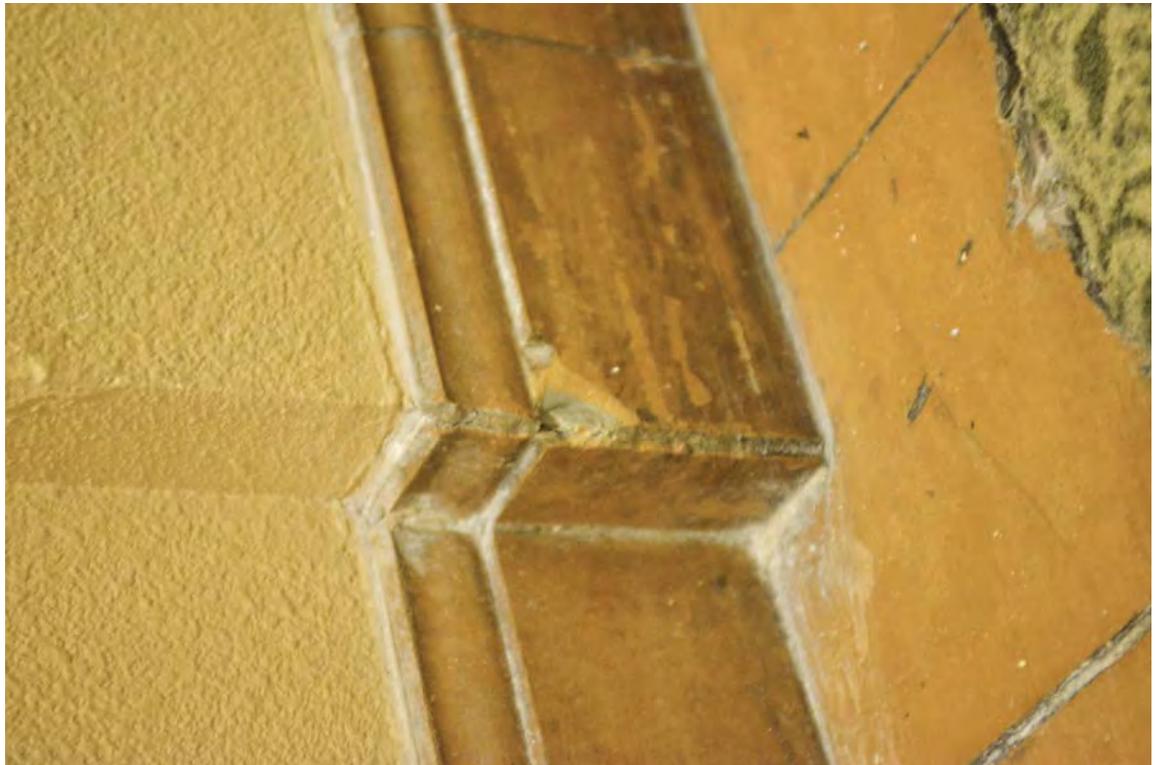
Name: Saint Anthony Hotel, 300 East Travis Street, San Antonio, Texas
View: Third floor corridor tile border and base detail
Description: Detail view of typical damage to tile base at projecting corners
Date: September 2012

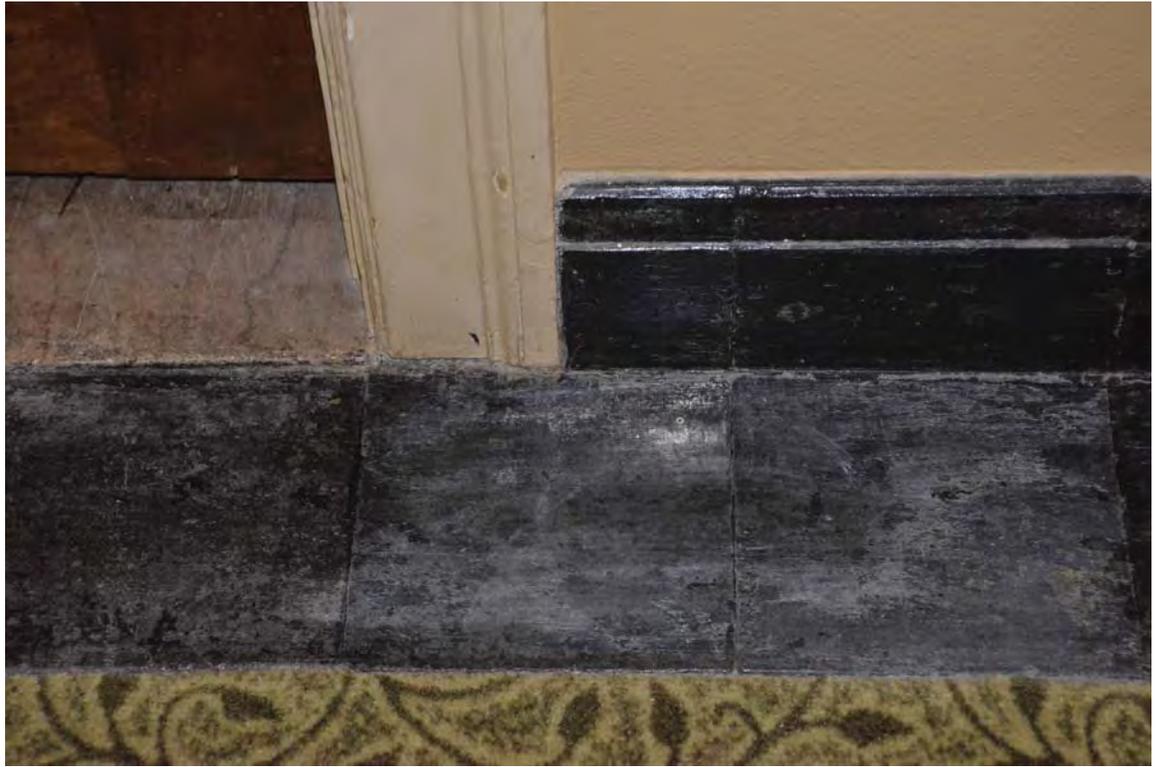
Name: Saint Anthony Hotel, 300 East Travis Street, San Antonio, Texas
View: Fourth and fifth floor corridor tile border and base detail
Description: Example of dirt, abrasion, wear and chemical staining to tile at door thresholds
Date: September 2012

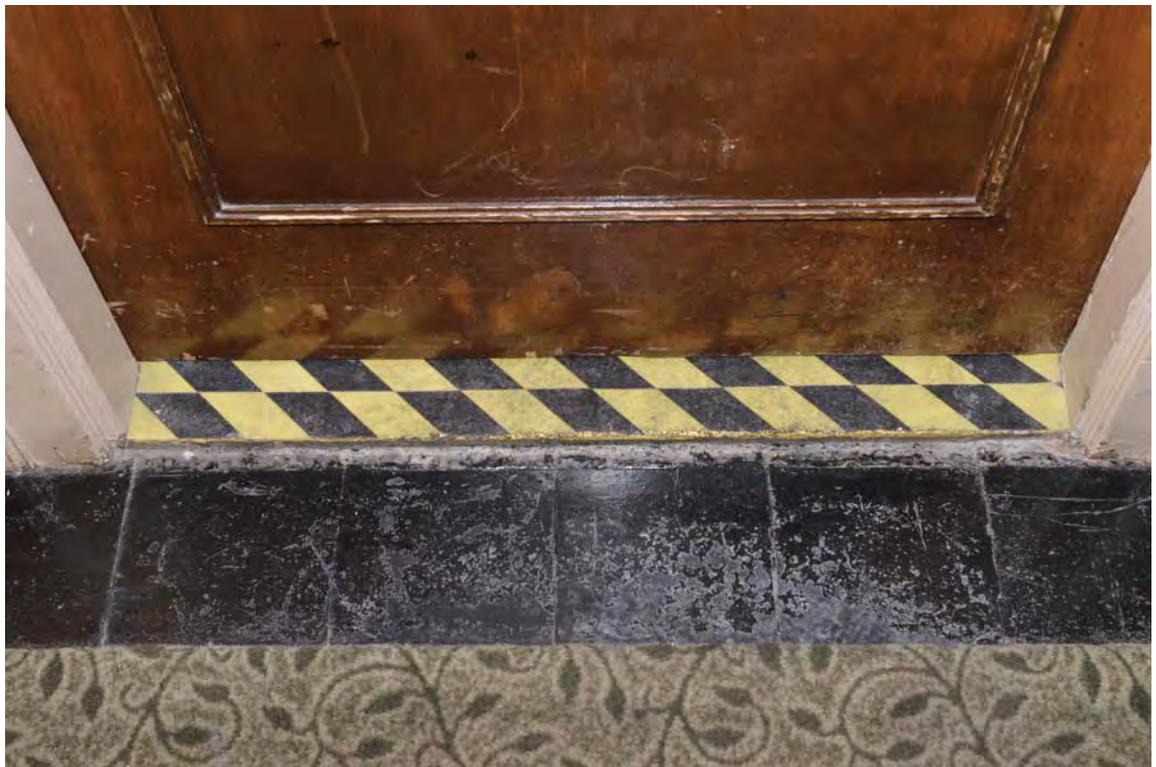
Name: Saint Anthony Hotel, 300 East Travis Street, San Antonio, Texas
View: Fourth and fifth floor corridor tile border and base detail
Description: Example of deep pitting, scratches, abrasion, & wear to tile at door thresholds
Date: September 2012

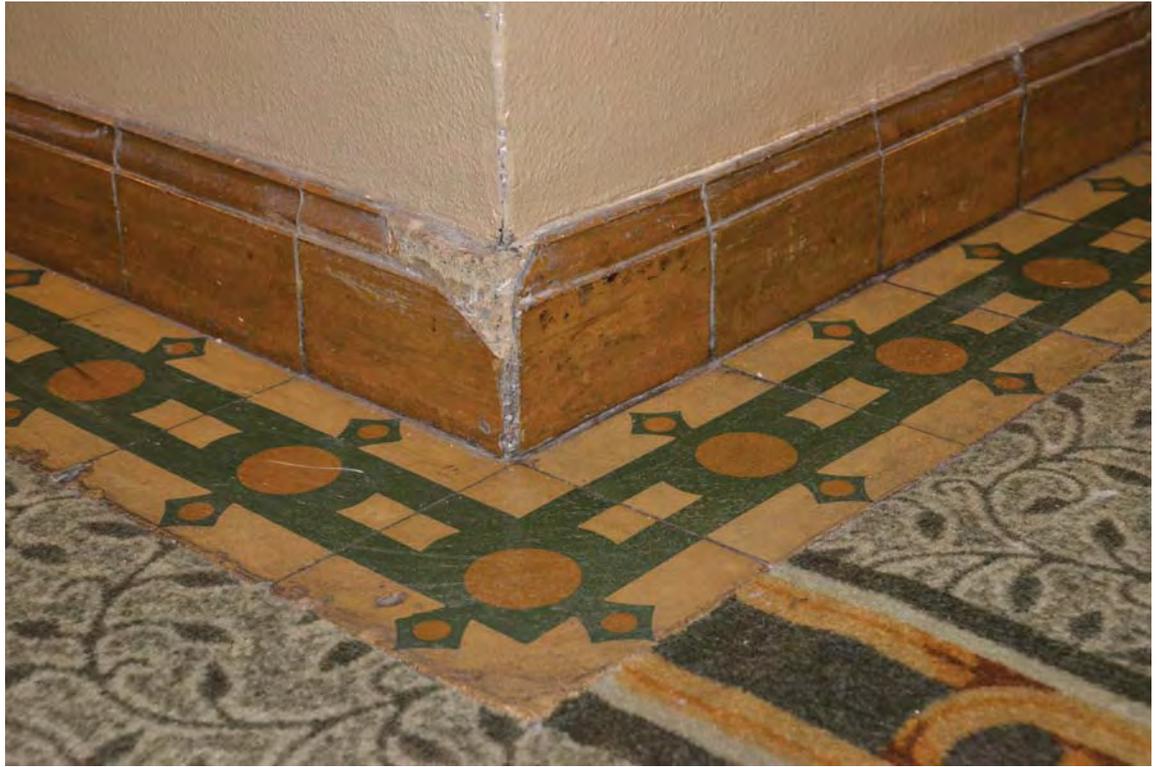
Name: Saint Anthony Hotel, 300 East Travis Street, San Antonio, Texas
View: Sixth floor corridor tile border and base detail
Description: Example of typical damage to tile base at projecting corners & chipped border
Date: September 2012

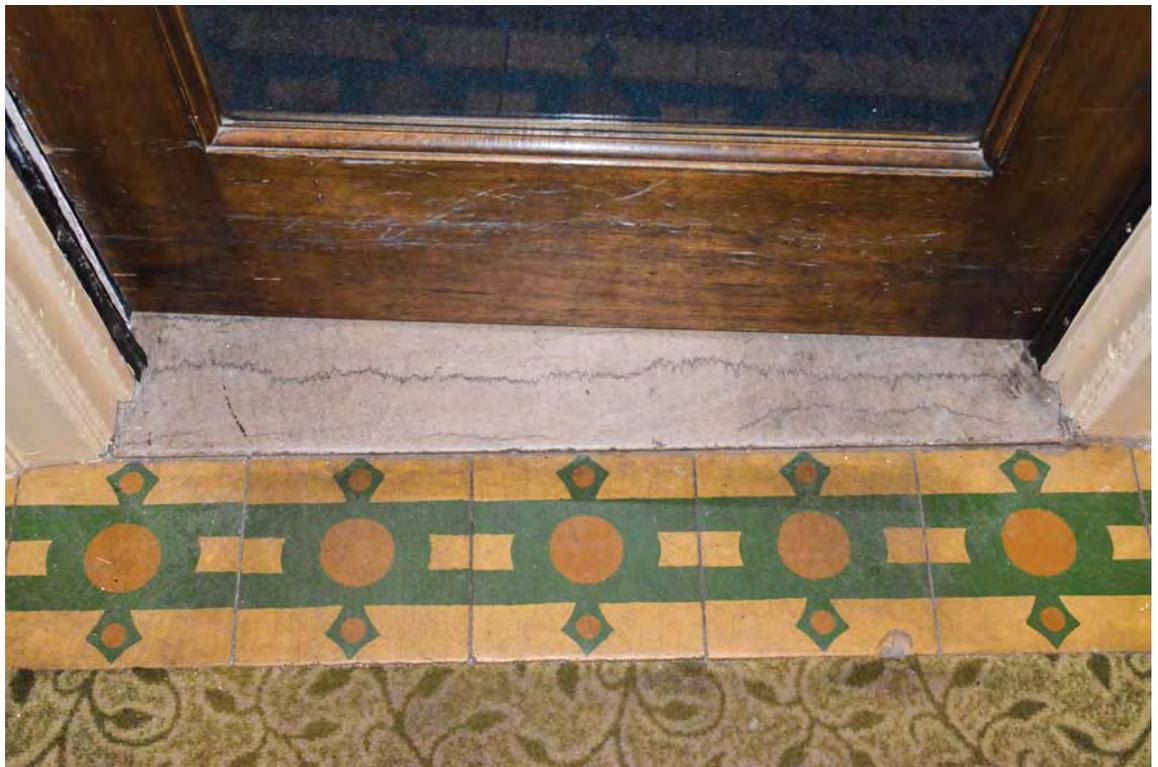
Name: Saint Anthony Hotel, 300 East Travis Street, San Antonio, Texas
View: Sixth floor corridor tile border and base detail
Description: Example of dirt, abrasion and wear to tile border at door thresholds
Date: September 2012

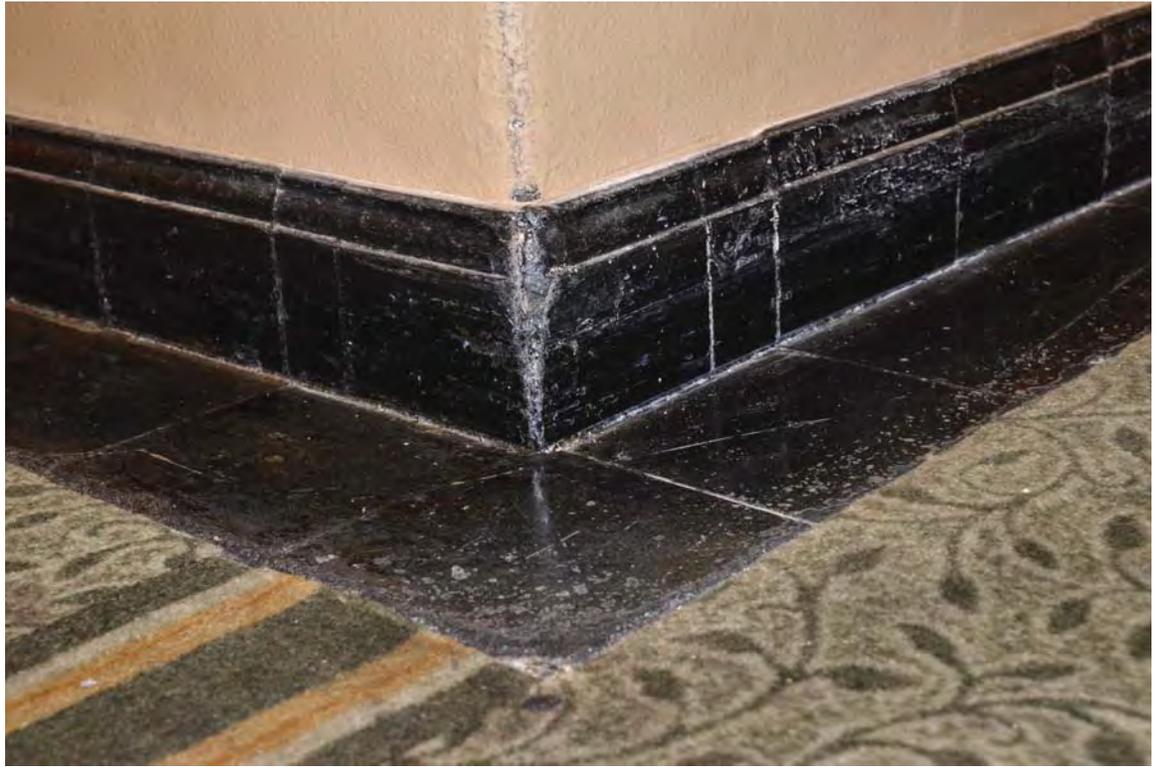
Name: Saint Anthony Hotel, 300 East Travis Street, San Antonio, Texas
View: Fourth and fifth floor corridor tile border and base detail
Description: Example of typical damage to tile base at projecting corners & pitted tile border
Date: September 2012

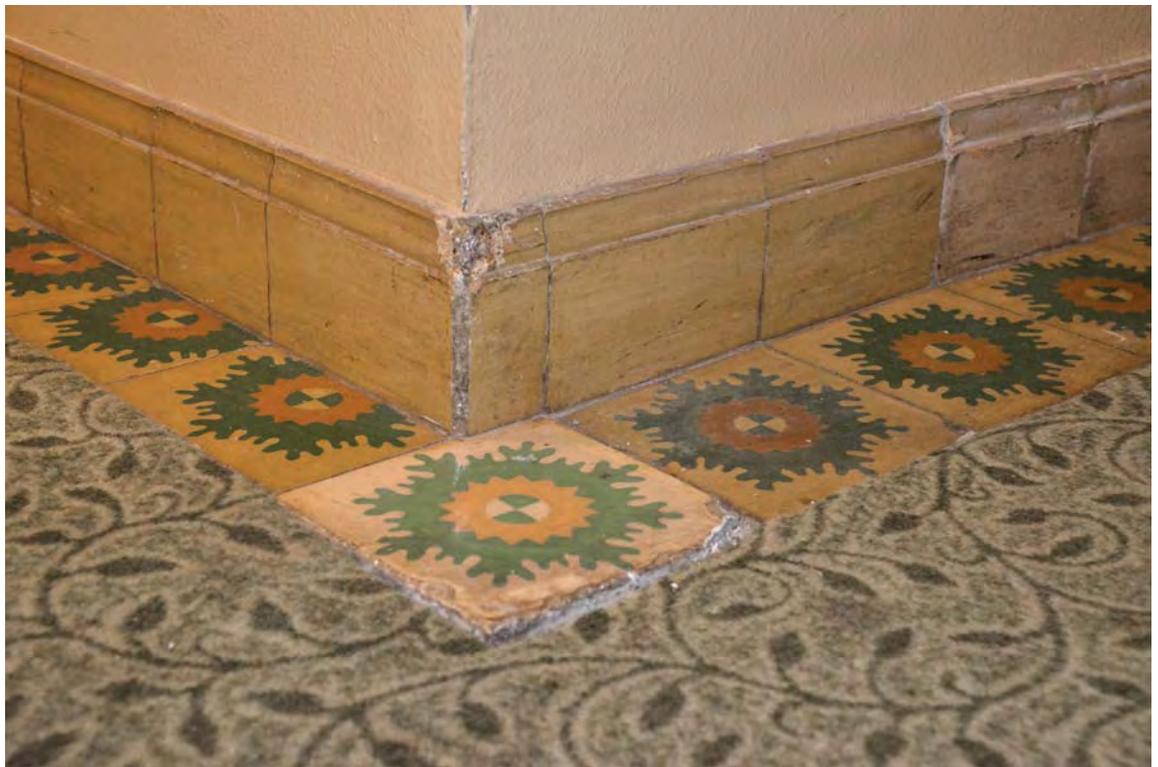
Name: Saint Anthony Hotel, 300 East Travis Street, San Antonio, Texas
View: Seventh and tenth floor corridor tile border and base detail
Description: Typical damage to tile base at projecting corners & replacement border tile
Date: September 2012

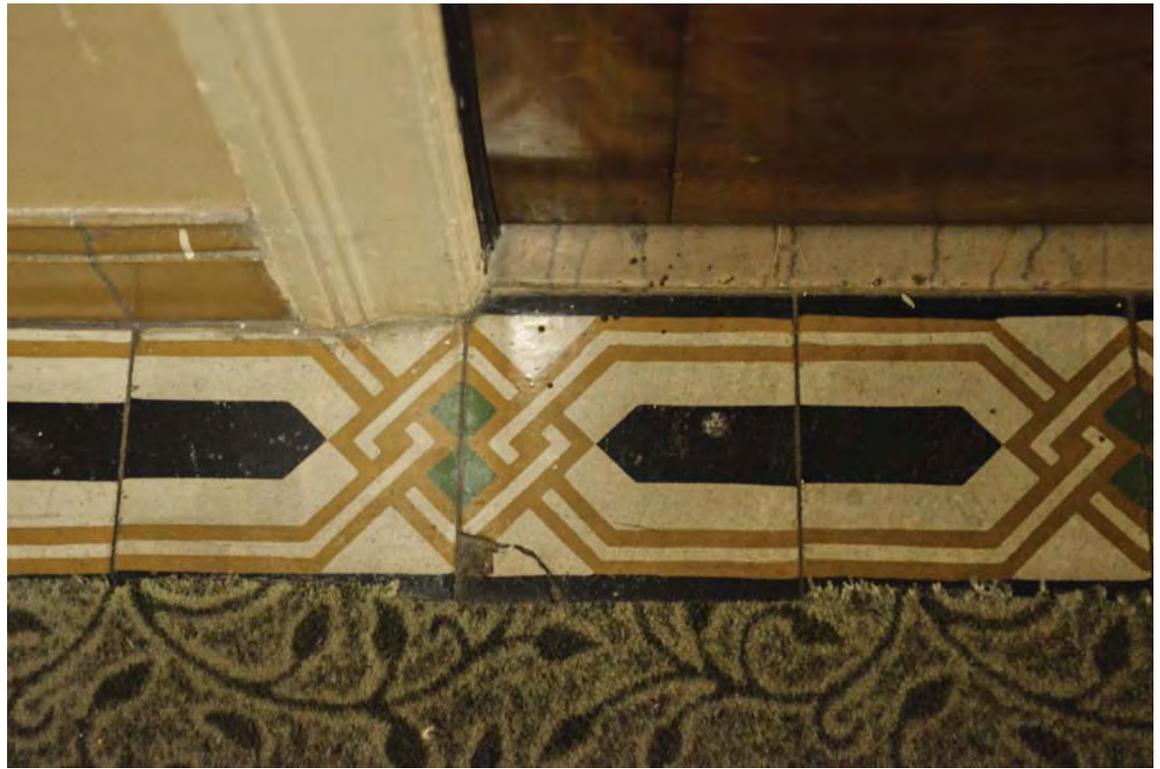
Name: Saint Anthony Hotel, 300 East Travis Street, San Antonio, Texas
View: Eighth and ninth floors corridor tile border and base detail
Description: Example of cracks, abrasion, & wear to tile at door thresholds
Date: September 2012

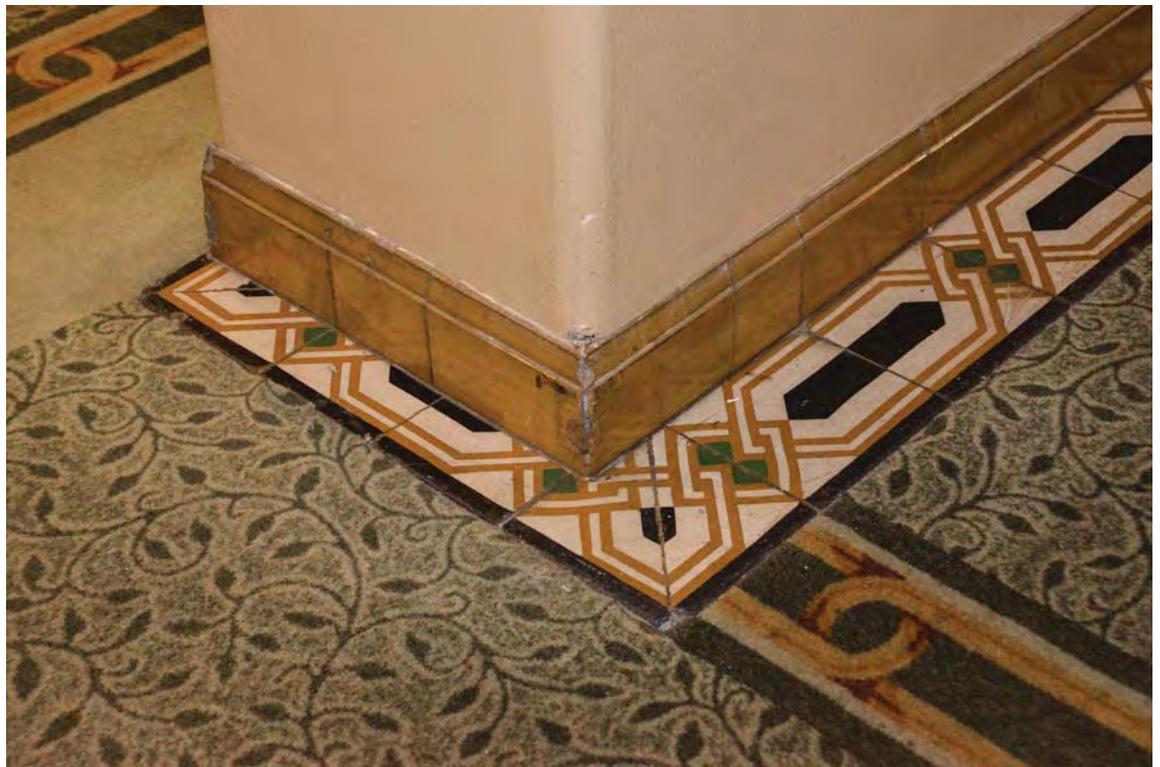
Name: Saint Anthony Hotel, 300 East Travis Street, San Antonio, Texas
View: Eighth and ninth floors corridor tile border and base detail
Description: Example of typical damage to tile base at projecting corners & tile border
Date: September 2012

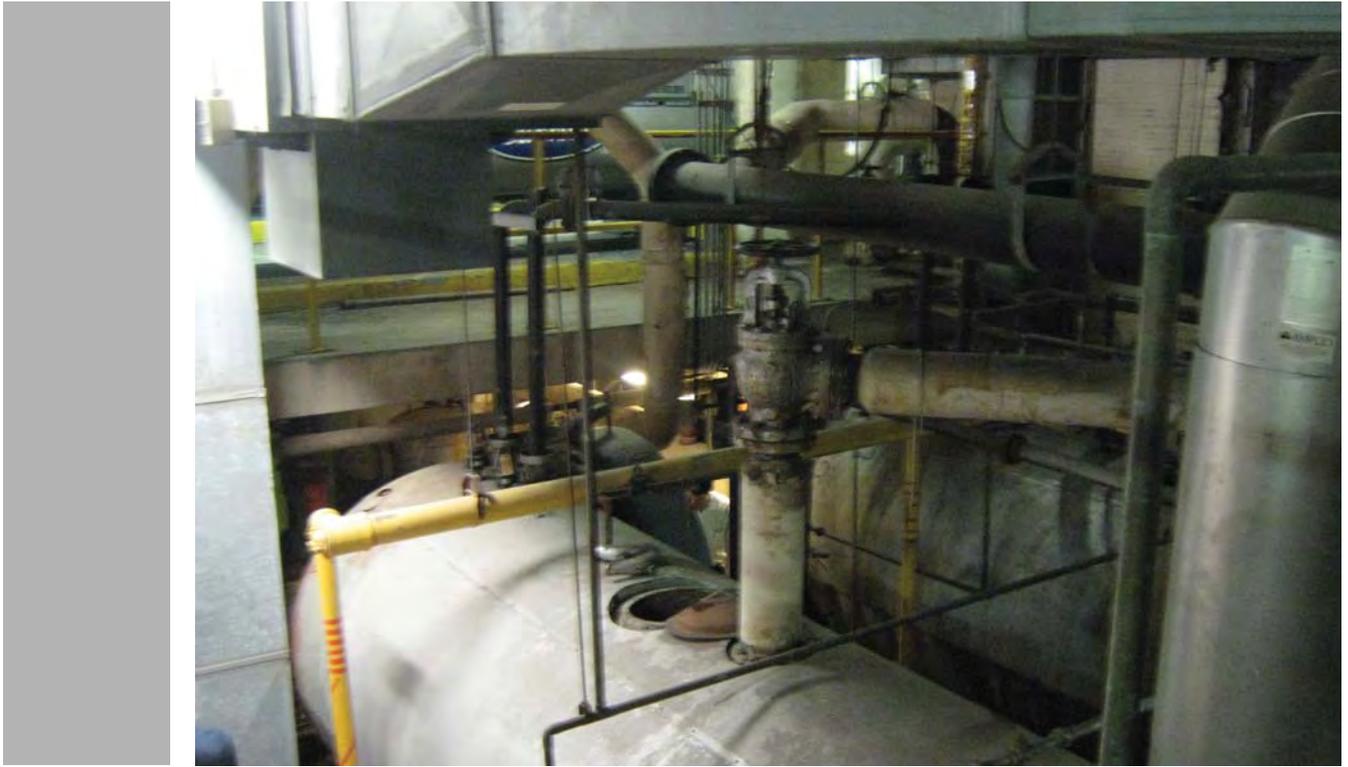
Name: Saint Anthony Hotel, 300 East Travis Street, San Antonio, Texas
View: Basement level boiler room
Description: Defunct mechanical equipment to be replaced or modernized
Date: September 2012

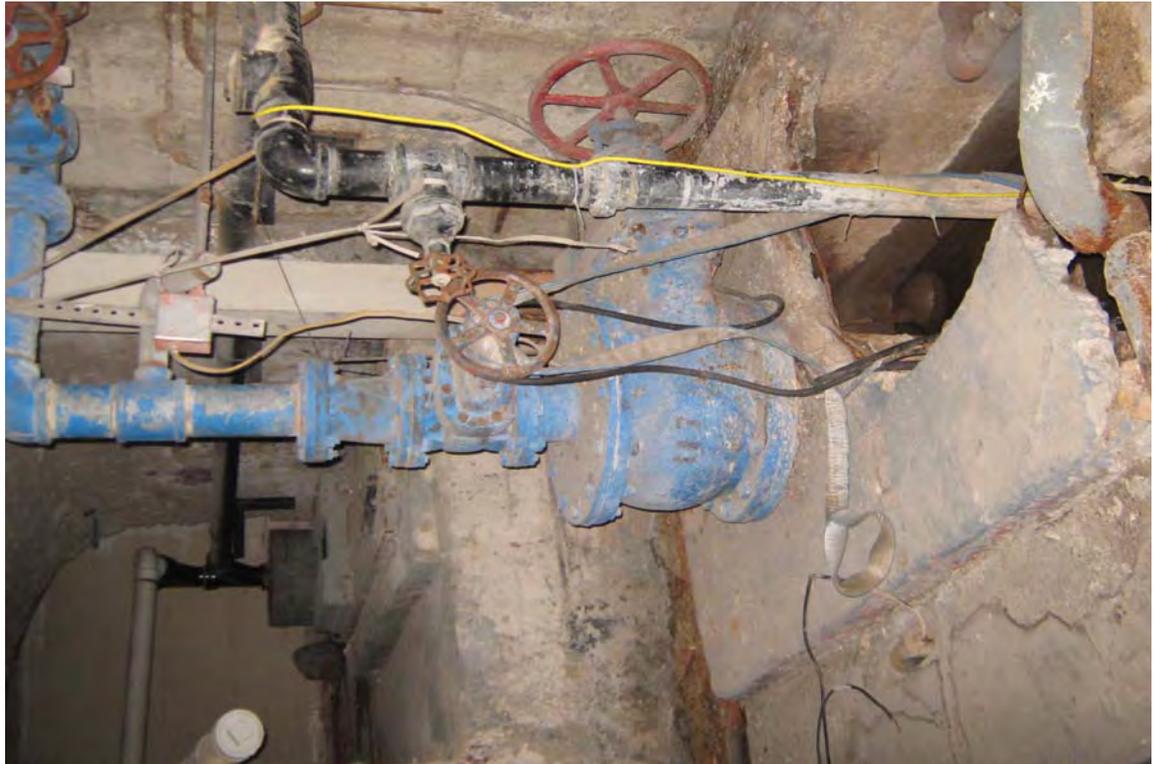
Name: Saint Anthony Hotel, 300 East Travis Street, San Antonio, Texas
View: Basement level mechanical room
Description: Deteriorated concrete slab at mechanical piping
Date: September 2012

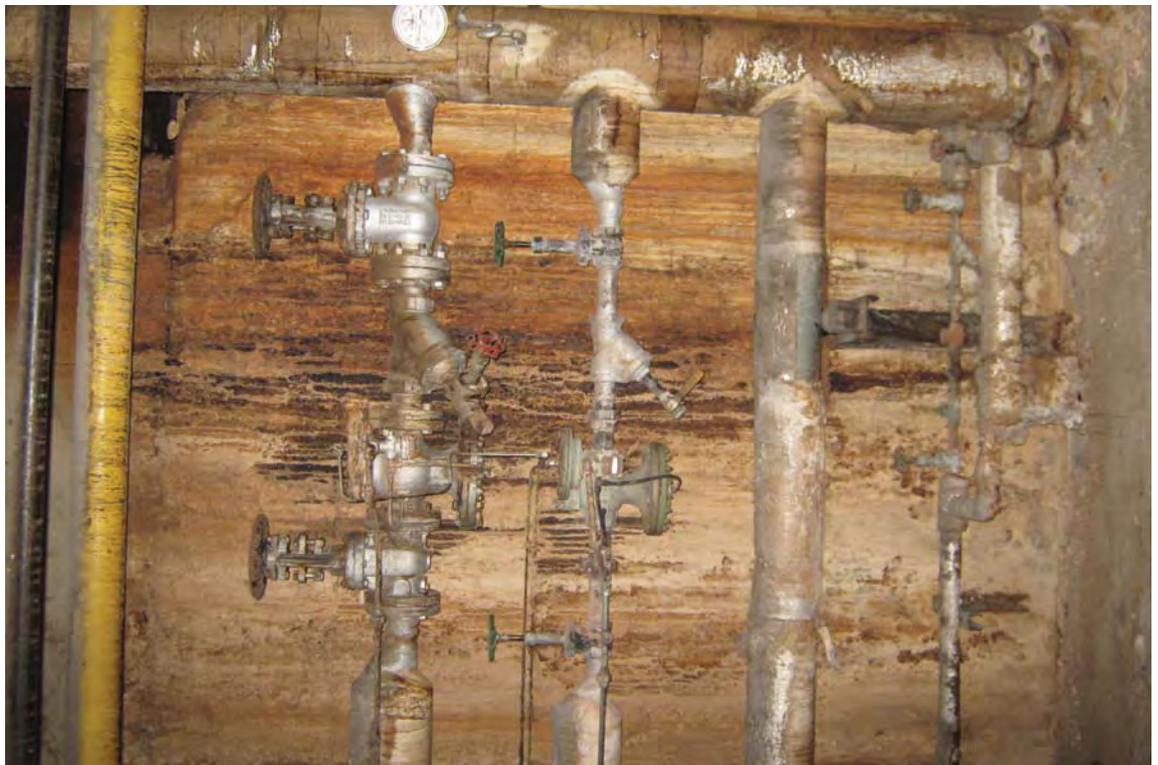
Name: Saint Anthony Hotel, 300 East Travis Street, San Antonio, Texas
View: Basement level mechanical room
Description: Typical stained and dirty concrete walls and floors throughout basement
Date: September 2012

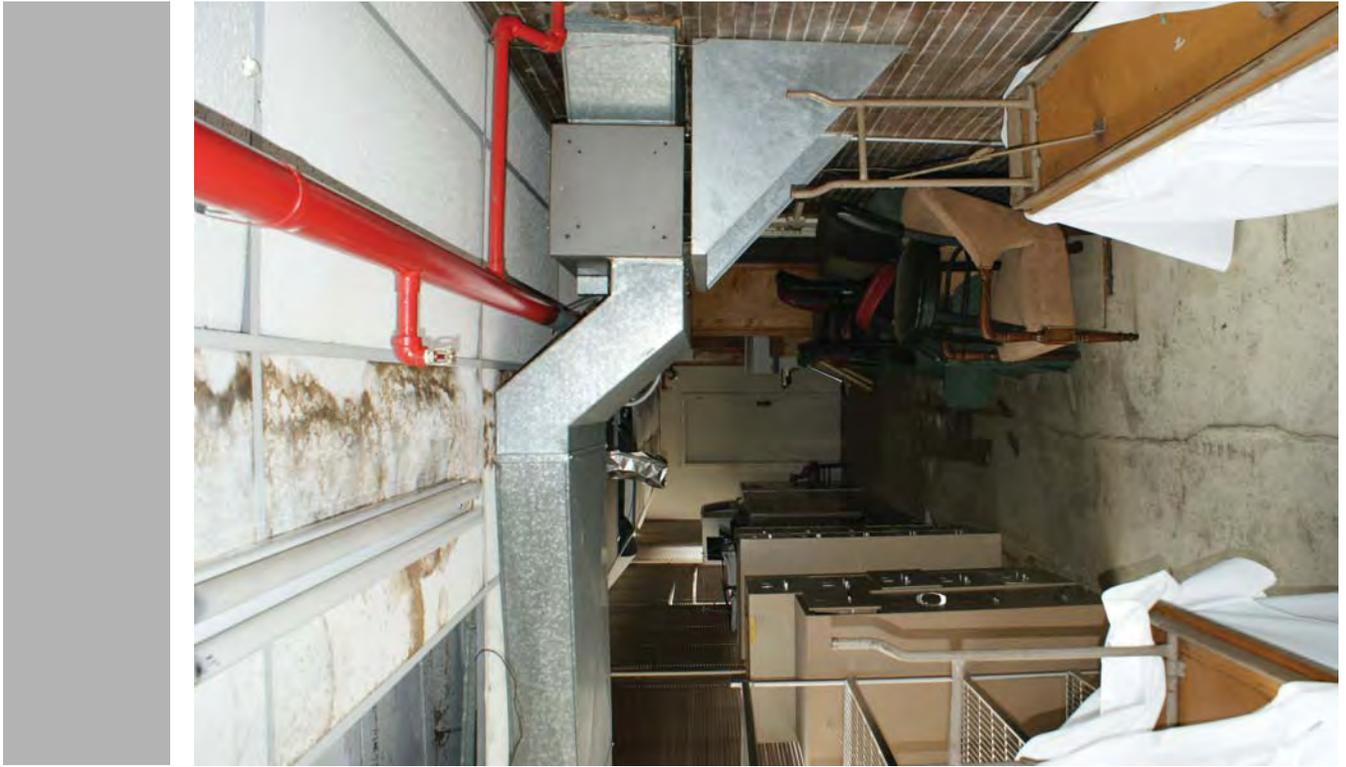
Name: Saint Anthony Hotel, 300 East Travis Street, San Antonio, Texas
View: Mezzanine level at terrace above Navarro Street arcade
Description: Mechanical ductwork, fire suppression piping, and lay-in ceiling to be removed
Date: September 2012

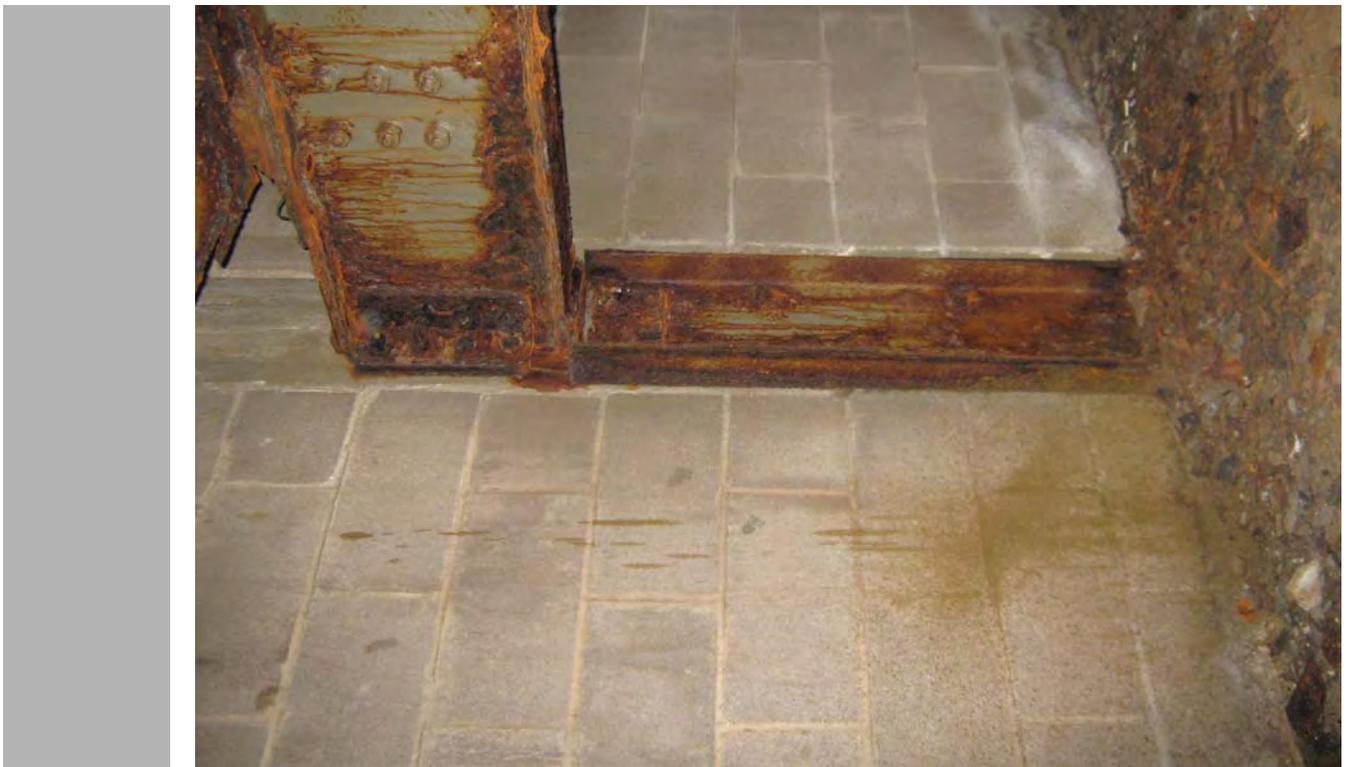
Name: Saint Anthony Hotel, 300 East Travis Street, San Antonio, Texas
View: Fifth floor level in parking garage
Description: Corroded structural steel supporting sixth floor swimming pool above
Date: September 2012
