HISTORIC AND DESIGN REVIEW COMMISSION

HDRC CASE NO: 2016-016
ADDRESS: 304 E TRAVIS ST
LEGAL DESCRIPTION: NCB 415 BLK 18 LOT A-7, A- 8, A-9, P-100, P-101 & P-102
ZONING: D HE
CITY COUNCIL DIST.: 1
LANDMARK: St Anthony Hotel
APPLICANT: Brandon Raney
OWNER: BCL St. Anthony ML, LP
TYPE OF WORK: Tax Certification
REQUEST:

RE: St. Anthony Hotel Tax Certification Application

St. Anthony Hotel
Scope Summary of Exterior Rehabilitation

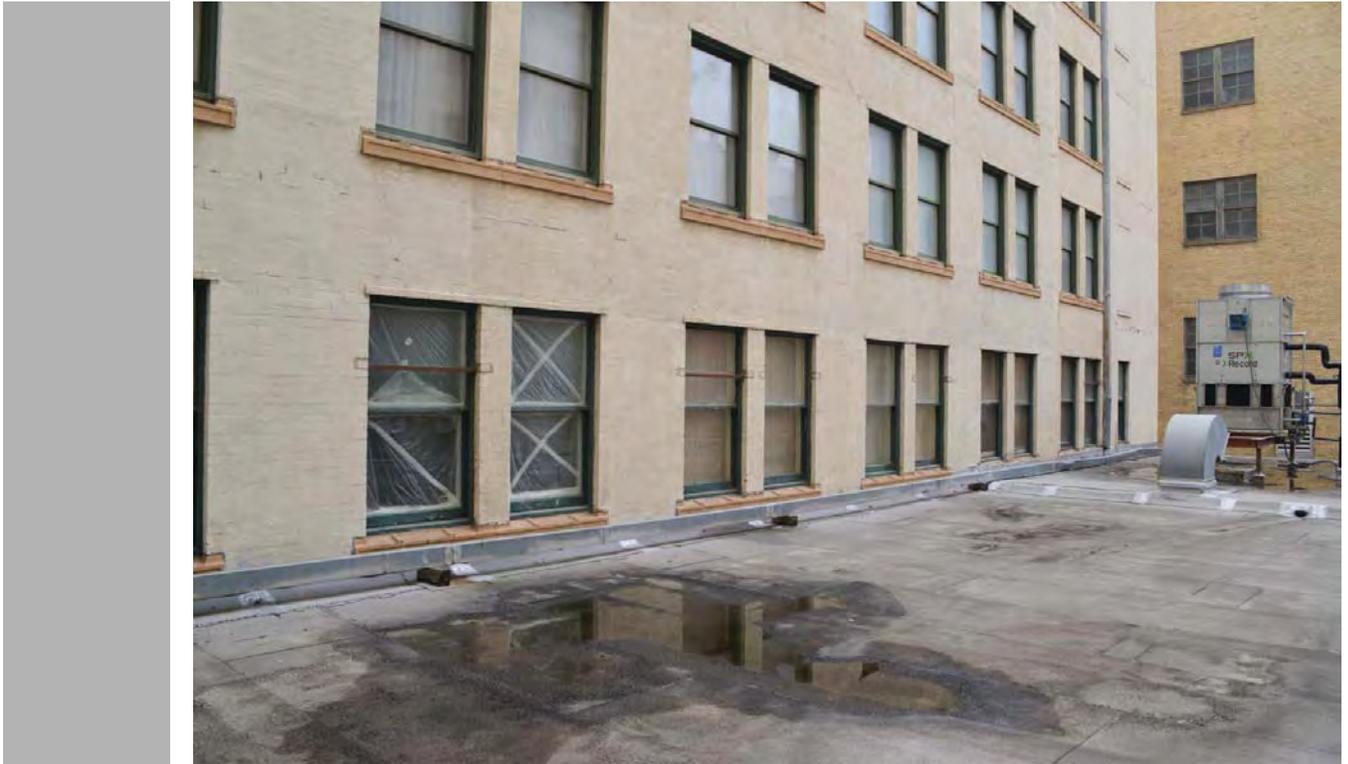
Name: Saint Anthony Hotel, 300 East Travis Street, San Antonio, Texas
View: Roof above Mezzanine between Towers 2 & 3, looking southeast
Description: Deteriorated wood windows to be rehabilitated; roof repairs/replacement
Date: November 2012

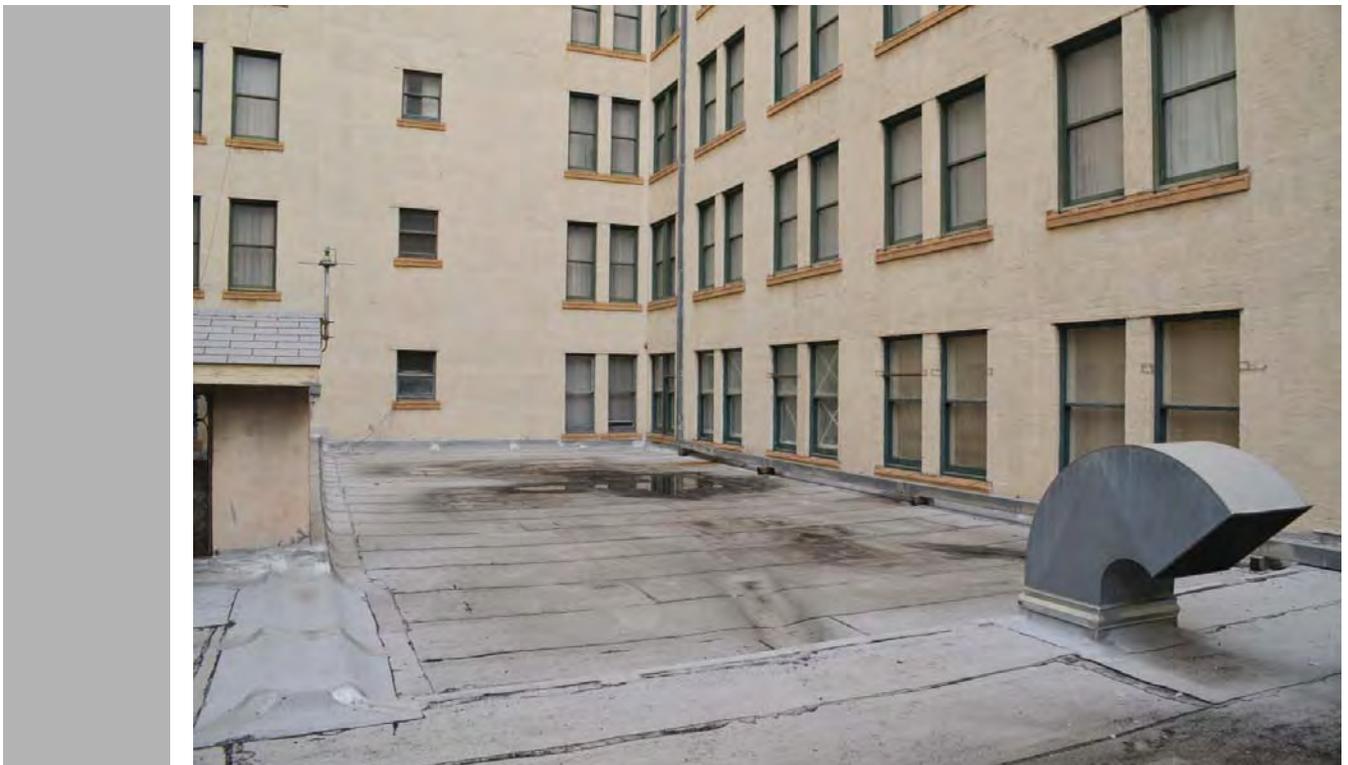
Name: Saint Anthony Hotel, 300 East Travis Street, San Antonio, Texas
View: Roof above Mezzanine between Towers 2 & 3, looking northeast
Description: Deteriorated wood windows to be rehabilitated; roof repairs/replacement
Date: November 2012

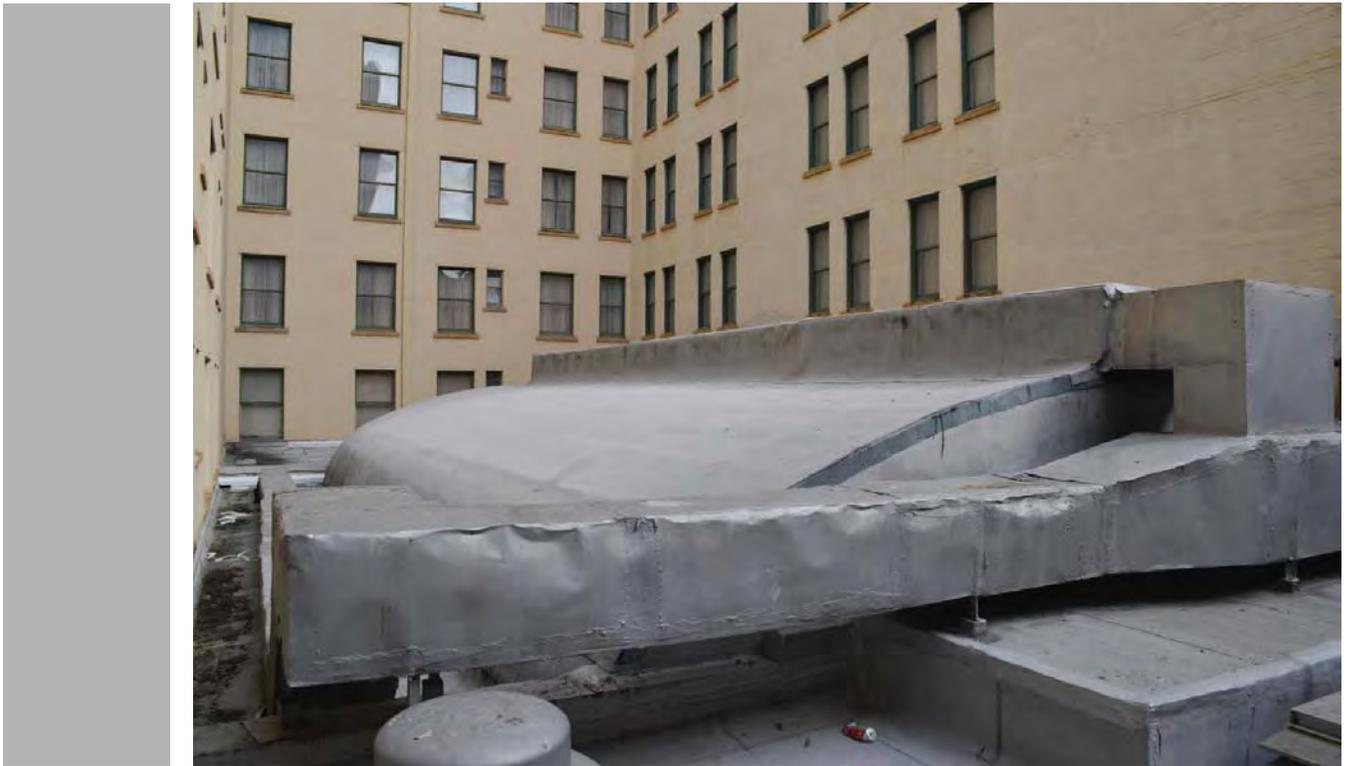
Name: Saint Anthony Hotel, 300 East Travis Street, San Antonio, Texas
View: Roof above Mezzanine between Towers 1 & 2, looking northeast
Description: Deteriorated wood windows to be rehabilitated; roof repairs/replacement
Date: November 2012

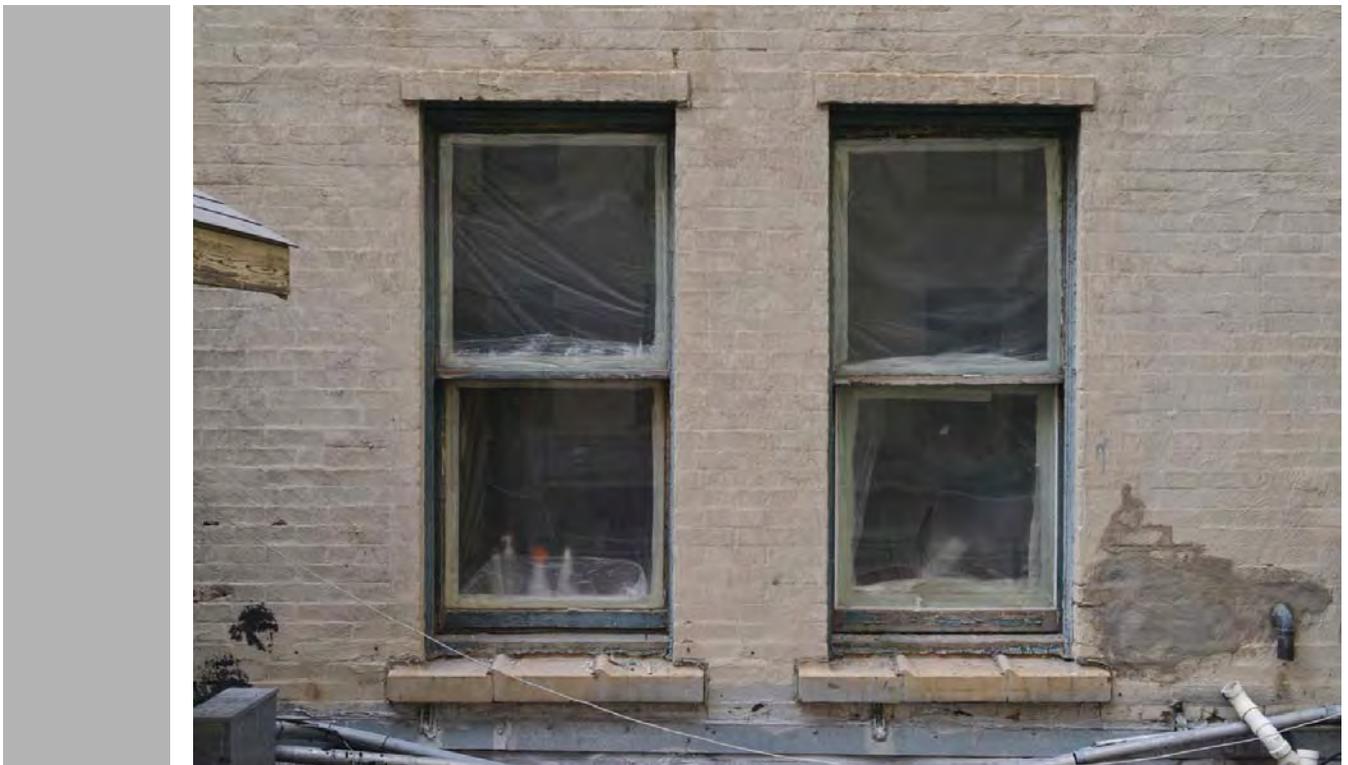
Name: Saint Anthony Hotel, 300 East Travis Street, San Antonio, Texas
View: Typical wood windows at Third Level
Description: Deteriorated wood window to be rehabilitated; masonry cleaned
Date: November 2012

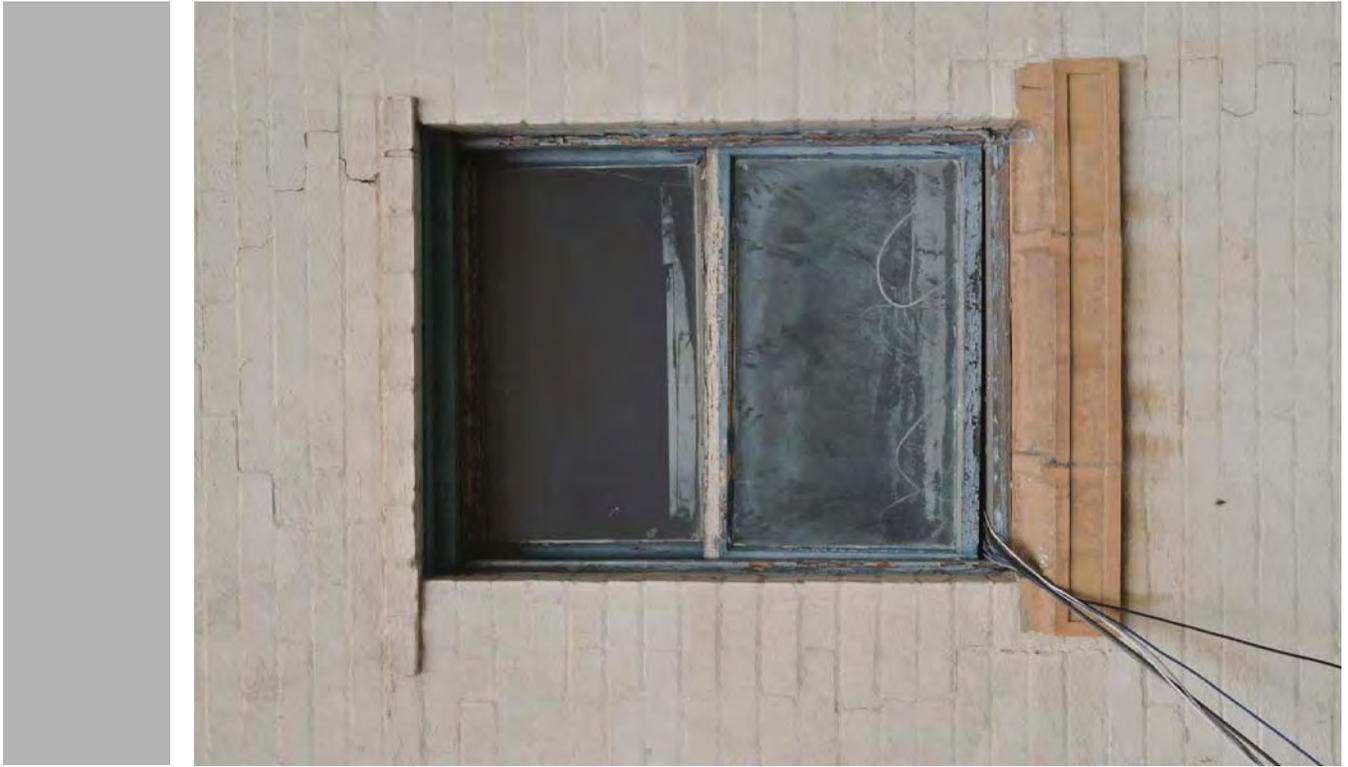
Name: Saint Anthony Hotel, 300 East Travis Street, San Antonio, Texas
View: Typical wood window at Third Level
Description: Deteriorated wood window to be rehabilitated; masonry cleaned
Date: November 2012

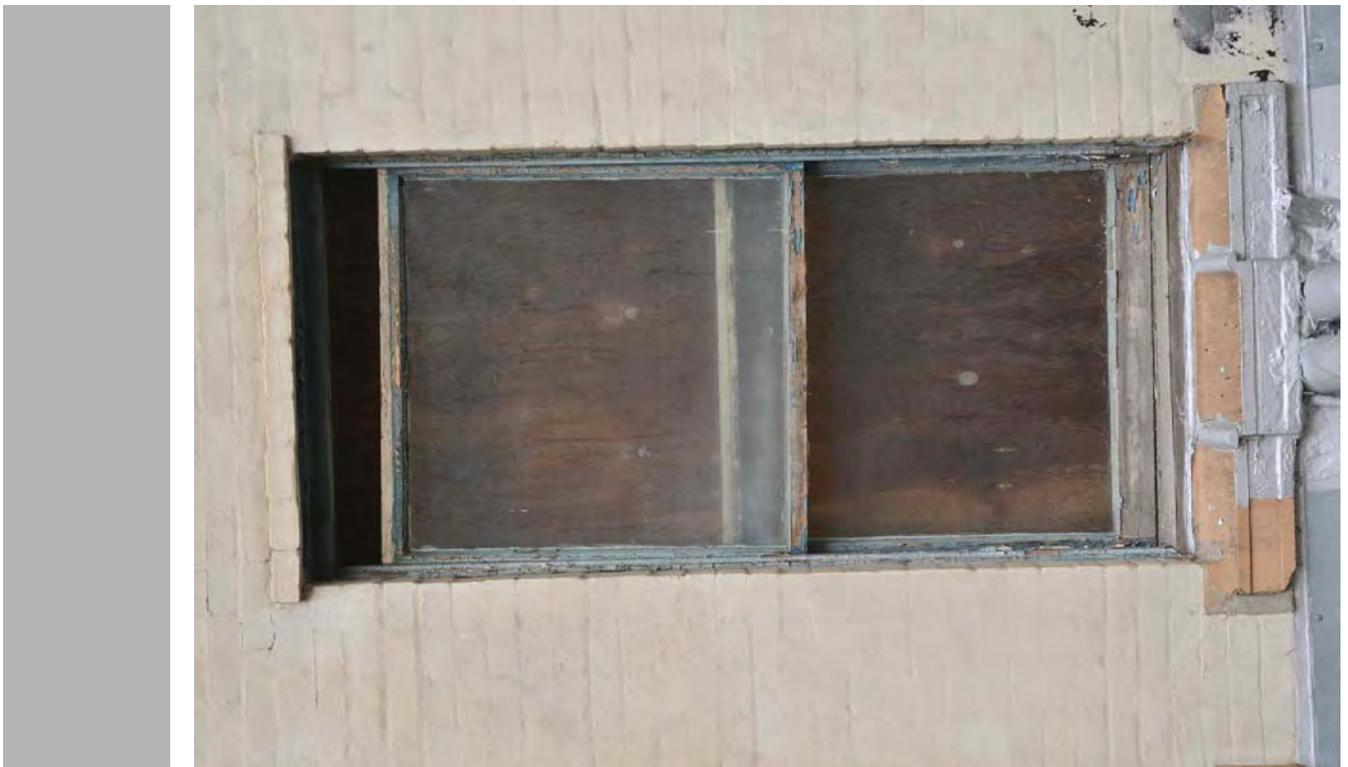
Name: Saint Anthony Hotel, 300 East Travis Street, San Antonio, Texas
View: Typical wood window at Third Level
Description: Deteriorated wood window to be rehabilitated; masonry cleaned
Date: November 2012

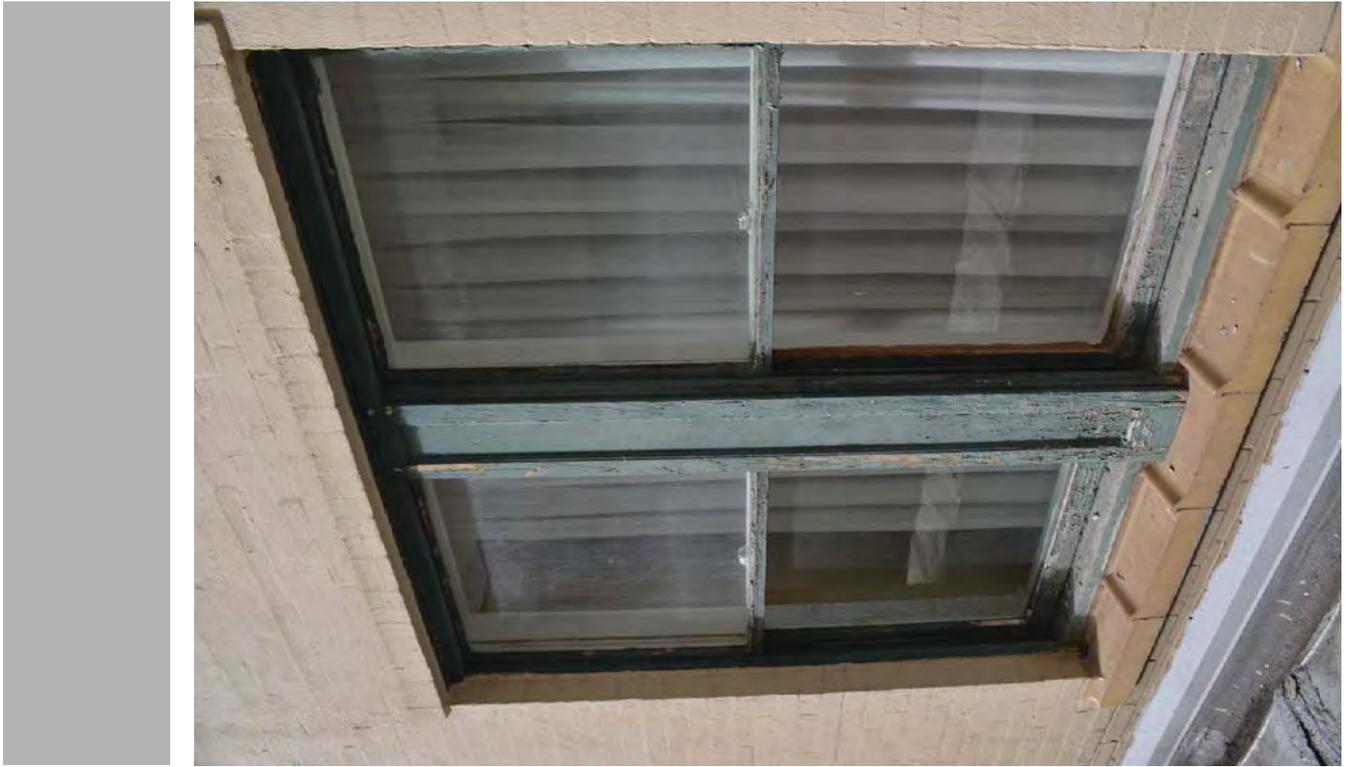
Name: Saint Anthony Hotel, 300 East Travis Street, San Antonio, Texas
View: Typical pair of wood windows at Third Level with central wood mull panel
Description: Deteriorated wood windows to be rehabilitated; masonry cleaned
Date: November 2012

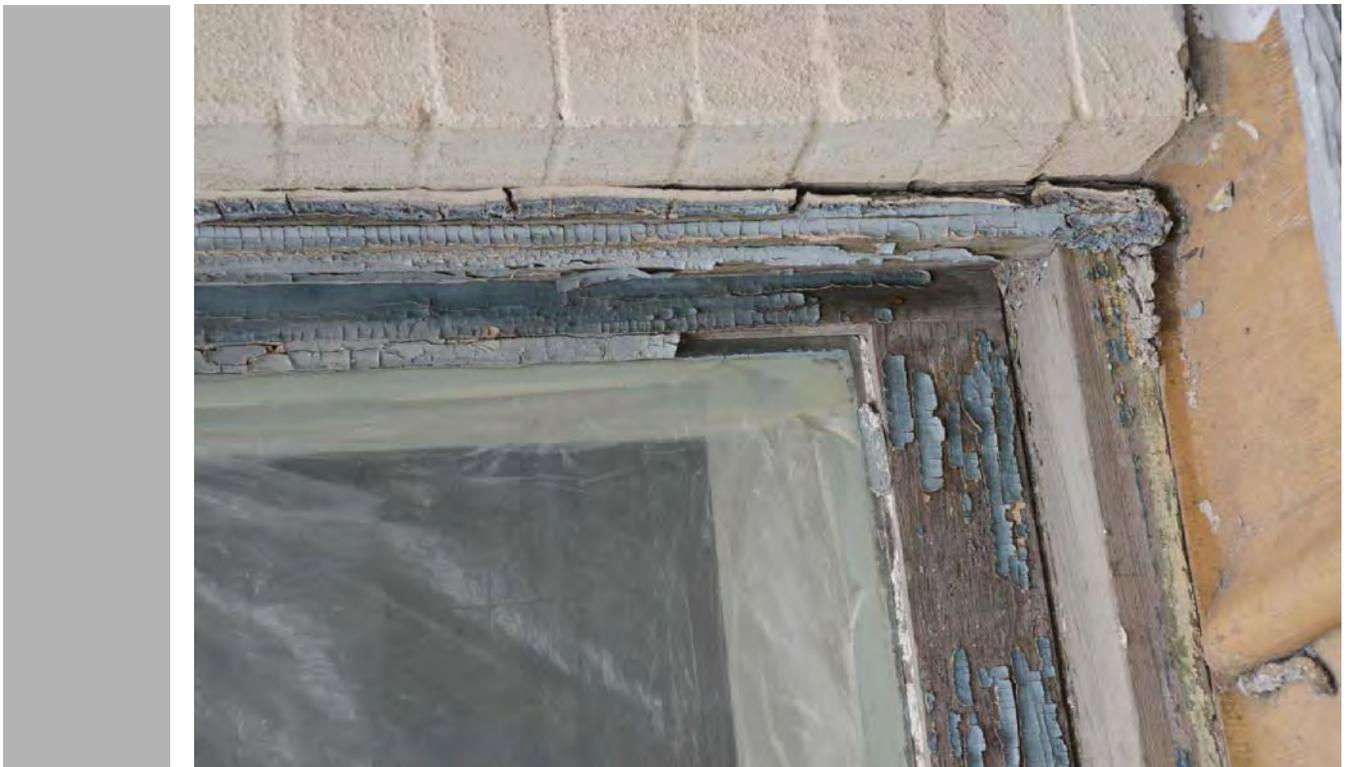
Name: Saint Anthony Hotel, 300 East Travis Street, San Antonio, Texas
View: Detail view of typical wood window at Third Level
Description: Deteriorated wood windows to be rehabilitated; masonry cleaned
Date: November 2012

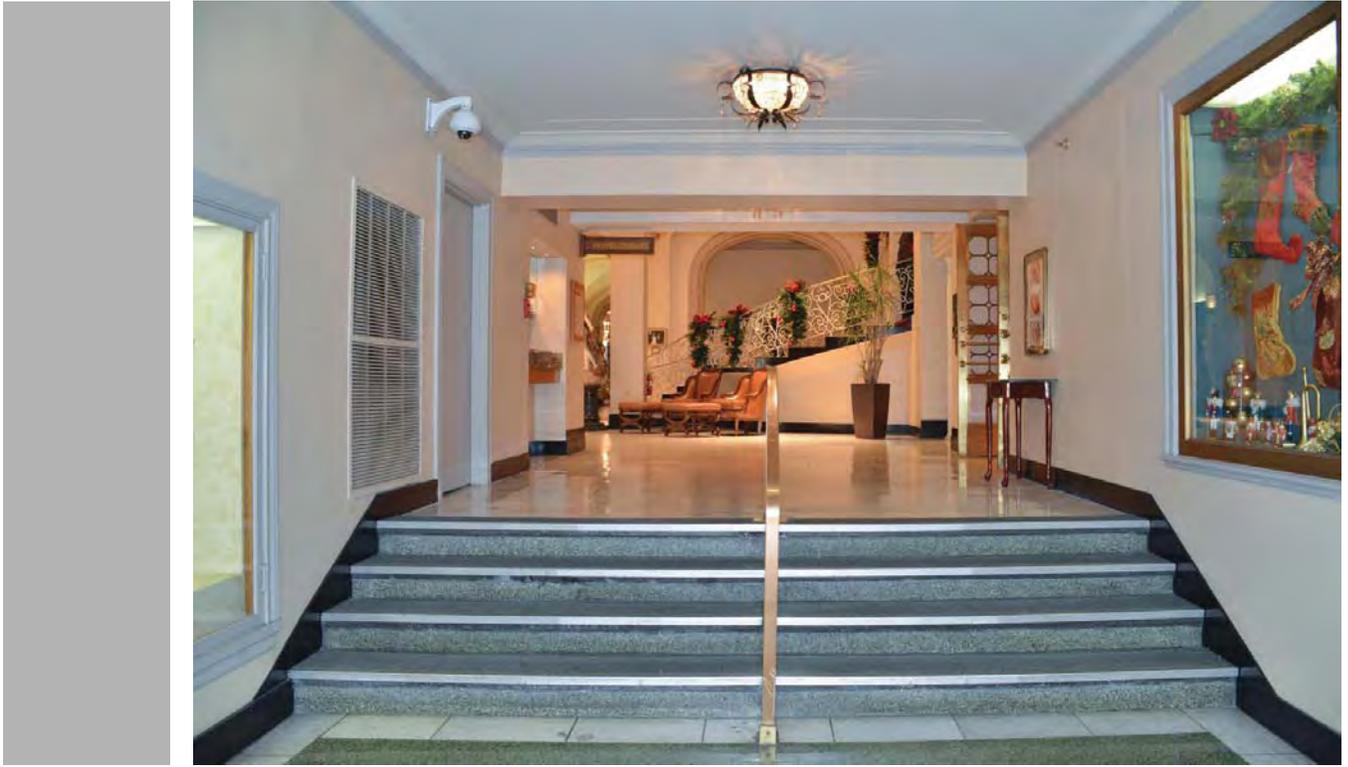
Name: Saint Anthony Hotel, 300 East Travis Street, San Antonio, Texas
View: First Floor Navarro Street entry lobby interior, looking east at stair and rail
Description: Historic stair retained; non-historic rail replaced; display cases removed
Date: November 2012
