## HISTORIC AND DESIGN REVIEW COMMISSION

**HDRC CASE NO:** 2015-401  
**ADDRESS:** 714 N PINE ST  
**LEGAL DESCRIPTION:** NCB 1659 BLK G LOT 5  
**ZONING:** R6 H  
**CITY COUNCIL DIST.:** 2  
**DISTRICT:** Dignowity Hill Historic District  
**APPLICANT:** Leo Parker  
**OWNER:** Leo Parker  
**TYPE OF WORK:** window replacement

The applicant is requesting a Certificate of Appropriateness for approval to replace 28 wood windows in the house at 714 N Pine with low-e vinyl replacement windows.

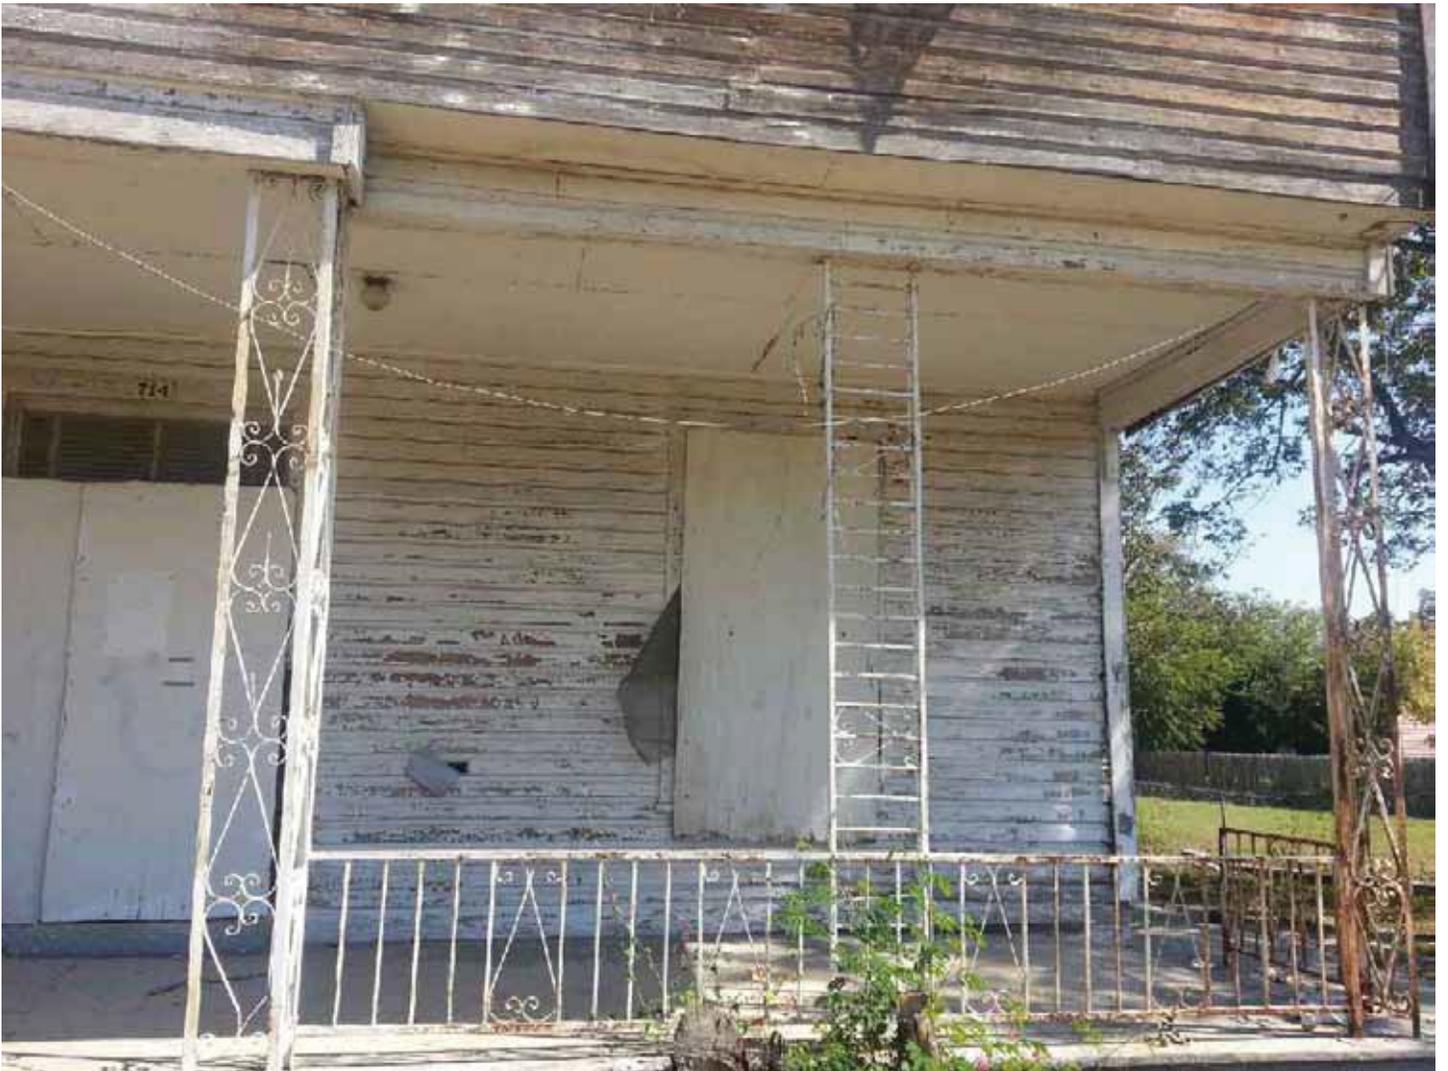
## Front porch 02

we plan to open the second story front porch back up and put white pillars on both levels to take the home back to its original state with a deck on the front which will bring the curb appeal up substantially and take the home back closer to what it was.

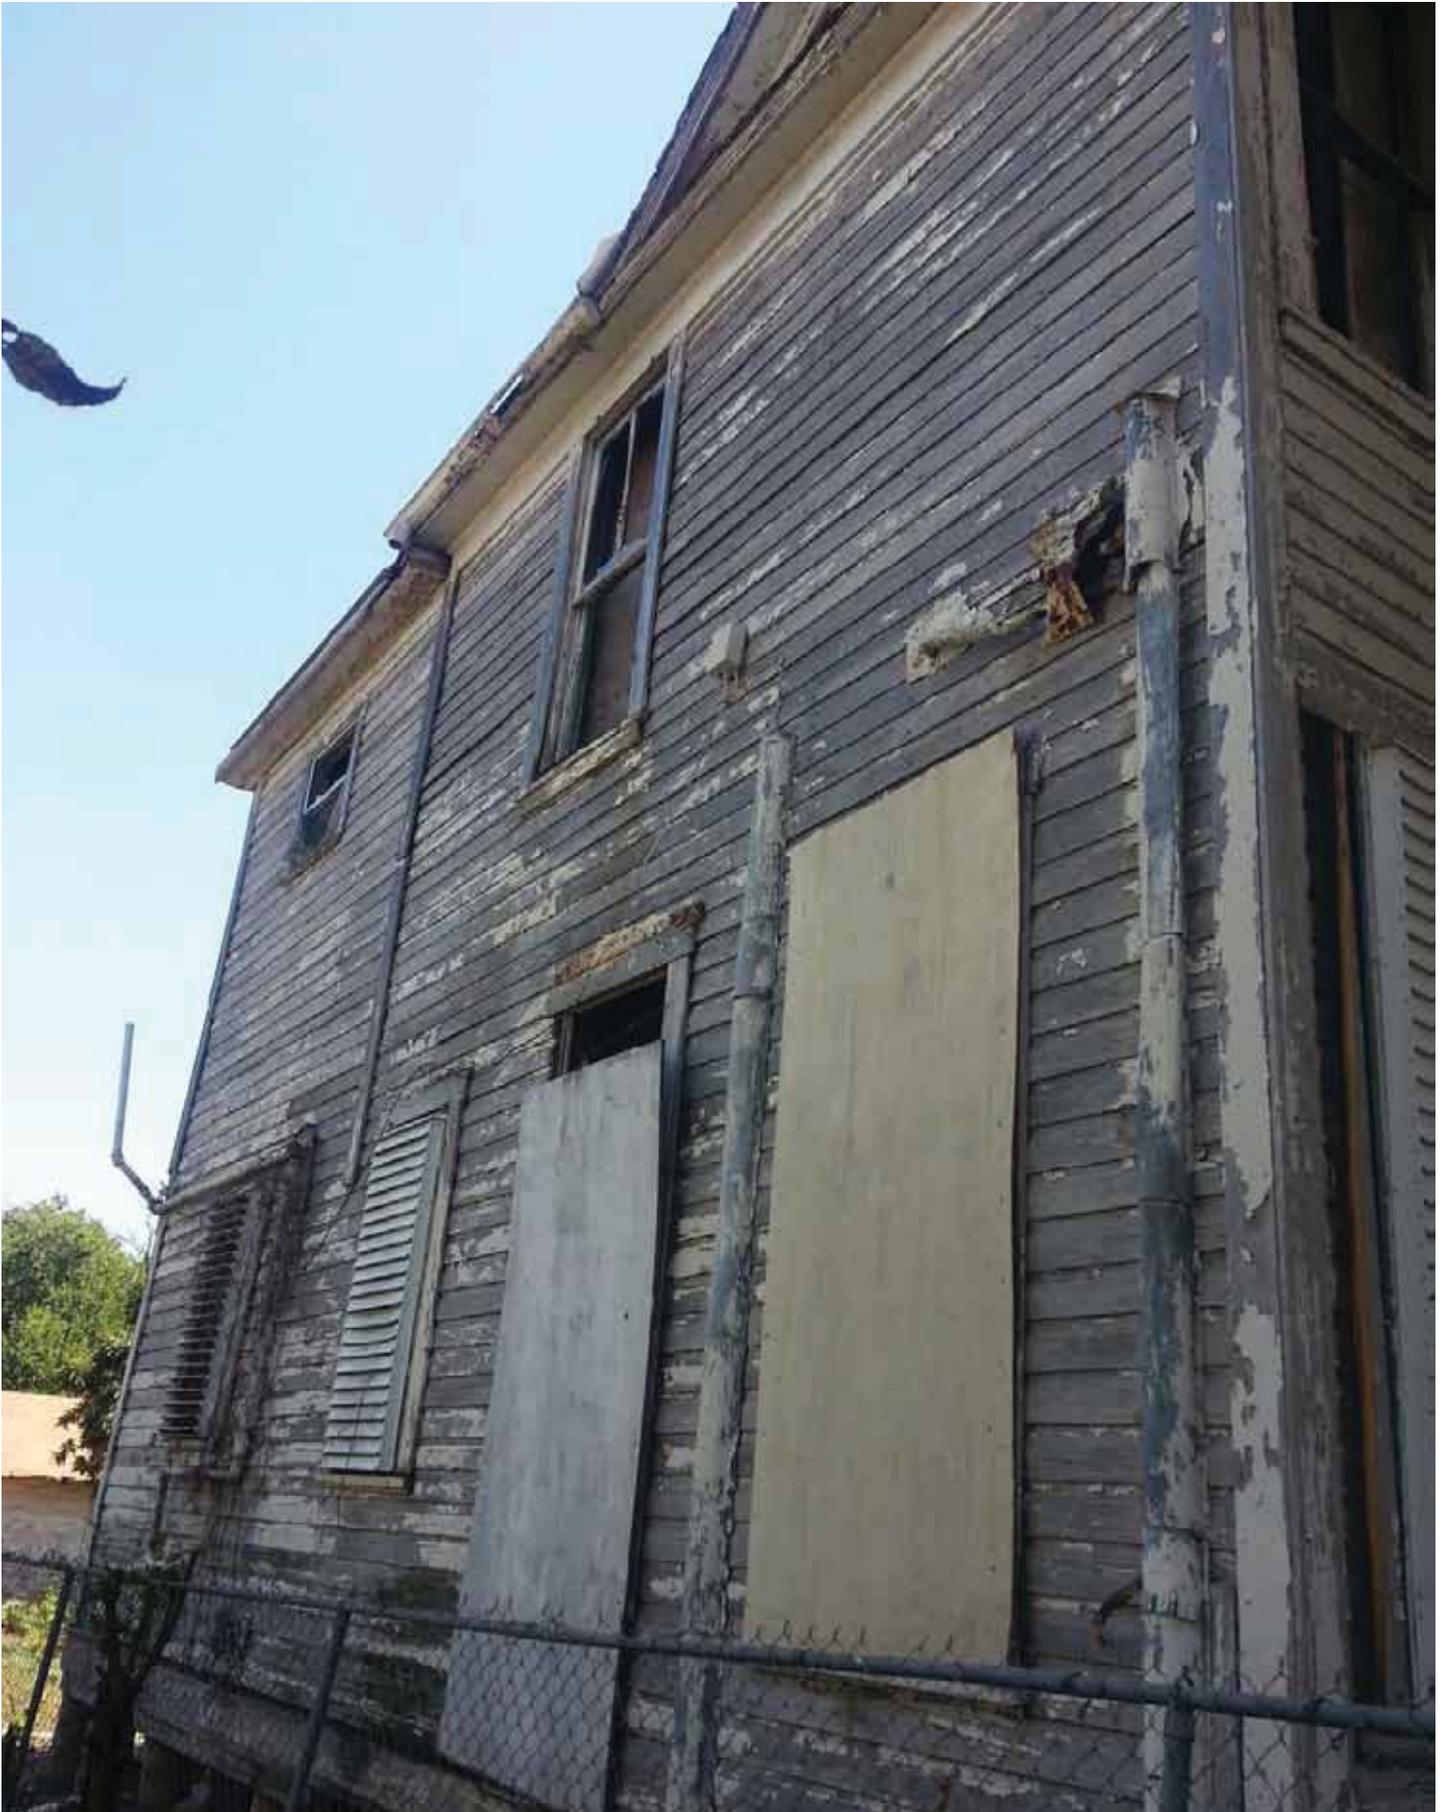
## Back wall 01

we will repair and paint the back deck that goes into the second story. The door will be in the master suite.

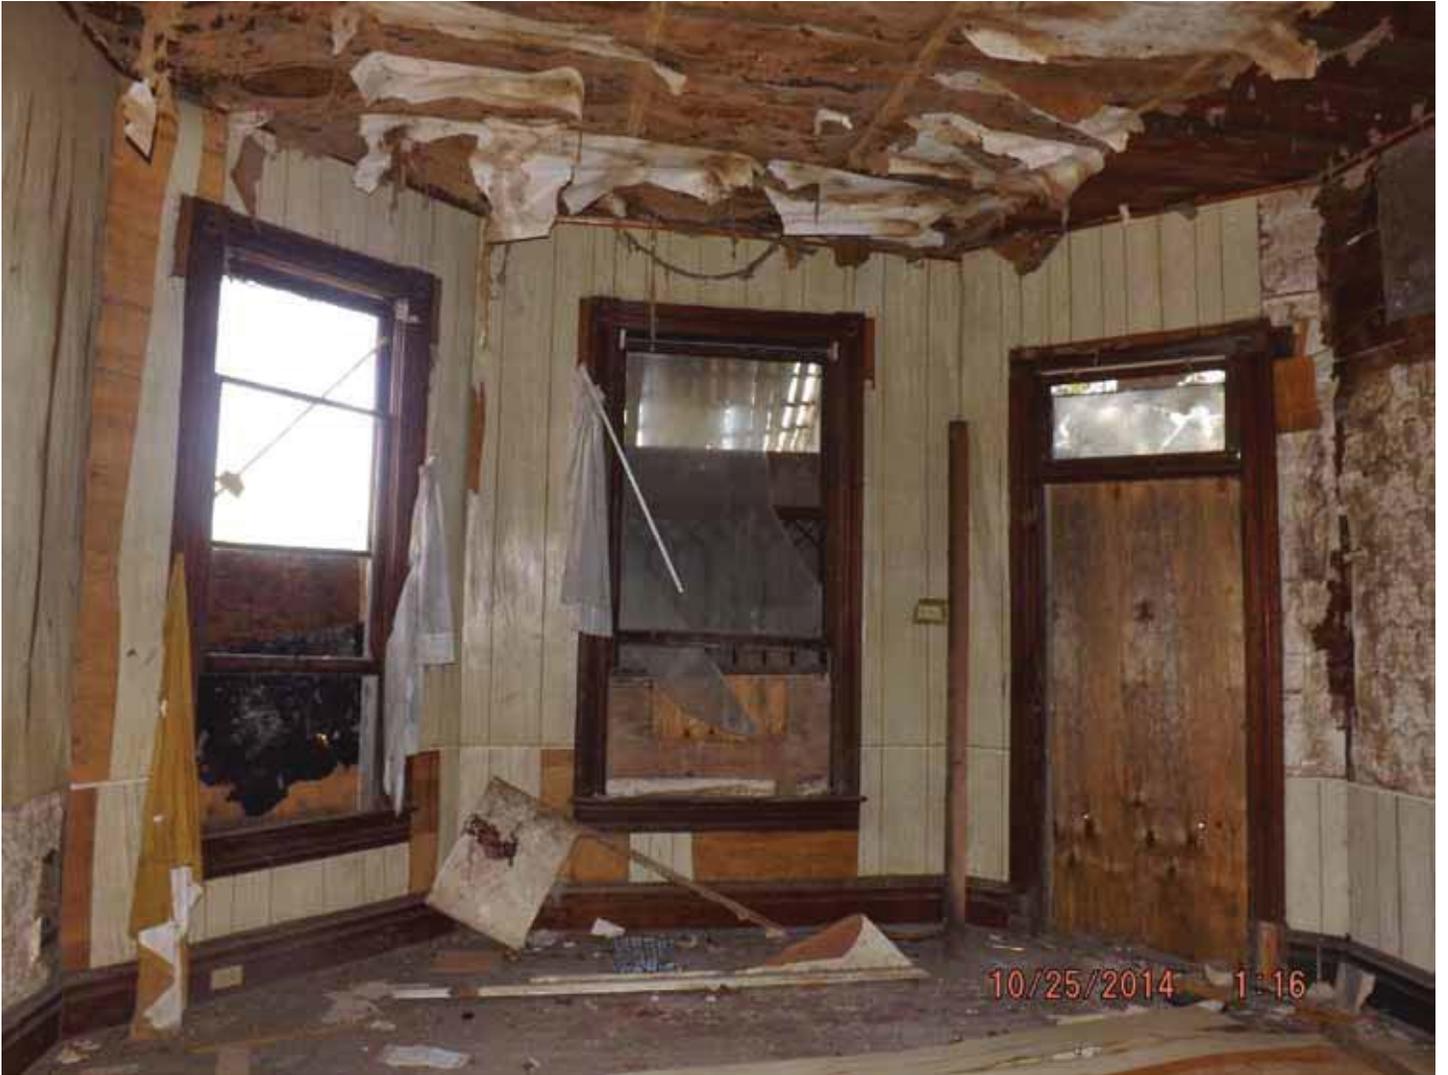
- b) A site visit by staff revealed that many of the first floor elements, including original wood work and windows remain intact. The majority of the original wood windows are large, one-over-one double hung windows with the exception of the formal dining room which features a decorative divided-lite top sash. Staff finds that the majority of the first floor windows can be repaired.

formal dining room

- 1.The salvageable original windows on the first floor are recommended to be repaired rather than replaced.
- 2.Original windows that are damaged beyond repair are recommended to be replaced with compatible wood windows instead of the proposed vinyl windows. If the HDRC approves the applicants request for vinyl windows, staff recommends the added stipulation that the applicant select a window product that features a block frame that can be set within the existing openings versus a product with a flush flange or nailing strip. All replacement windows should be simple, one-over-one designs versus a faux divided-lite design.
- 3.Staff recommends that the non-original windows on the 2<sup>nd</sup>-floor addition be replaced with vinyl windows meeting the specifications noted above. Final approved specifications must be verified by staff prior to purchase and installation.

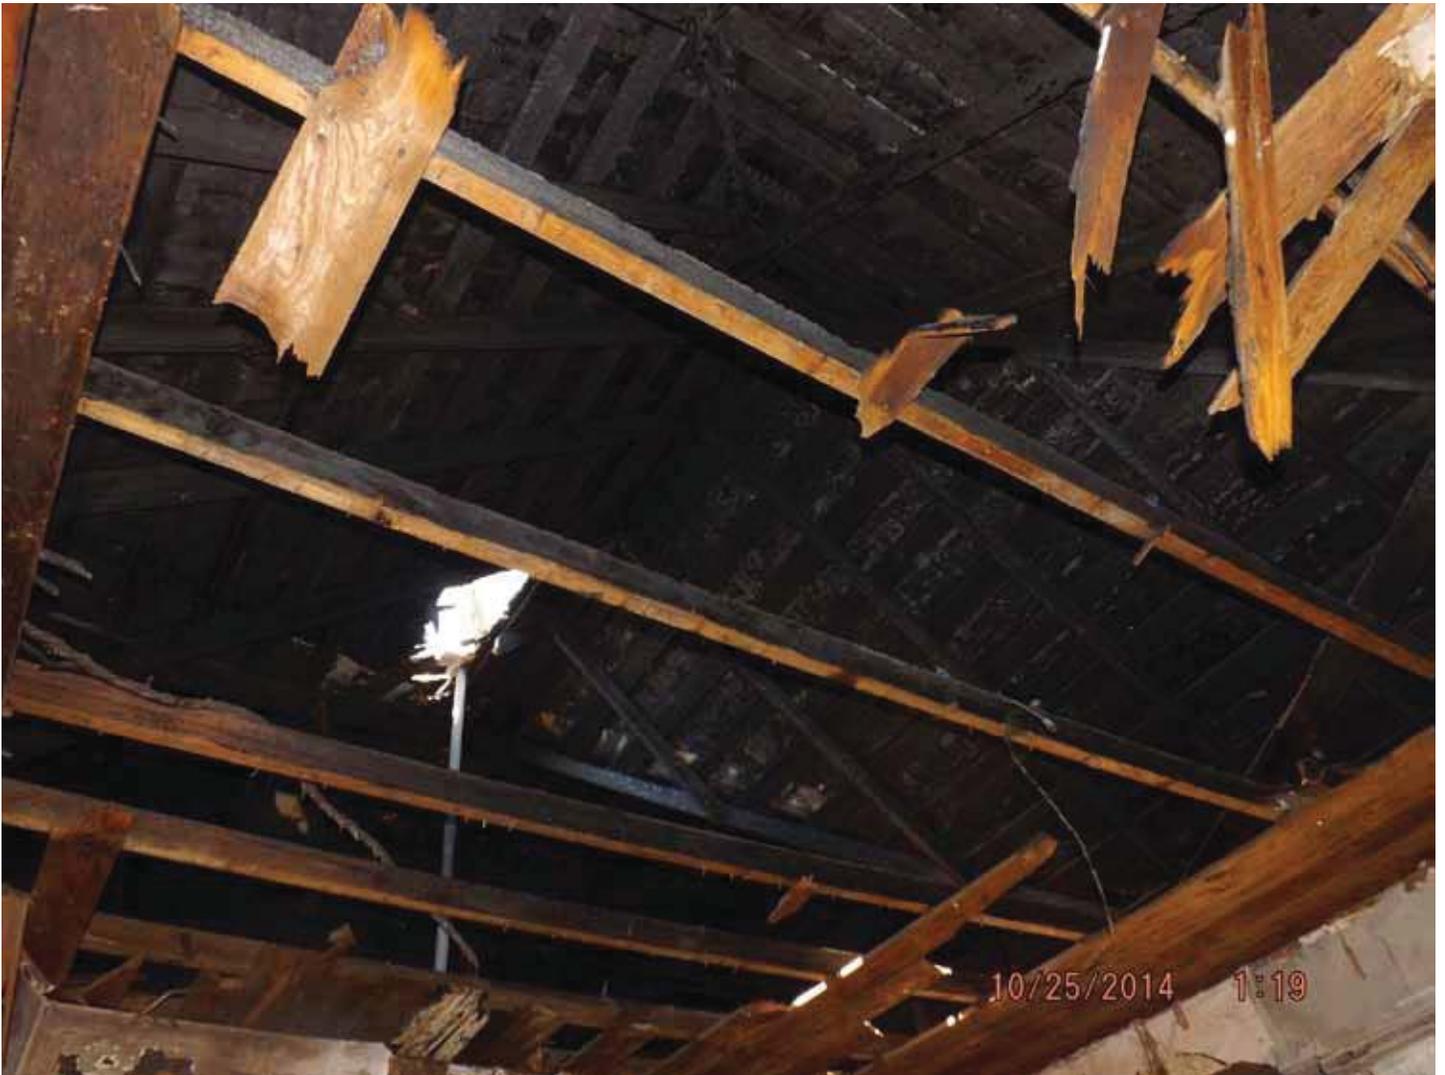
## Ceiling and burn damage.

we will start here removing roof and all burned or affected wood and replace all rafters and decking before doing anything else on inside. we plan to vault the ceiling in at least the master bedroom.

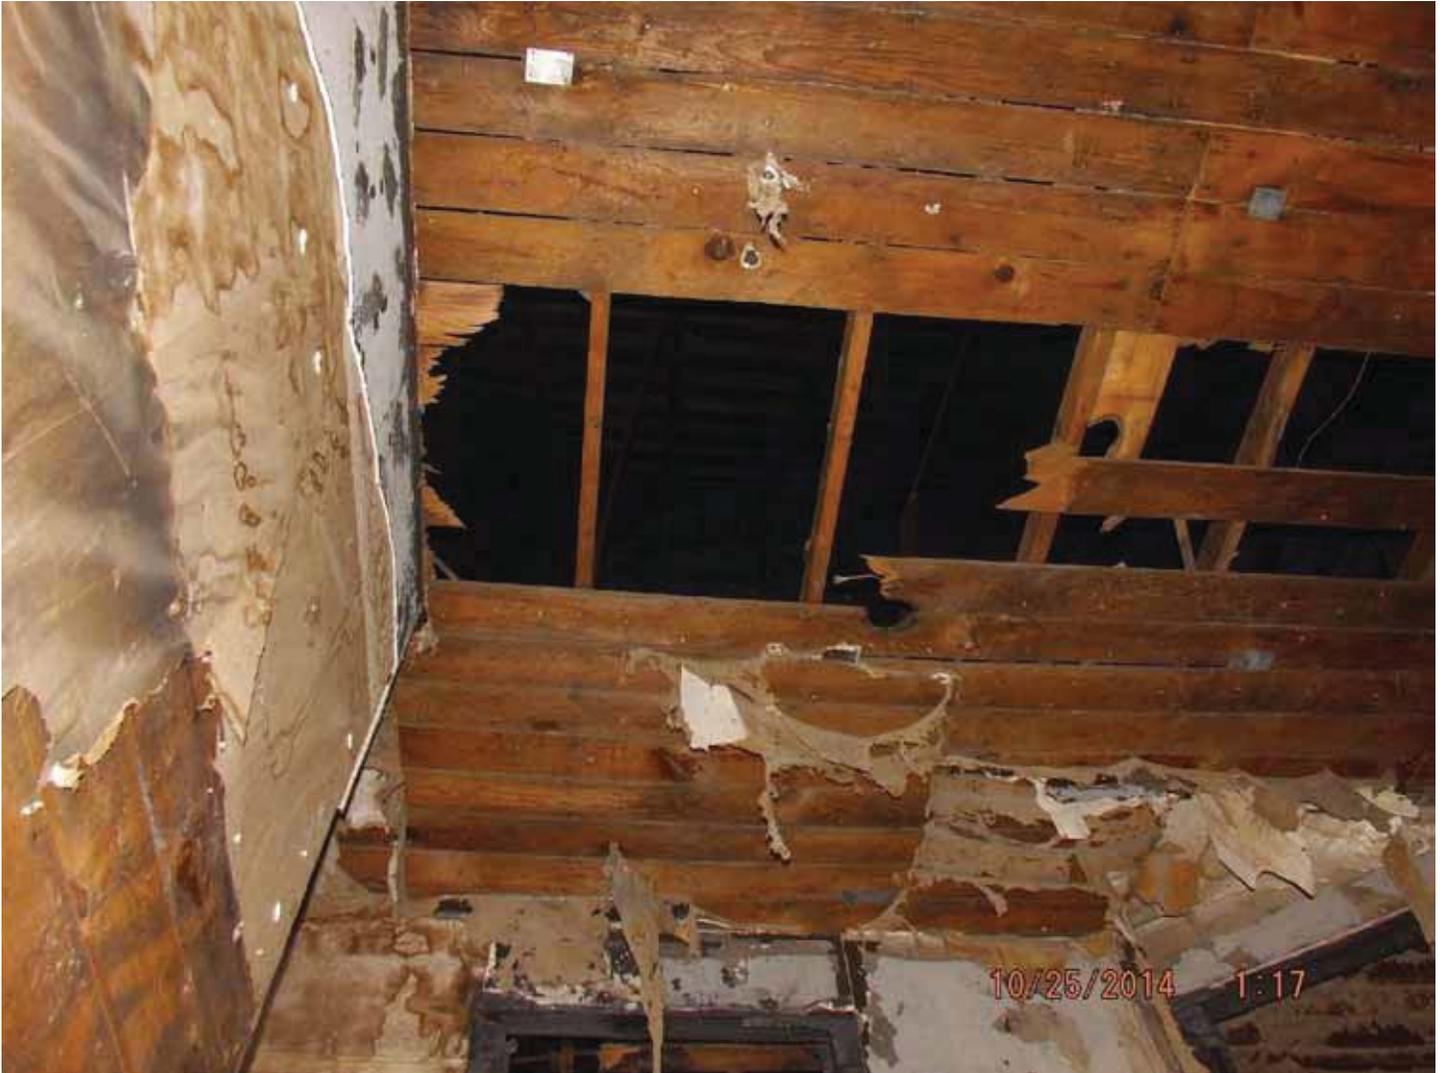
burnt door frame

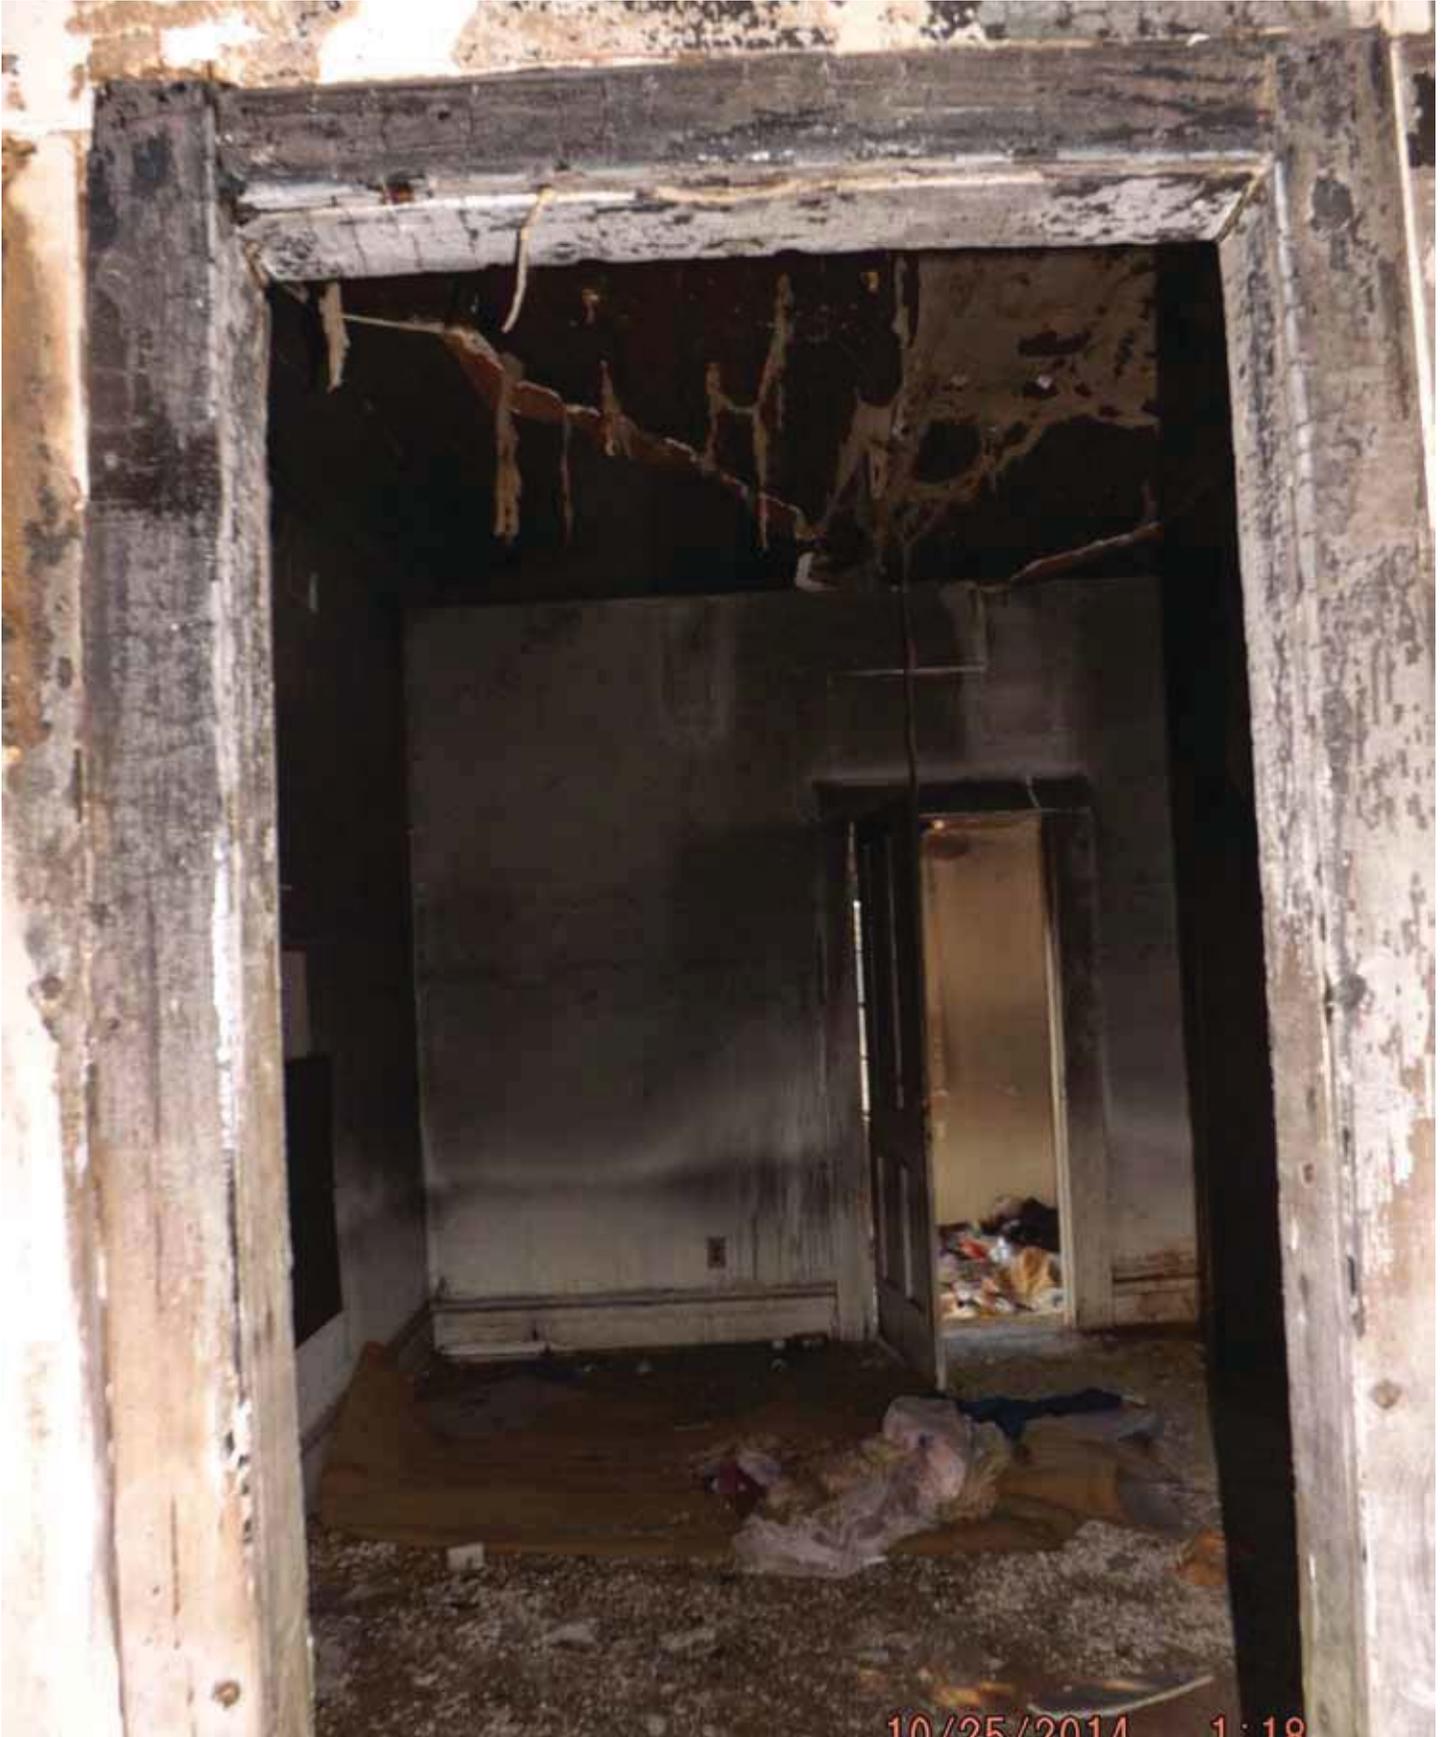
burnt door frame

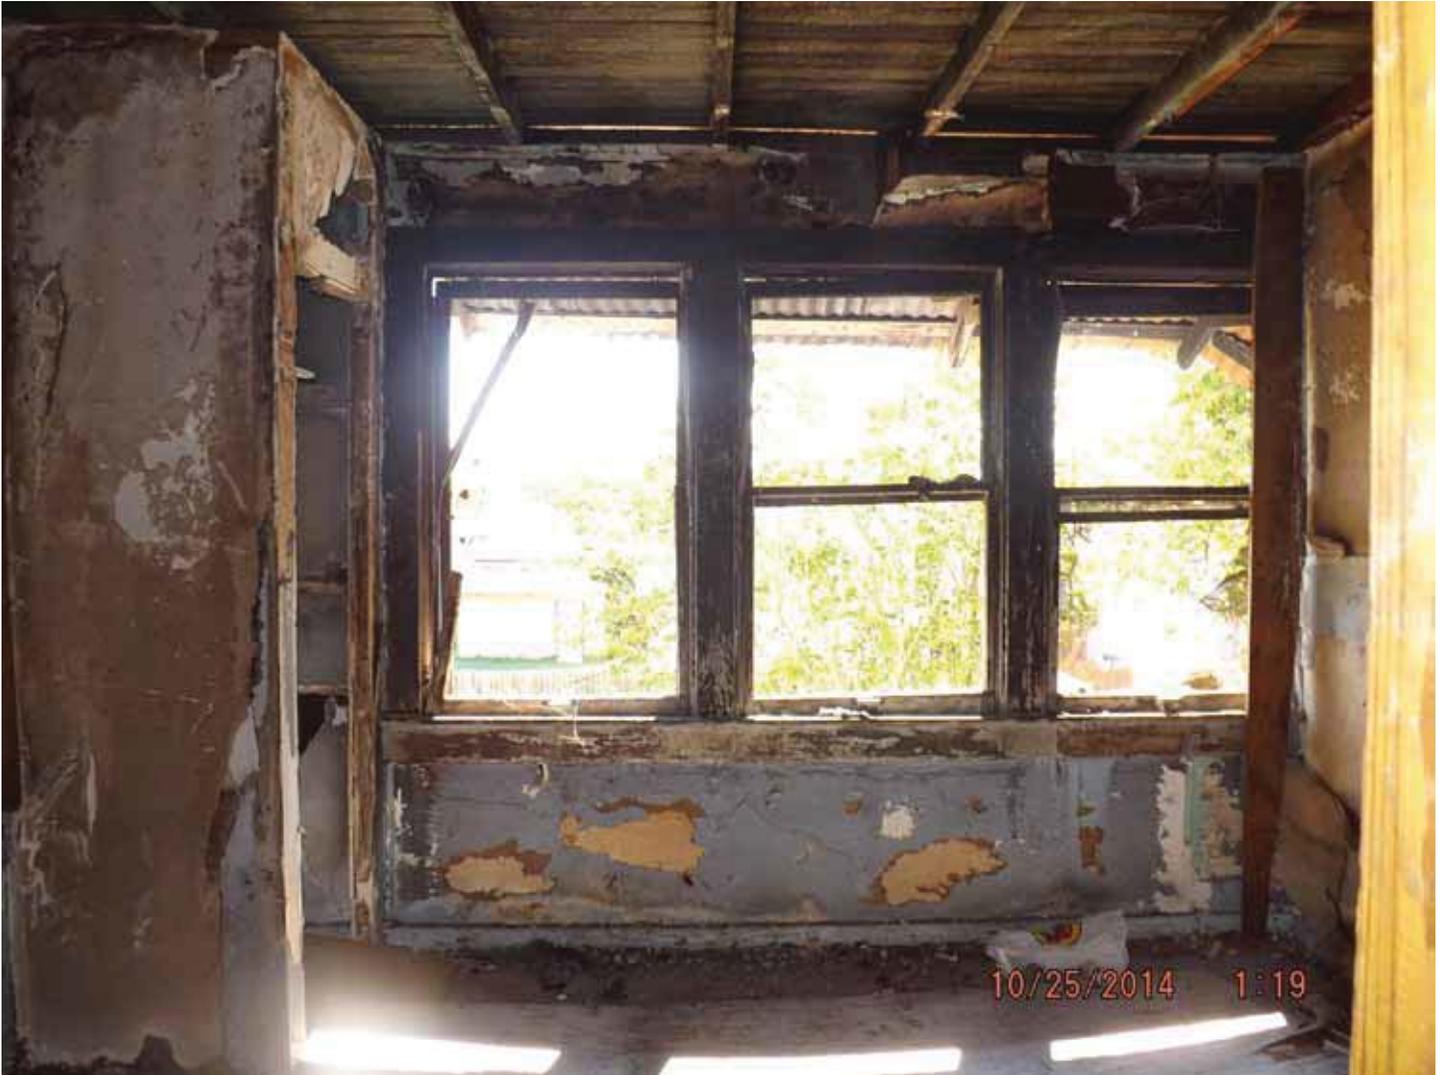
windows upstairs

- a) Staff commends the applicant for undertaking the rehabilitation of this structure which has previously been threatened with demolition. The house has suffered a fire, and many of the windows on the second story have been damaged beyond feasible repair.

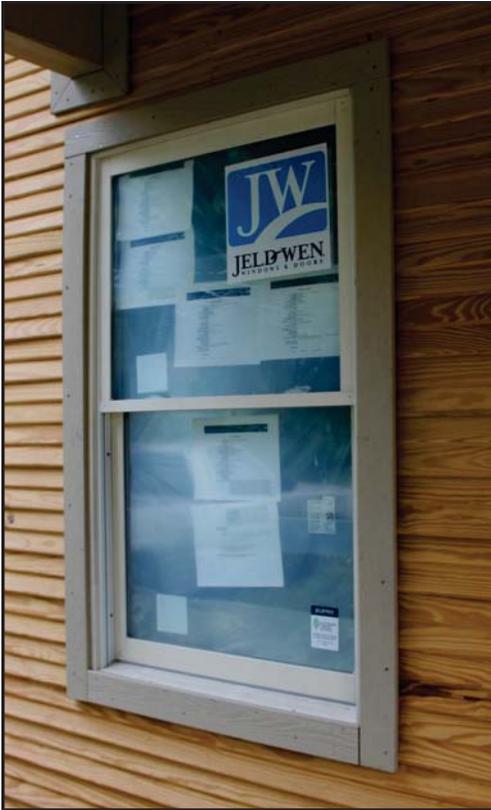
Wood windows recommended for fire-damaged windows that are beyond repair

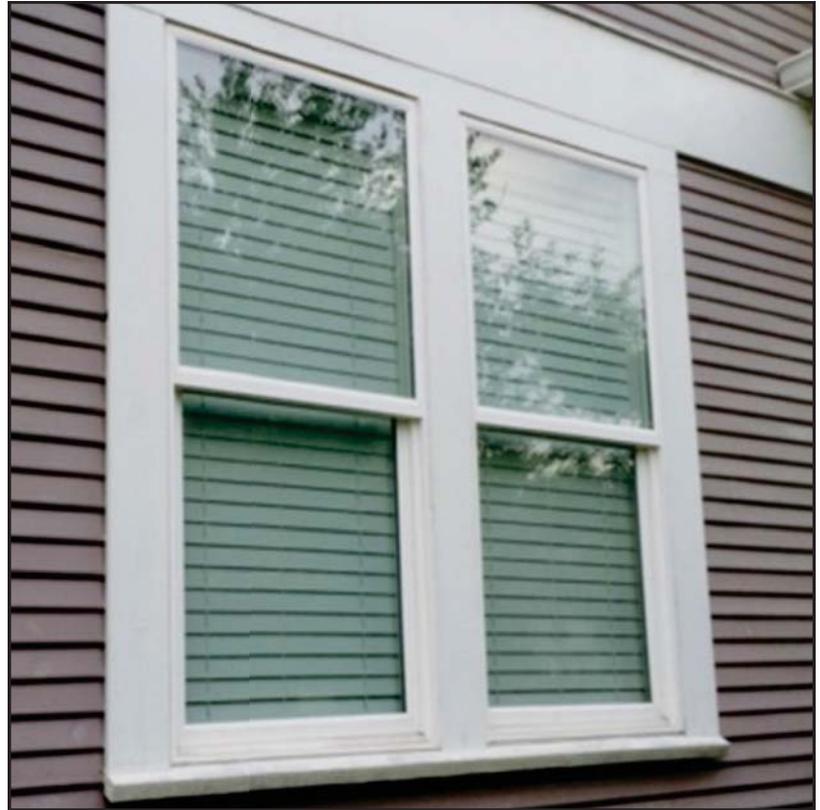
Block-frame vinyl windows are recommended should the HDRC find a change in material to be appropriate

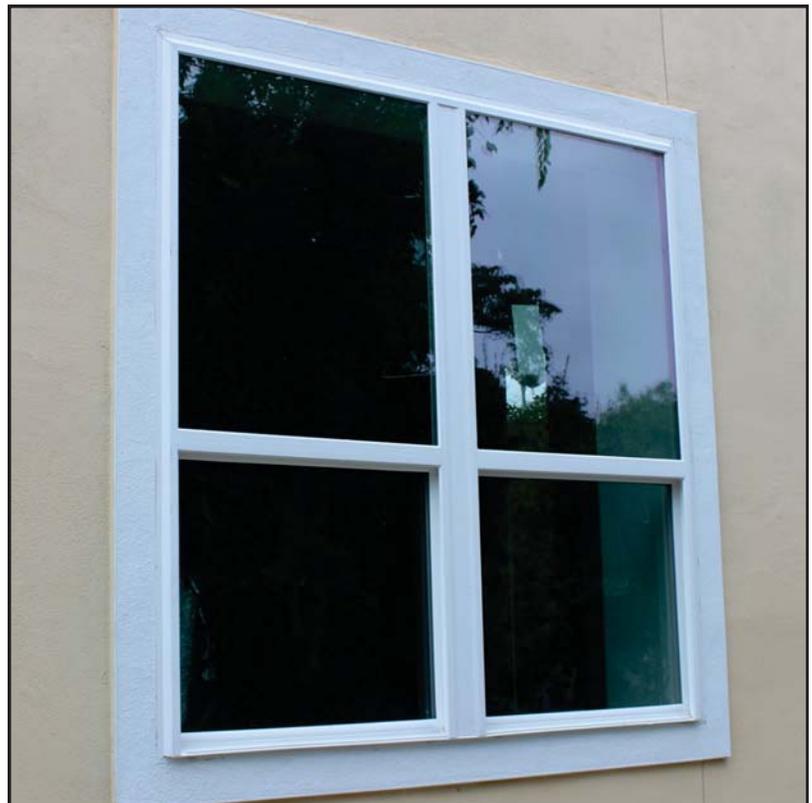
Vinyl windows with a flush flange or nailing strip protrude beyond the window trim and are not recommended.
