HISTORIC AND DESIGN REVIEW COMMISSION

HDRC CASE NO: 2017-365
ADDRESS: 1126 N ST MARYS
LEGAL DESCRIPTION: NCB 819 BLK 30 LOT N IRR 200 FT OF A2 NCB 834 BLK 19 LOT S
ZONING: TRI 156.35 OF N 205 OF A1
CITY COUNCIL DIST.: FBZ T6-2 RIO-2
APPLICANT: 1
OWNER: Benito Polendo
TYPE OF WORK: Luis Kernion
REQUEST: Exterior modifications, landscaping and hardscaping modifications

Arrow Upholstery Building

Structural Evaluation

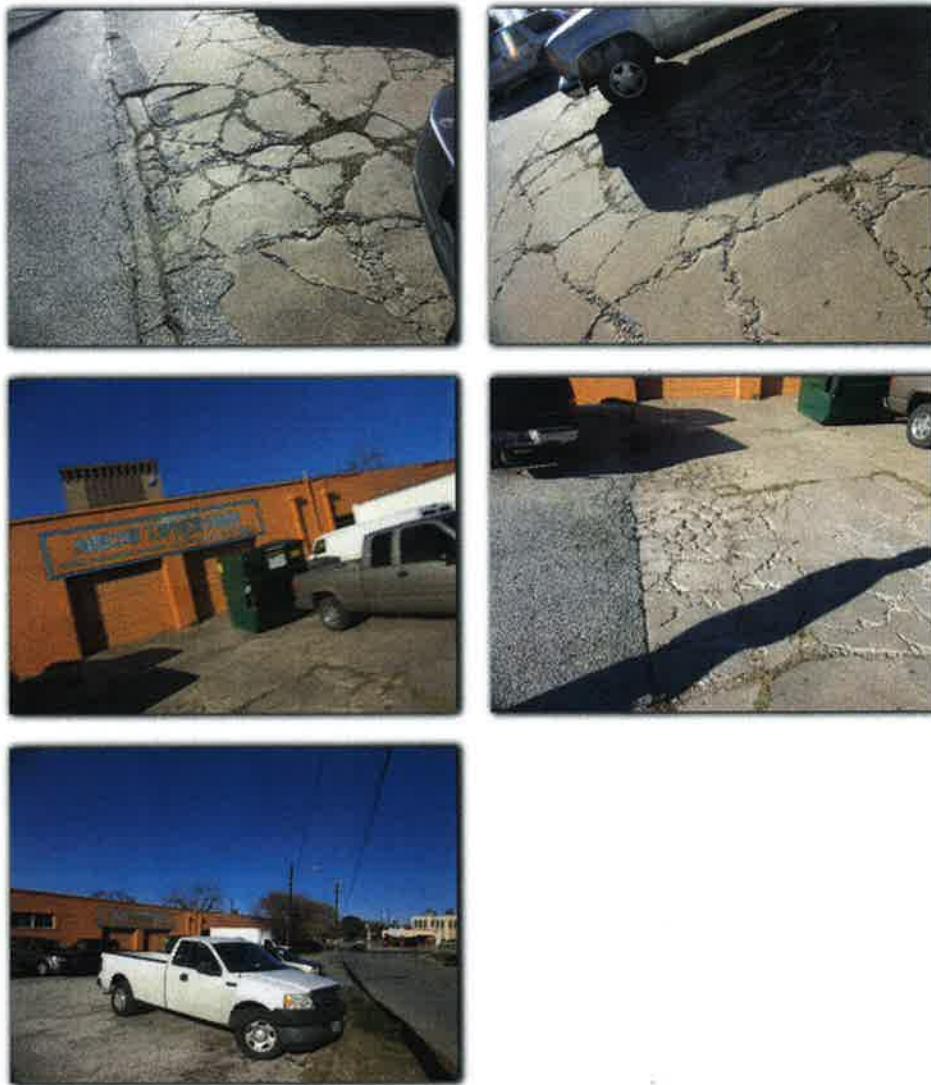
The asphalt/concrete at the left side is poor, with surface failure, poor drainage and the lack of proper markings/signs. .

Noted no fire lane markings or handicap parking. The buildings are not ADA compliance. (Not Included with this PCA)

It is recommended that further investigation with appropriate service and/or repair contractors is made to determine the full costs involved in correcting the drainage and repairs to the walks/parking areas.

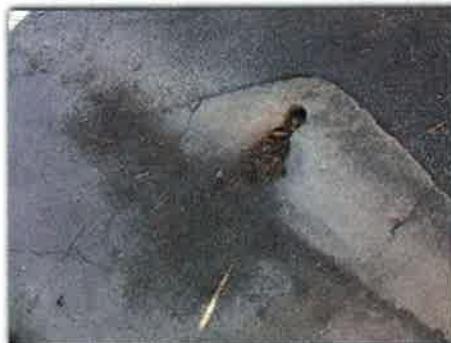
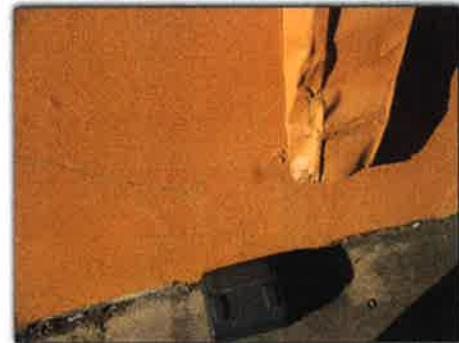
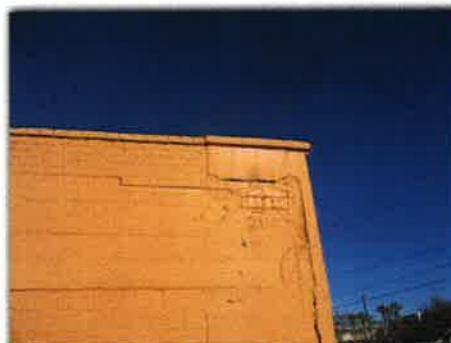
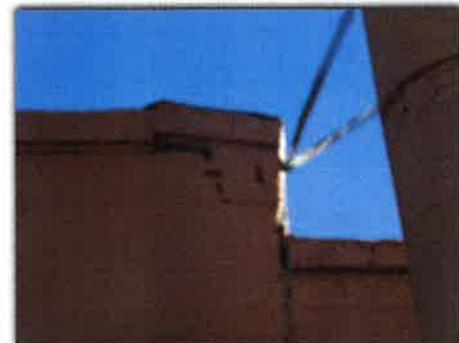
Surface drainage drains towards the building at both sides, with an

unknown drain in the left parking area. The roof drains to a system of scuppers located at the edge of the roof and downspouts do not divert water away from the foundation properly.

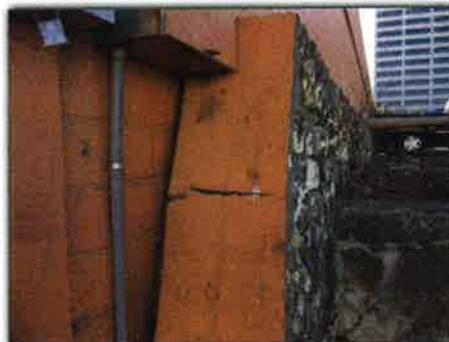
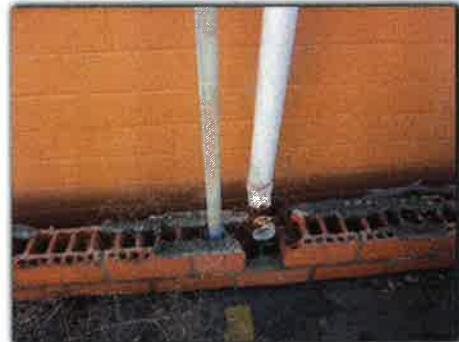
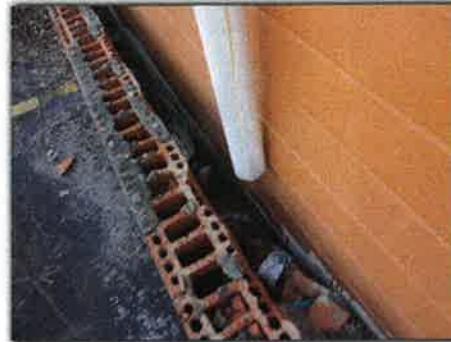
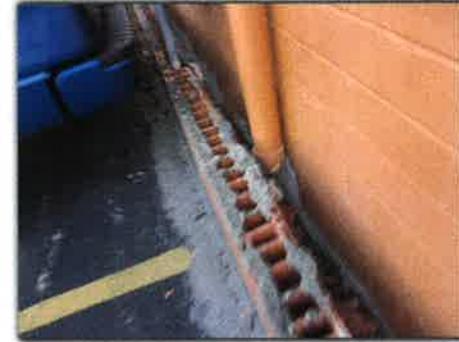
The right side retaining wall is leaning and has some cracking. Drainage from within the void between the building and adjacent lot is unknown.

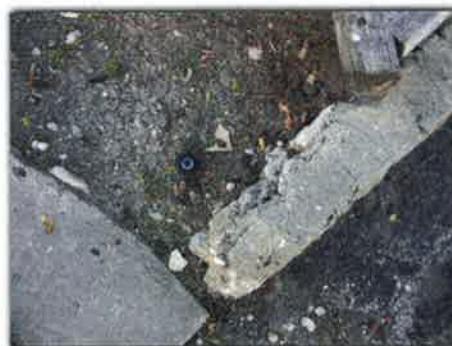
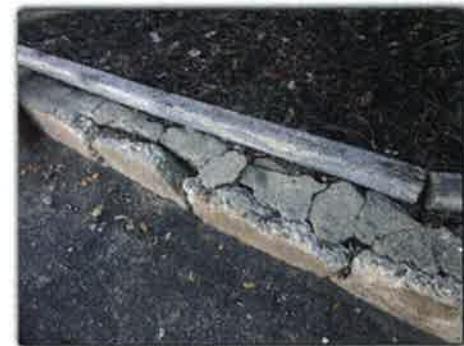
Noted cracking in the front concrete curbs.

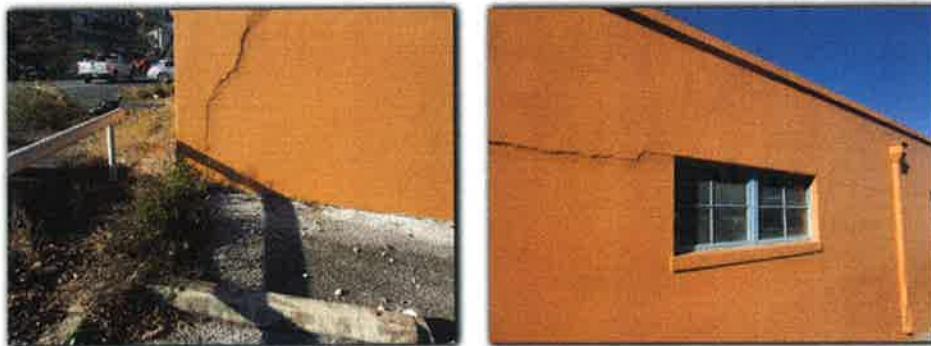
The exterior inspection of the walls revealed some cracking associated with the structural movement. Cracks were seen in the CMU walls at the rear and sides.

It is recommended that further investigation with appropriate service and/or repair contractors is made to determine the costs involved to correct the exterior conditions.

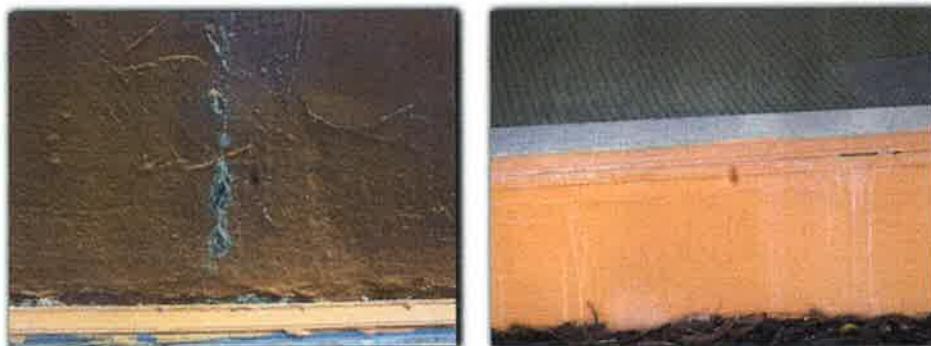
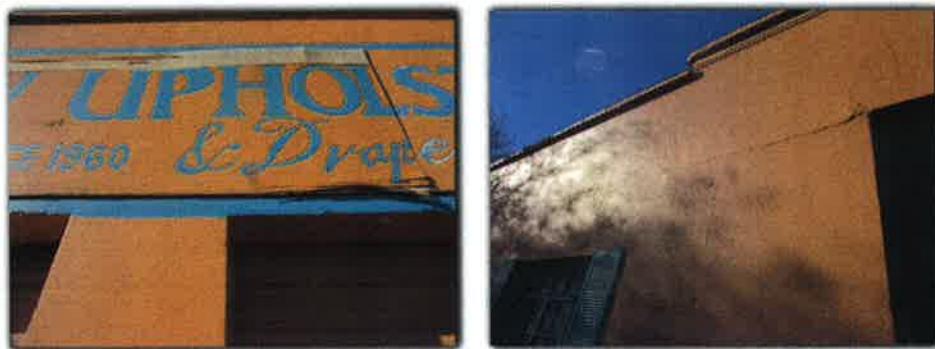
Noted water stains at the exterior windows and other wall breaks that indicate moisture build up within the walls.

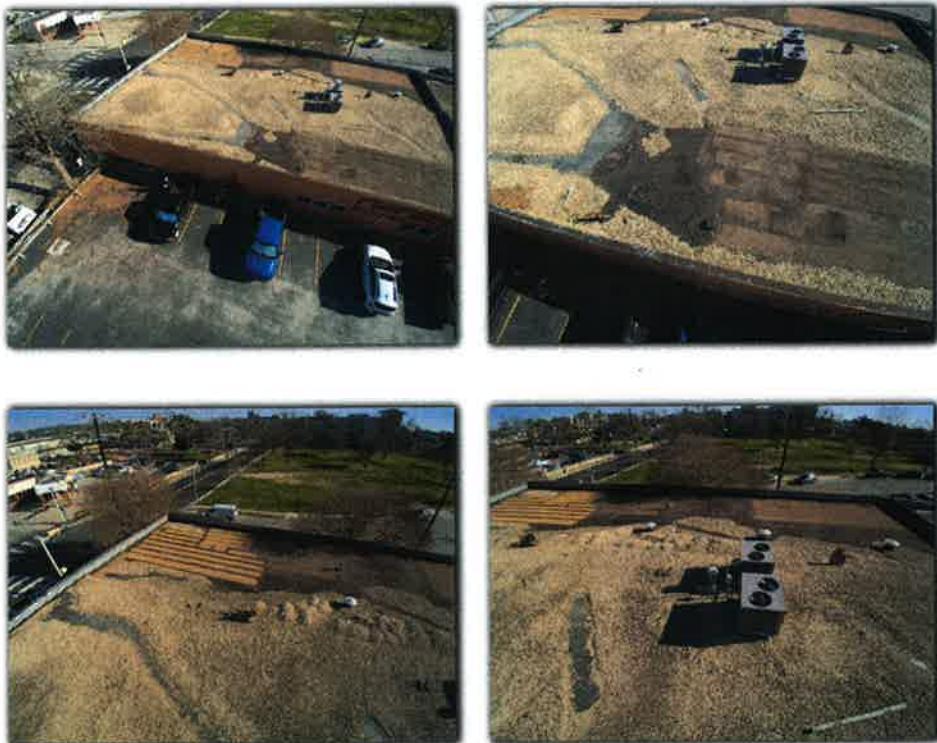
The roof on the structure is a combination of built up gravel and rolled roofing with numerous areas of failure and indications of ongoing leakage.

The over all condition of the roofing systems is poor, and any immediate repairs should be considered as preventative in nature. It is recommended that the client include in budget expenditures for replacement of the roof.

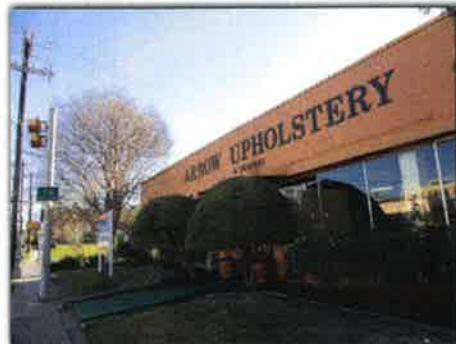
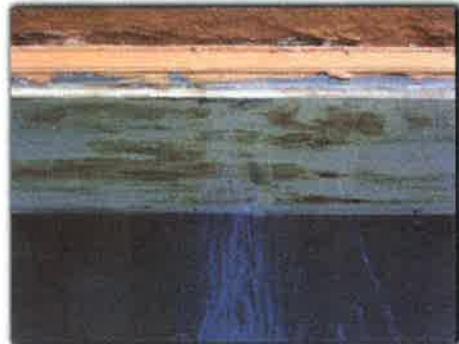
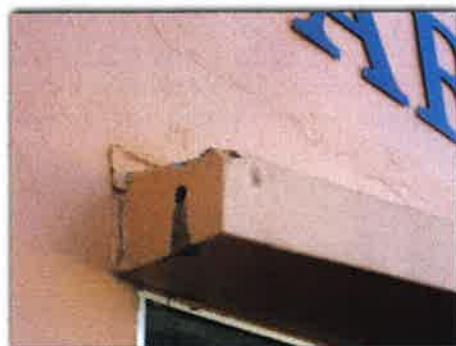
The front facade appears to be leaking.

Noted indications of active links across the front window areas.

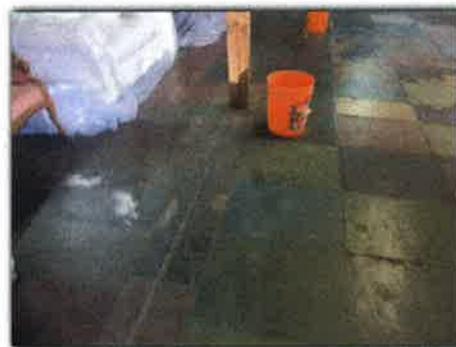
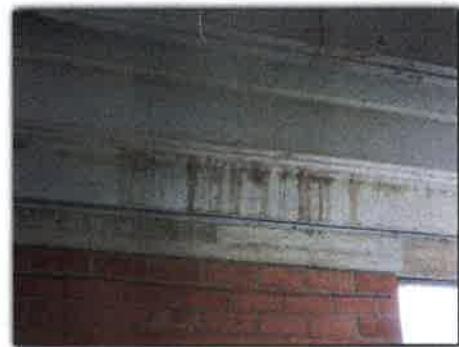
Noted numerous areas throughout the warehouse where the roof appears to be leaking as indicated by water stains and placement of buckets throughout where some water in buckets.

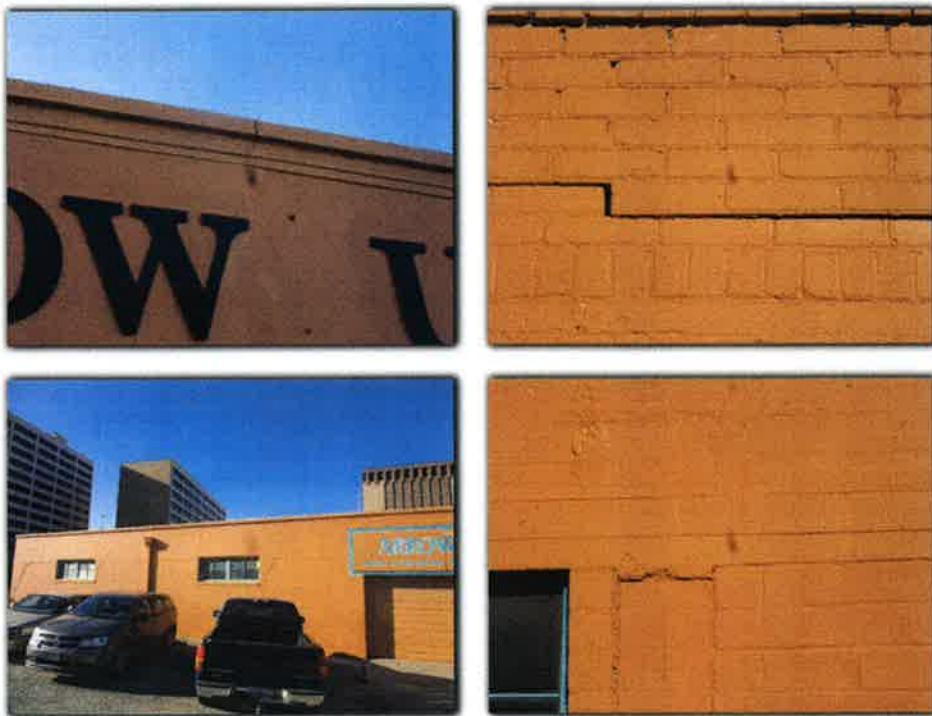
The exterior inspection revealed some cracking associated with the structural movement.

The floors inside the front show room are out of level.

The floating slab at the left warehouse is out of level.

Noted some off sets and signs of movement between joints in the warehouse exposed slabs.

The visual inspection revealed signs of structural movement/distress which indicates repairs may be needed. The client should seek additional opinions from a structural engineer to determine scope of any needed corrective actions and improvements needed for planned renovations.

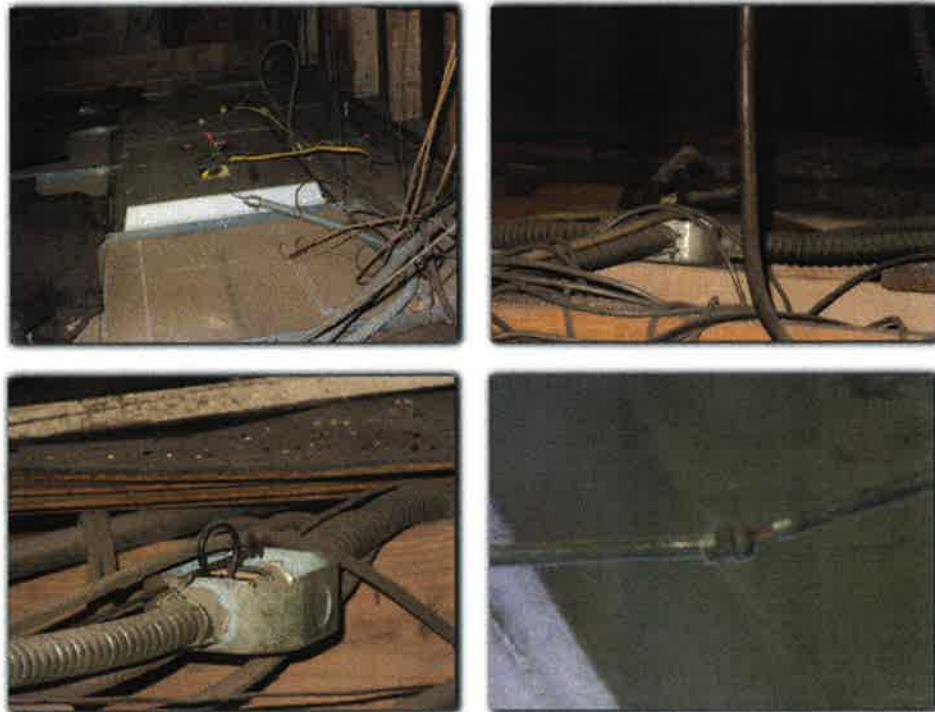
Observation of the electrical equipment and systems revealed deferred maintenance. Categories including loose wiring, open and missing junction boxes, loose conduit/boxes, and miscellaneous minor to moderate conditions requiring general servicing by a licensed electrician.

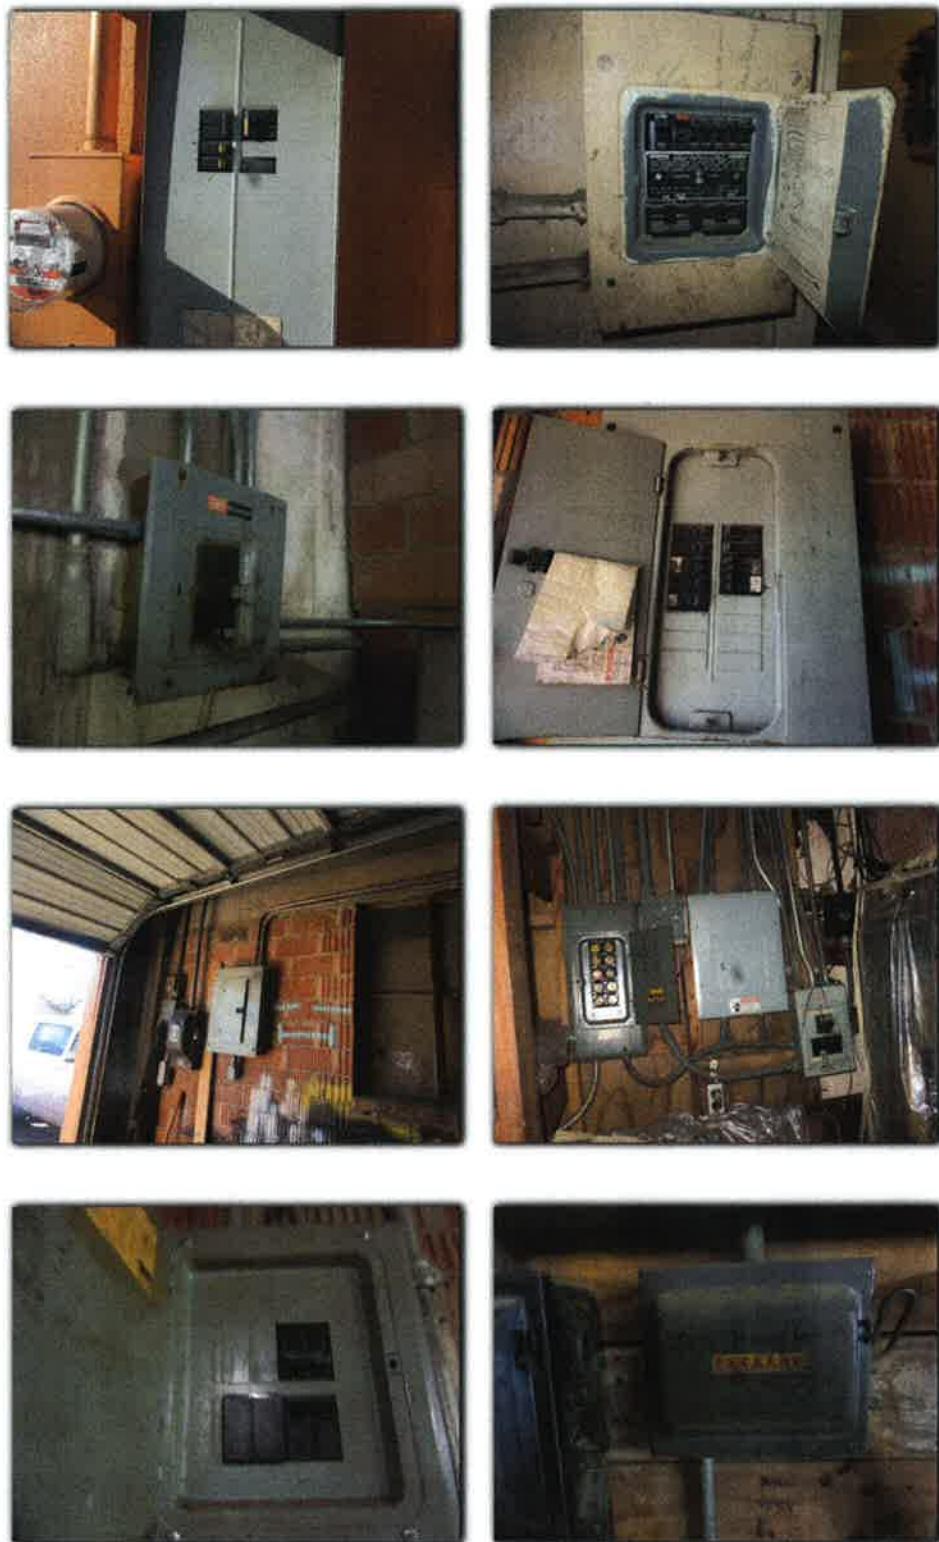
The electrical panels are poorly or not labeled.

Noted many of the interior lights are out.

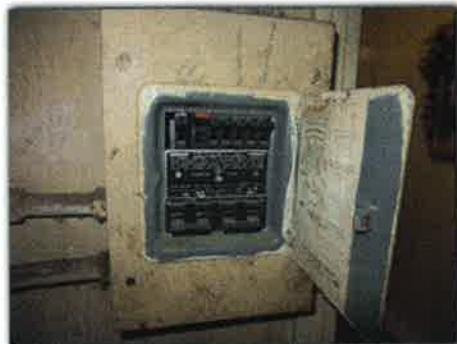
Noted the use of a Federal Pacific Electric "Stab-Lock" panel. These

panels are known to have a high rate of failure, and are considered a safety hazard.

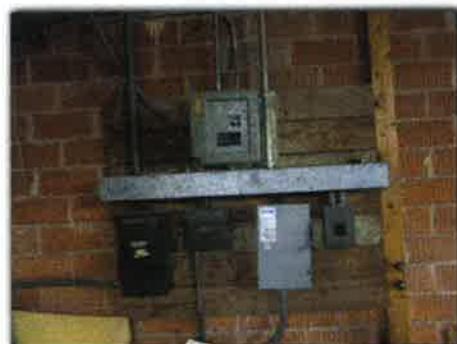
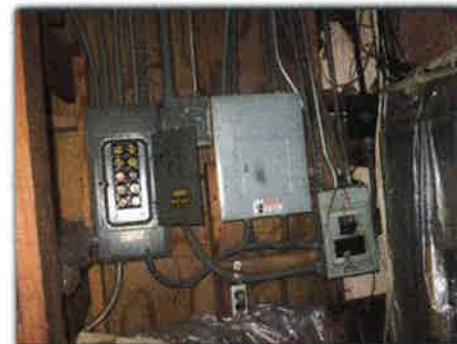
The wooden framed part of the warehouse has several electrical panels located at the front left including some dated glass-based fuses with plastic covering some equipment to protect it from water leaks from the roof. This equipment will need to be carefully examined to determine extent of needed repairs or replacement.

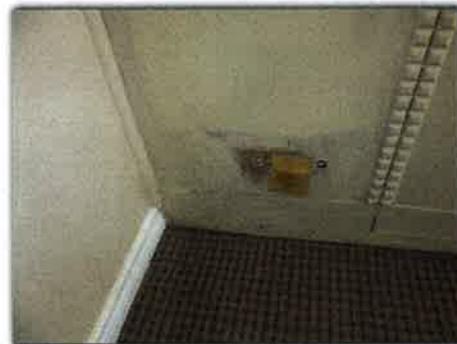
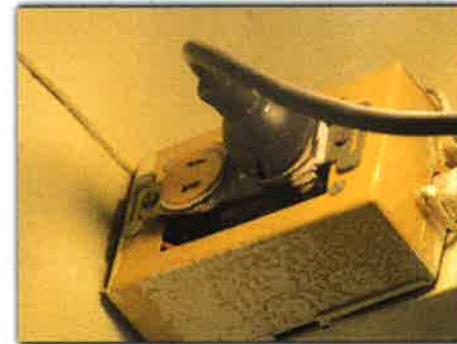
Noted some of the electrical outlets or the original two wire system which may not all be grounded

It is recommended that further investigation with appropriate service and/or repair contractors is made to determine the full costs involved with repairs and updating of the electrical system.

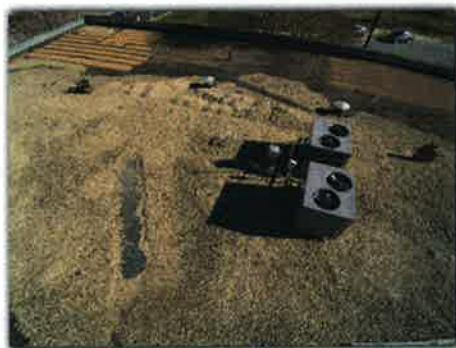
The HVAC system for the front office is operating, however is not cooling properly. Two roof top mounted units.

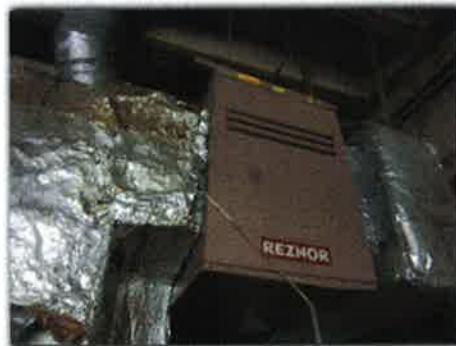
The gas heater for the front office was not tested.

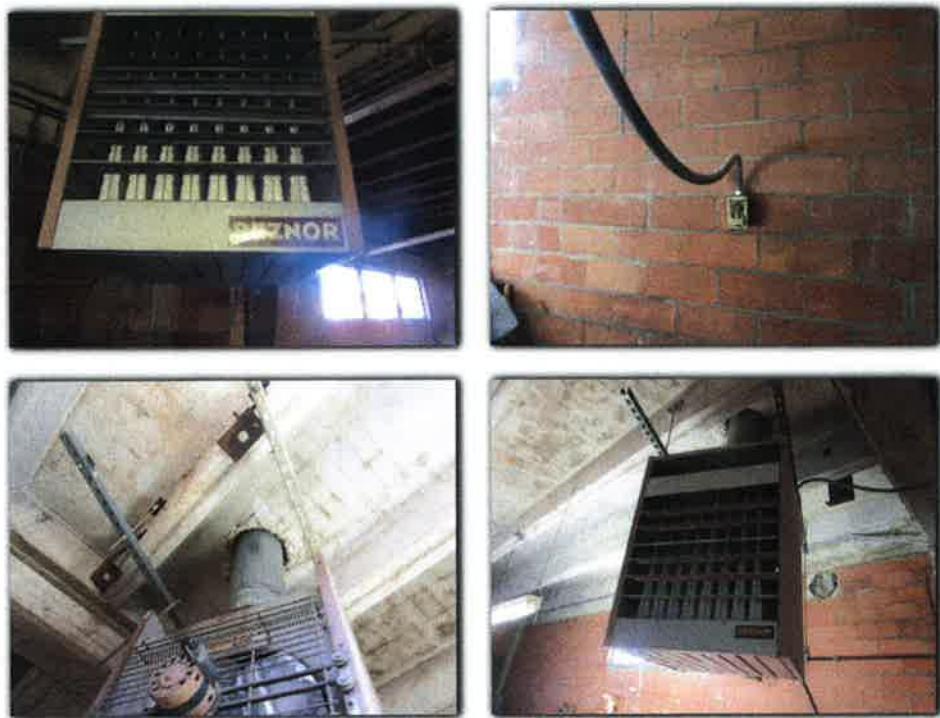
The thermostat one or more of the warehouse heaters do not appear to be operating.

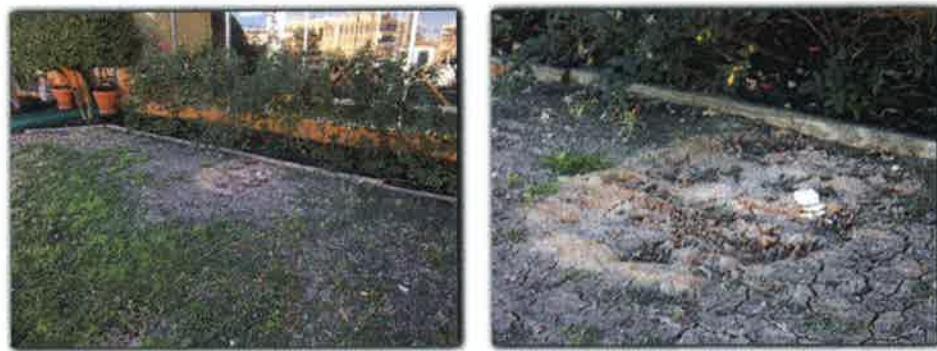
There's a sewer clean out located the front and appears to have been recently installed or repaired. Additional information from the sellers recommended.

Based on visual observation of the conditions of the plumbing systems, this building plumbing has deferred maintenance conditions. Further investigations are recommended to determine the full extent of costs involved in bringing the property up to acceptable standards. Plumbing repairs/replacement should be considered in regards to any planned improvements. It is recommended that the water and sewer lines are tested.

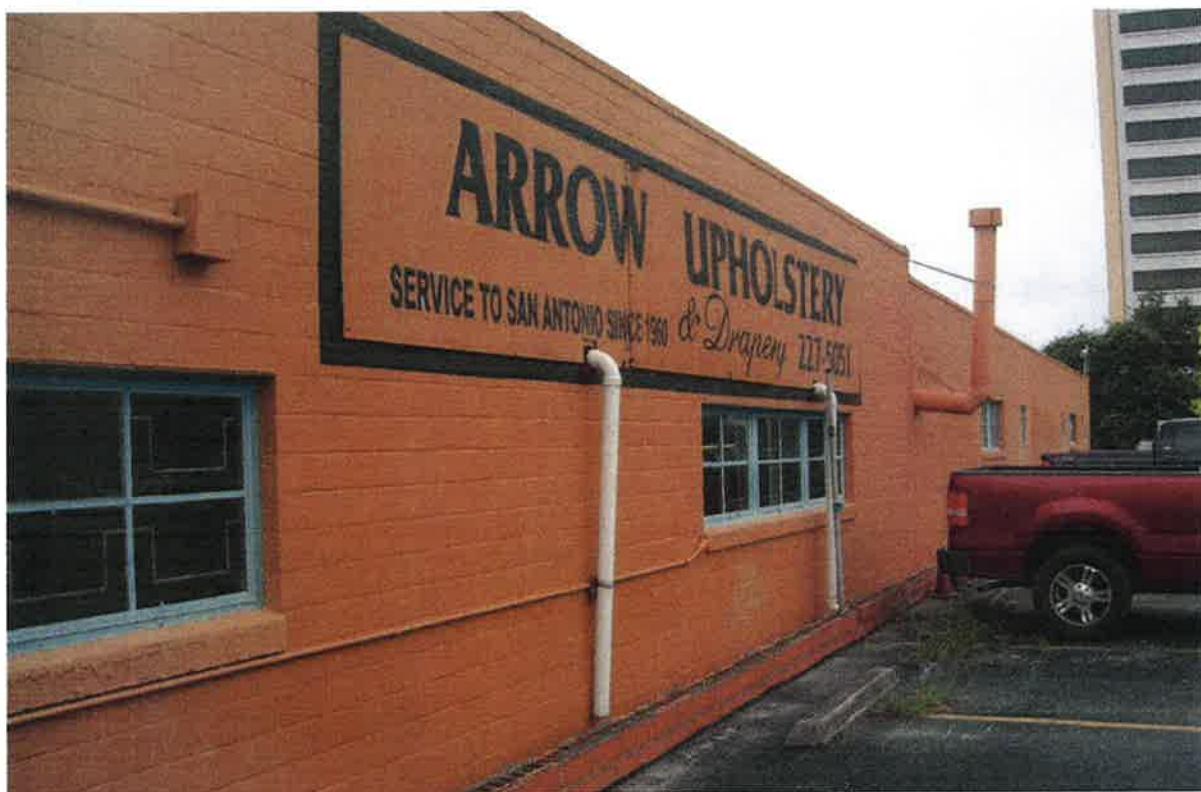
4. Storm water control at the site is poor overall. The roof drainage is inadequate and downspouts discharge at the base of the walls. (Figure 1)
5. Foliage from trees adjacent to the building has clogged downspouts and contributed to the drainage issues and deterioration of the roof. (Figure 2)

Figure 1: Drainage basin between the building and adjacent parking lot retaining wall.

1. *Re-route roof downspouts (new and/or existing) into new below-grade drains that discharge into the city storm drains. Add supplemental roof drains as required to achieve the capacity, pending future plans for the roof structure.*
2. *Correct the deficiencies in the existing water and sewer utilities that are planned to remain. Remove all deteriorated, abandoned, and non-functioning utilities.*
3. *Remove trees and vegetation next to the building.*
4. *Create a permanent void between the clay soil and the underside of the grade beams. This can be done by excavating under the grade beams and installing soil retainers to prevent the soil from filling the voids.*

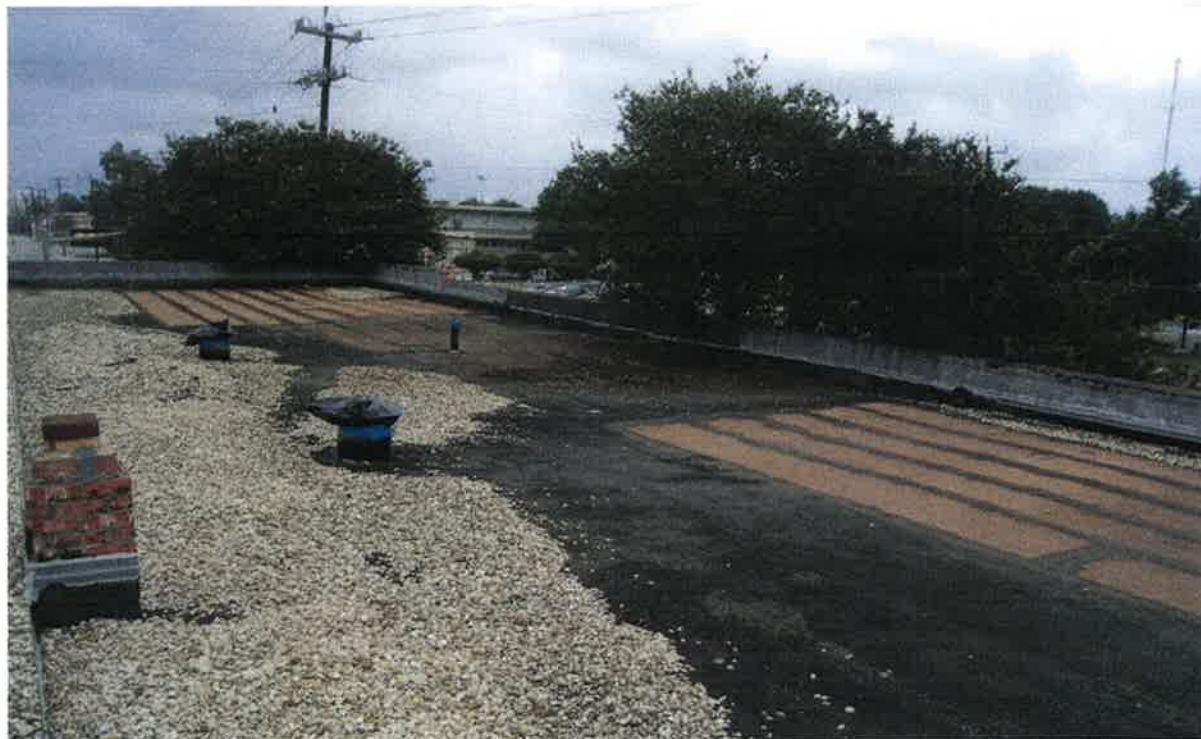
Figure 2: Drainage inadequacy from tree foliage above roof.

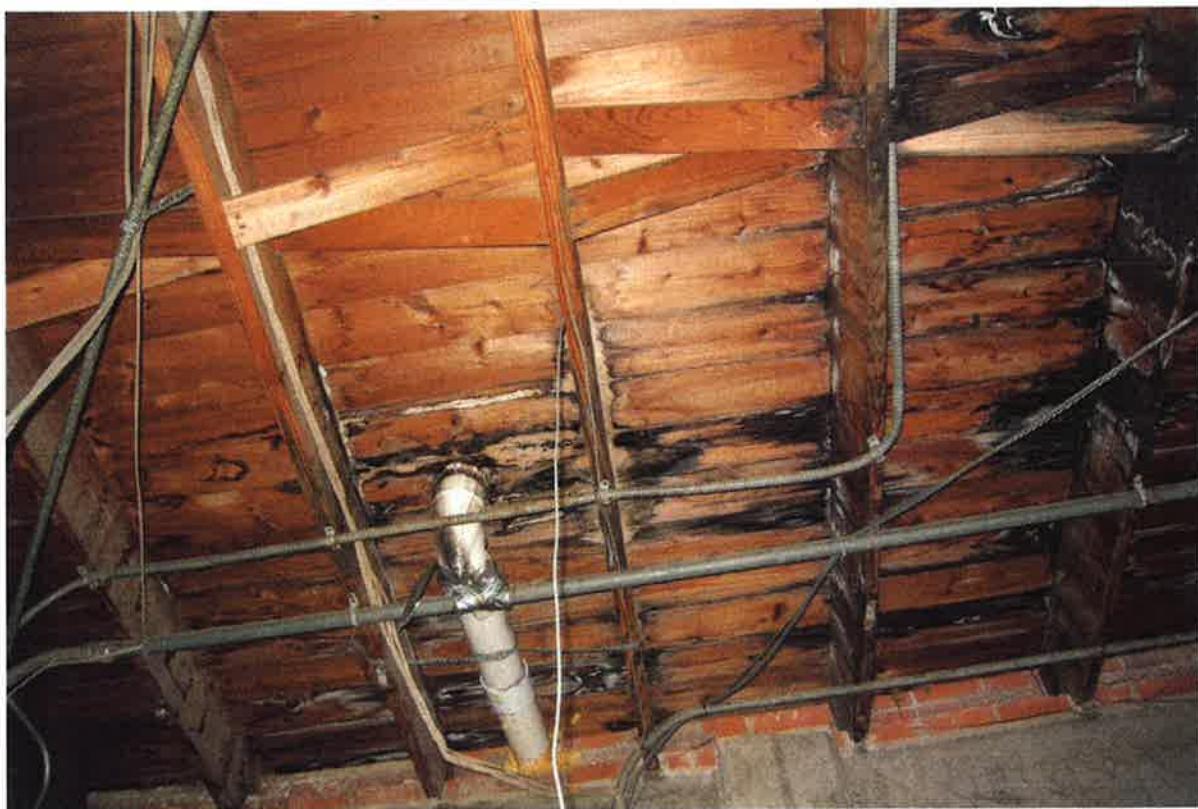
Figure 3: Deterioration of the roof deck and framing below poor roof drainage.

1. There are some locations with decay in the joists and decking which appear to correlate with a scupper on the roof and a location of apparent ponding (Figure 3). We anticipate the wood framed portion of the building will be removed and replaced for the new structure. At a minimum, removal and replacement of the decayed framing is required when the roofing is replaced.
2. Our analysis indicates that the wood framing is efficiently designed for roof loading only. Strengthening will be required for other uses/types of loading.

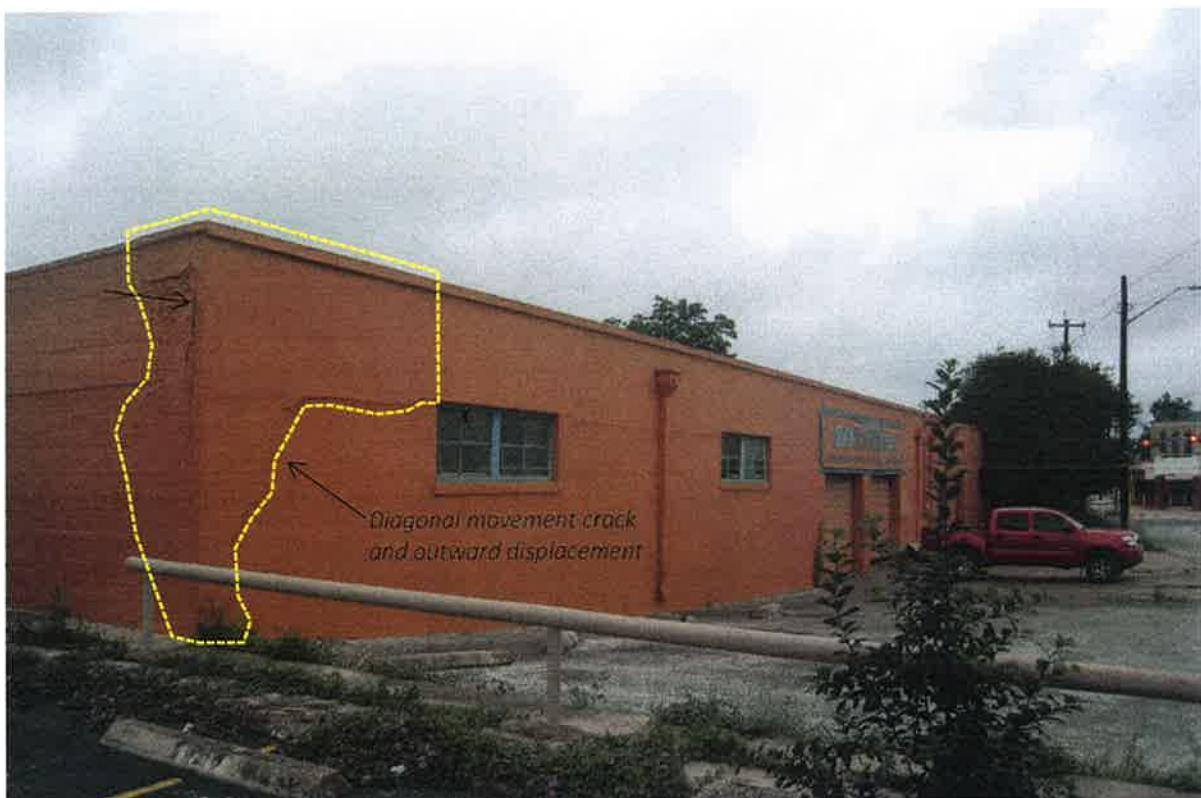
Figure 4: Cracking at the southeast corner along horizontal datum of the lintels and concrete frame.

3. frame, vertical leg of lintels). In addition, there is some cracking which is characteristic of and correlates with the observed building movement. (Figure 4)
4. On the west side, a piece of the brick parapet is loose where the vent pipe is anchored to the building. (Figure 5)
5. The mortar on the parapet is in poor condition (i.e. cracked, loose, or missing). The condition is especially notable on the south side where it is not protected with veneer/stucco finish.
6. The cantilever awning on the main facade appears to be reinforced concrete construction. Overall, it appears to be in good condition with no visible distress. The presence and condition of waterproofing on top of the awning and flashing at the building, which is critical for this type of cantilever feature, is unclear and requires further study.

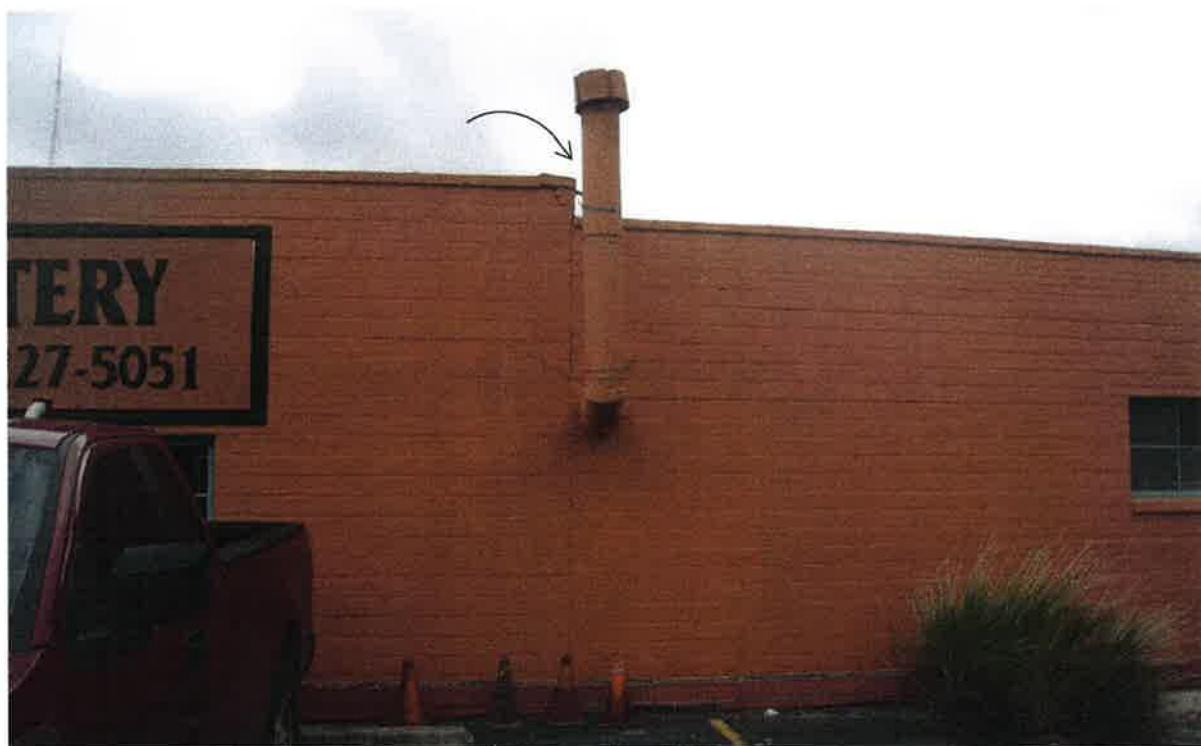
Figure 5: Loose parapet masonry at the vent roof tie-back.

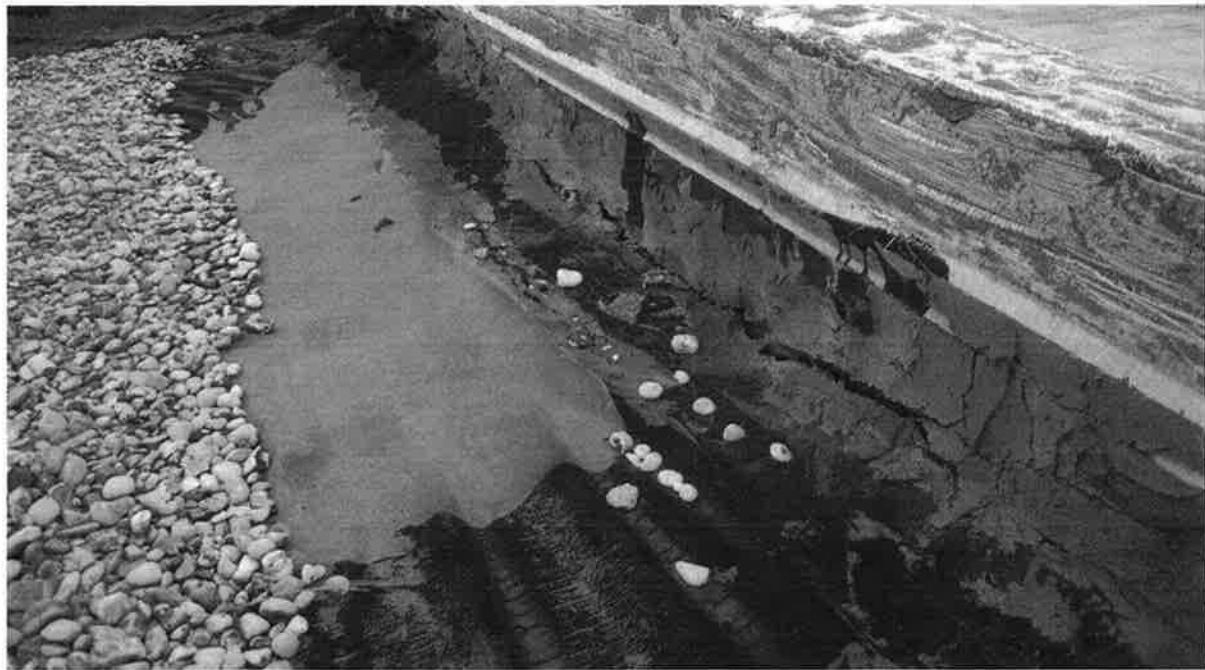
The gravel surfaced built-up roof and perimeter roof flashing has reached the end of its useful life and requires replacement (Figure 6). Correcting deficiencies in the roof drainage and waterproofing to protect the structure below are required as part of a plan for rehabilitation.

Figure 6: Drainage inadequacy is causing water to pond on the roof.
