# HISTORIC AND DESIGN REVIEW COMMISSION

May 01, 2020

**HDRC CASE NO:** 2020-122  
**ADDRESS:** 533 E CARSON  
**LEGAL DESCRIPTION:** NCB 993 BLK 3 LOT S 96.91 FT 7 (ARB 7C)  
**ZONING:** MF-33, H  
**CITY COUNCIL DIST.:** 2  
**DISTRICT:** Government Hill Historic District  
**APPLICANT:** Mary Jo Vargas/VARGAS MARY JOSEPHINE  
**OWNER:** Mary Jo Vargas/VARGAS MARY JOSEPHINE  
**TYPE OF WORK:** Siding and window replacement  
**APPLICATION RECEIVED:** March 04, 2020  
**60-DAY REVIEW:** May 03, 2020  
**CASE MANAGER:** Huy Pham

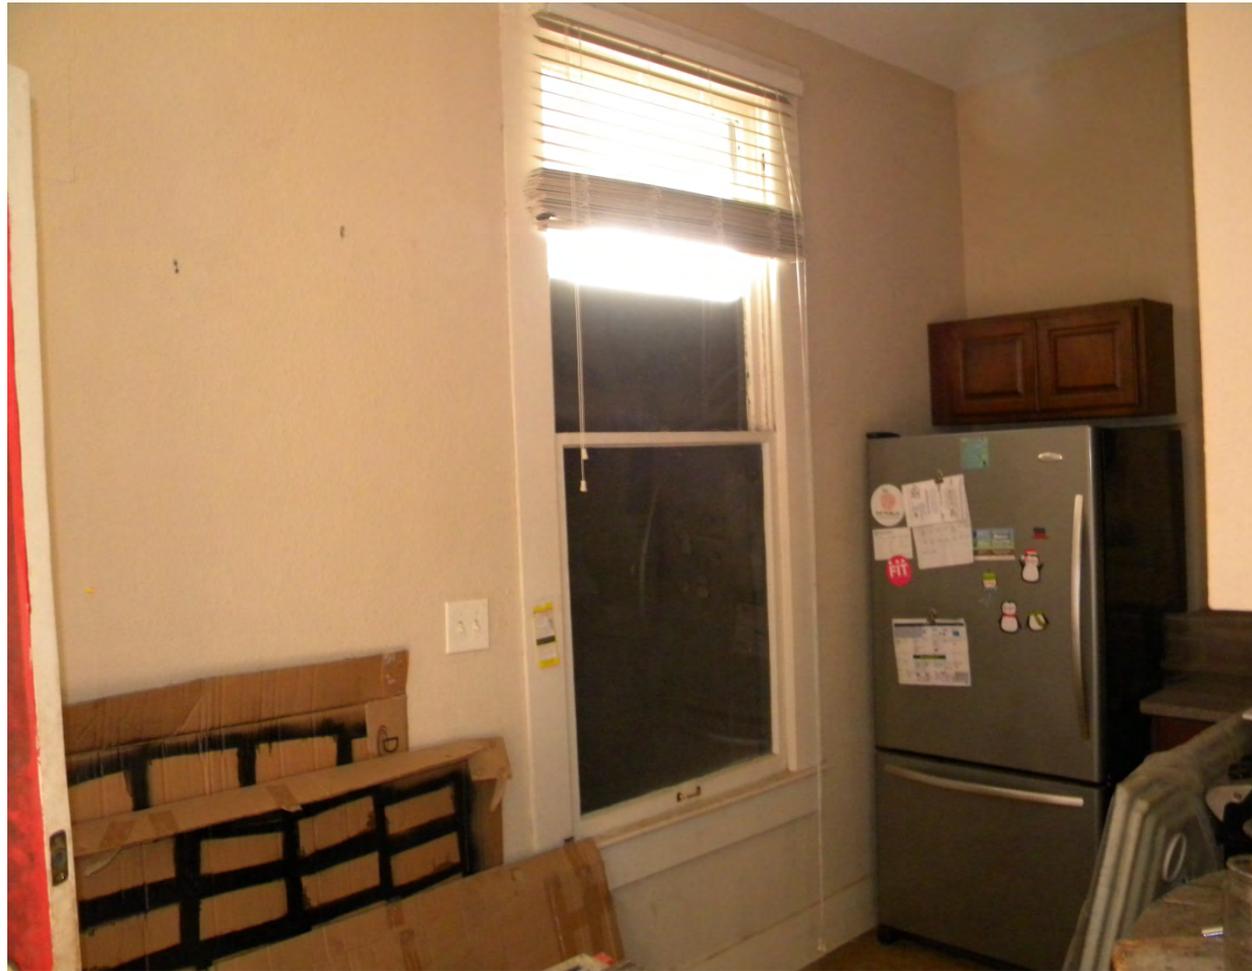
# Unit I, Living Kitchen Window A

Faces front of property, requires lead paint remediation. If replaced, a 4 panel wood Pella window would be used.

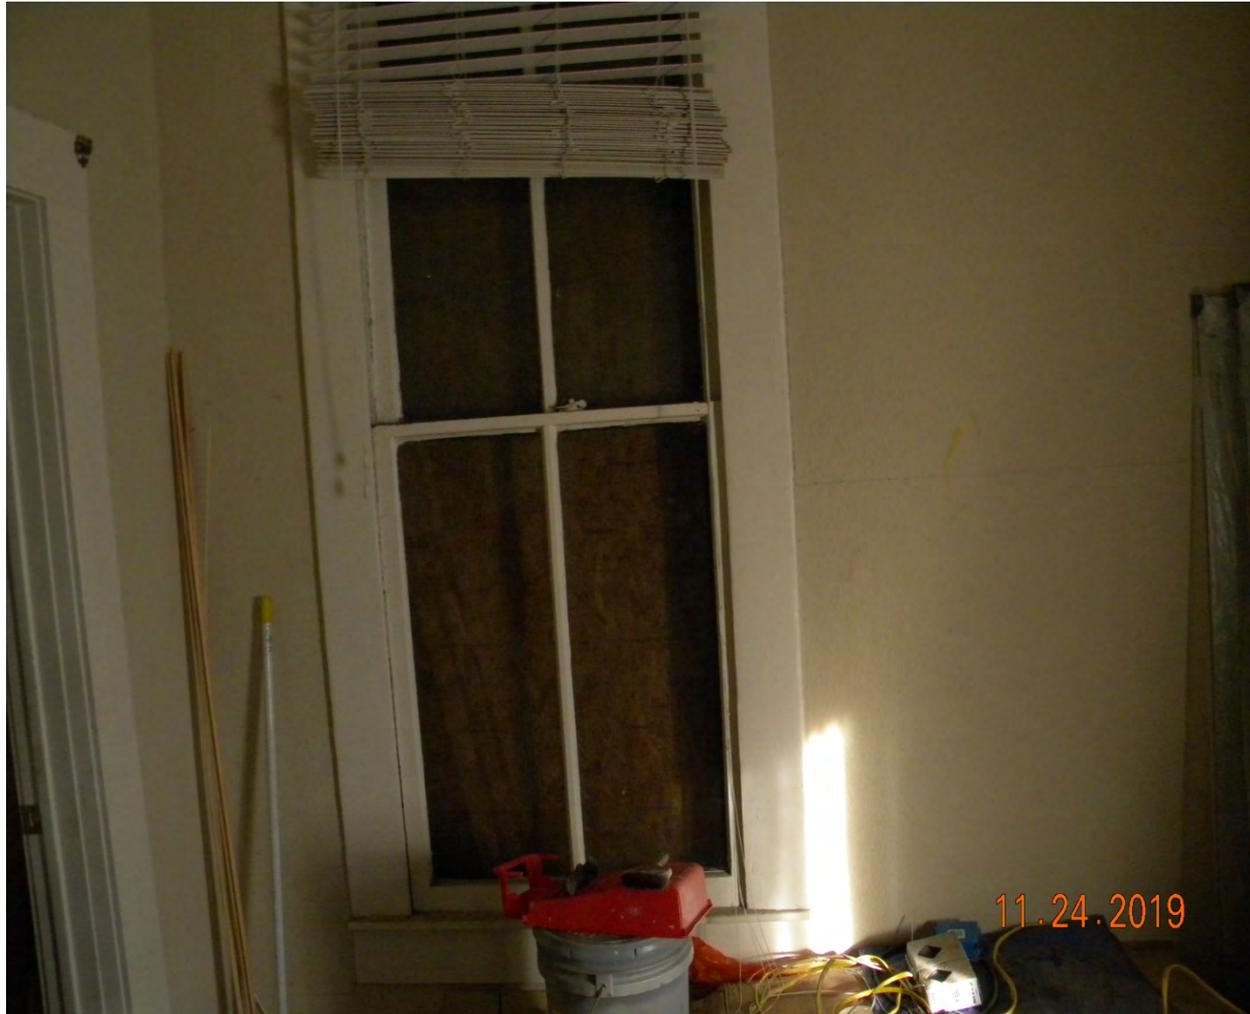
# Unit I, Living Room, Window B

Requires lead  
paint  
remediation  
and repairs.

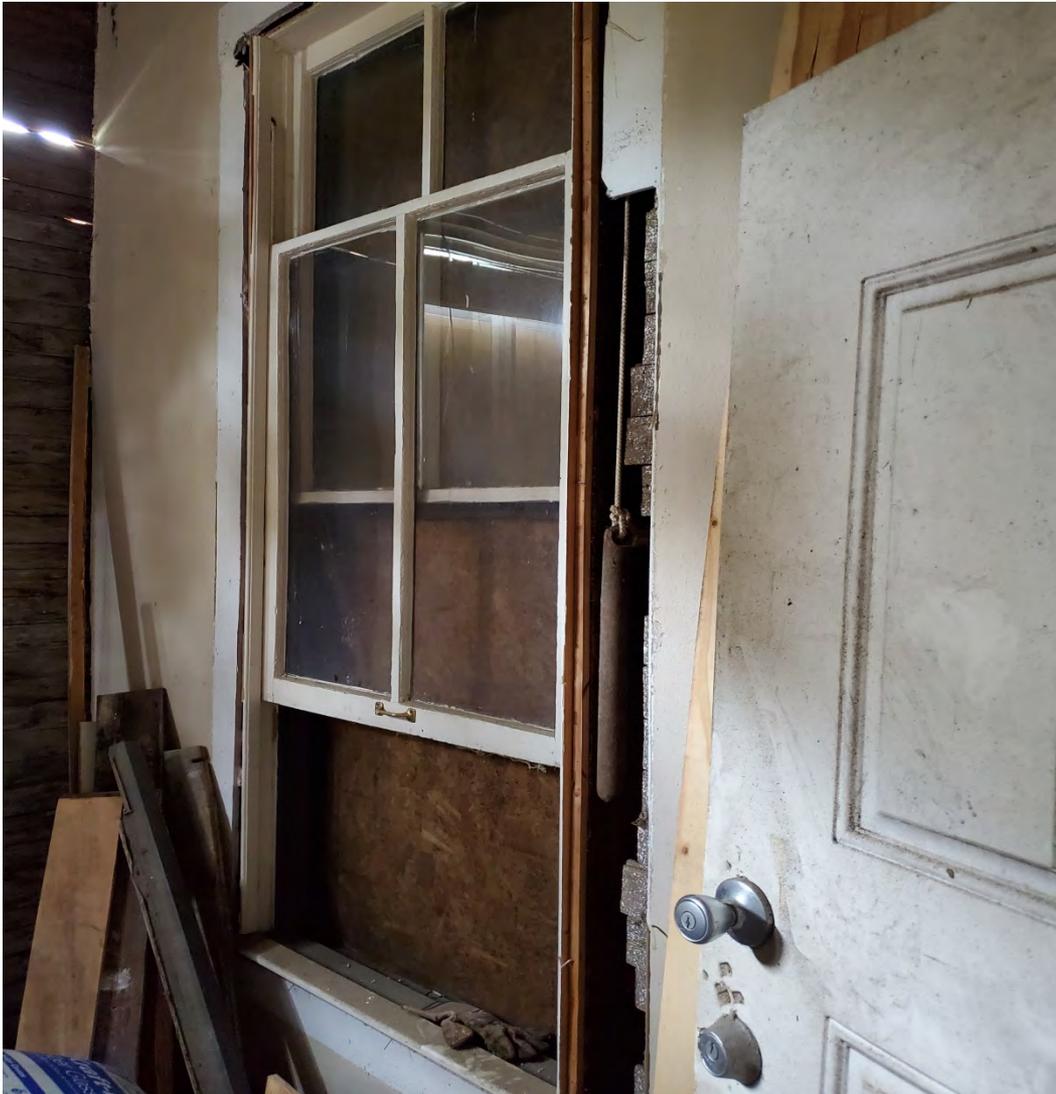
# Unit I, Bedroom 1, Window C

Requires lead  
paint  
remediation  
and repairs.

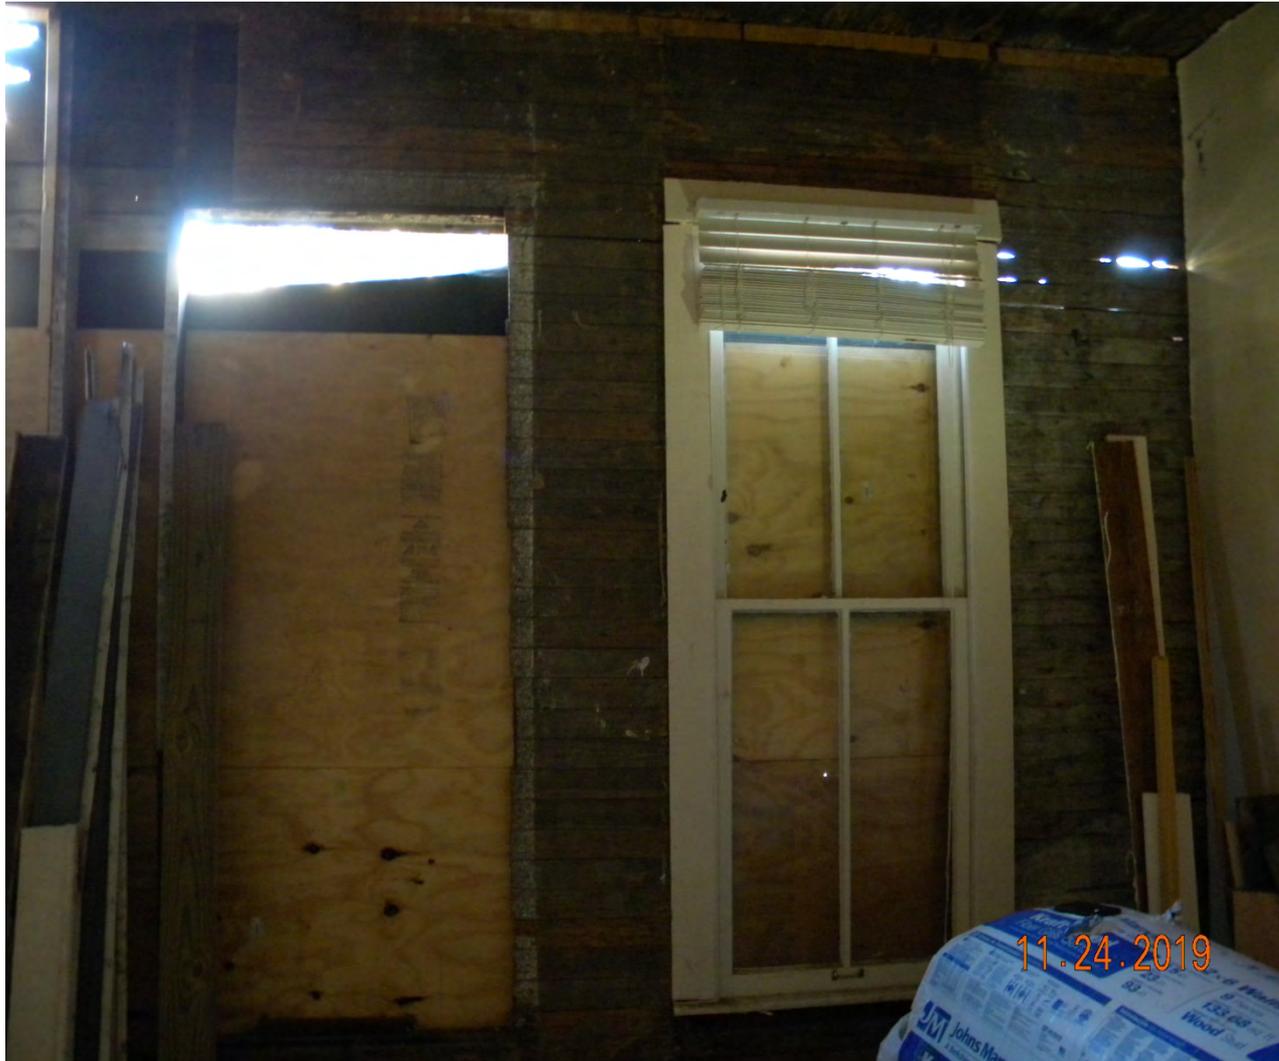
# Unit I, Bedroom 1, Windows

Windows D  
and E of  
Unit I,  
Bedroom 1

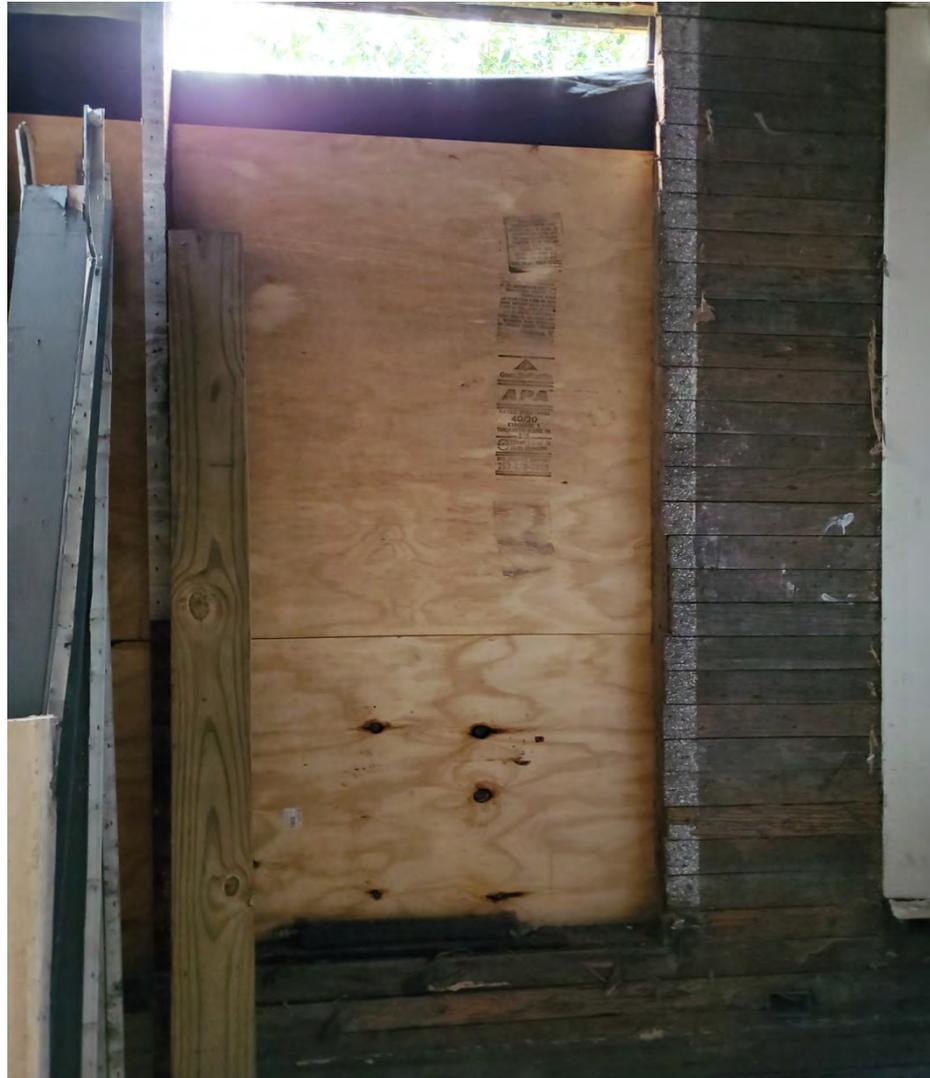
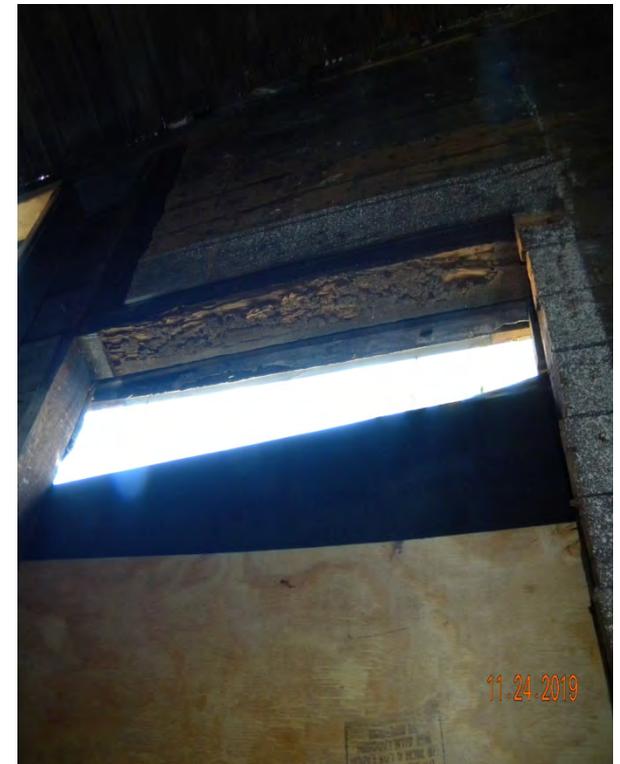
# Unit I, Bedroom 1, Window E

Window burned and damaged during fire suppression activities.

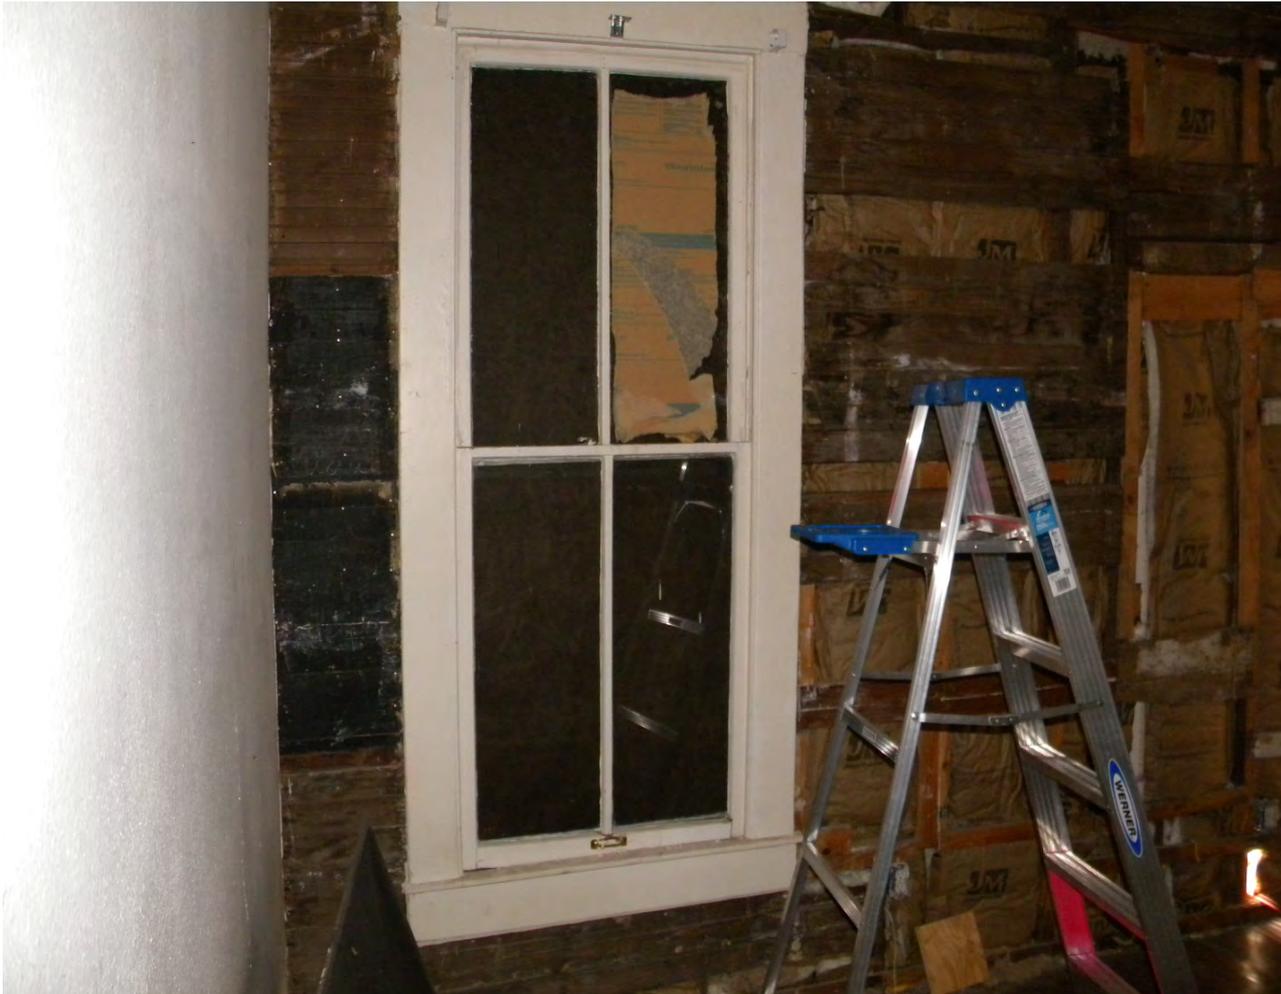
# Unit I, Bedroom 2, Window F

Requires lead paint remediation and repairs. Next two slides provide closer view of window.

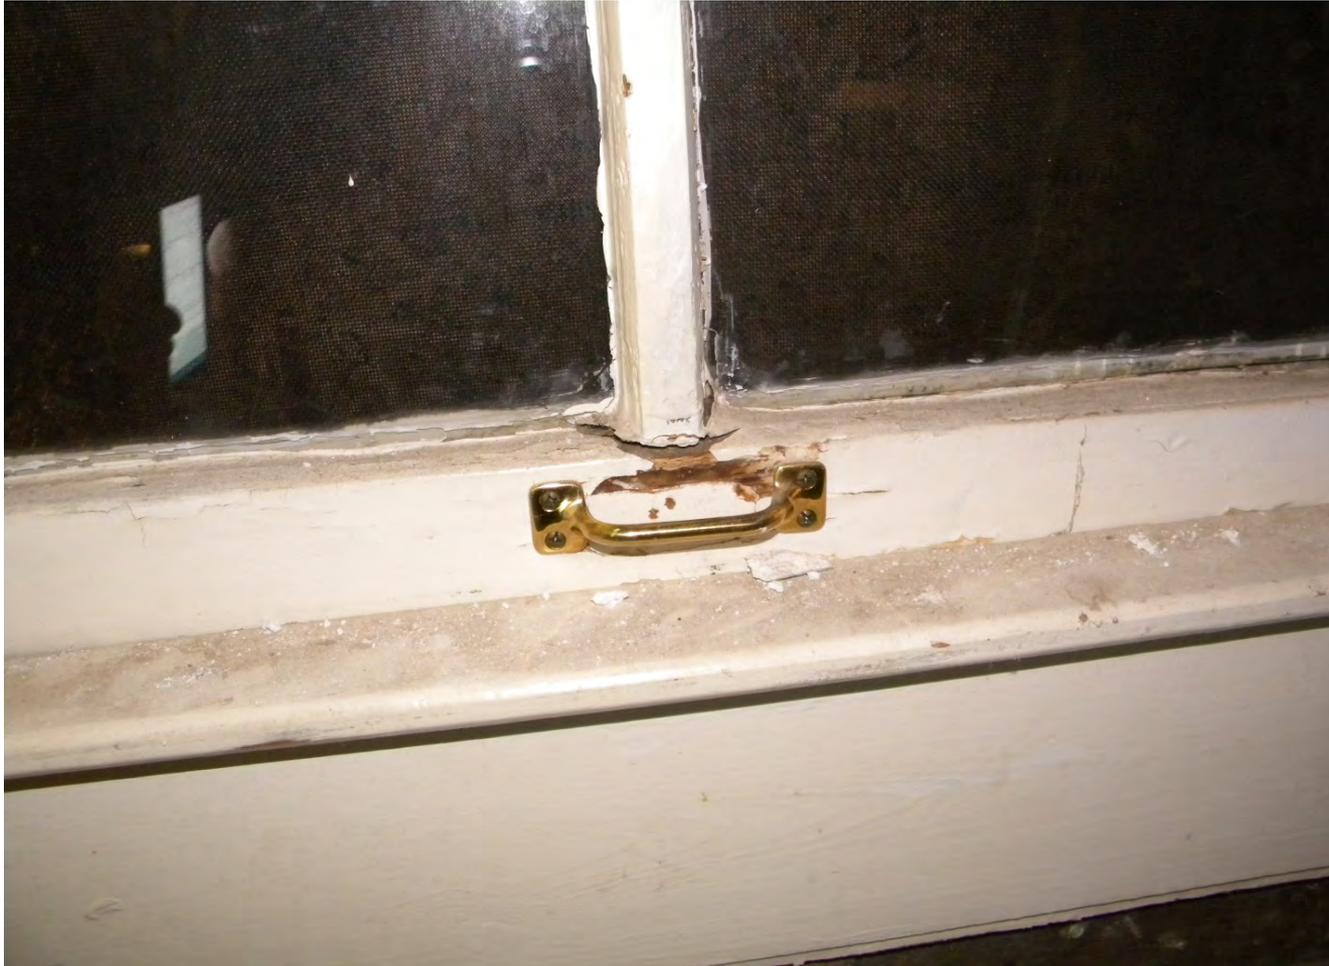
# Unit I, Bedroom 2, Window F, cont.

Requires lead  
paint  
remediation  
and repairs.

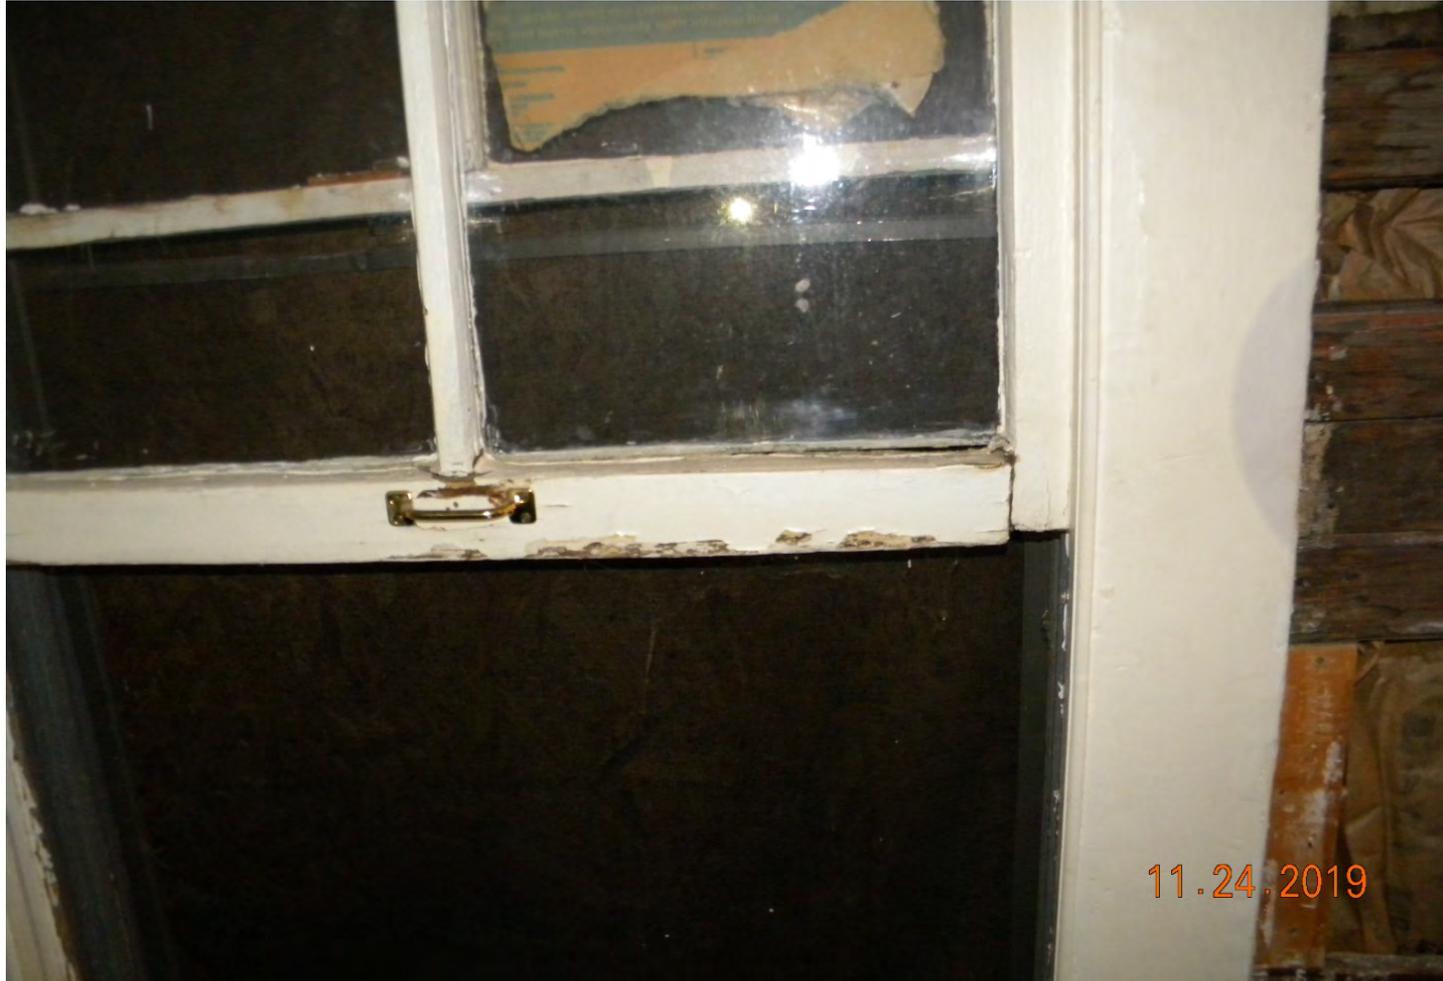
# Unit I, Bedroom 2, Window F, cont.

Requires  
lead paint  
remediation  
and repairs.

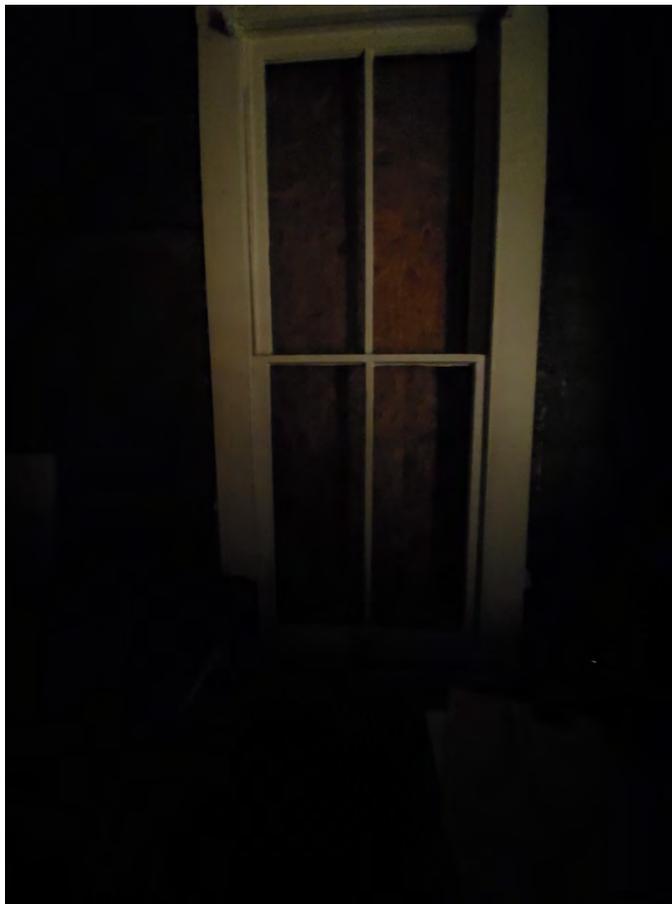
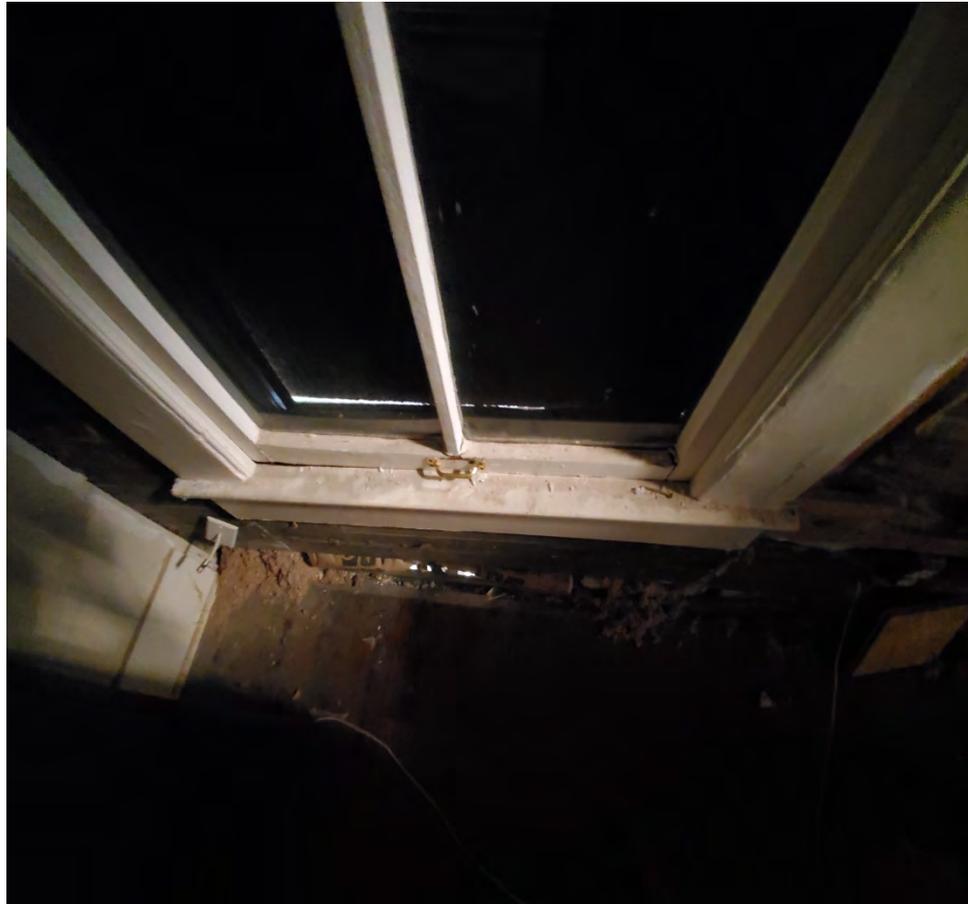
# Unit II, Living Room, Window G

Requires lead paint remediation and repairs.

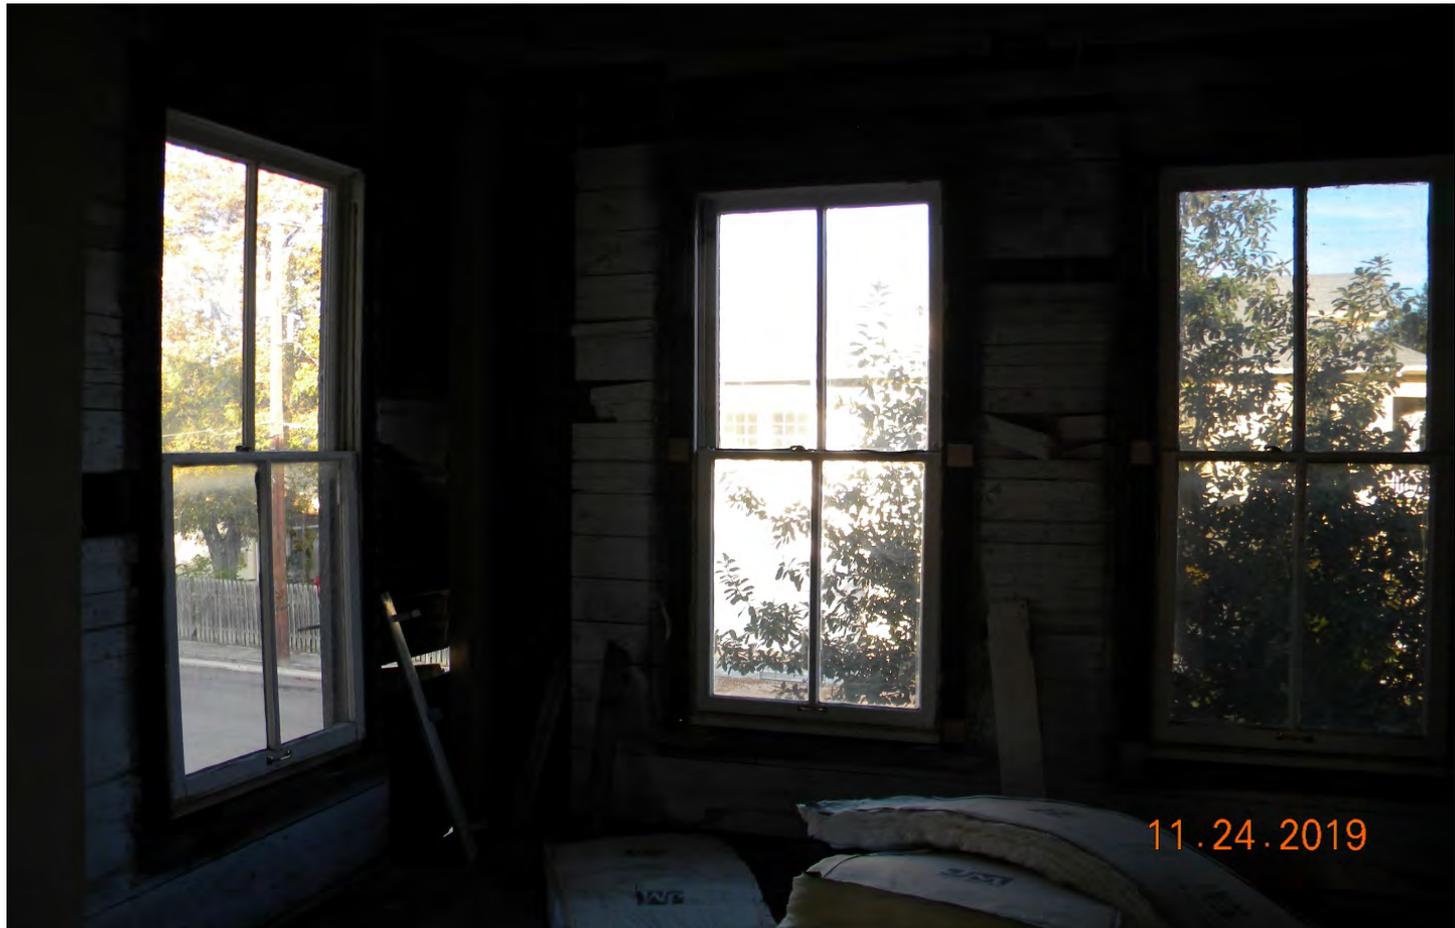
# Unit III, Bedroom 1, Windows

Windows from right to left are H, I and J

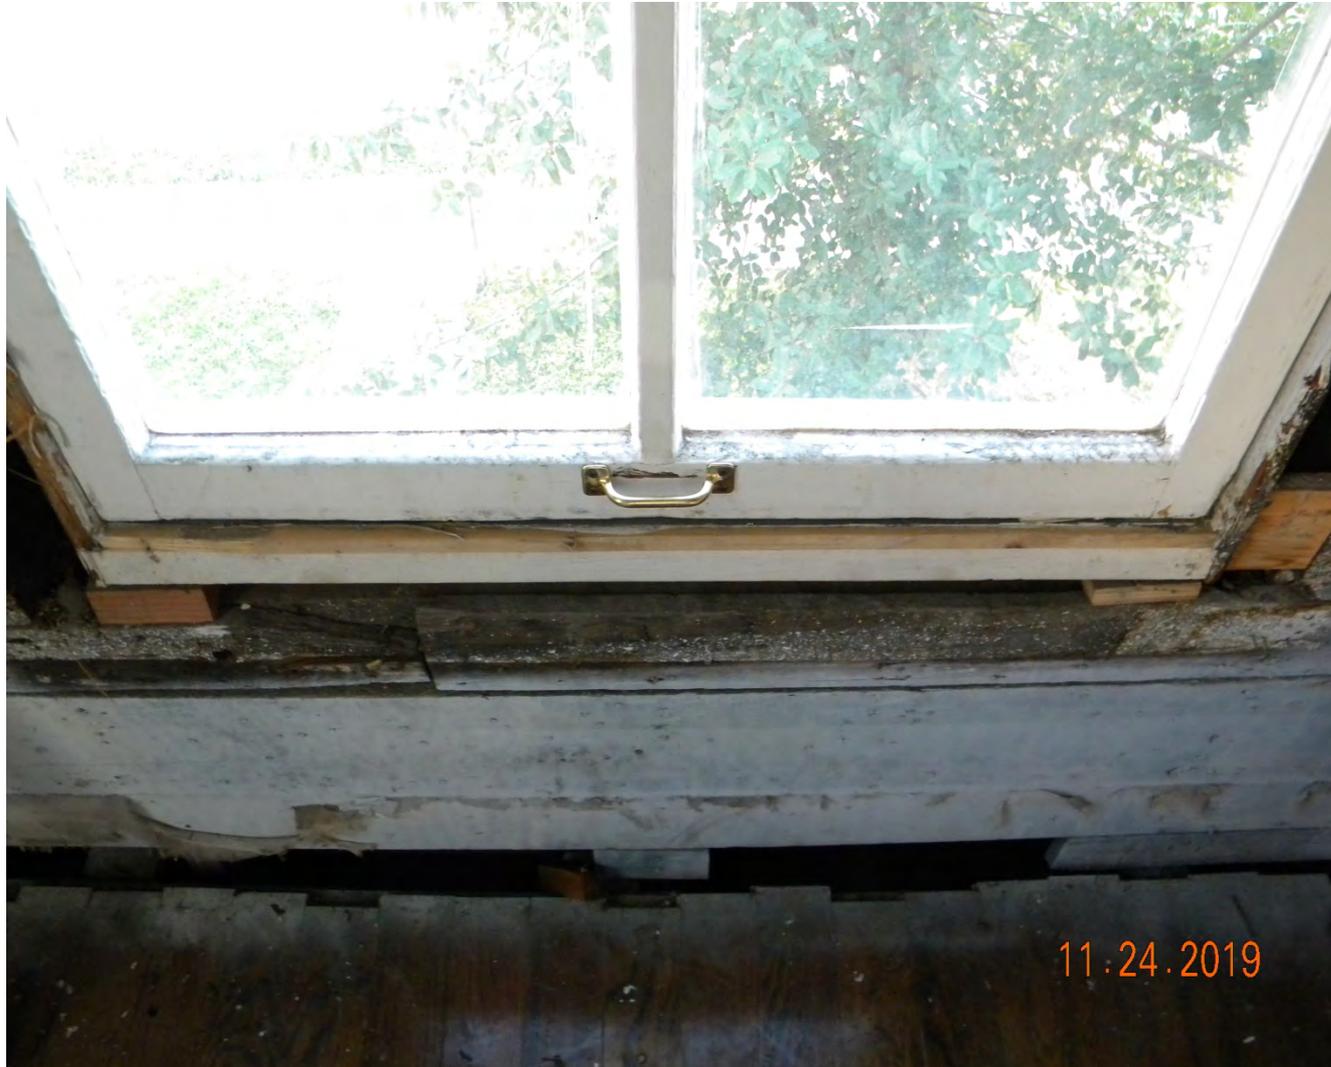
# Unit III, Bedroom 1, Window H

Requires  
lead paint  
remediation  
and repairs.

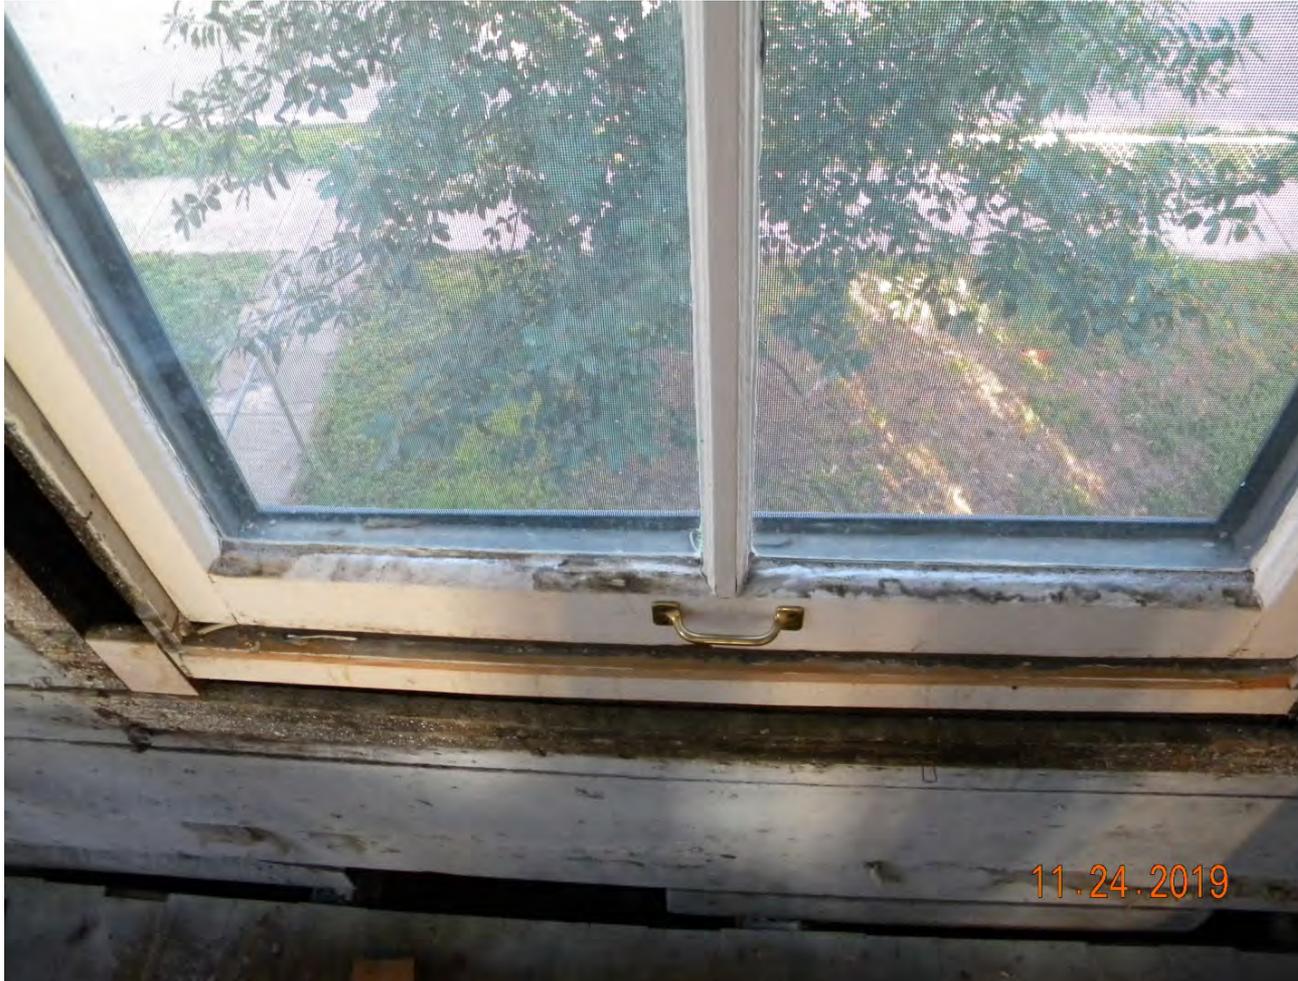
# Unit III, Bedroom 1, Window I

Requires  
lead paint  
remediation  
and repairs.

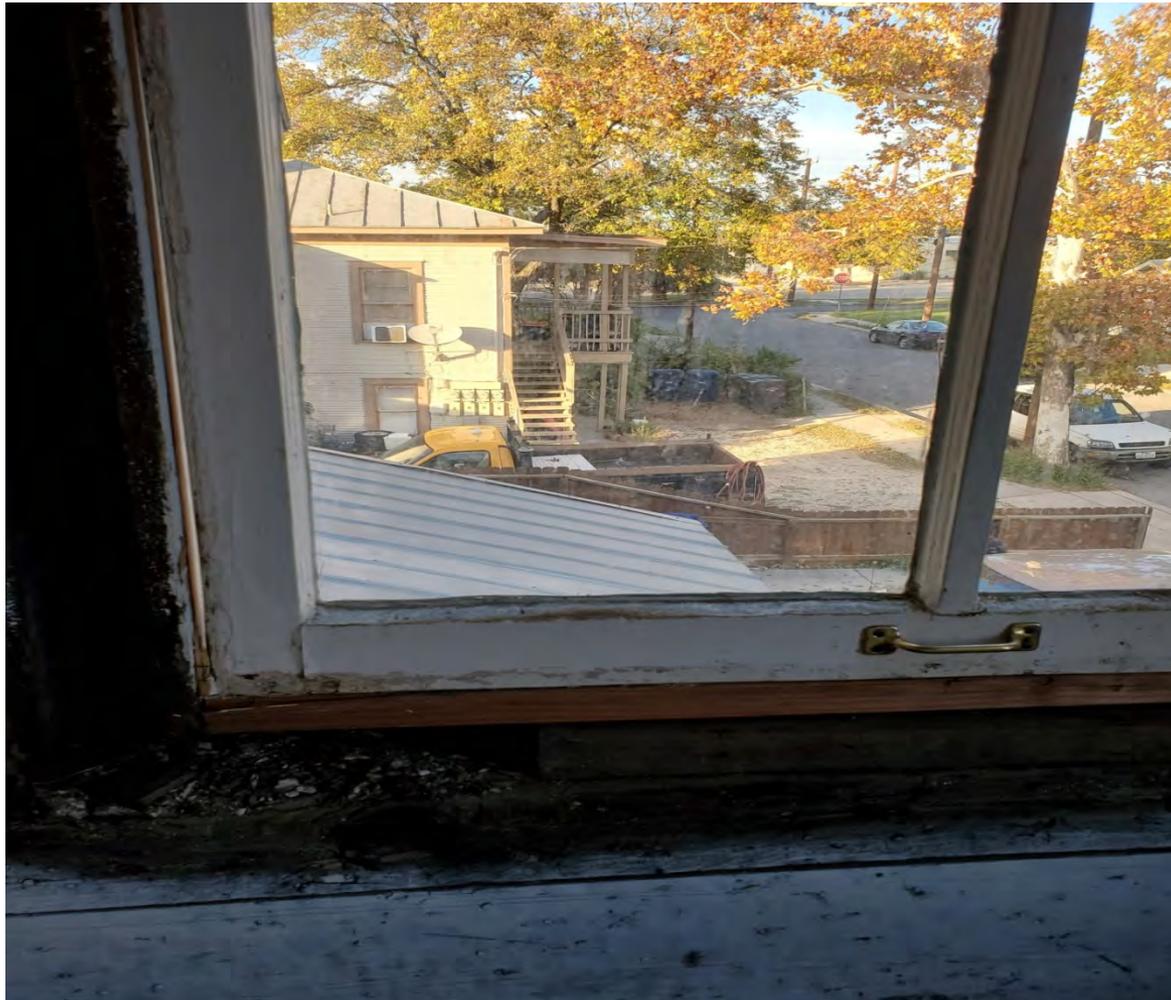
# Unit III, Bedroom 1, Window J

Requires lead  
paint  
remediation  
and repairs.

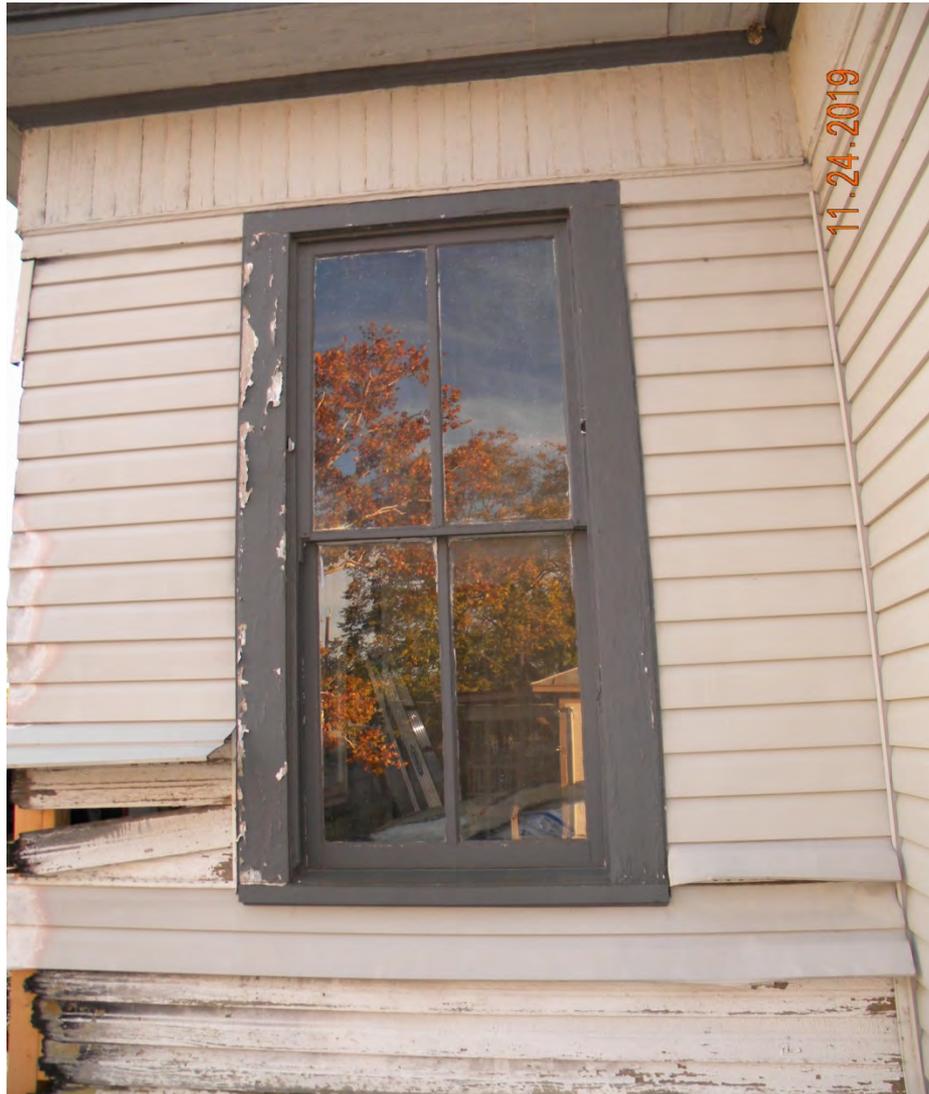
# Unit III, Bedroom 1, Window J

Exterior window  
requires lead paint  
remediation and repairs.

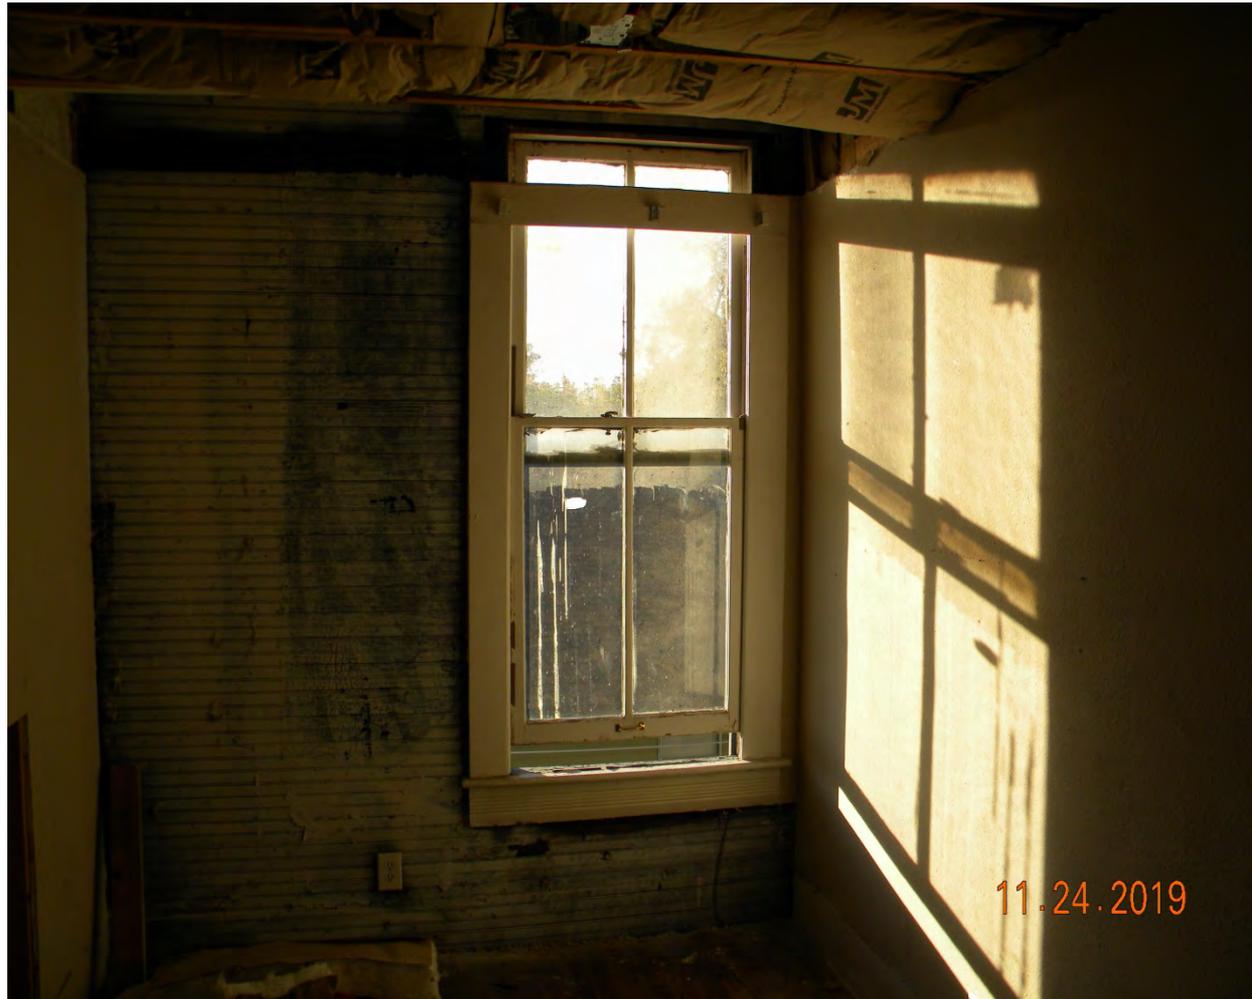
# Unit III, Living Room Window K

Requires lead  
paint  
remediation  
and repairs.

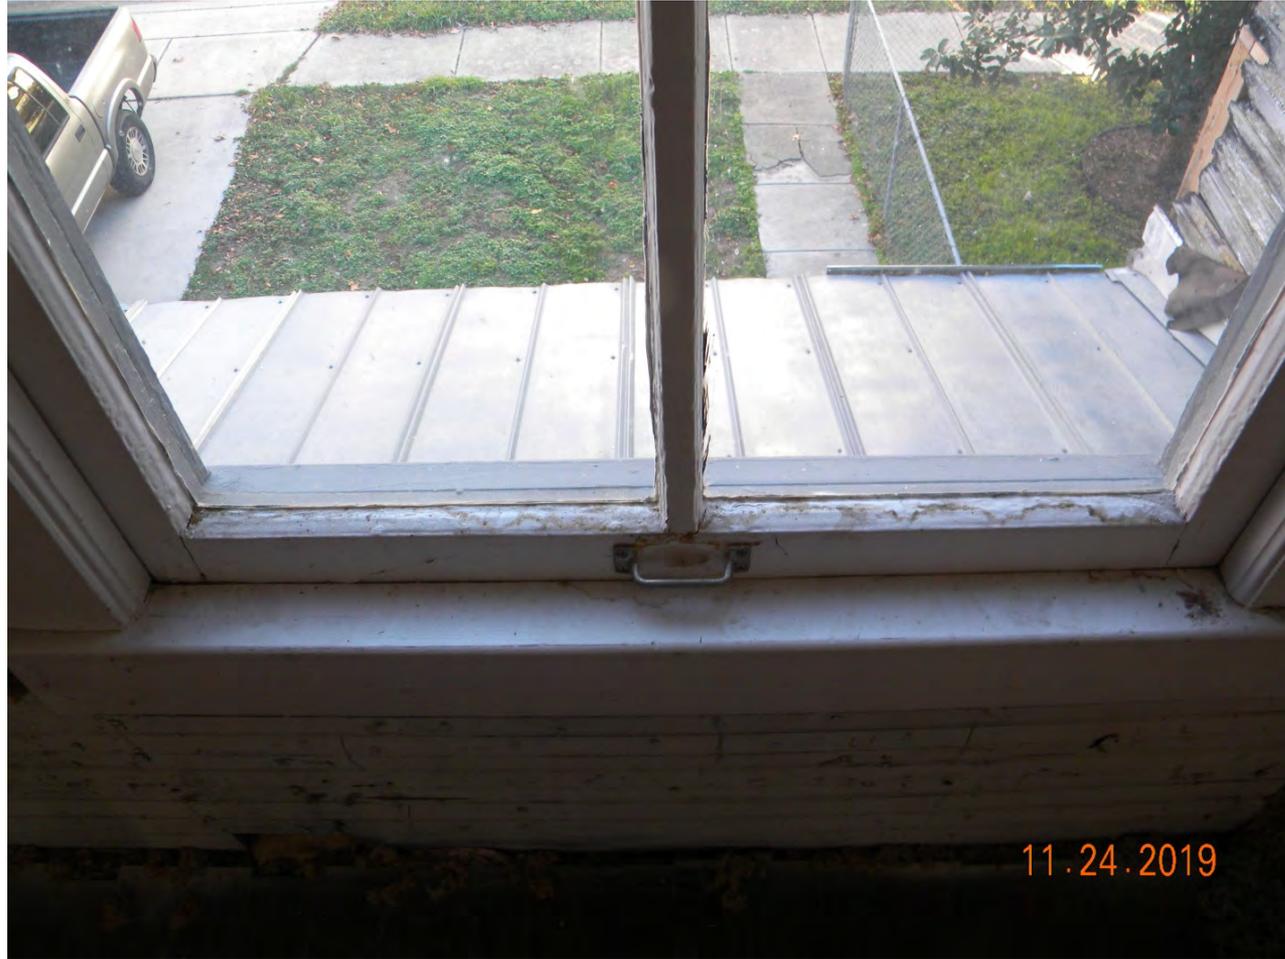
# Unit IV, Living Room Window L

Requires lead paint remediation and repairs.

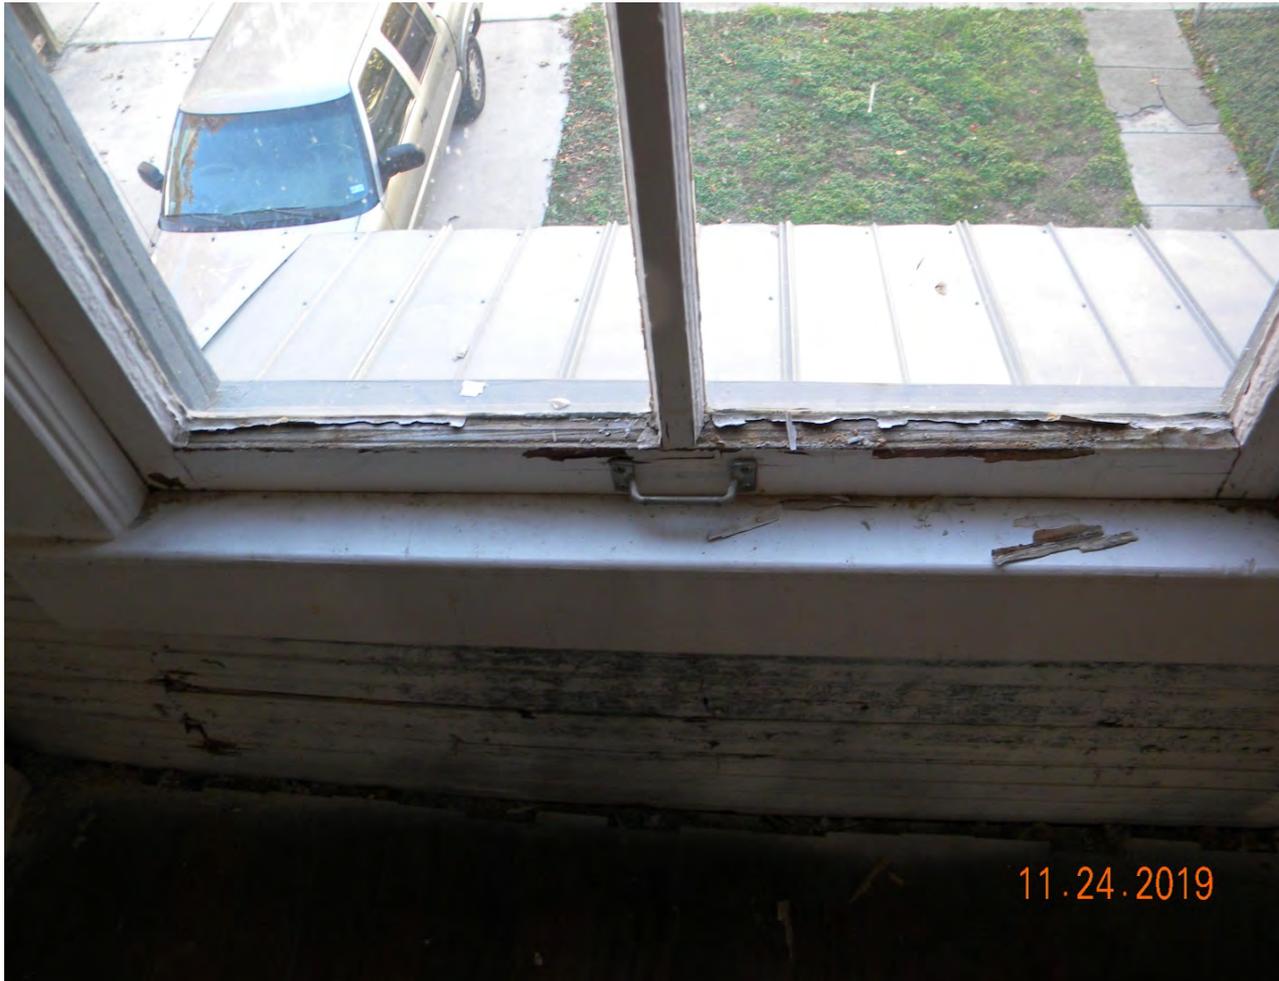
# Unit IV, Living Room Window M

Requires  
lead paint  
remediation  
and repairs.
