# HISTORIC AND DESIGN REVIEW COMMISSION

May 01, 2020

**HDRC CASE NO:** 2020-122  
**ADDRESS:** 533 E CARSON  
**LEGAL DESCRIPTION:** NCB 993 BLK 3 LOT S 96.91 FT 7 (ARB 7C)  
**ZONING:** MF-33, H  
**CITY COUNCIL DIST.:** 2  
**DISTRICT:** Government Hill Historic District  
**APPLICANT:** Mary Jo Vargas/VARGAS MARY JOSEPHINE  
**OWNER:** Mary Jo Vargas/VARGAS MARY JOSEPHINE  
**TYPE OF WORK:** Siding and window replacement  
**APPLICATION RECEIVED:** March 04, 2020  
**60-DAY REVIEW:** May 03, 2020  
**CASE MANAGER:** Huy Pham

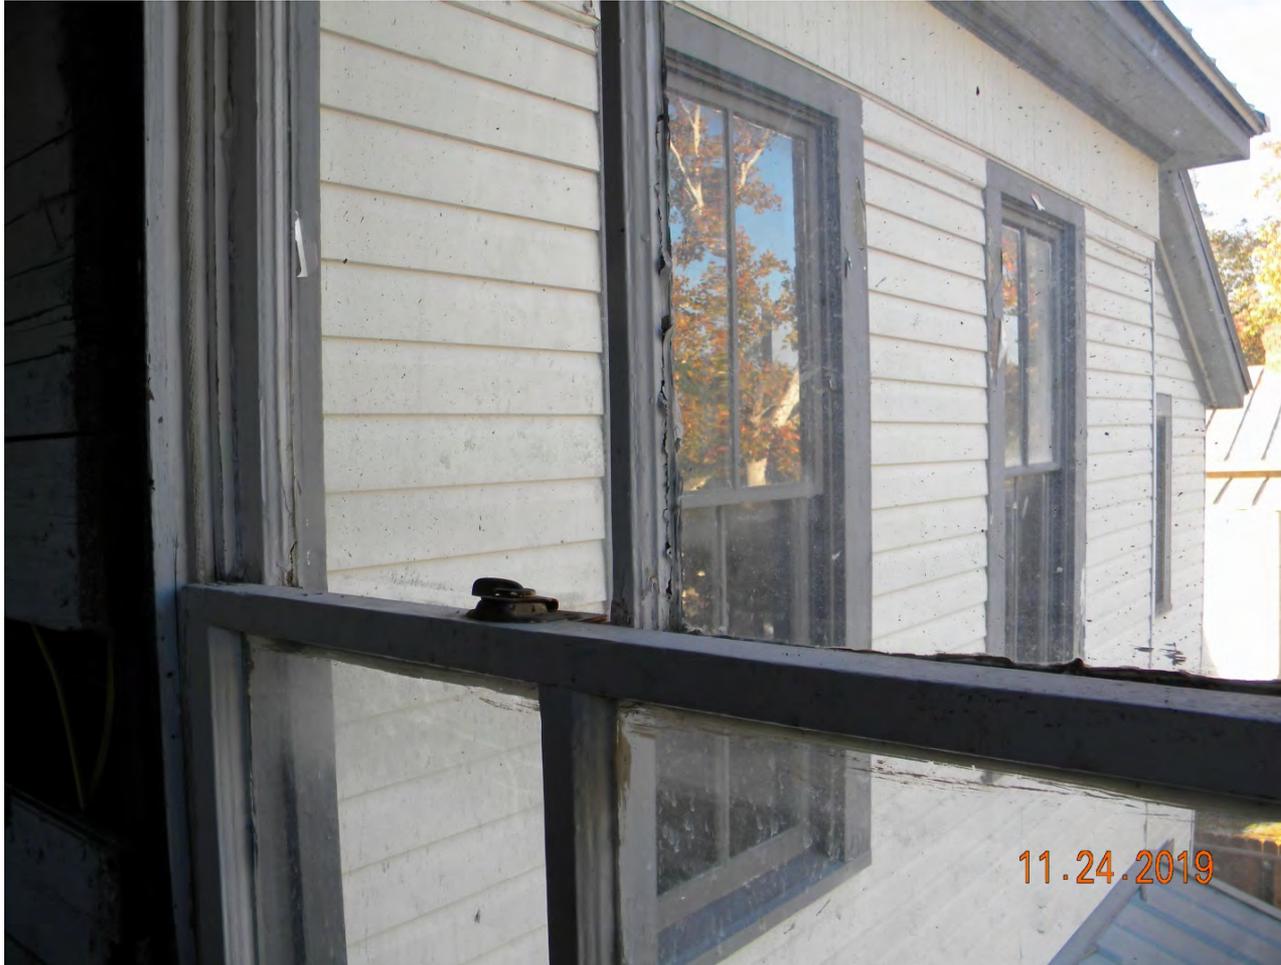
# Unit IV, Living Room Windows

Exterior windows L and M, requires lead paint remediation and repairs.

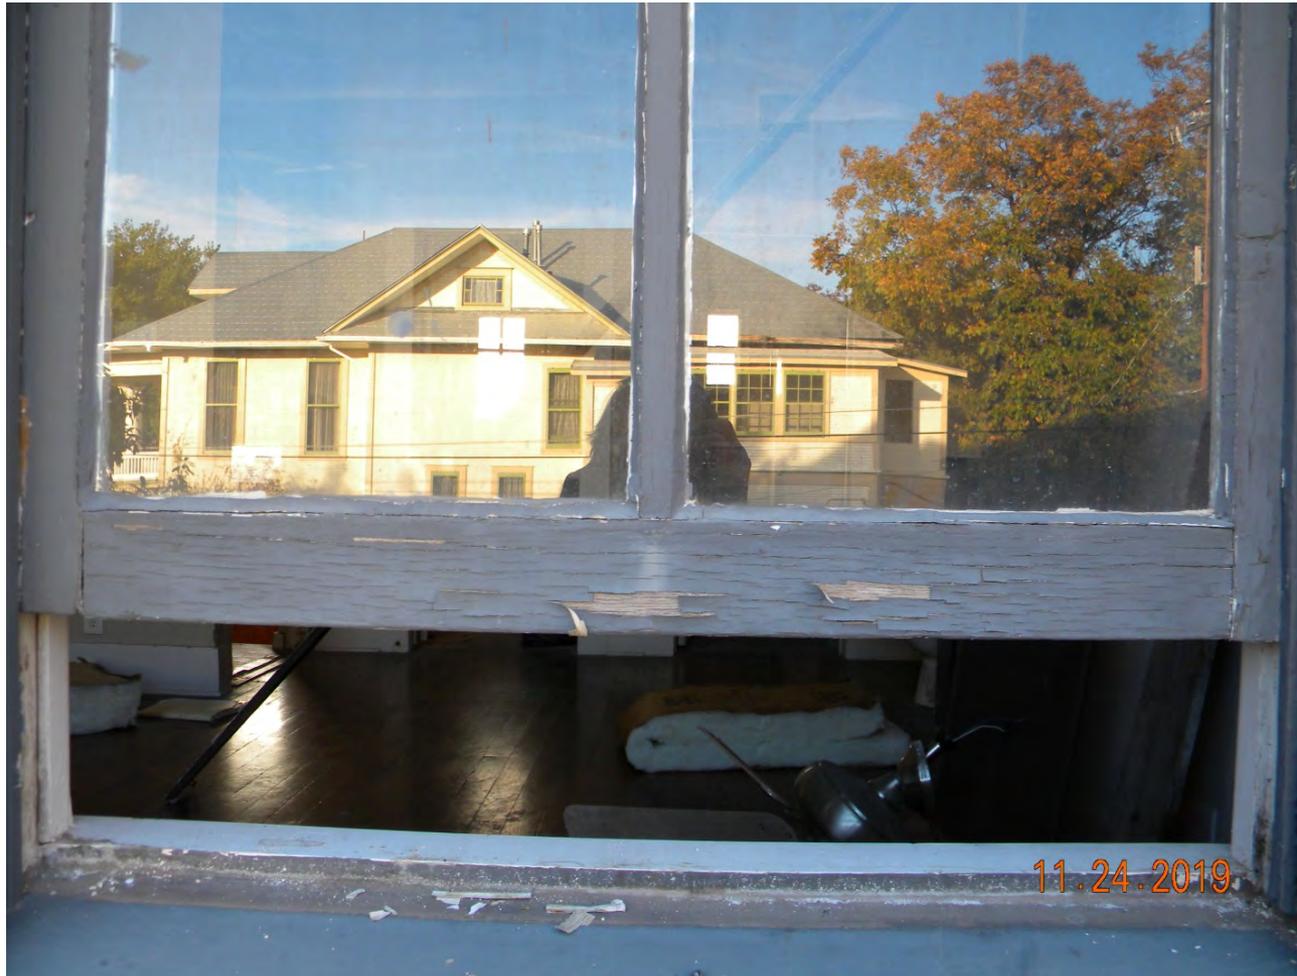
# Unit IV, Living Room Window L

Exterior window, requires lead paint remediation and repairs.

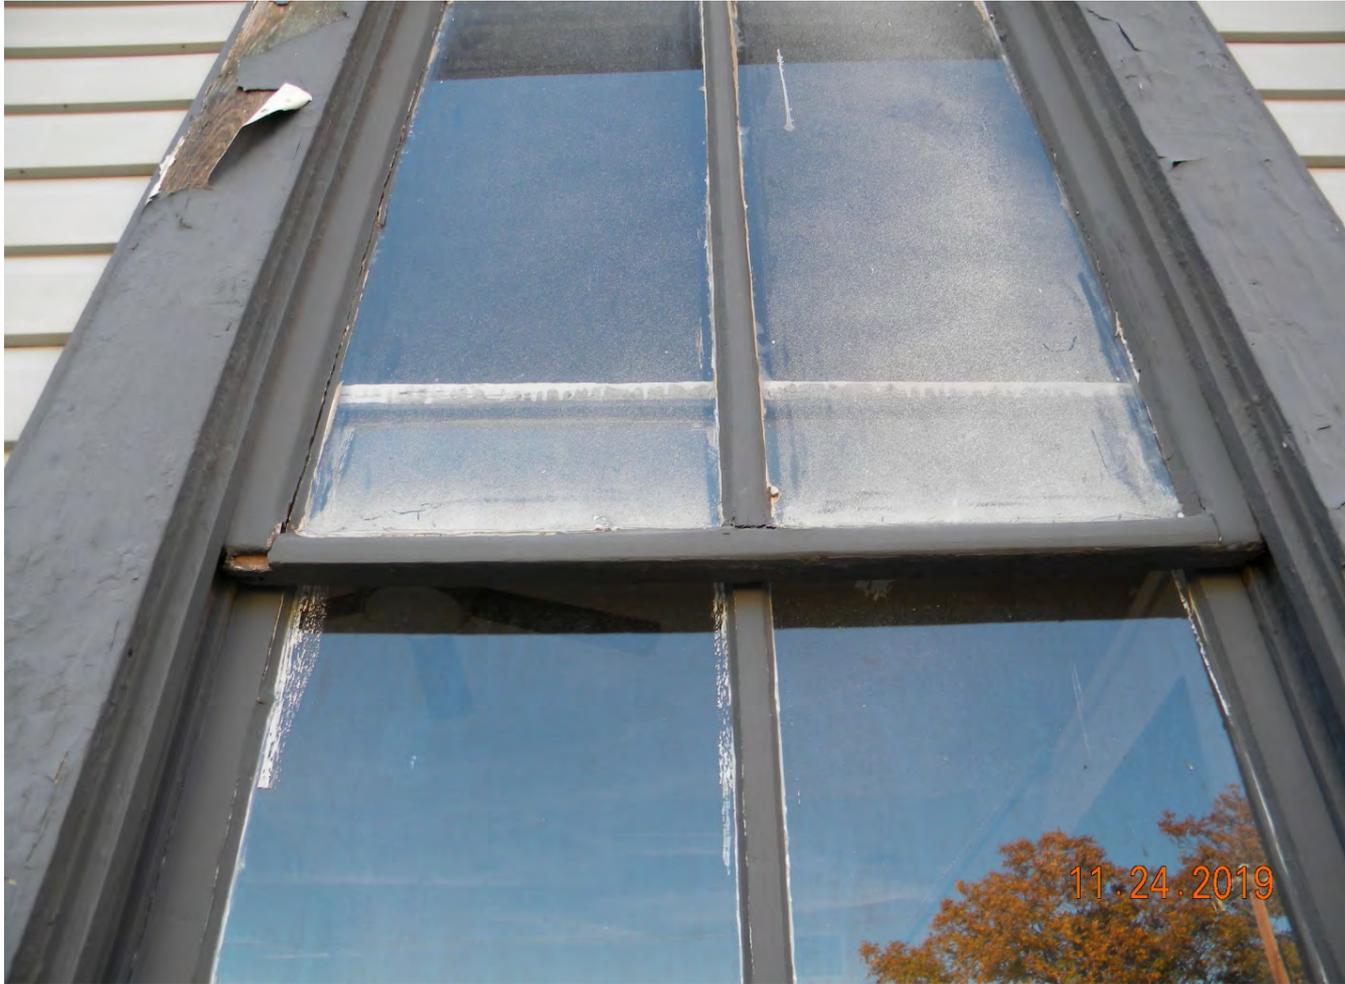
# Unit IV, Living Room Window M

Exterior window requires lead paint remediation and repairs.

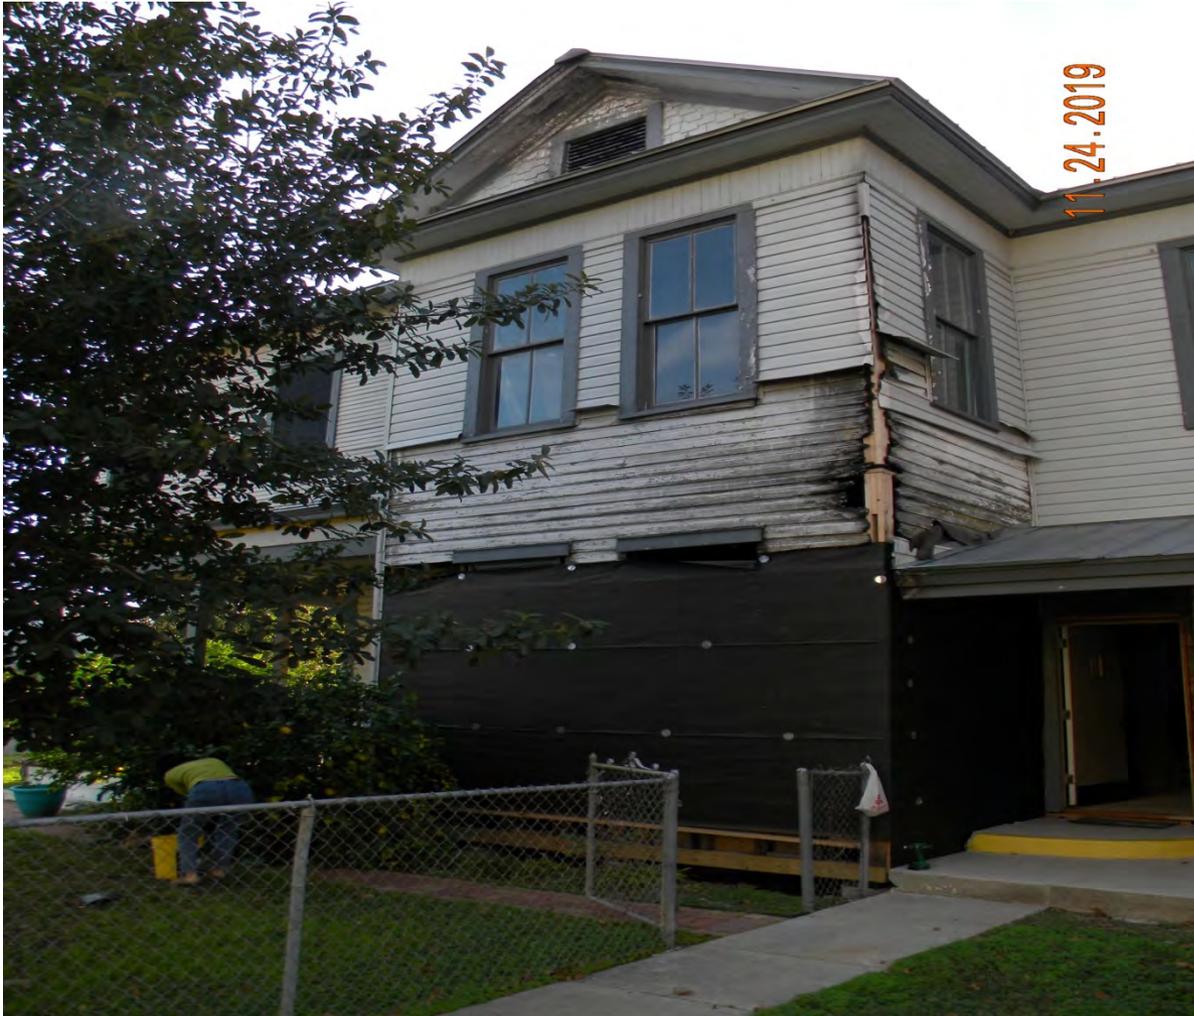
# Exterior, East Side of Property

The extent of the fire damage is evident when the aluminum siding is peeled back. The east side of the property had aluminum, except for the second story portion above the porch. A picture of this area can be seen in the next slide.

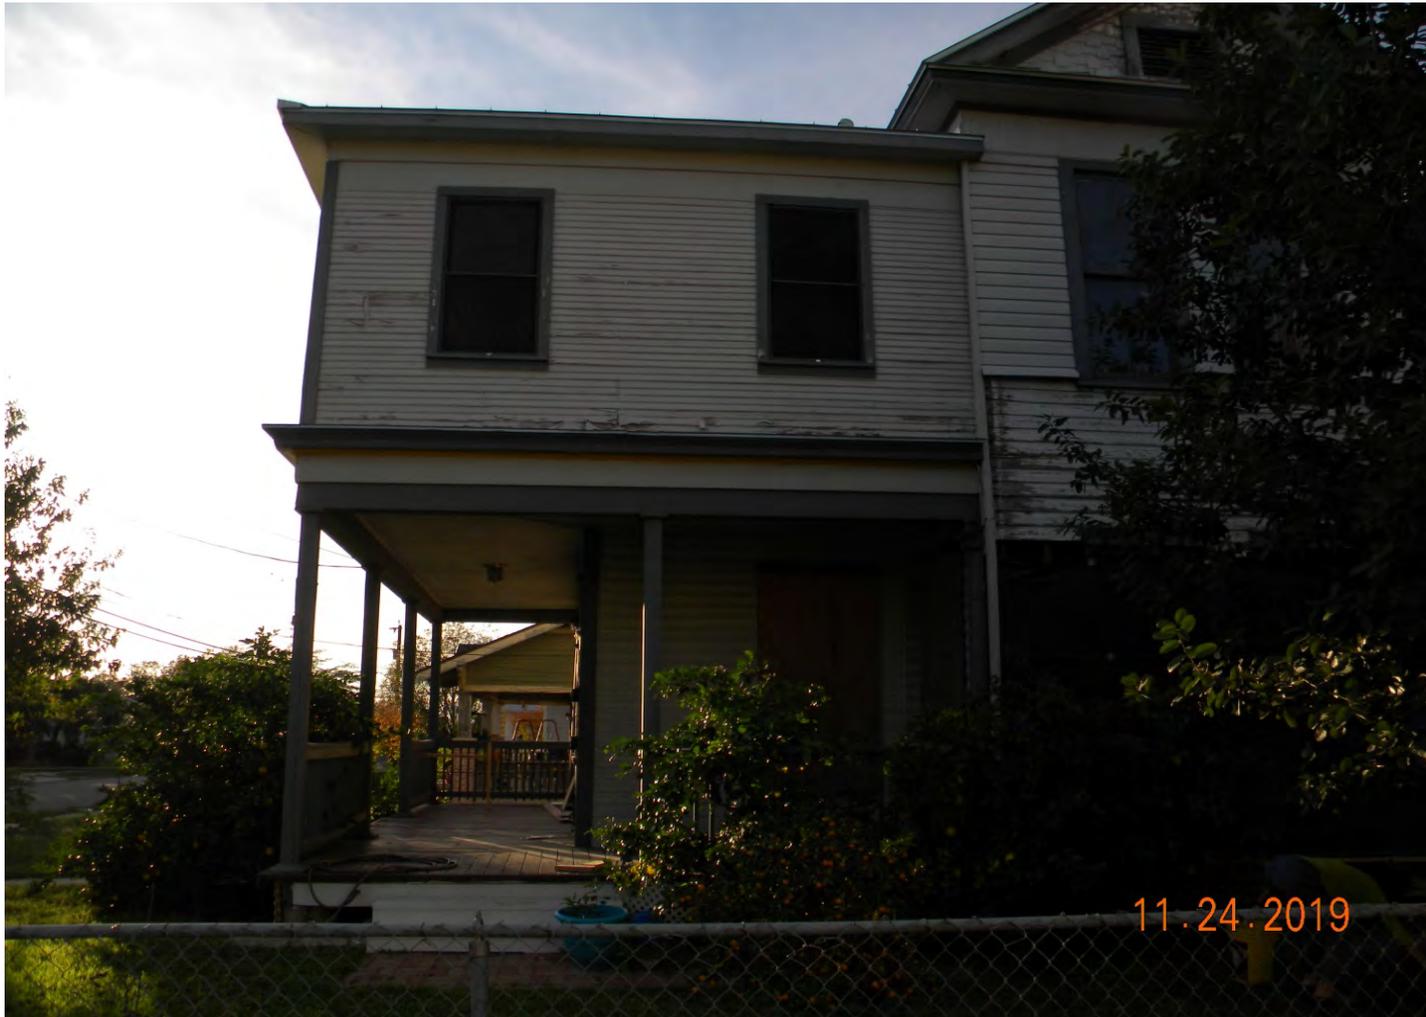
# Exterior, East Side of Property

Upstairs area above the porch was enclosed using waterfall siding.

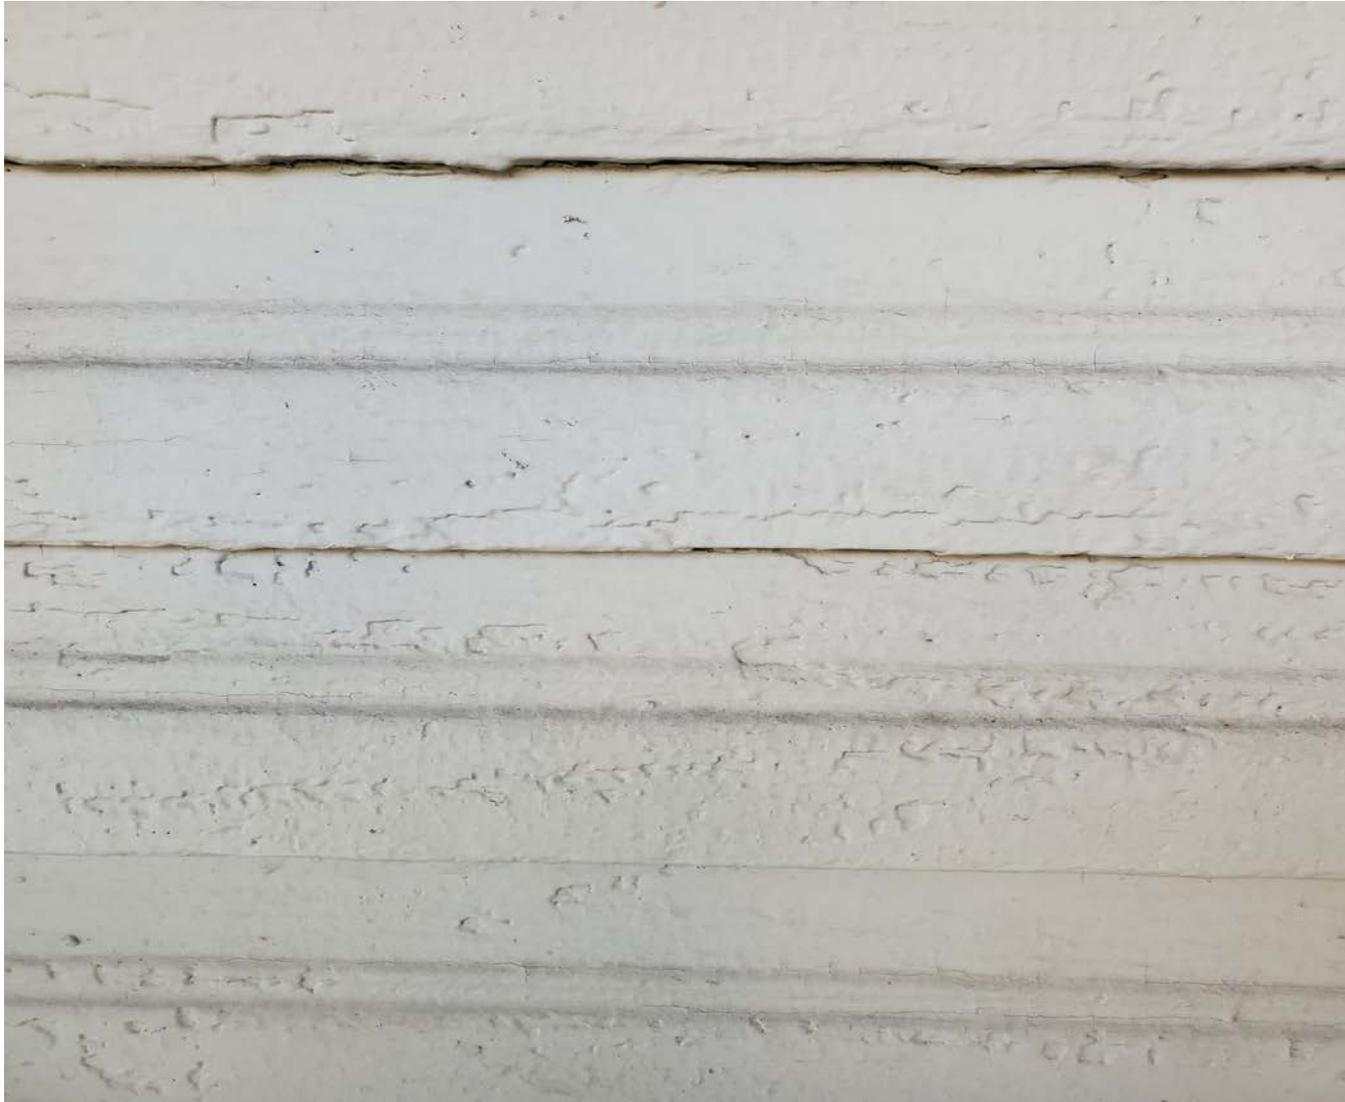
# Picture of Original Siding

Original siding is located on the front of the property and requires lead paint remediation and repairs.

Staff does not recommend approval of items 1, 2, and 3 based on finding c. All existing wood siding should be restored in place, and any completely missing or fire damaged areas should feature wood lap siding that matches the historic profile.

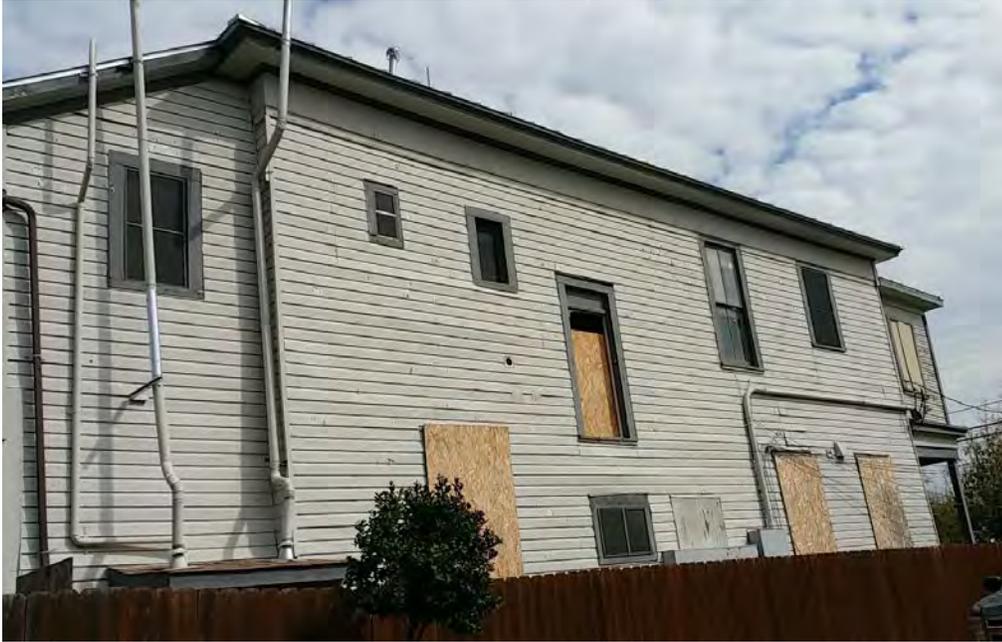
Aluminum siding on the east side of the property

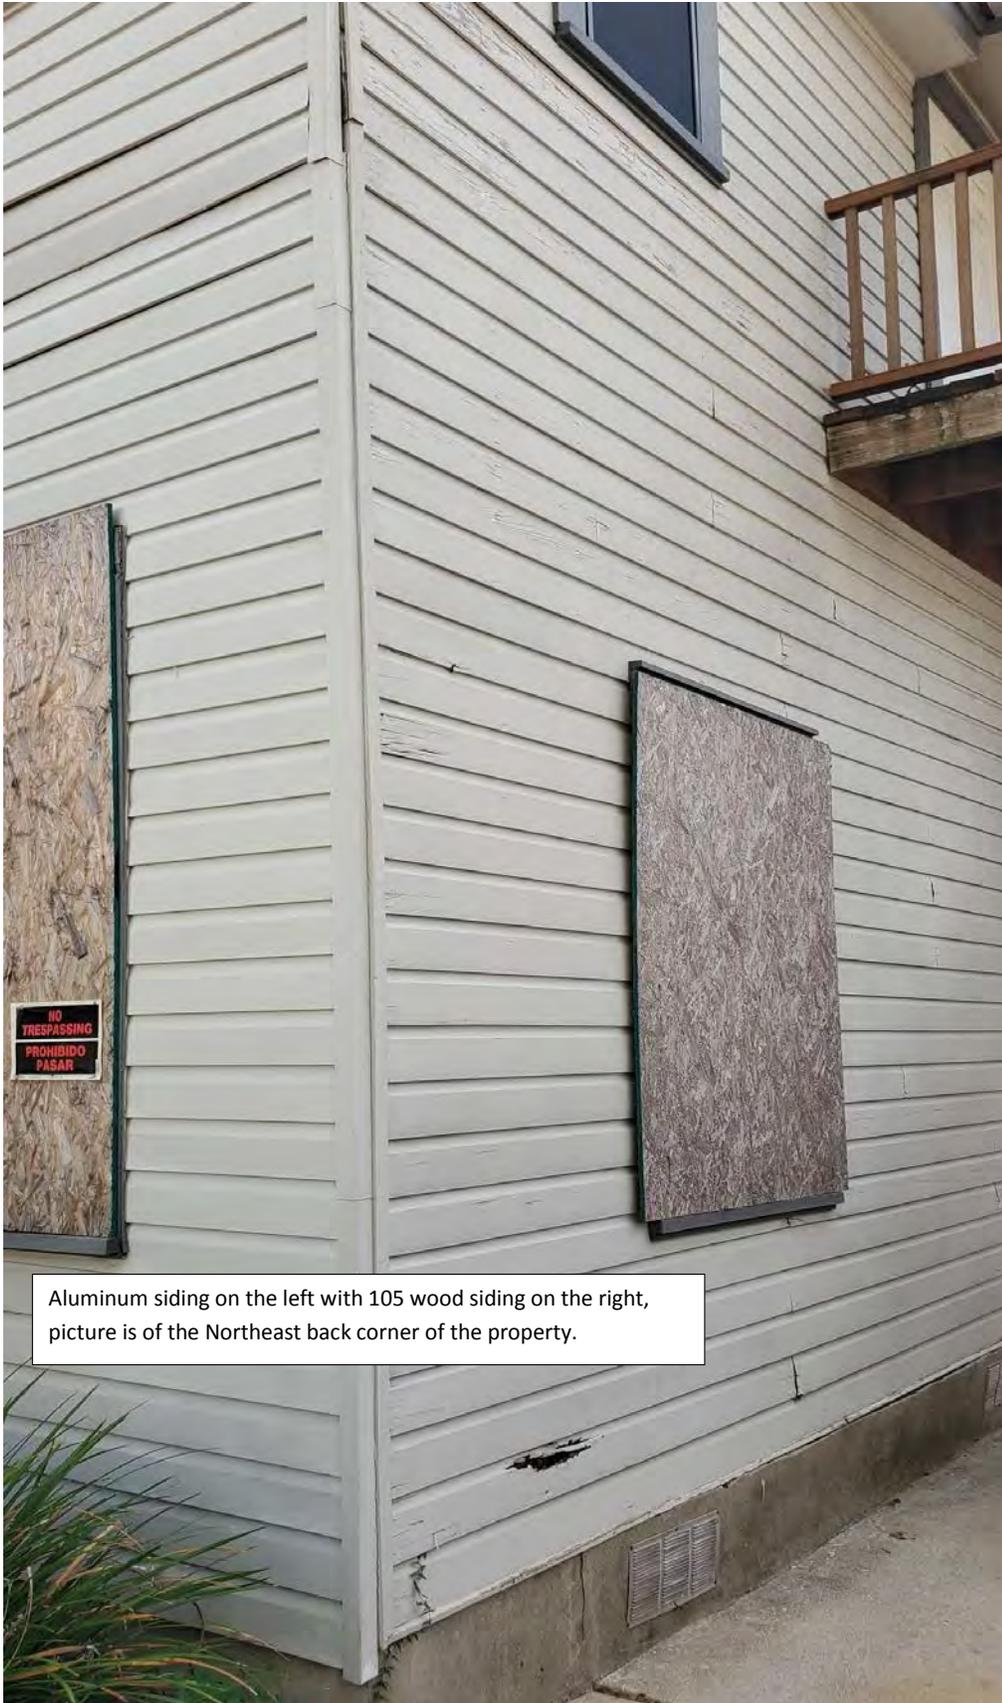
Aluminum siding on the left with 105 wood siding on the right, picture is of the Northeast back corner of the property.

Damage to aluminum siding does not appear to be extensive. Fire went through attic and out of gable.

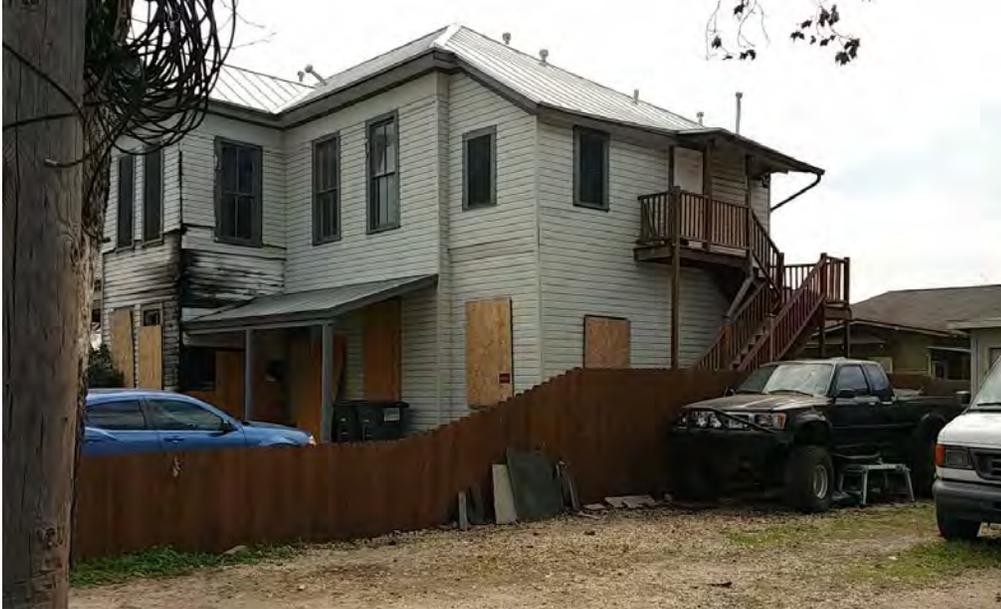
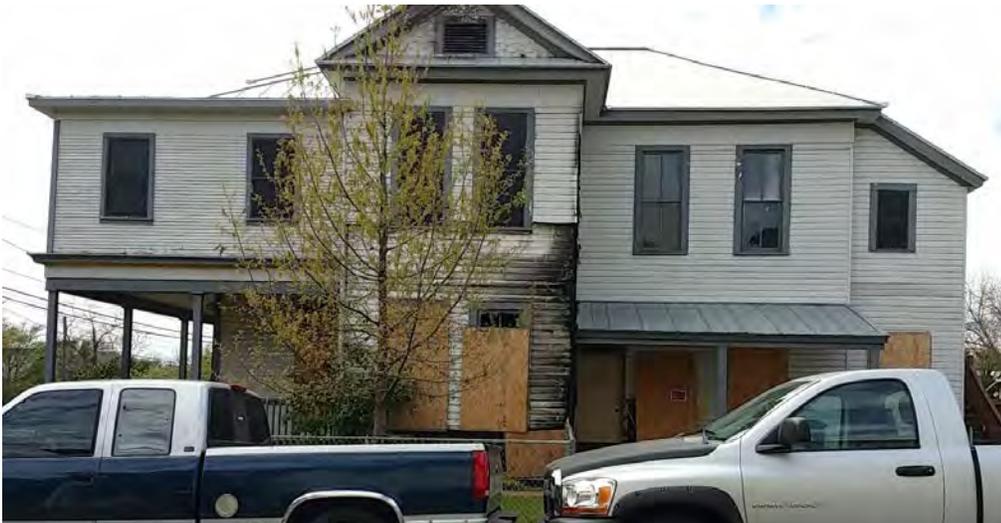
Above and below pictures shows how extensive the wood siding was fire damaged once the aluminum siding was removed.

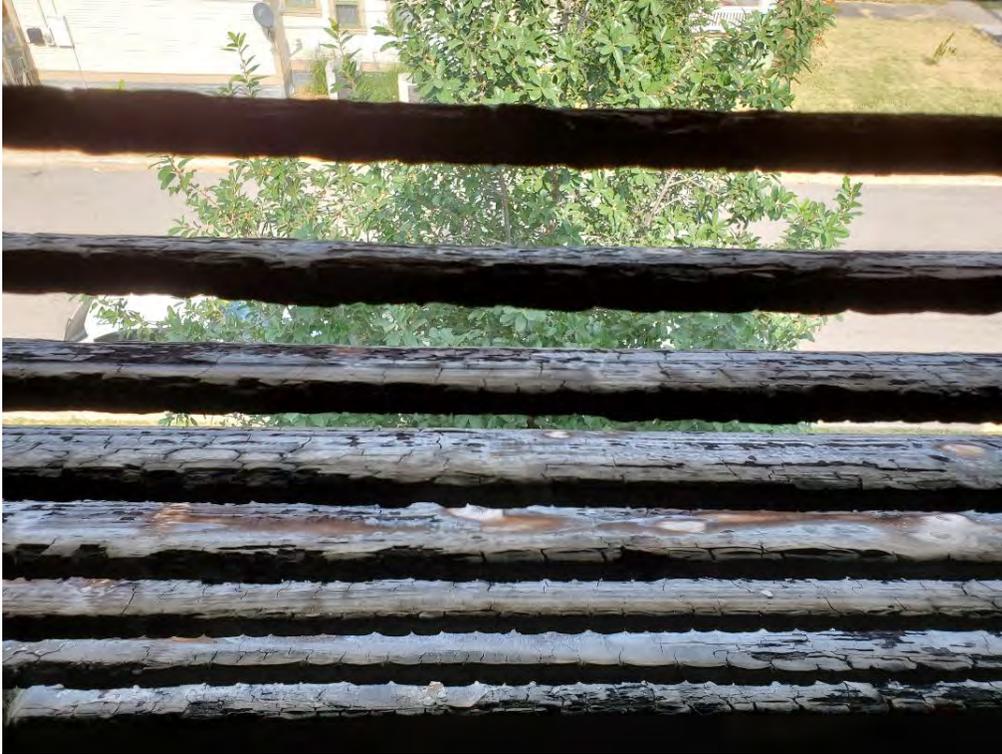
View from inside the attic looking through the gable on the east side of the property.

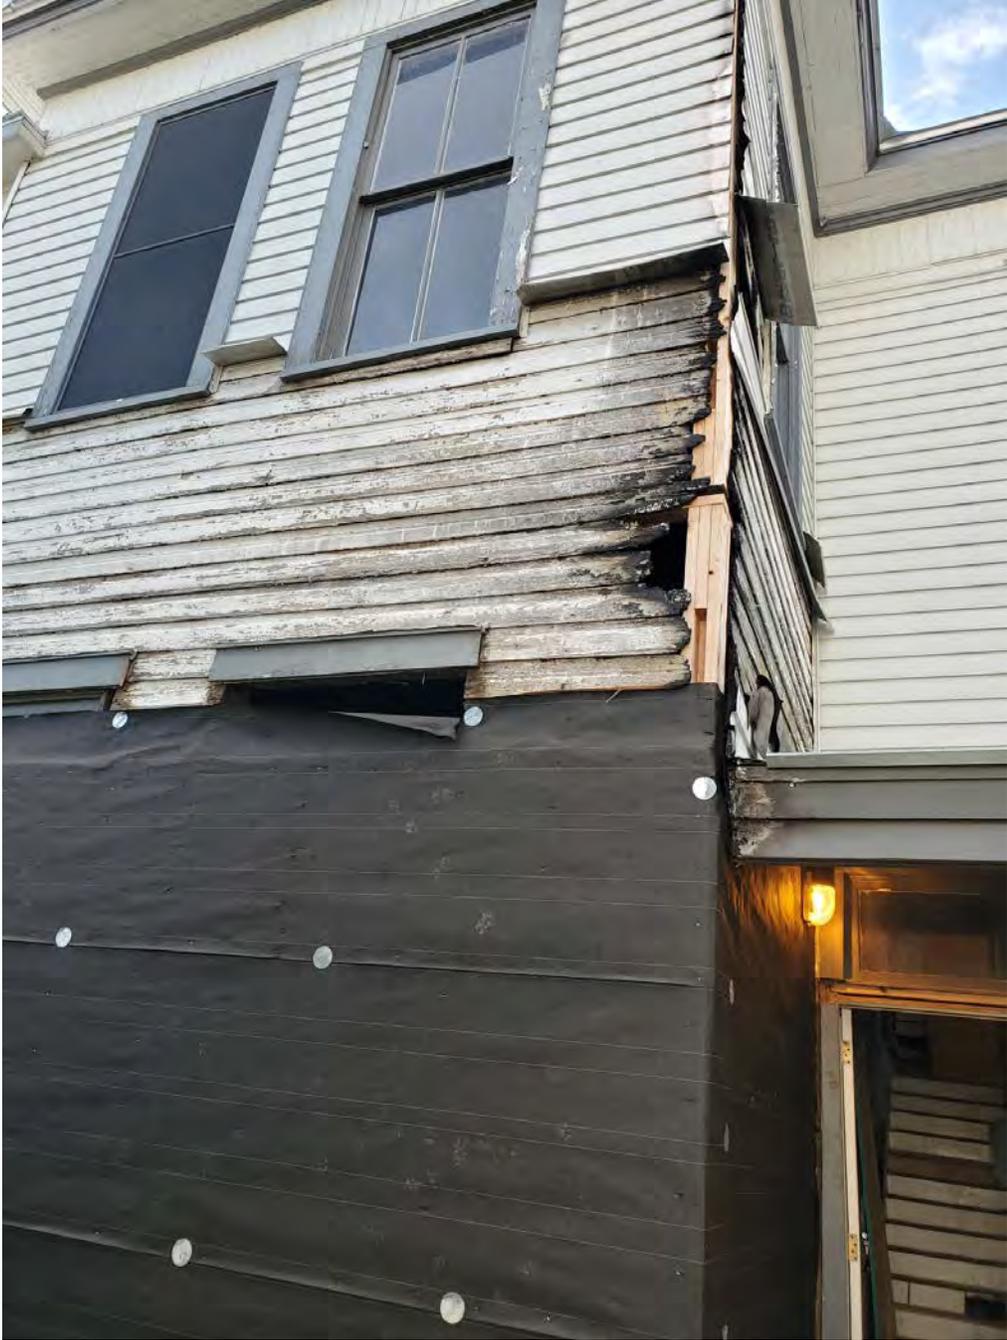
Fire damaged wall cavities that were removed.
