HISTORIC AND DESIGN REVIEW COMMISSION

May 15, 2019

HDRC CASE NO: 2019-260
ADDRESS: 107 N FLORES ST
LEGAL DESCRIPTION: NCB 122 BLK LOT 1 & 2
ZONING: D, H, RIO-7B
CITY COUNCIL DIST.: 1
DISTRICT: Main/Military Plaza Historic District
APPLICANT: David Hannan/Fisher Heck Architects
OWNER: All Out of Bubblegum LP
TYPE OF WORK: Storefront system replacement, window replacement, rehabilitation
APPLICATION RECEIVED: April 30, 2019
60-DAY REVIEW: June 29, 2019
CASE MANAGER: Edward Hall
REQUEST:

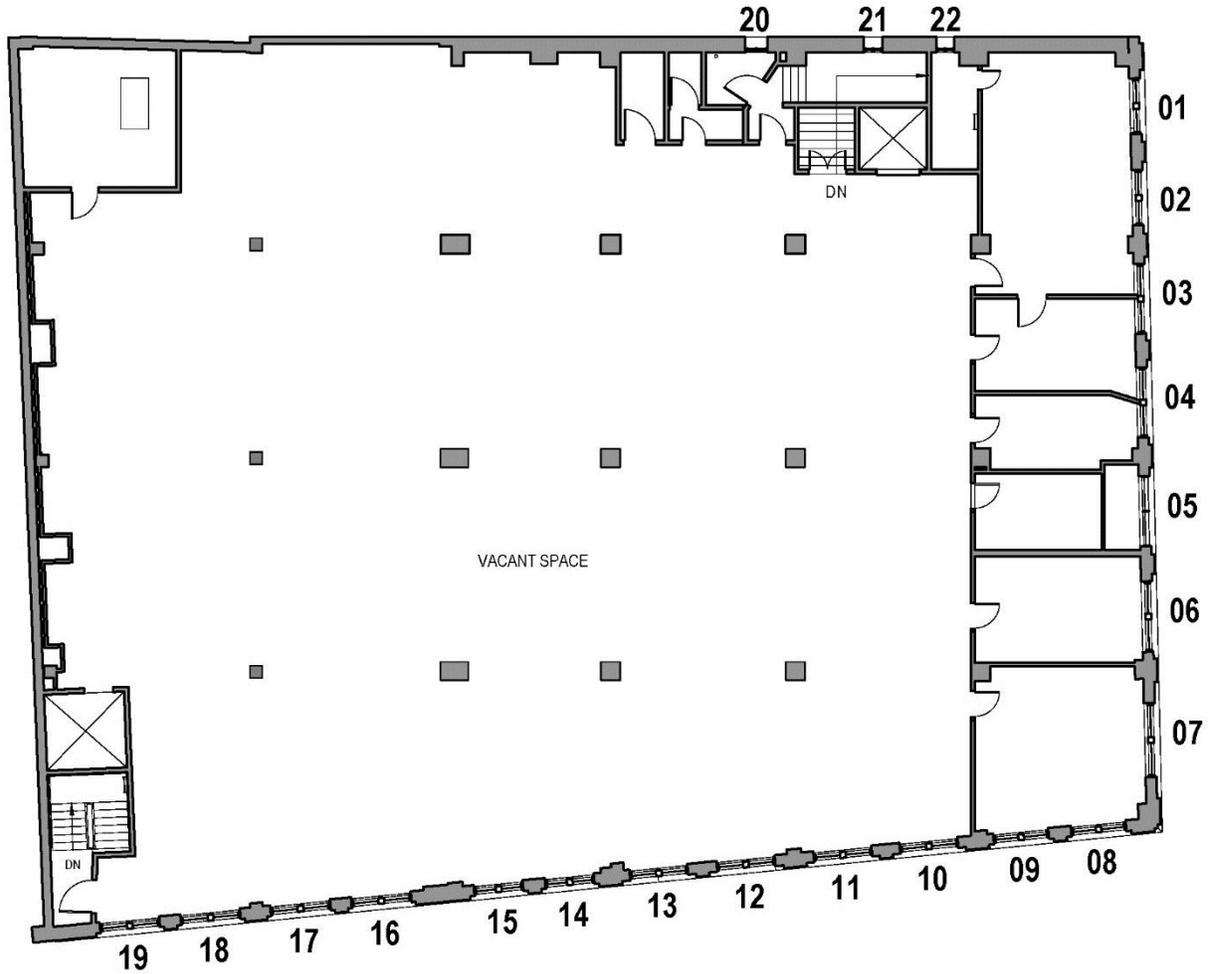
WINDOW 01

Notes: Window sashes, glazing and frame are in fair condition; the lower sashes and exterior sill show signs of decay and rot from moisture exposure; Interior casing and window hardware are in good condition and will be refinished and reinstalled; Glazing putty has completely deteriorated.

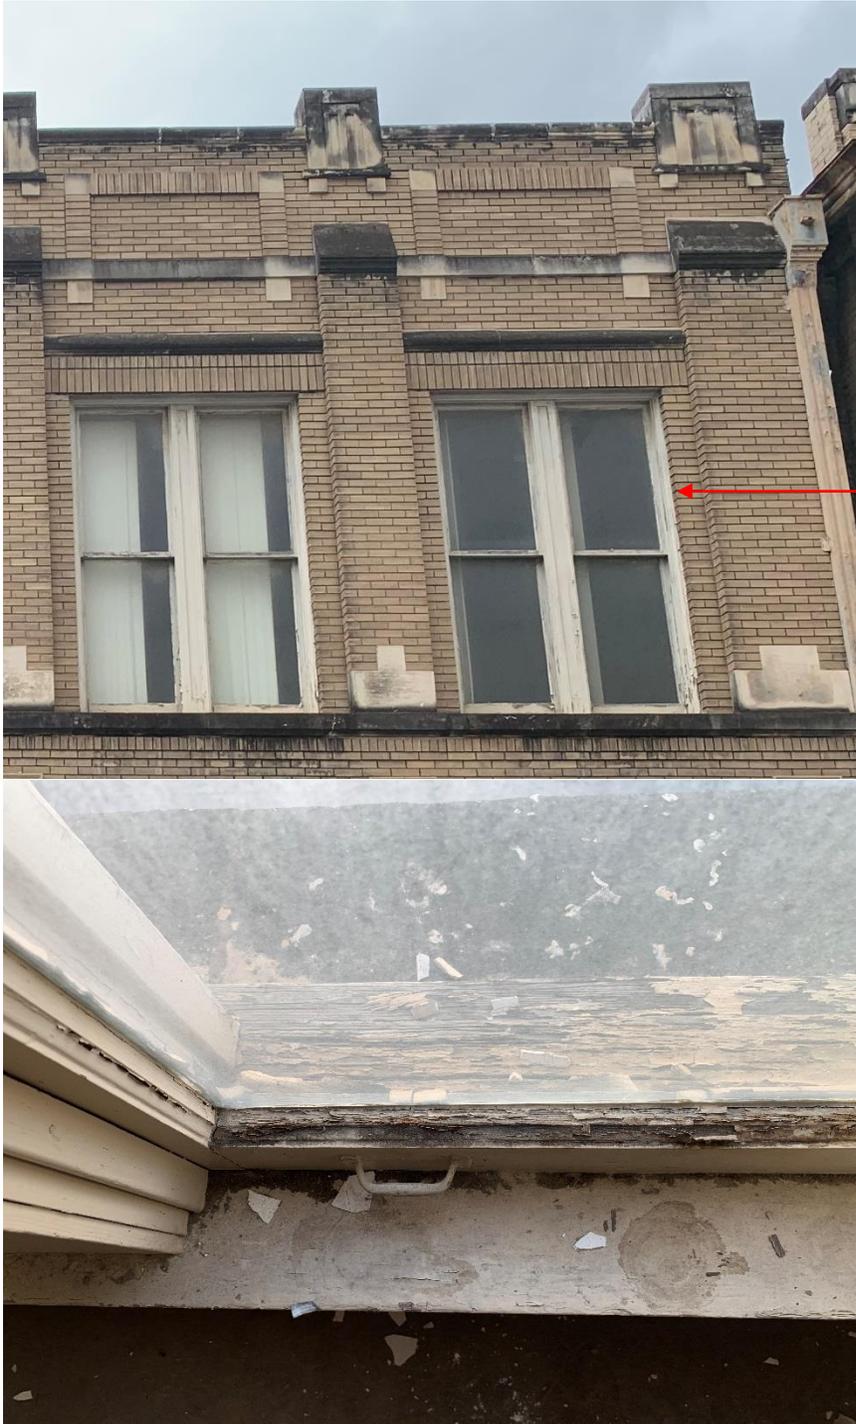
WINDOW 02

Notes: Window sashes, glazing and frame are in fair condition; the lower sashes and exterior sill show signs of decay and rot from moisture exposure; Interior casing and window hardware are in good condition and will be refinished and reinstalled; Glazing putty has completely deteriorated.

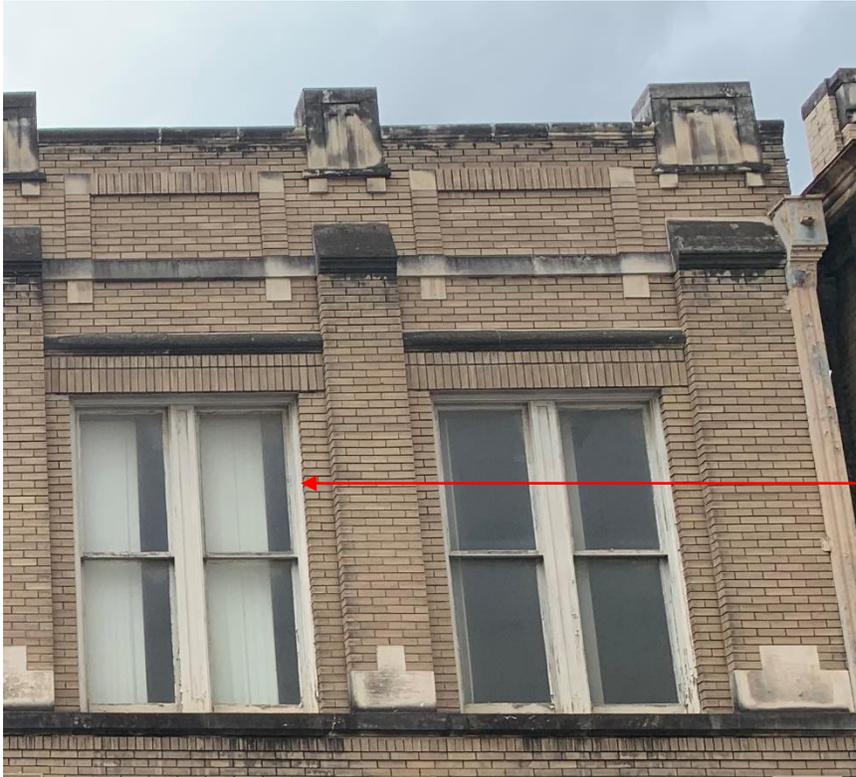
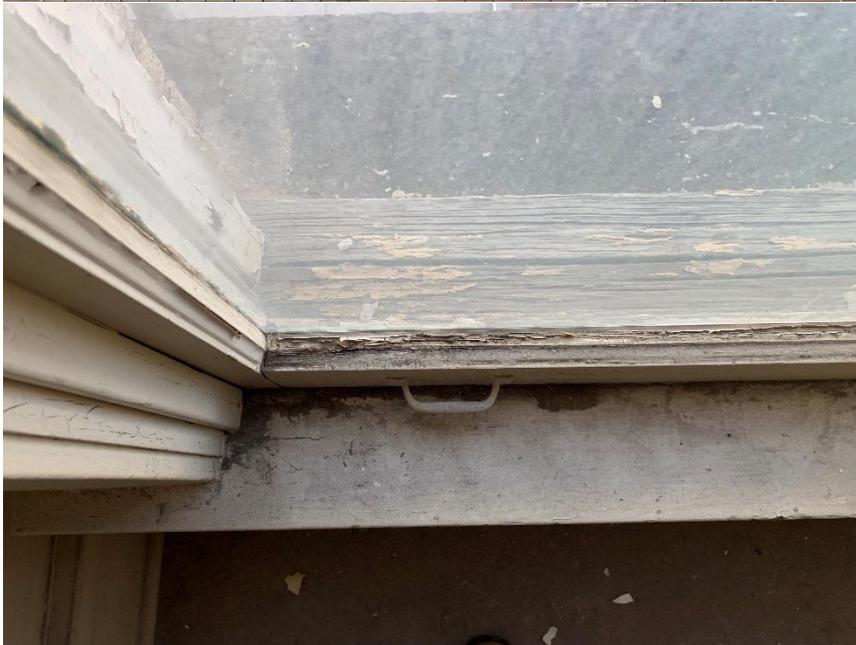
WINDOW 03

Notes: Window sashes, glazing and frame are in fair condition; the lower sashes and exterior sill show signs of decay and rot from moisture exposure; Interior casing and window hardware are in good condition and will be refinished and reinstalled; Glazing putty has completely deteriorated.

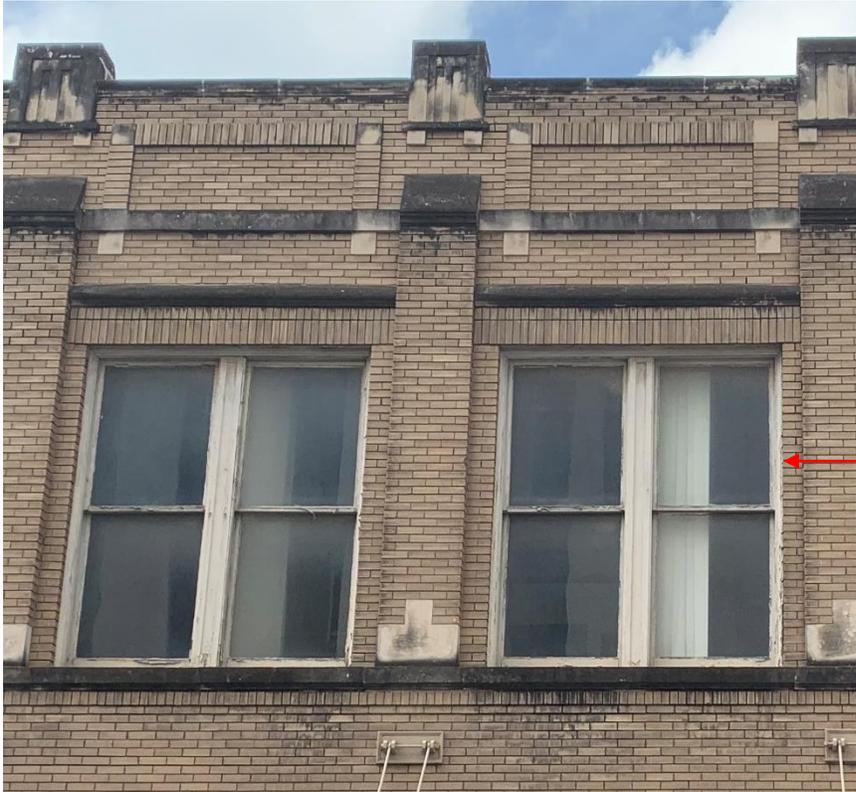
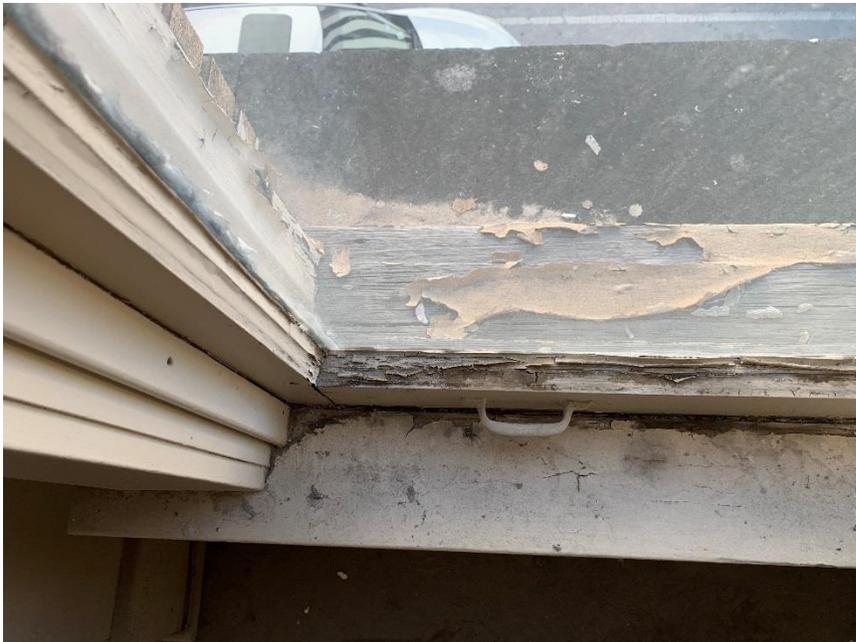
WINDOW 04

Notes: Window sashes, glazing and frame are in fair condition; the lower sashes and exterior sill show signs of decay and rot from moisture exposure; Interior casing and window hardware are in good condition and will be refinished and reinstalled; Glazing putty has completely deteriorated.

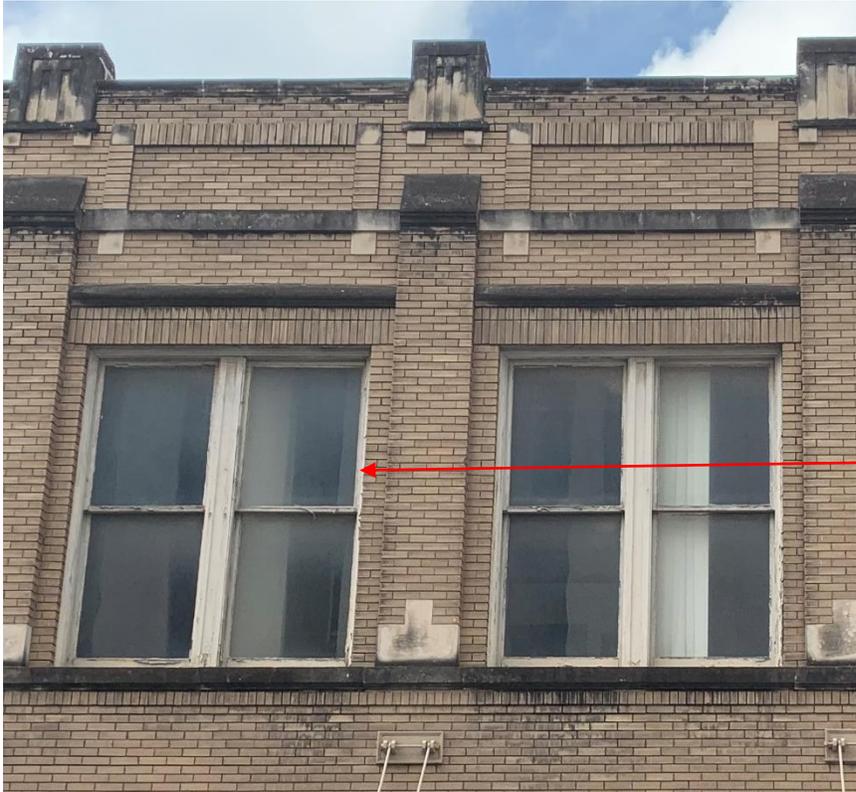
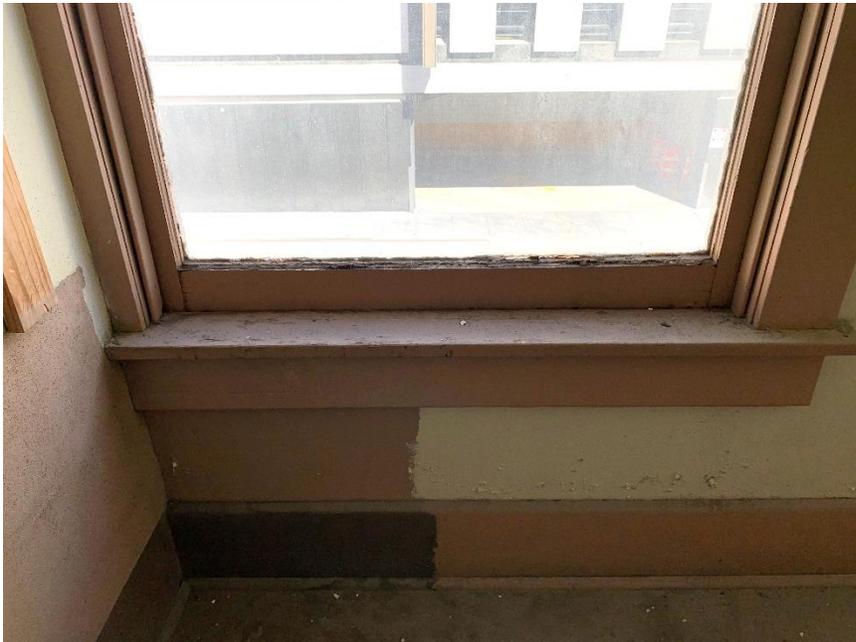
WINDOW 05

Notes: Window sashes, glazing and frame are in poor condition; the window has been heavily modified to accommodate a louver grille below, which is no longer required; the lower sashes and exterior sill show signs of decay and rot from moisture exposure; Interior & exterior casings would have to be replaced; Glazing putty has completely deteriorated.

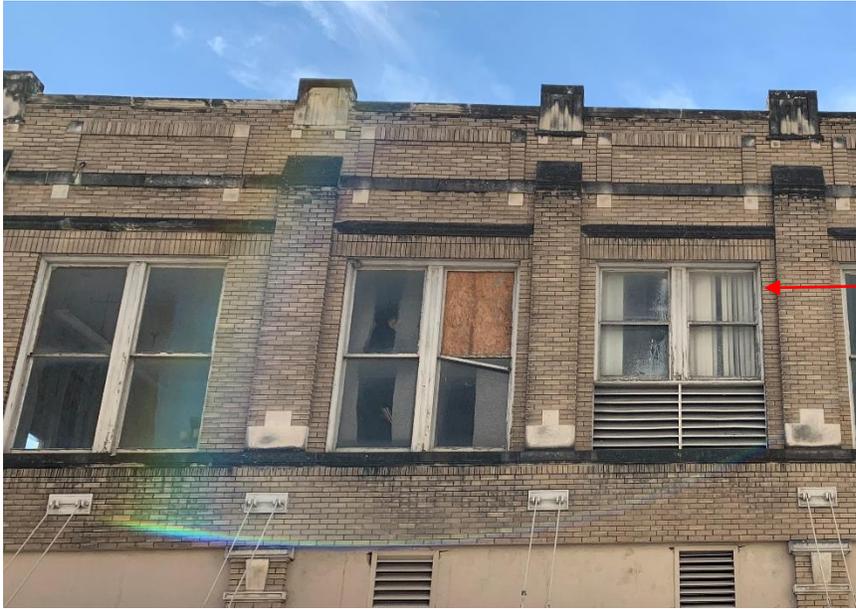
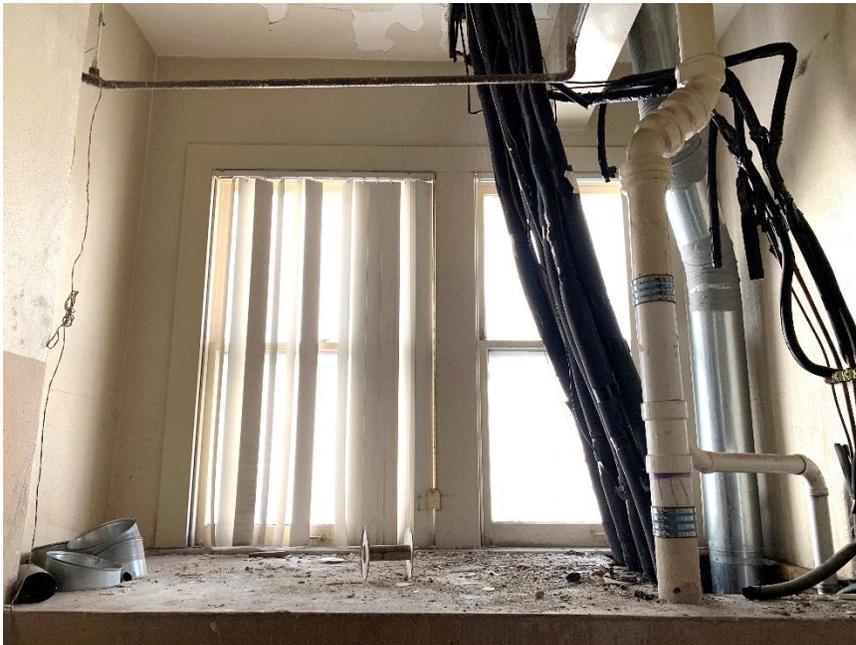
WINDOW 06

Notes: Window sashes, glazing and frame are in poor condition; the sashes are starting to fall apart and one of the glass panes is broken; the lower sashes and window sill show signs of decay and rot from moisture exposure; Interior casing and hardware are in good condition and will be refinished and reinstalled; Glazing putty has completely deteriorated.

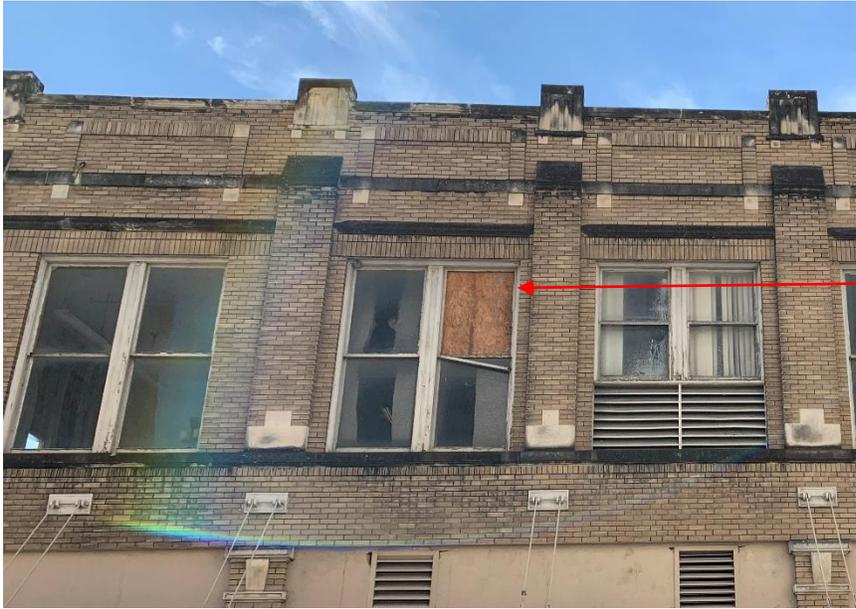
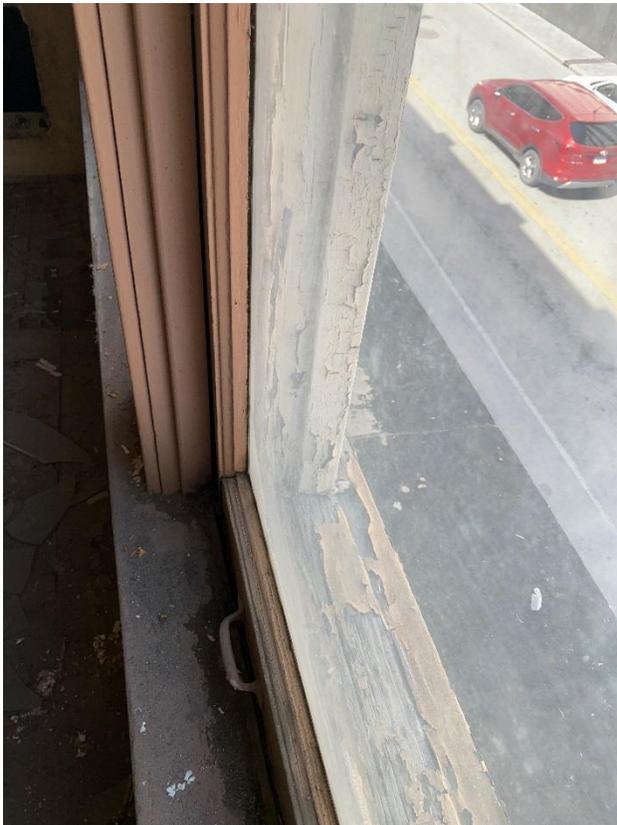
WINDOW 07

Notes: Window sashes, glazing and frame are in fair condition; the lower sashes and exterior sill show signs of decay and rot from moisture exposure; Interior casing and hardware are in acceptable condition and will be refinished and reinstalled; Glazing putty has completely deteriorated.

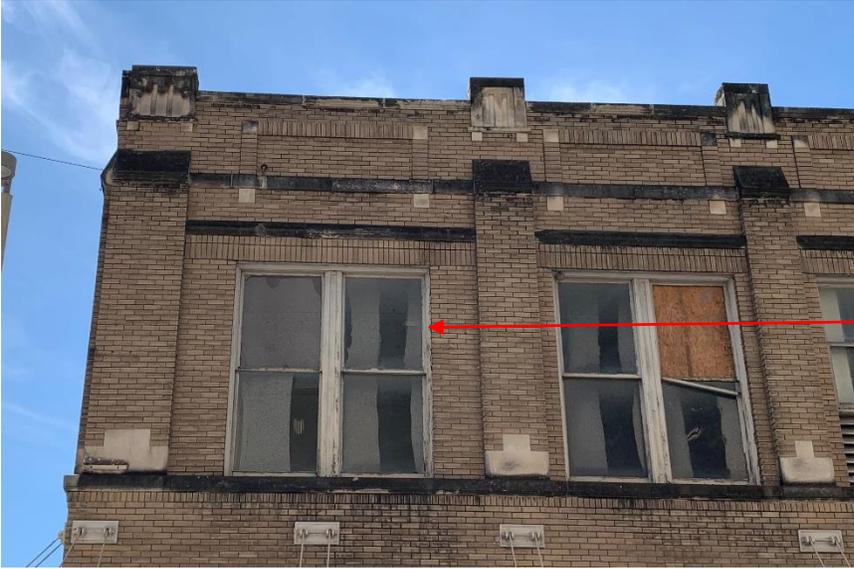
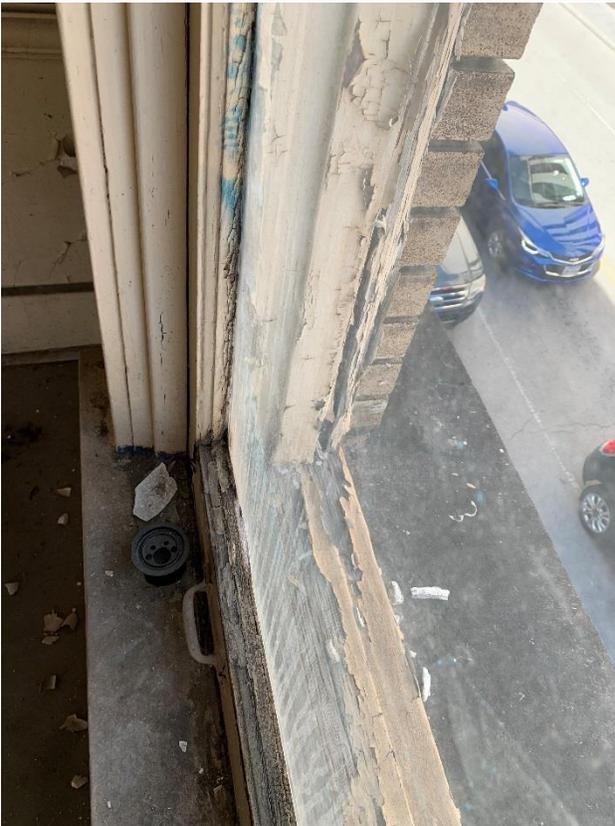
WINDOW 08

Notes: Window sashes, glazing and frame are in very poor condition; the lower sashes and exterior sill show signs of decay and rot from moisture exposure. Interior casing and hardware are in acceptable condition and will be refinished and reinstalled; Two of the four glass panels are broken and have been replaced with plywood; Glazing putty has completely deteriorated.

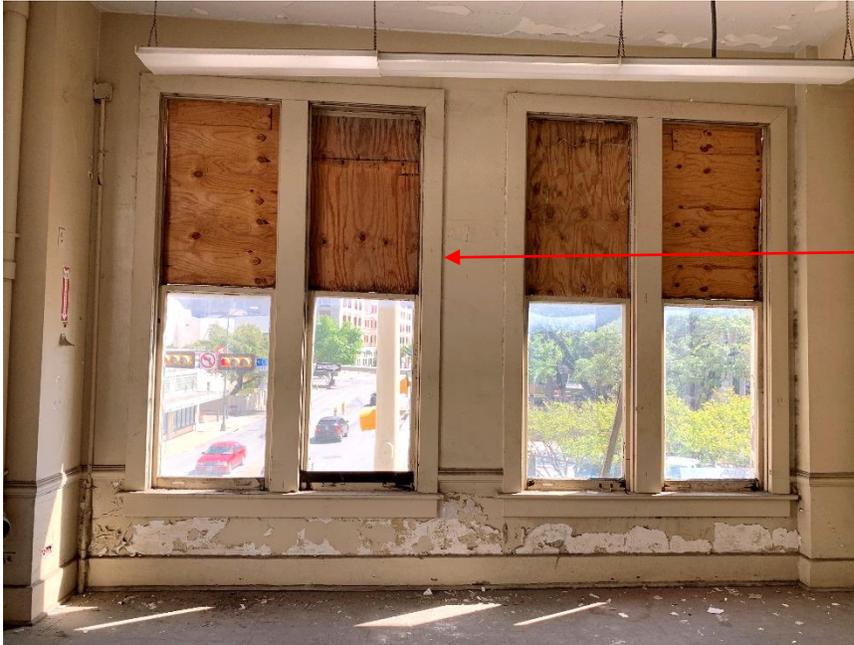
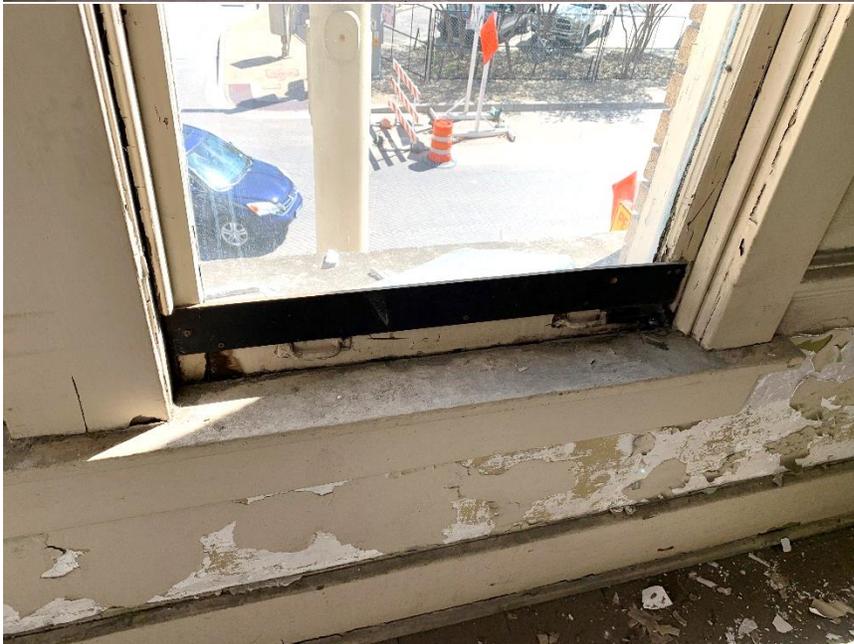
WINDOW 09

Notes: Window sashes, glazing and frame are in very poor condition; the lower sashes and exterior sill show signs of decay and rot from moisture exposure. Interior casing and hardware are in acceptable condition and will be refinished and reinstalled; Two of the four glass panels are broken and have been replaced with plywood; Glazing putty has completely deteriorated.

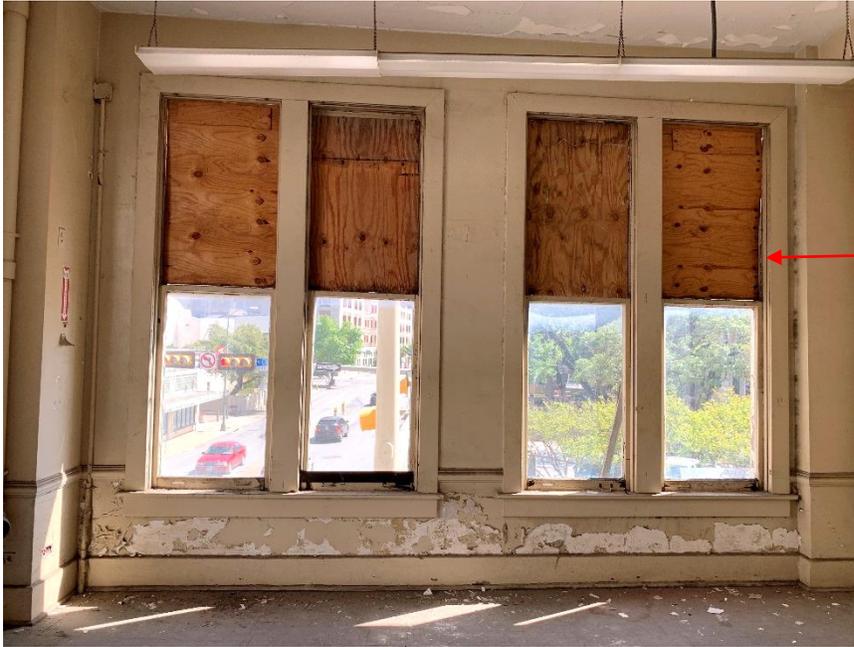
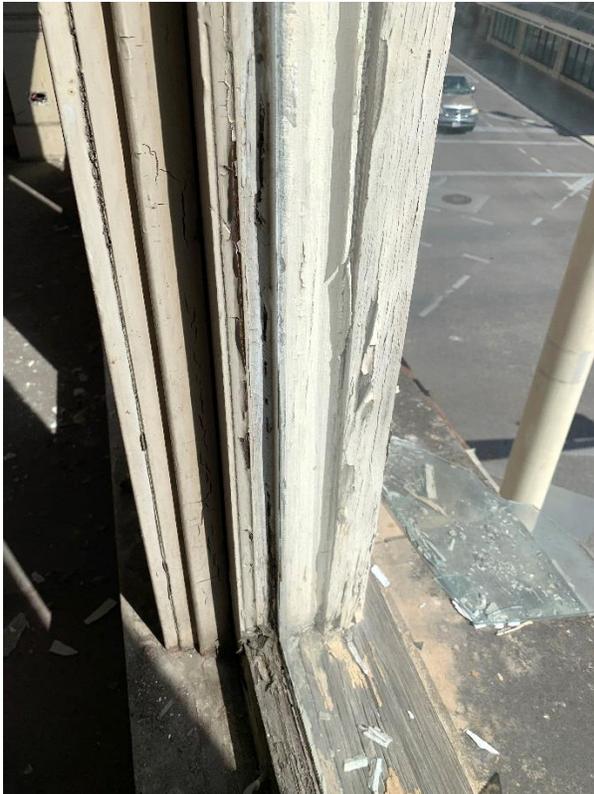
WINDOW 10

Notes: Window sashes, glazing and frame are in poor condition; the lower sashes and exterior sill show signs of decay and rot from moisture exposure; Interior casing and hardware are in good condition and will be refinished and reinstalled; The meeting rails do not match each other; Glazing putty has completely deteriorated.

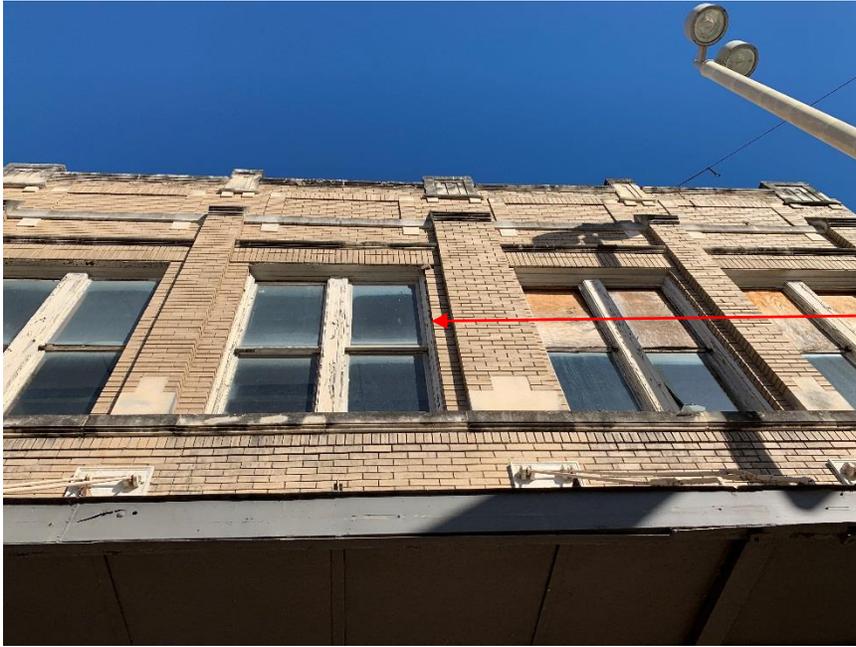
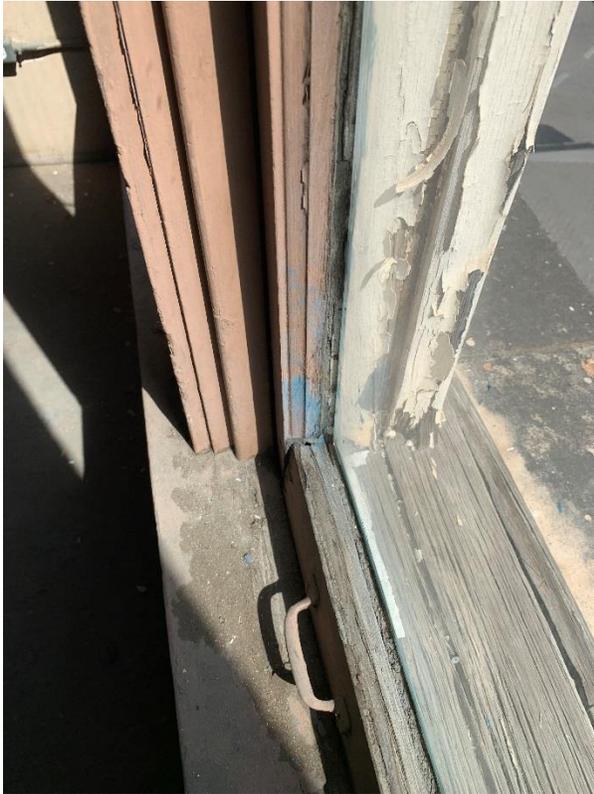
WINDOW 11

Notes: Window sashes, glazing and frame are in poor condition; the lower sashes and exterior sill show signs of decay and rot from moisture exposure; Interior casing and hardware are in good condition and will be refinished and reinstalled; The meeting rails do not match each other; Glazing putty has completely deteriorated.

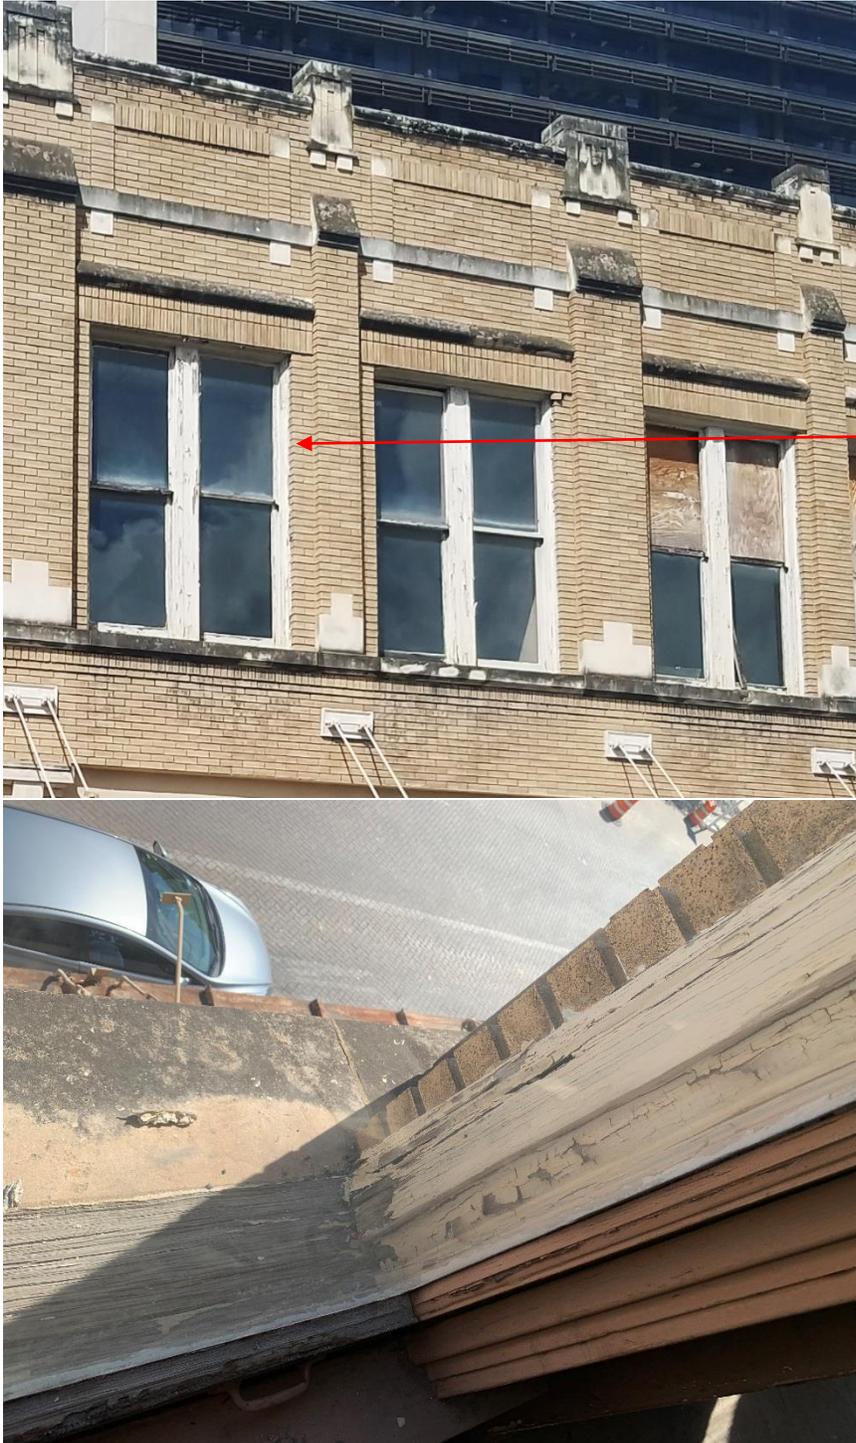
WINDOW 12

Notes: Window sashes, glazing and frame are in poor condition; the lower sashes and exterior sill show signs of decay and rot from moisture exposure. One of the glass panels has been broken and replaced with plywood; Interior casing and hardware are in good condition and will be refinished and reinstalled; The meeting rails do not match each other; Glazing putty has completely deteriorated.

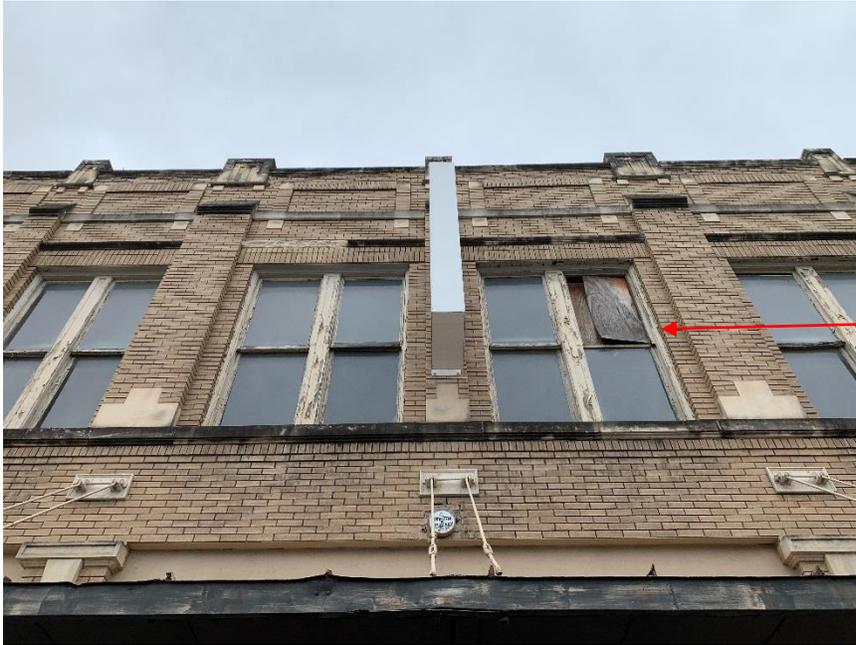
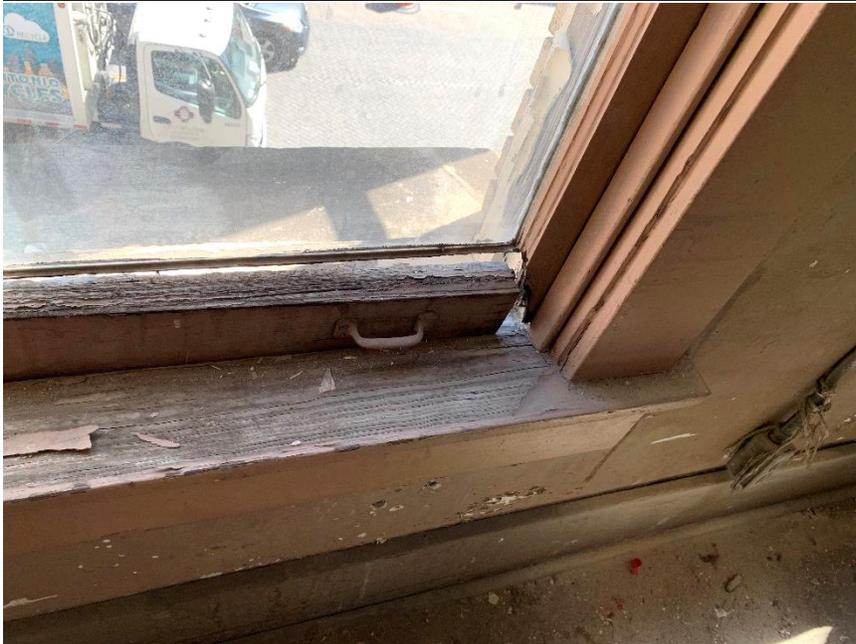
WINDOW 13

Notes: Window sashes, glazing and frame are in poor condition; the lower sashes and exterior sill show signs of decay and rot from moisture exposure; Interior casing and hardware are in good condition and will be refinished and reinstalled; The meeting rails do not match each other; Glazing putty has completely deteriorated.

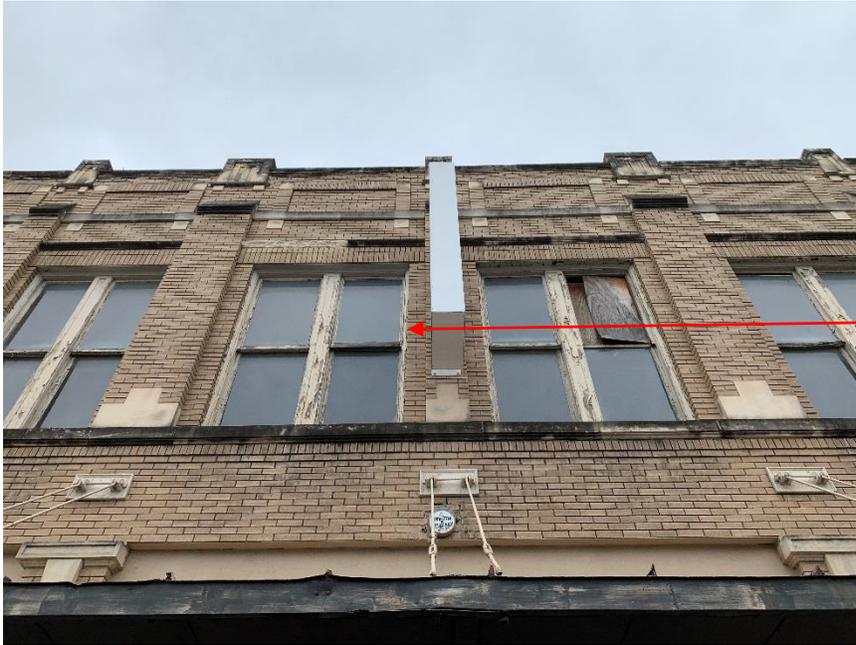
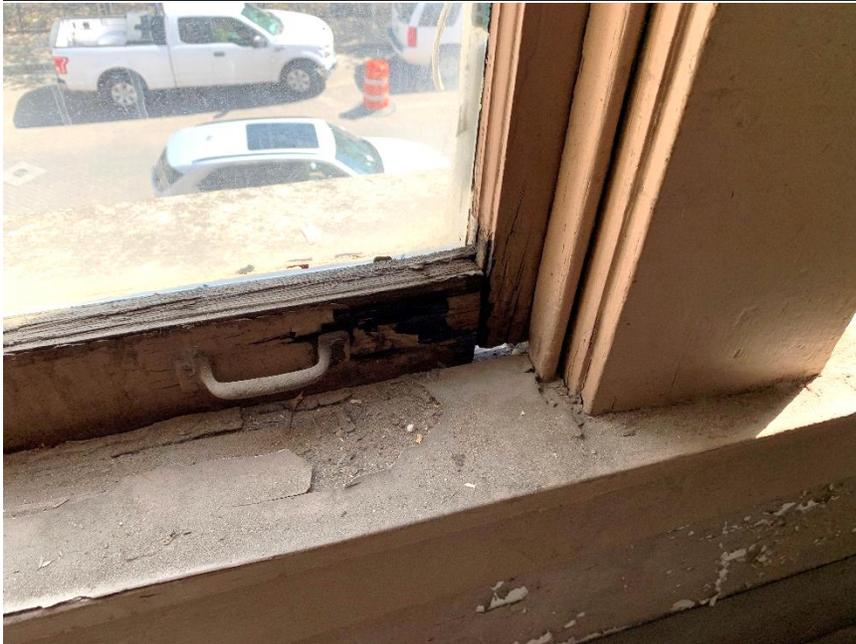
WINDOW 14

Notes: Window sashes, glazing and frame are in poor condition; the lower sashes and exterior sill show signs of decay and rot from moisture exposure; The glass has begun to separate from the sash; Interior casing and hardware are in good condition and will be refinished and reinstalled; Glazing putty has completely deteriorated.

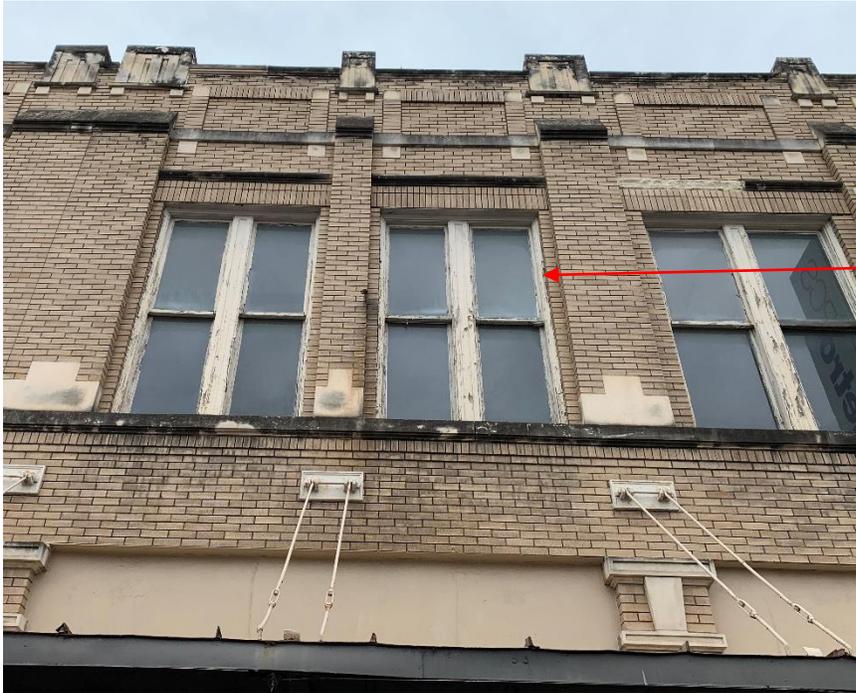
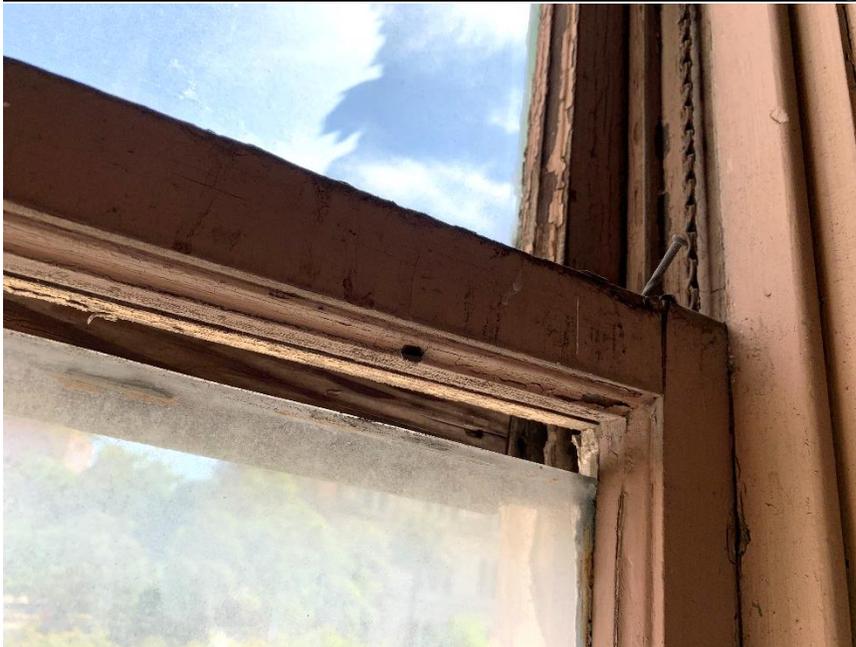
WINDOW 15

Notes: Window sashes, glazing and frame are in poor condition; the lower sashes and exterior sill show signs of decay and rot from moisture exposure; Interior casing and hardware are in good condition and will be refinished and reinstalled; Glazing putty has completely deteriorated.

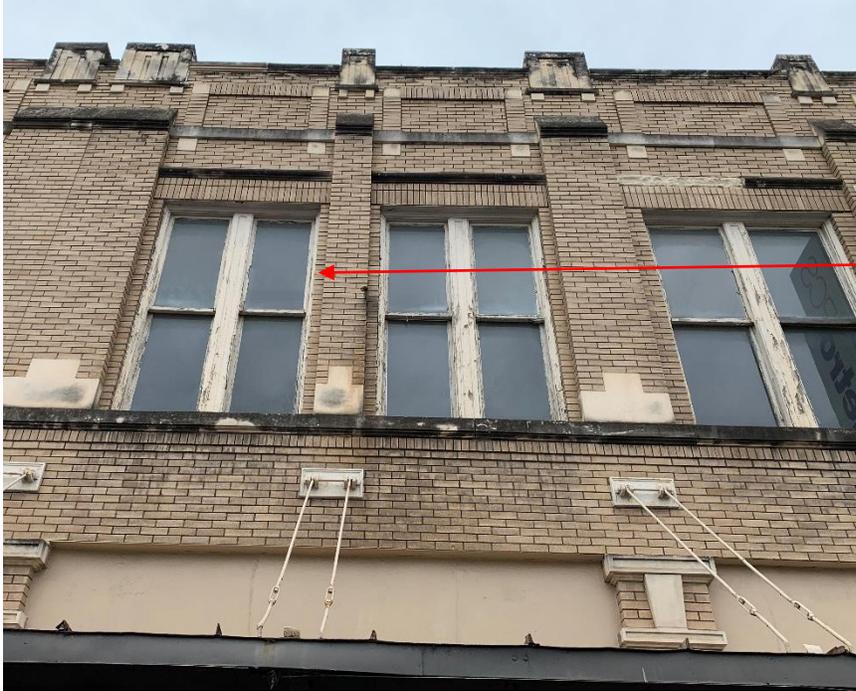
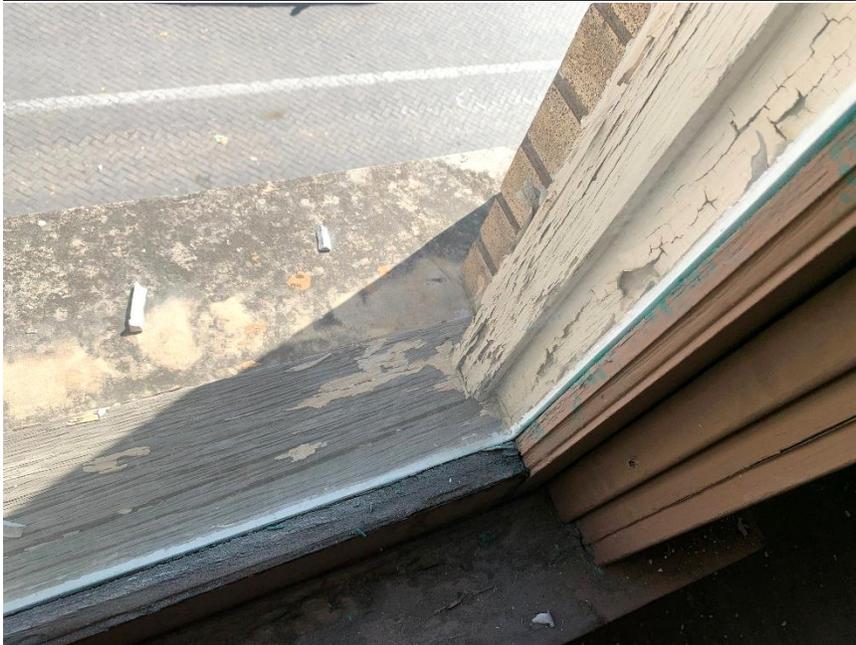
WINDOW 16

Notes: Window sashes, glazing and frame are in poor condition; the lower sashes and exterior sill show signs of decay and rot from moisture exposure; One of the glass panels and sash have been removed and replaced with plywood; Interior casing and hardware are in good condition and will be refinished and reinstalled; Glazing putty has completely deteriorated.

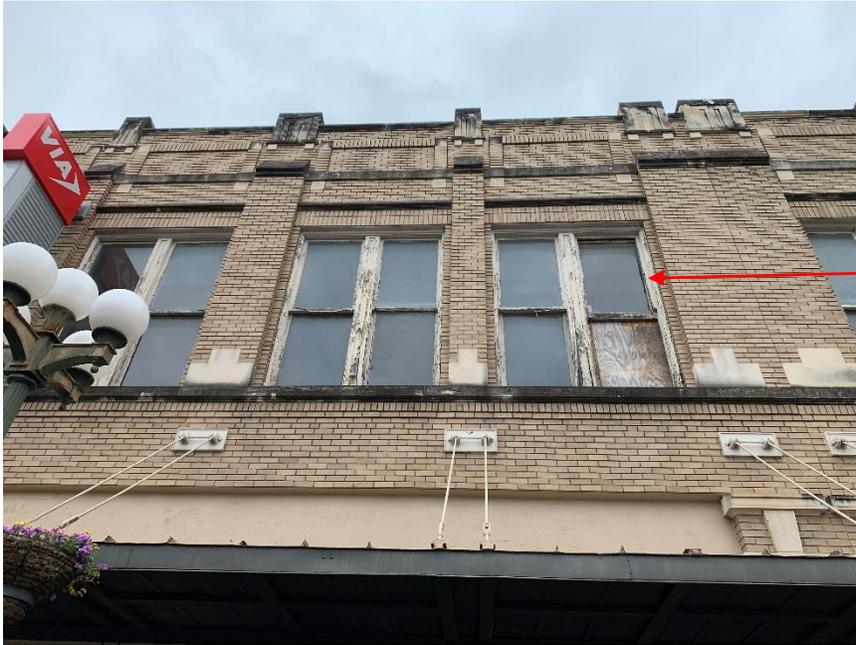
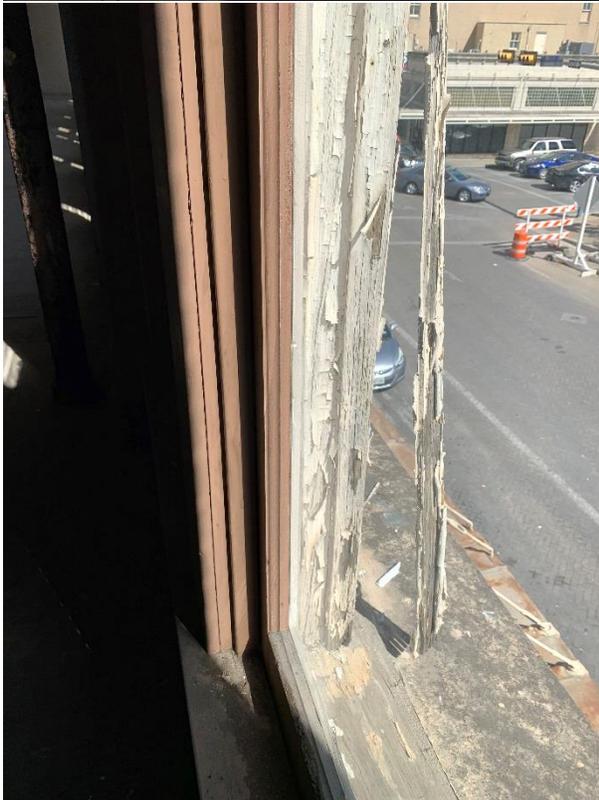
WINDOW 17

Notes: Window sashes, glazing and frame are in poor condition; the lower sashes and exterior sill show signs of decay and rot from moisture exposure; One of the lower sashes has begun to split apart; Interior casing and hardware are in good condition and will be refinished and reinstalled; Glazing putty has completely deteriorated.

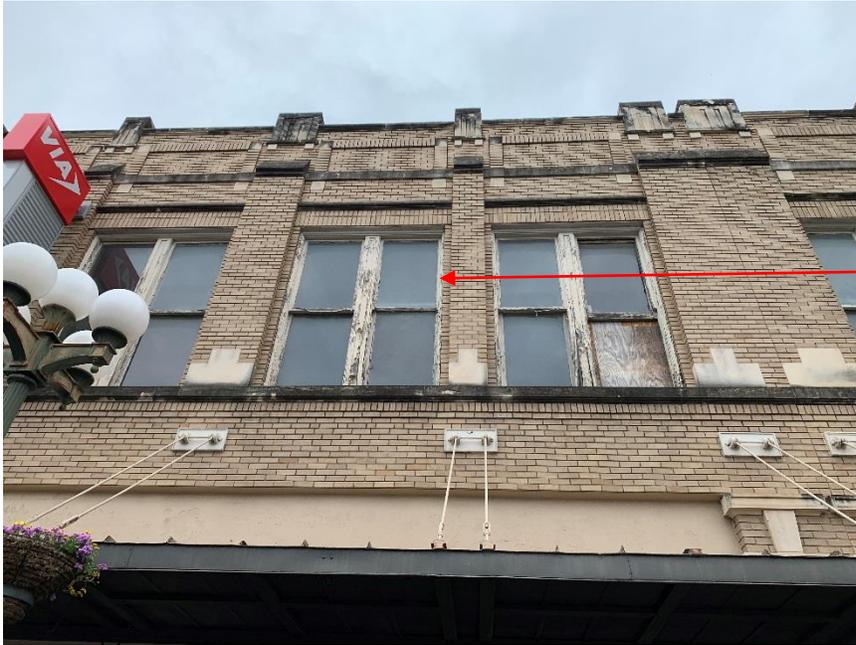
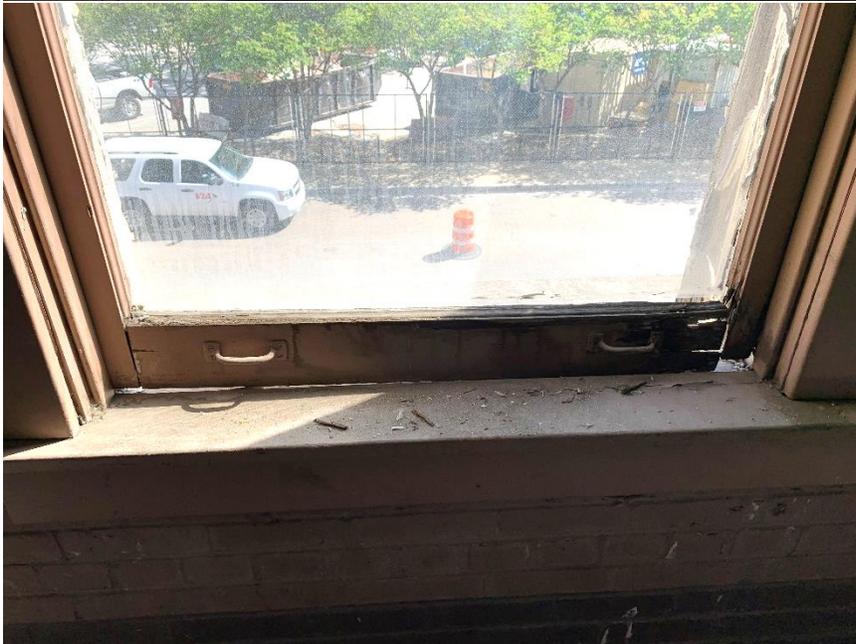
WINDOW 18

Notes: Window sashes, glazing and frame are in poor condition; the lower sashes and exterior sill show signs of decay and rot from moisture exposure; The meeting rails do not match each other; One of the lower sashes has begun to split apart; Interior casing and hardware are in good condition and will be refinished and reinstalled; Glazing putty has completely deteriorated.

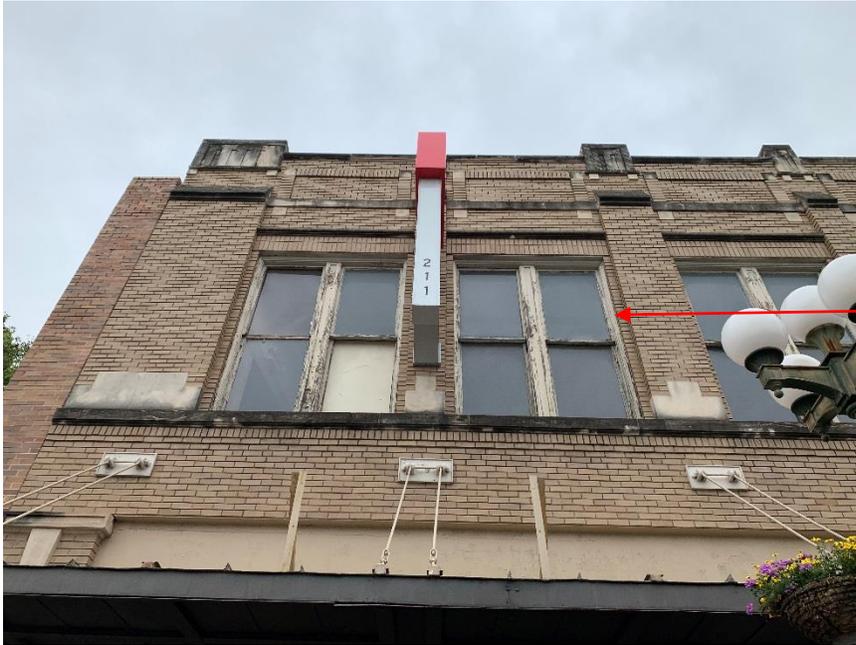
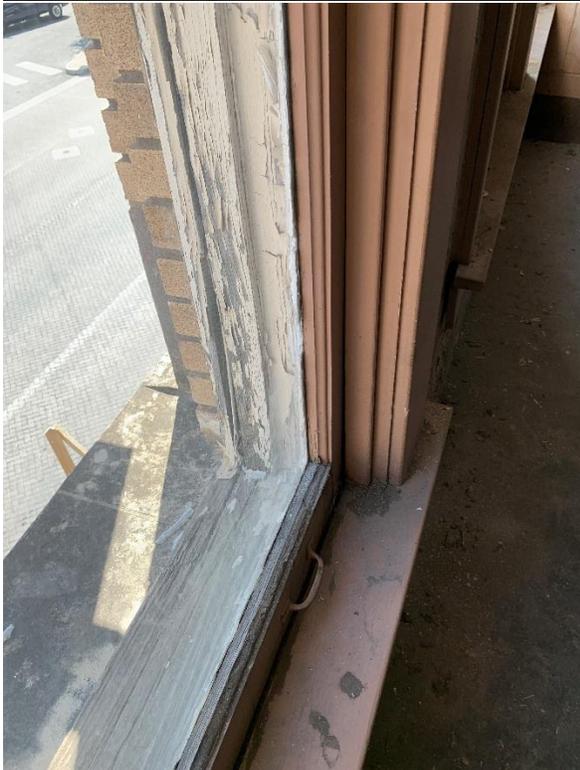
WINDOW 19

Notes: Window sashes, glazing and frame are in poor condition; the lower sashes and exterior sill show signs of decay and rot from moisture exposure; One side of the window is completely missing the sashes and has been replaced with wood stops and plexiglass; On the other side, one window pane has been broken and replaced with masonite; Interior casing and hardware are in good condition and will be refinished and reinstalled; Glazing putty has completely deteriorated.
