HISTORIC AND DESIGN REVIEW COMMISSION

May 15, 2019

HDRC CASE NO: 2019-260
ADDRESS: 107 N FLORES ST
LEGAL DESCRIPTION: NCB 122 BLK LOT 1 & 2
ZONING: D, H, RIO-7B
CITY COUNCIL DIST.: 1
DISTRICT: Main/Military Plaza Historic District
APPLICANT: David Hannan/Fisher Heck Architects
OWNER: All Out of Bubblegum LP
TYPE OF WORK: Storefront system replacement, window replacement, rehabilitation
APPLICATION RECEIVED: April 30, 2019
60-DAY REVIEW: June 29, 2019
CASE MANAGER: Edward Hall
REQUEST:

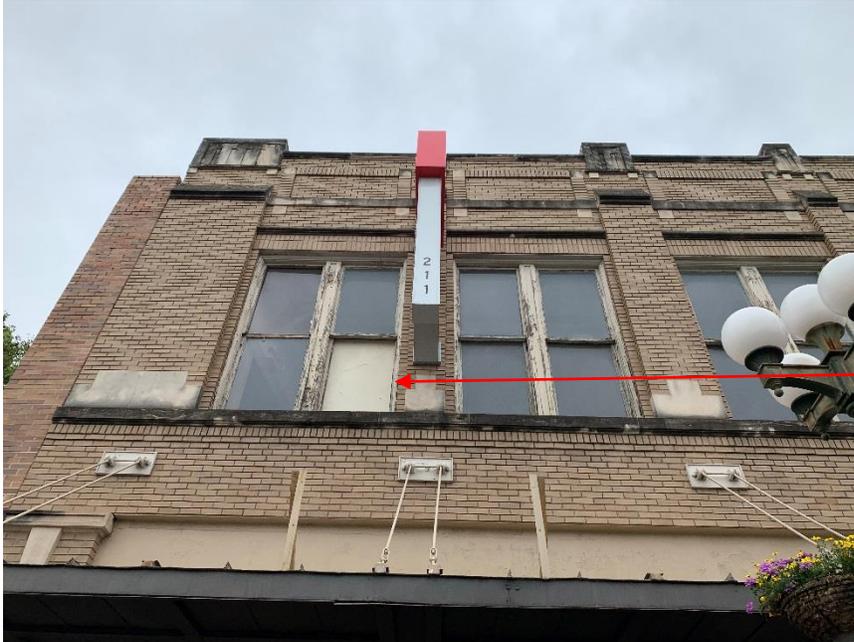
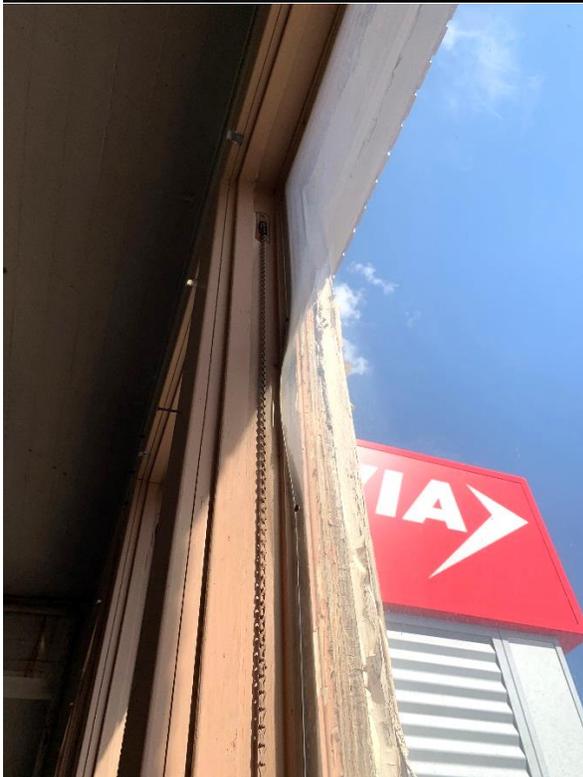
WINDOW 20

Notes: Window sashes, glazing and frame are in fair condition; the lower sashes and exterior sill show signs of minor decay; Interior casing and hardware are in good condition and will be refinished and reinstalled; Glazing putty has completely deteriorated.

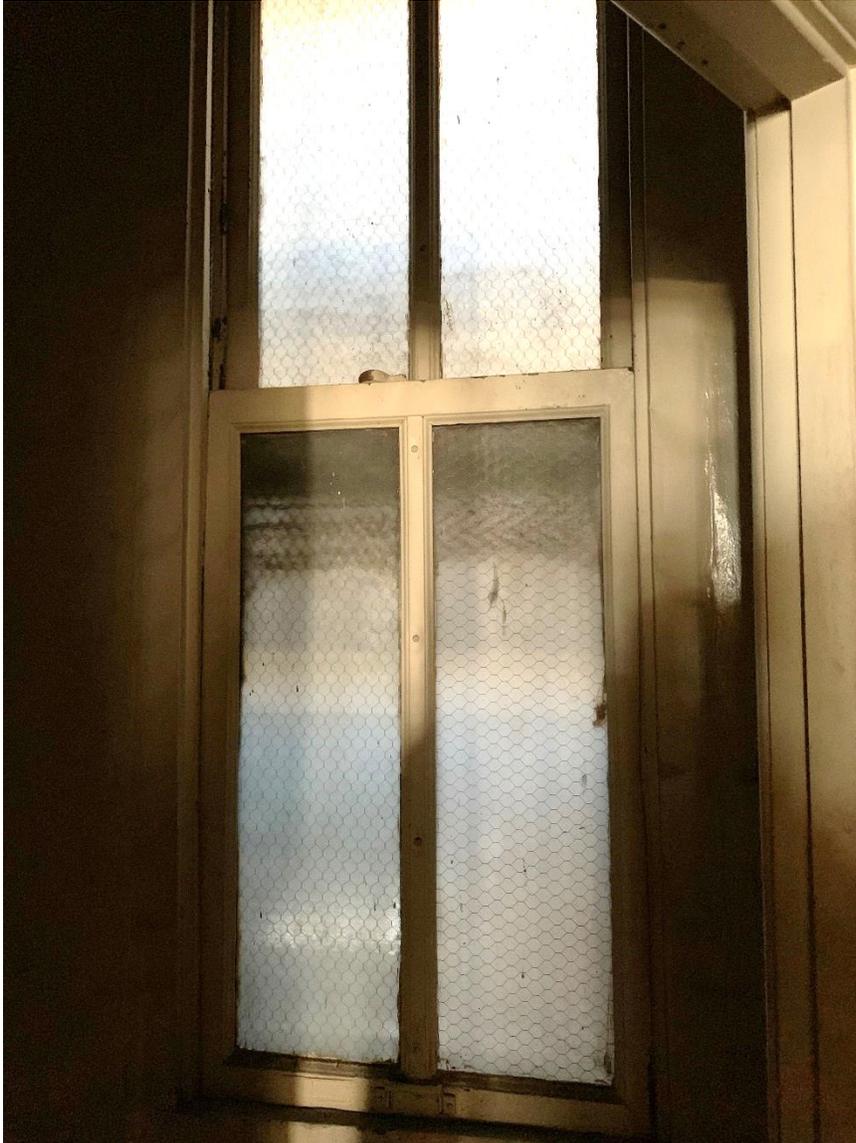
WINDOW 21

Notes: Window sashes, glazing and frame are in fair condition; the lower sashes and exterior sill show signs of minor decay; Interior casing and hardware are in good condition and will be refinished and reinstalled; Glazing putty has completely deteriorated.

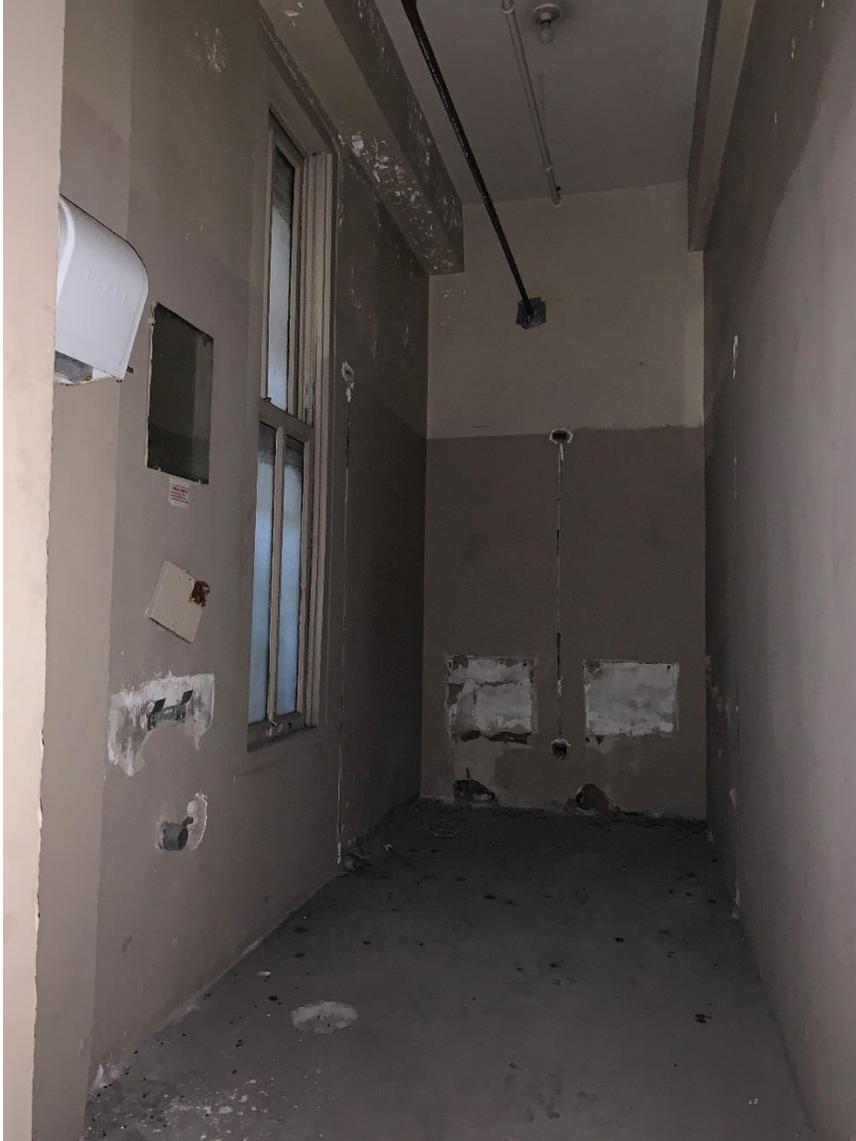
WINDOW 22

Notes: Window sashes, glazing and frame are in fair condition; the lower sashes and exterior sill show signs of minor decay; Interior casing and hardware are in good condition and will be refinished and reinstalled; Glazing putty has completely deteriorated.
