## HISTORIC AND DESIGN REVIEW COMMISSION

### Agenda Item No: 23

**HDRC CASE NO:** 2015-288  
**ADDRESS:** 239 / 241 / 243 CENTER  
**LEGAL DESCRIPTION:** NCB 580 BLK 11 LOT 17 (SUNSET CENTER STREET SUBD) 2012-NEW ACCT PER SPLIT PER PLAT 9621/133-135 FILED 3/11/2011  
**ZONING:** D, H, HE  
**CITY COUNCIL DIST.:** 2  
**DISTRICT:** St. Paul Square Historic District  
**LANDMARK:** Guenther, Colin Building  
**APPLICANT:** Pam Carpenter/Seventh Generation Design  
**OWNER:** Zachry Realty  
**TYPE OF WORK:** Demolition and new construction of multi-family building  
**REQUEST:**

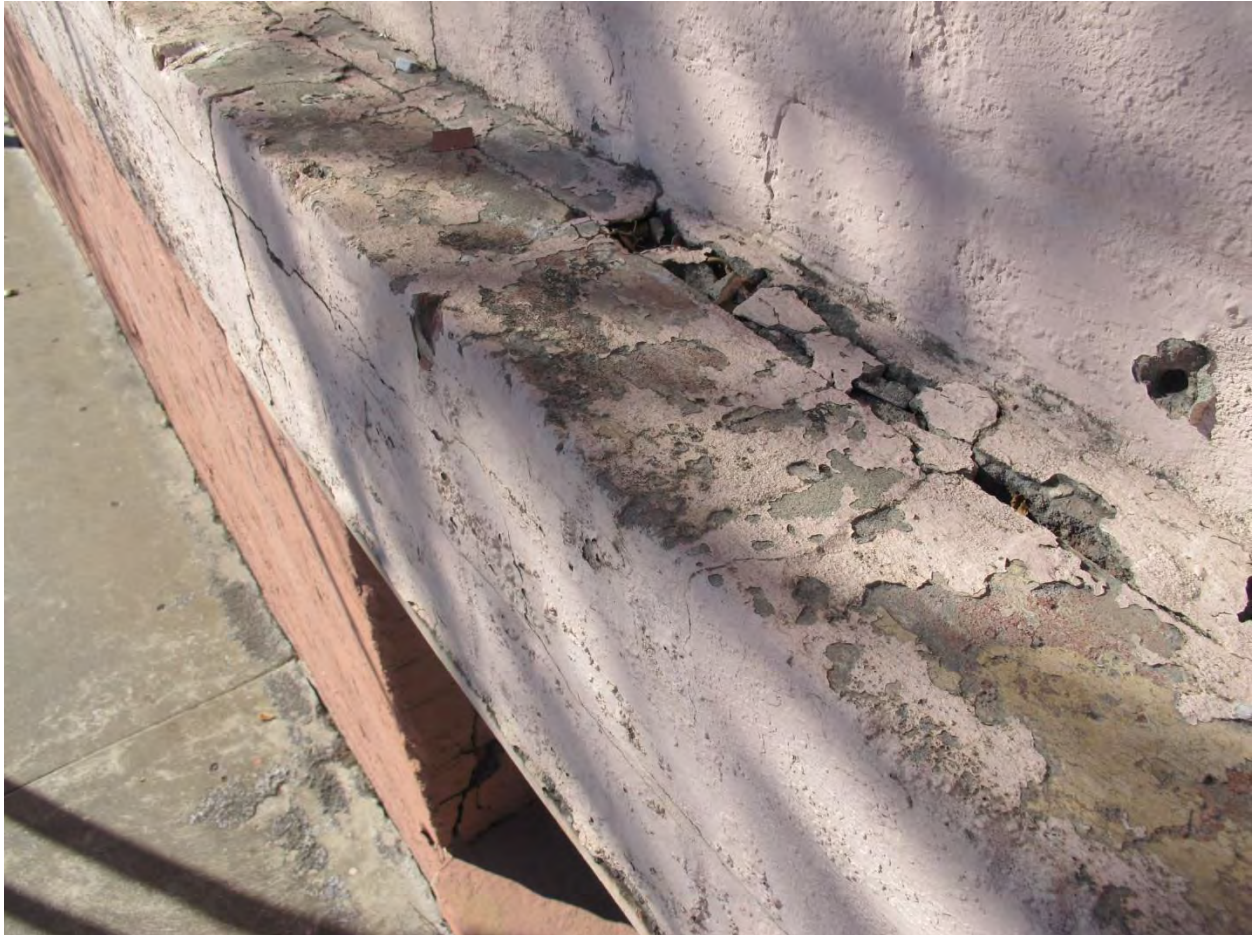
**Photo 7:** A view of the top of the water table along the south elevation. Note that the wash material has failed and the open mortar joint is an entry point for water.

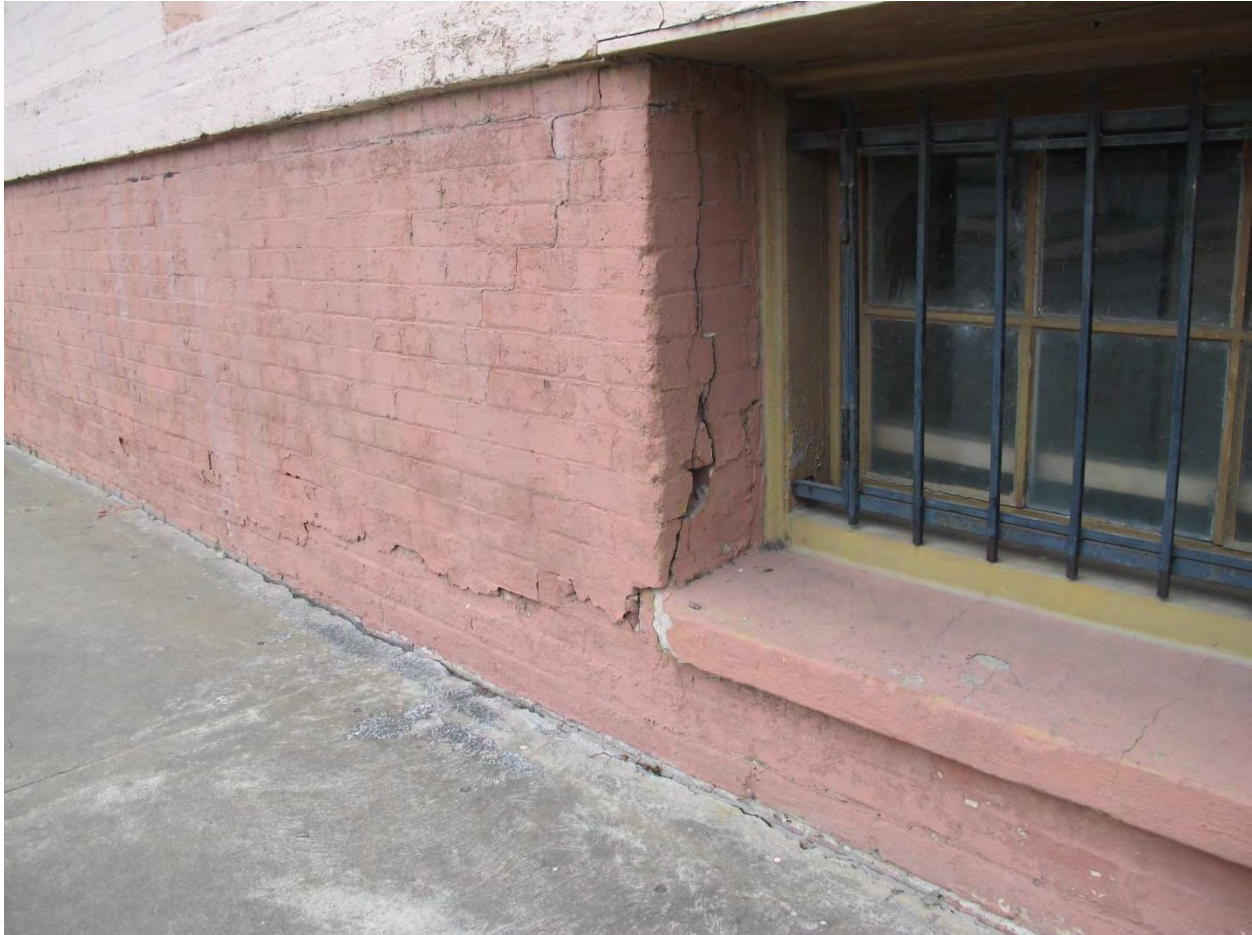
**Photo 9:** A view of distress in the masonry at a basement window that is attributable to the water infiltration from the water table defects above this area. Note that the crack extends horizontally beyond the window opening, and this area was sounded and found to be delaminated.

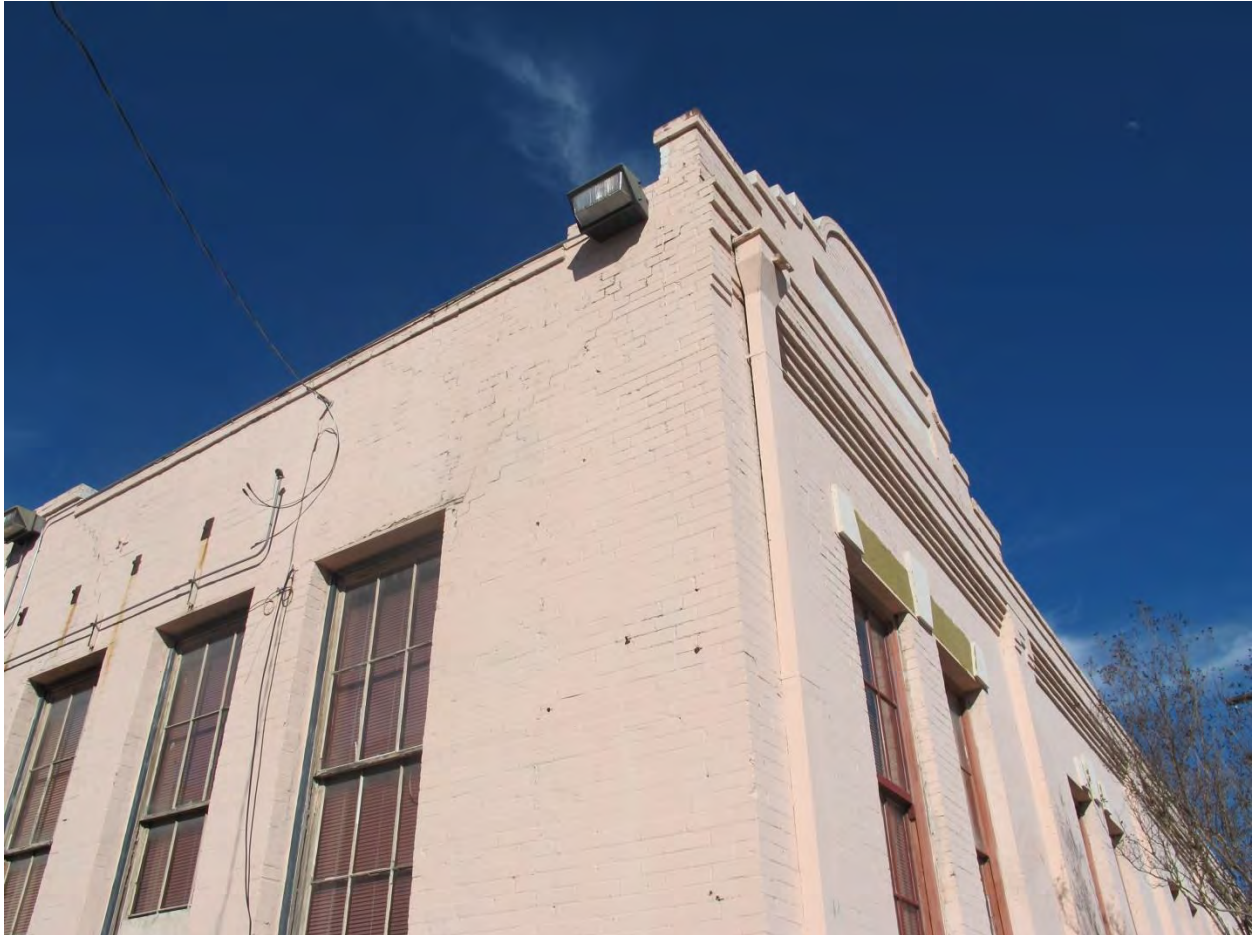
**Photo 11:** A view of the upper portion of the southwest corner of 243 Center Street. Note the diagonal cracking (previously repaired) at the upper areas of the masonry, which is most likely attributable to foundation settlement at the southwest corner.

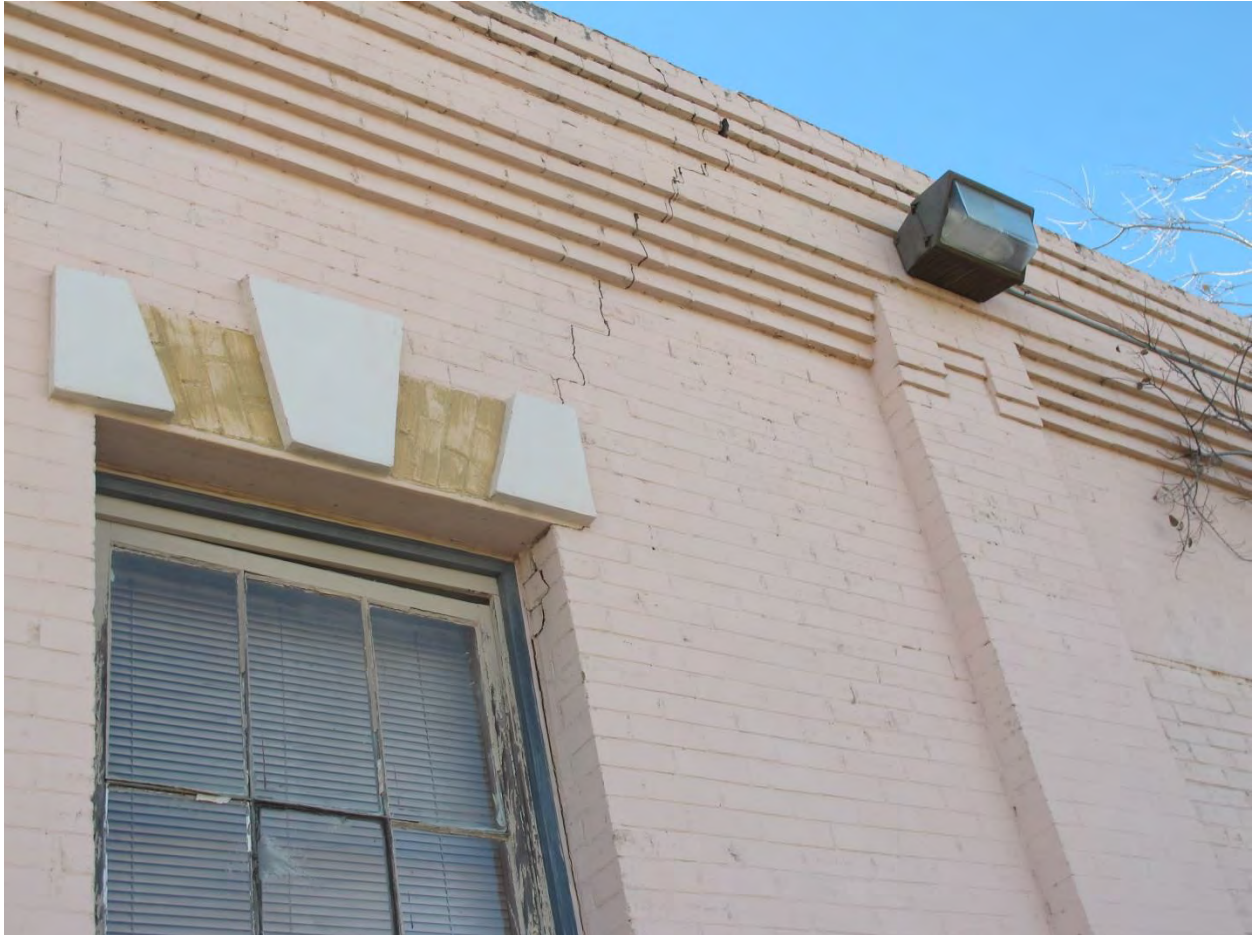
**Photo 13:** A view of the first window from the southeast corner with crack from the parapet to the window head and down the jamb line.

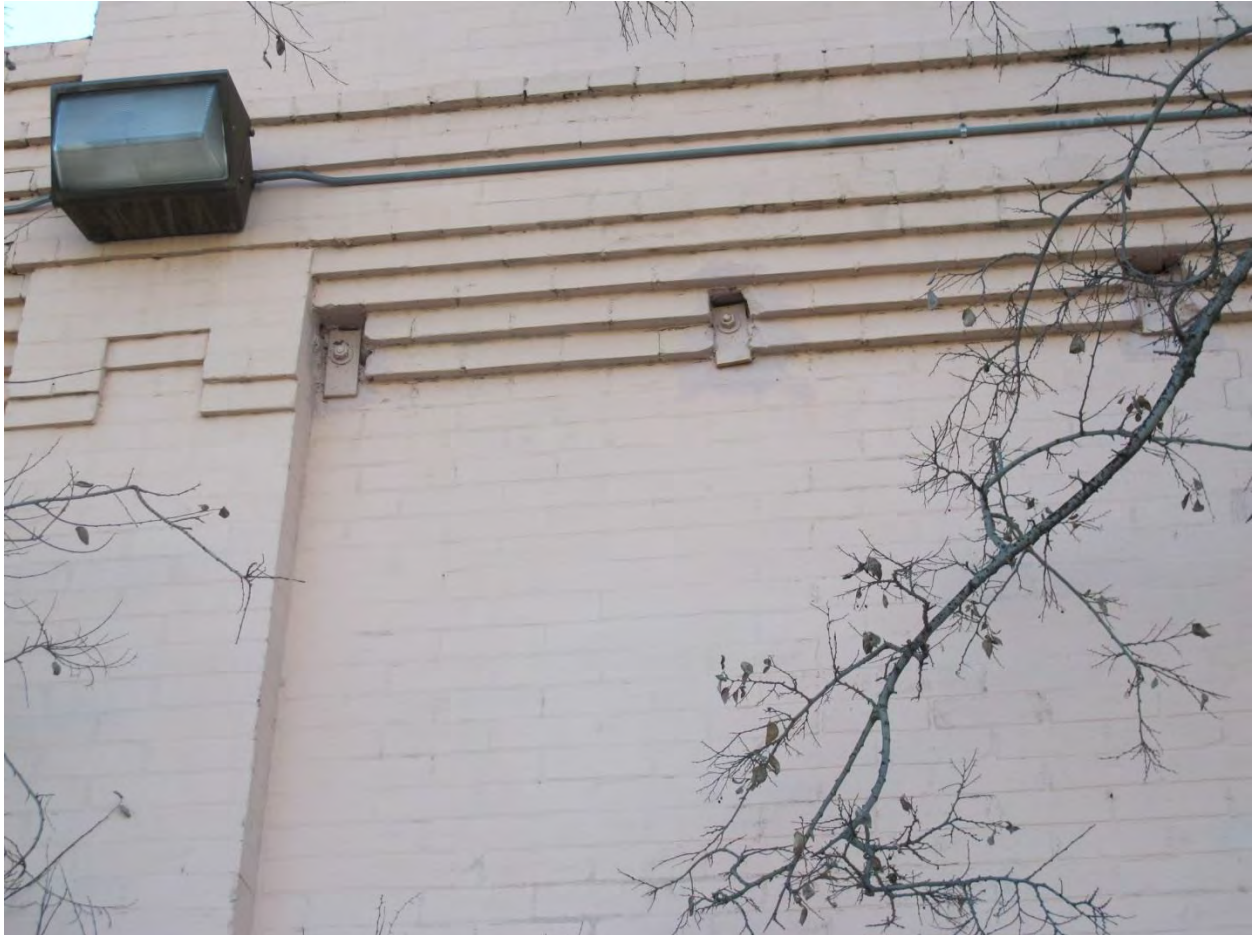
**Photo 14:** A view of the recently installed roof diaphragm connectors that involved some masonry damage.

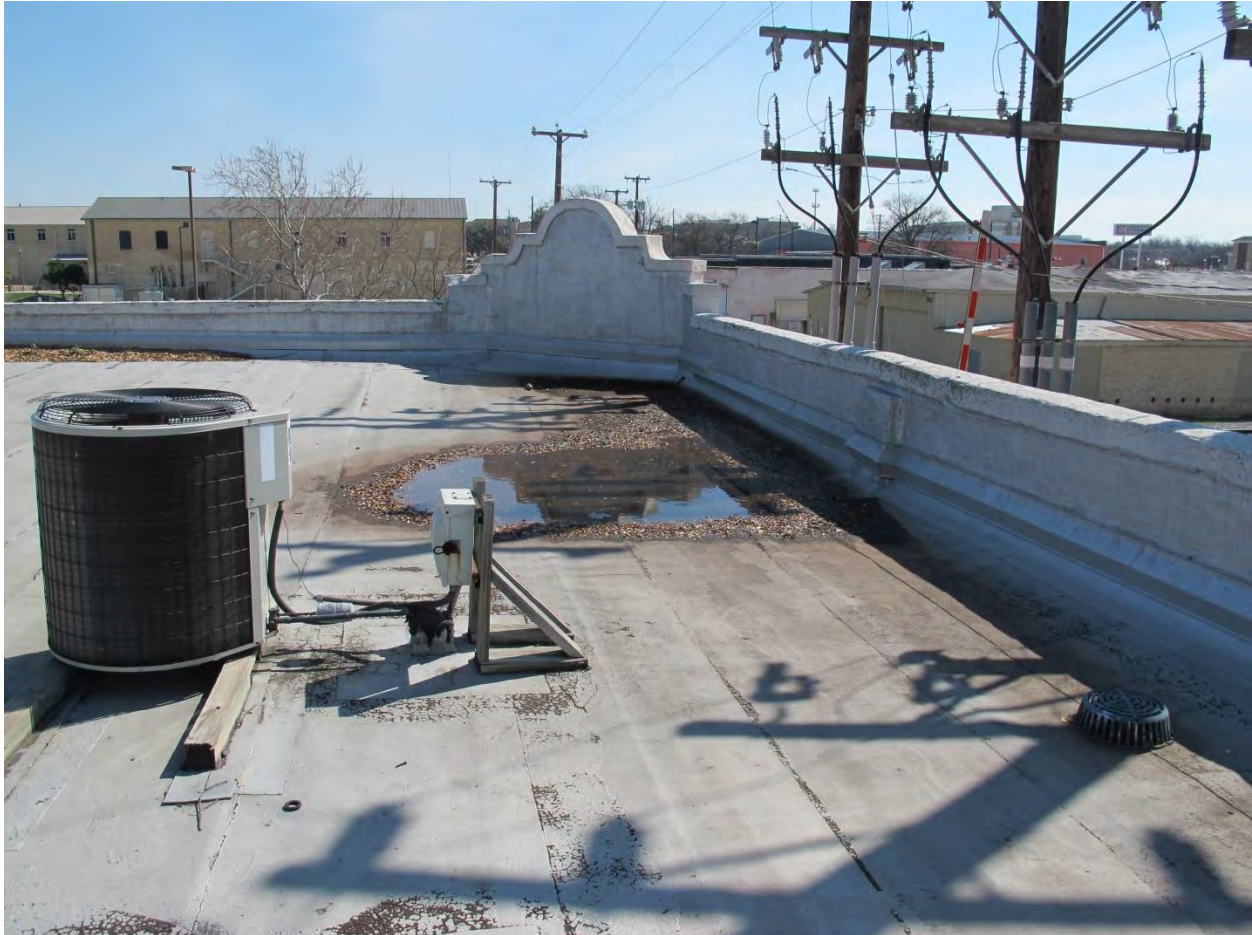
**Photo 18:** A view of the southeast corner of the roof. Note that there is a low point (bird bath), which is a drainage deficiency.

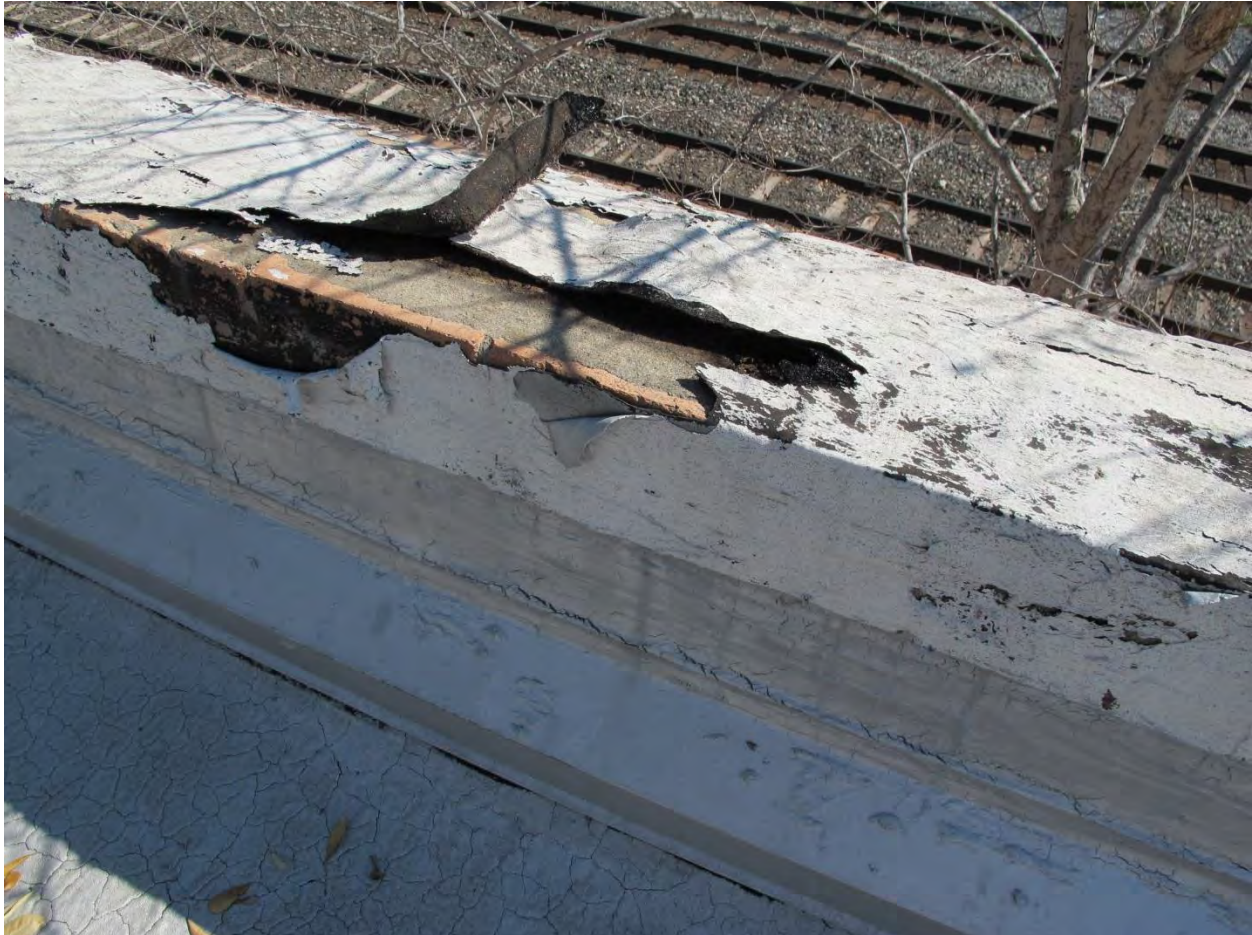
**Photo 20:** A close up view of a representative area of the east side parapet with roofing membrane cover. Note that the membrane has failed and will allow water infiltration. The top of the parapet does not have a coping, and the original brick masonry can be seen in the photo.

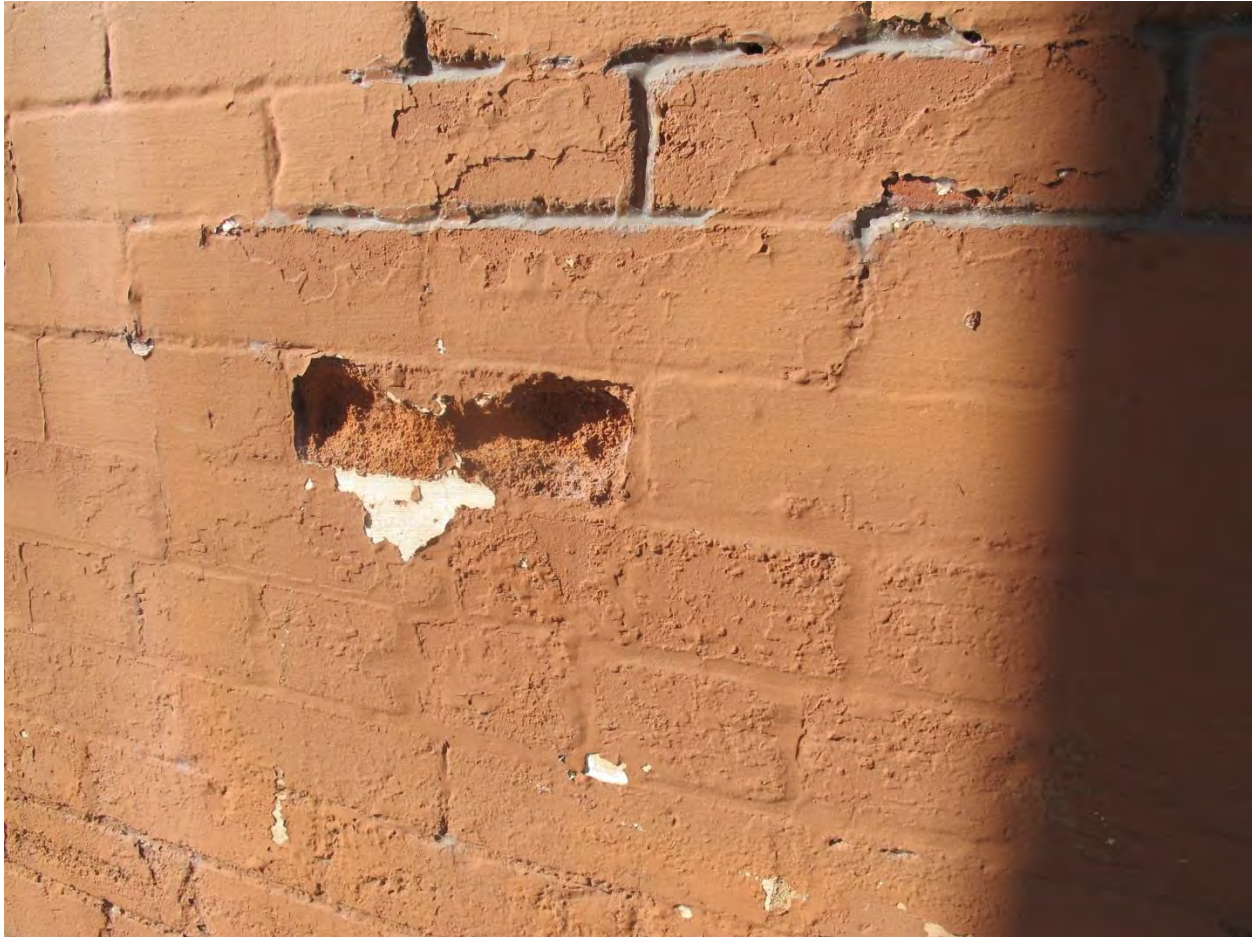
**Photo 21:** A close up view of a spalled face shell of a brick unit above the sidewalk on the south elevation. There are randomly located brick with spalls, but most are near and slightly above the grade of the sidewalk area along Center Street. Note the delamination of the coating which is the indicative of moisture infiltration within the masonry construction.

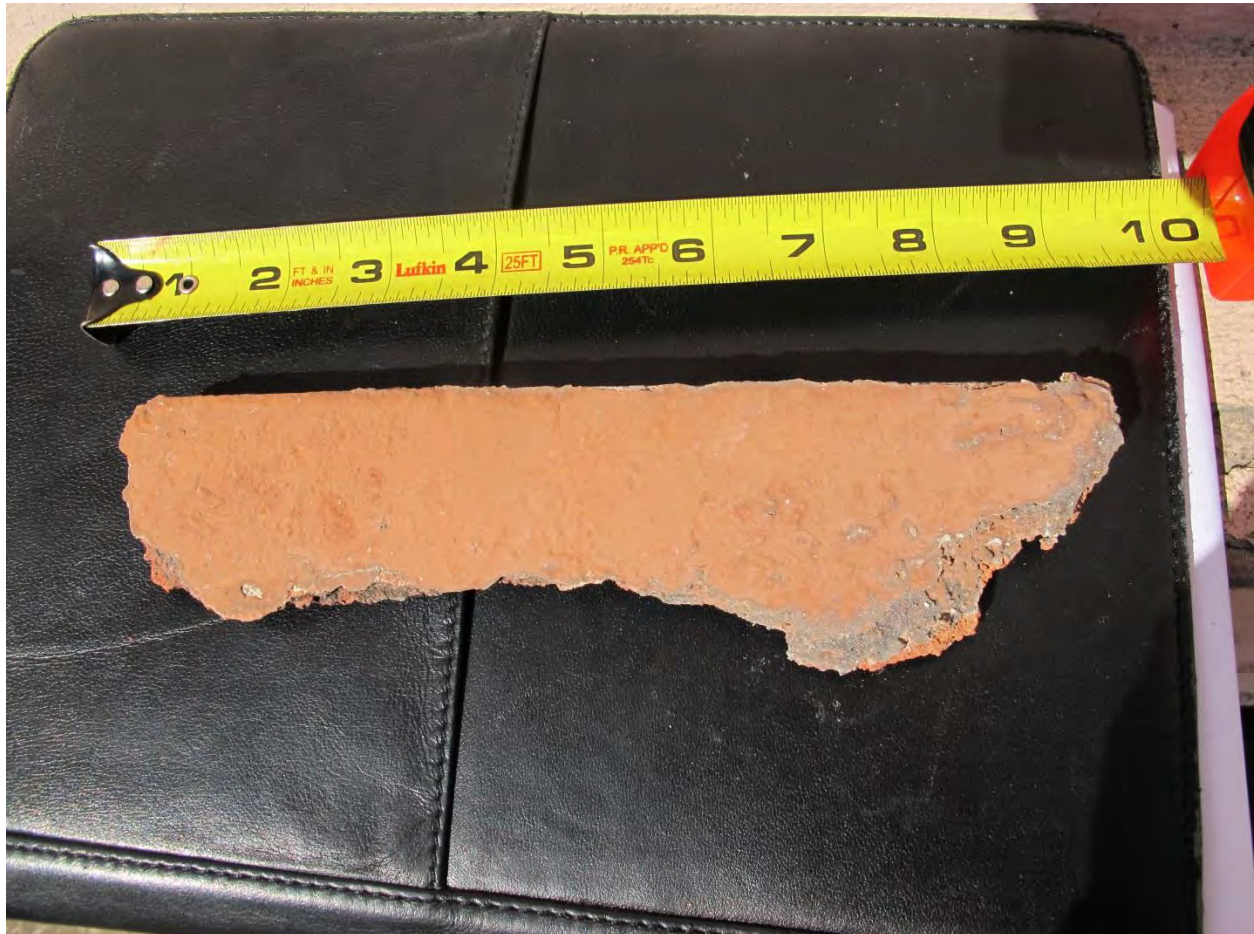
**Photo 22:** Looking at a piece of a spalled face from a brick on the south elevation.

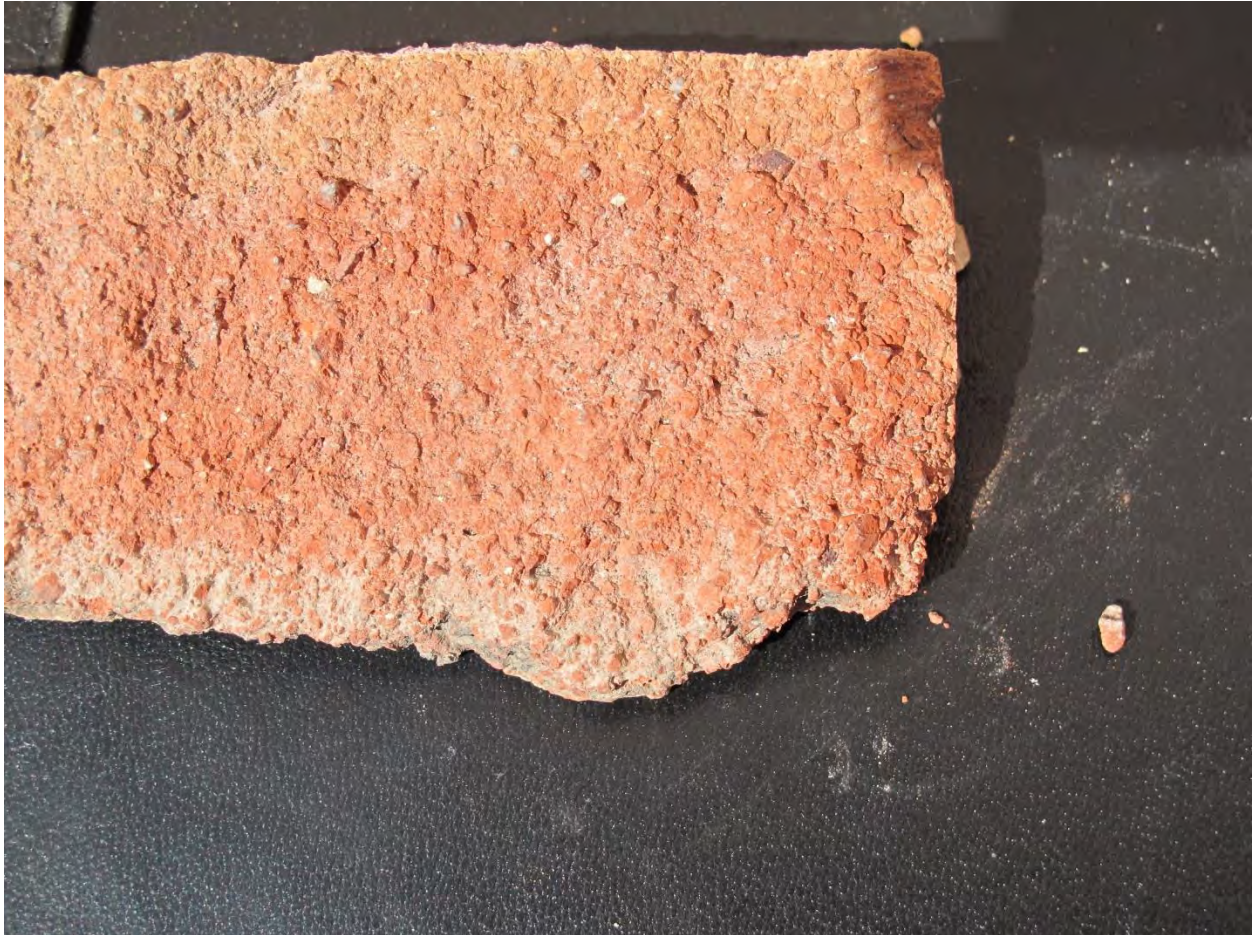
**Photo 23:** A close up view of the interior of the spall that is seen in Photo 22. Note the composition of the originally fired material, and this is suggestive of a porous brick.

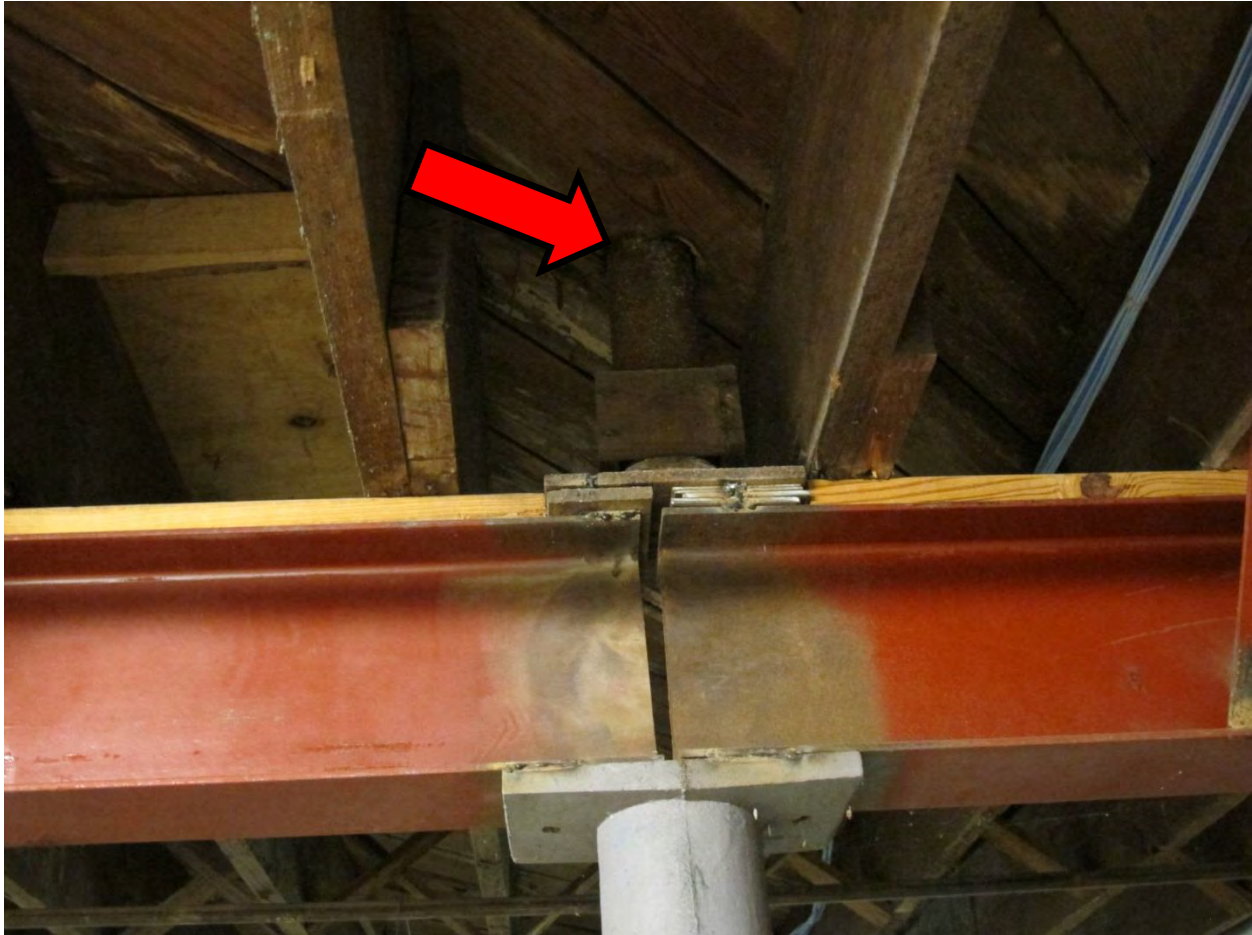
**Photo 28:** A close up view of a representative area where new W 10 beams were installed to replace the original construction. Note that the upper cast iron column was installed on shim plates that straddle the two beams below.

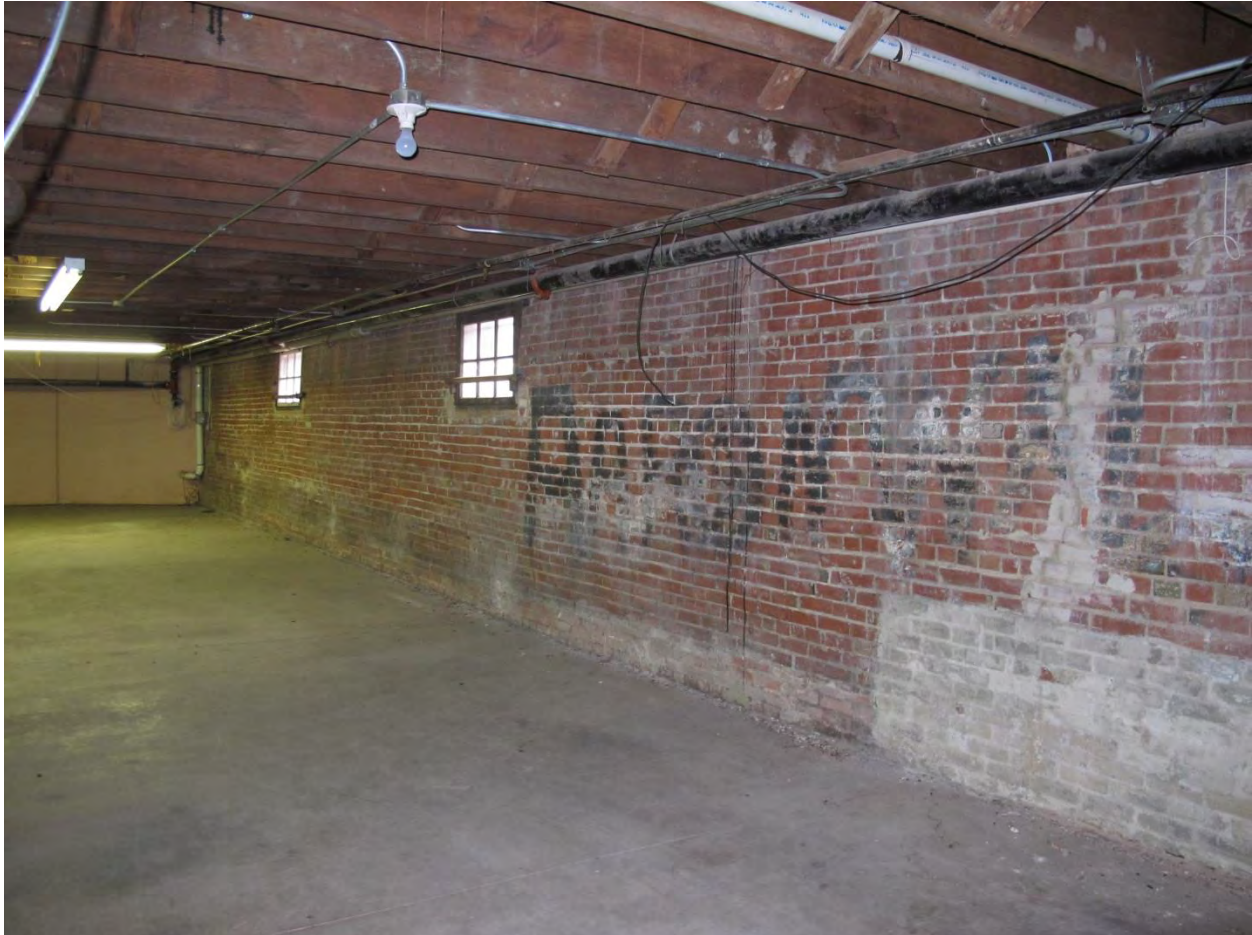
**Photo 30:** A view of the south elevation basement wall from the west foundation wall looking east. This area was observed to have an inward lateral displacement of the masonry from about 50 to 80 inches above the concrete slab. Of note, header courses were installed every six courses.

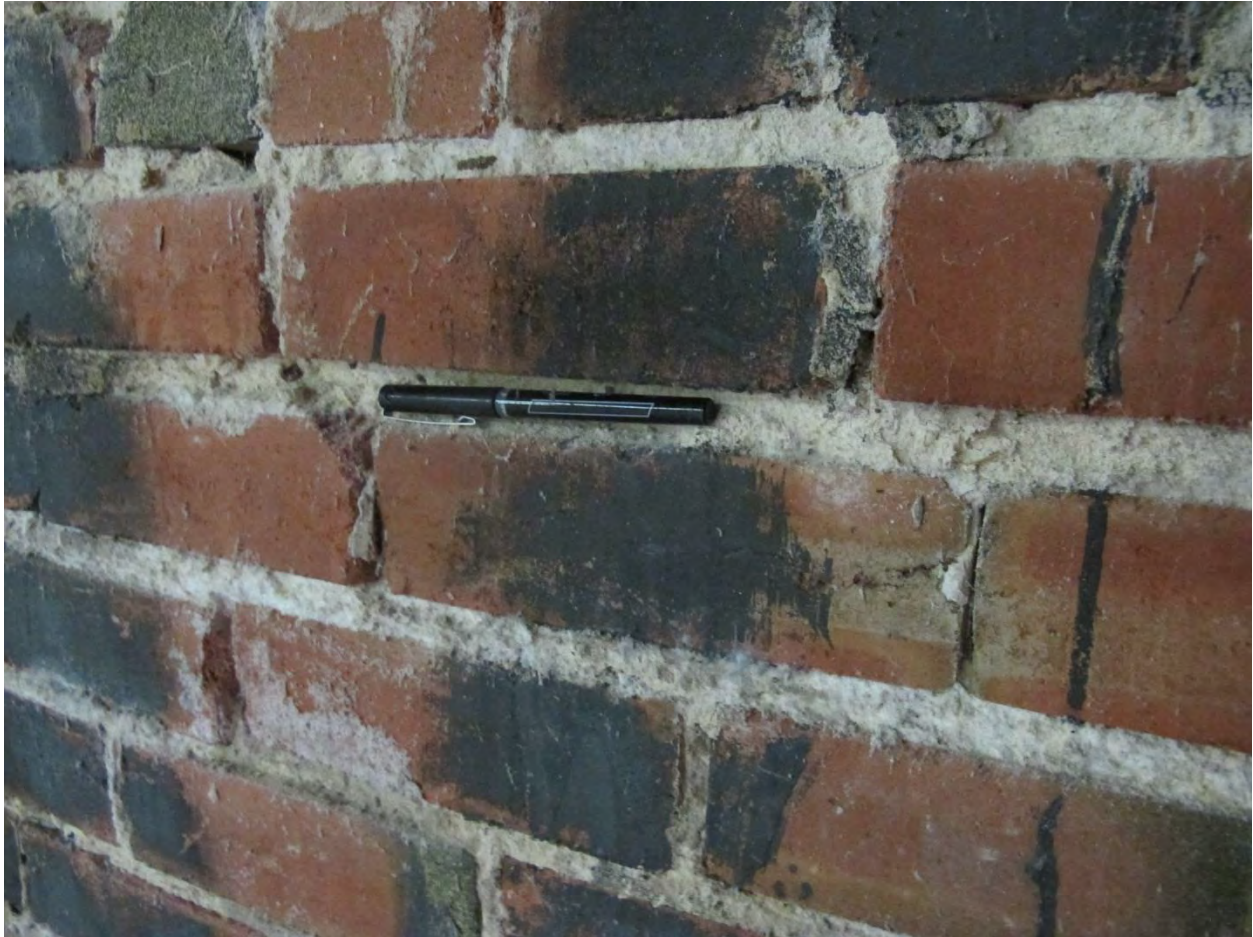
**Photo 31:** A close up view of the interior mortar joints at the basement level along the south elevation. Moisture infiltration has caused the mortar to disintegrate and erode.

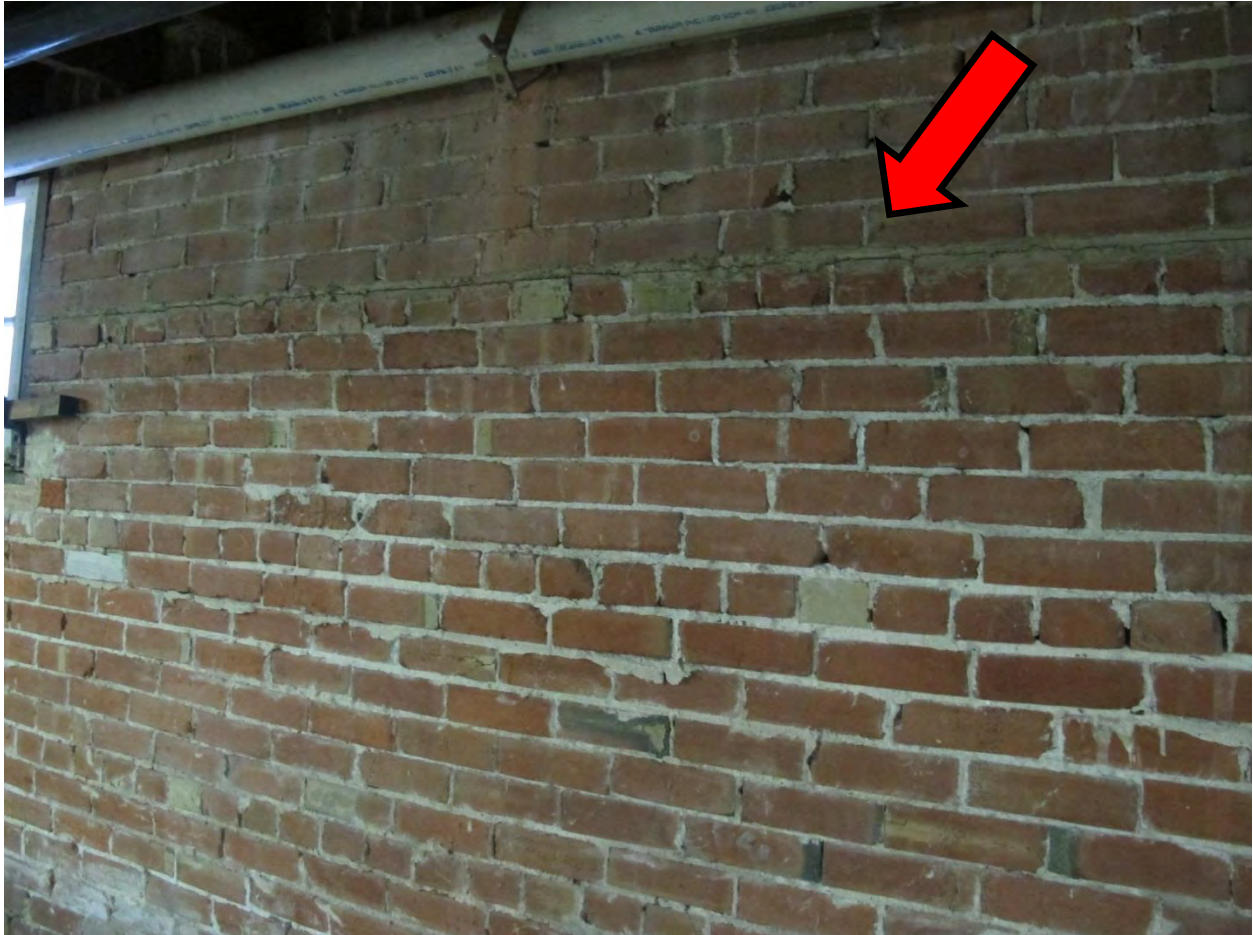
**Photo 33:** A view of the south elevation basement wall and the arrow points to a crack and the course which is most inwardly displaced.

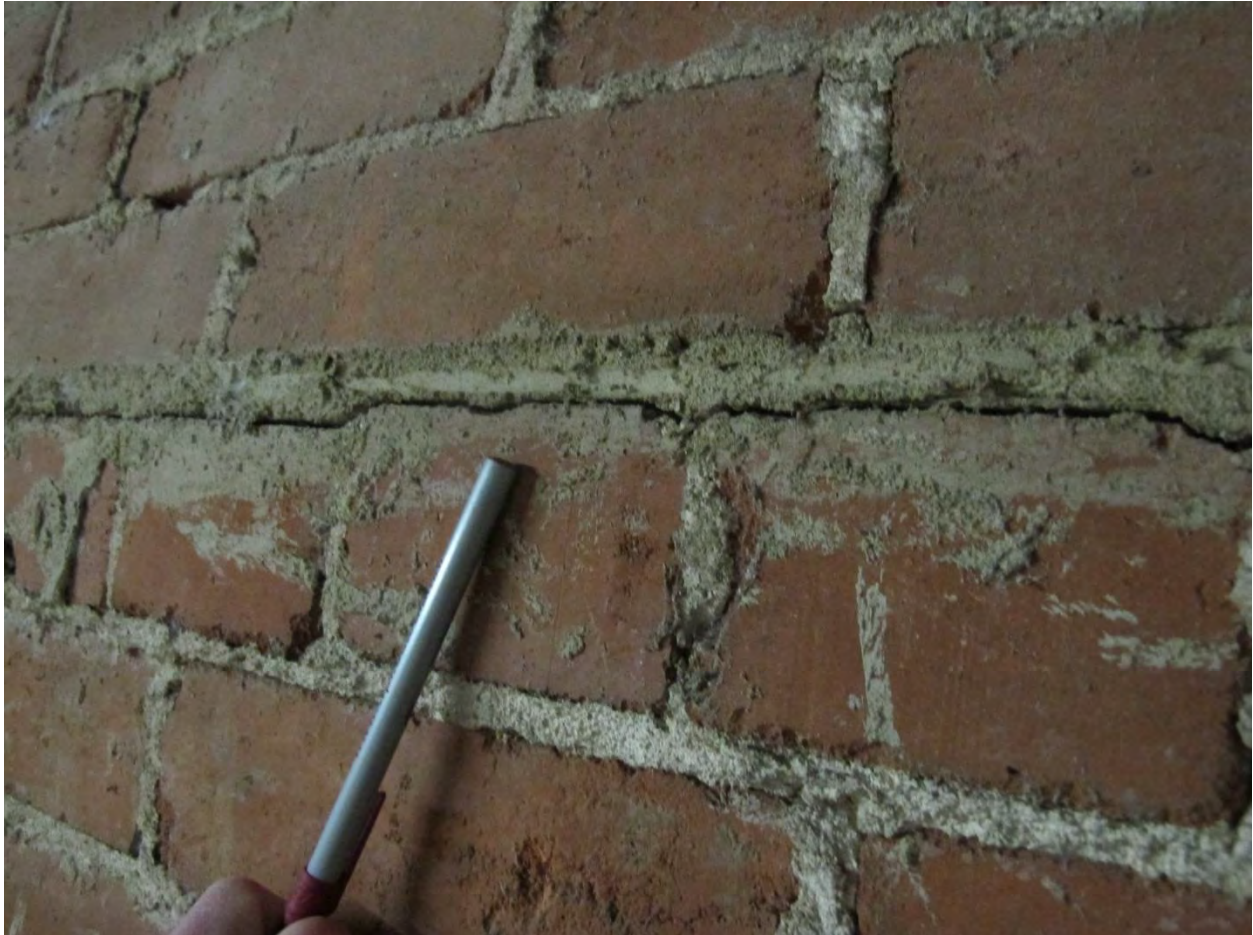
**Photo 34:** A close up view of the crack seen in Photo 33. Note that the crack had been previously filled with a cement mortar and has reopened.

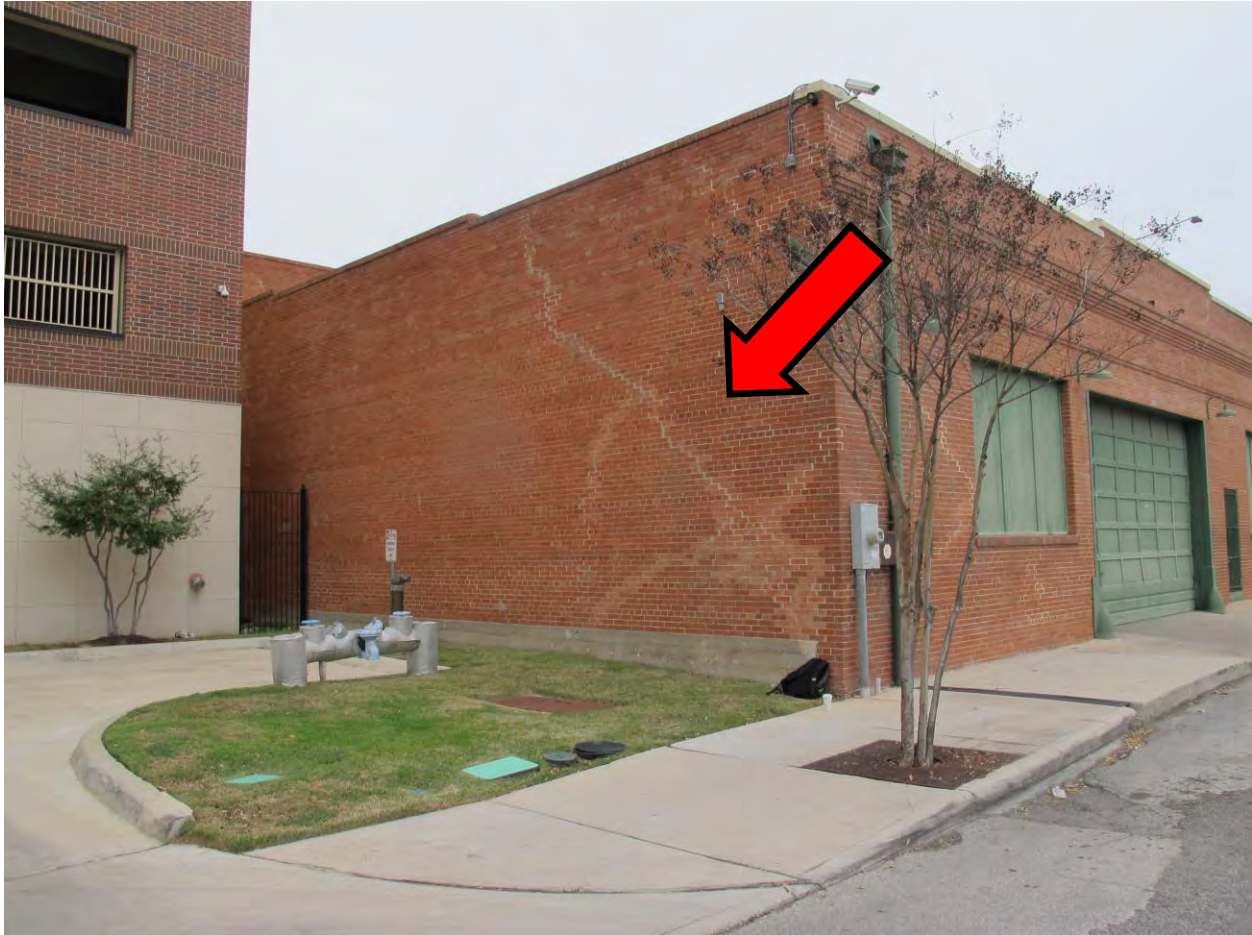
**Photo 2:** The west elevation with the south elevation in view. Note the cracking on both sides of the southwest corner. The crack on the west elevation appears to emanate from the truss bearing point.

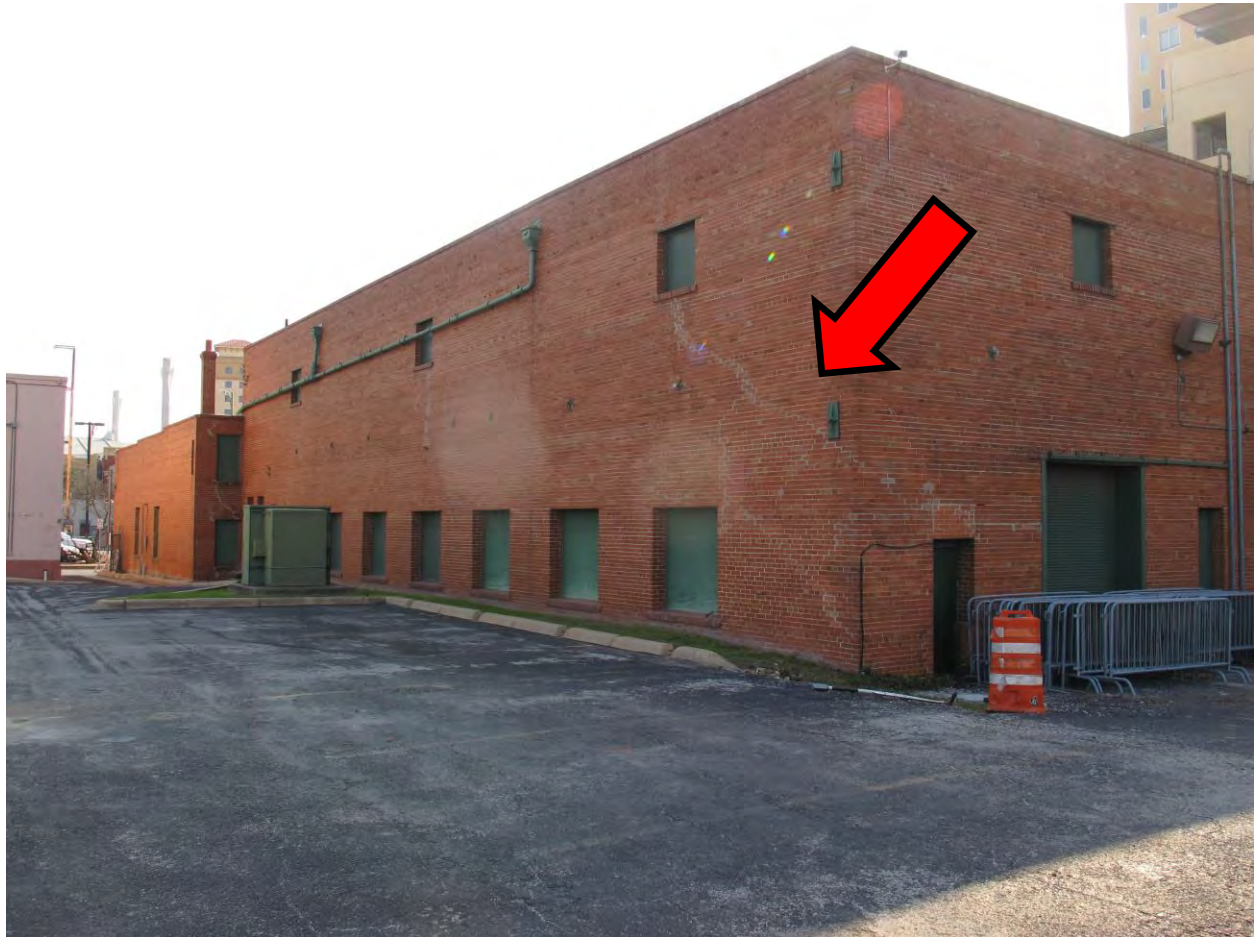
**Photo 3:** Looking south at the east elevation. Note that there cracking along the elevation which appears to have been previously repaired.

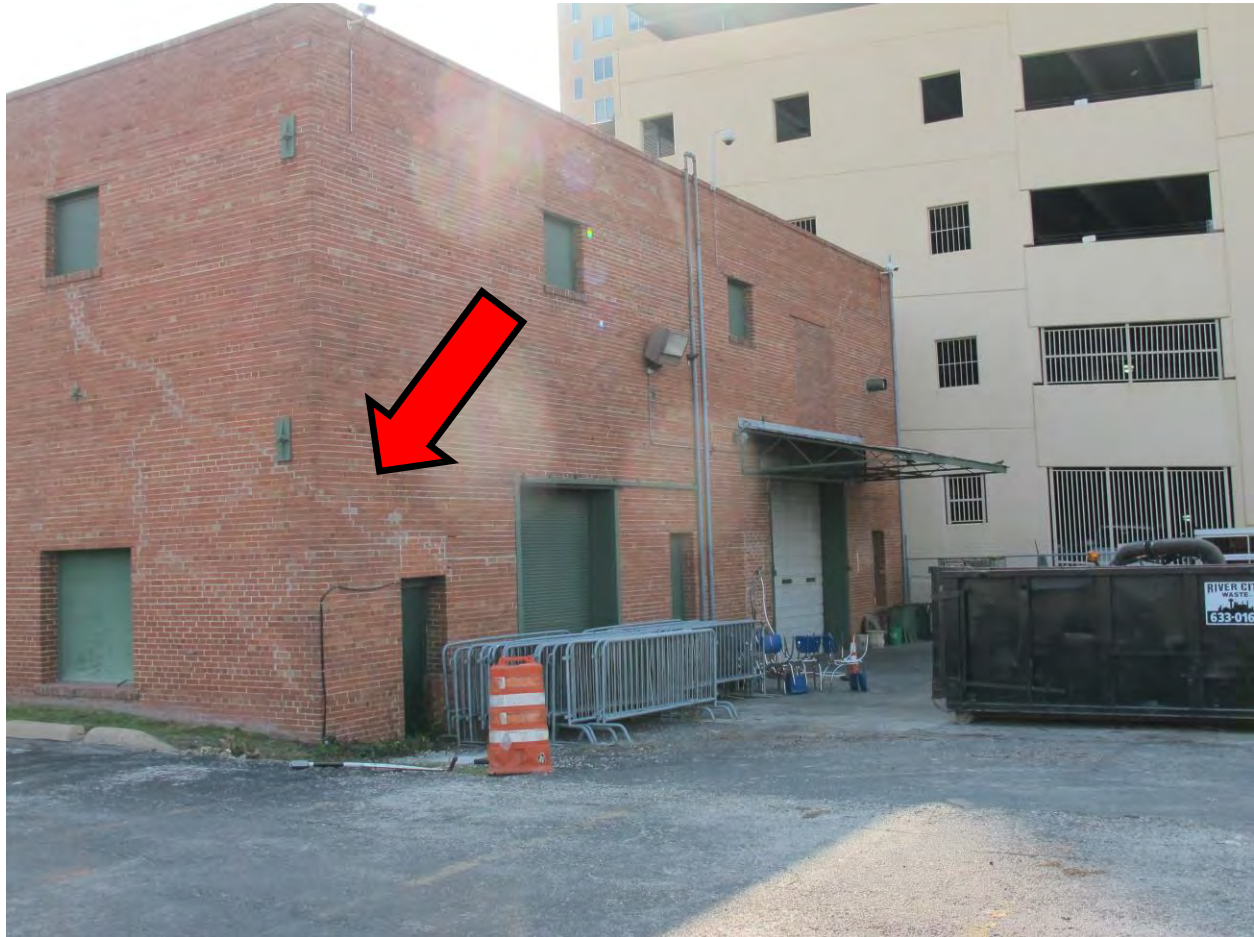
**Photo 8:** A view of the north elevation which shows cracking extending from the east elevation to the north side.
