HISTORIC AND DESIGN REVIEW COMMISSION

HDRC CASE NO: 2016-444
ADDRESS: 114 PRINCESS PASS
LEGAL DESCRIPTION: NCB 3094 BLK 10 LOT 10 & P-100 (PT OF ALLEY)
ZONING: R-4 H
CITY COUNCIL DIST.: 1
DISTRICT: Monte Vista Historic District
APPLICANT: Chris Schultz
OWNER: Chris Schultz
TYPE OF WORK: Historic Tax Verification
REQUEST:

Final Renovation Expenses for Repair/Rehabilitation of Schultz Residence

114 Princess Pass
San Antonio, Texas

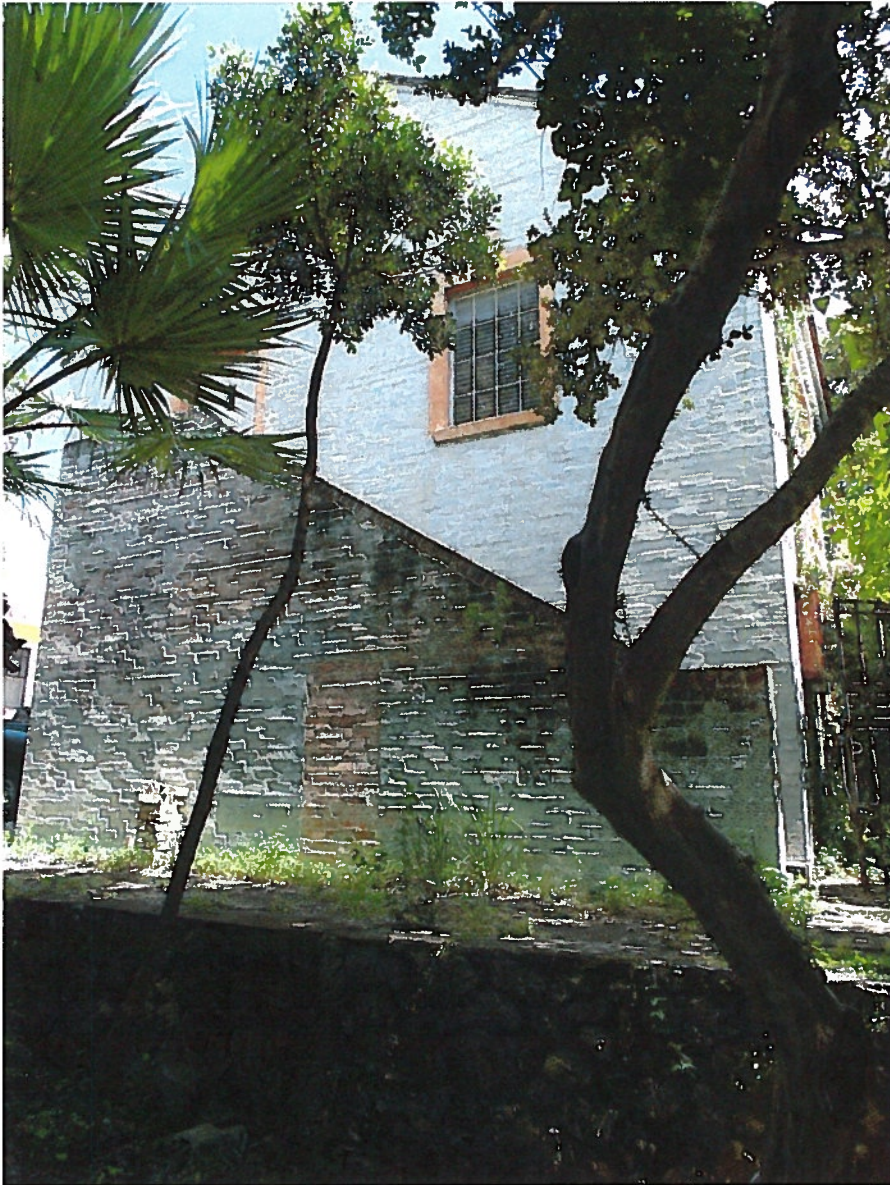
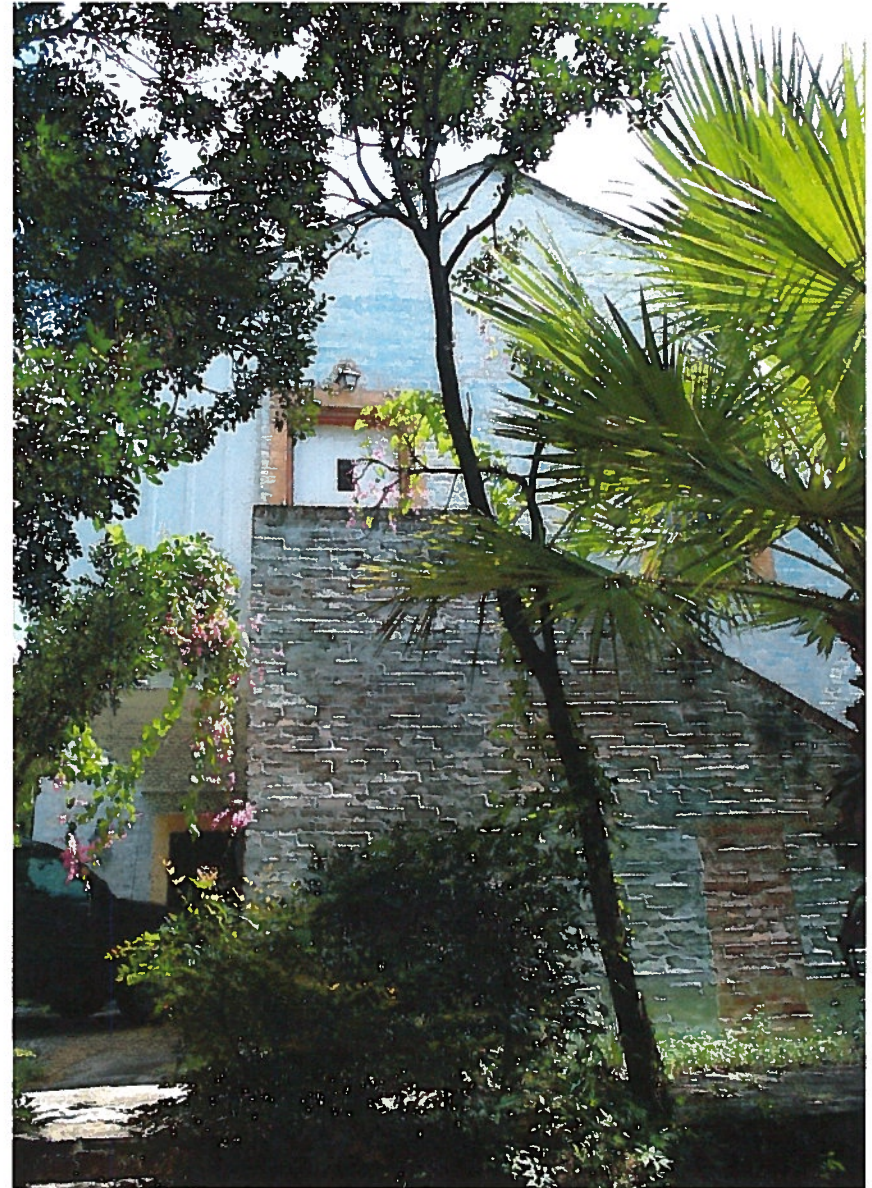
Street Façade (Southwest Elevation) – repointed masonry in various places; infilled access door below stairs with D'Hanis solid bricks (one of a variety of bricks used in original construction); re-installed existing Ludowici roof tiles over new underlayment with copper flashing and new redwood eave trim to match existing profile and dimension throughout (existing trim had significant wood rot and termite damage); new board and batten siding (dimensions and profiles matching existing) on cantilevered second floor kitchen over garage below (existing siding had significant wood rot); refurbished and repainted existing front door.

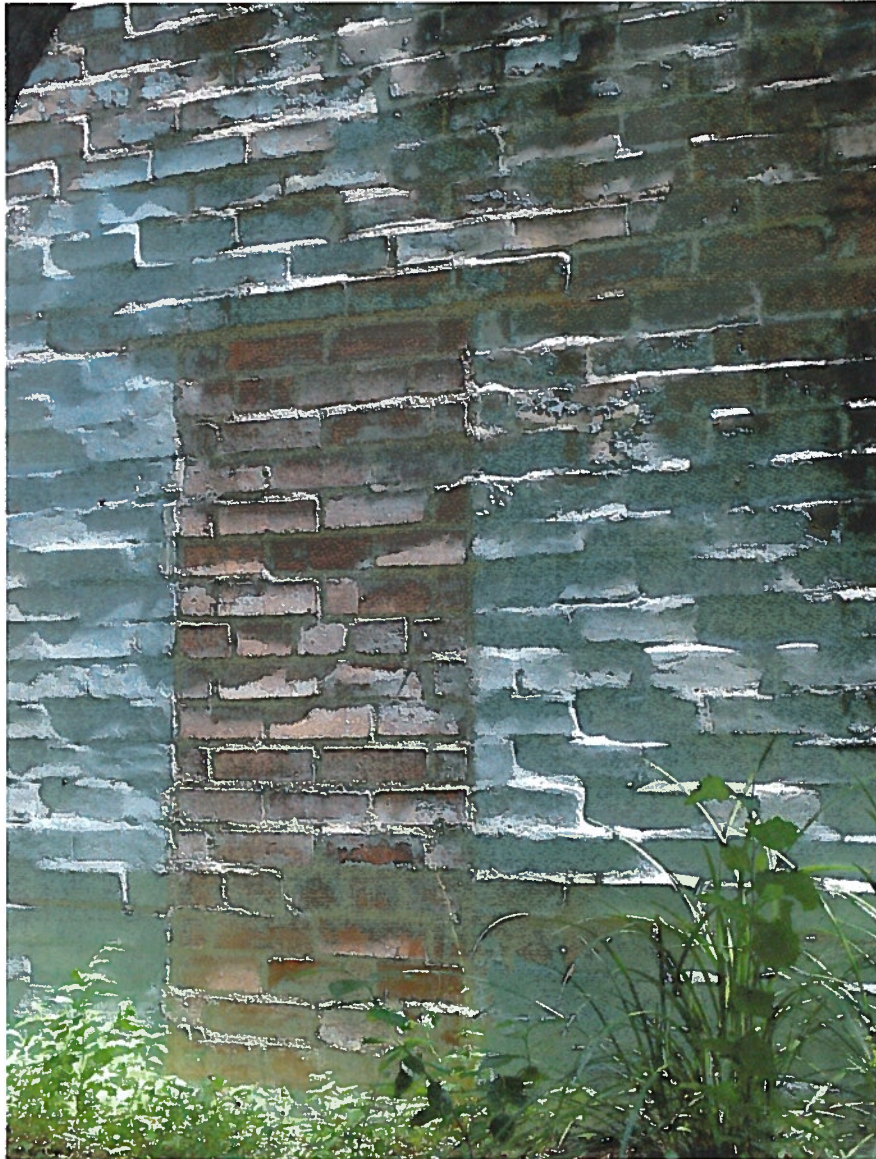
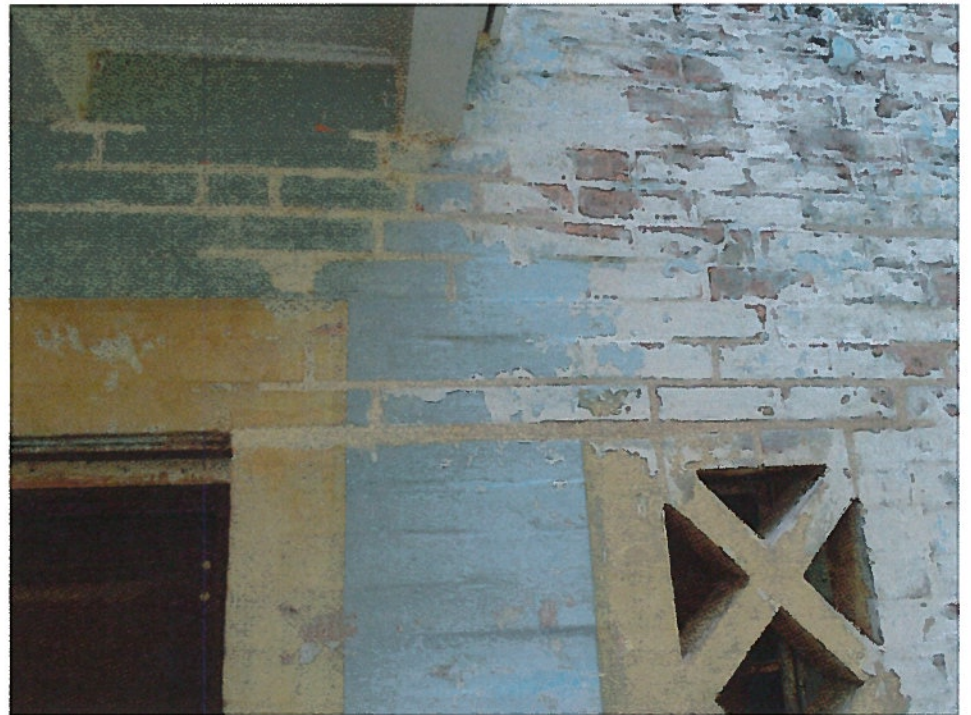
Street Façade – (left) Detail of infill masonry below stairs – tried to emulate slightly irregular placement of individual bricks seen in existing masonry; (right) Detail of repointed masonry joints using white masonry cement, and medium coarse sand in 1:3 ratio similar to existing mortar (picture taken below cantilevered second floor kitchen next to garage door)

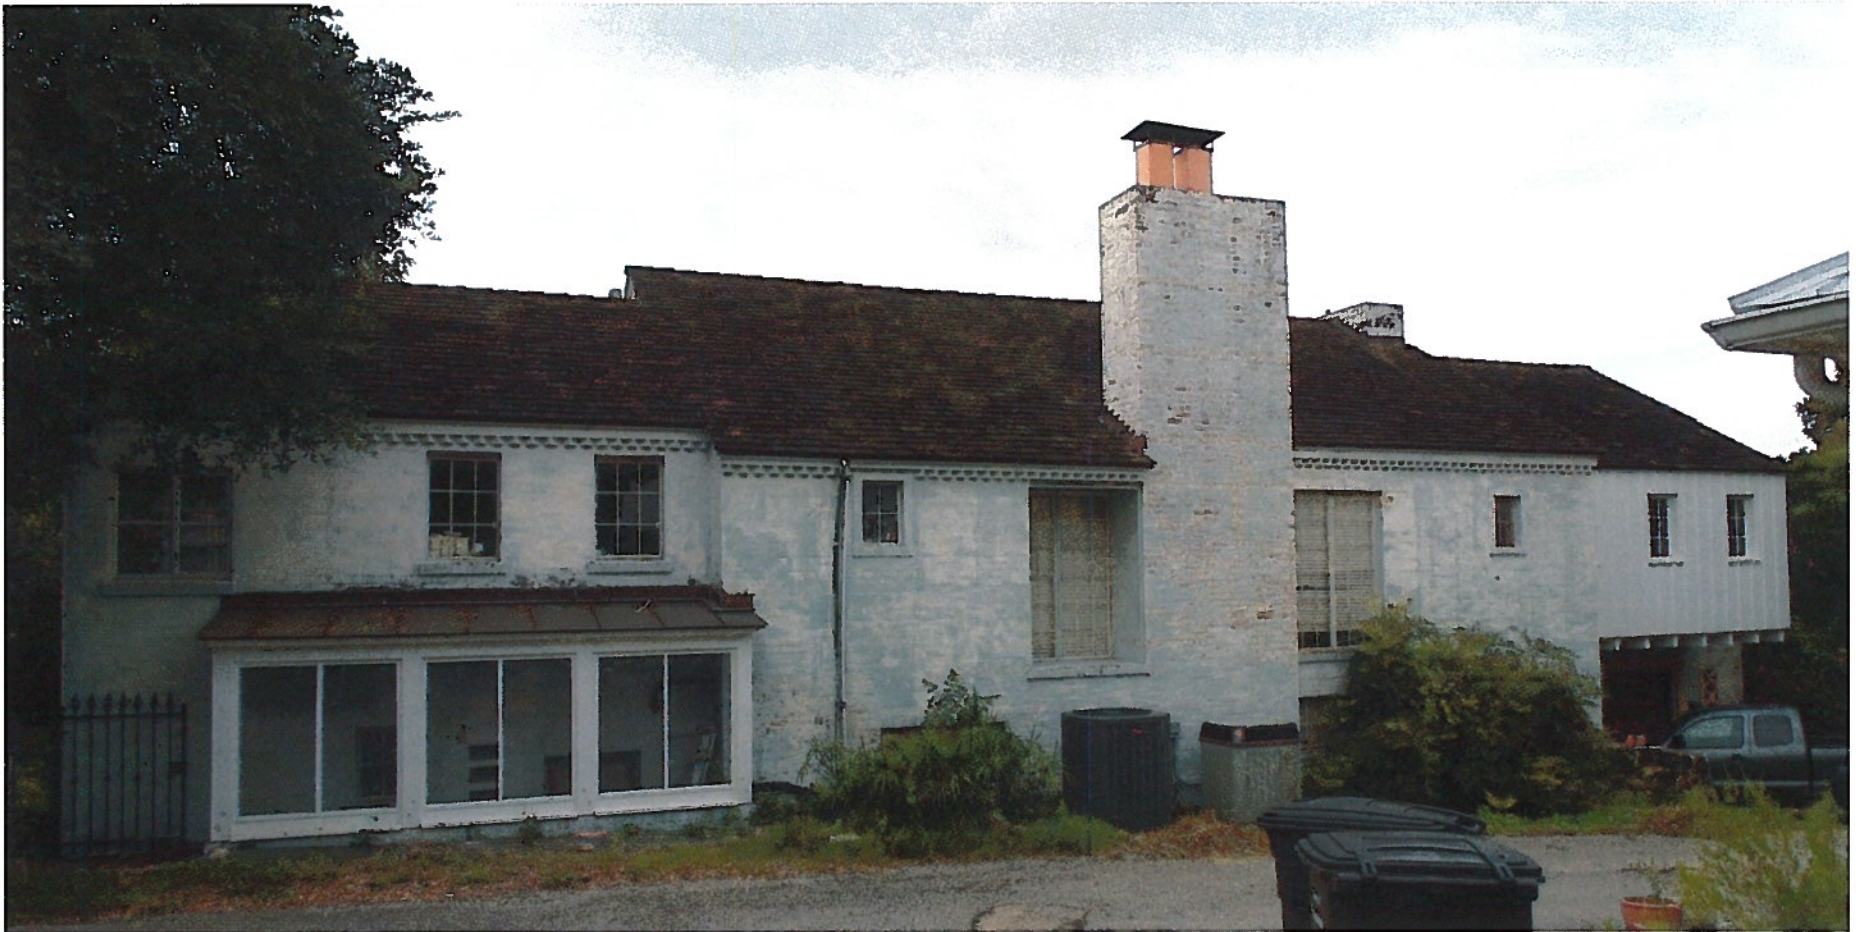
Driveway Façade (Northwest Elevation) – New replacement window far left upstairs to replace fire-damaged existing; refurbished roofing, copper flashing and perimeter eave trim as noted earlier (roof now has some hail damage – awaiting repair);repointed masonry in numerous locations; new standing seam copper roof over rear porch covering stairs down to first floor kitchen; also new glazed rain screen and wood frames at rear porch openings (to prevent flooding of stairwell – replaced existing “temporary” corrugated plastic panels); new outdoor HVAC condensing unit (taller one on left) relocated from former location near garage; new board and batten siding, refurbished windows and insulated floor at second floor cantilevered kitchen (far right of photo)

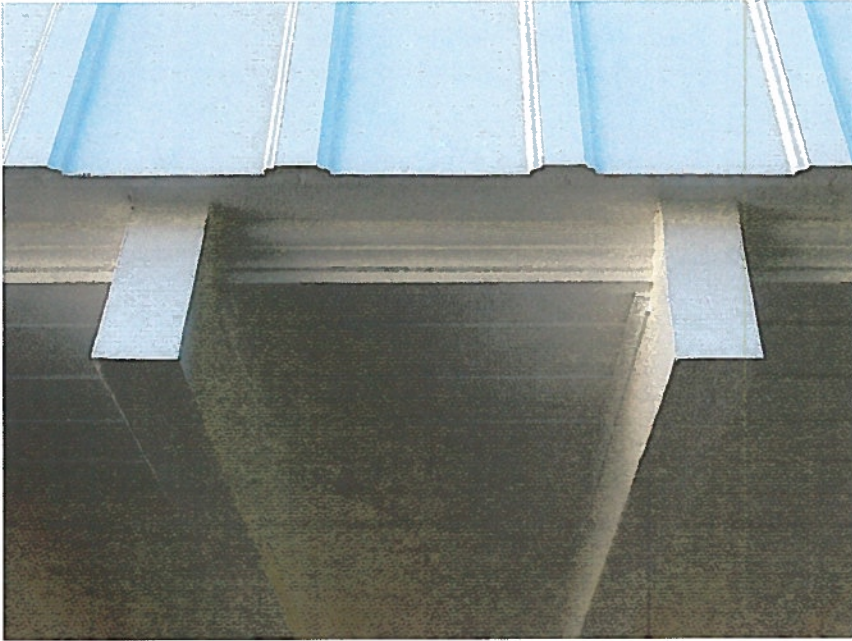
Detail of board and batten siding and insulated floor with covering decking and trim at cantilevered second floor kitchen over garage

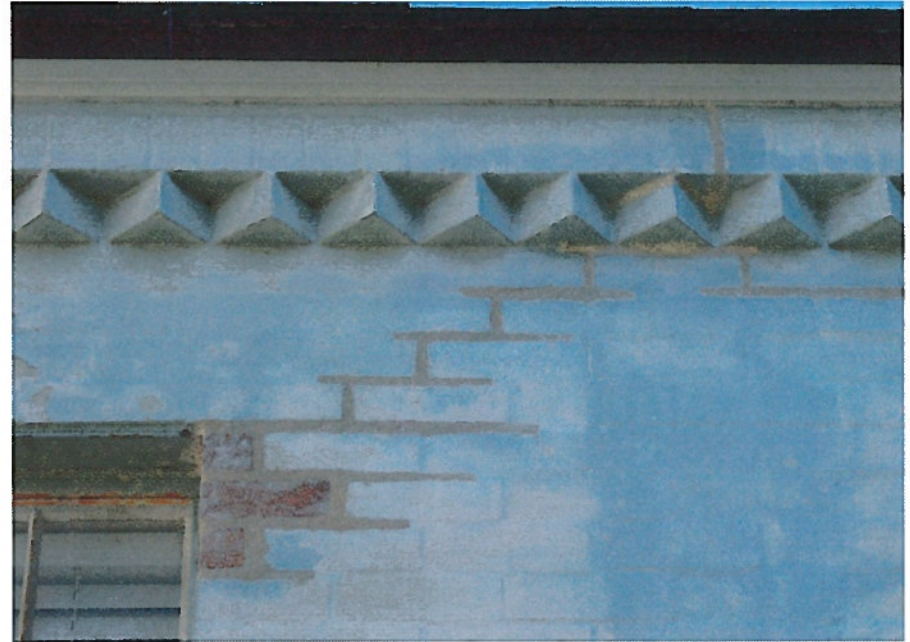
Detail of repointed masonry joints, replaced broken/cracked masonry (at window jamb/head corner), new painted redwood eave trim and copper drip edge (typical at all roof locations)

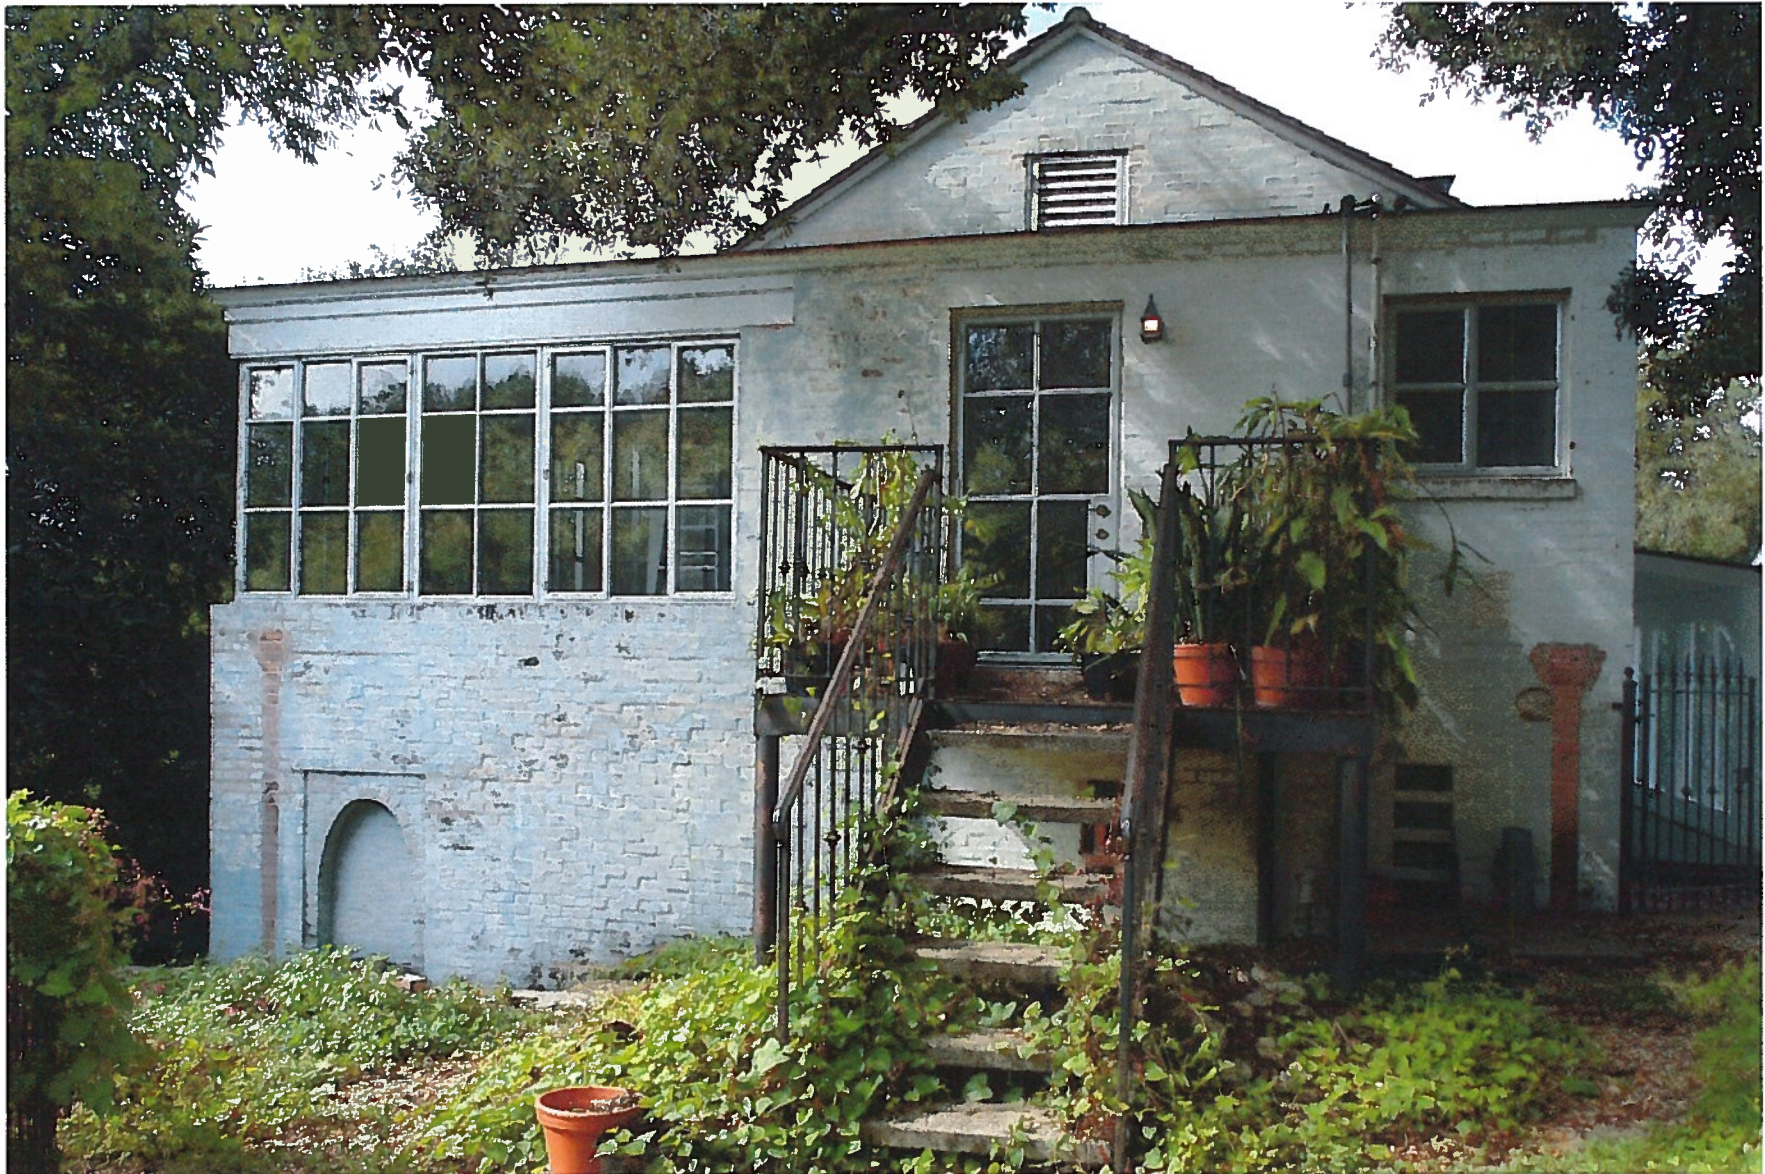
Rear Façade (Northeast Elevation) – New roof beam and trim and casement windows at second floor sunporch (upper left) to replace those damaged by fire; new glazed rear door and upper right window to match replacement windows at sunporch; new perimeter eave trim and copper flashing throughout; new roofing over new tapered roof insulation at flat roof area; new attic louver/access door in gable to replace existing damaged by fire department; repointed masonry joints in numerous locations; new decorative masonry "lattice" over first floor window (partially obscured by metal stairway – detail later). Note: circular hole in masonry on lower far right will be filled by first floor kitchen exhaust hood once interior renovation begins.

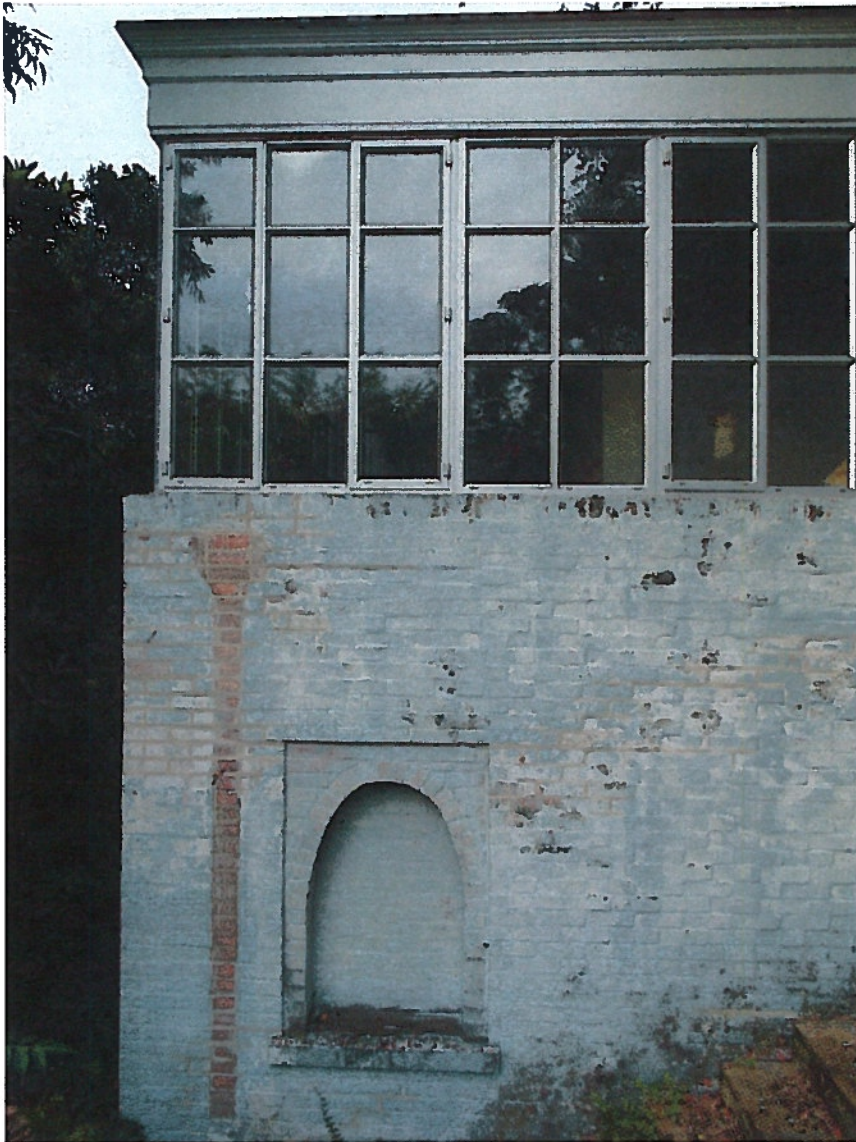
Detail of sunporch beam and replacement windows; repointed masonry, especially at exterior corner below windows. Note: former sheet metal downspout was damaged by roofing operations and removed – opening was infilled with D'Hanis solid brick

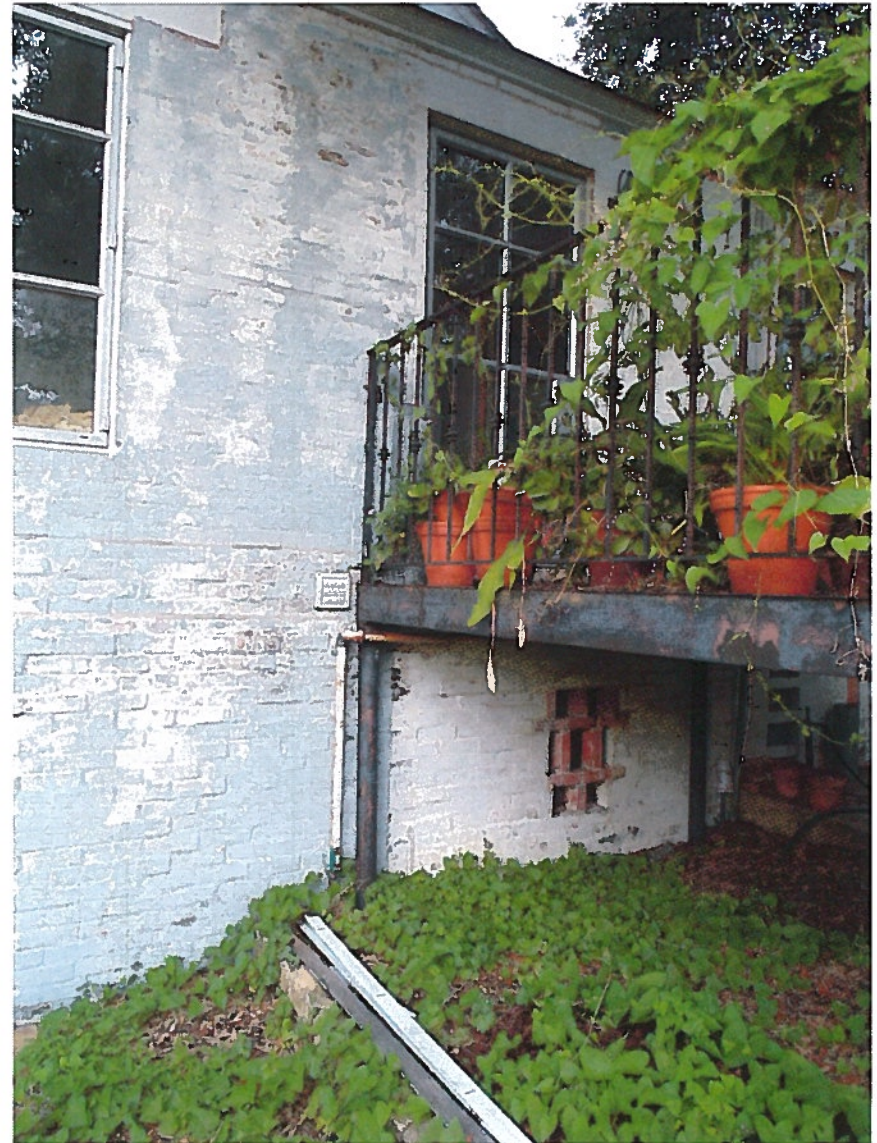
Detail of replacement glazed door above and new brick "lattice" over first floor window (pattern of lattice confirmed by existing masonry evidence – original lattice was missing when residence was purchased in 1996, painting delayed until entire house can be painted)

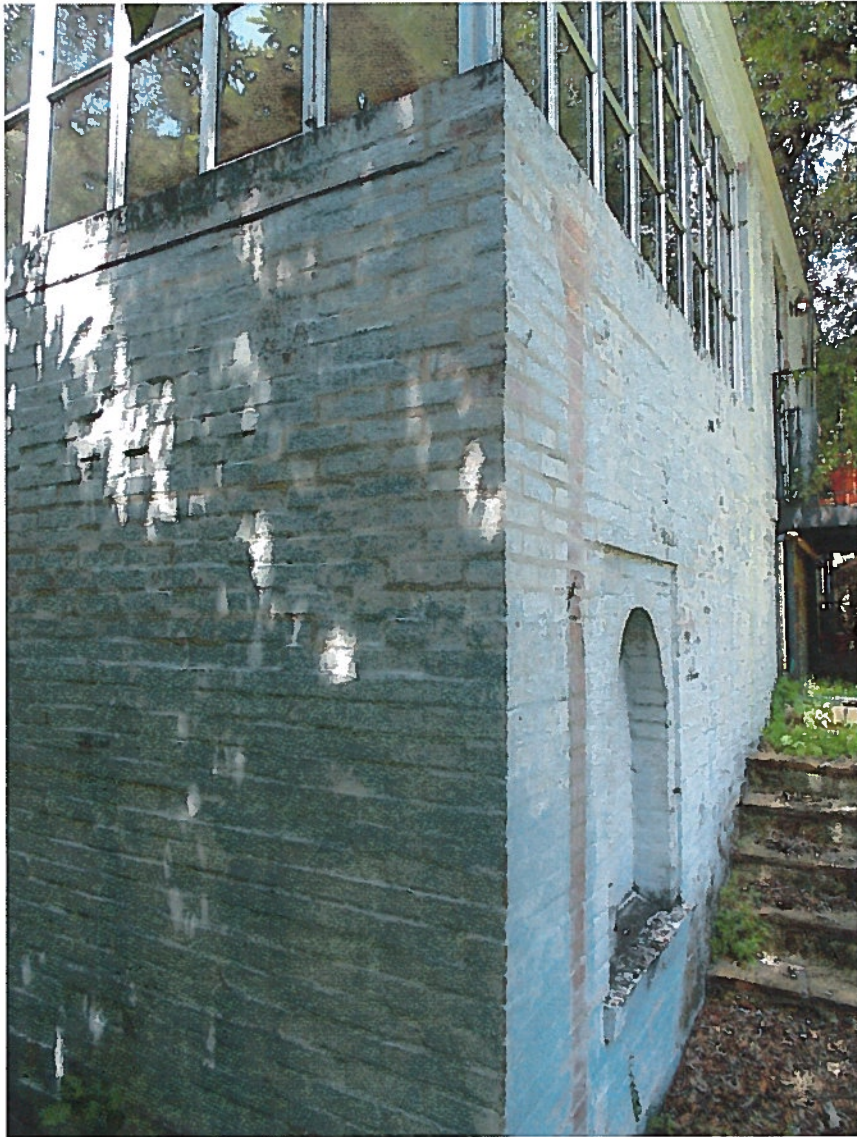
Detail of repointed masonry

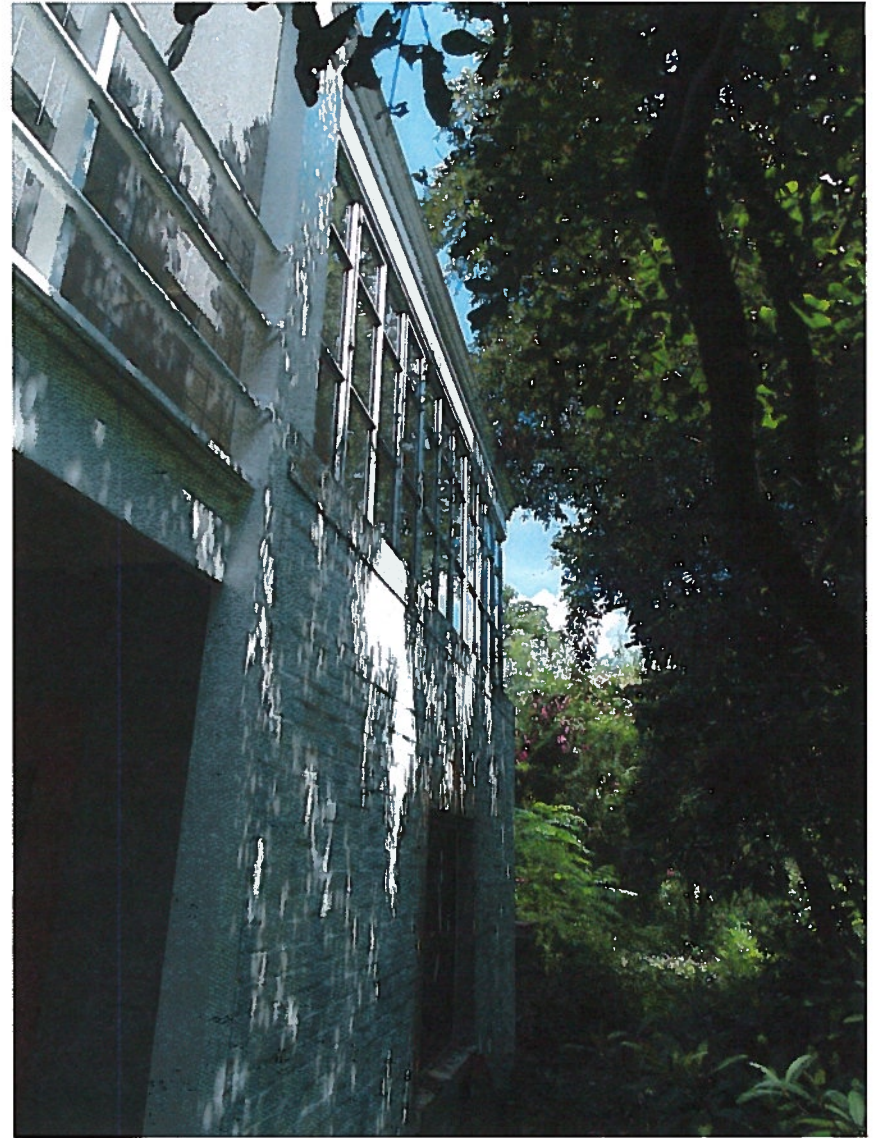
Detail of replacement roof beam/trim and windows at second floor sunporch; replacement 6x6 wood two-story porch column (top burned in fire) and new porch flooring, railings, and screening similar to original photo)

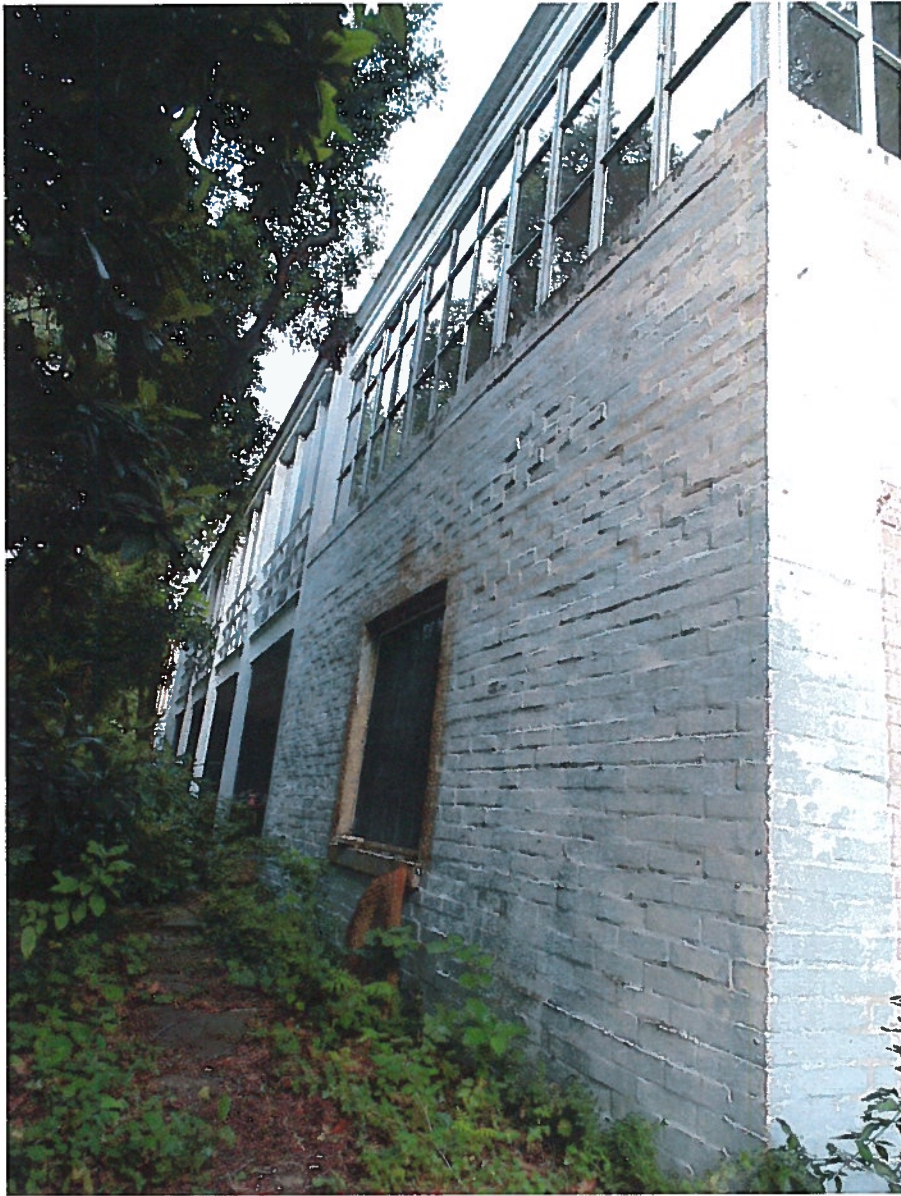
Side Façade (Southeast Elevation) – Repointed masonry throughout; new roof beam/trim and windows at second floor sunporch; replacement 6x6 wood porch columns, new balcony porch flooring, railings and screening

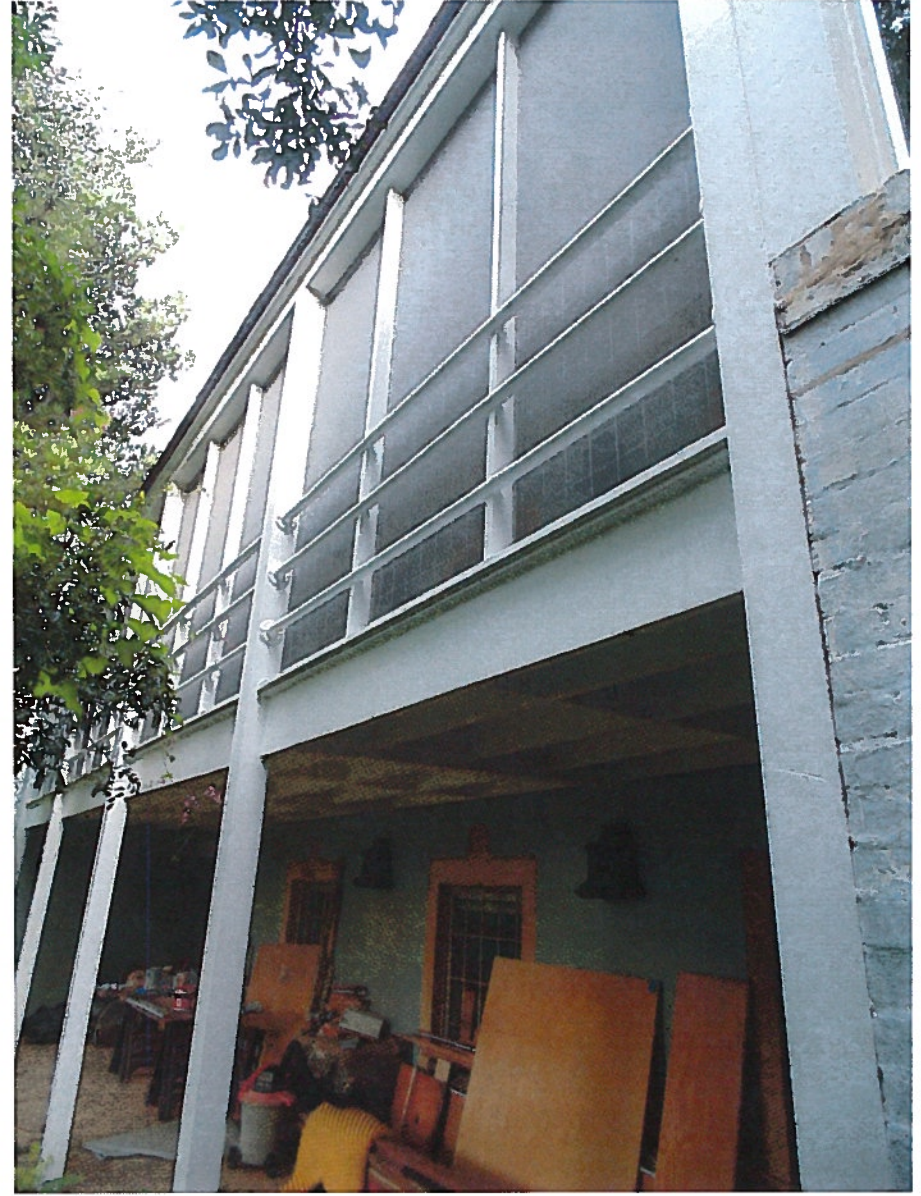
Detail of balcony railings and screening

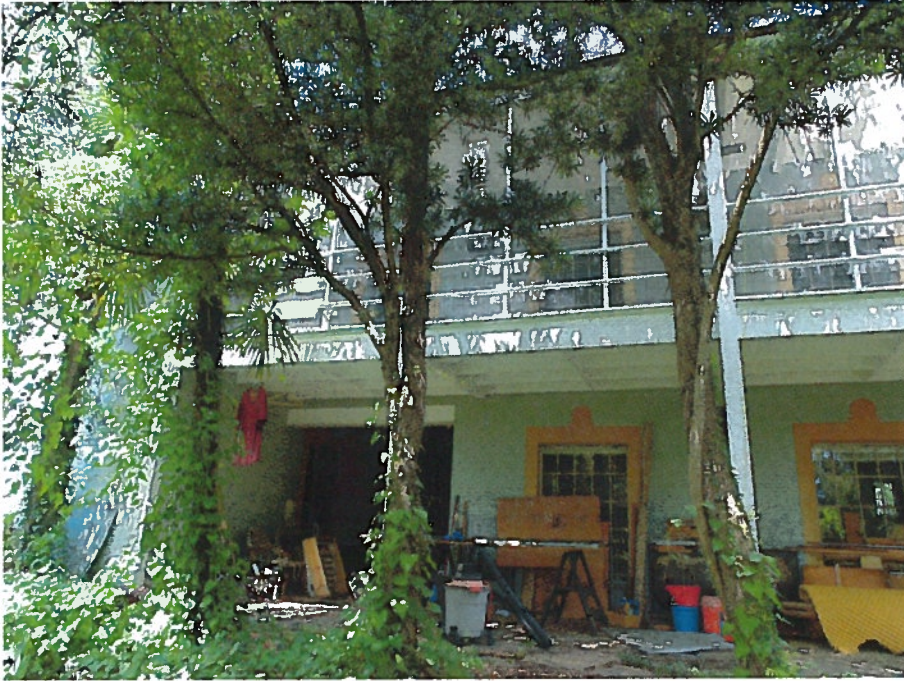
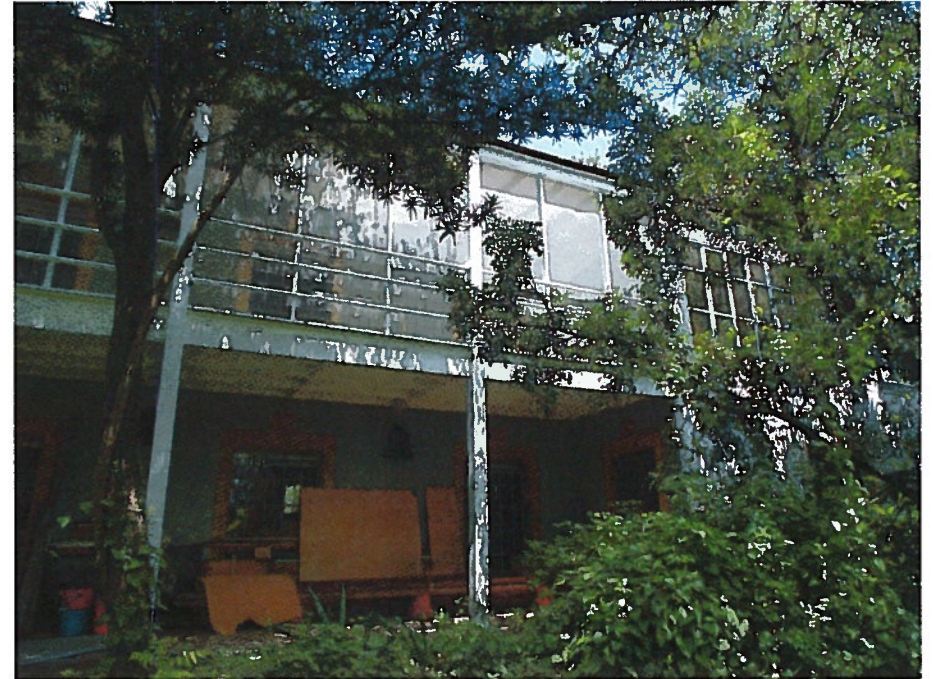
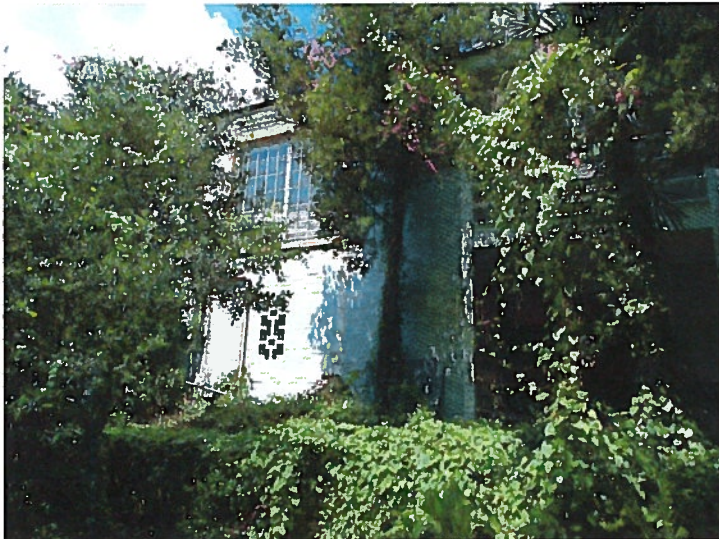
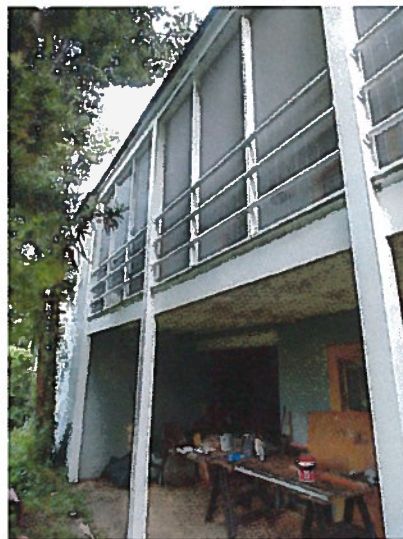
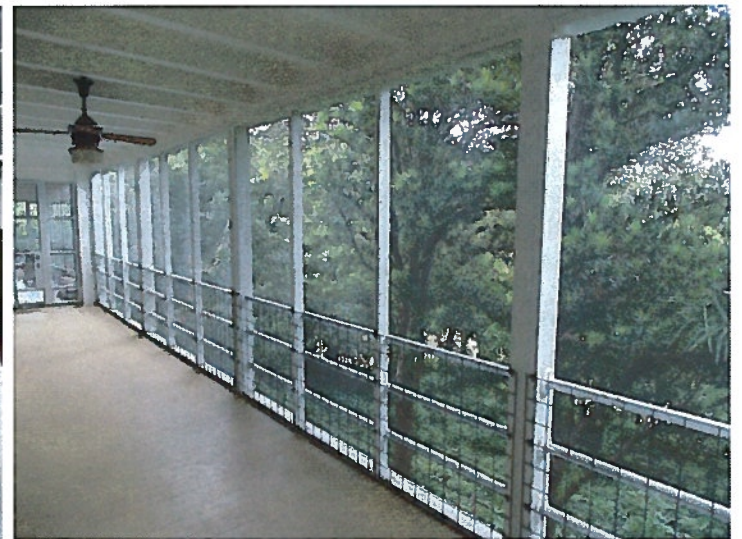
Side Façade (Southeast Elevation) – new porch columns; new porch flooring, railings and screening. Note: this elevation is difficult to photograph in its entirety due to tree canopies

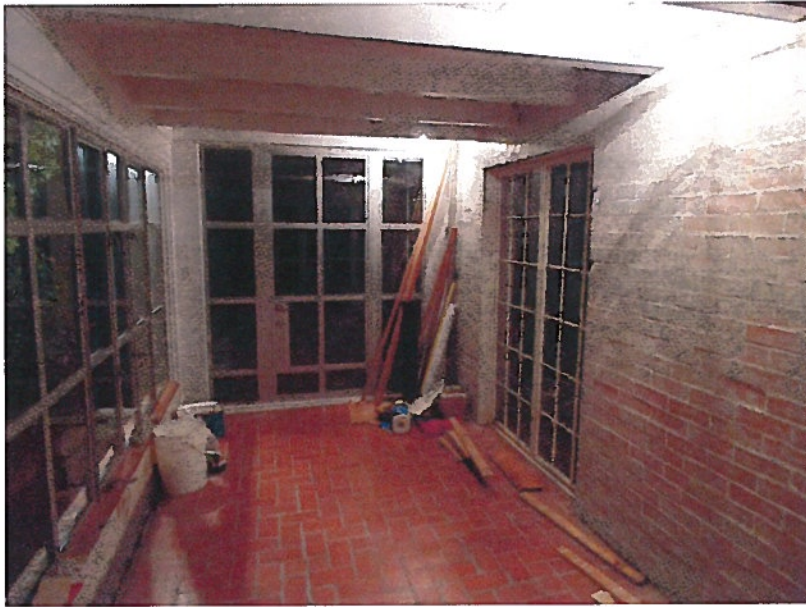
Interior of sunporch (repair of fire damage): replacement windows on left and new glazed door with sidelites at center (access onto existing balcony); last two bays have replacement ceiling decking (destroyed by fire); new lighting (reinstallation of fixtures already in my possession)

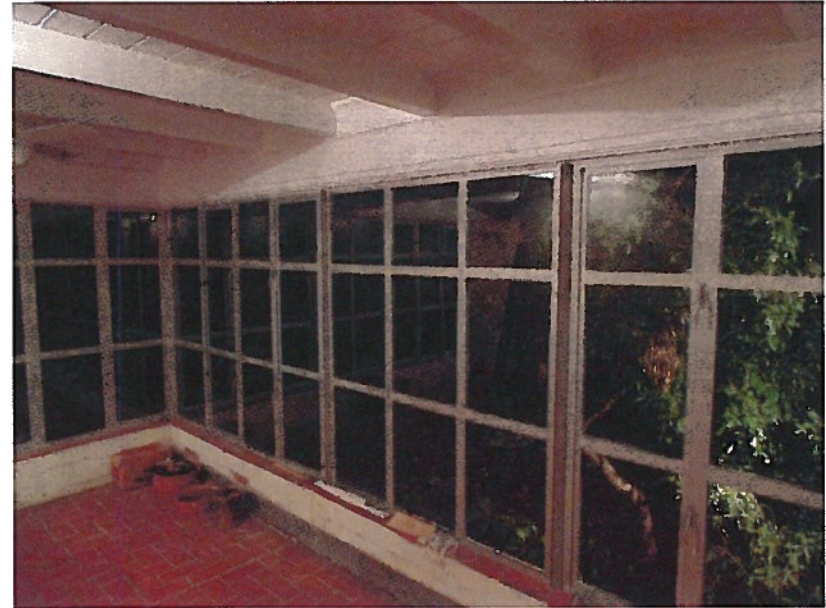
Replacement windows, new wood roof beam above windows with finish trim; existing roof beams and decking repainted; existing tile floor cleaned

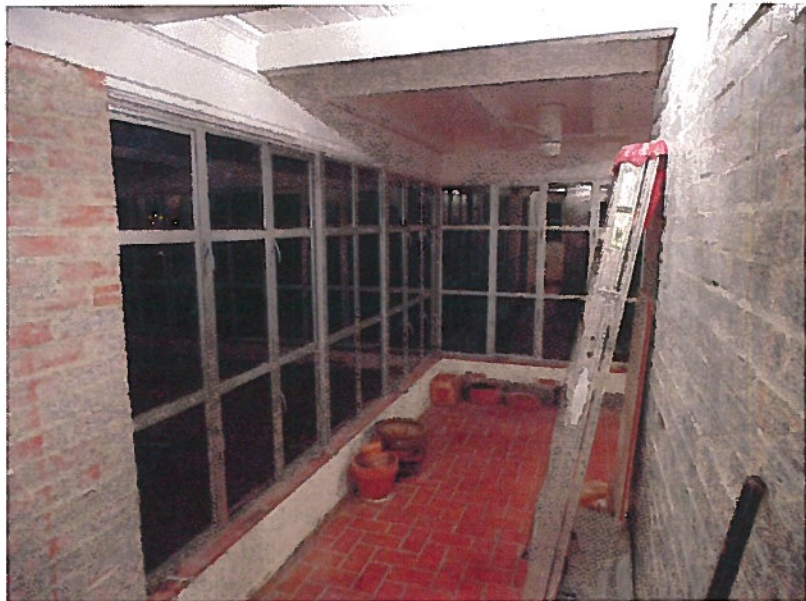
Interior corner of sunporch with replacement windows

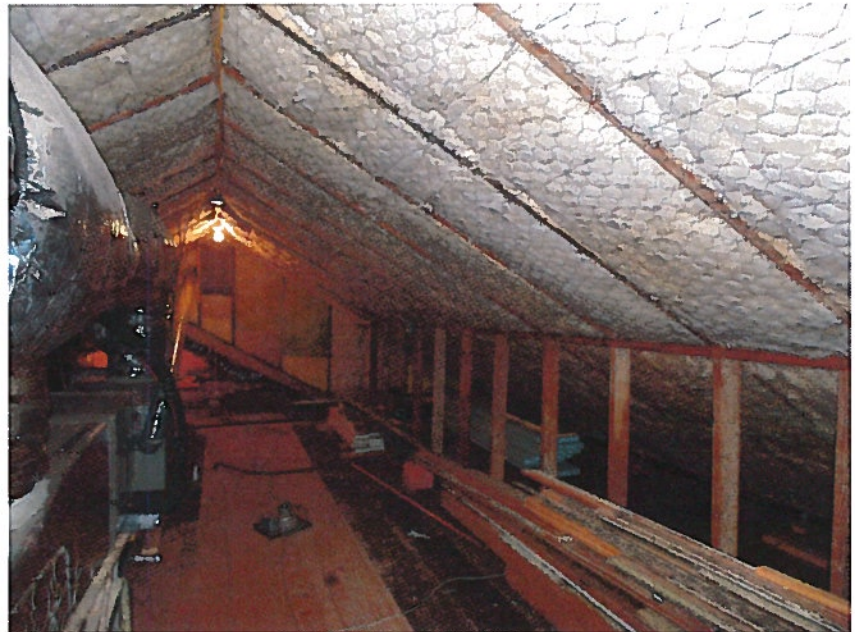
Attic showing new batt insulation at rafters with poultry netting support
