Summary Report

Performance Evaluation of Pavement & Sidewalks

Terracon Project No. 90171081

Re: **SUMMARY REPORT - Performance Evaluation of Pavement & Sidewalks**
City of San Antonio
2007 & 2012 Bond Projects
San Antonio, Texas
Terracon Project No. 90171081

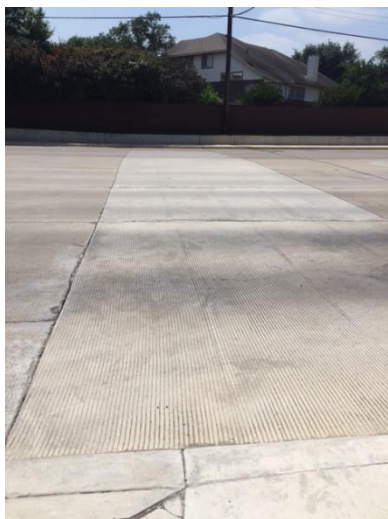
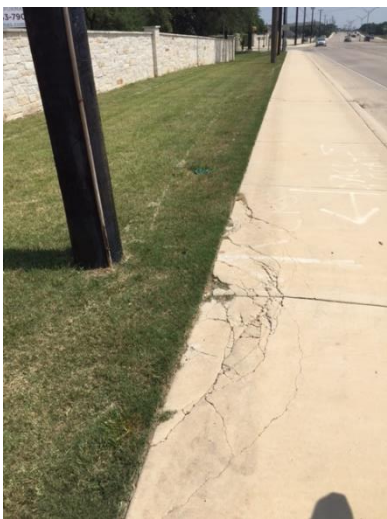
- Panels replaced at 22050 Bulverde Road north bound and south bound except right most south bound lane. Possibly related to the presence of underground utilities.
- North bound and south bound left most lanes appear to be more worn than the middle and right lanes.
- Sidewalk distress at Ravello Hills intersection on the south side of the intersection. This could be distress caused during installation of the new electric pole.
- Some sidewalk replaced in front of Emerald Retirement home. Possibly done during construction of the retirement home.
- Distress on the right most lane in front of the retirement home. Appears to be related to a fire.
- Southbound sidewalk may have been constructed more recently as compared to the street.
- Distress observed around utility man holes in the drive lanes. Higher level of severity on wheel path.

<p>Some panels replaced perhaps related to underground utilities</p>	<p>Sidewalk distress; Appears to be related to installation of utility pole</p>

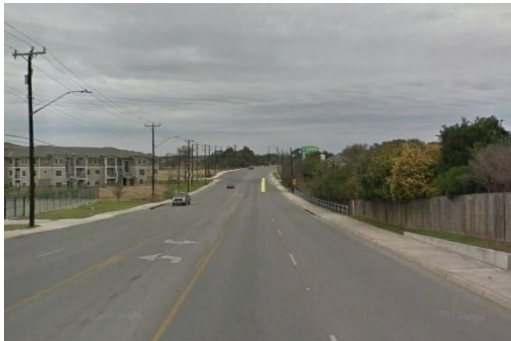
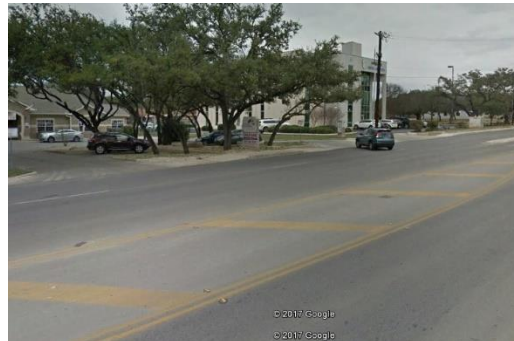
- Rougher ride quality on the east bound right lane as compared to the other three lanes. May be the result of a higher concentration of bus traffic.
- Some minor distresses observed which may be considered as normal part of wear and tear.
- Considerable amount of new construction is being done within the project limits on the street.
- The surface drainage is more towards the east bound right lane past Hart Ranch going towards Babcock Road.
- Some minor distress observed in the sidewalks.

No major distresses observed

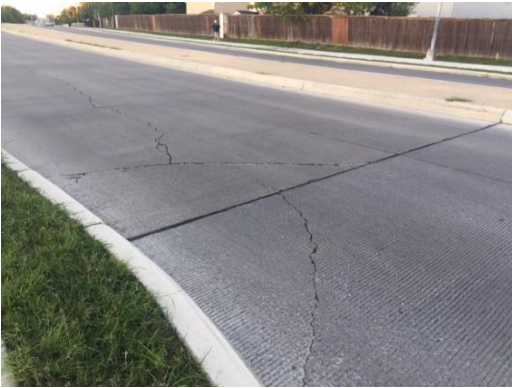
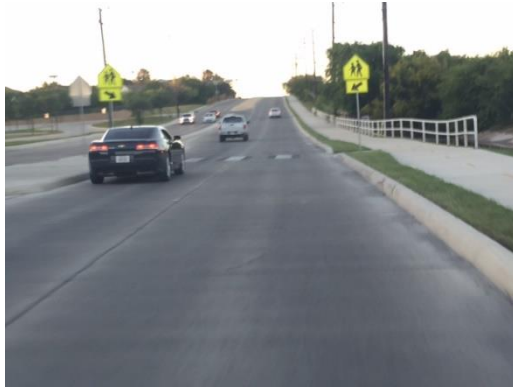
- § Hunt Lane – Most of the concrete pavement performing well and as would be expected based on the age, traffic and other site specific conditions.
 - Some cracked panels of concrete pavement in low areas. Cracks possibly the result of changes in the moisture content of expansive subsurface soils and/or loss of support.

- Slopes towards Potranco Road one side and another half towards Ingram road.
- Severe distress observed in two or three locations.
- Narrow sidewalks.
- Bumpy ride quality.
- Some areas drainage may be a concern.
- Smaller concrete panels.
- Joint sealant may need some attention and maintenance.
- Possible causes for distress include moisture content changes in subsurface soils (and resulting volumetric changes in the soil) or loss of pavement support.

Distress panels close to Ingram Intersection	Signs of water ponding along the curb.

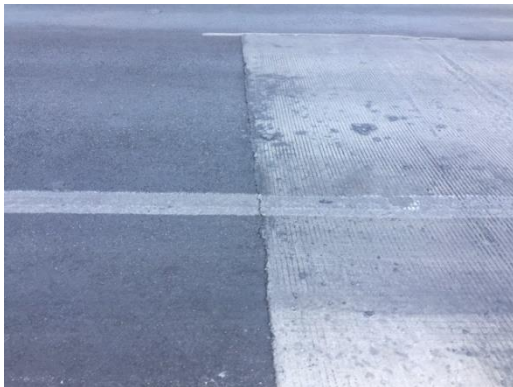
- Rough transitions from asphalt pavement to concrete bus stop pavement. Important to maintain proper joint sealant at this interface.
- § West Vestal Place – Asphalt paving performing well and as would be expected based on the age, traffic and other site specific conditions.

- Areas around the bus stop concrete may have not been compacted and sealed properly. Rough transition from asphalt and concrete.
- The concrete sections within the bus stop limits are “wavy.”
- Old Marking signs or signs used during the construction phase tend to be visually confusing.
- Depression around manholes.
- Some segregation of aggregates observed on the surface.

**Intersection of Asphalt Pavement and
Concrete bus stop**

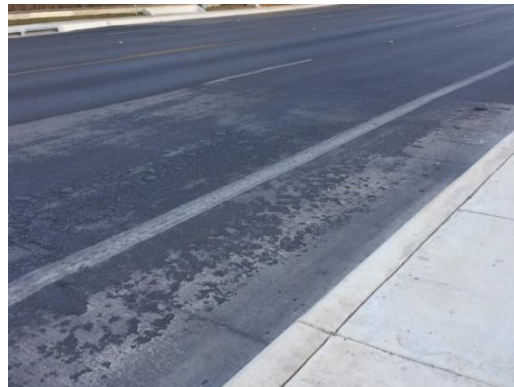
Evidence of poor workmanship

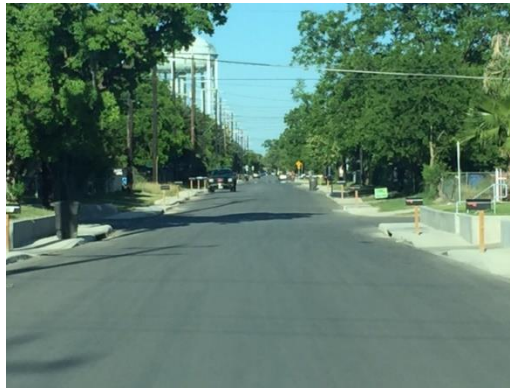
- Minor depression around utility alignment within pavement limits.
- New sidewalks and driveways.
- No major distress observed.
- Mature trees along the edge of the pavement.
- Smooth ride quality

No major distresses observed
