HISTORIC AND DESIGN REVIEW COMMISSION

HDRC CASE NO: 2017-387
ADDRESS: 815 N HACKBERRY ST
LEGAL DESCRIPTION: NCB 538 BLK 22 LOT N 66.3 FT OF 14 & N 66.3 FT OF E 9.52 FT OF 13
ZONING: R-5 H
CITY COUNCIL DIST.: 2
DISTRICT: Dignowity Hill Historic District
APPLICANT: Eduardo Martinez
OWNER: Eduardo Martinez
TYPE OF WORK: Historic Tax Certification
REQUEST:

Hook and Ladder Inspections

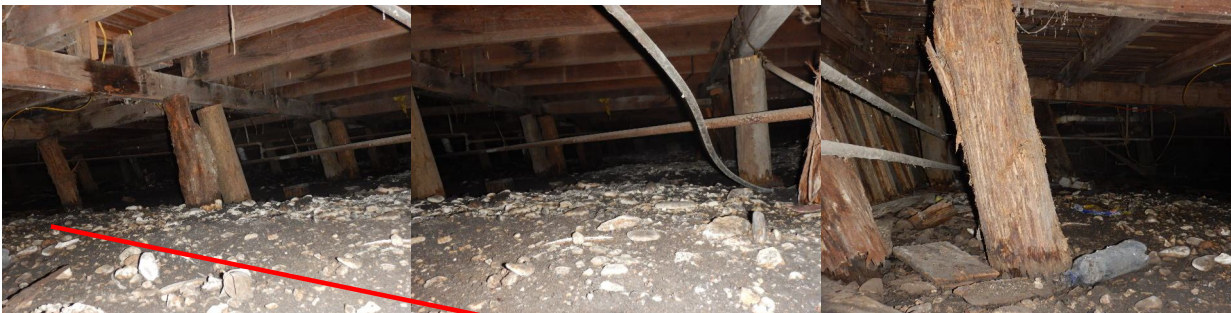
Comments: Foundation has piers that are leaning towards rear of house. There are no perimeter vents in place around exterior of crawl space, excess moisture may build up.

Leaning piers

- ☐ At this time, the foundation appears to be supporting the structure and immediate significant repair needs are not evident.
- ☒ Prior to closing, the foundation should be inspected by a qualified structural engineer, familiar with the soils and construction methods of the region, in order to determine if permanent repairs are required.

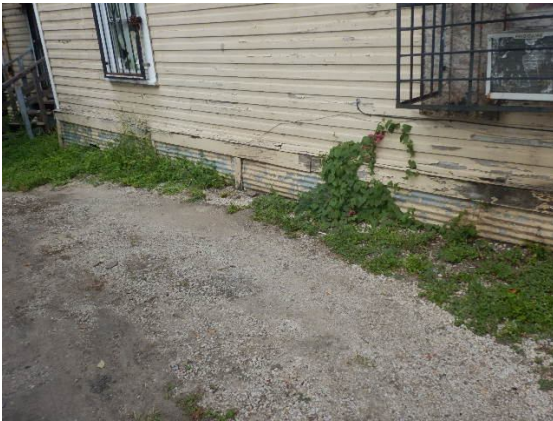
No perimeter vents

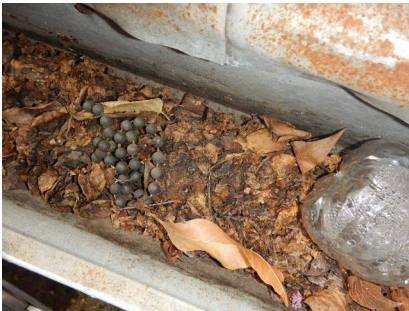
Debris in gutters

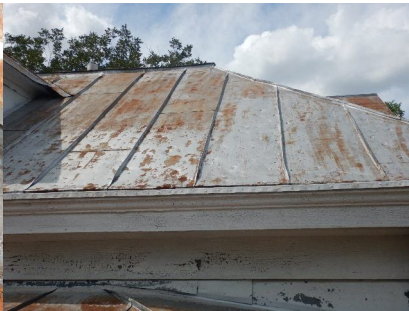
Comments: There are areas of rust and dents to metal roof.

Rust and dents to metal roofing

Condition: Roof should be evaluated by certified roofing company

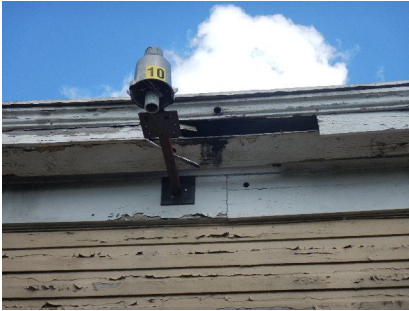
Opening to attic

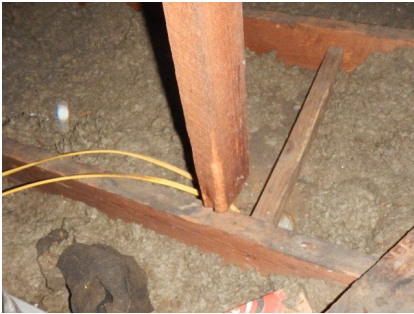
Unsecure point load

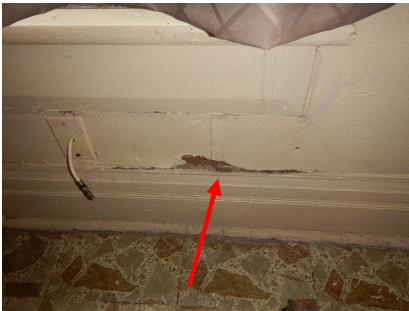
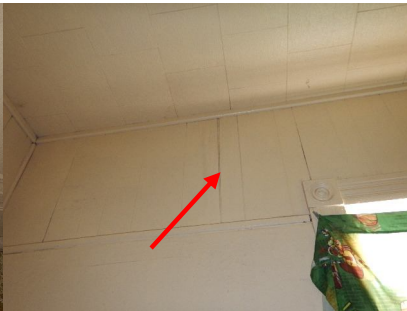
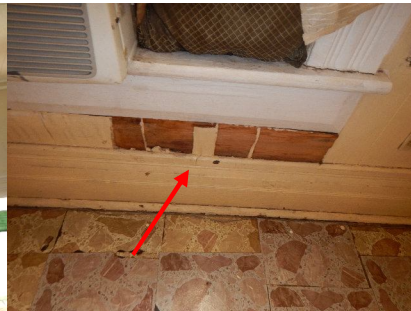
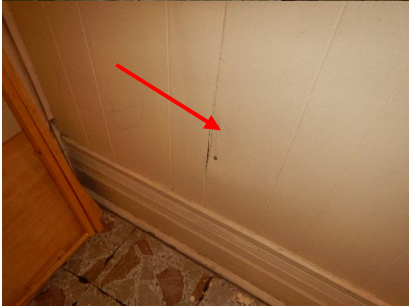
Comments: The interior and exterior walls have damage and woodrot to exterior see examples below.

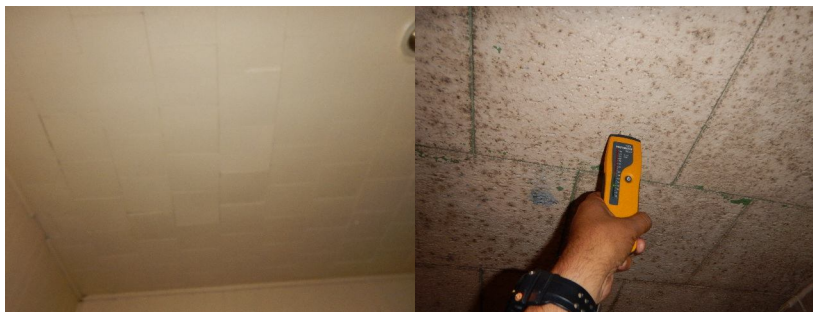
Loose ceiling tiles

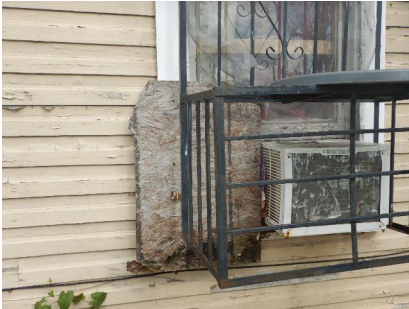
Comments: Consider removing burglar bars due to life safety hazard. There are several broken windows in house and have some make-shift repairs in place. Windows were not opened due to items in place and or not in operation.

Makeshift repair

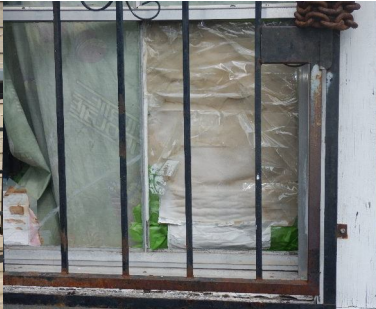
Broken window

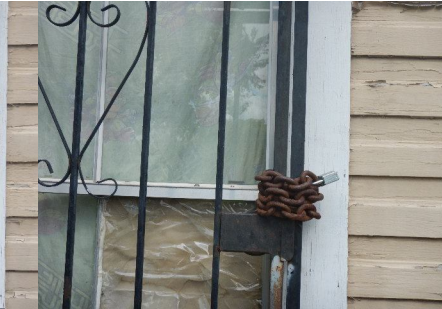
Safety hazard

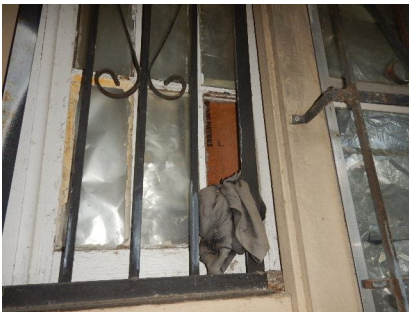
Broken window

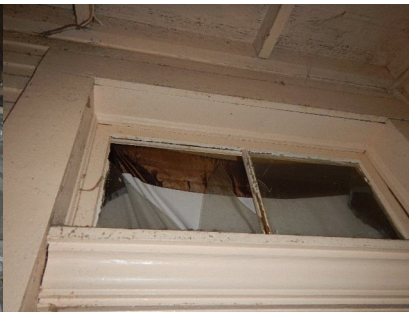
Broken window

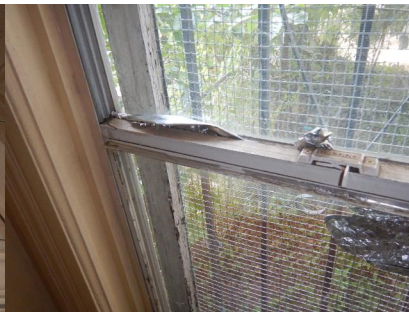
Not sealed properly

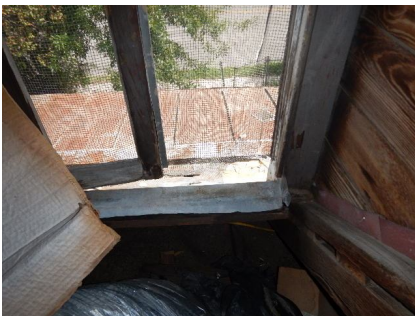
Broken window in attic

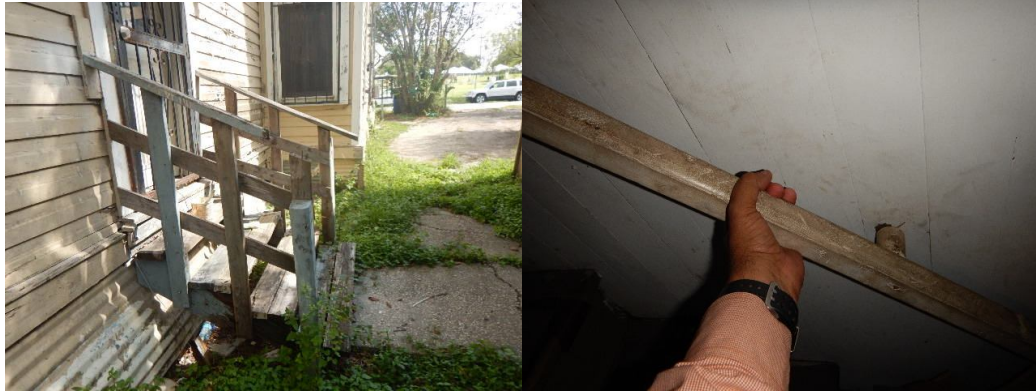
☒ ☐ ☐ ☒**I. Stairways (Interior and Exterior)***Comments: Rotting to handrails and steps./ Loose grab bar to attic*

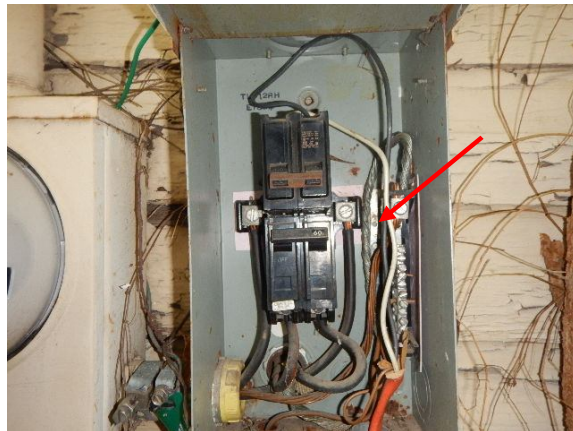
MAIN PANEL

Panel Condition Main cover panel is missing

Cover missing

☒ Due to defects observed, recommend service and complete system check by licensed electrician

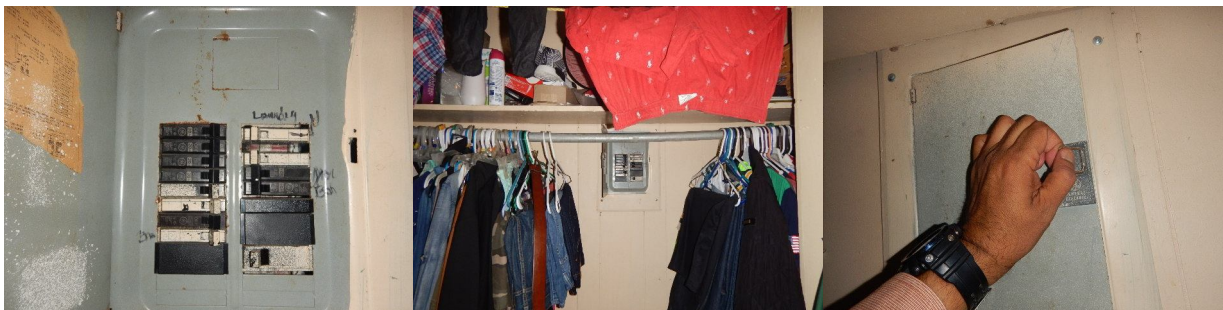
SUB-PANEL

Not labeled

Improper location

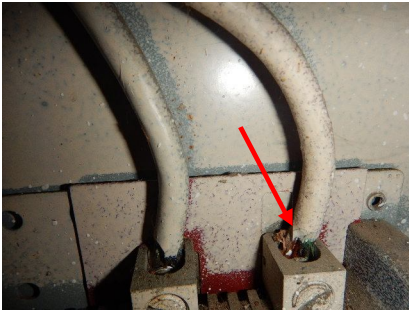
No wire grease

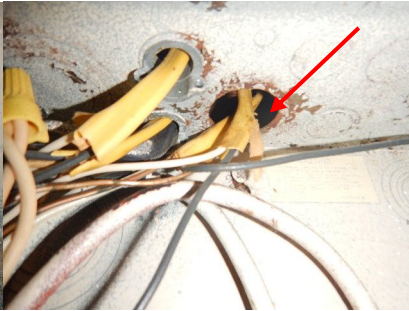
No bushings in place

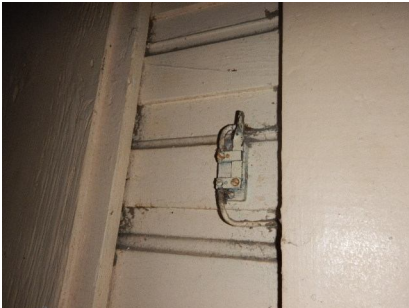
Exposed wire

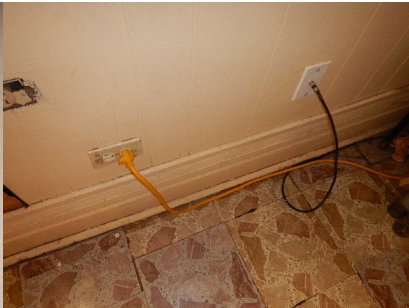
Extension cord in use

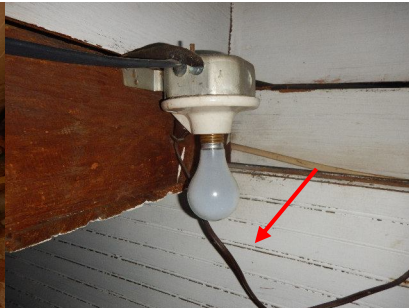
Extension cord in use at fixture

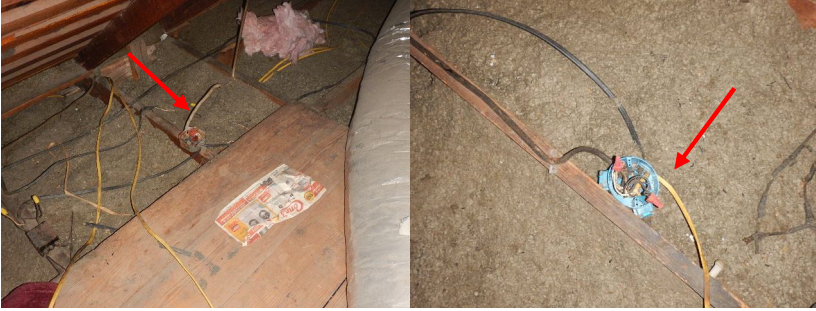
Open boxes

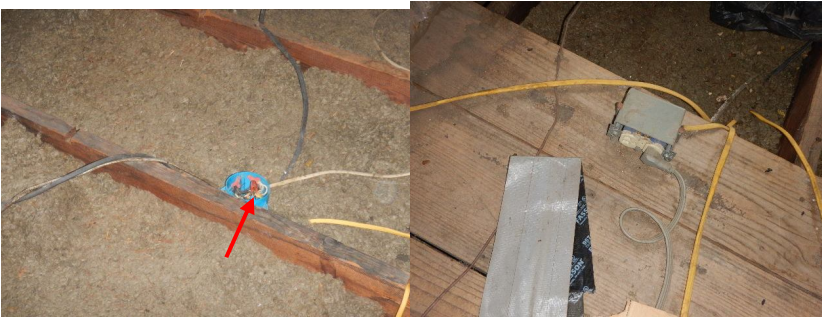
No outlet cover

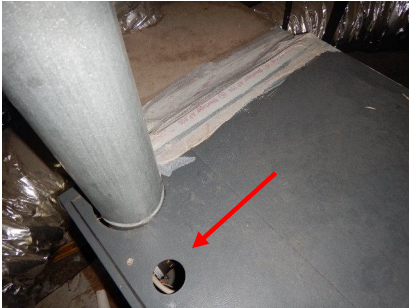
Opening at unit

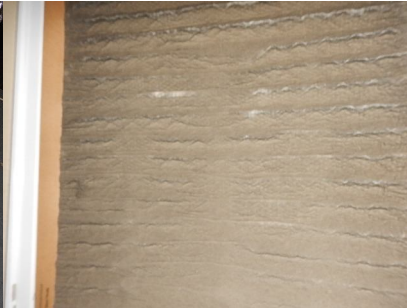
Dirty filter

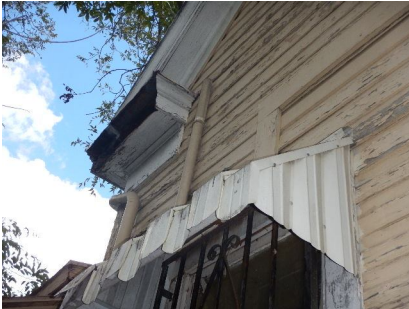
☒ ☐ ☐ ☒
B. Drain, Wastes and Vents*Comments: Vent stack does not pass roof line/ Leak under house*

Vent stack does not pass roof line

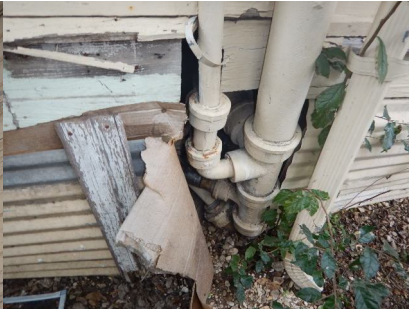
Cast iron piping

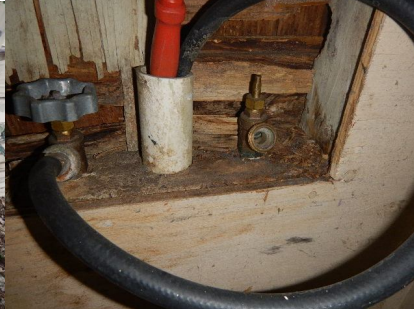
Missing handle

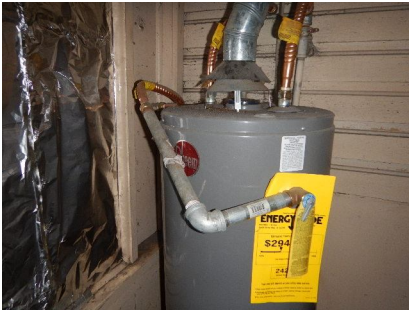
TPV piping runs uphill

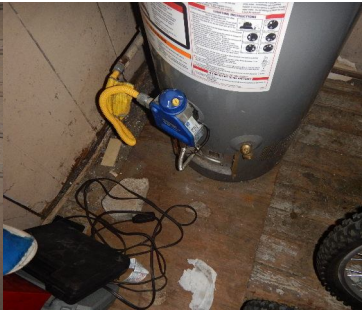
No pan and drain

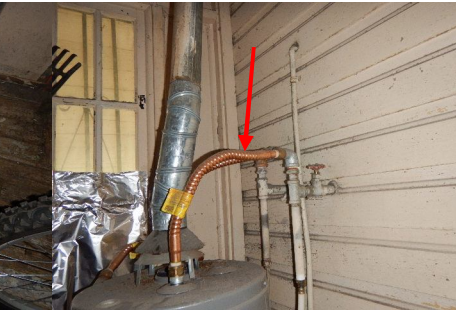
No loops at supply lines

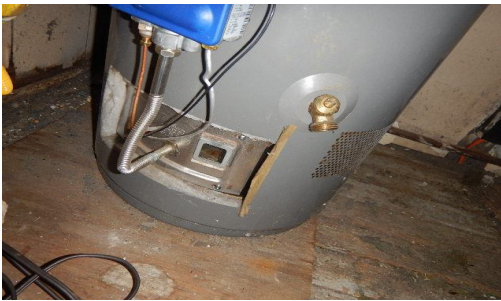
No cover in place
