Re: Fill Evaluation  
Vance Jackson Tract  
Vance Jackson Road and Callaghan Road  
San Antonio, Texas

InTEC Project No. **S151246**

**Fill Evaluation**

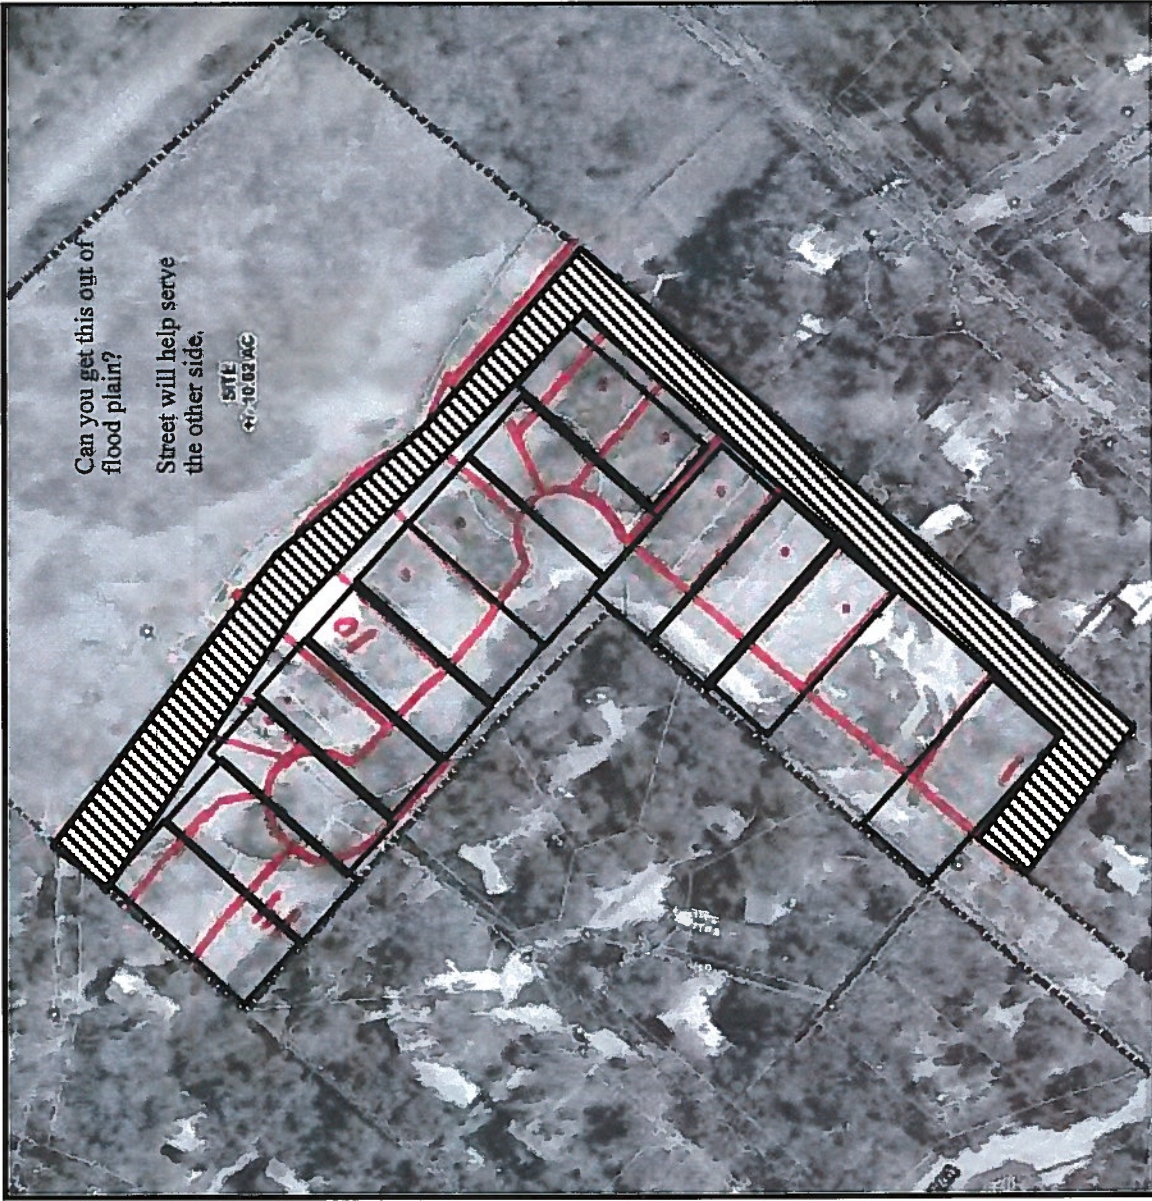
Less fill on the insides  
Concrete pavement  
can reduce site work

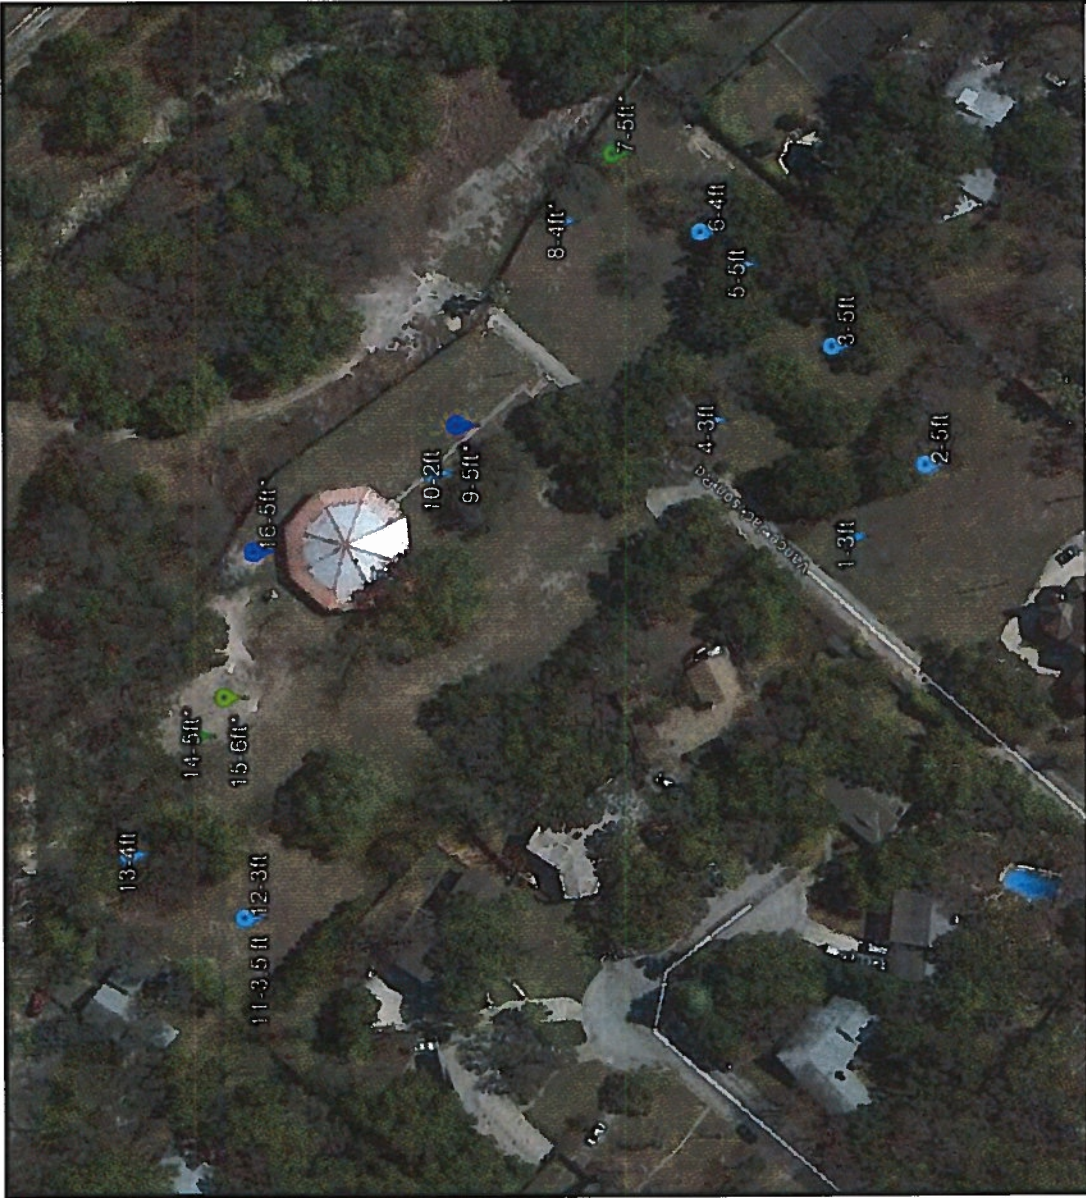
| Fill Evaluation<br>Vance Jackson Tract<br>NW of Callaghan and Vance Jackson<br>San Antonio, Texas | Approximate Test Pit Locations | |

1-3ft = Pit 1, 3 feet of fill

7-5ft\* = Pit 7, 5 feet of fill with some undesirable fill material

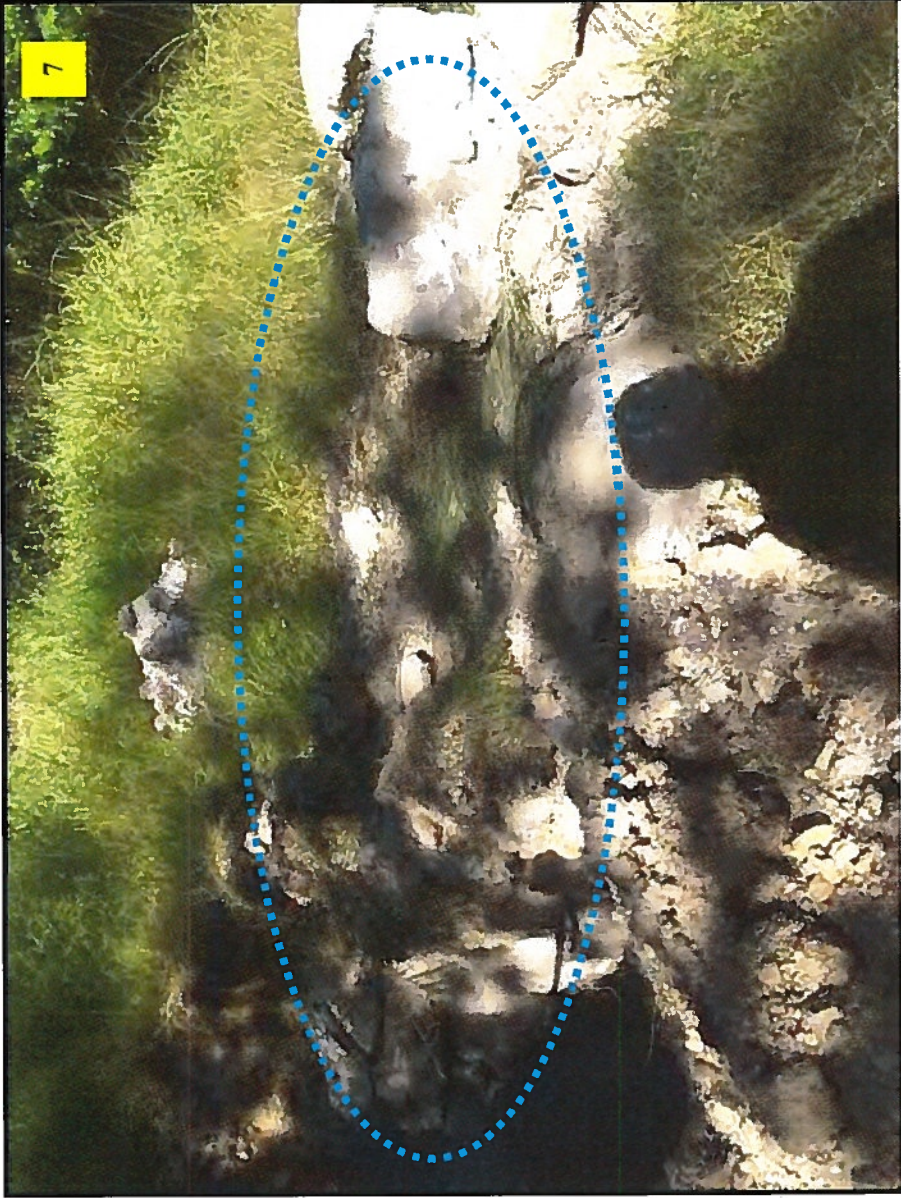
Undesirable fill material

- We anticipate the fill along the retaining wall to be reprocessed (removed, deleterious material screened, and hauled off)
- Historical aerial maps show a prior structure underneath or in the vicinity of the gazebo like structure. Additional investigation is needed in this area.
- Based on the fill and the hard surface encountered during test pit excavation and the soil maps, we anticipate a Potential Vertical Movement on the order of 2 to 4 inches in the proposed lot locations.

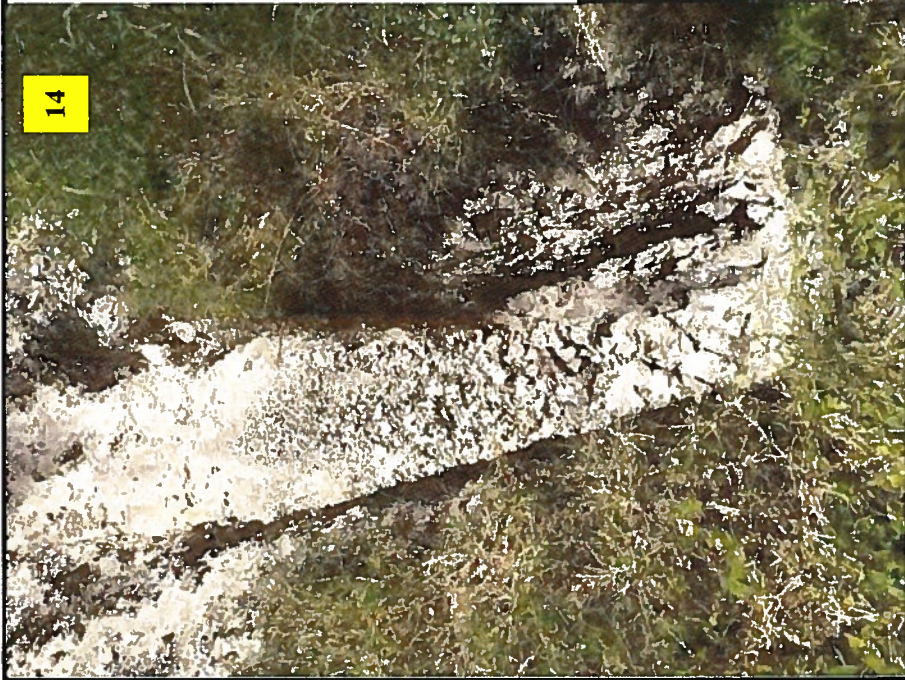
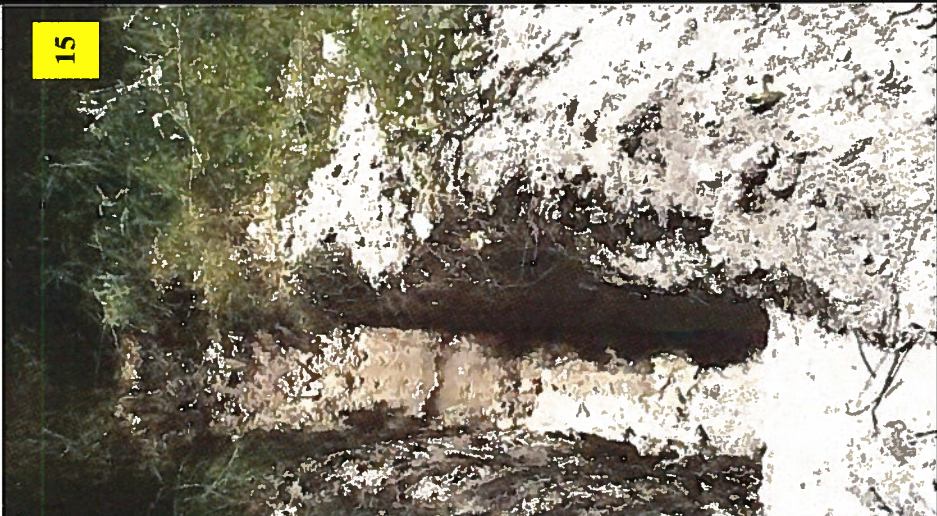
| Pit No. | Fill Depth (feet) | Comments |
|---|---|---|
| 14 | 5 | Debris found |
| 15 | 6 | Debris found |

| <div>14</div> | <div>15</div> | bricks |

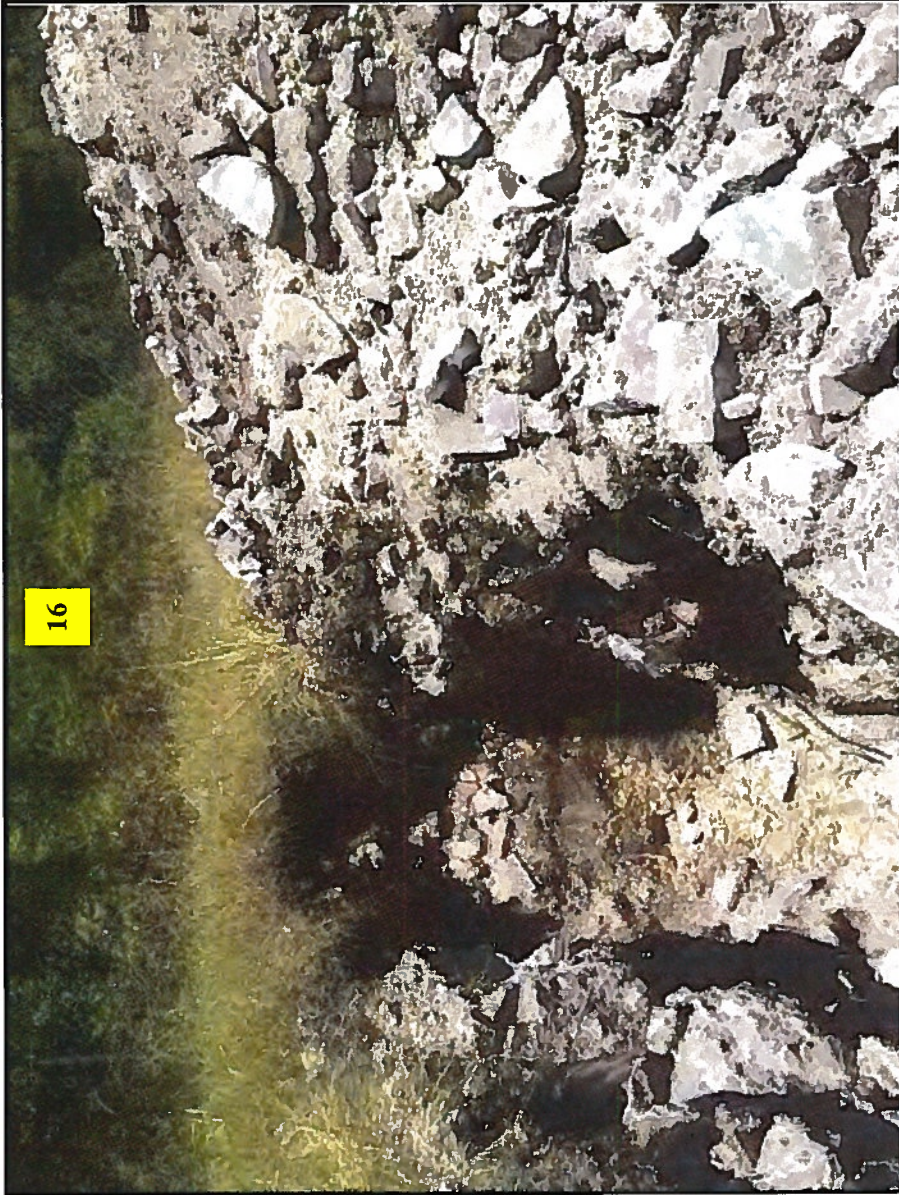
bricks
