## HISTORIC AND DESIGN REVIEW COMMISSION

**HDRC CASE NO:** 2018-062  
**ADDRESS:** 222 W GUENTHER ST  
**LEGAL DESCRIPTION:** NCB 2973 BLK 5 LOT 1  
**ZONING:** RM-4,HS  
**CITY COUNCIL DIST.:** 1  
**DISTRICT:** Nathan Historic District  
**LANDMARK:** House  
**APPLICANT:** Robert Murray  
**OWNER:** Robert Murray  
**TYPE OF WORK:** Demolition of a rear accessory structure, Historic Tax Certification  
**APPLICATION RECEIVED:** January 11, 2018  
**60-DAY REVIEW:** March 12, 2018  
**REQUEST:**

**PROPERTY CONDITION INSPECTION:**  
**222 W. Guenther**  
**San Antonio, Texas 78204**

The property condition inspection of 222 W. Guenther, San Antonio, Texas, was performed at the request of Mr. Bob Murray. A representative of ATS Engineers conducted the site inspection on December 5, 2017.

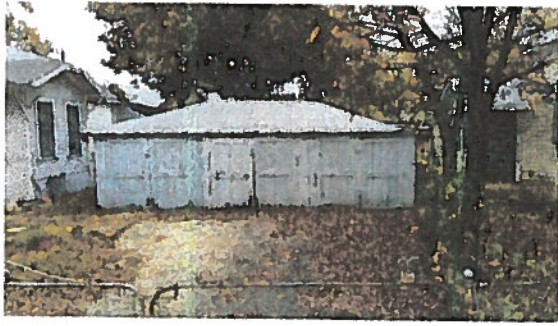
Photo 1

4. The structure is deflected approximately 4-inches out of plane (Photo #1). It is ATS Engineers' opinion that the structure is not sufficiently laterally supported to resist the service loads described in the adopted code. This constitutes an "*unsafe*" condition as defined by the *IEBC*.

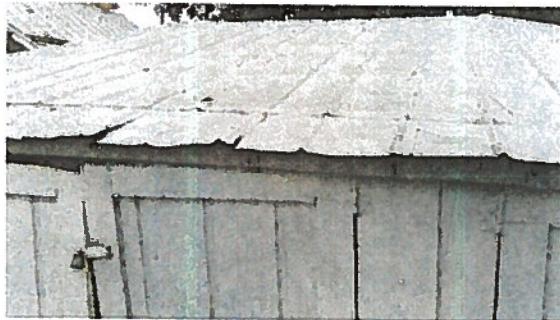
Photo 5

1. Portions of the existing roof decking are deteriorated and decayed. The roof is no longer effective at preventing rain from entering the structure. Roof leaks are evidenced by damaged and/or deteriorated roof framing and wall components (Photos #5 and #6). This creates a "*dangerous*" condition as defined by the *IEBC*.

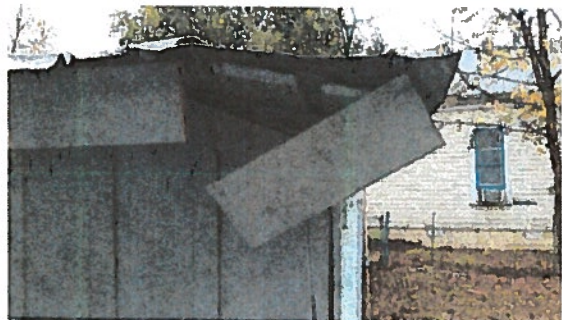
Photo 6

2. Many portions of the roof, fascia and wall wood-framing members are decayed, deteriorated and/or inadequately designed to support the service loads required by the adopted code. The wood siding is decayed and unable to properly support the shed doors (Photos #6 and #11). This creates a "*dangerous*" condition as defined by the *IEBC*.

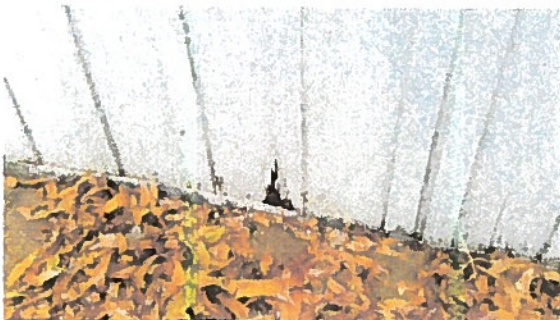
Photo 7

5. The shed is not sealed to prevent the entrance of rodents (Photos #7 and #9). This creates an unsanitary condition. This constitutes an "*unsafe*" condition as defined by the *IEBC*.

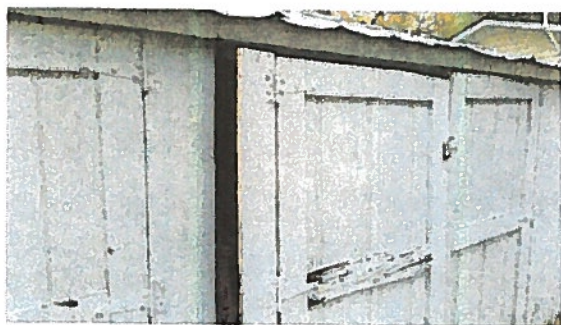
Photo 9

6. The adjacent shed is not adequately secured against entry as the doors can be pulled open (Photo #9). This constitutes an "*unsafe*" condition as defined by the *IEBC*.

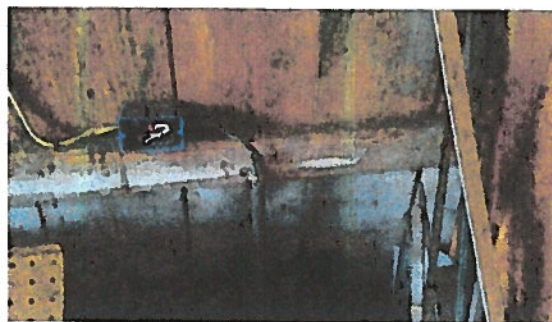
Photo 10

3. There are exposed, nonmetallic wiring "NM" wiring connections that are improperly made and/or are not secured within a listed enclosure as required by the *National Electrical Code (NEC)* (Photo #10). This constitutes an "*unsafe*" condition as defined by the *IEBC*.
