## HISTORIC AND DESIGN REVIEW COMMISSION

**HDRC CASE NO:** 2019-079  
**ADDRESS:** 112 LINDELL PLACE  
**LEGAL DESCRIPTION:** NCB 6204 BLK 5 LOT 1  
**ZONING:** MF-33, H, RIO-1  
**CITY COUNCIL DIST.:** 1  
**DISTRICT:** River Road Historic District  
**APPLICANT:** Jim Bailey/Alamo Architects  
**OWNER:** Asher Reilley  
**TYPE OF WORK:** Amendments to a previously approved design including the reconstruction of original walls  
**APPLICATION RECEIVED:** February 15, 2019  
**60-DAY REVIEW:** April 16, 2019  
**REQUEST:**

RE: Engineer's Opinion Statement  
**112 Lindell Place**  
San Antonio, TX

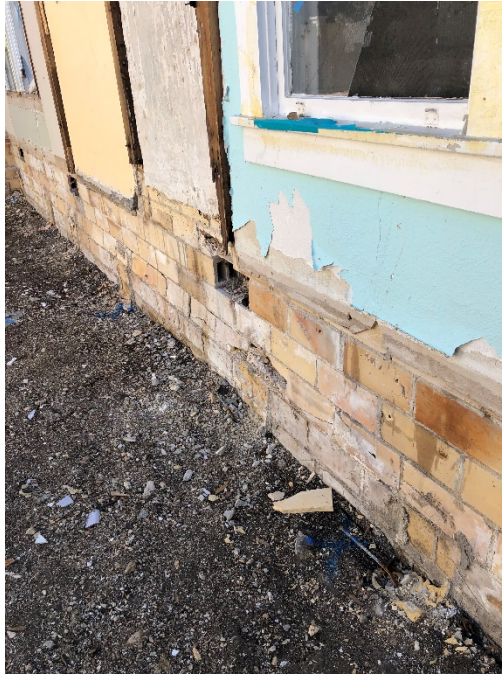
Based on our experience and our site observations, the degradation and cracking of the clay unit walls was extensive and has compromised the load carrying capacity. The clay units are very fragile and many have cracked/broken beyond repair. Some of the walls exhibit a buckling failure at base of the wall and diagonal fractures through the wall body. The conditions below grade are still unknown but likely similar or worse due to their contact with wet soils. Due to the extensive degradation of the walls we deem them not safe for the public and therefore we recommend all walls be deconstructed and rebuilt to similar or like conditions.

1. Base of wall buckled.

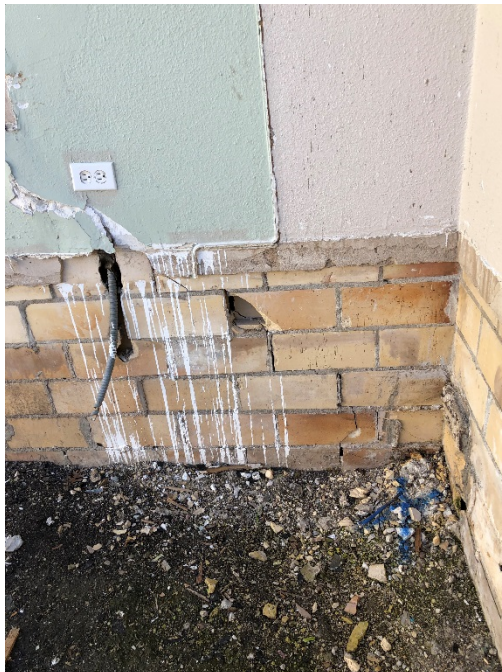
2. Diagonal crack through wall body.

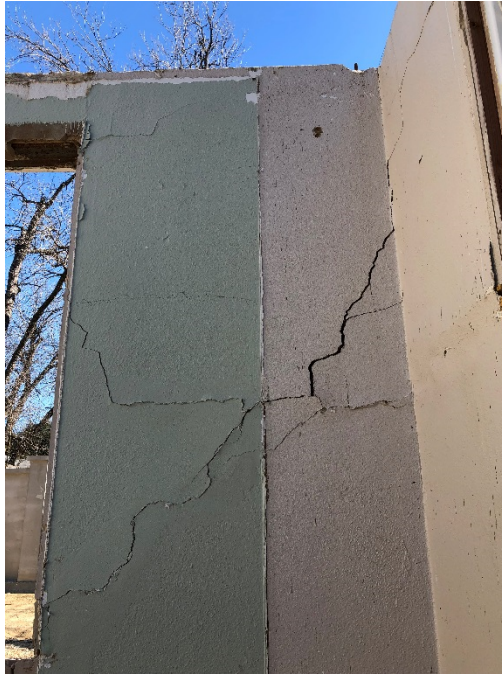
3. Horizontal Crack through wall.

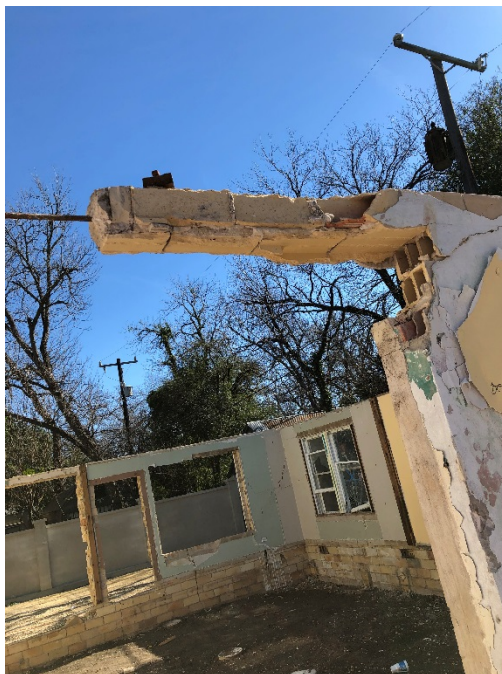
4. Typical lintel construction.
