CITY OF SAN ANTONIO
DEVELOPMENT SERVICES DEPARTMENT

NCB 6938 Property Address: 205 Ostrom Drive

STRUCTURAL ASSESSMENT FOR:

SEADC LLC

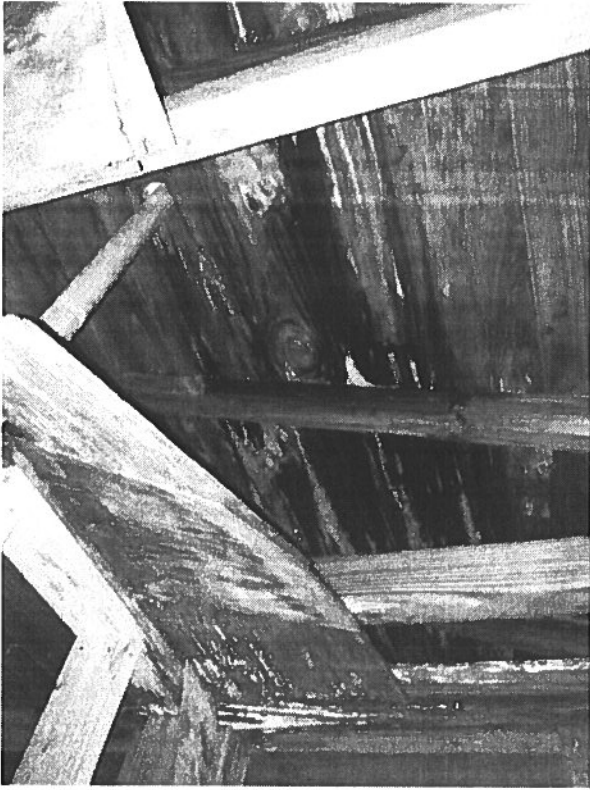
- Deck: The roof deck has the following conditions: wet rot, dry rot, covered in mold and deteriorated.
 - Ceiling: The ceiling has the following conditions: the ceiling has delaminated plywood (from being in constant wet conditions), wet rot, and dry rot, covered in mold and deteriorated. The quarter inch sheetrock is falling down.

Photo 1 Wet Rot and Mold on Roof Deck

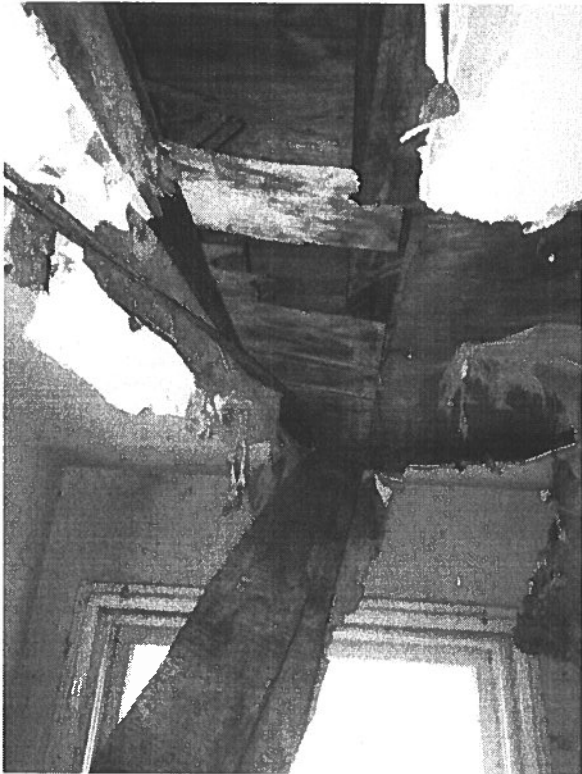
Photo 2 Ceiling Plywood is delaminating and is infested with Wet Rot, Sheetrock is falling

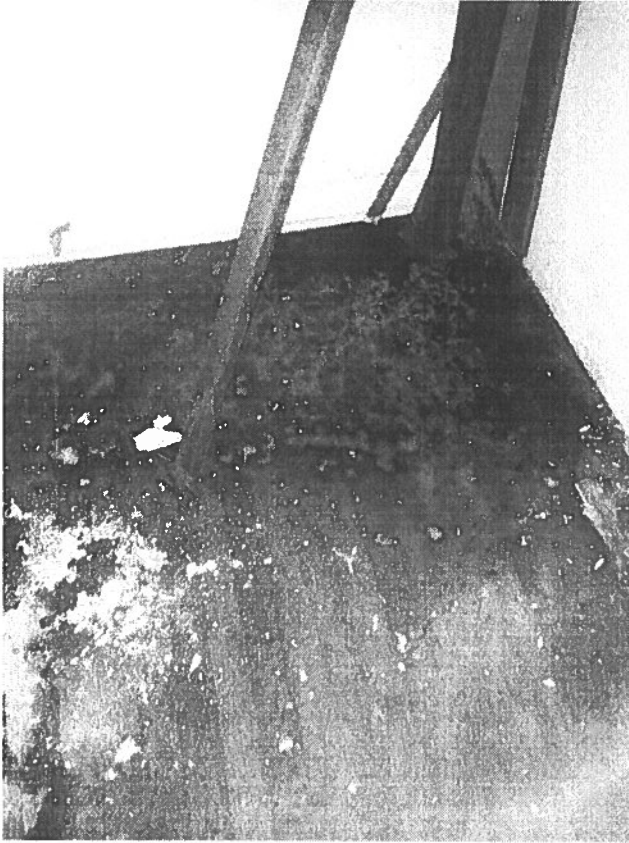
Photo 3 Water damage and Mold on Floors

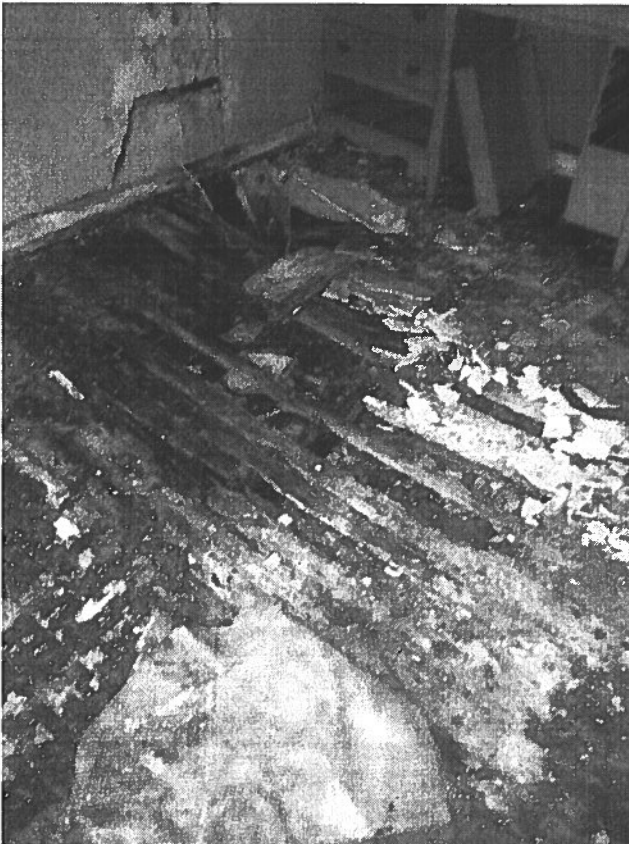
- Joists: The wood in the joists has the following conditions; termite damage, wet rot, dry rot, covered in mold, and some are missing because they have deteriorated/decomposed.

- Wood flooring: The wood flooring has the following conditions; termite damage, wet rot, dry rot, covered in mold and large sections are missing because they have deteriorated.

Photo 4 Wood Floor and Wood Floor Joist Deteriorated and/or Missing

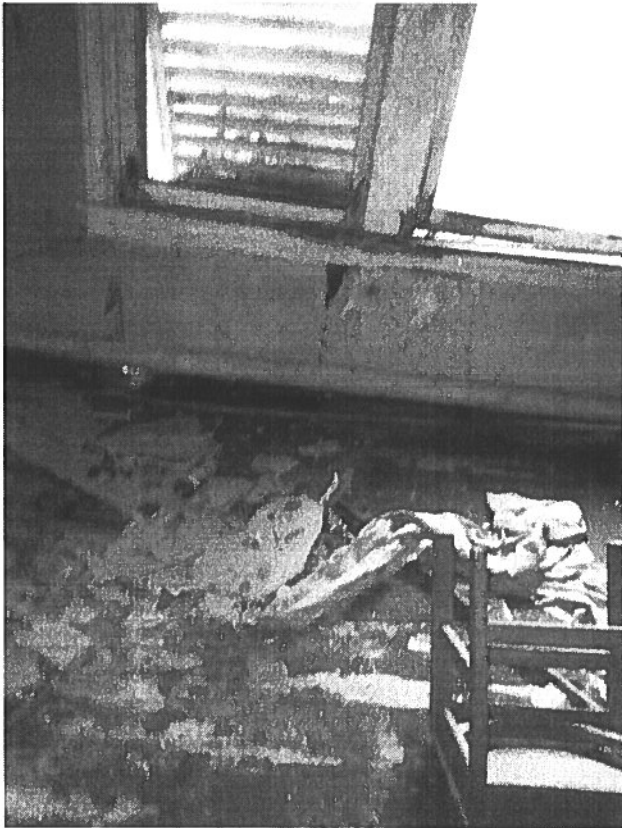
Photo 5 Floor and Floor Joists Fallen Away from the Exterior Wall Floor Base

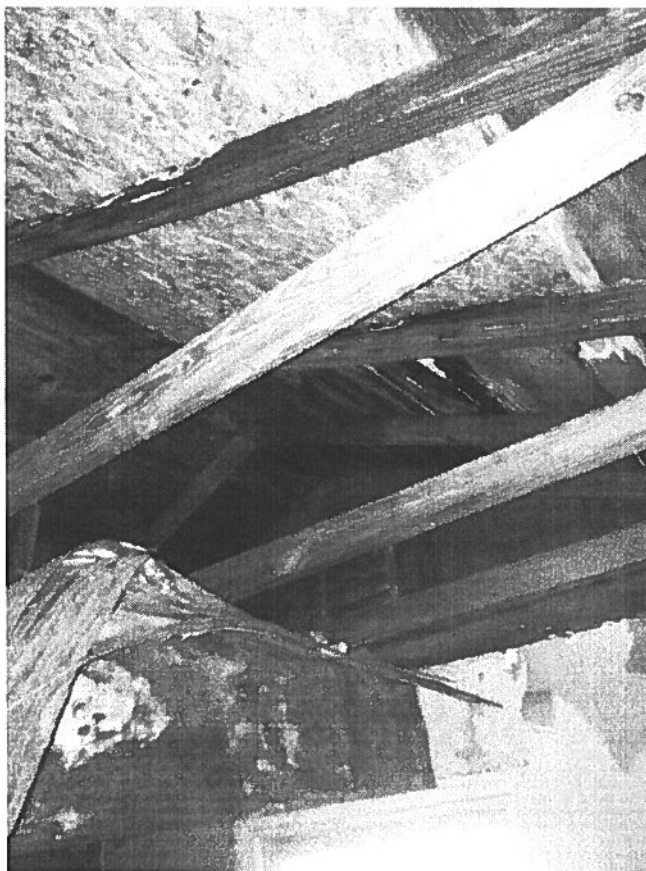
- Truss System:
 - Roof trusses: The wood members of the roof trusses have the following conditions: wet rot, dry rot, covered in mold and deteriorated.

MAE concludes that deteriorated roof trusses and rafter tails do not have the structural integrity to support a new roof system.

Photo 6 Roof Patch Trusses Infected by Wet Rot and Mold

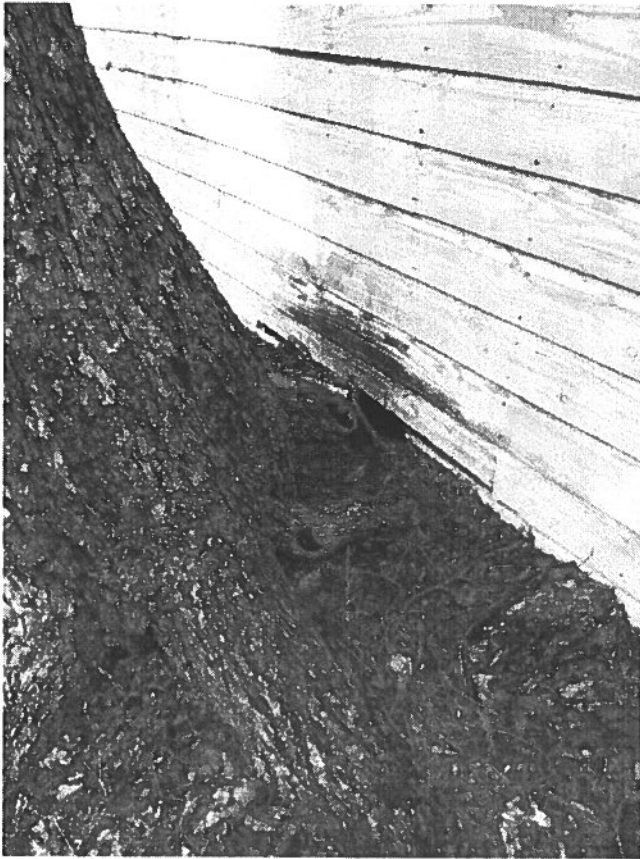
- Pier System: The piers are cedar posts and are not in line. Some posts are missing and some posts do not have the weight of the house bearing upon them.
 - Sloped floors: The elevations taken of the house have a difference of at least 12".
 - Large roots have grown into the foundation system.
- Floor System:

Photo 7 Root Intrusion in the Foundation System

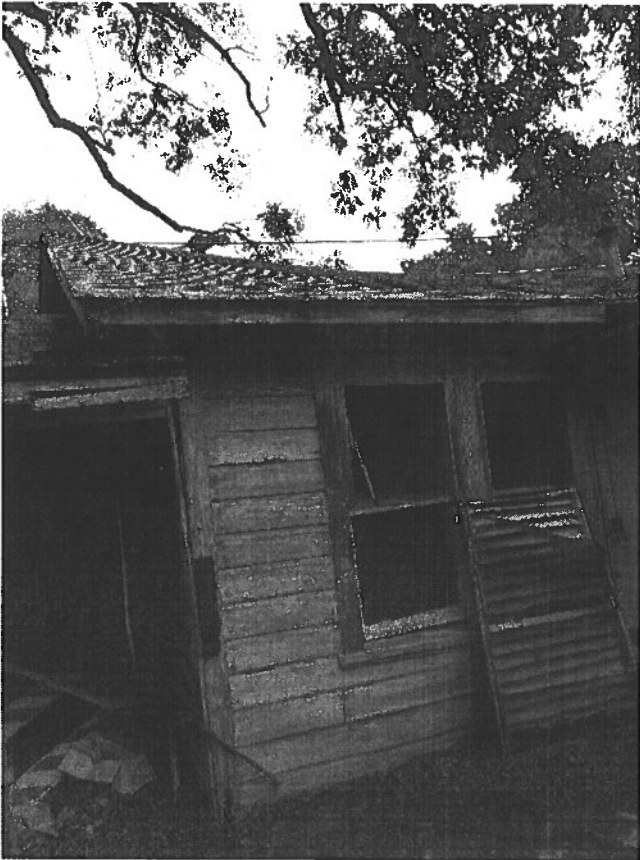
- Roof System:
 - Broken ridge beams: The ridge beam in several areas has a marked difference in elevation. This is an indication that the ridge beam is broken and nonfunctional.

- Eroded and degraded composite roof: The composite roof systems are designed to degrade over a period of time. This roof is beyond that time period. This roof has degraded to a condition that the existing roof has lost its ability to shed water.

MAE concludes that several ridge beams are broken in several locations reducing the structural integrity of this building. It is unknown if these ridge beams can be fixed.

Photo 8 Ridge Beam Broken, Fascia Deteriorated, Composite Roof Deteriorated

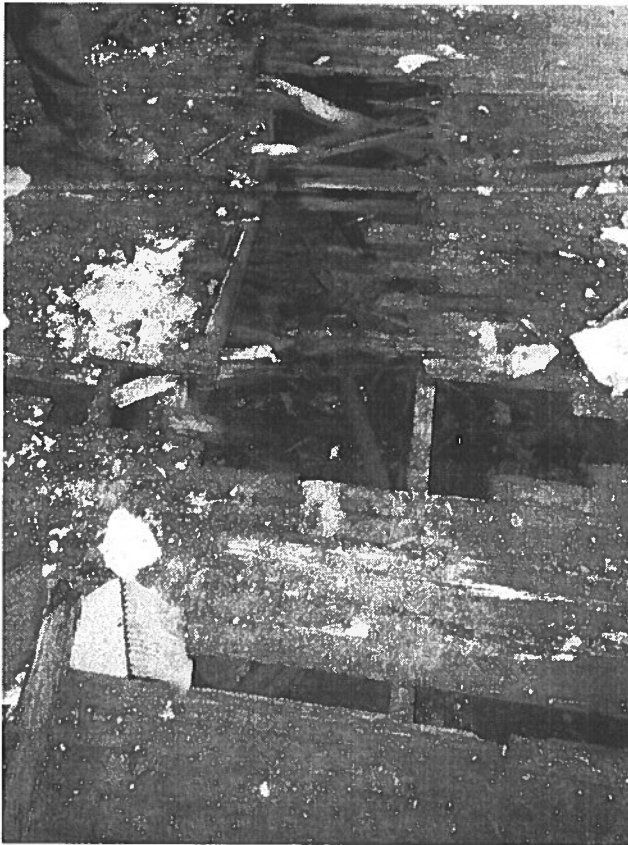
Photo 9 Wood Flooring Damaged by Intruder arrested by SAPD

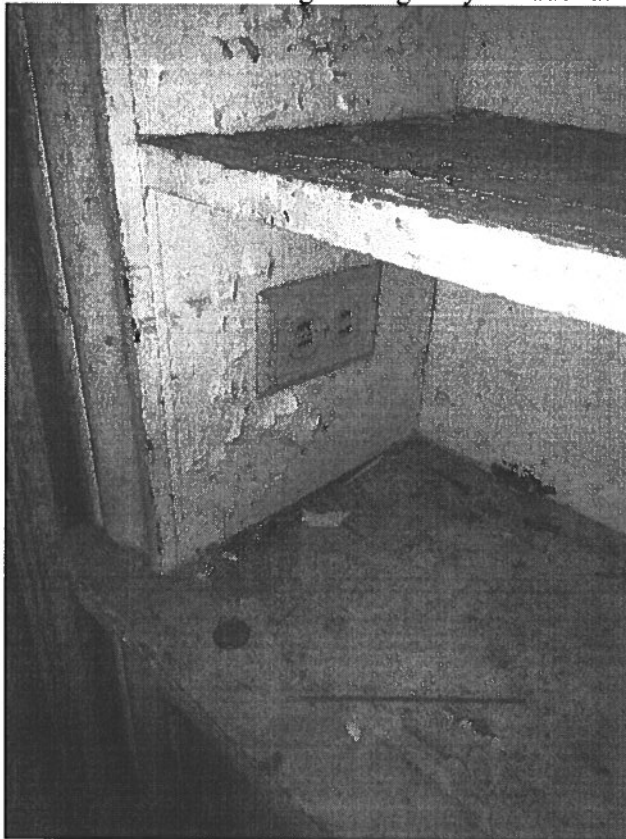
Photo 10 Non Grounded Electrical Receptacle in Bedroom

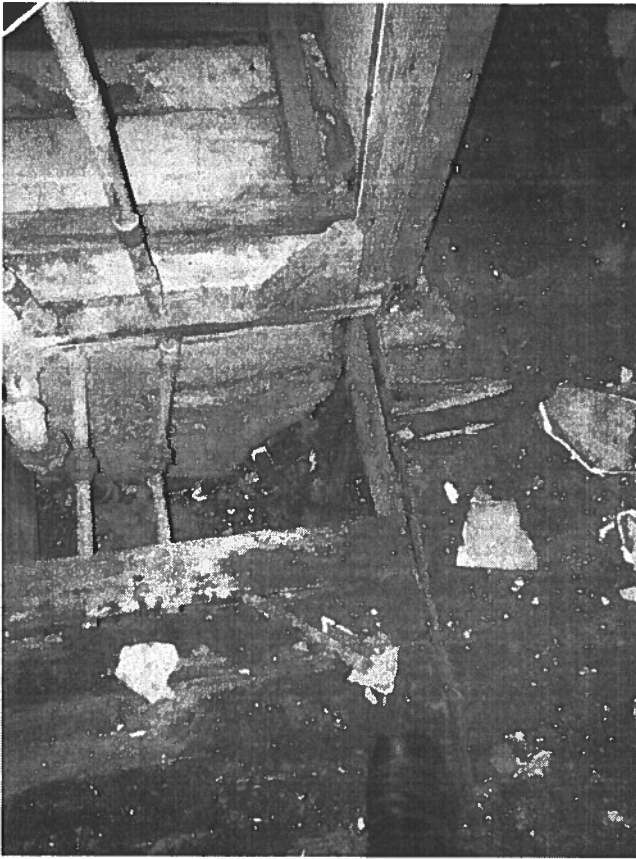
- Broken supply pipes: Galvanized water pipes are sheared apart under floor.

Photo 11 Sheared Steel Water Pipes

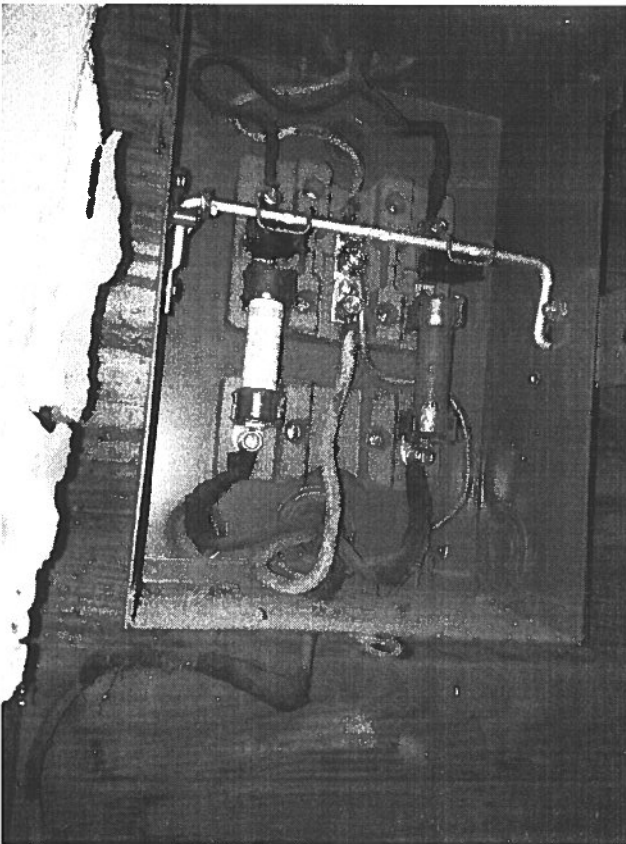
Photo 12 Common Ground and Neutral in Fuse Box. Different Size Fuses on Each Circuit

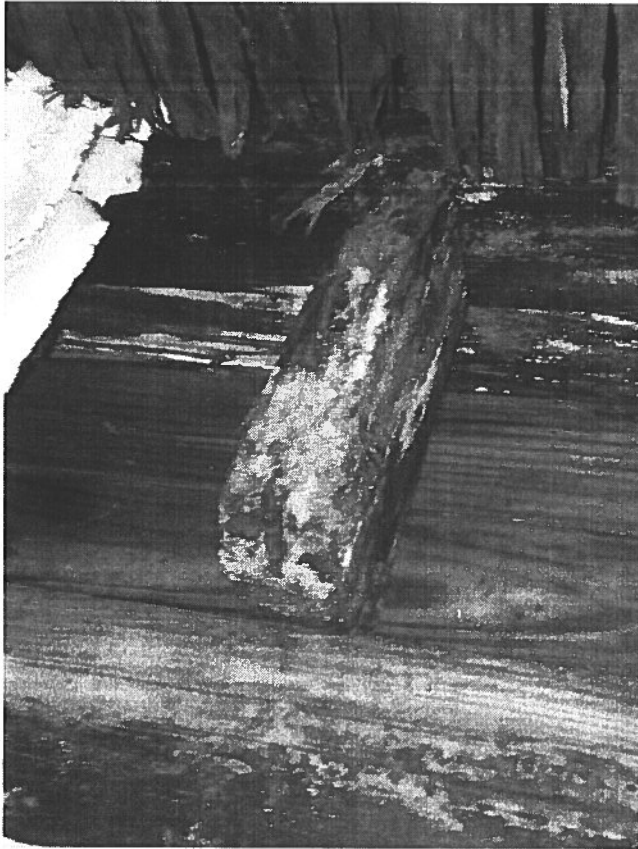
MAE concludes that the dry rot (a decaying condition caused by fungi that digest the part of the wood that gives wood its strength and stiffness), wet rot (a decaying condition caused by a different fungi that that digest the part of the wood that gives wood its strength and stiffness), termite damage (a decaying condition caused by an insect that digests the part of the wood that gives wood its strength and stiffness), deteriorated wood, and mold damage. All these conditions affect the structural ability of the wood members to provide the structural integrity required of the buildings structural systems. Any one of these conditions (we are dealing with five different conditions) would affect the ability of the wood in these systems to meet the mathematical values that are required to compute the following structural requirements of: weight bearing capacity, shear stresses, moment stresses, axial stress forces, span lengths of wood members, and nail and bolt pull-out calculations for all of the wood connections. This building has structurally failed. It is only a matter of time that this building will be in catastrophic failure.

Photo 13 Example of Dry Rot Wet Rot and Mold

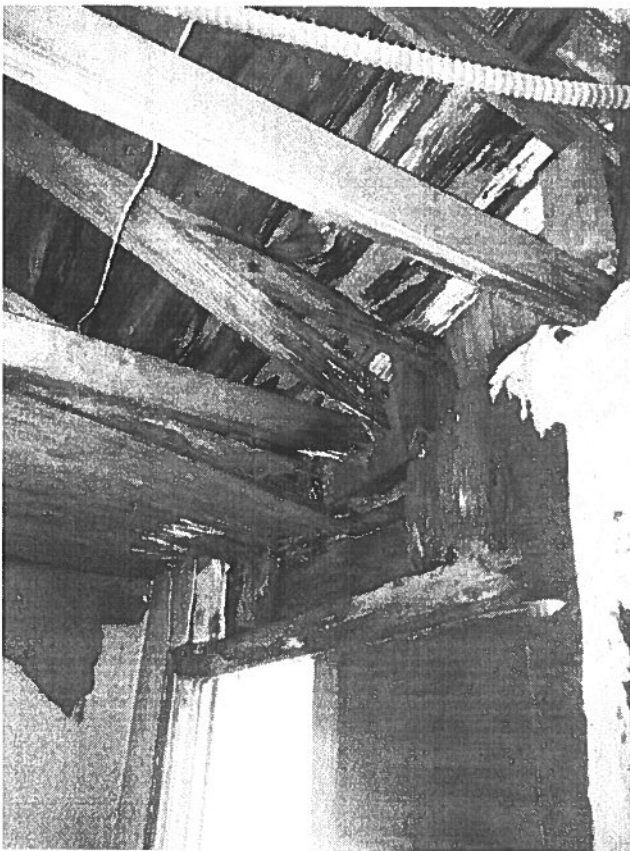
Photo 14 Example of Damaged Ceiling Framing

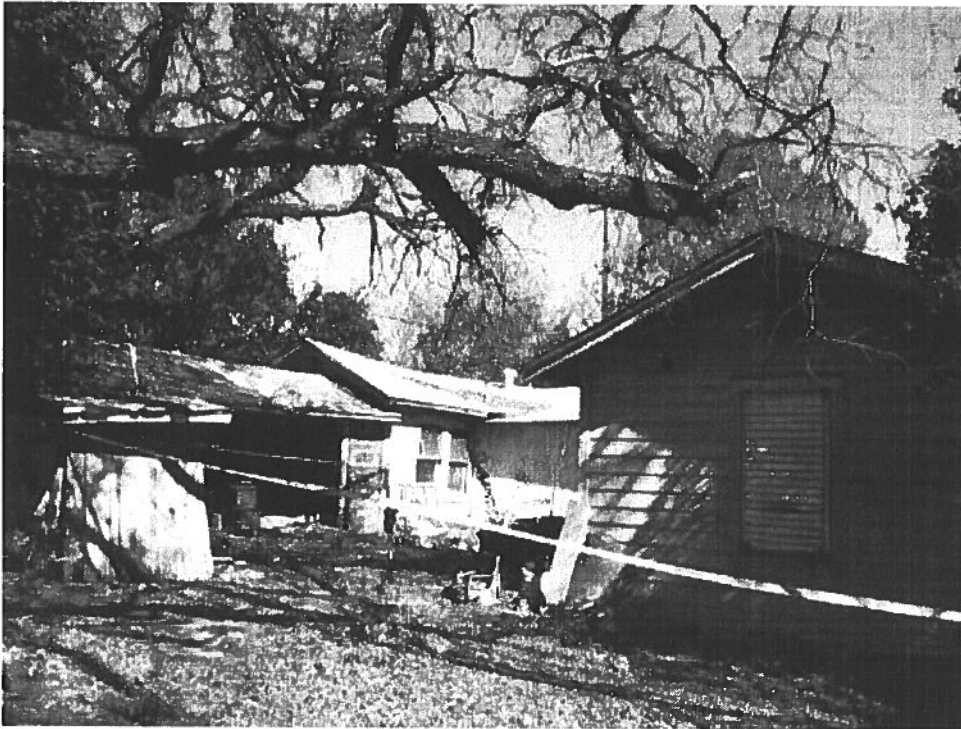
Photo 1: Overall of House (looking northeast)

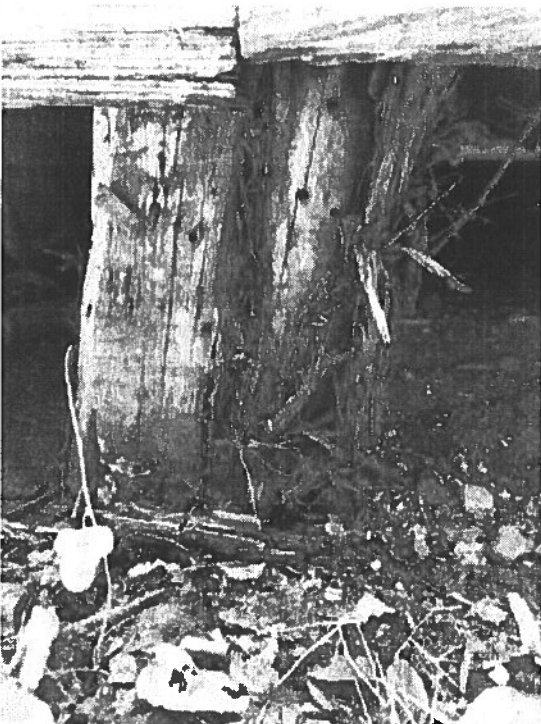
Photo 2: Timber Pile Foundation Loss of Section and Signs of Infestation

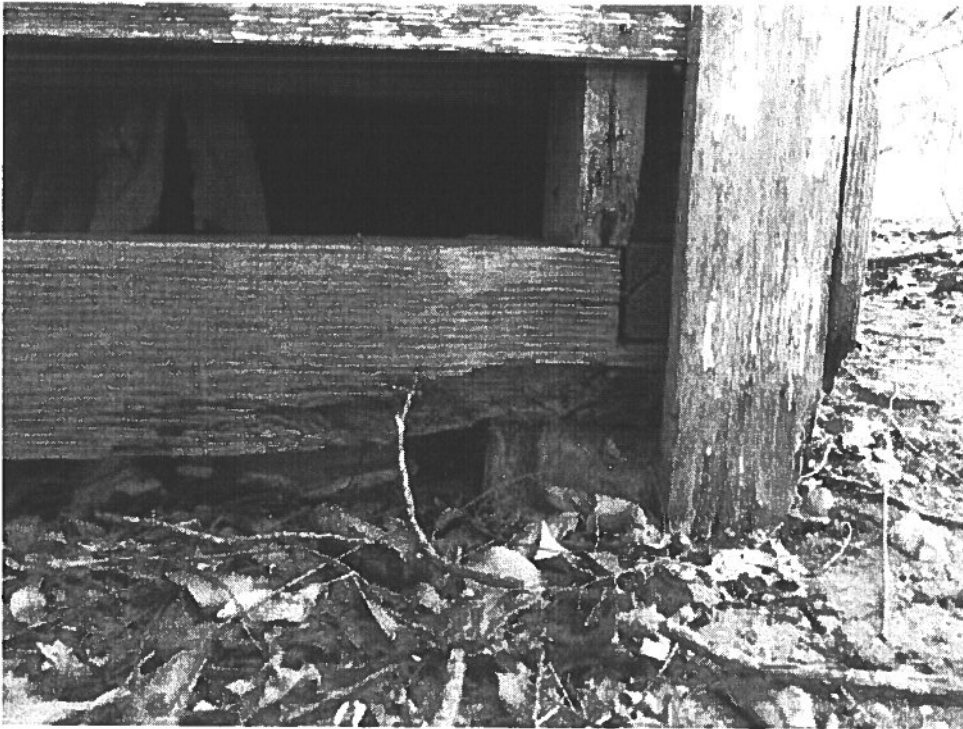
Photo 3: Wooden Beam Loss of Section and Bearing Area

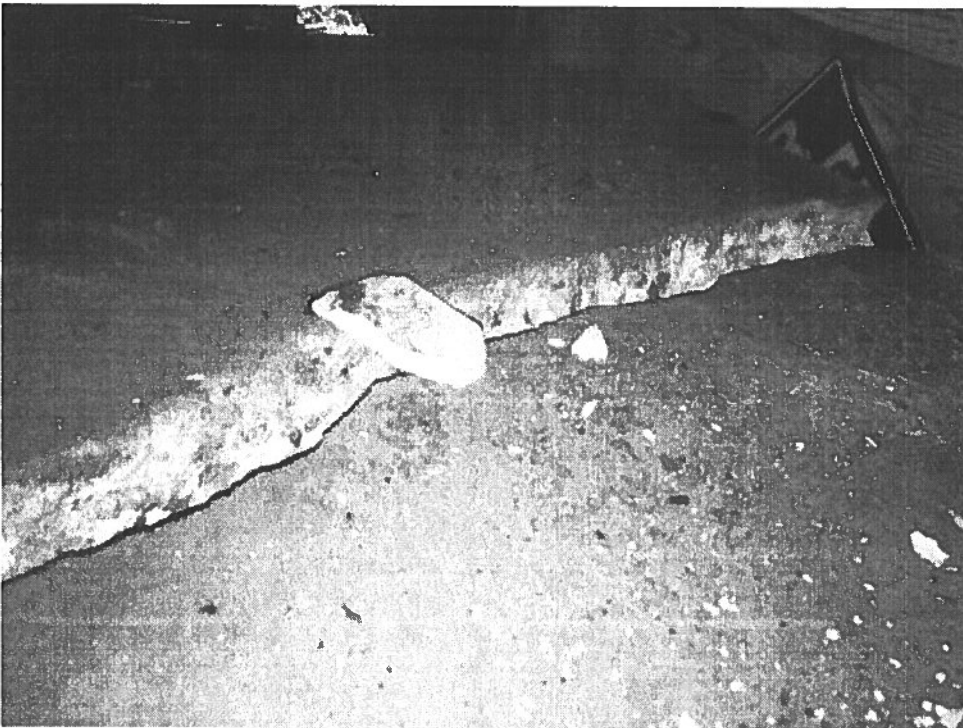
Photo 4: Concrete Slab Foundation Cracking and Movement

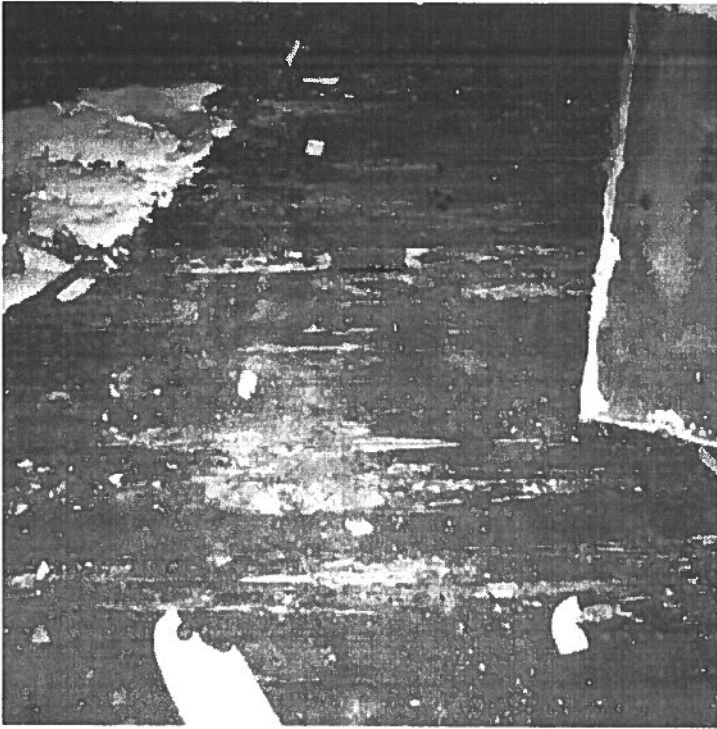
Photo 5: Typical Wood Flooring Deterioration

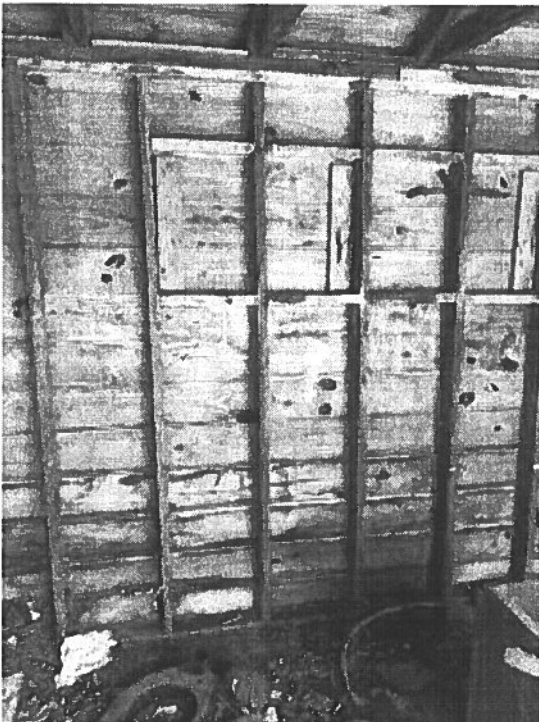
Photo 6: Wall Section with Multiple Signs of Fungus Infestation

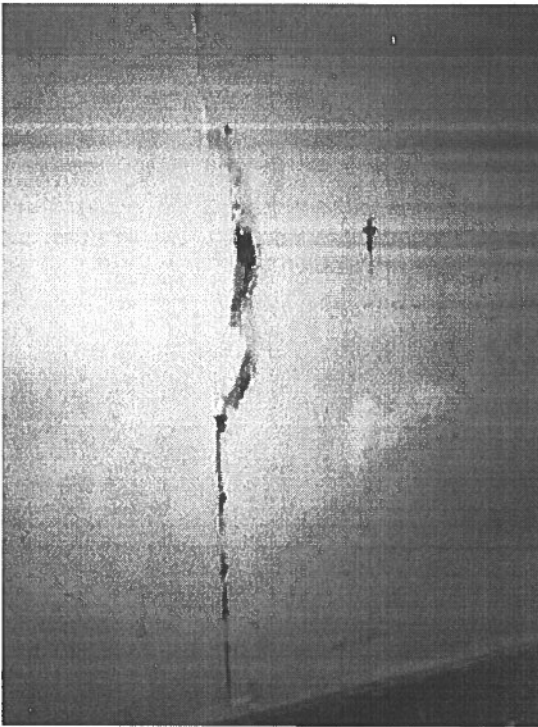
Photo 7: Cracking in Wall Sheathing

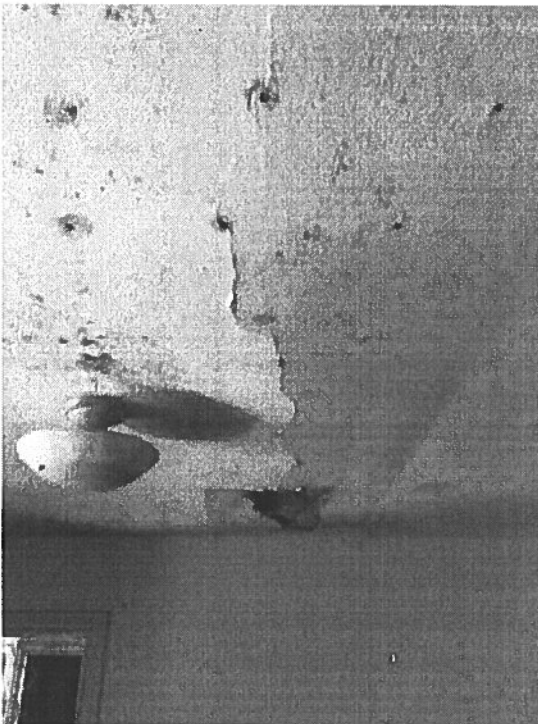
Photo 8: Cracking in Ceiling Sheathing

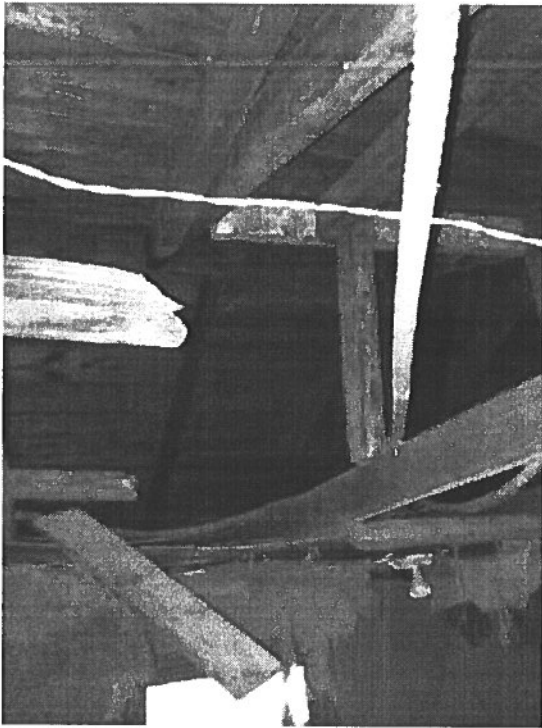
Photo 9: Collapsed Section of Wooden Roof Joists and Beams

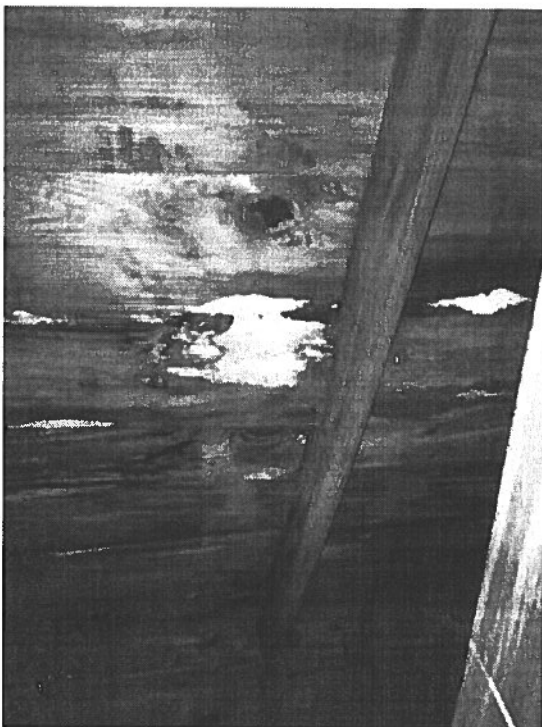
Photo 10: Signs of Fungus Infestation for Roof's Wooden Framing
