# HISTORIC AND DESIGN REVIEW COMMISSION

March 20, 2019

**HDRC CASE NO:** 2019-124  
**ADDRESS:** 517 LABOR  
**LEGAL DESCRIPTION:** NCB 926 BLK 4 LOT S IRR 79.3FT OF N IRR 93.3FT OF 29 & N TRI 25FT OF 30  
**ZONING:** C-2,H  
**CITY COUNCIL DIST.:** 1  
**DISTRICT:** Lavaca Historic District  
**APPLICANT:** Cindy Castro  
**OWNER:** Guadalupe Castro  
**TYPE OF WORK:** Demolition of primary structure with new construction of a Tuff shed  
**APPLICATION RECEIVED:** January 03, 2019  
**60-DAY REVIEW:** March 04, 2019; 30 day decision period – April 3, 2019  
**CASE MANAGER:** Stephanie Phillips  
**REQUEST:**

SUB: Forensic Inspection and Micro-Elevation Survey of the Foundation

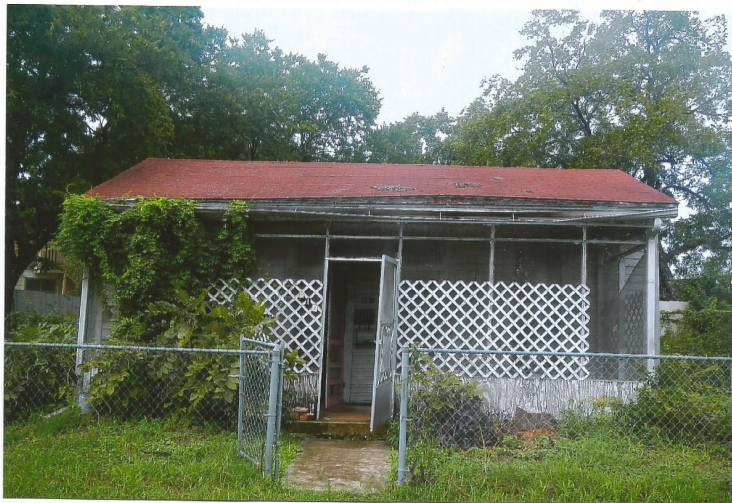
**PHOTOGRAPH NO. 1**

East (front) view, of the Castro property located at 517 Labor Street, San Antonio, Texas.

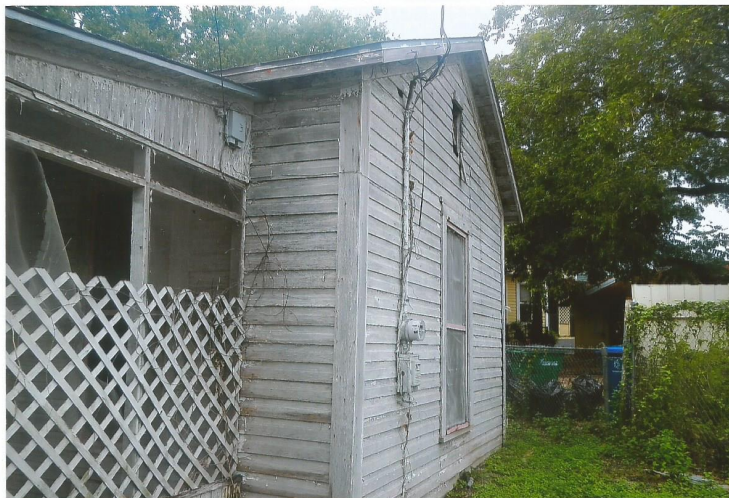
**PHOTOGRAPH NO. 2**

North view, of the East portion of the property.

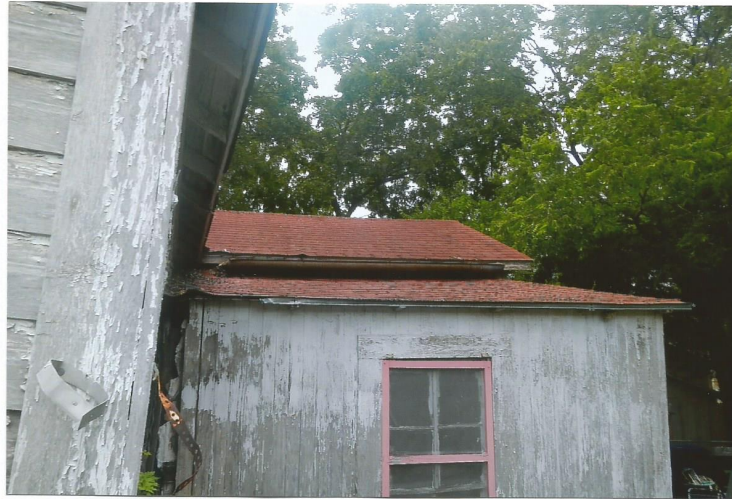
**PHOTOGRAPH NO. 3**

North view, of the West portion of the property.

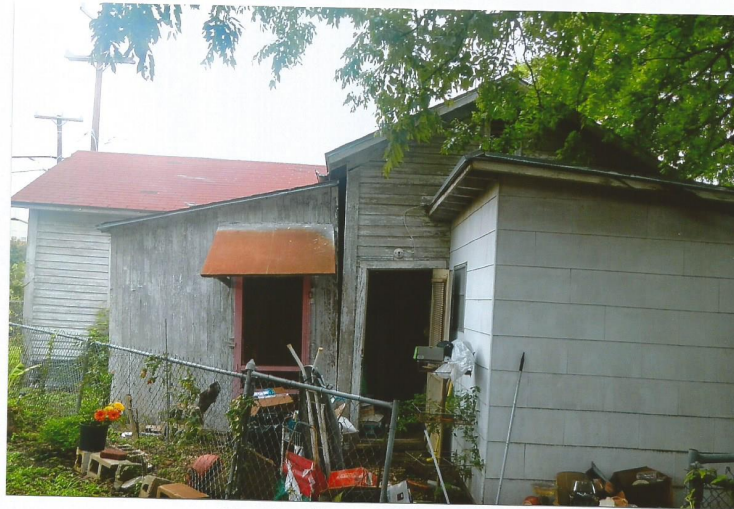
**PHOTOGRAPH NO. 4**

West (back) view of the residence.

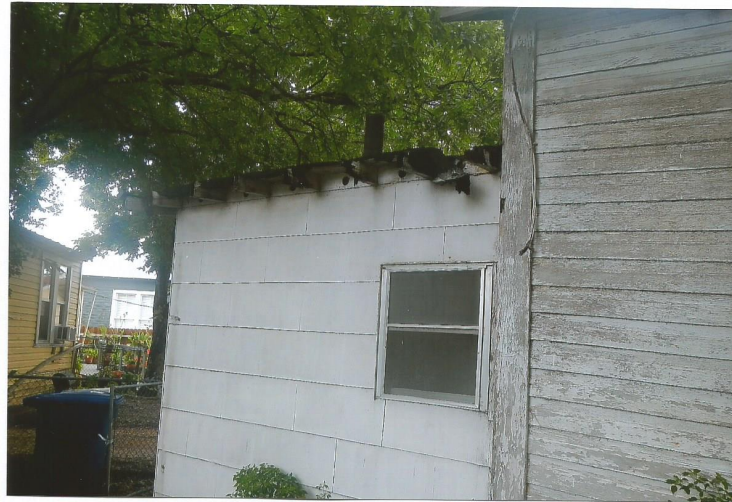
**PHOTOGRAPH NO. 5**

South view, of the West portion in the property.

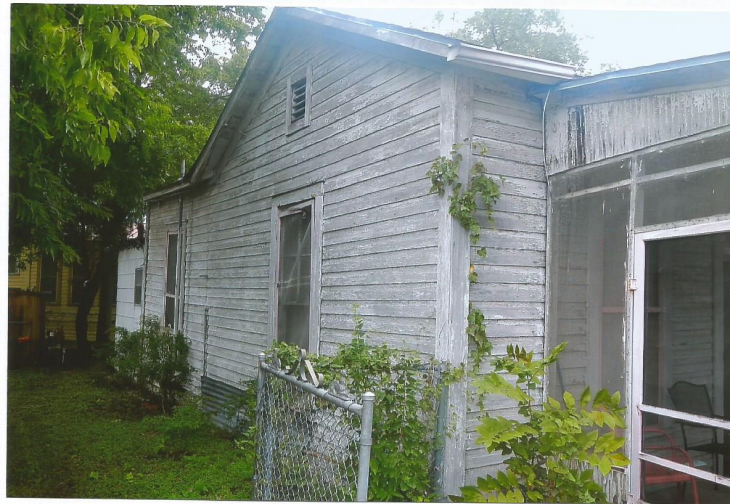
**PHOTOGRAPH NO. 6**

South view, of the East portion in the property.

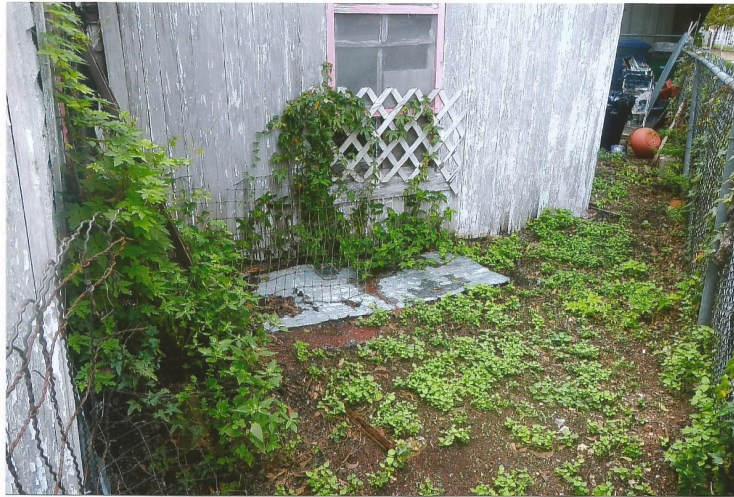
PHOTOGRAPH NO. 7

View of the separation between the breakfast room and the main house.

- 5) The exterior wood siding has water damage and rot, separations of the trim and is bowed along the bottom of the walls.
- 6) All of the additions have separated from the main house.

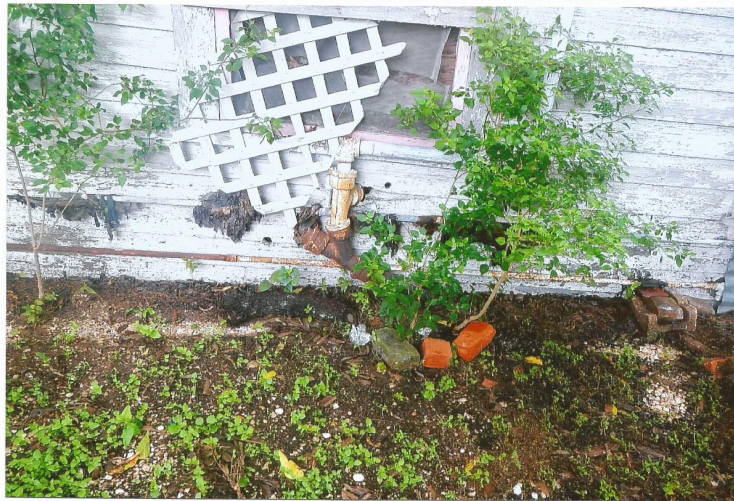
PHOTOGRAPH NO. 8

View of the cleanout installed in the sanitary drain line by the South side of the kitchen.

- #8 – View of the cleanout installed in the sanitary drain line by the South side of the kitchen.
- #9 – View of damaged wood flooring and deteriorated wood floor joists and beams.

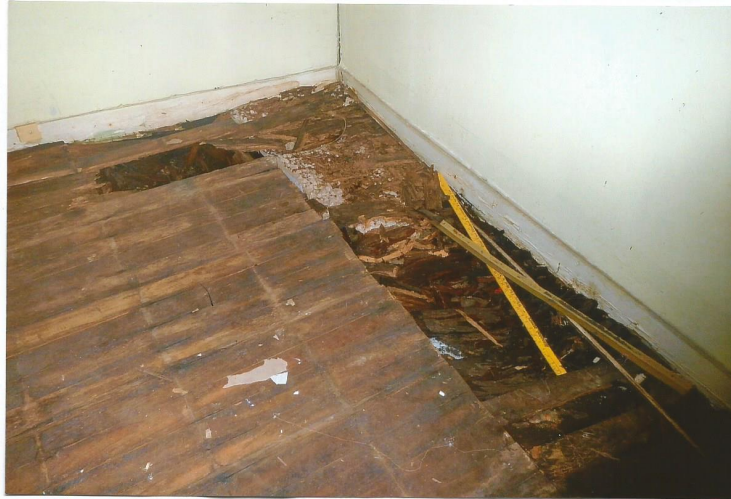
**PHOTOGRAPH NO. 9**

View of damaged wood flooring and deteriorated floor joist and beams.

- 9) The foundation piers and wood support beams could not be fully observed due to the presence of water and mud just below the wood floor. The portions of the wood beams that can be seen are completely deteriorated and in very poor condition.

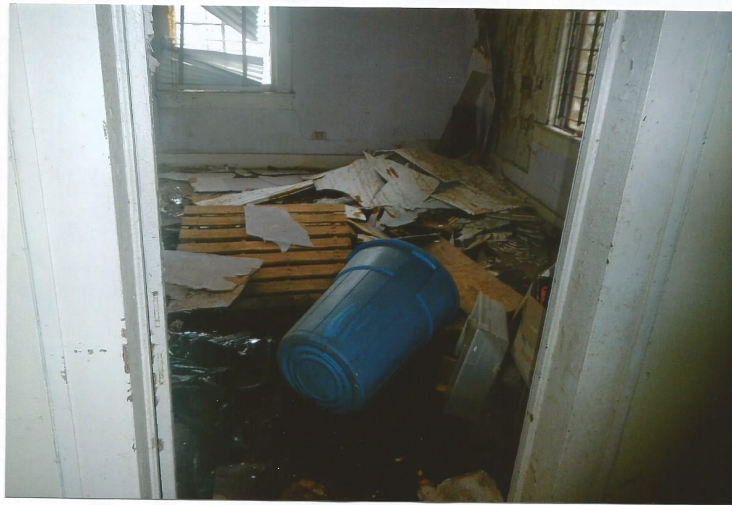
**PHOTOGRAPH NO. 10**

View of damaged wood flooring and wood structure in bedroom.

- #10 – View of damaged wood flooring and wood structure in the bedroom.
- #11 – View of damaged wood flooring and wood structure in the bedroom.
- #12 – View of damaged wood flooring, wood structure and standing water in the bedroom.

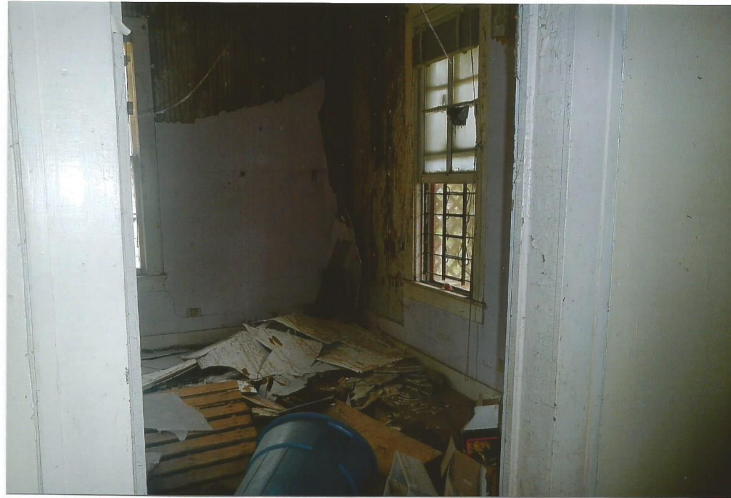
PHOTOGRAPH NO. 11

View of damaged wood flooring and wood structure in the bedroom.

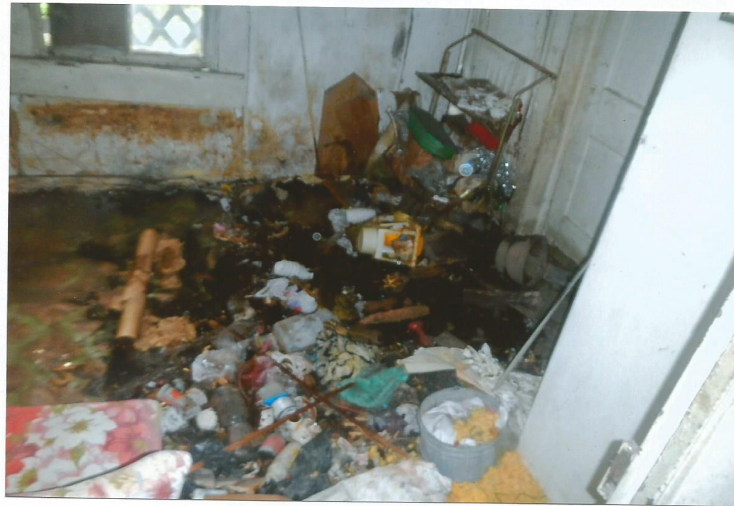
PHOTOGRAPH NO. 12

View of damaged wood flooring, wood structure and standing water in the bedroom.

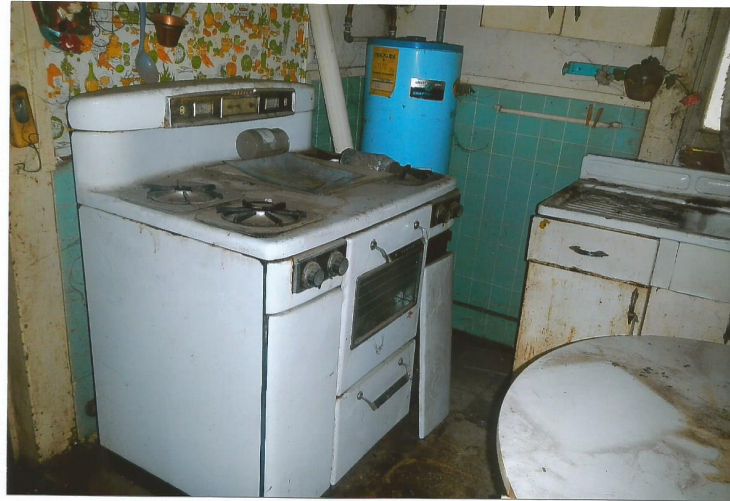
**PHOTOGRAPH NO. 13**

View of the kitchen and damaged flooring (out-of-level).

- #13 – View of the kitchen and damaged flooring (out-of-level).
- #14 – View of the damaged ceiling and leaking roof above the breakfast room.
- #15 – View of the floor in the bathroom.

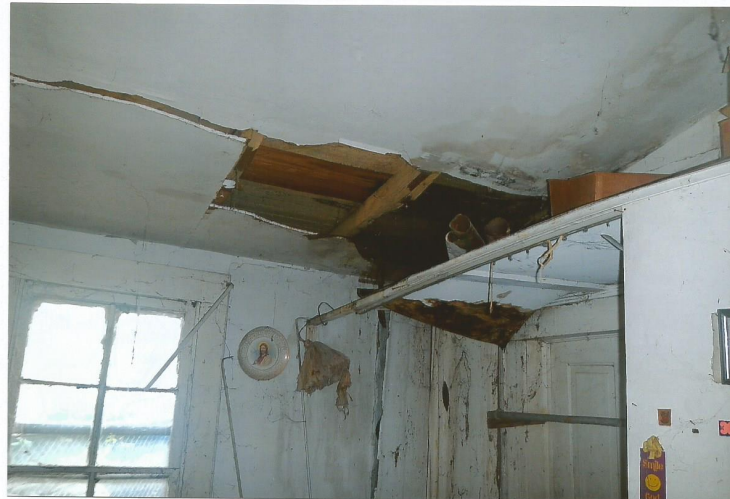
**PHOTOGRAPH NO. 14**

View the damaged ceiling and leaking roof above the breakfast room.

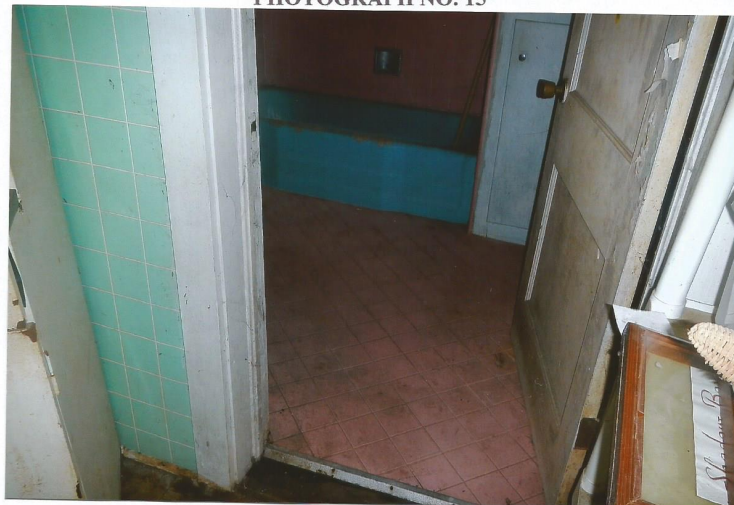
PHOTOGRAPH NO. 15

View of the floor in the bathroom.

- 10) The ceilings are cracked, have large holes, sagging and water soaked.
- 11) The concrete foundation below the bathroom is out-of level and has separated from the main house.
