Re: JLSA King House Relocation  
San Antonio, TX

Pursuant to our visit to the above referenced facility, we submit the following report of our findings. The purpose of this observation was to evaluate the feasibility for moving the existing structure across the street and place the structure on a new foundation.

# **DR. KING HOUSE**

# **DODSON HOUSE MOVING**

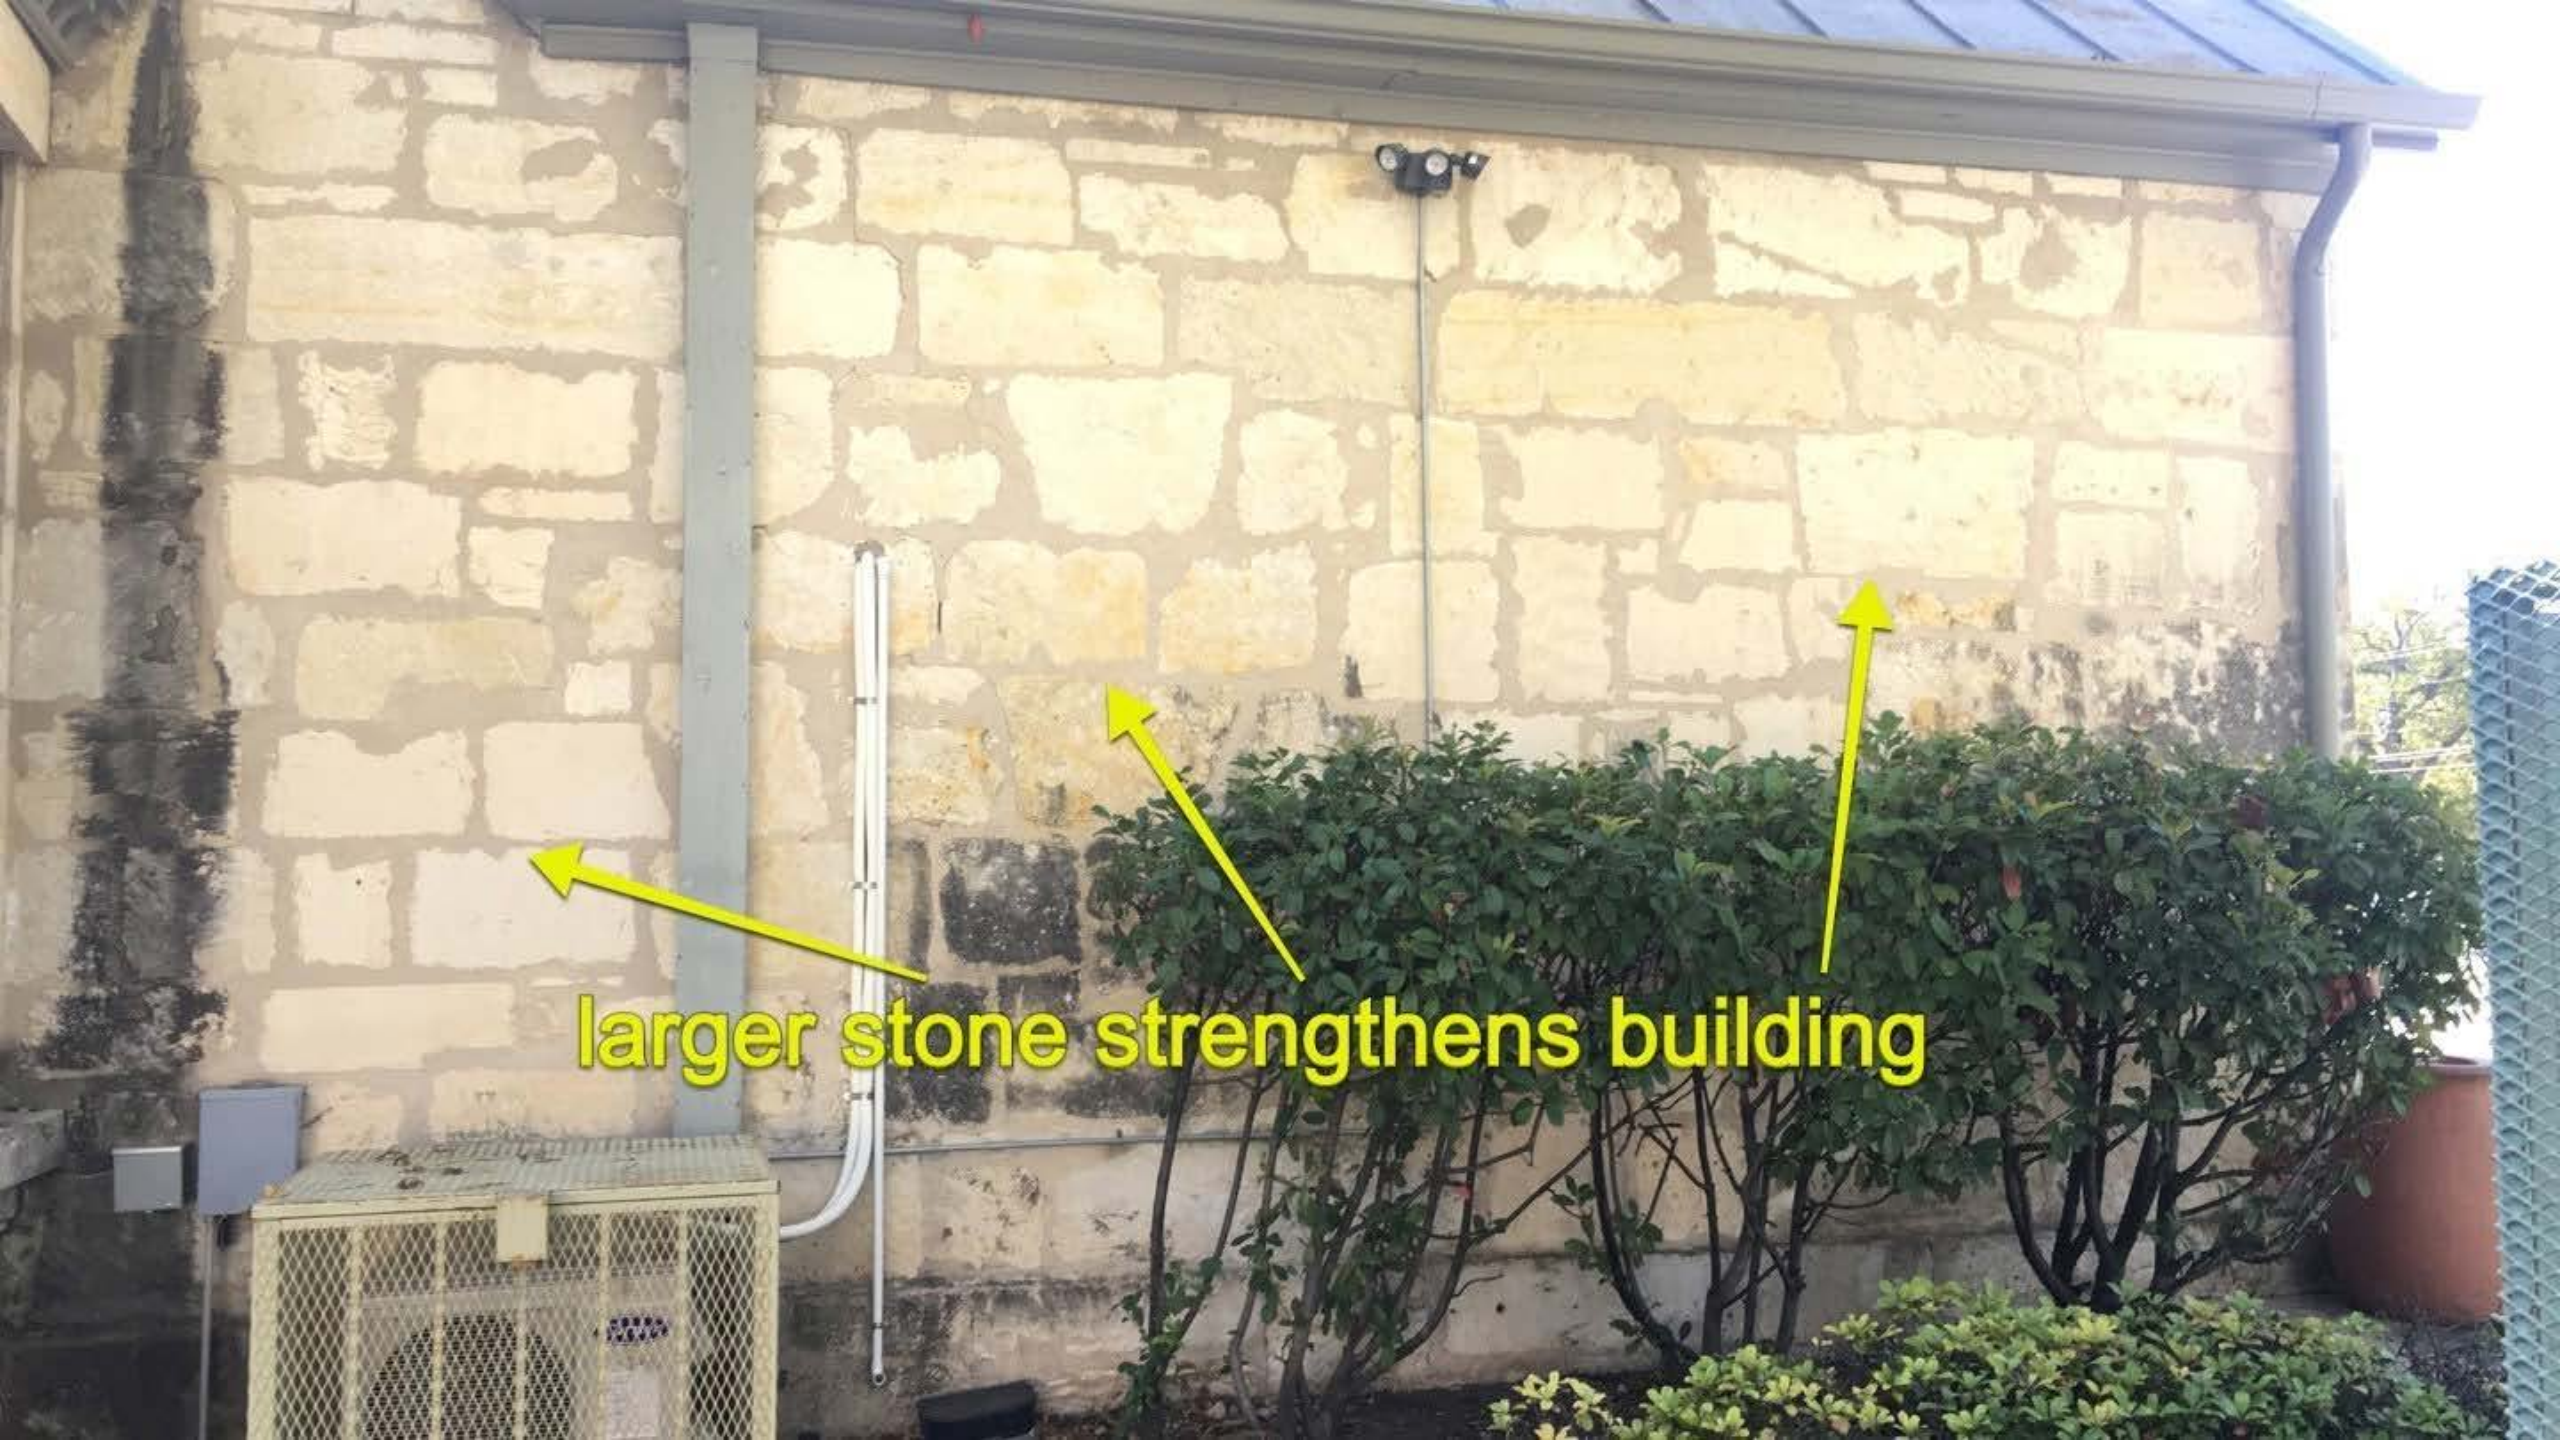
larger stone strengthens building

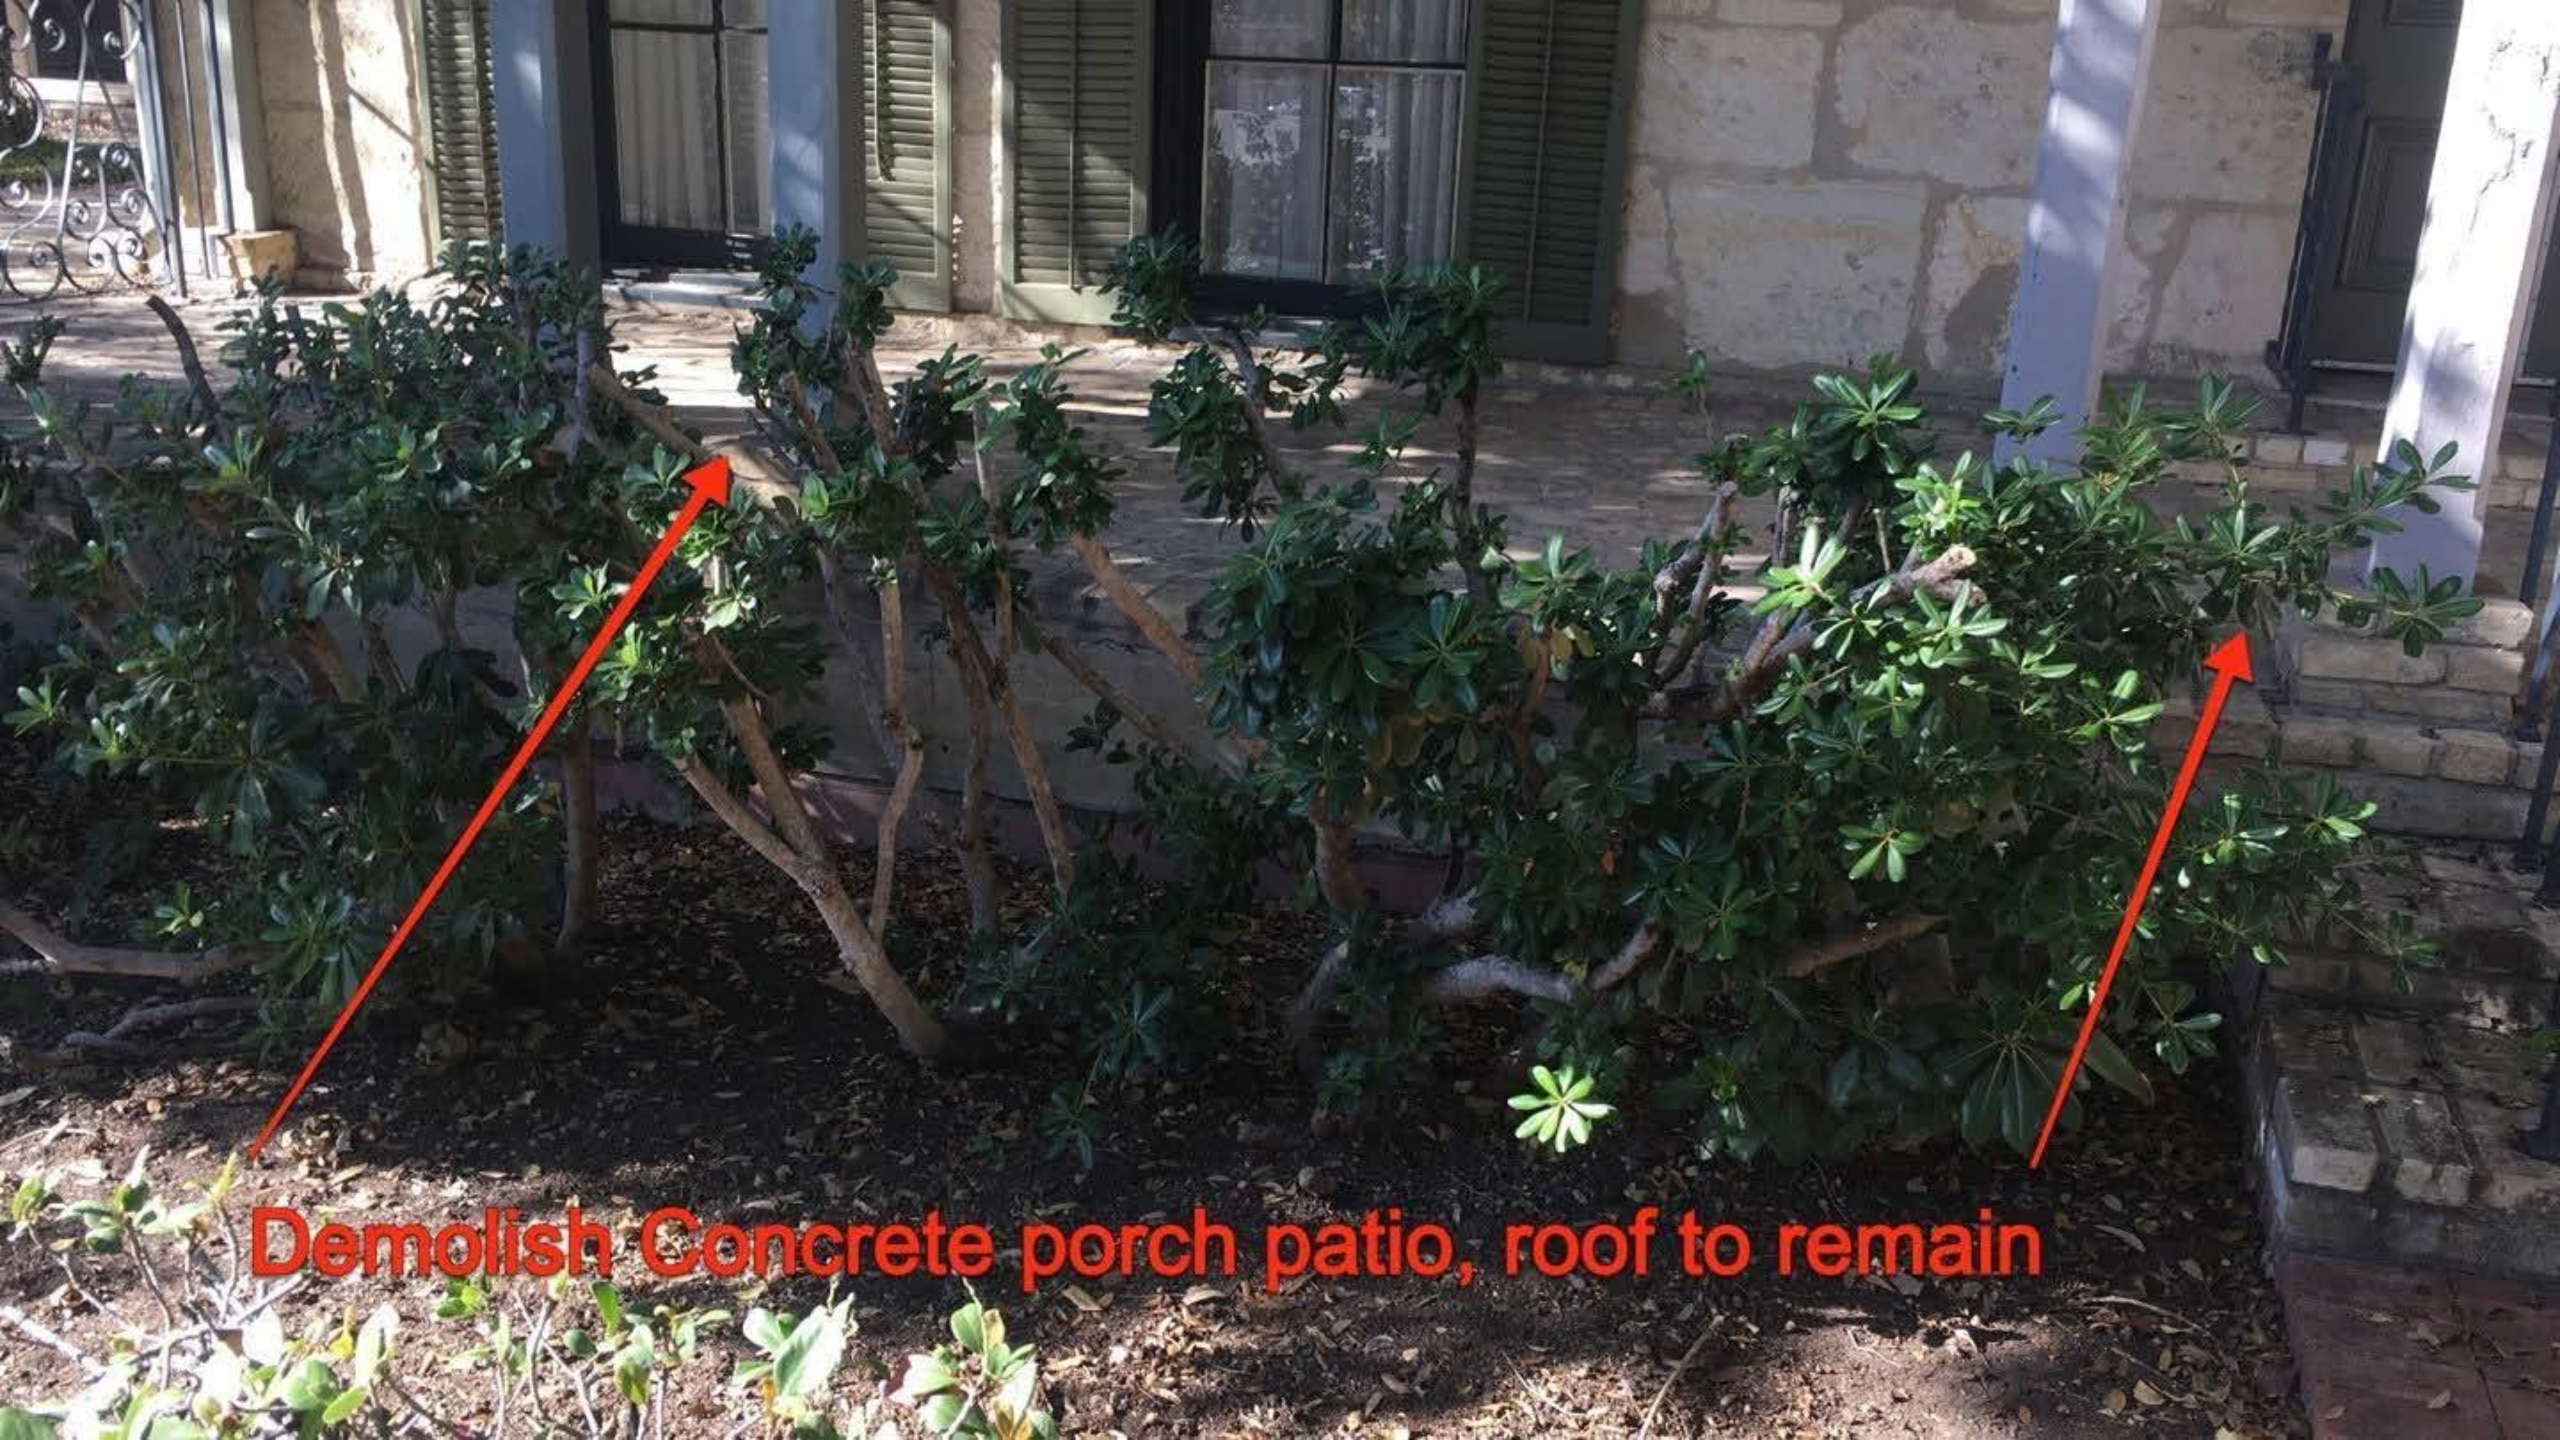
**Demolish Concrete porch patio, roof to remain**

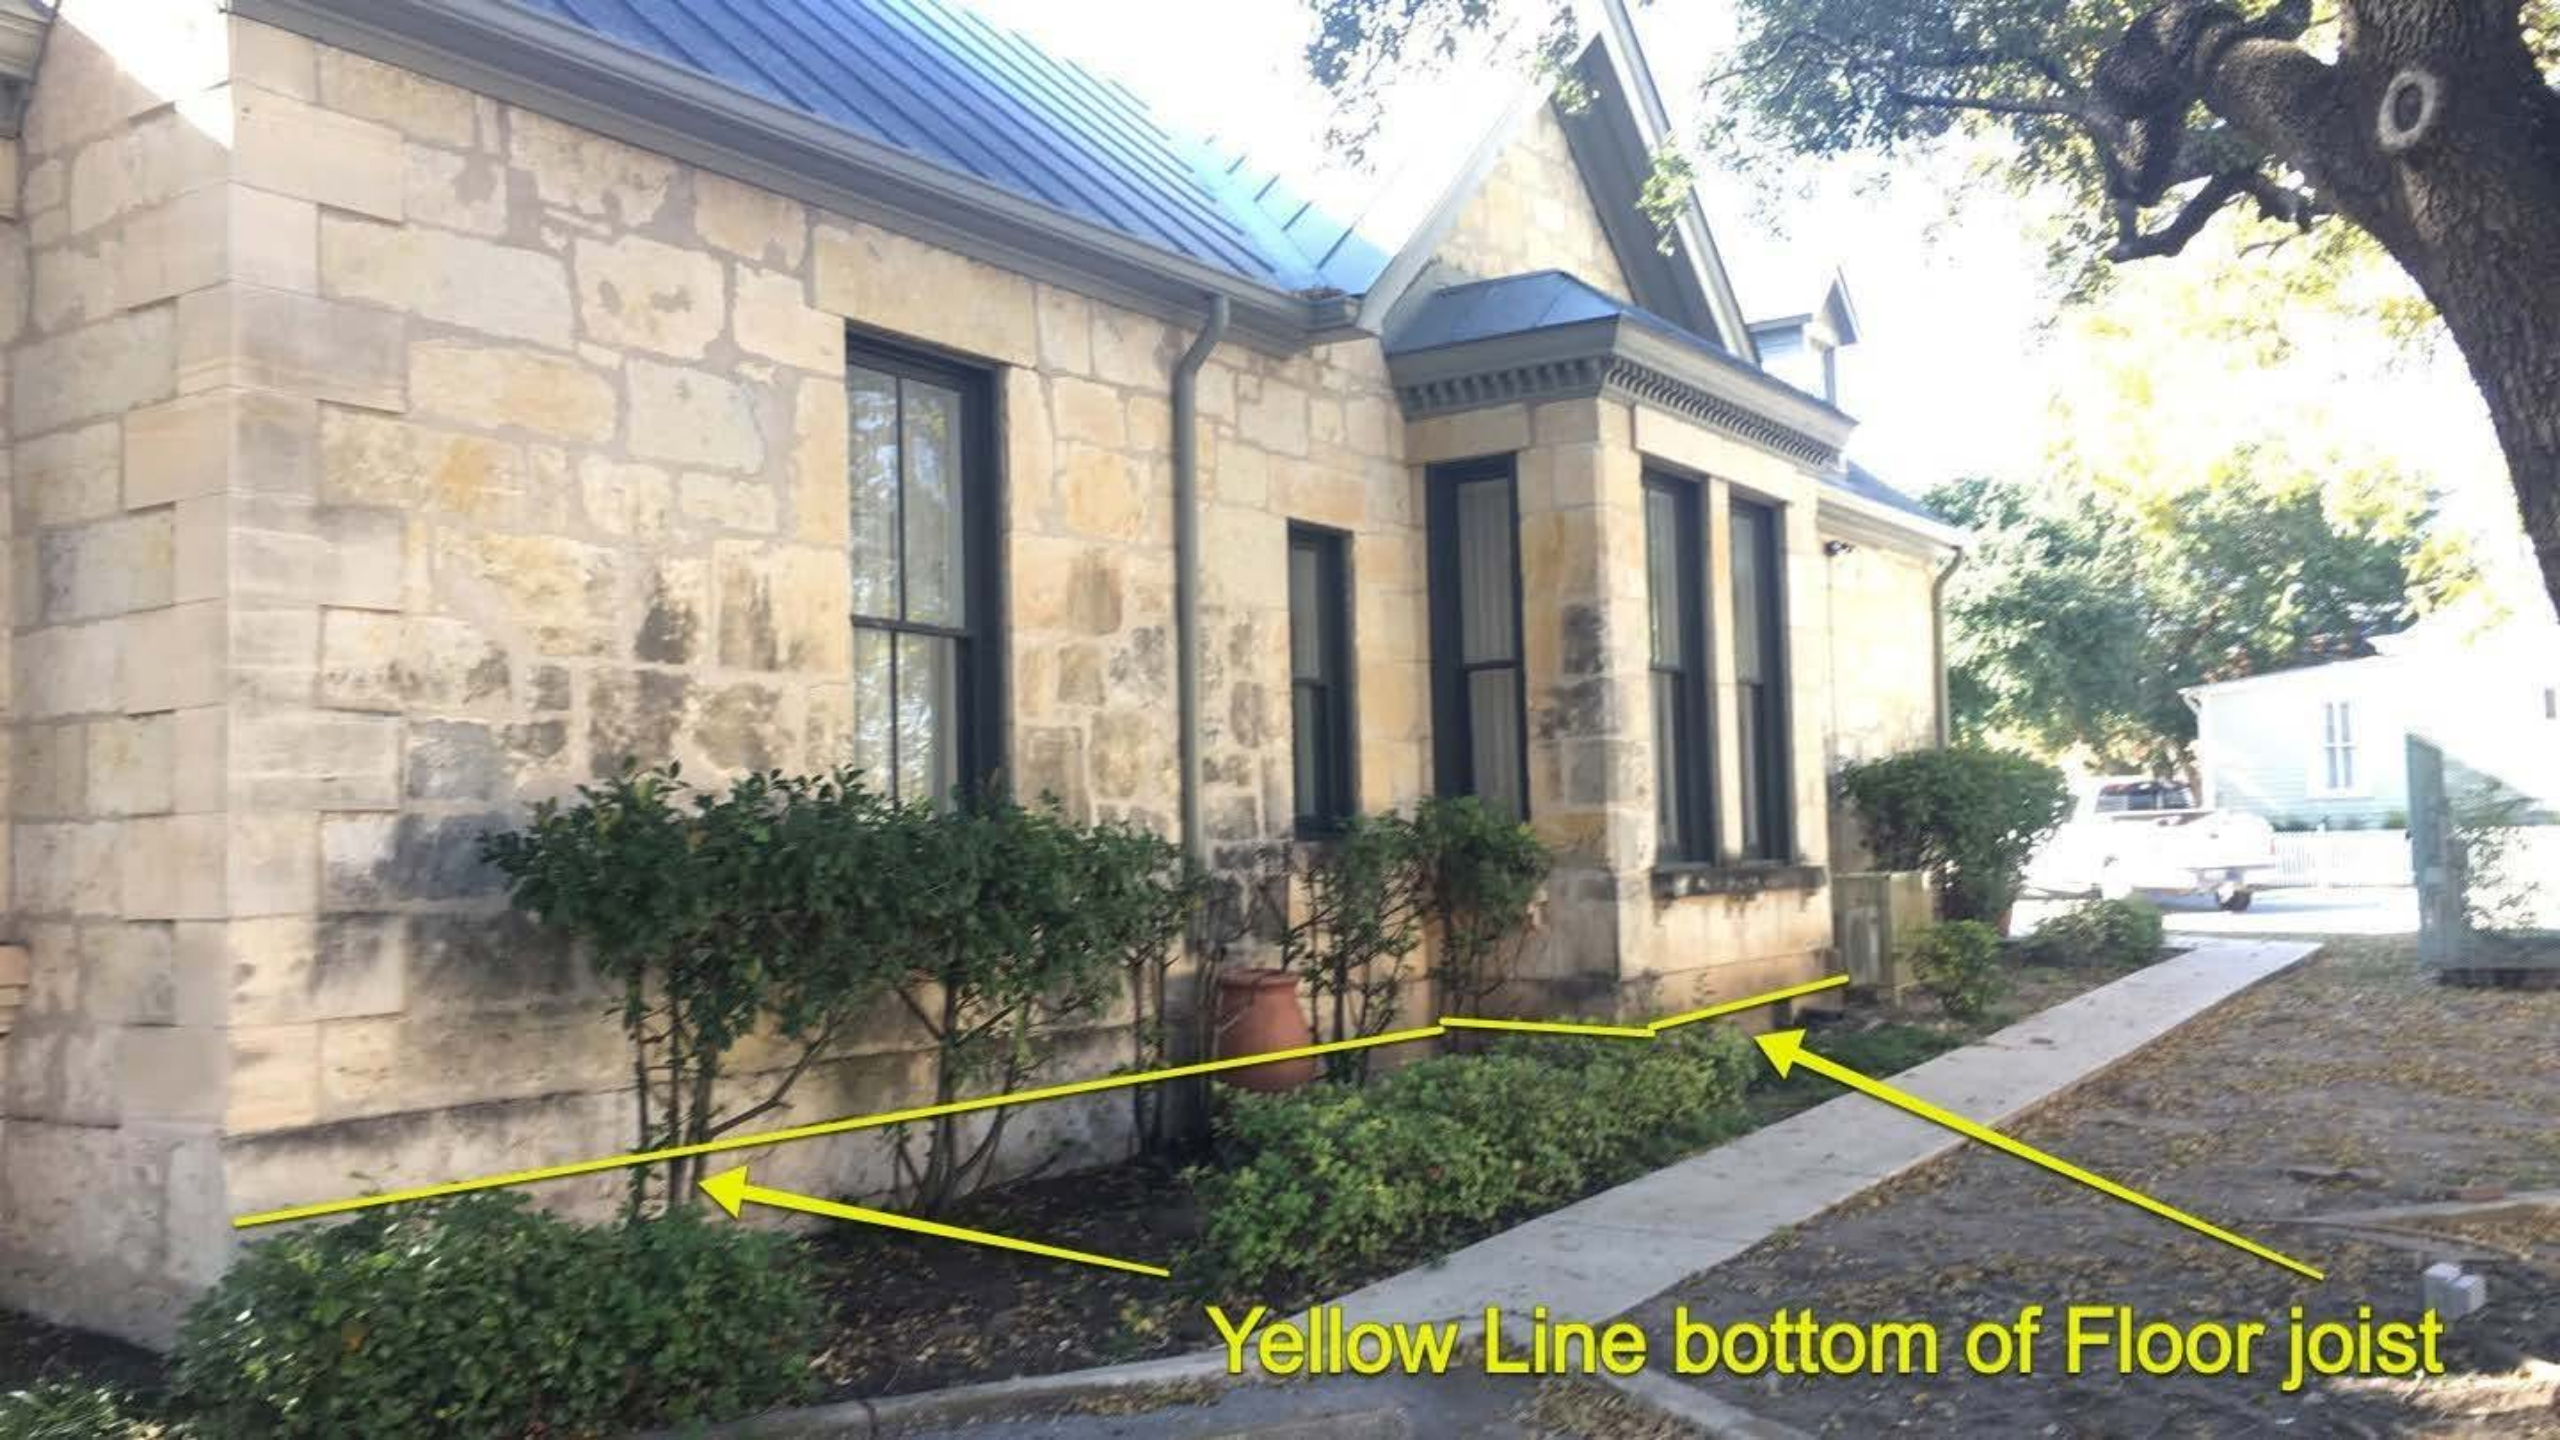
Yellow Line bottom of Floor joist

Cross Loaders
