Re: JLSA King House Relocation  
San Antonio, TX

Pursuant to our visit to the above referenced facility, we submit the following report of our findings. The purpose of this observation was to evaluate the feasibility for moving the existing structure across the street and place the structure on a new foundation.

# **DR. KING HOUSE**

# **DODSON HOUSE MOVING**

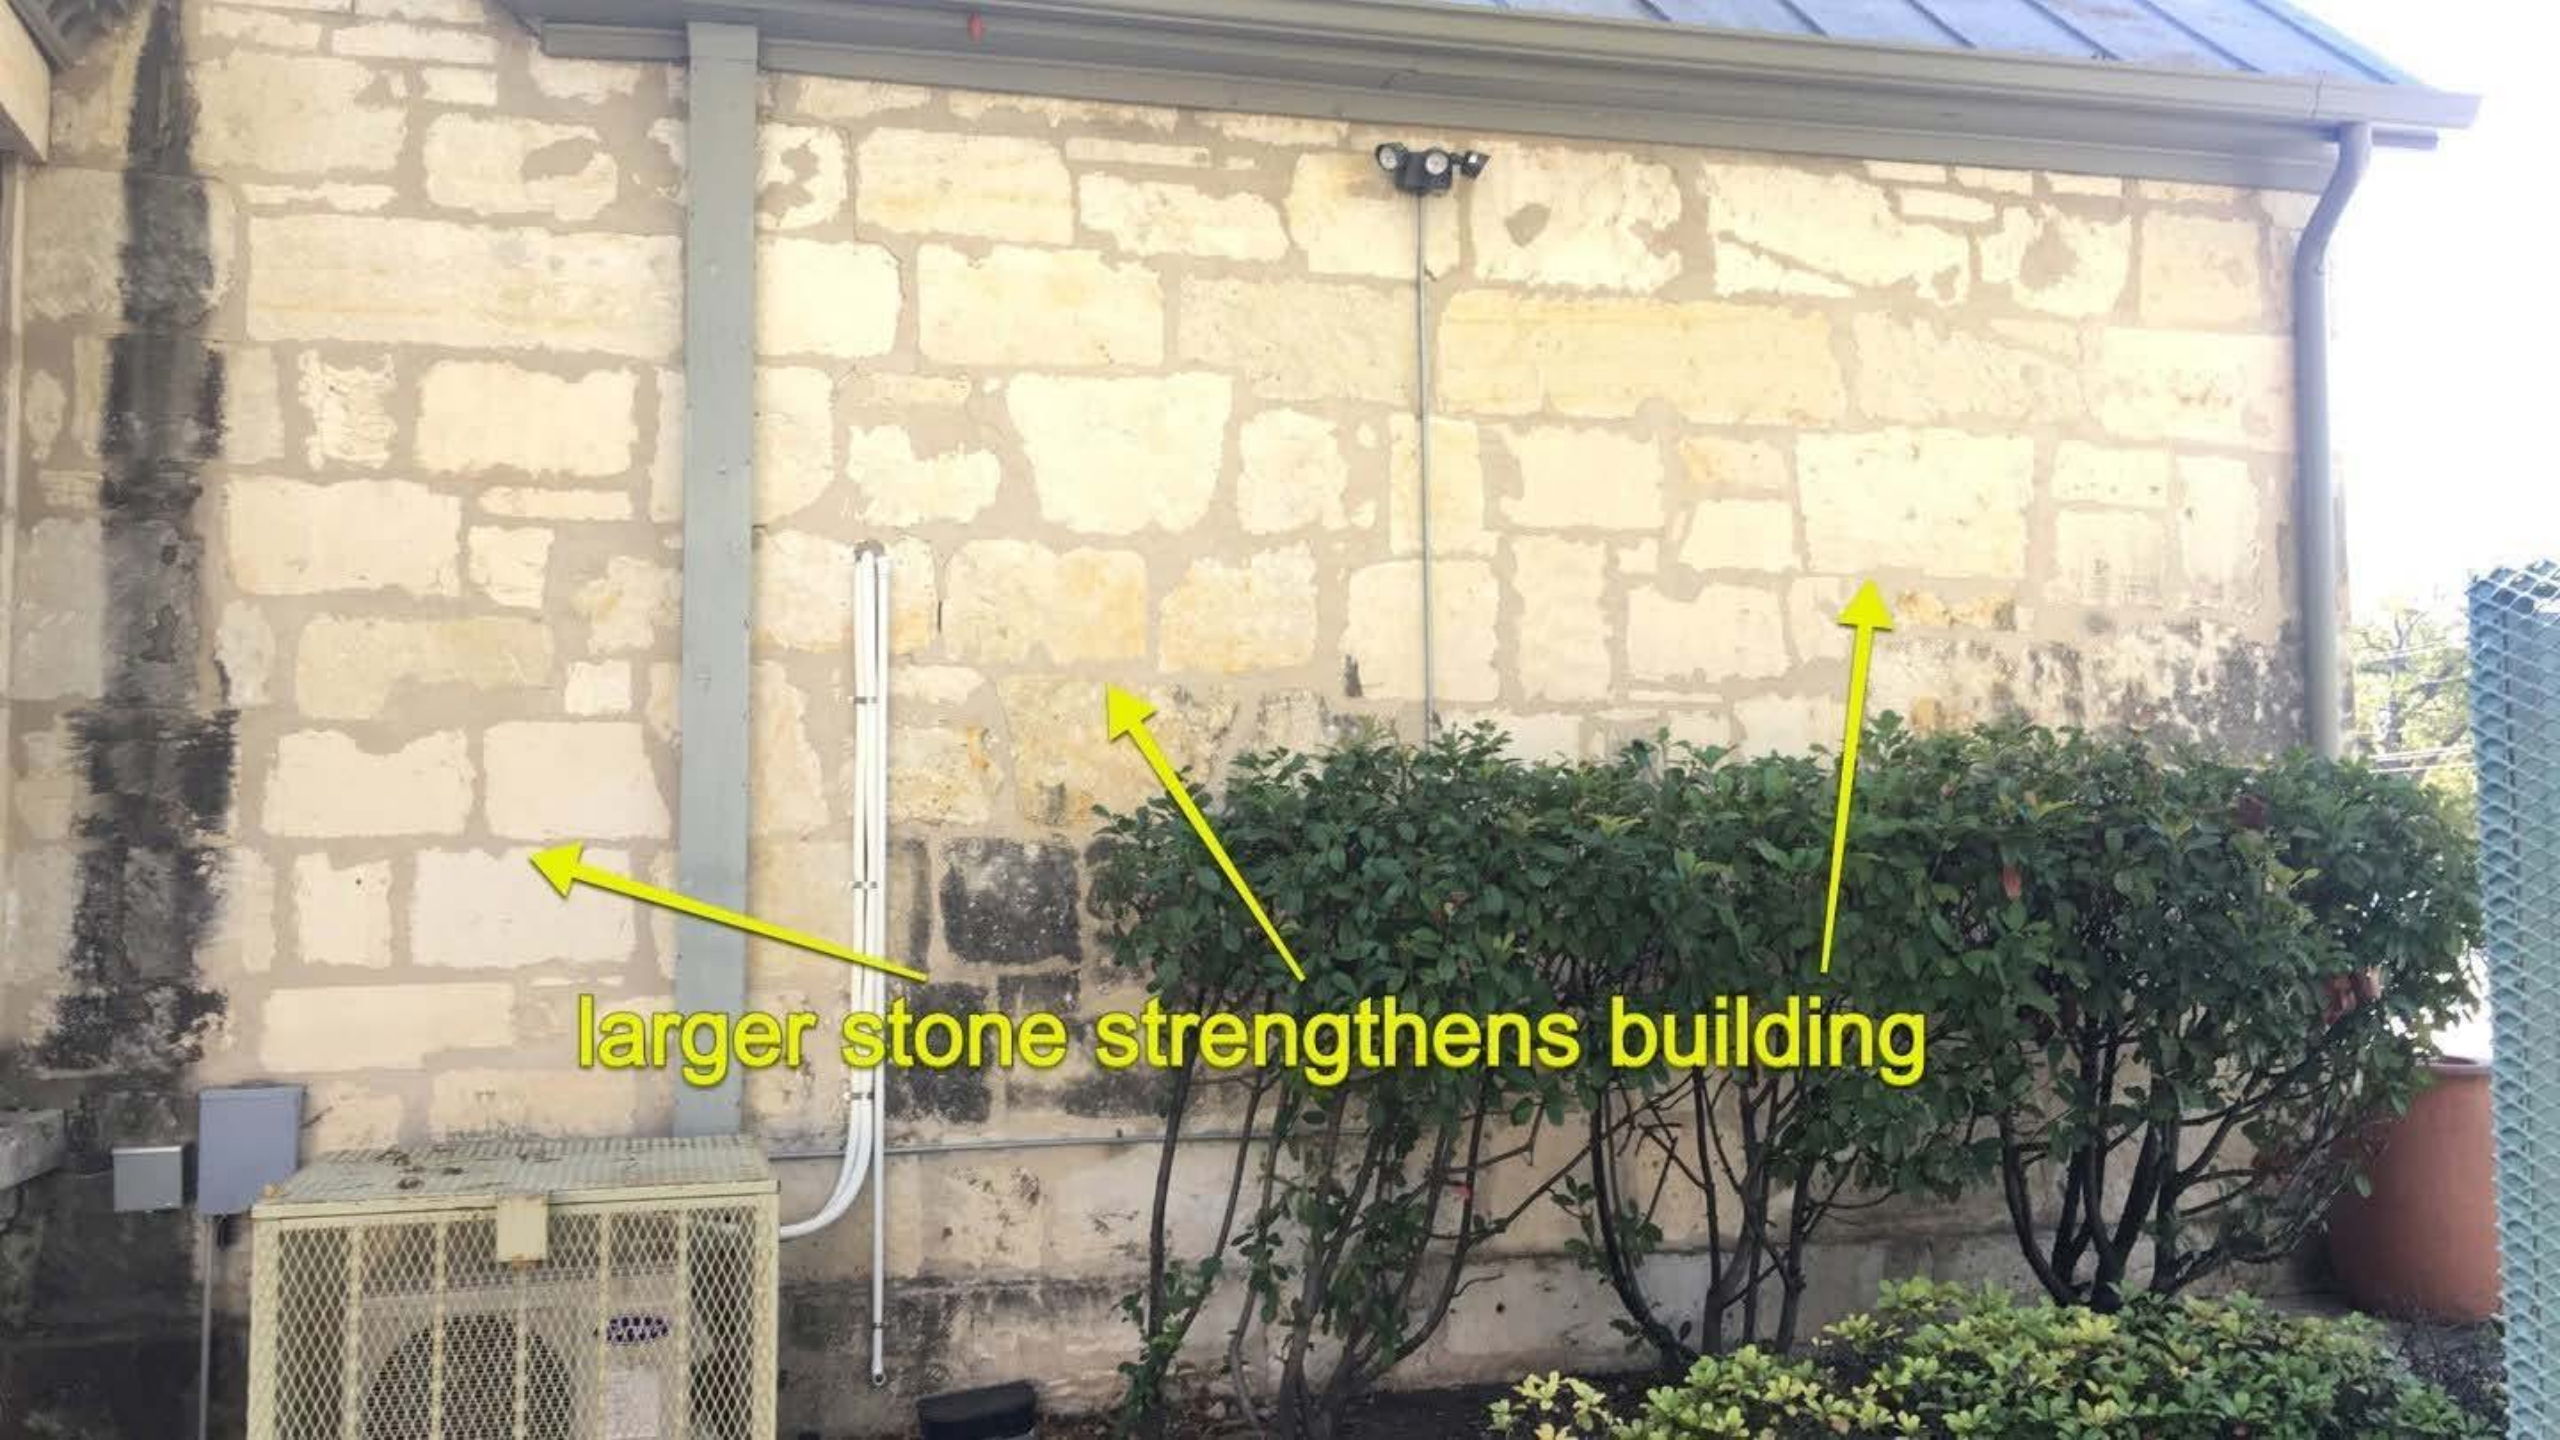
larger stone strengthens building

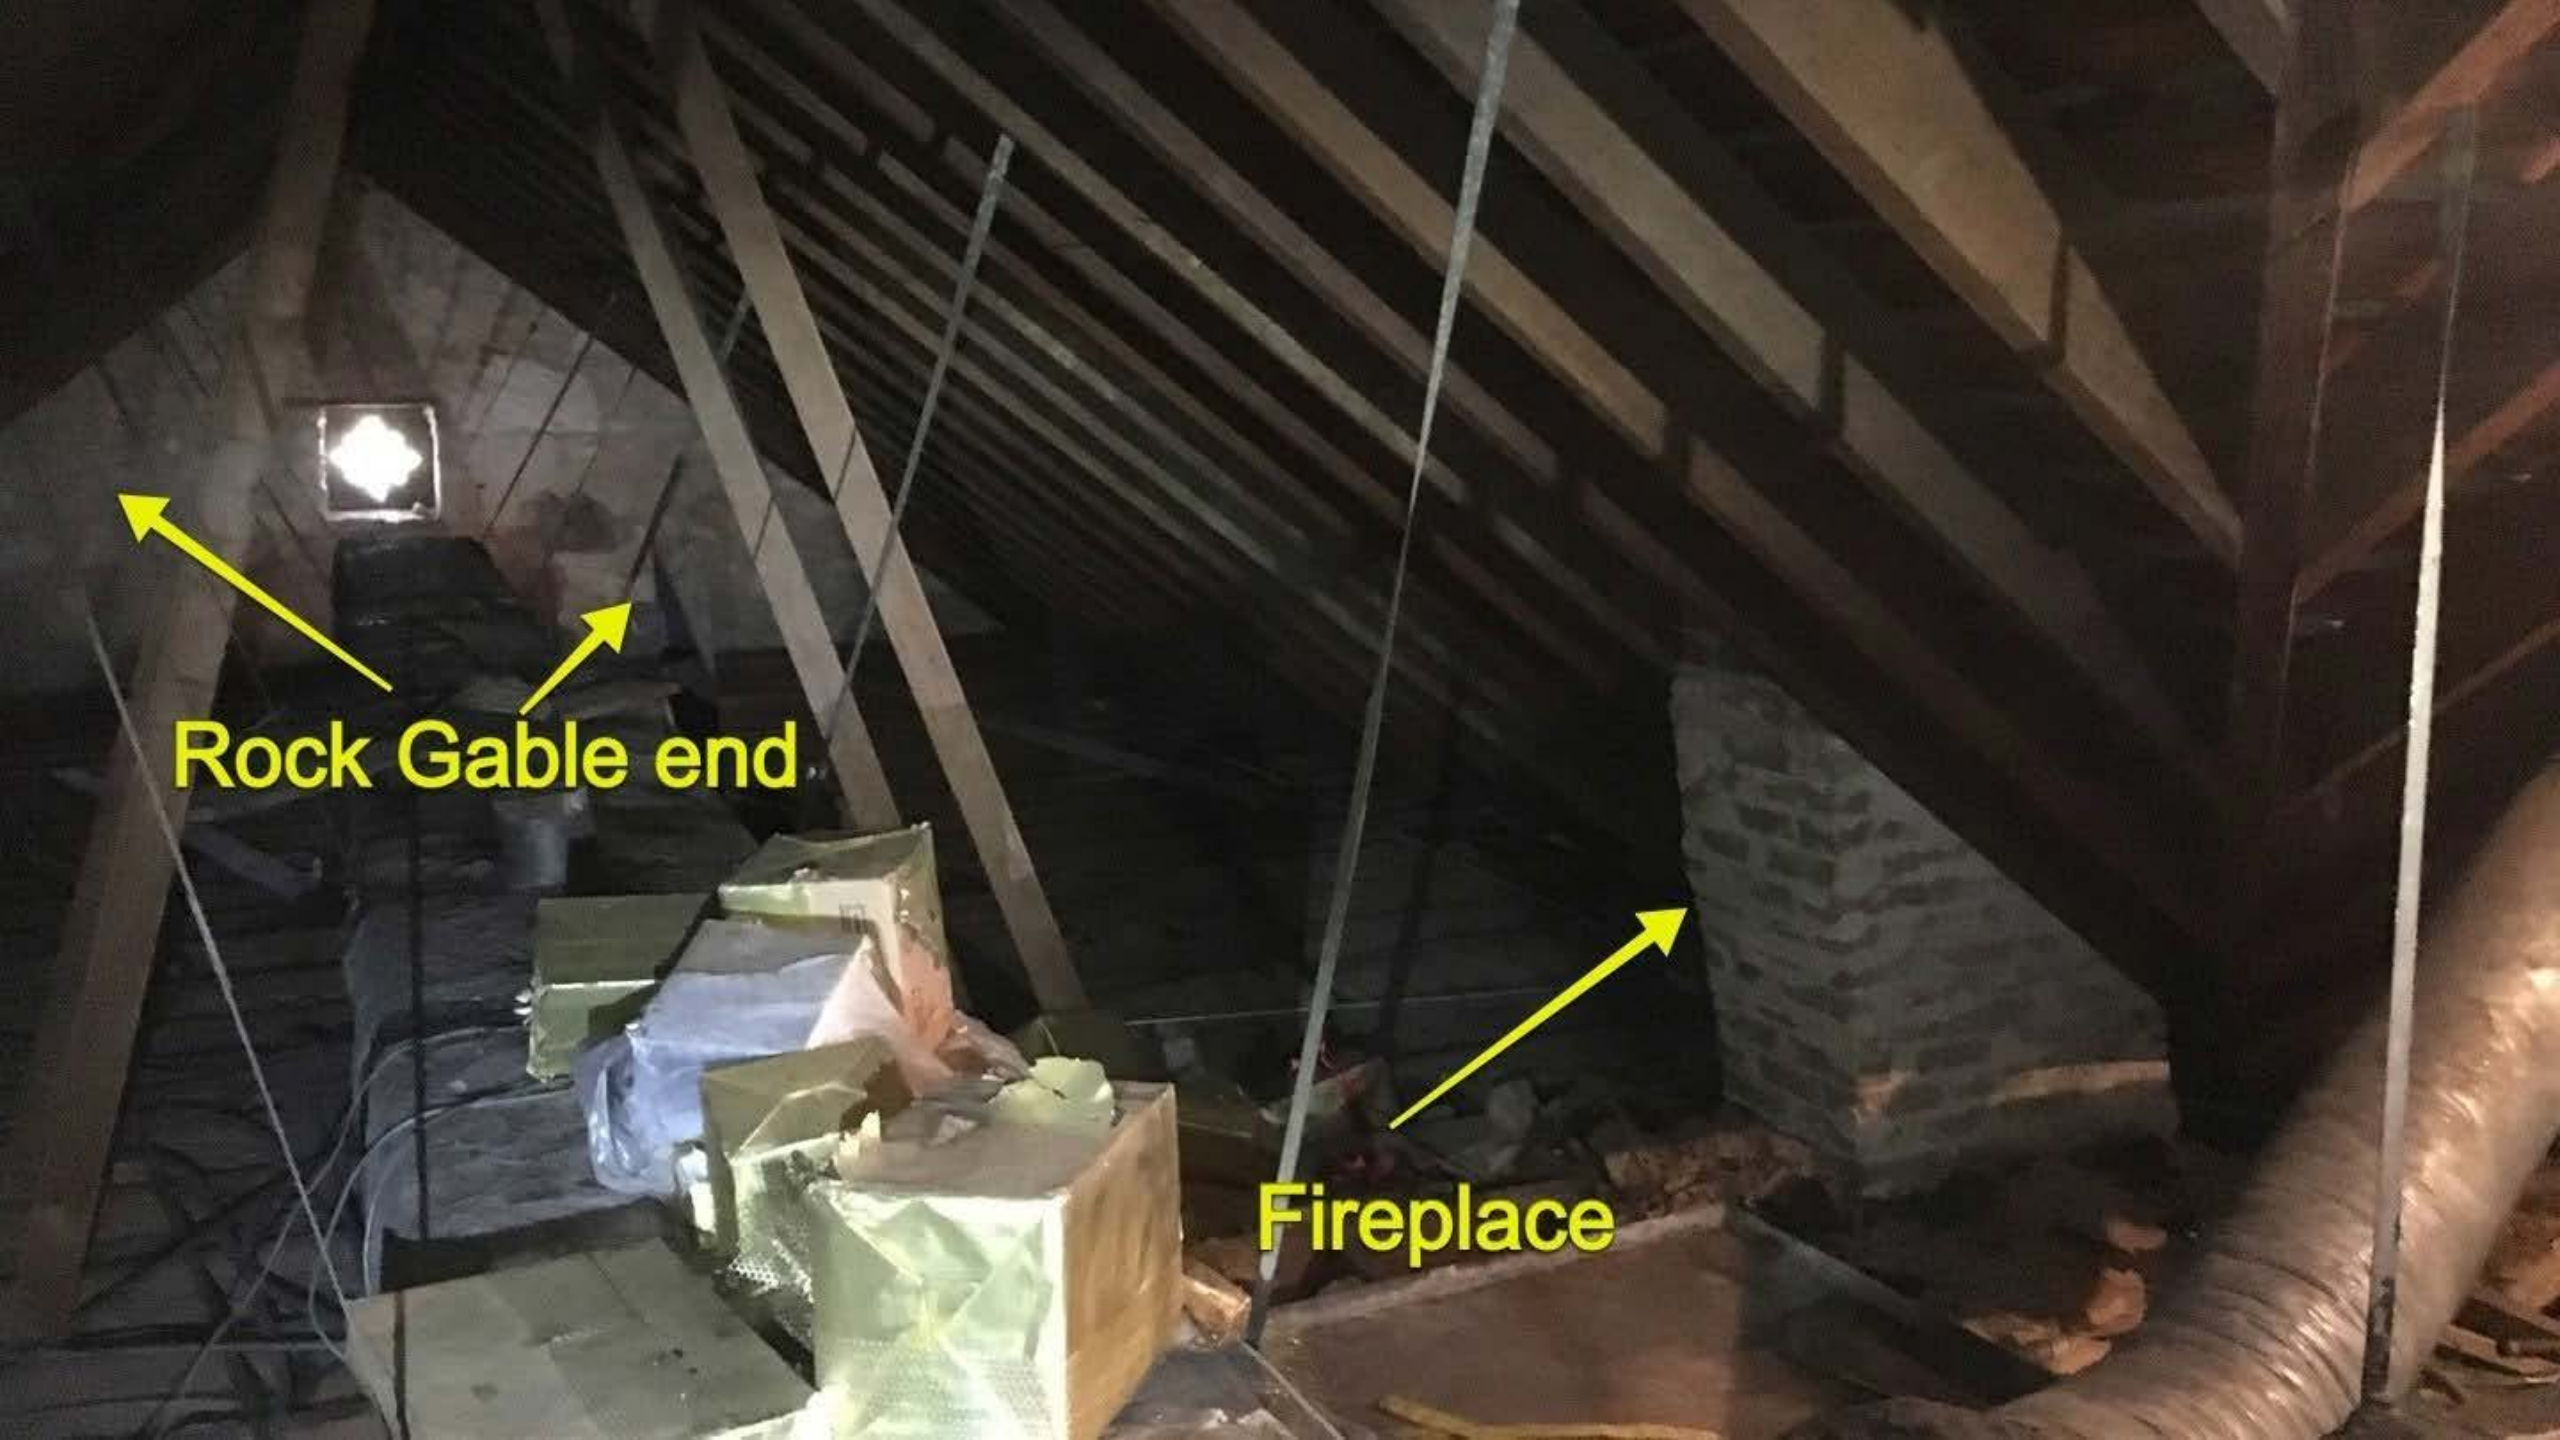
Rock Gable end

Fireplace

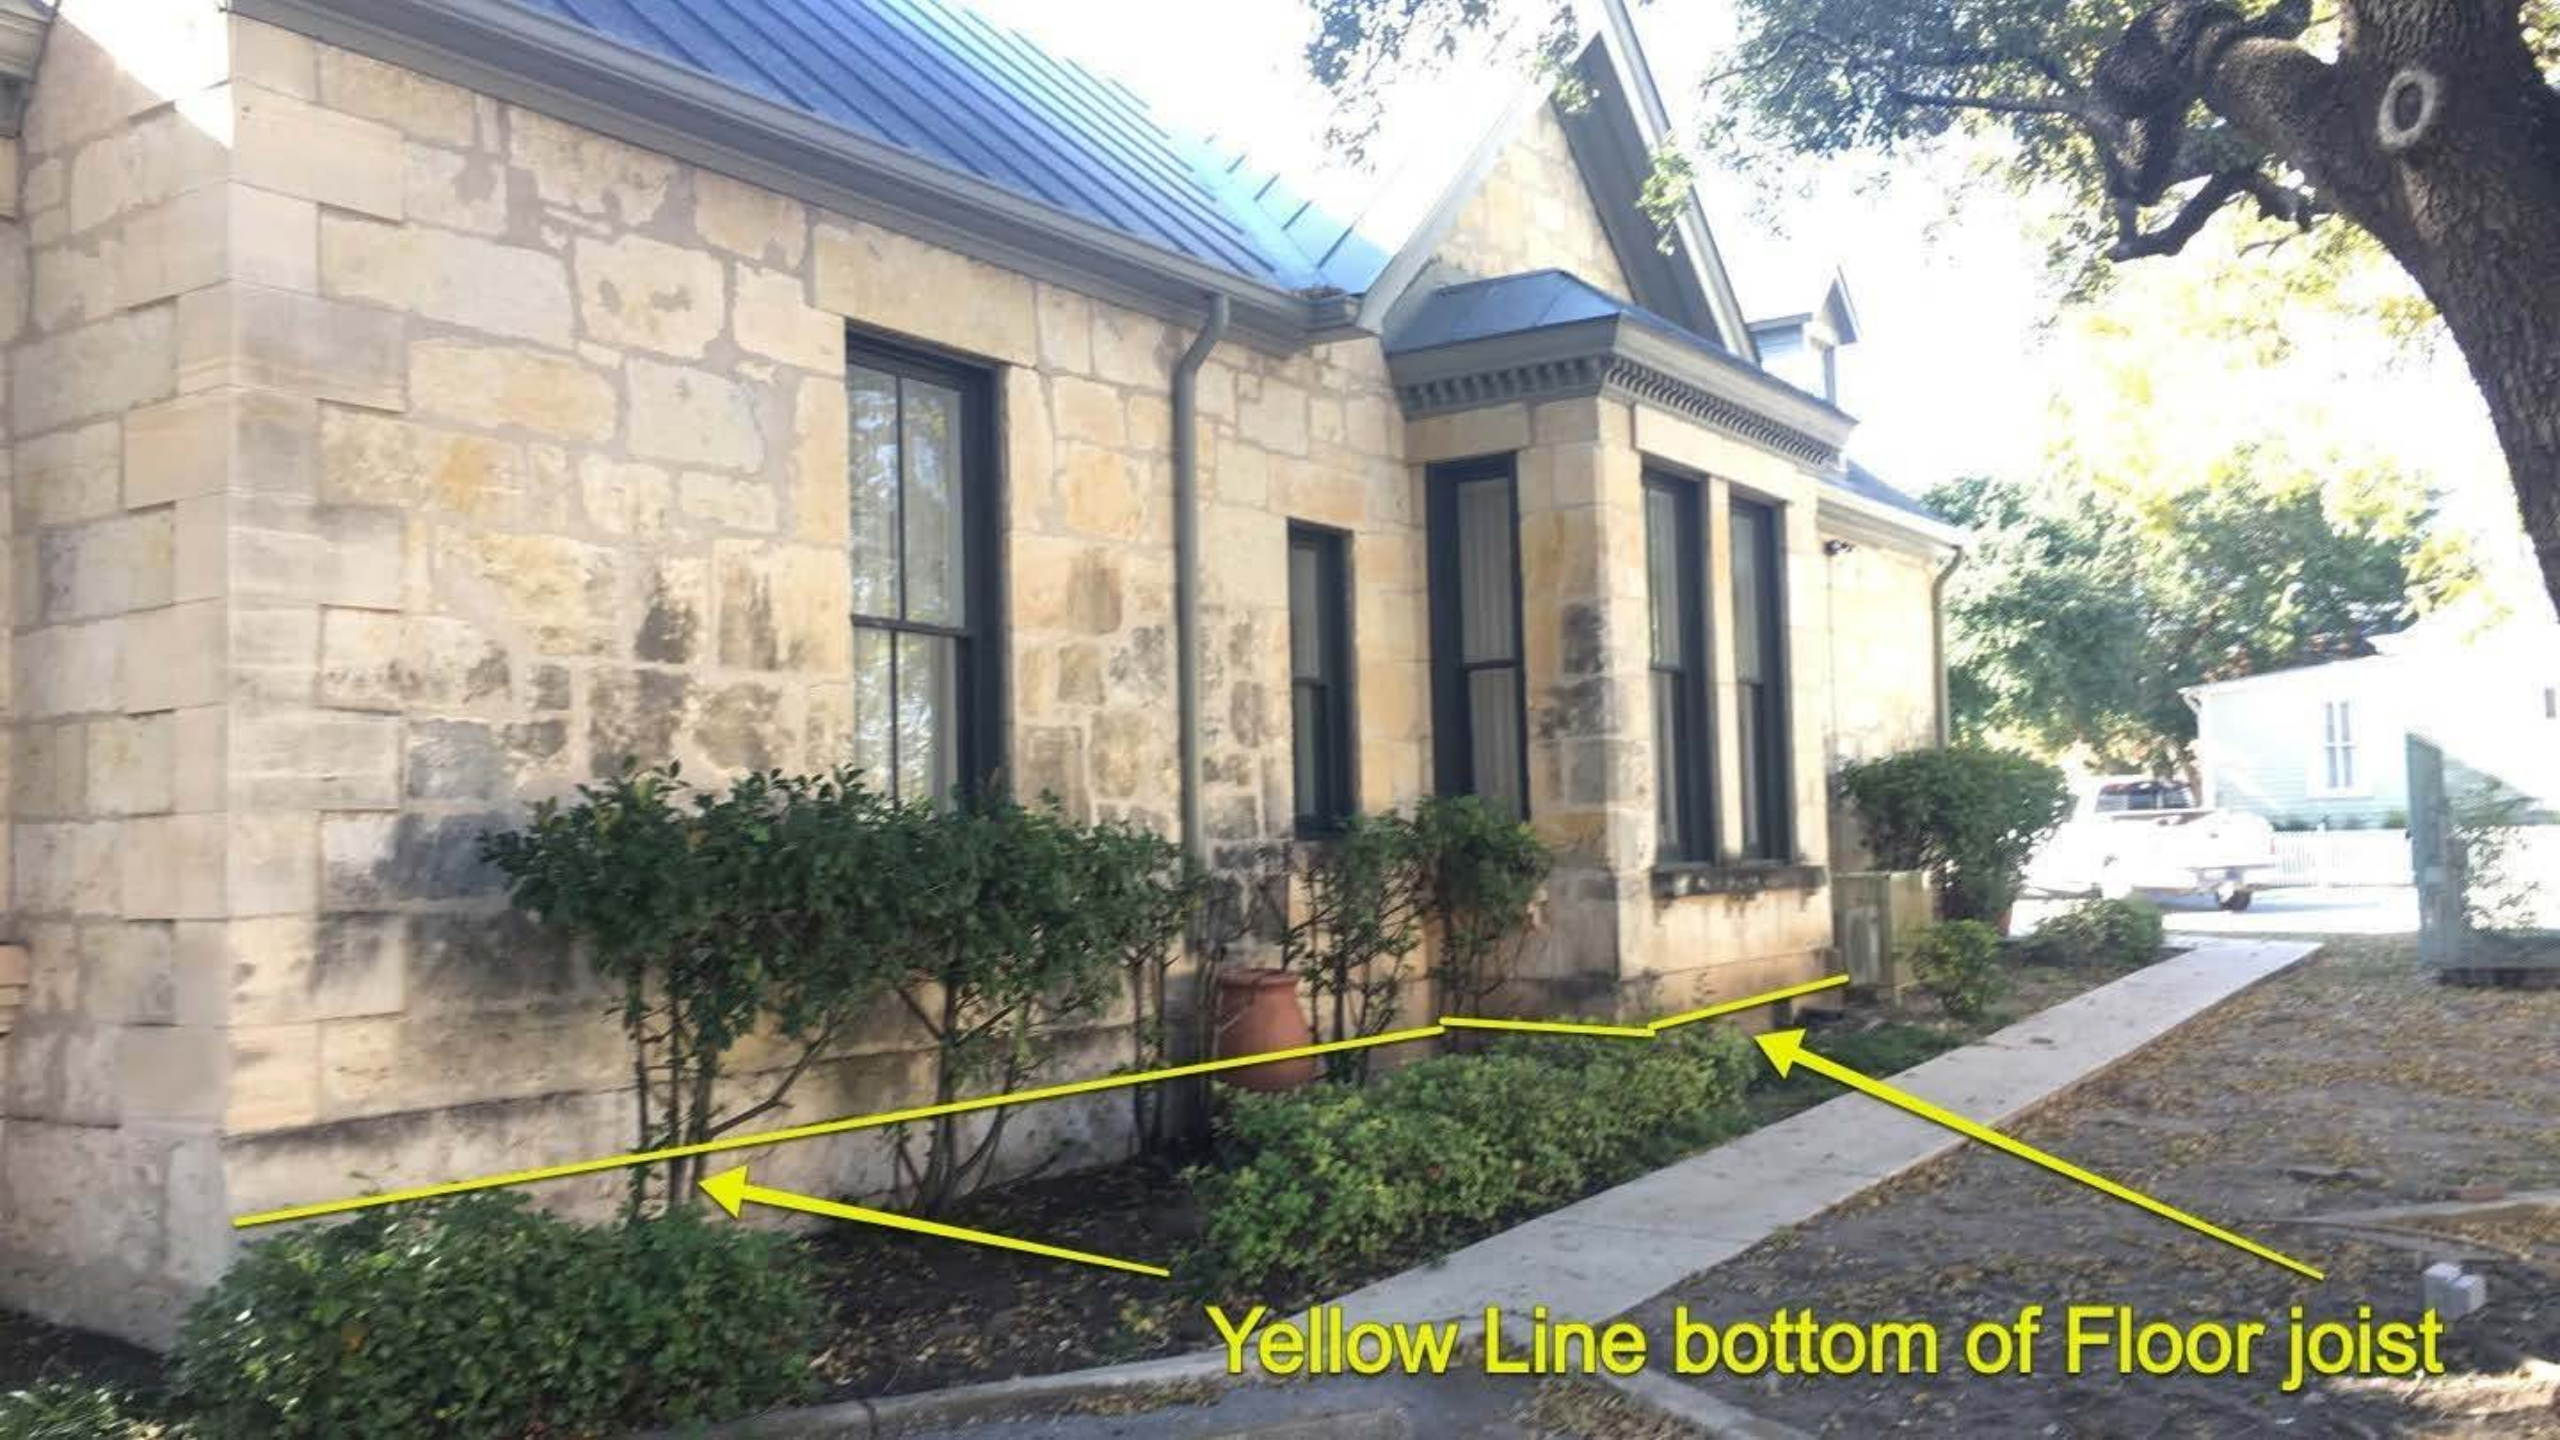
Yellow Line bottom of Floor joist

Cross Loaders
