HISTORIC AND DESIGN REVIEW COMMISSION

June 05, 2019

HDRC CASE NO: 2019-260
ADDRESS: 107 N FLORES ST
LEGAL DESCRIPTION: NCB 122 BLK LOT 1 & 2
ZONING: D, H, RIO-7B
CITY COUNCIL DIST.: 1
DISTRICT: Main/Military Plaza Historic District
APPLICANT: David Hannan/Fisher Heck Architects
OWNER: All Out of Bubblegum LP
TYPE OF WORK: Storefront system replacement, window replacement, rehabilitation
APPLICATION RECEIVED: April 30, 2019
60-DAY REVIEW: June 29, 2019
CASE MANAGER: Edward Hall
REQUEST:

107 N Flores St

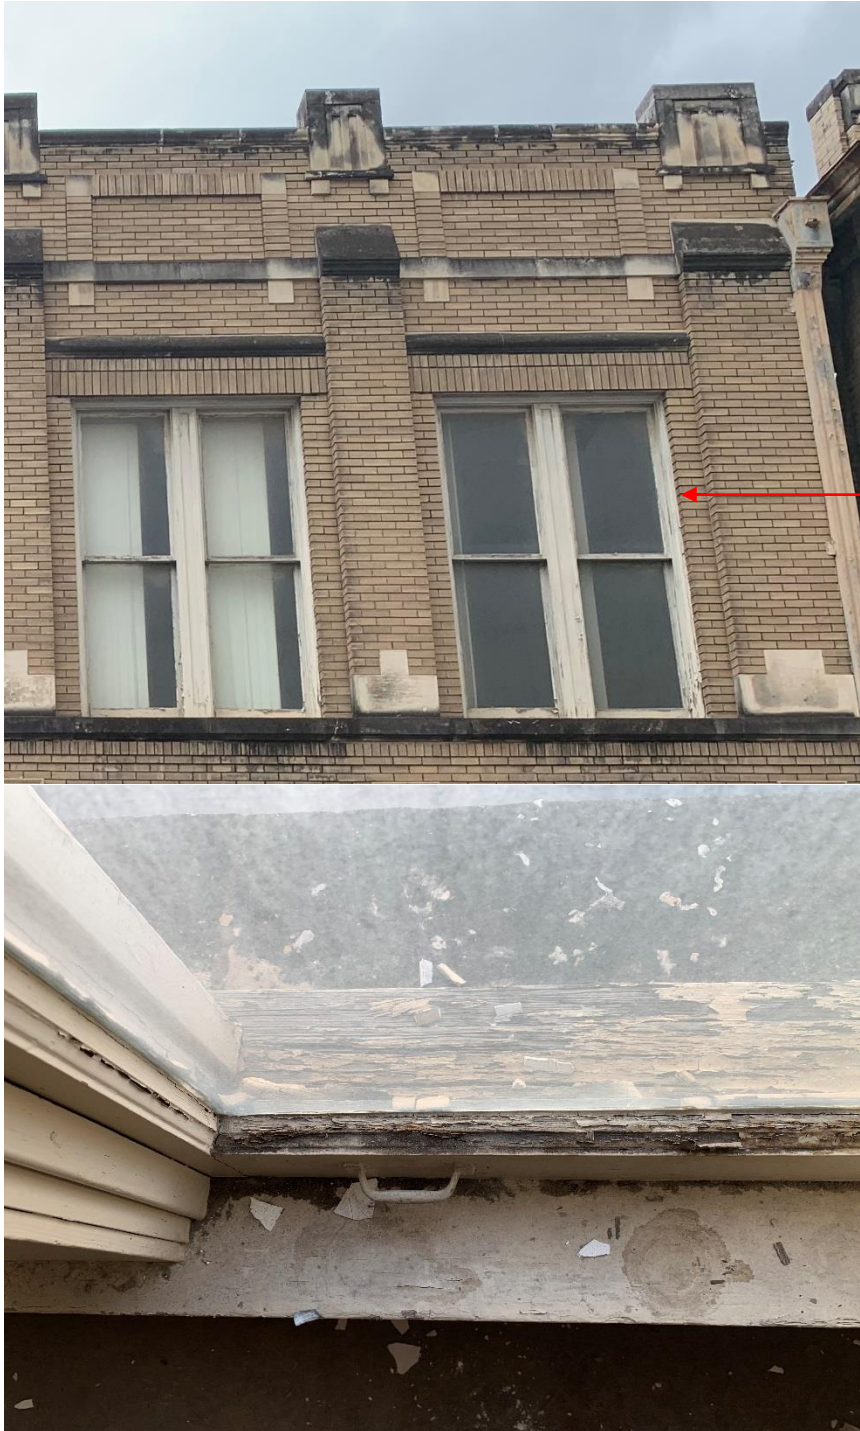
WINDOW 02

Notes: Window sashes, glazing and frame are in fair condition; the lower sashes and exterior sill show signs of decay and rot from moisture exposure; Interior casing and window hardware are in good condition and will be refinished and reinstalled; Glazing putty has completely deteriorated.

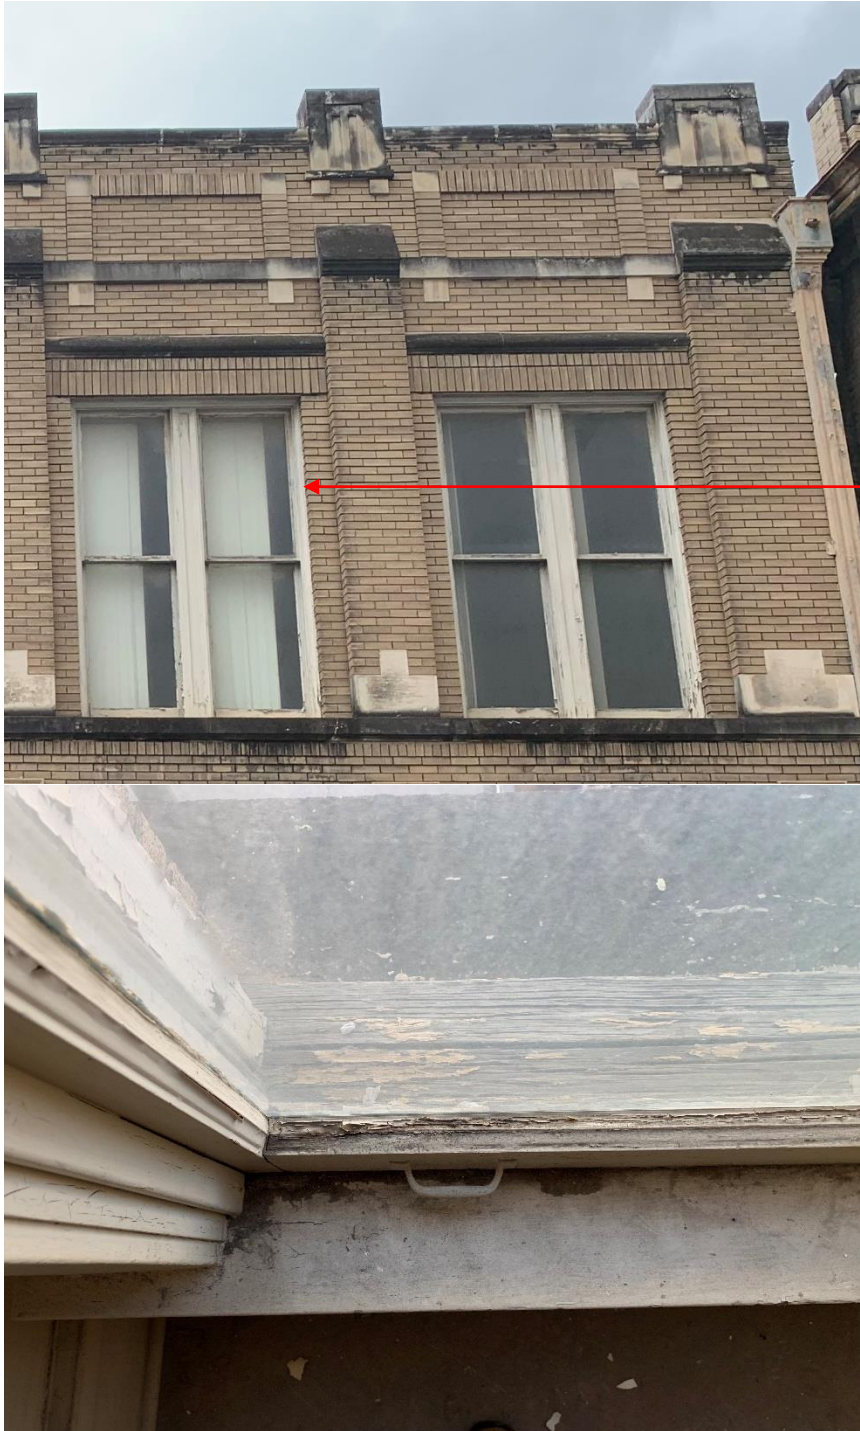
WINDOW 03

Notes: Window sashes, glazing and frame are in fair condition; the lower sashes and exterior sill show signs of decay and rot from moisture exposure; Interior casing and window hardware are in good condition and will be refinished and reinstalled; Glazing putty has completely deteriorated.

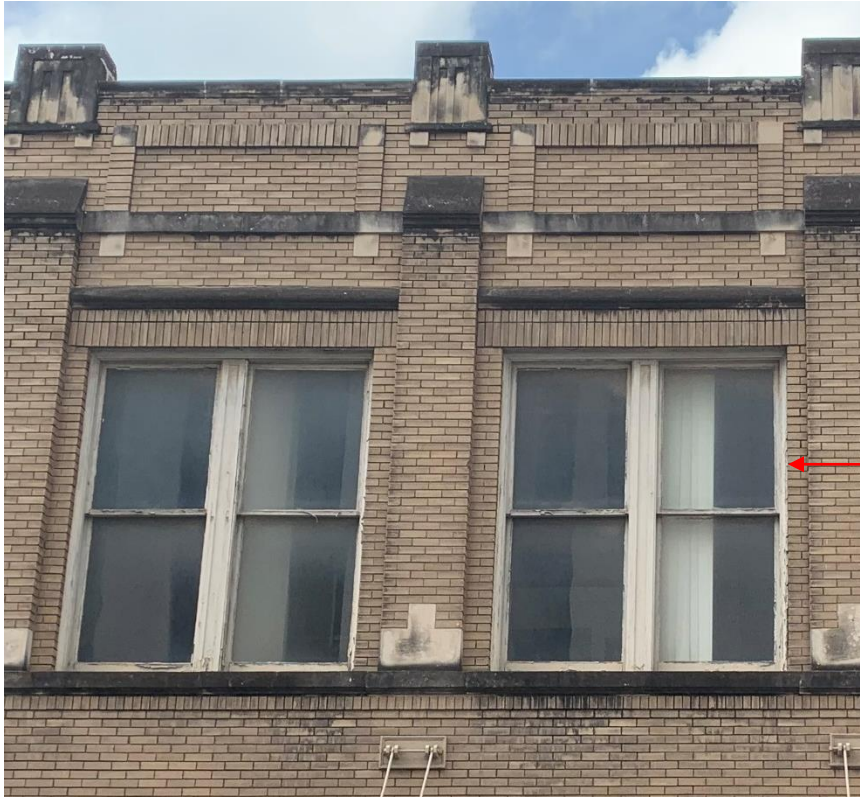
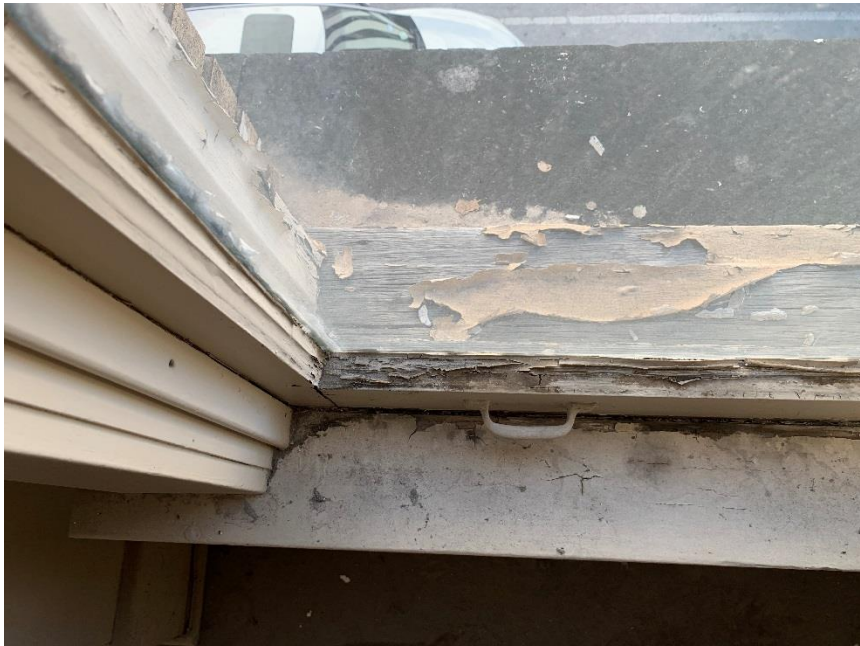
WINDOW 04

Notes: Window sashes, glazing and frame are in fair condition; the lower sashes and exterior sill show signs of decay and rot from moisture exposure; Interior casing and window hardware are in good condition and will be refinished and reinstalled; Glazing putty has completely deteriorated.

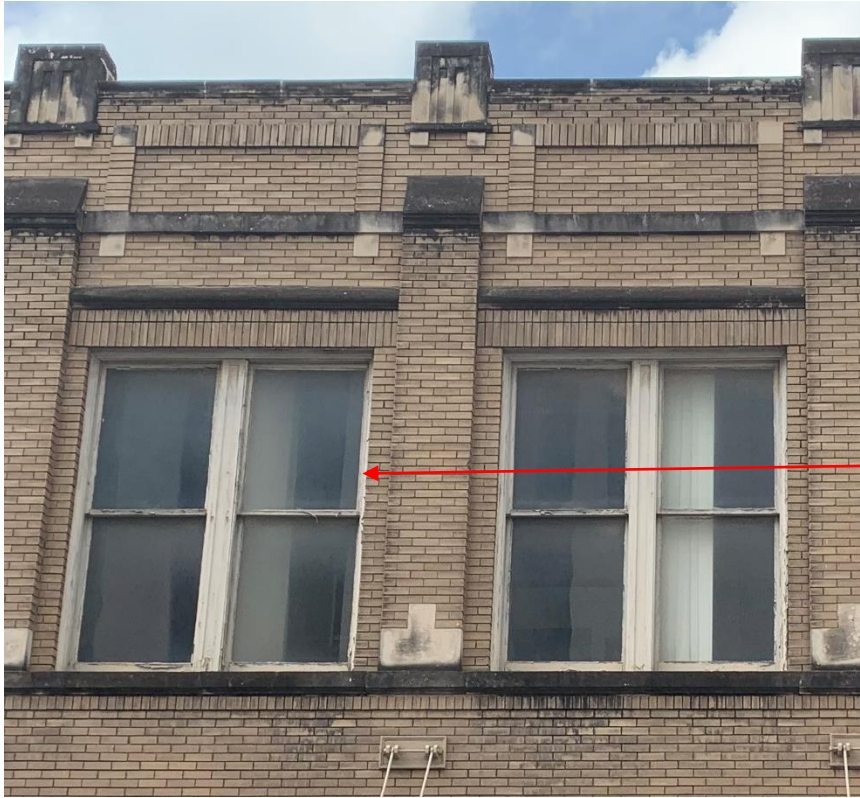
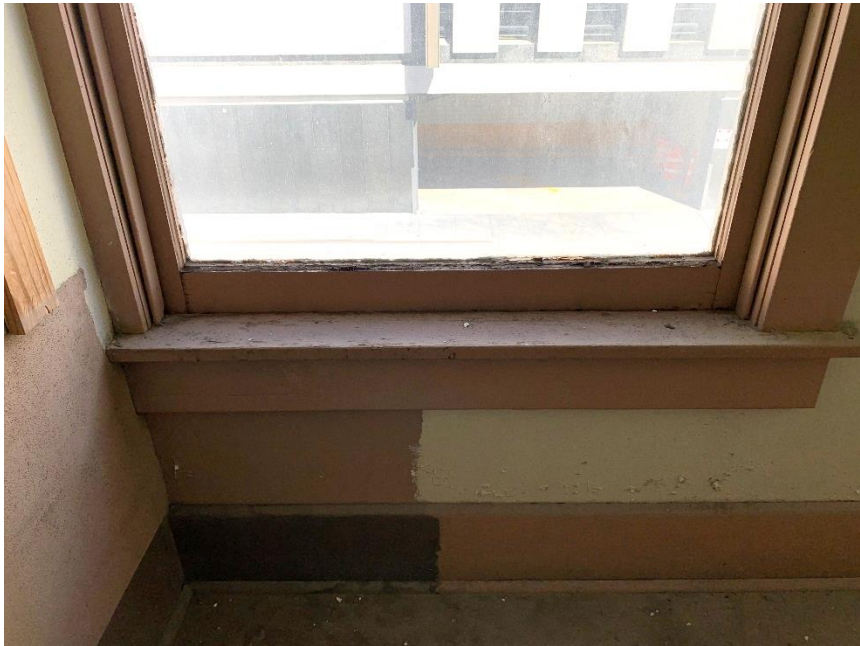
WINDOW 05

Notes: Window sashes, glazing and frame are in poor condition; the window has been heavily modified to accommodate a louver grille below, which is no longer required; the lower sashes and exterior sill show signs of decay and rot from moisture exposure; Interior & exterior casings would have to be replaced; Glazing putty has completely deteriorated.

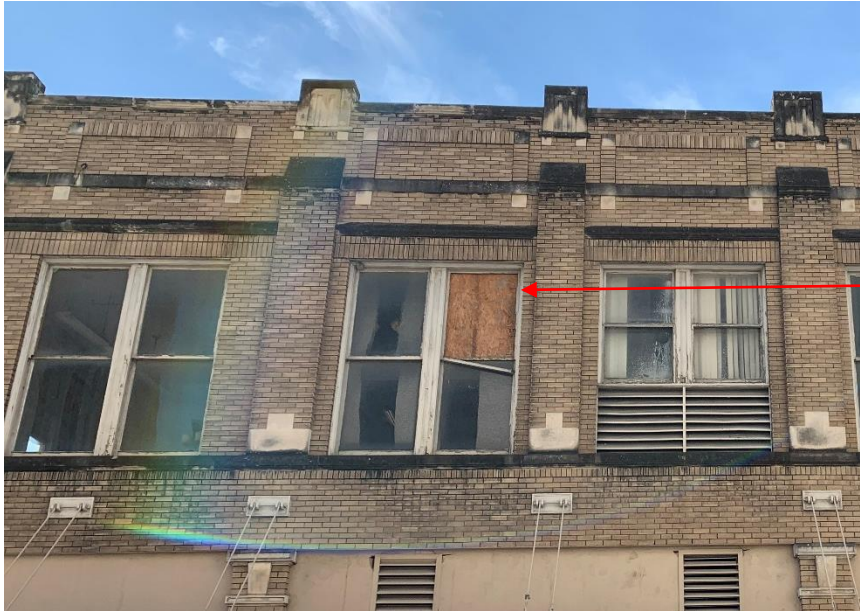
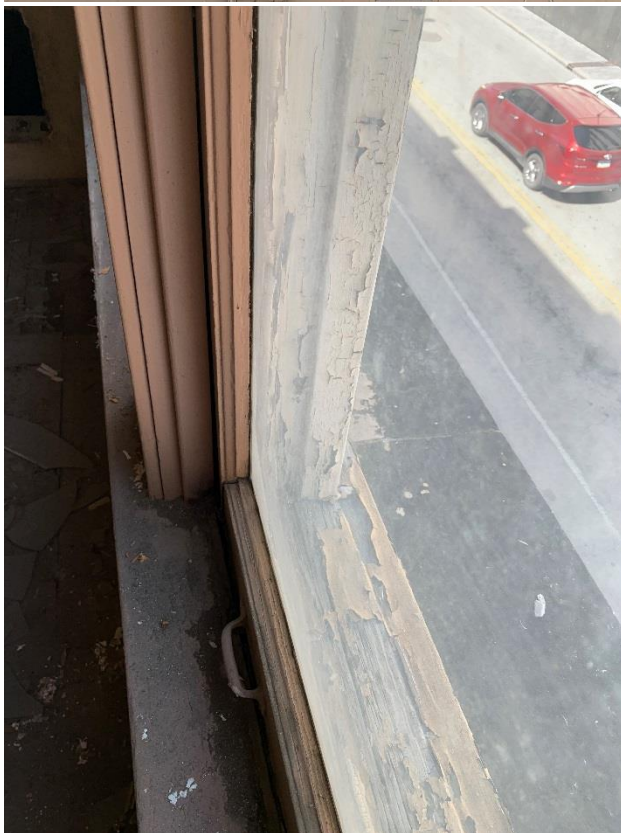
WINDOW 07

Notes: Window sashes, glazing and frame are in fair condition; the lower sashes and exterior sill show signs of decay and rot from moisture exposure; Interior casing and hardware are in acceptable condition and will be refinished and reinstalled; Glazing putty has completely deteriorated.

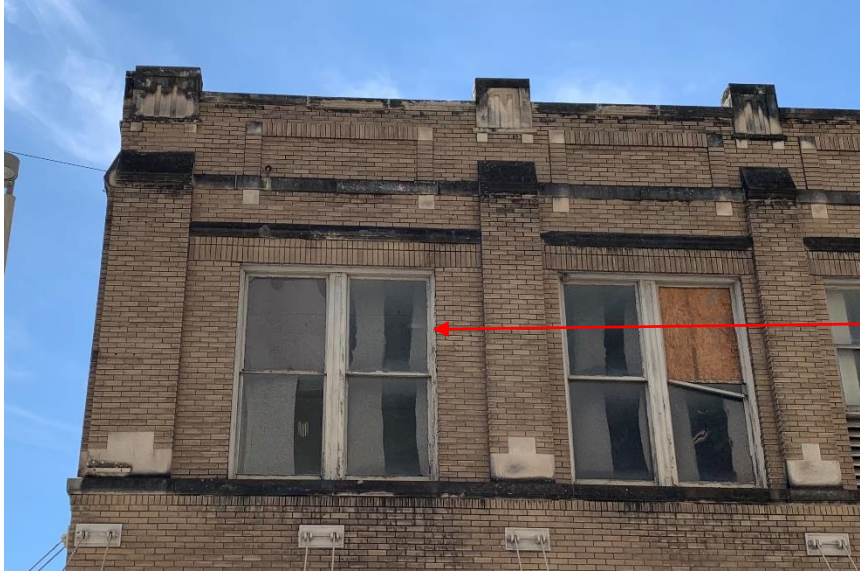
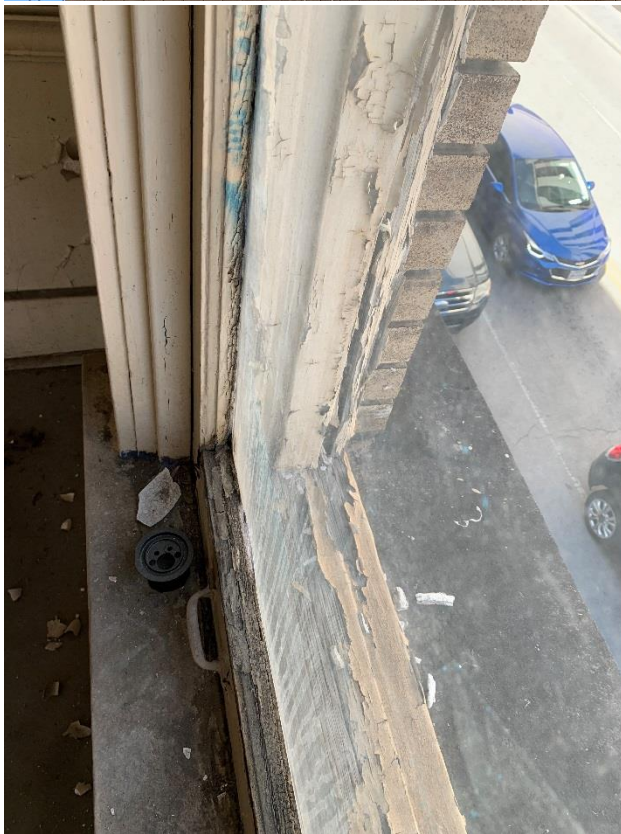
WINDOW 08

Notes: Window sashes, glazing and frame are in very poor condition; the lower sashes and exterior sill show signs of decay and rot from moisture exposure. Interior casing and hardware are in acceptable condition and will be refinished and reinstalled; Two of the four glass panels are broken and have been replaced with plywood; Glazing putty has completely deteriorated.

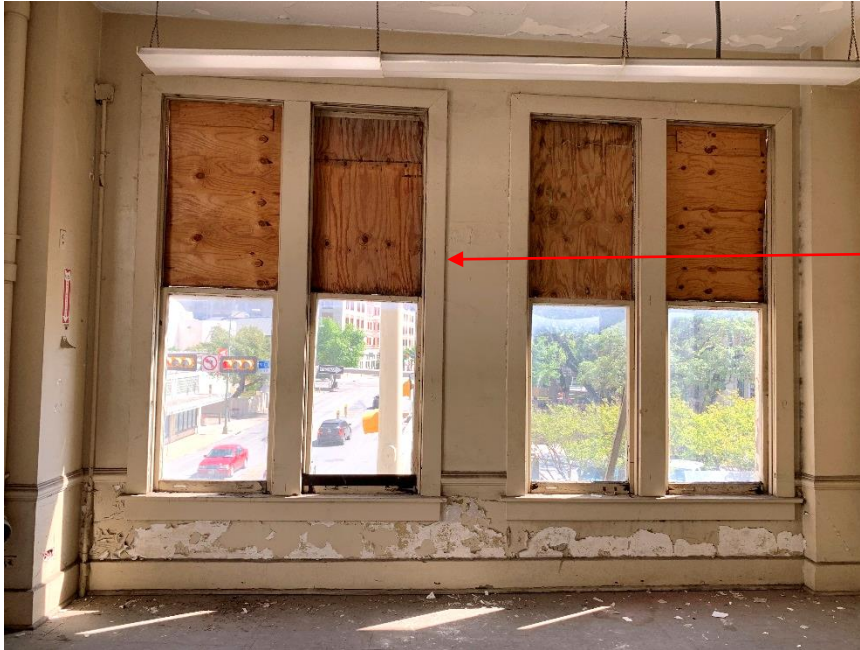
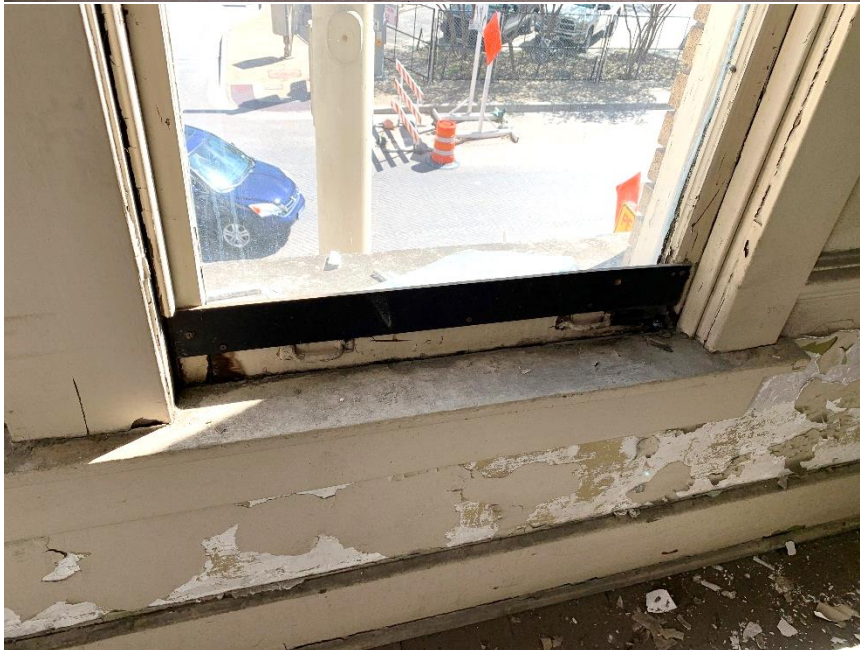
WINDOW 09

Notes: Window sashes, glazing and frame are in very poor condition; the lower sashes and exterior sill show signs of decay and rot from moisture exposure. Interior casing and hardware are in acceptable condition and will be refinished and reinstalled; Two of the four glass panels are broken and have been replaced with plywood; Glazing putty has completely deteriorated.

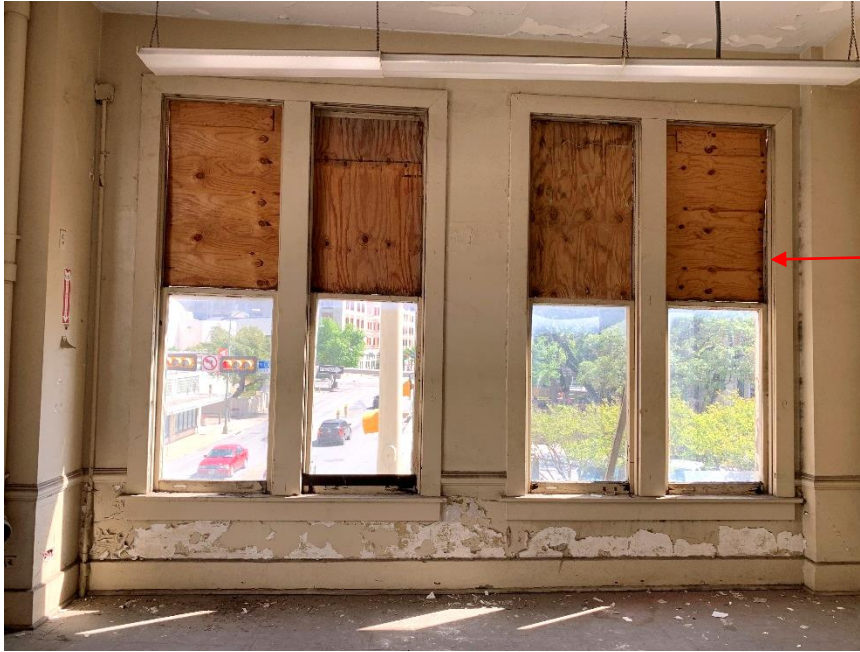
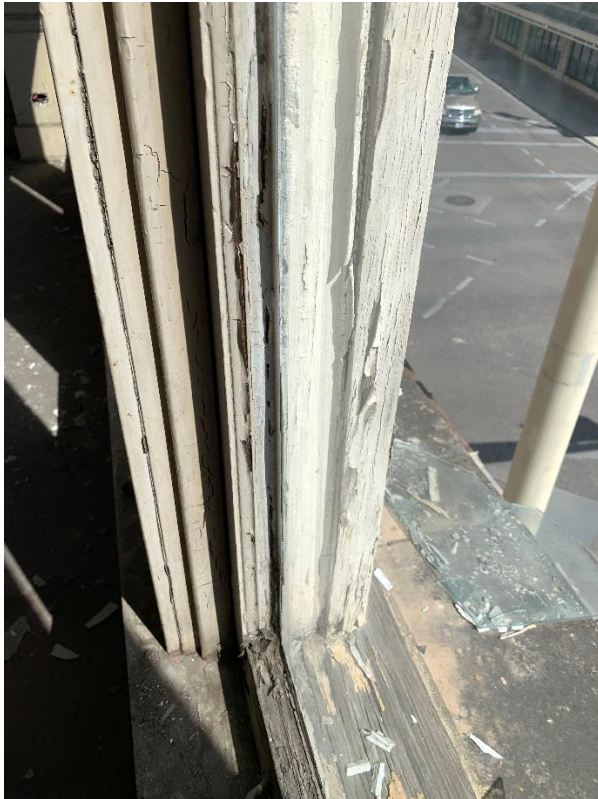
WINDOW 10

Notes: Window sashes, glazing and frame are in poor condition; the lower sashes and exterior sill show signs of decay and rot from moisture exposure; Interior casing and hardware are in good condition and will be refinished and reinstalled; The meeting rails do not match each other; Glazing putty has completely deteriorated.

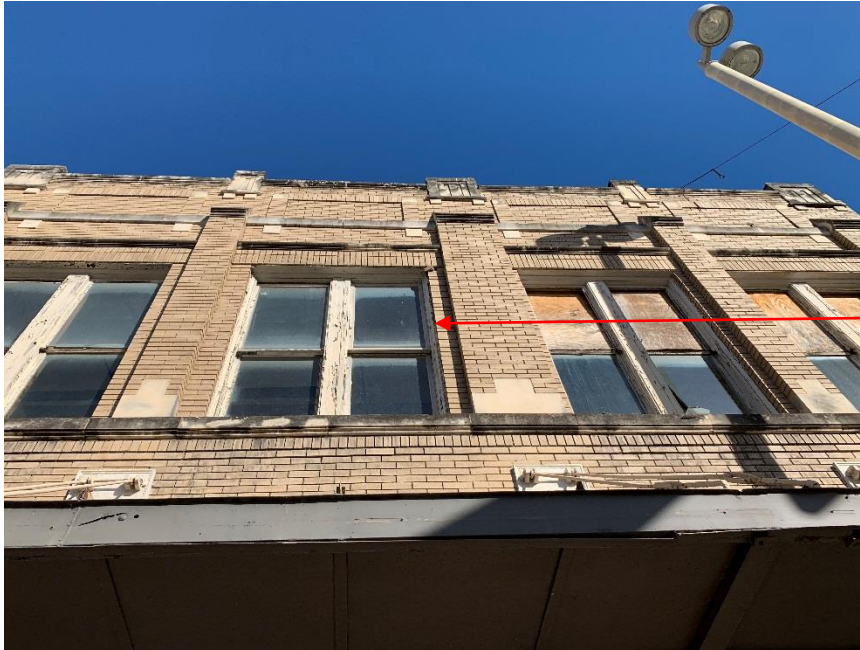
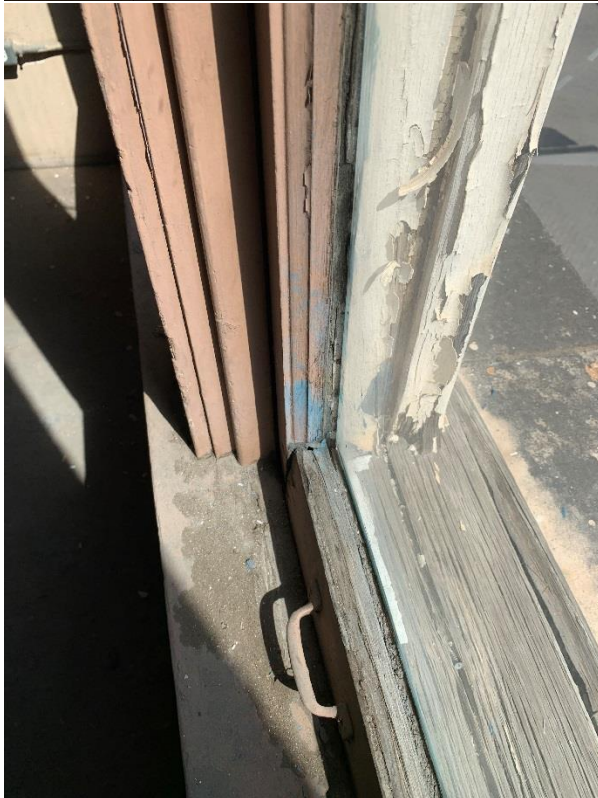
WINDOW 11

Notes: Window sashes, glazing and frame are in poor condition; the lower sashes and exterior sill show signs of decay and rot from moisture exposure; Interior casing and hardware are in good condition and will be refinished and reinstalled; The meeting rails do not match each other; Glazing putty has completely deteriorated.

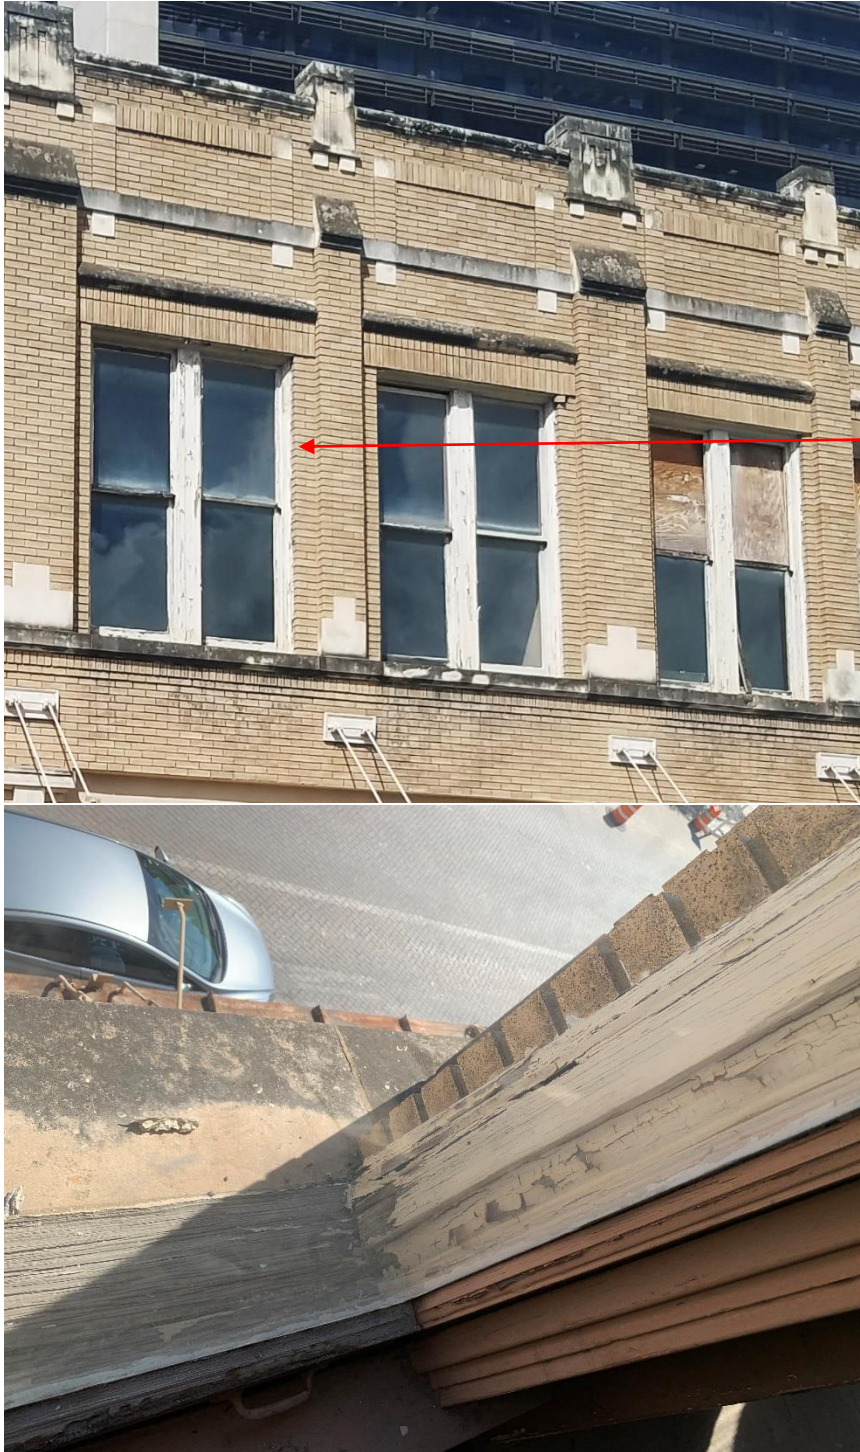
WINDOW 12

Notes: Window sashes, glazing and frame are in poor condition; the lower sashes and exterior sill show signs of decay and rot from moisture exposure. One of the glass panels has been broken and replaced with plywood; Interior casing and hardware are in good condition and will be refinished and reinstalled; The meeting rails do not match each other; Glazing putty has completely deteriorated.

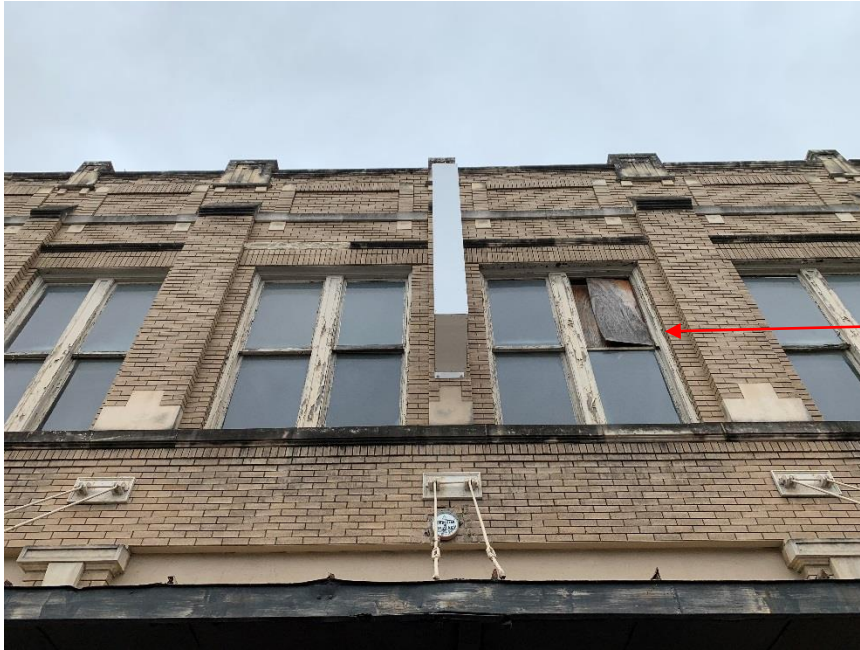
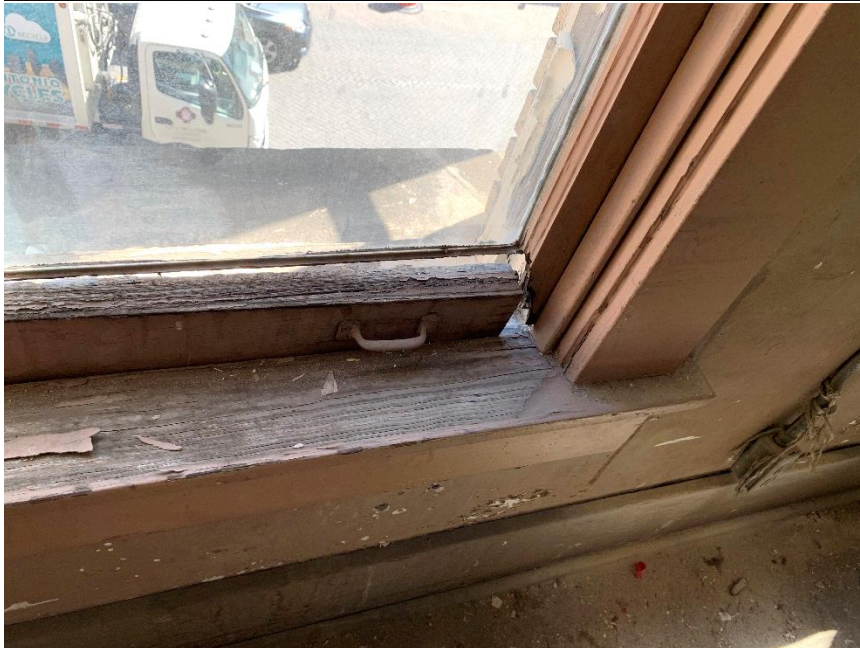
WINDOW 13

Notes: Window sashes, glazing and frame are in poor condition; the lower sashes and exterior sill show signs of decay and rot from moisture exposure; Interior casing and hardware are in good condition and will be refinished and reinstalled; The meeting rails do not match each other; Glazing putty has completely deteriorated.

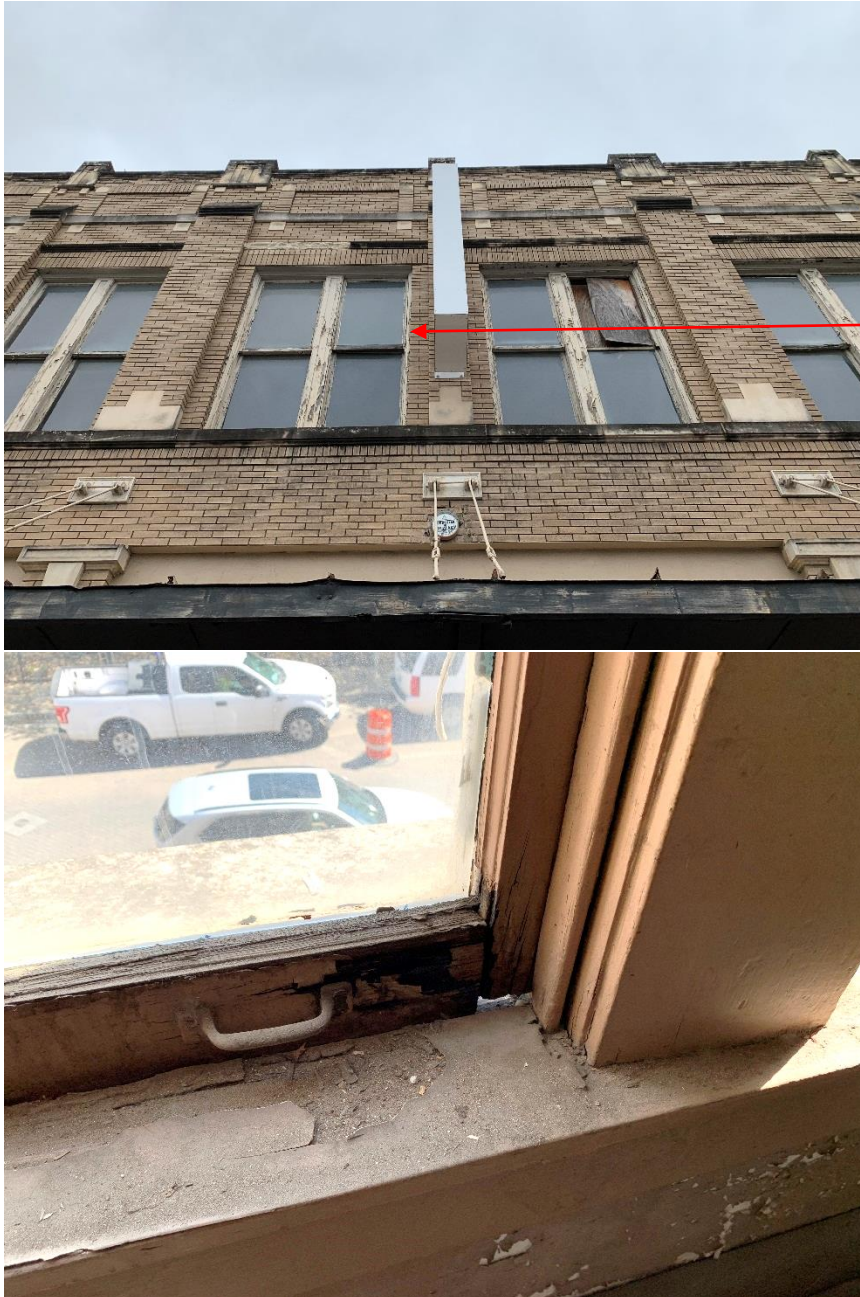
WINDOW 14

Notes: Window sashes, glazing and frame are in poor condition; the lower sashes and exterior sill show signs of decay and rot from moisture exposure; The glass has begun to separate from the sash; Interior casing and hardware are in good condition and will be refinished and reinstalled; Glazing putty has completely deteriorated.

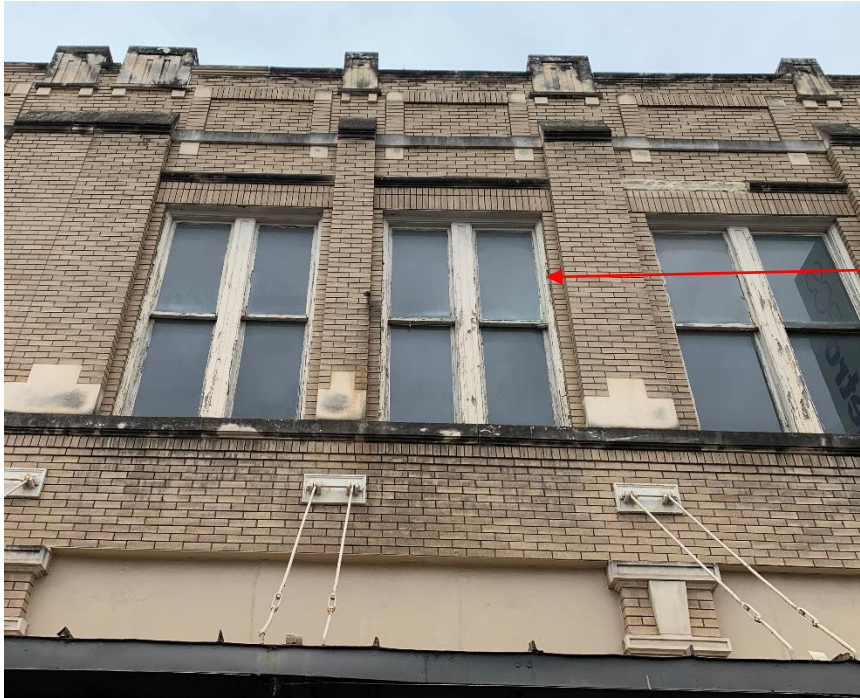
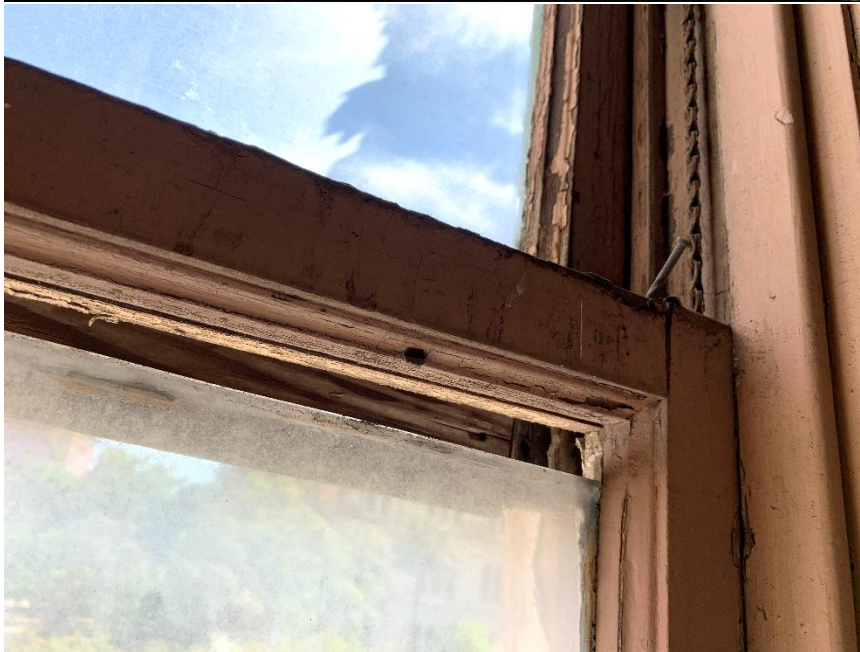
WINDOW 15

Notes: Window sashes, glazing and frame are in poor condition; the lower sashes and exterior sill show signs of decay and rot from moisture exposure; Interior casing and hardware are in good condition and will be refinished and reinstalled; Glazing putty has completely deteriorated.

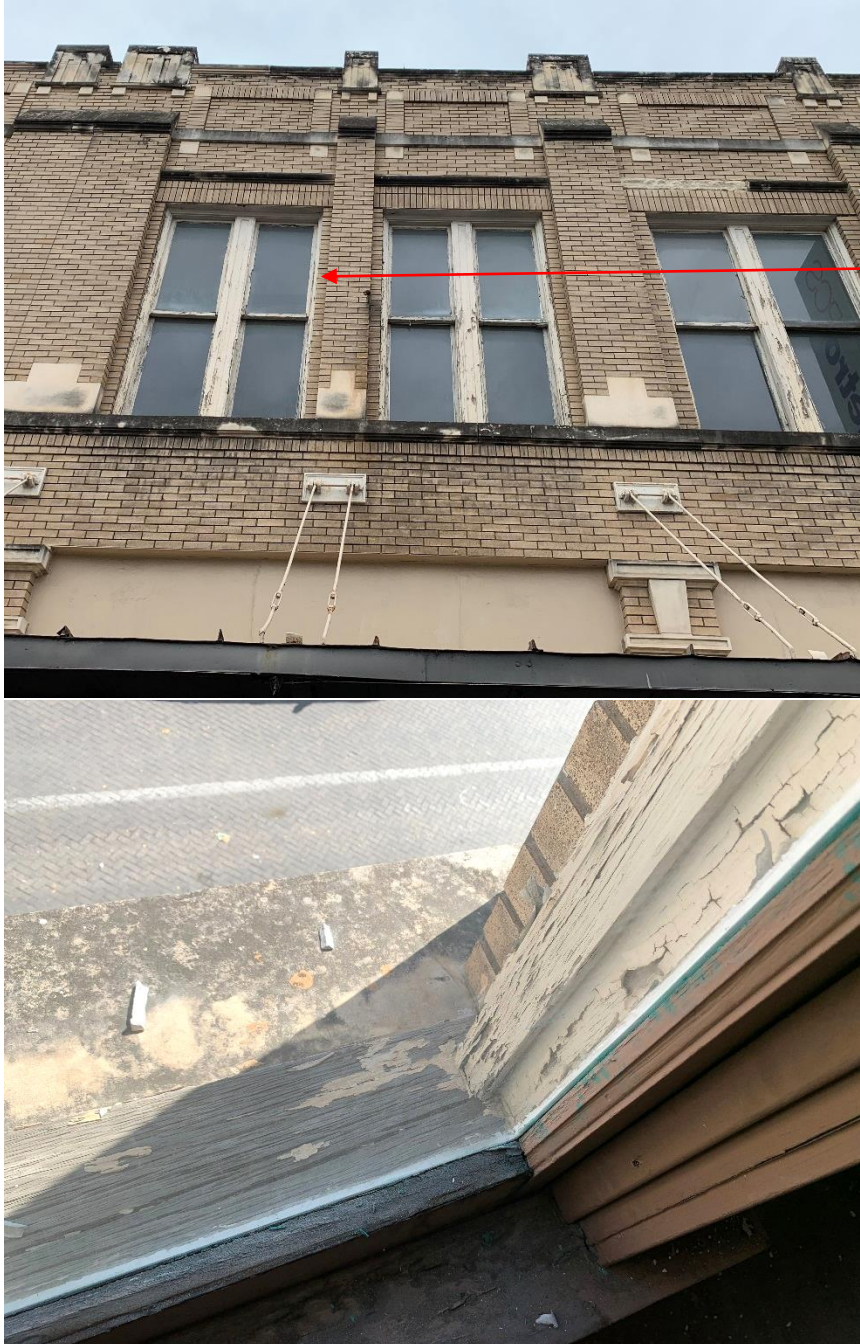
WINDOW 16

Notes: Window sashes, glazing and frame are in poor condition; the lower sashes and exterior sill show signs of decay and rot from moisture exposure; One of the glass panels and sash have been removed and replaced with plywood; Interior casing and hardware are in good condition and will be refinished and reinstalled; Glazing putty has completely deteriorated.

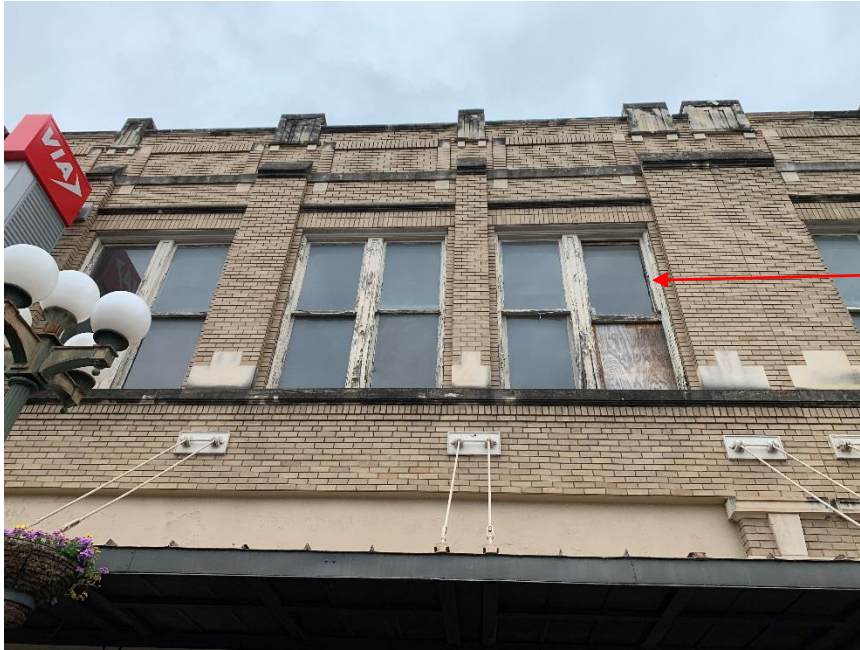
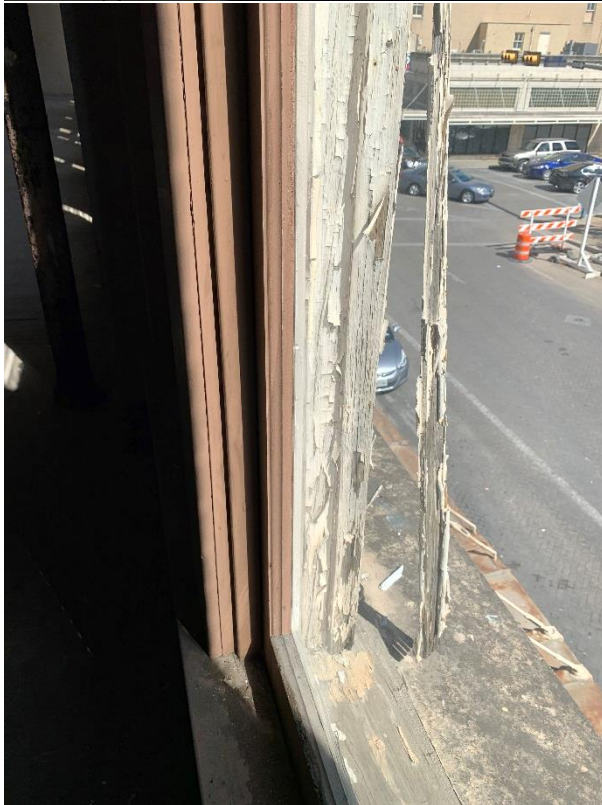
WINDOW 17

Notes: Window sashes, glazing and frame are in poor condition; the lower sashes and exterior sill show signs of decay and rot from moisture exposure; One of the lower sashes has begun to split apart; Interior casing and hardware are in good condition and will be refinished and reinstalled; Glazing putty has completely deteriorated.

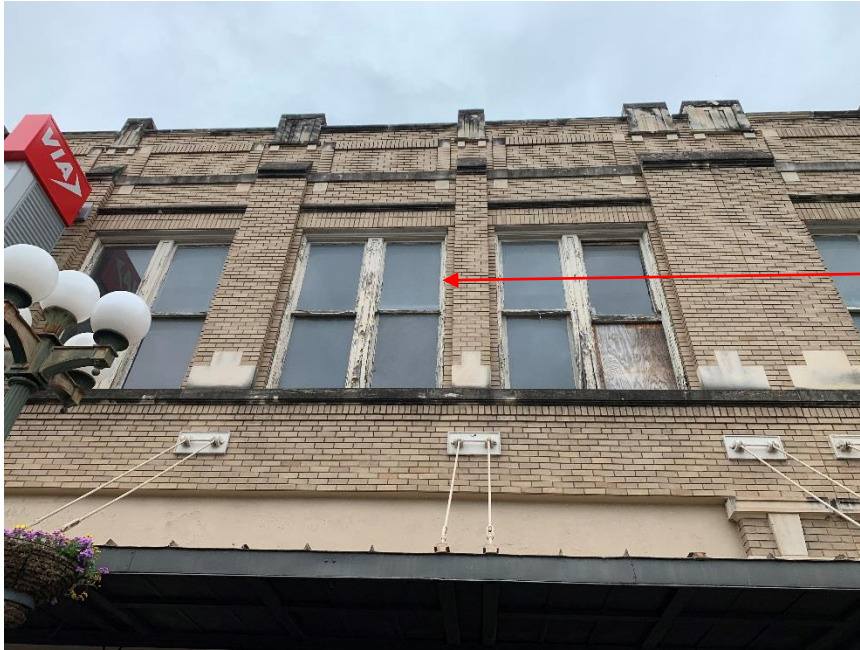
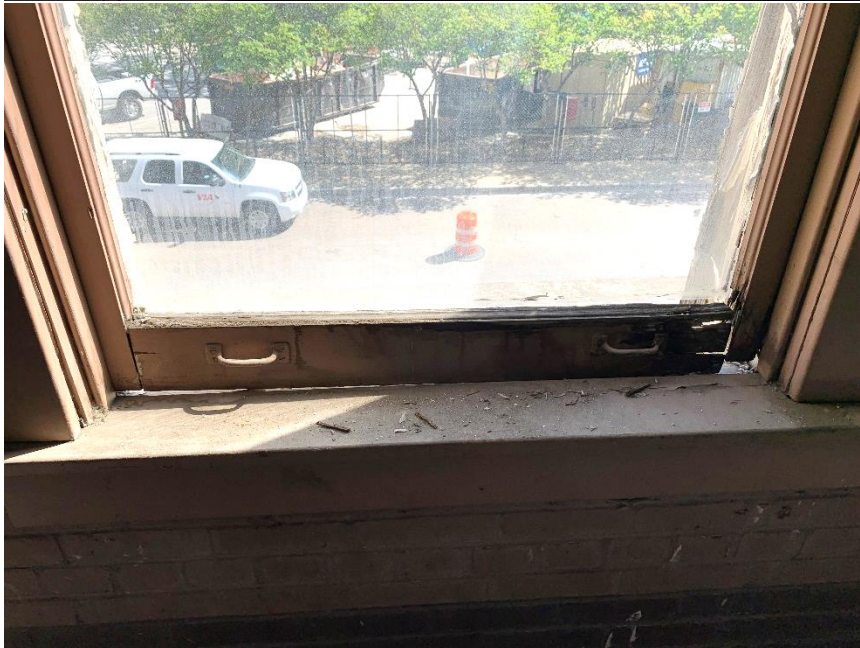
WINDOW 18

Notes: Window sashes, glazing and frame are in poor condition; the lower sashes and exterior sill show signs of decay and rot from moisture exposure; The meeting rails do match each other; One of the lower sashes has begun to split apart; Interior casing and hardware are in good condition and will be refinished and reinstalled; Glazing putty has completely deteriorated.

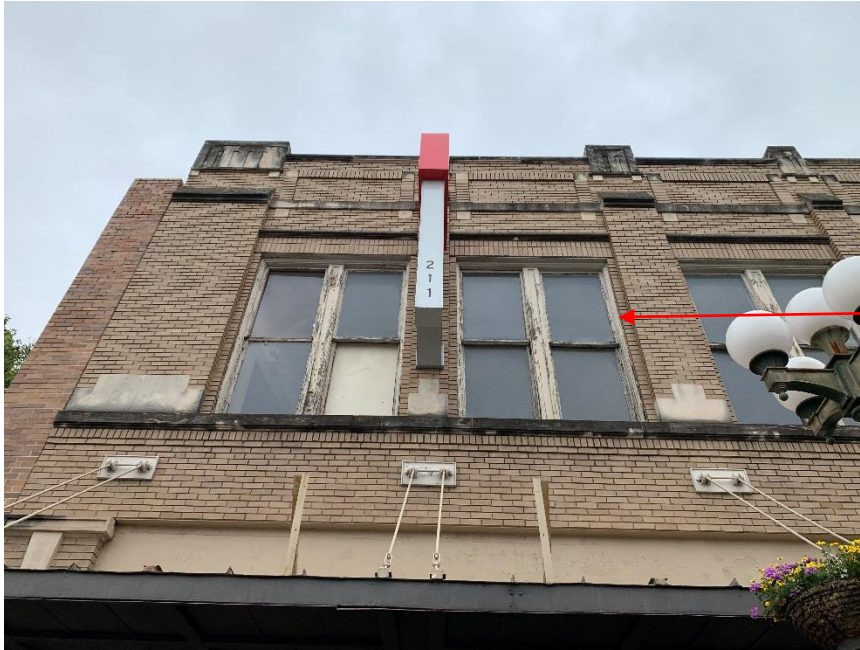
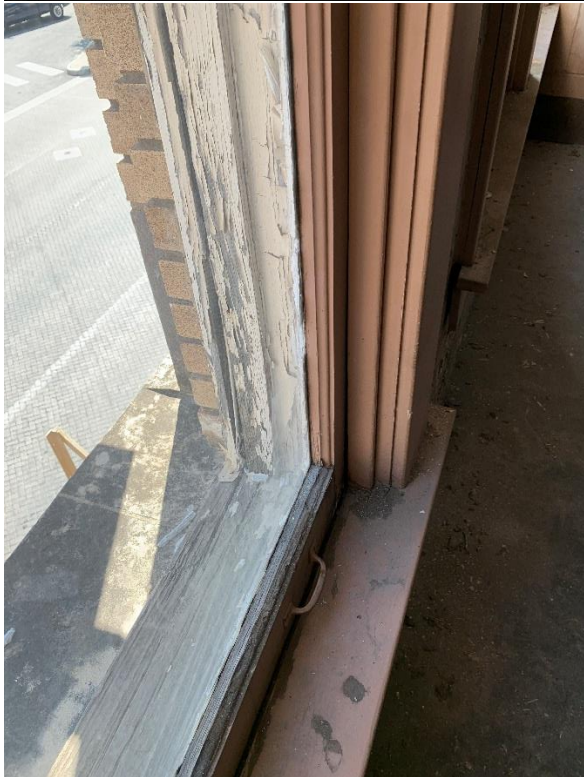
WINDOW 19

Notes: Window sashes, glazing and frame are in poor condition; the lower sashes and exterior sill show signs of decay and rot from moisture exposure; One side of the window is completely missing the sashes and has been replaced with wood stops and plexiglass; On the other side, one window pane has been broken and replaced with masonite; Interior casing and hardware are in good condition and will be refinished and reinstalled; Glazing putty has completely deteriorated.

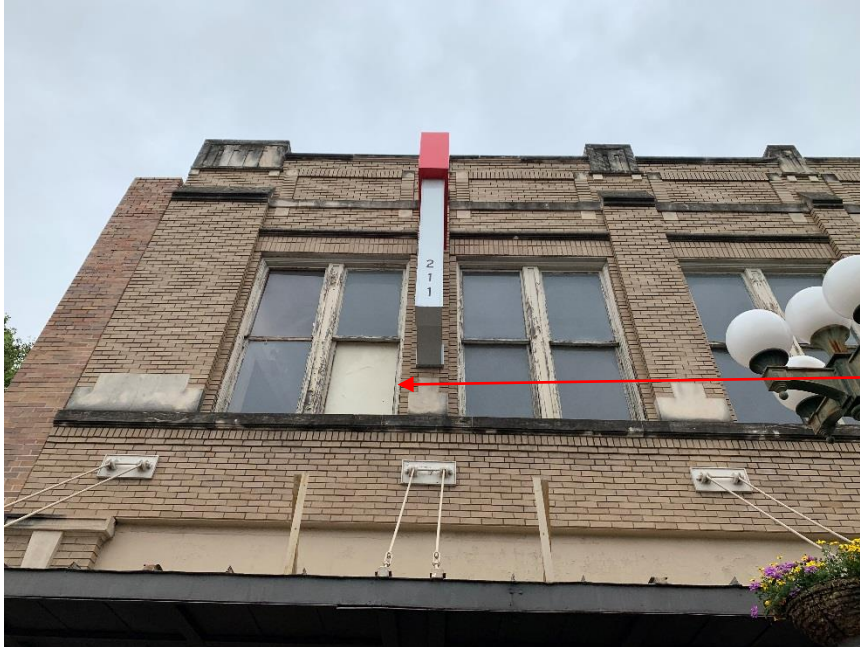
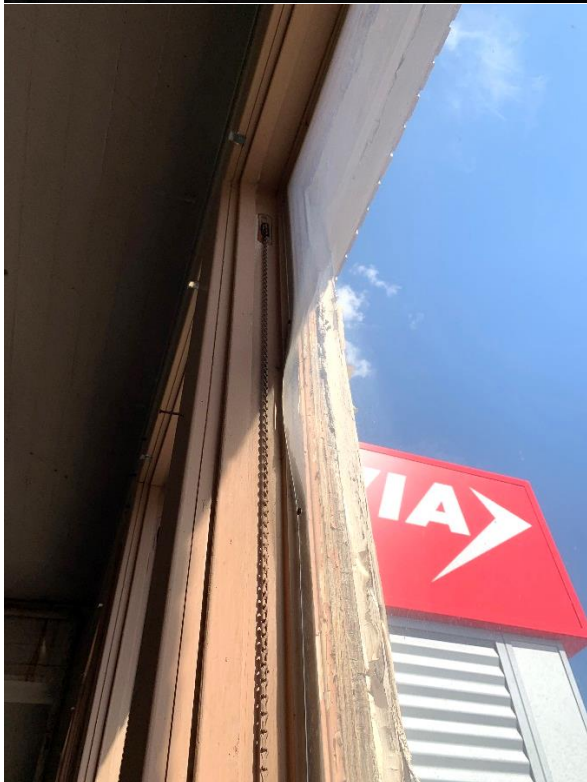
WINDOW 20

Notes: Window sashes, glazing and frame are in fair condition; the lower sashes and exterior sill show signs of minor decay; Interior casing and hardware are in good condition and will be refinished and reinstalled; Glazing putty has completely deteriorated.

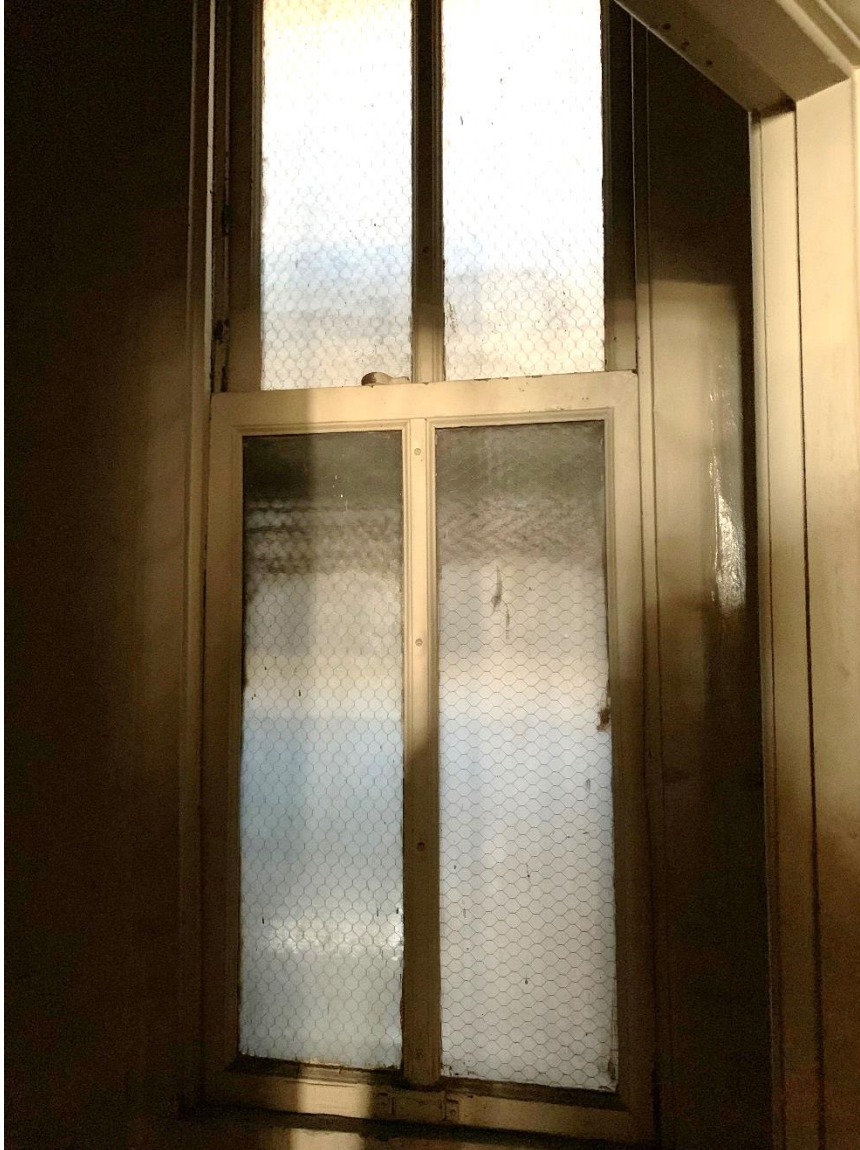
WINDOW 21

Notes: Window sashes, glazing and frame are in fair condition; the lower sashes and exterior sill show signs of minor decay; Interior casing and hardware are in good condition and will be refinished and reinstalled; Glazing putty has completely deteriorated.
