HISTORIC AND DESIGN REVIEW COMMISSION

June 05, 2019

HDRC CASE NO: 2019-260
ADDRESS: 107 N FLORES ST
LEGAL DESCRIPTION: NCB 122 BLK LOT 1 & 2
ZONING: D, H, RIO-7B
CITY COUNCIL DIST.: 1
DISTRICT: Main/Military Plaza Historic District
APPLICANT: David Hannan/Fisher Heck Architects
OWNER: All Out of Bubblegum LP
TYPE OF WORK: Storefront system replacement, window replacement, rehabilitation
APPLICATION RECEIVED: April 30, 2019
60-DAY REVIEW: June 29, 2019
CASE MANAGER: Edward Hall
REQUEST:

107 N Flores St

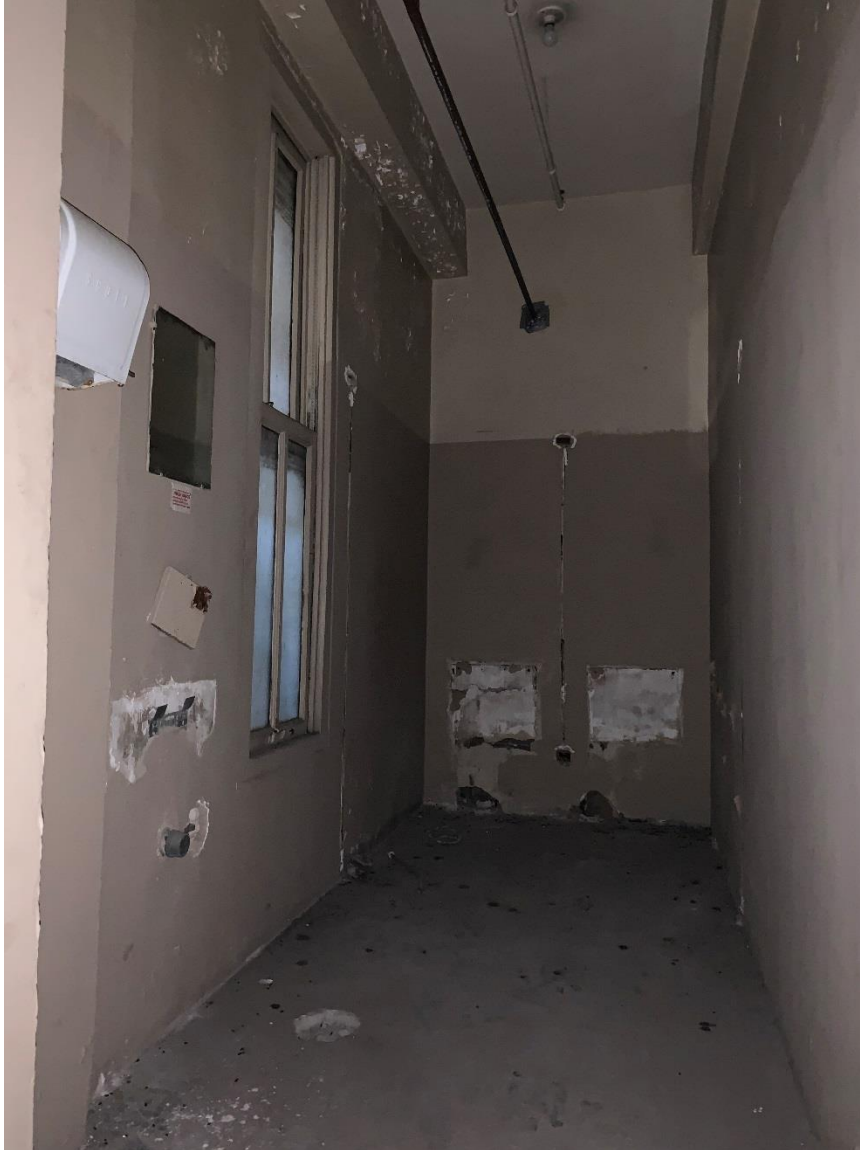
WINDOW 22

Notes: Window sashes, glazing and frame are in fair condition; the lower sashes and exterior sill show signs of minor decay; Interior casing and hardware are in good condition and will be refinished and reinstalled; Glazing putty has completely deteriorated.
