# HISTORIC AND DESIGN REVIEW COMMISSION

July 17, 2019

**HDRC CASE NO:** 2019-344  
**ADDRESS:** 104 BEAUREGARD  
**LEGAL DESCRIPTION:** NCB 742 BLK 1 LOT NE 75.4 FT OF 1 & 2  
**ZONING:** RM-4,H  
**CITY COUNCIL DIST.:** 1  
**DISTRICT:** King William Historic District  
**LANDMARK:** Hummel House  
**APPLICANT:** Marlo Montoya/MONTOYA MARLO R  
**OWNER:** Marlo Montoya/MONTOYA MARLO R  
**TYPE OF WORK:** Demolition of rear accessory structure  
**APPLICATION RECEIVED:** May 21, 2019  
**60-DAY REVIEW:** July 20, 2019  
**CASE MANAGER:** Stephanie Phillips  
**REQUEST:**

The applicant is requesting a Certificate of Appropriateness for approval to demolish an existing rear garage structure.

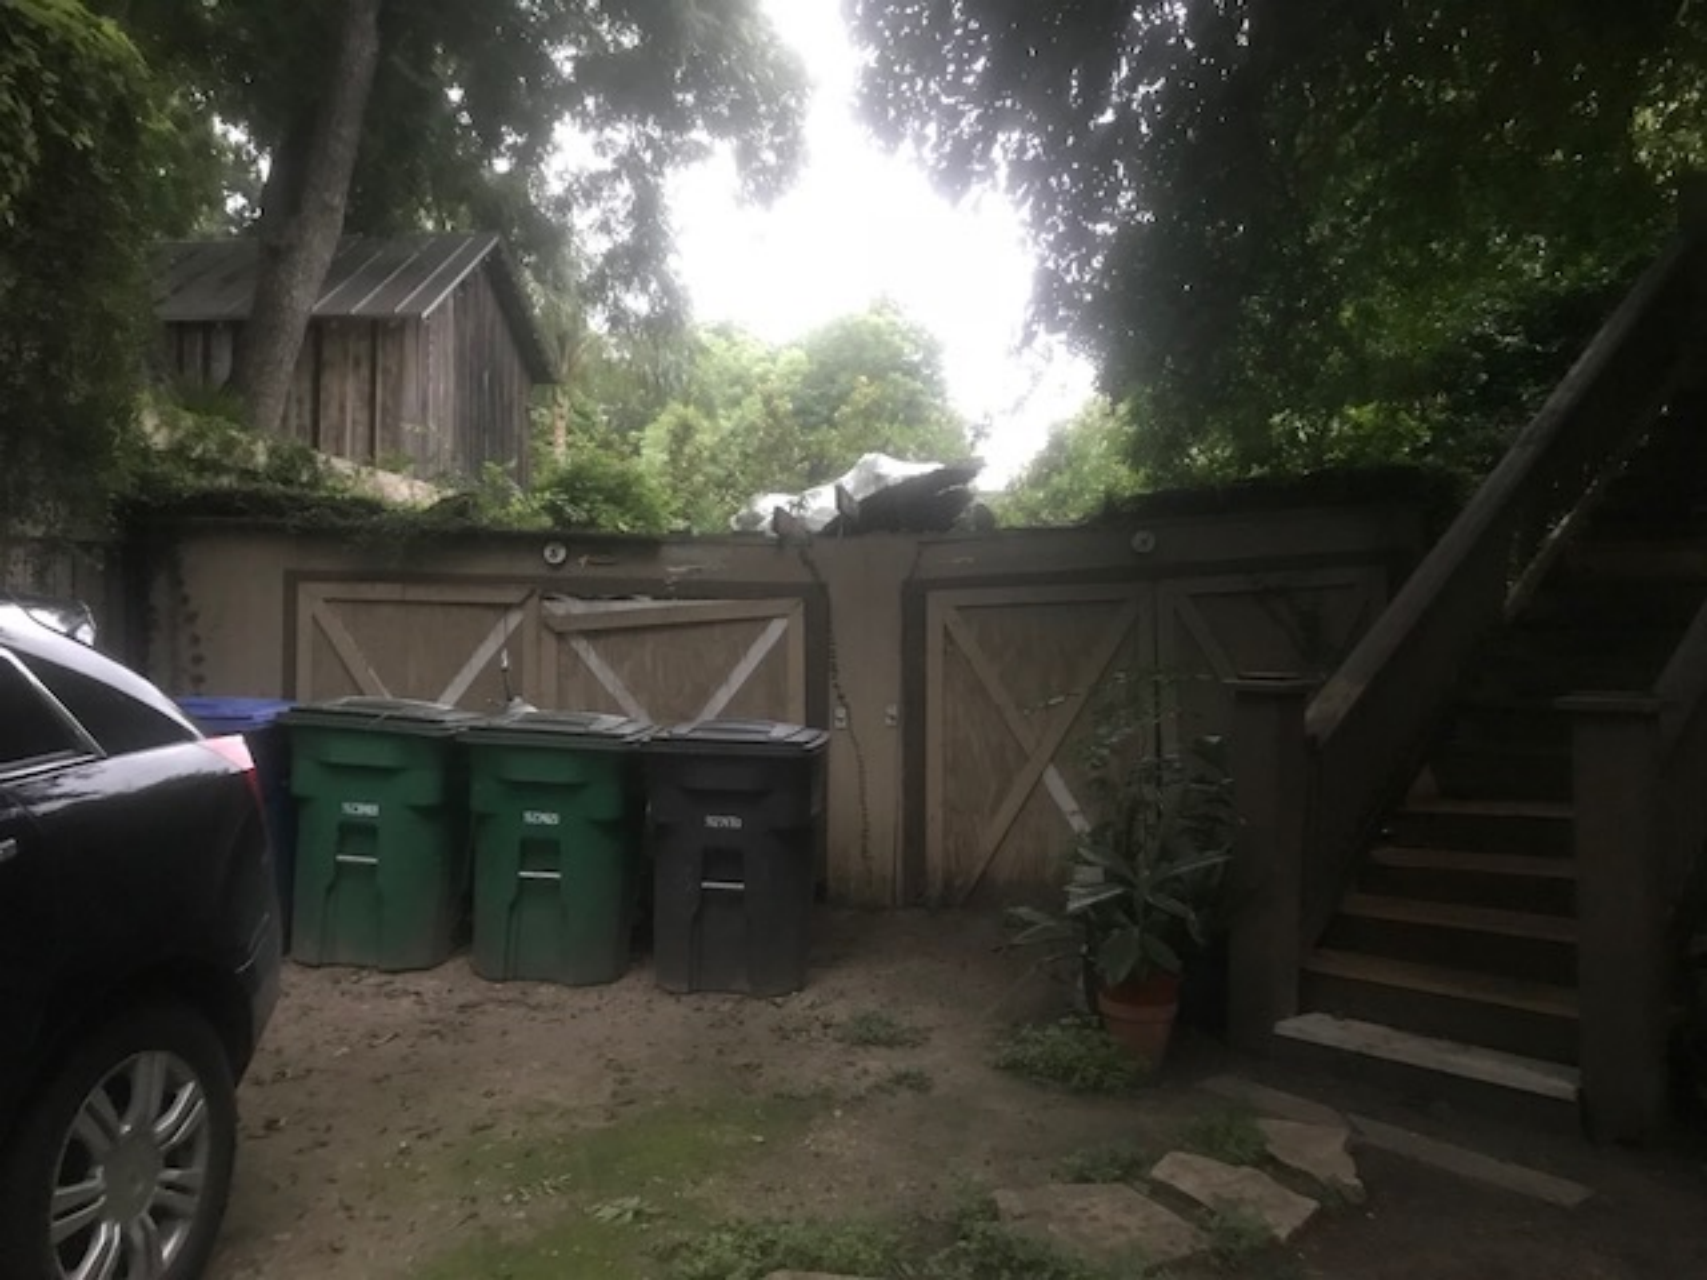
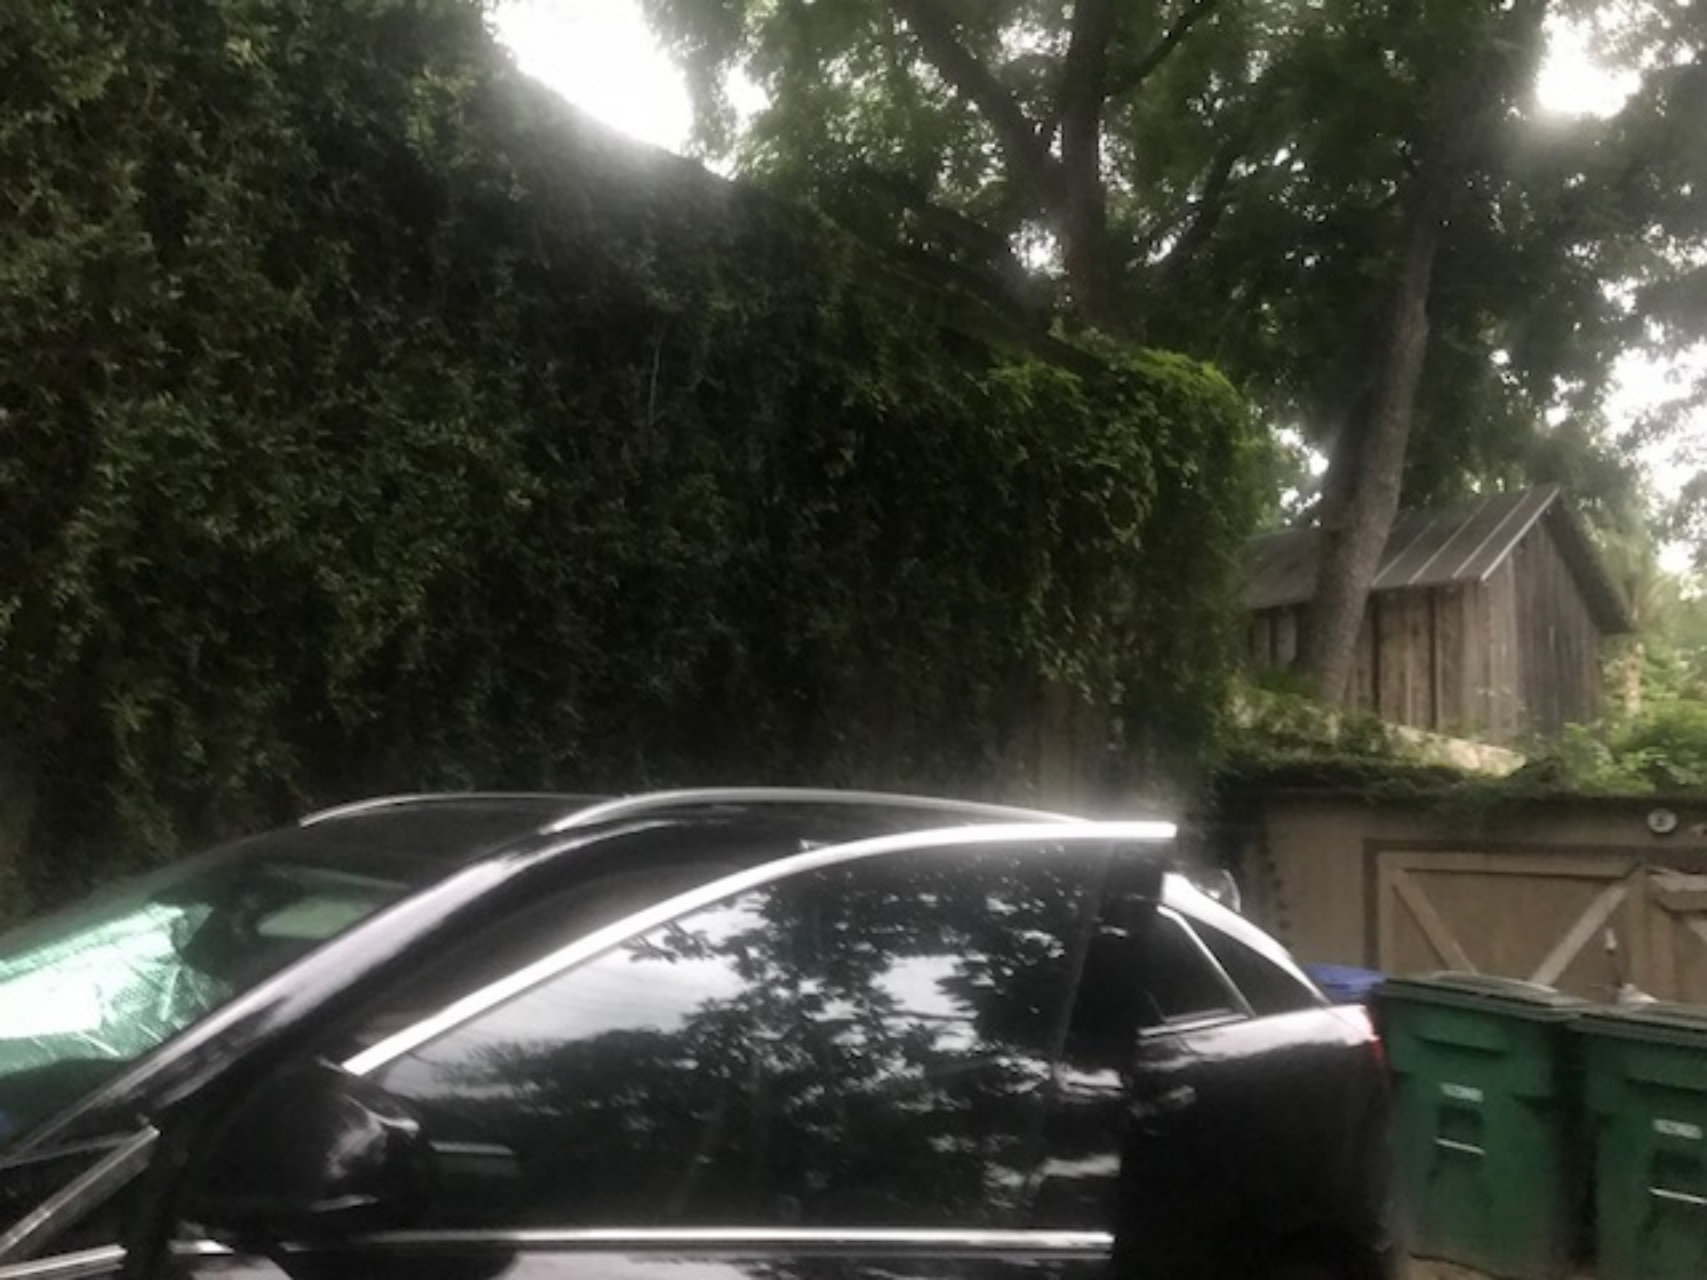
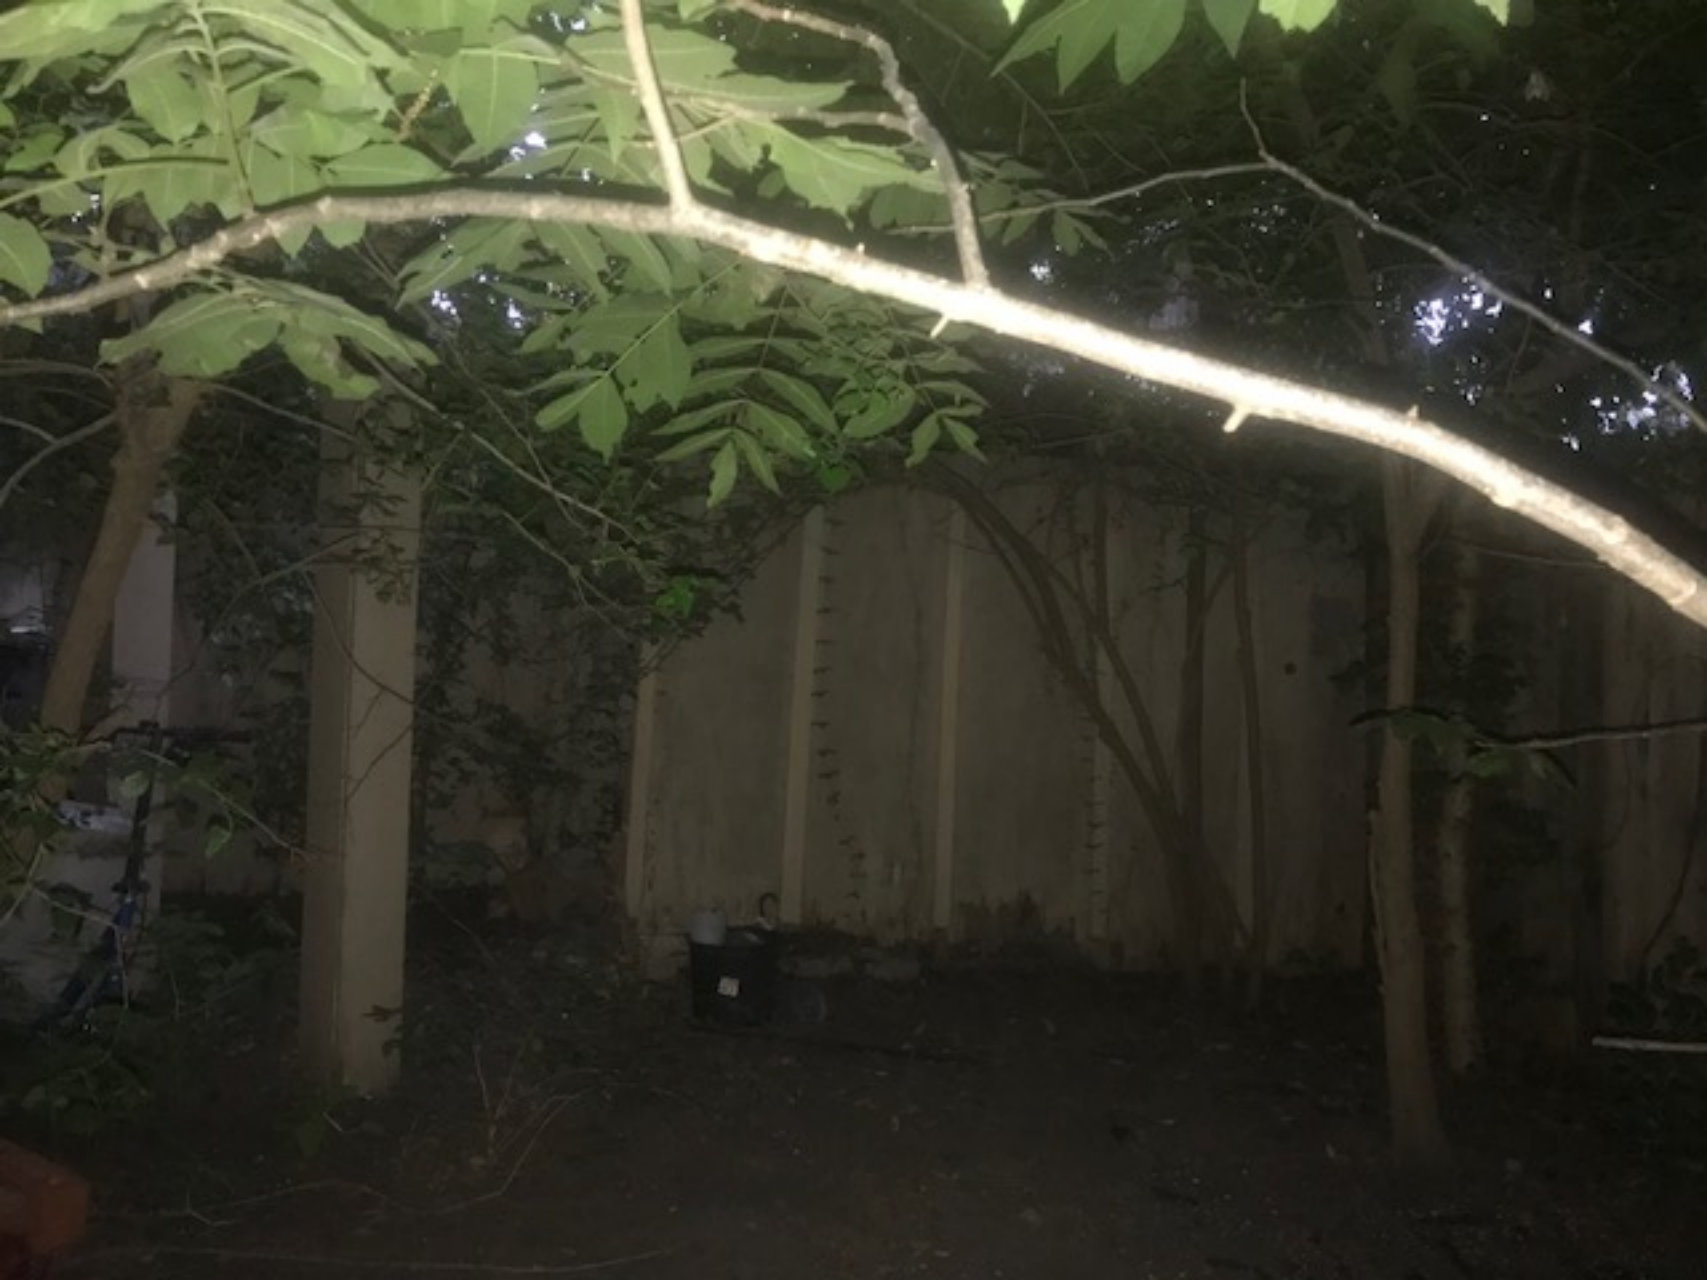
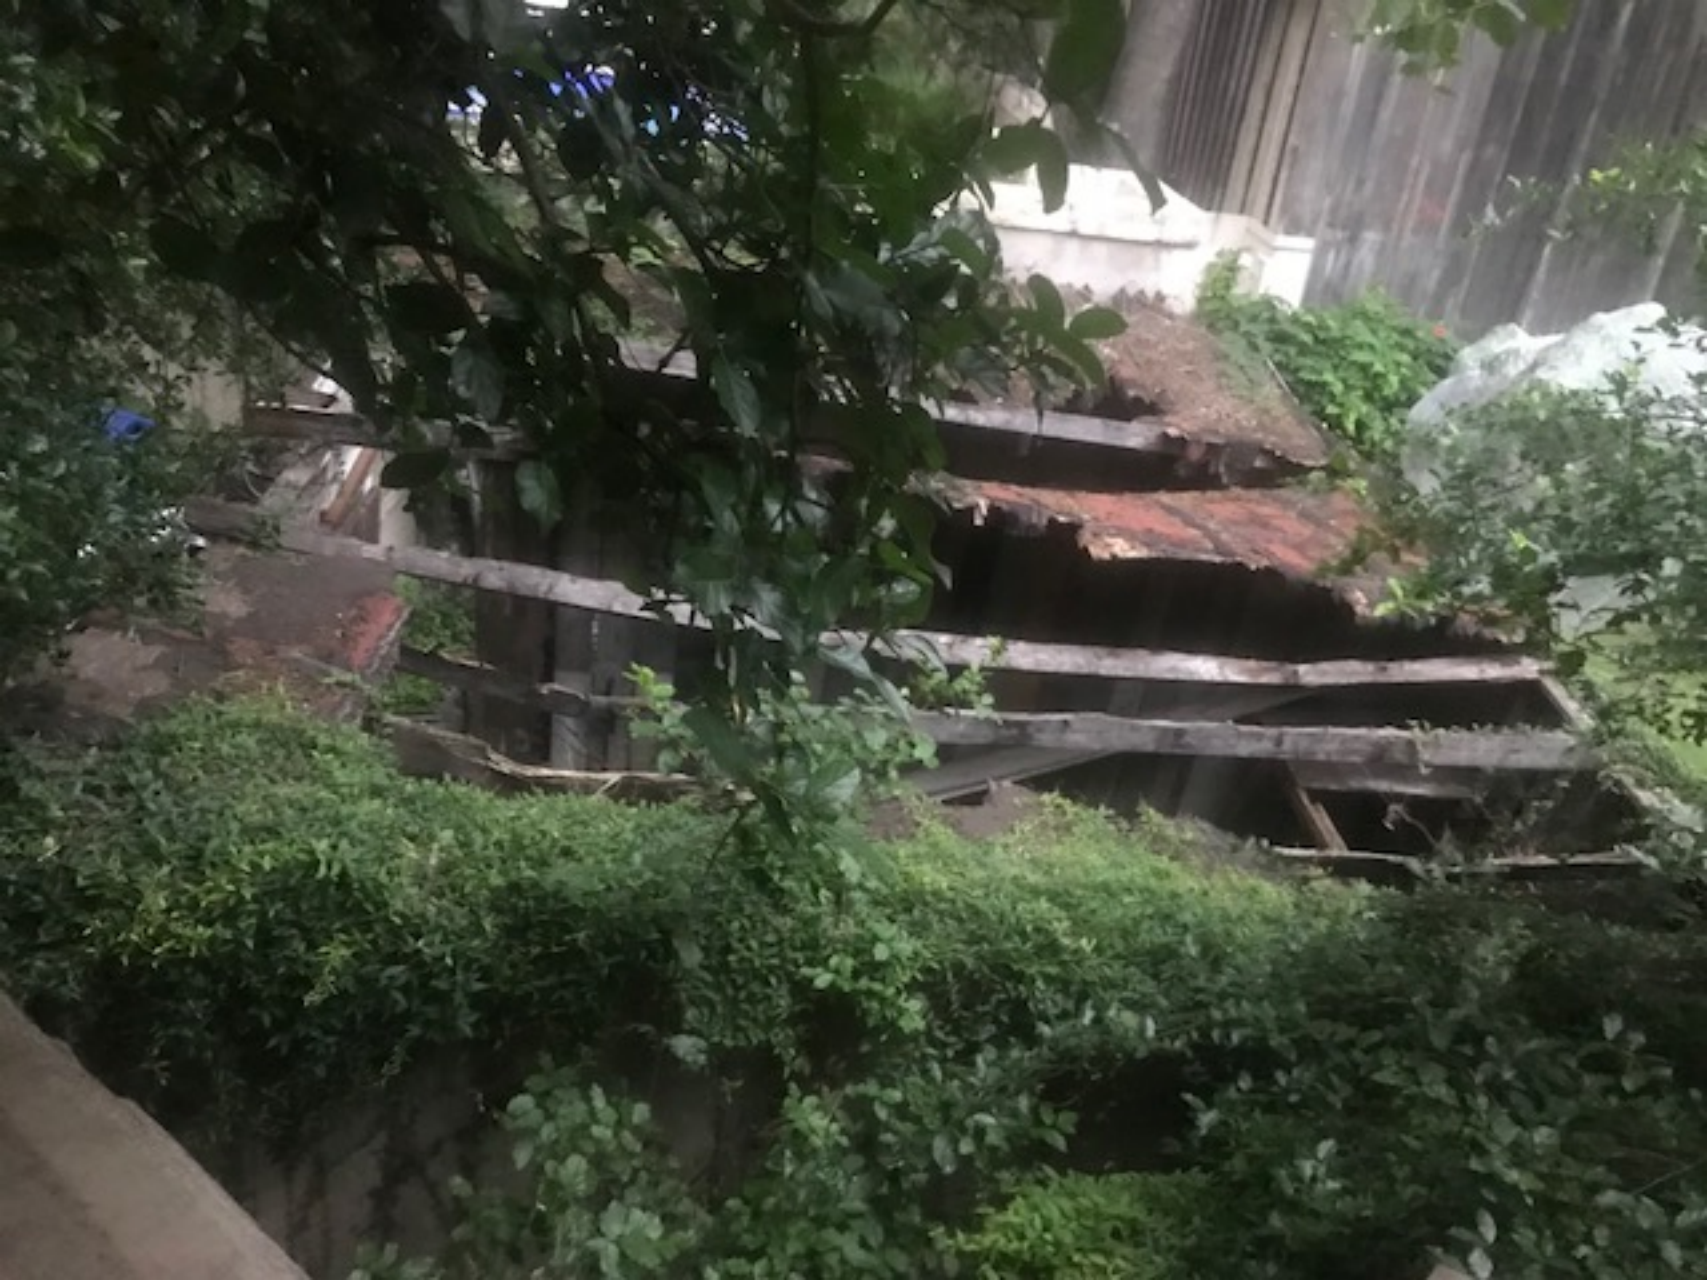
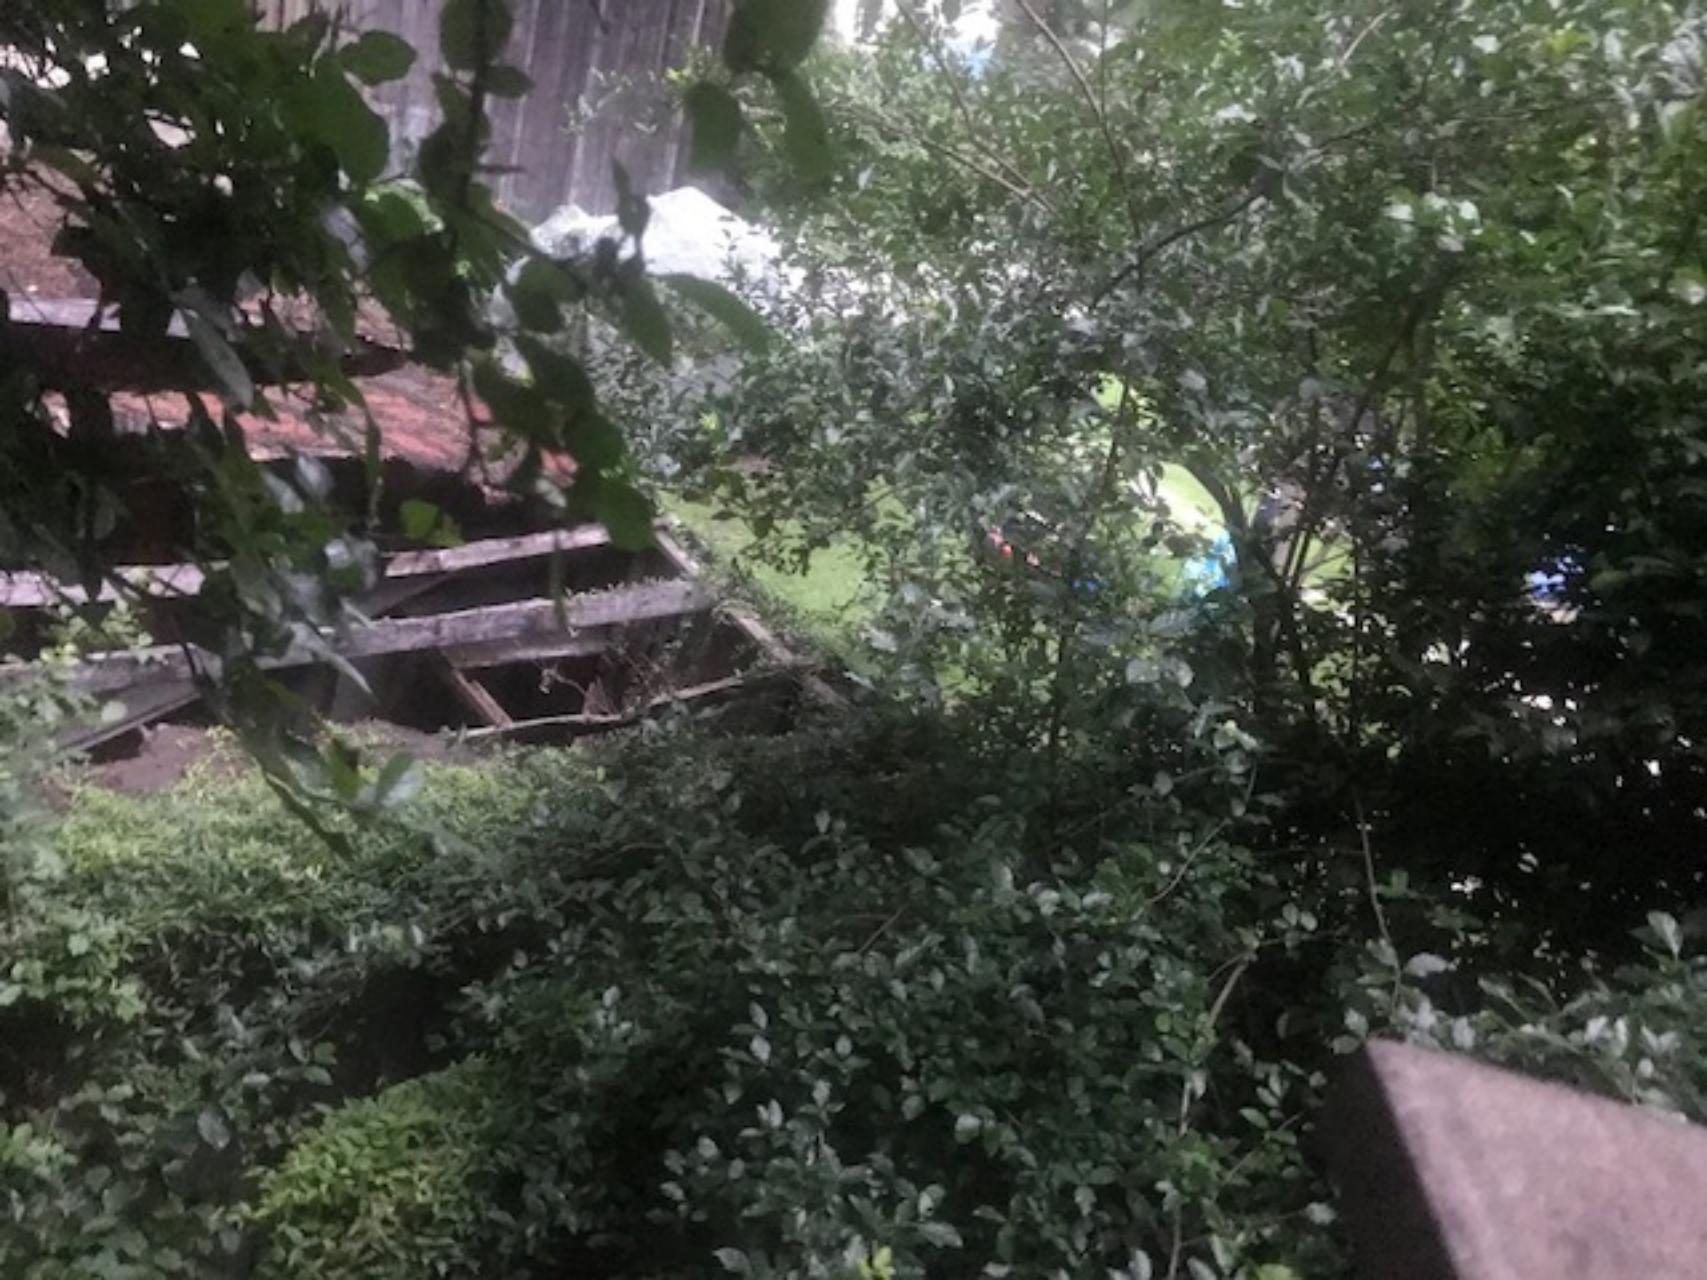
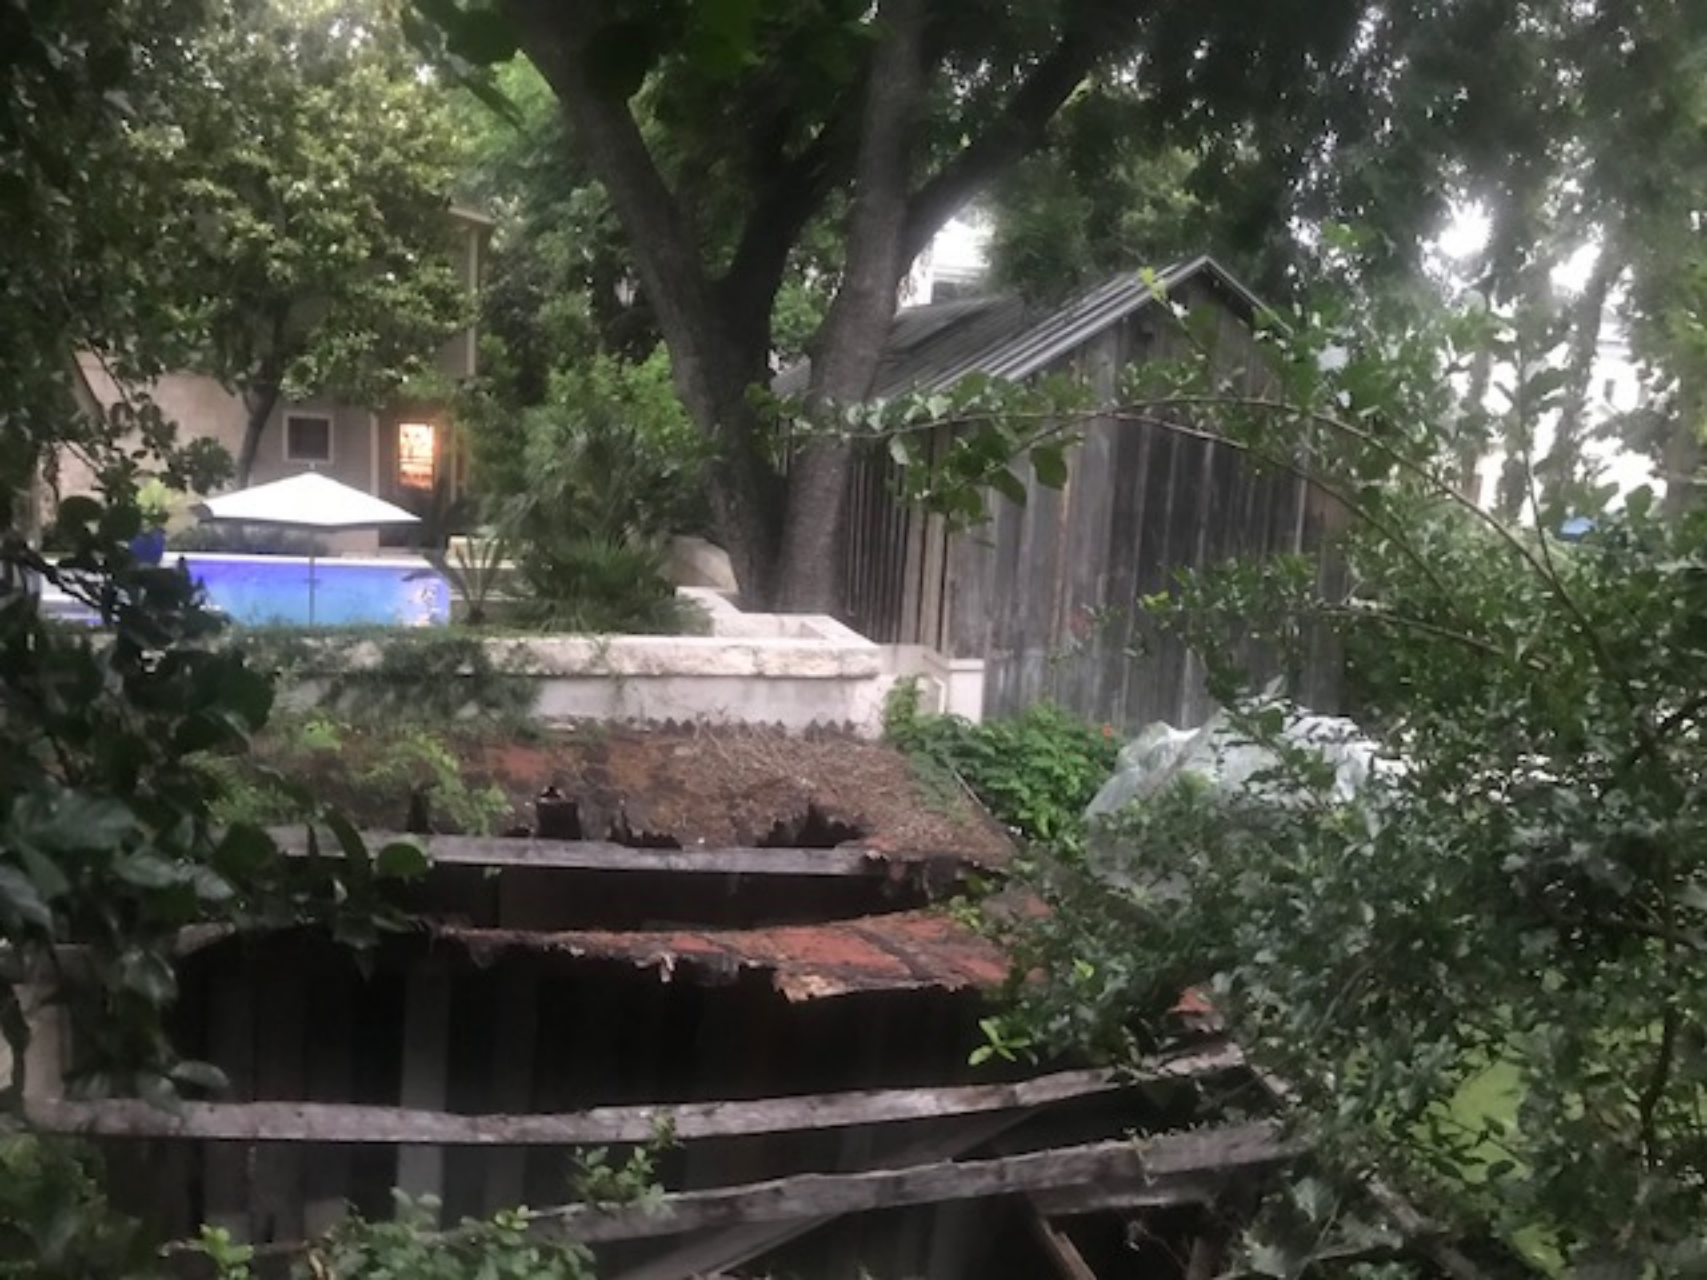
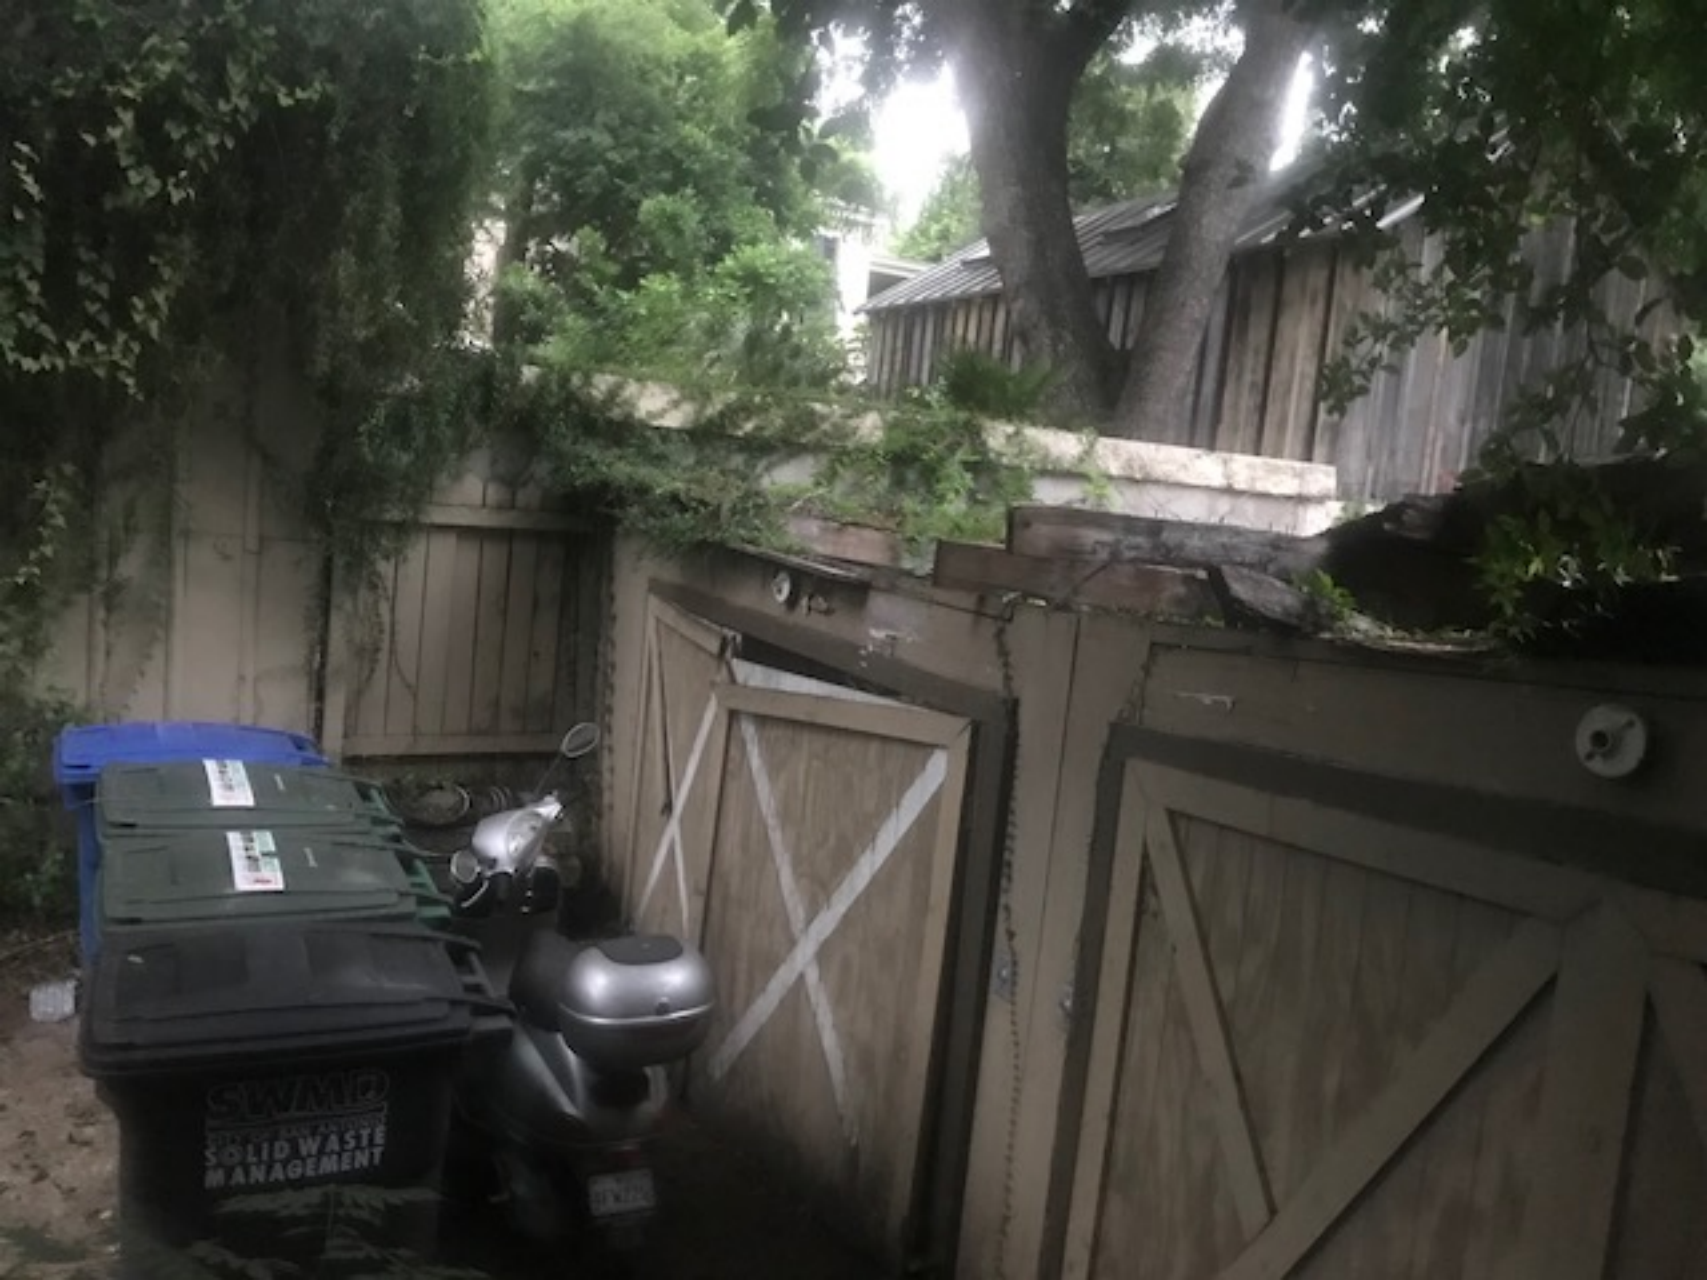
- c. CONTRIBUTING STATUS – The existing rear accessory structure as a one story, multiple bay garage and storage structure constructed in 1910 featuring wooden carriage doors. The structure appears on the 1911-1951 Sanborn Map. On May 28, 2019, staff conducted a site visit to evaluate the condition of the structure. While several original materials exist and the original footprint appears to be intact, the structure has undergone several ill-executed modifications over the years and has significantly deteriorated, particularly the roof, which has collapsed and is overgrown with greenery. While staff finds that the structure is rapidly deteriorating, the structure is still contributing to the district.

Thank you for the opportunity to bid on your project at 104 Beauregard. As discussed the garage is in extremely poor condition and a hazard. It is an economic hardship to you to try to rebuild the garage as it stands since there is no foundation nor roof and the roof joist are almost non-existent. The walls would have to be temporarily shored and raised to build a foundation below and wall studs would have to be entirely replaced since the ones there have been exposed to the elements for years. It would be difficult to impossible to shore walls and rebuild that is why price will be high because there are two of the four walls directly on property line and there is no room to place wall shores. We cannot place shores inside since we also have to build new foundation since there is only dirt as a foundation now.

- i. That materials from the historic accessory structure including salvageable wood siding, wood doors and carriage doors be salvaged and stored for use on site in future construction or donated or sold to a new end user. A salvage plan is required to be submitted to OHP staff prior to the issuance of a Certificate of Appropriateness.
