HISTORIC AND DESIGN REVIEW COMMISSION

HDRC CASE NO: 2019-322
ADDRESS: 648 LEIGH ST
LEGAL DESCRIPTION: NCB 2739 BLK LOT A15
ZONING: R-5,H
CITY COUNCIL DIST.: 1
DISTRICT: Lavaca Historic District
APPLICANT: JENNIFER BARRAR/BOBO CUSTOM BUILDERS
OWNER: LATASHA DUNN/DUNN LATASHA
TYPE OF WORK: Window replacement
APPLICATION RECEIVED: July 19, 2019
60-DAY REVIEW: September 17, 2019
CASE MANAGER: Stephanie Phillips
REQUEST:

Bobo Custom Builders (BCB) Field Observation Report

Project Name:	Dunn Remodeling		
Report No.:	1		
Prepared by:	Jennifer Barrar, Project Manager		
Date (MM/DD/YYYY):	07/10/2019		
Weather:	96 Max Temp. °F 77 Min Temp °F Condition: Partly Cloudy		
Report Details: Window Meeting to discuss restoration & renovation of existing windows			
Attendees:	Jennifer Barra, Project Manager; Cody Engel, Vice President; Luiz Elizondo, Specialist in Wood Doors & Windows Architectural Restoration & Renovation		
Number	Detail	Photo	Comments
1.1	Evidence of wood rot

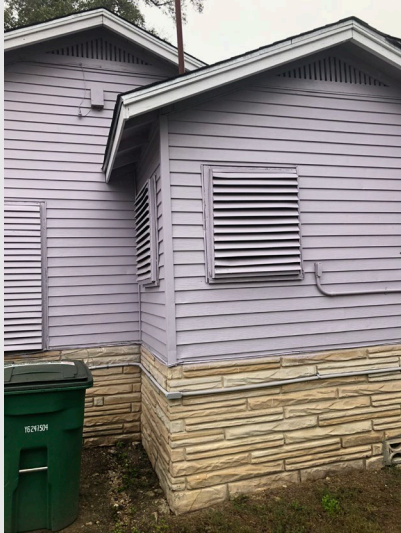
Report Details: Window Meeting to discuss restoration & renovation of existing windows			
1.7	Other windows are covered with louvres

Attempting to remove existing louvres is results in damaging existing windows.
1.8	Other windows are covered with louvres

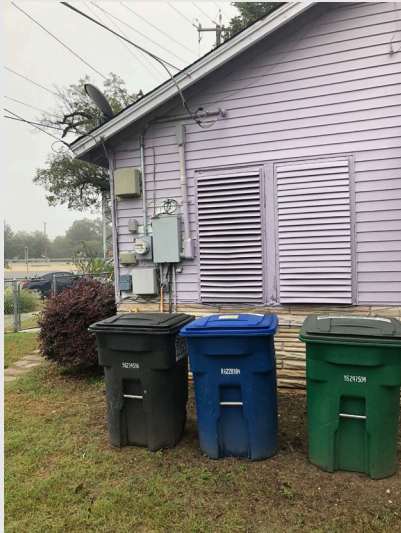
Attempting to remove existing louvres is results in damaging existing windows.
