# HISTORIC AND DESIGN REVIEW COMMISSION

**HDRC CASE NO:** 2019-322  
**ADDRESS:** 648 LEIGH ST  
**LEGAL DESCRIPTION:** NCB 2739 BLK LOT A15  
**ZONING:** R-5,H  
**CITY COUNCIL DIST.:** 1  
**DISTRICT:** Lavaca Historic District  
**APPLICANT:** JENNIFER BARRAR/BOBO CUSTOM BUILDERS  
**OWNER:** LATASHA DUNN/DUNN LATASHA  
**TYPE OF WORK:** Window replacement  
**APPLICATION RECEIVED:** July 19, 2019  
**60-DAY REVIEW:** September 17, 2019  
**CASE MANAGER:** Stephanie Phillips  
**REQUEST:**

## Bobo Custom Builders (BCB) Field Observation Report

<b>Project Name:</b>	Dunn Remodeling		
<b>Report No.:</b>	1		
<b>Prepared by:</b>	Jennifer Barrar, Project Manager		
<b>Date (MM/DD/YYYY):</b>	07/10/2019		
<b>Weather:</b>	96 Max Temp. °F      77 Min Temp °F      Condition: Partly Cloudy		
<b>Report Details: Window Meeting to discuss restoration &amp; renovation of existing windows</b>			
<b>Attendees:</b>	Jennifer Barra, Project Manager; Cody Engel, Vice President; Luiz Elizondo, Specialist in Wood Doors & Windows Architectural Restoration & Renovation		
<b>Number</b>	<b>Detail</b>	<b>Photo</b>	<b>Comments</b>
1.1	Evidence of wood rot

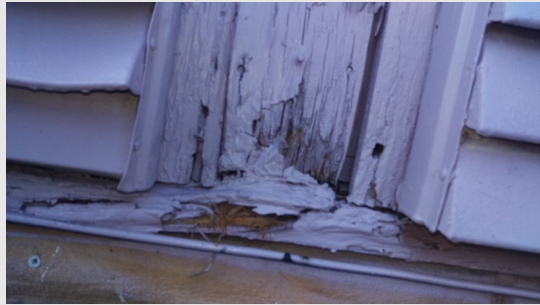
Deteriorating or missing sub-sills and sill boards
1.2	Evidence of wood rot

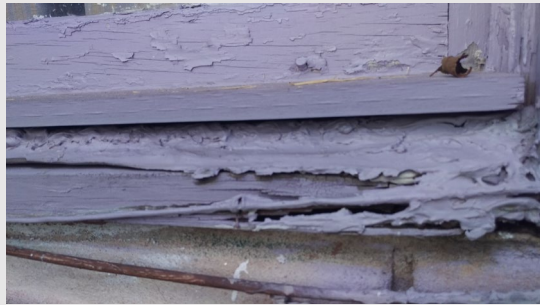
Deteriorating or missing sub-sills and sill boards

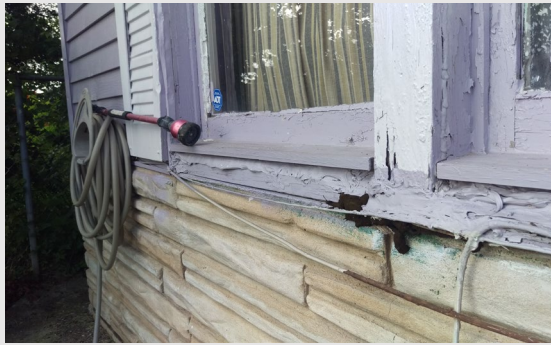
<b>Report Details: Window Meeting to discuss restoration &amp; renovation of existing windows</b>			
<b>Trade On Site:</b>	Luiz Elizondo, Specialist in Wood Doors & Windows Architectural Restoration & Renovation		
<i>Number</i>	<i>Detail</i>	<i>Photo</i>	<i>Comments</i>
1.3	Soft, punky wood though out jambs

Wood rot
1.4	Evidence of previous repairs

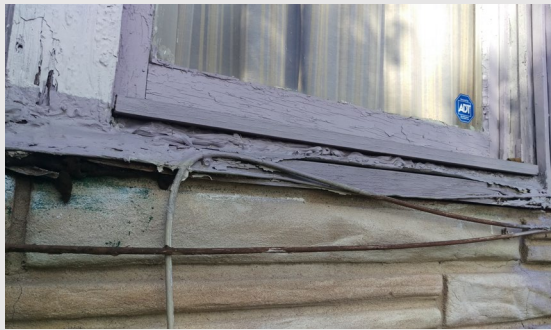
Executed incorrectly resulting in loss of original elements.
1.5	Disjointed sash members

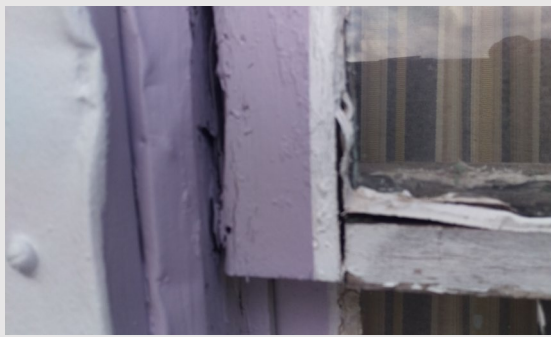
Particularly at meeting rails etc.

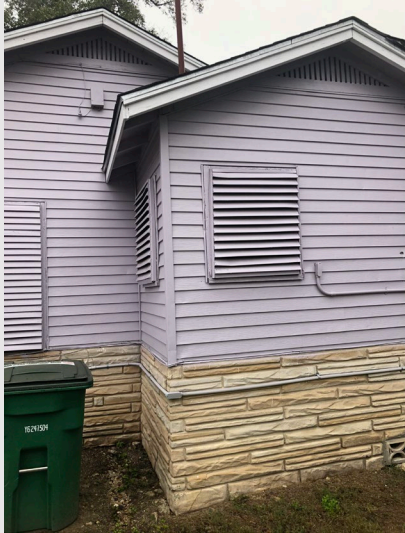
<b>Report Details: Window Meeting to discuss restoration &amp; renovation of existing windows</b>			
1.7	Other windows are covered with louvres

Attempting to remove existing louvres is results in damaging existing windows.
1.8	Other windows are covered with louvres

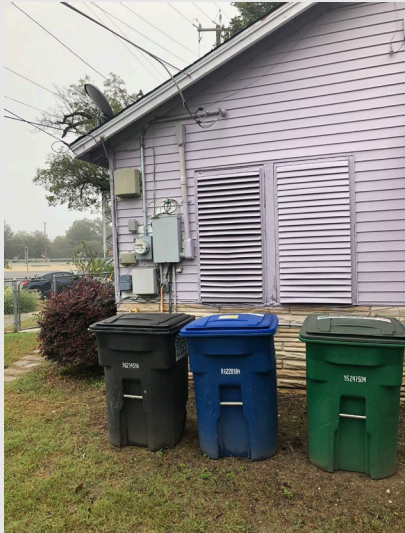
Attempting to remove existing louvres is results in damaging existing windows.
