HISTORIC AND DESIGN REVIEW COMMISSION

HDRC CASE NO: 2019-575
ADDRESS: 119 ADAMS ST
LEGAL DESCRIPTION: NCB 931 BLK LOT 17 AND 18
ZONING: RM-4,HS, H
CITY COUNCIL DIST.: 1
DISTRICT: King William Historic District
LANDMARK: Koehler House
APPLICANT: Nicole Corwin/Tatanka
OWNER: Jarod and Celeste Oliver
TYPE OF WORK: Historic Tax Verification
APPLICATION RECEIVED: September 24, 2019
60-DAY REVIEW: November 23, 2019
CASE MANAGER: Huy Pham
REQUEST:

The applicant is requesting Historic Tax Verification for the property at 119 Adams.

119 Adams

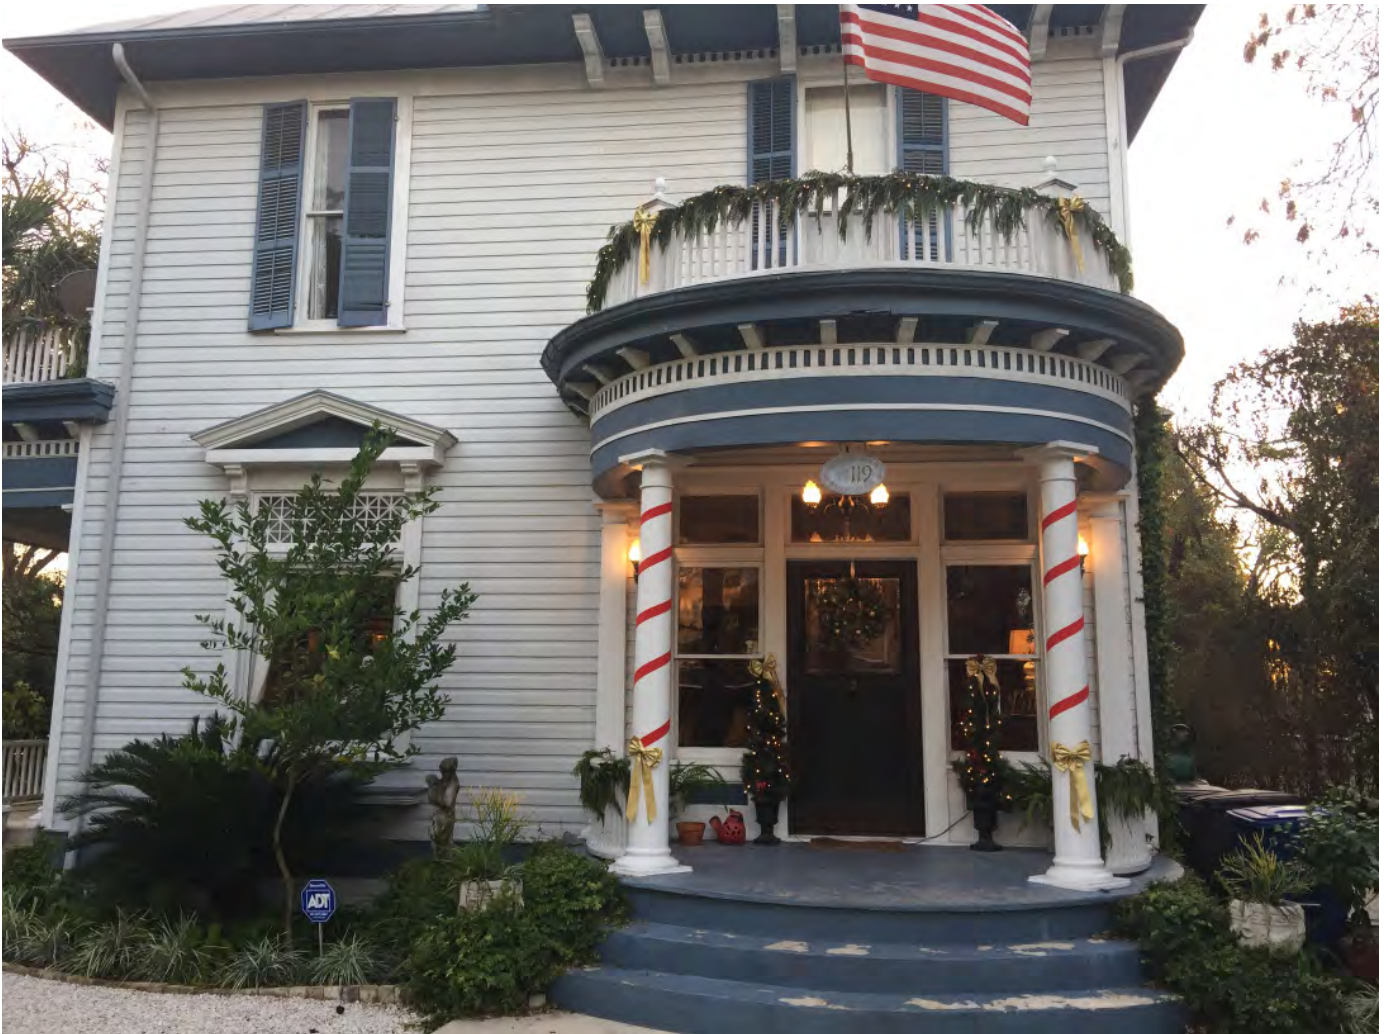
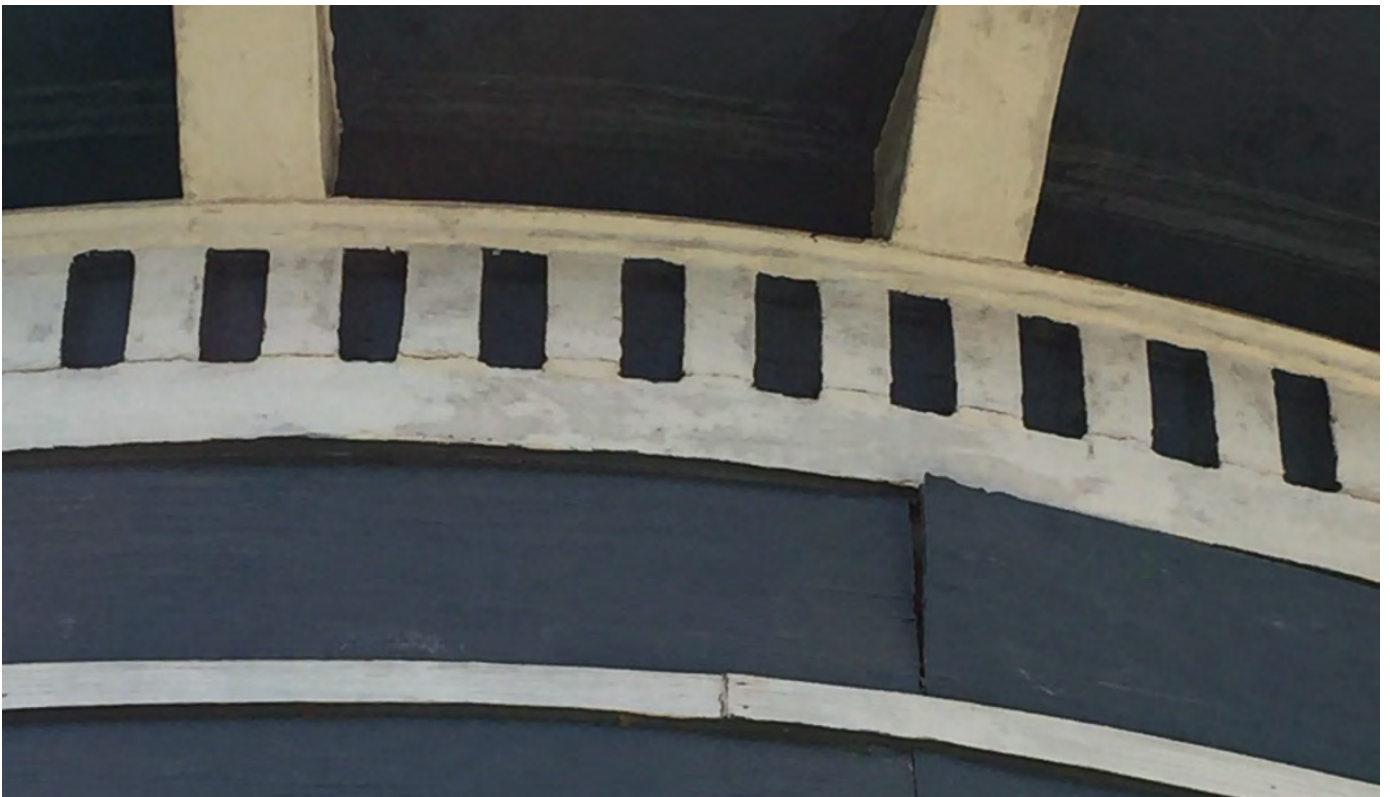
Pre-Remodel Exterior, Front

wood shutters to be repaired and replaces as needed, new paint throughout, wood railing & detailing to be repaired

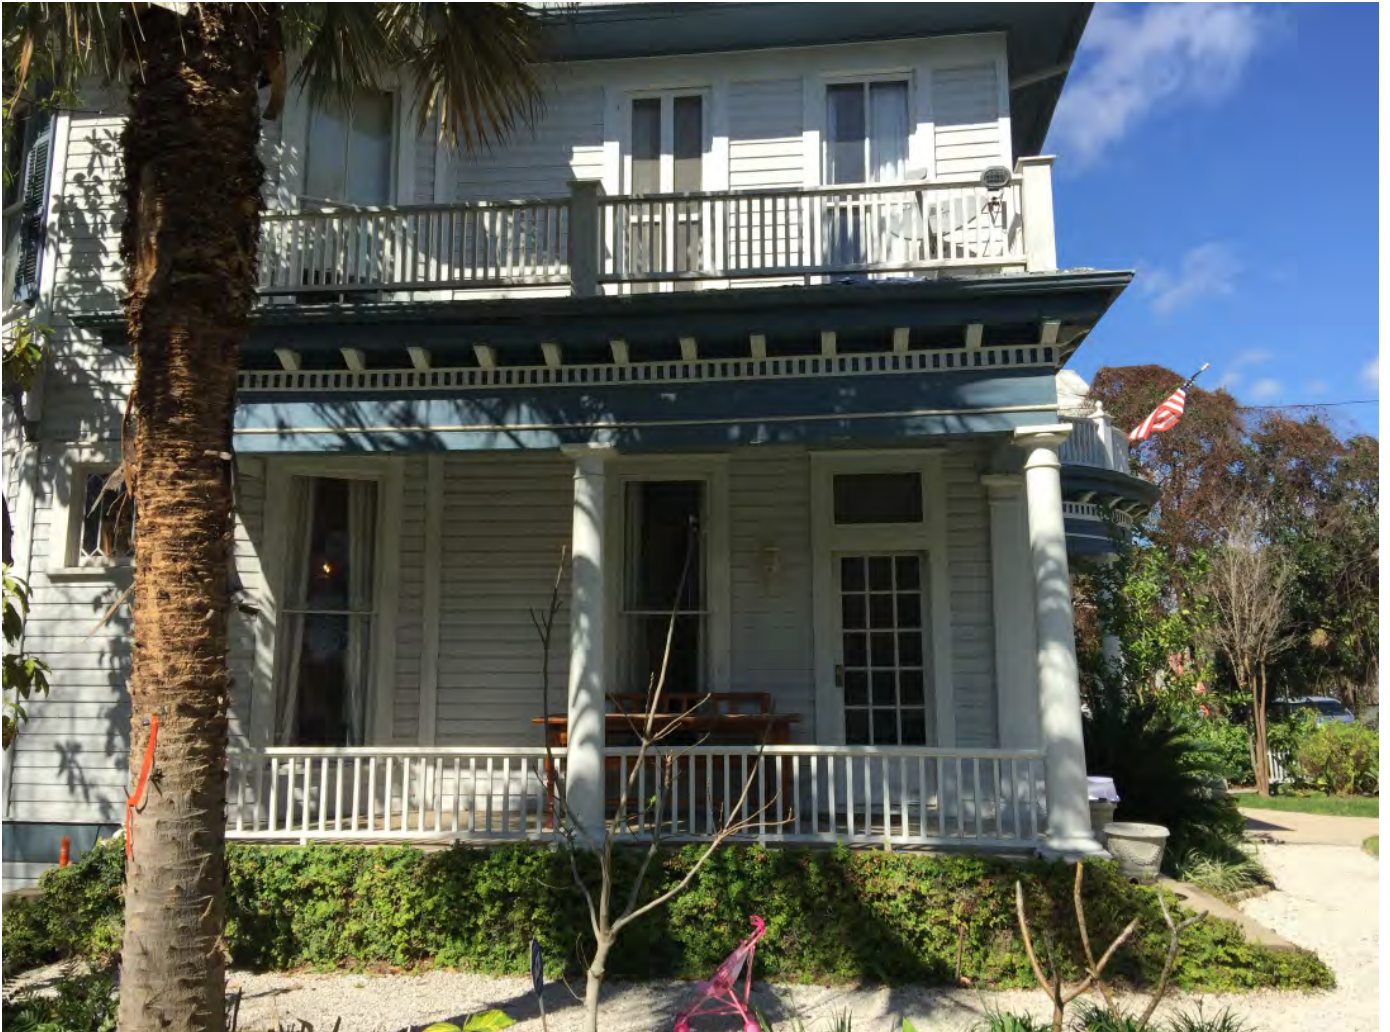
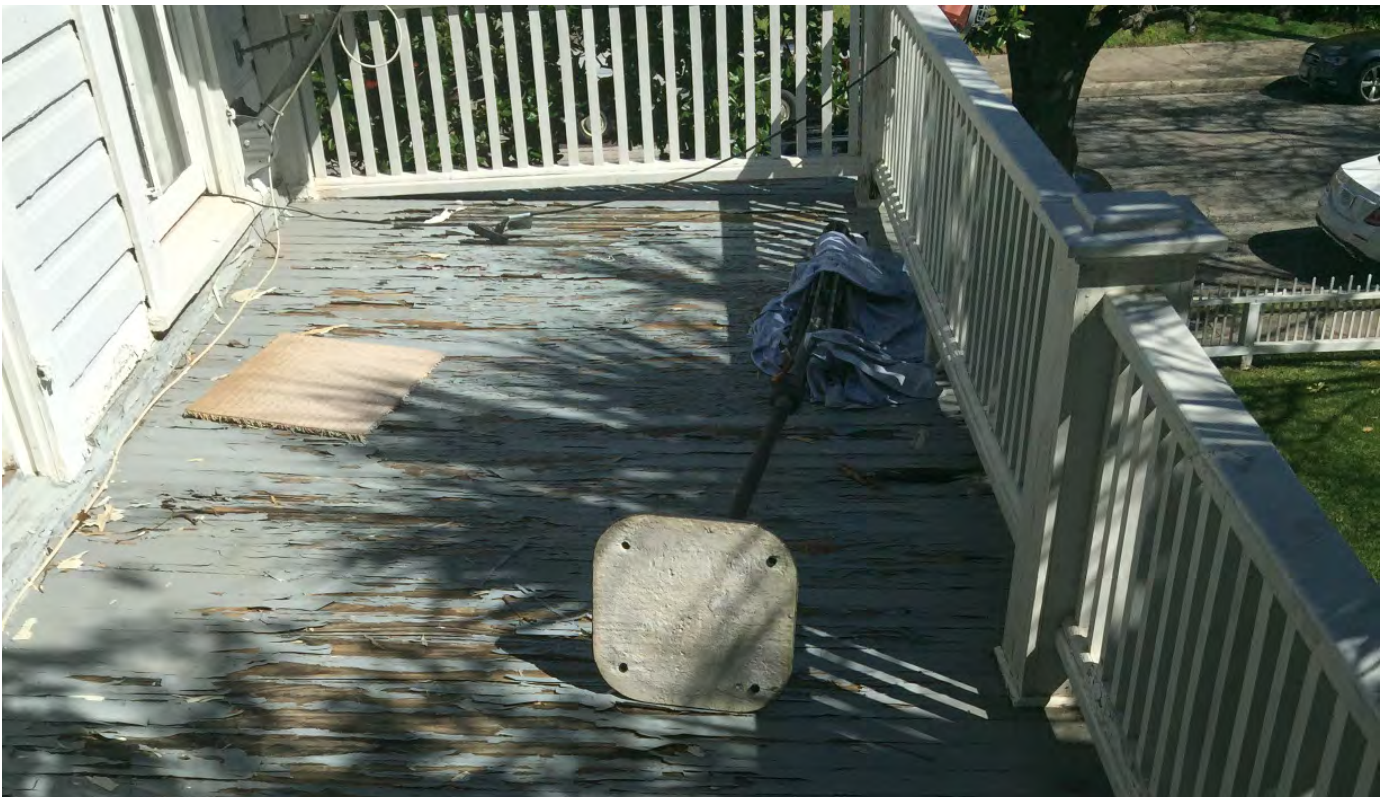
Pre-Remodel Exterior, Northwest Corner
wood shutters to be repaired and replaces as needed, new paint throughout, wood railing & deck to be repaired

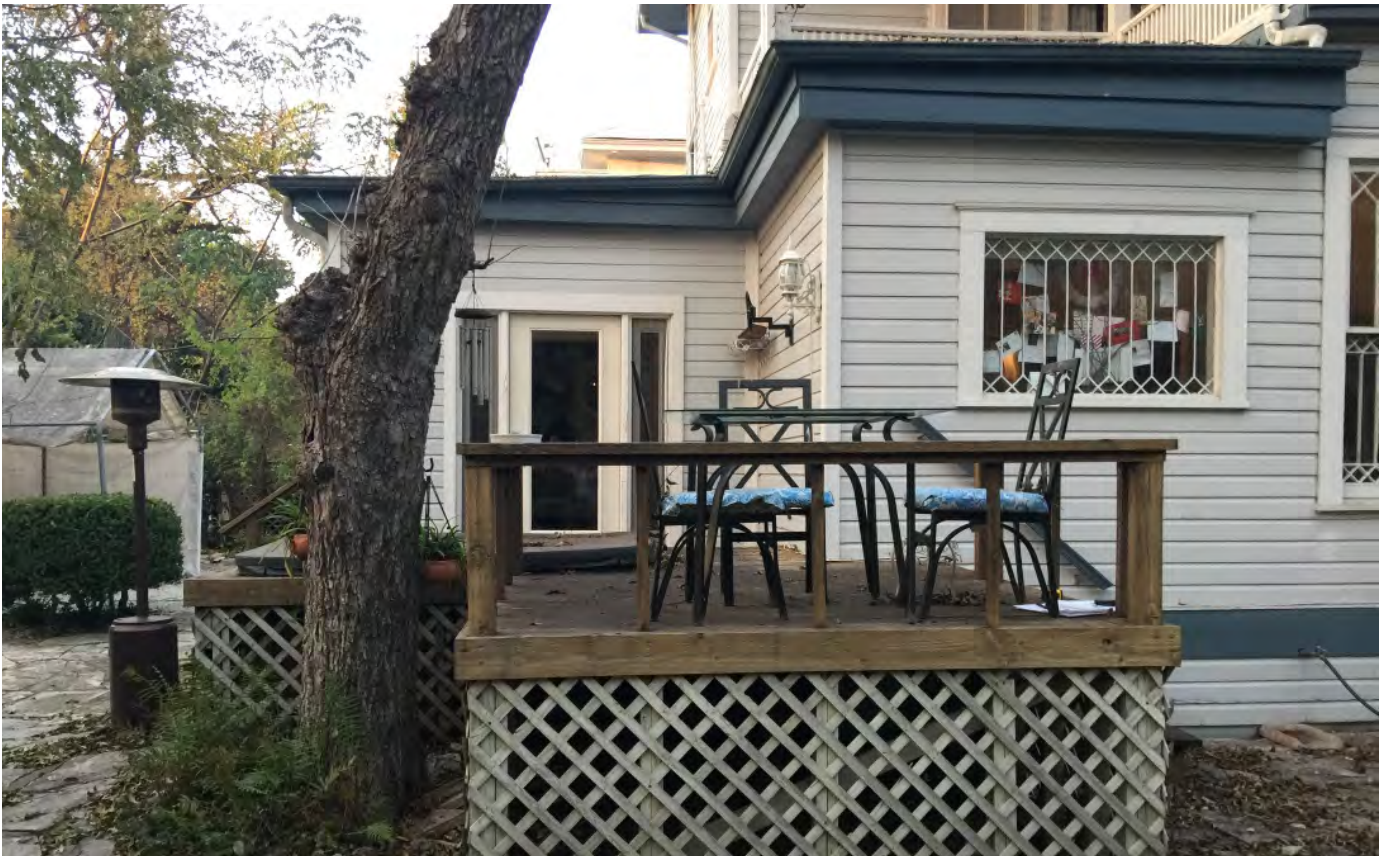
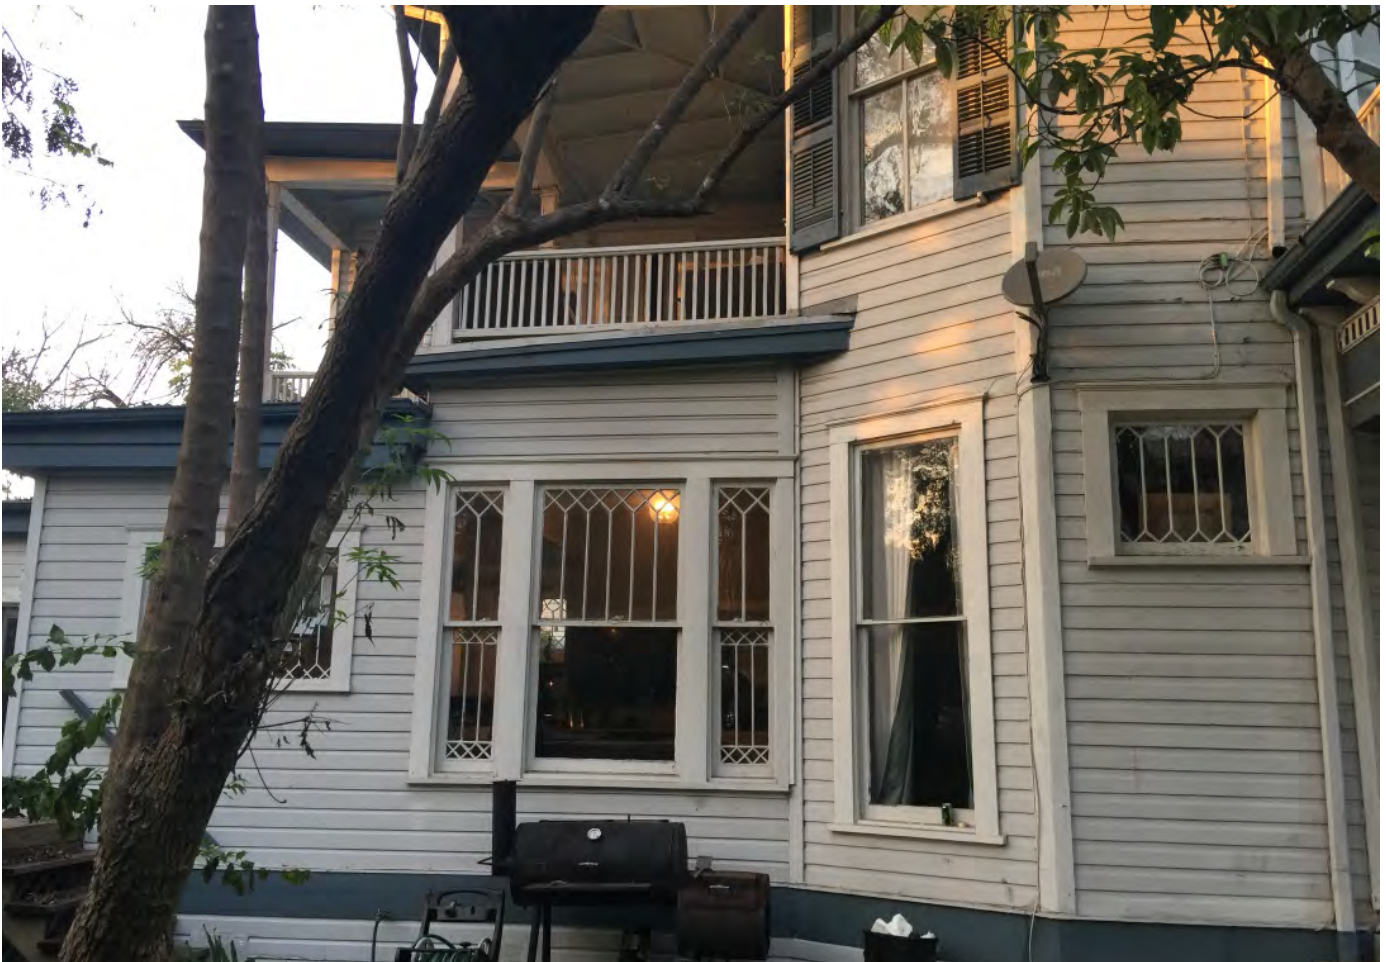
Pre-Remodel Exterior, Southwest Corner

Wood deck and spa to be removed, 2nd floor to be added onto and balcony relocated. Leaded glass windows to be relocated..

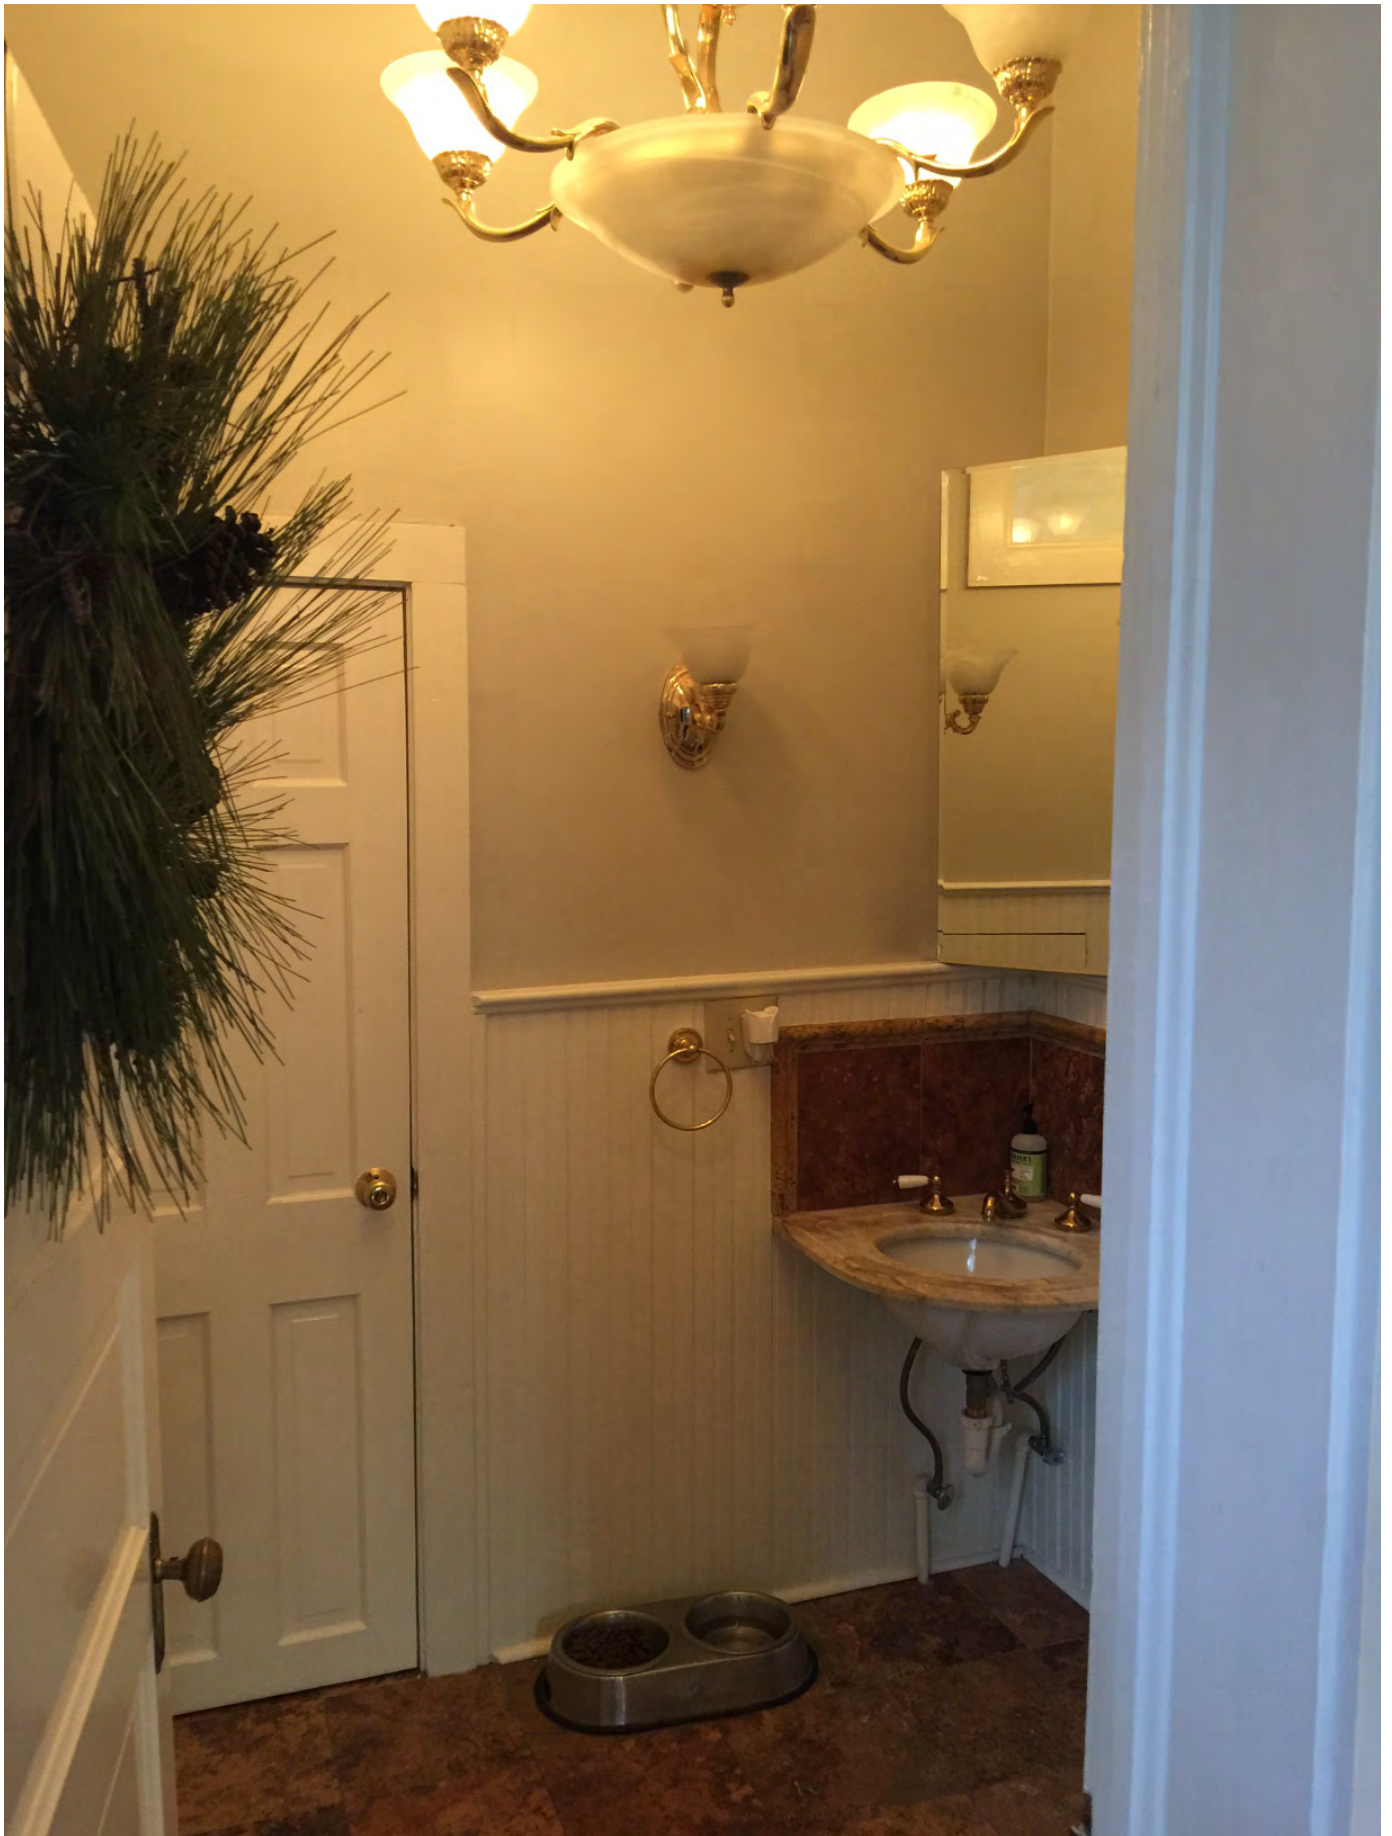
Pre-Remodel 1st Powder Room
to be reconfigured . all new finishes and fixtures

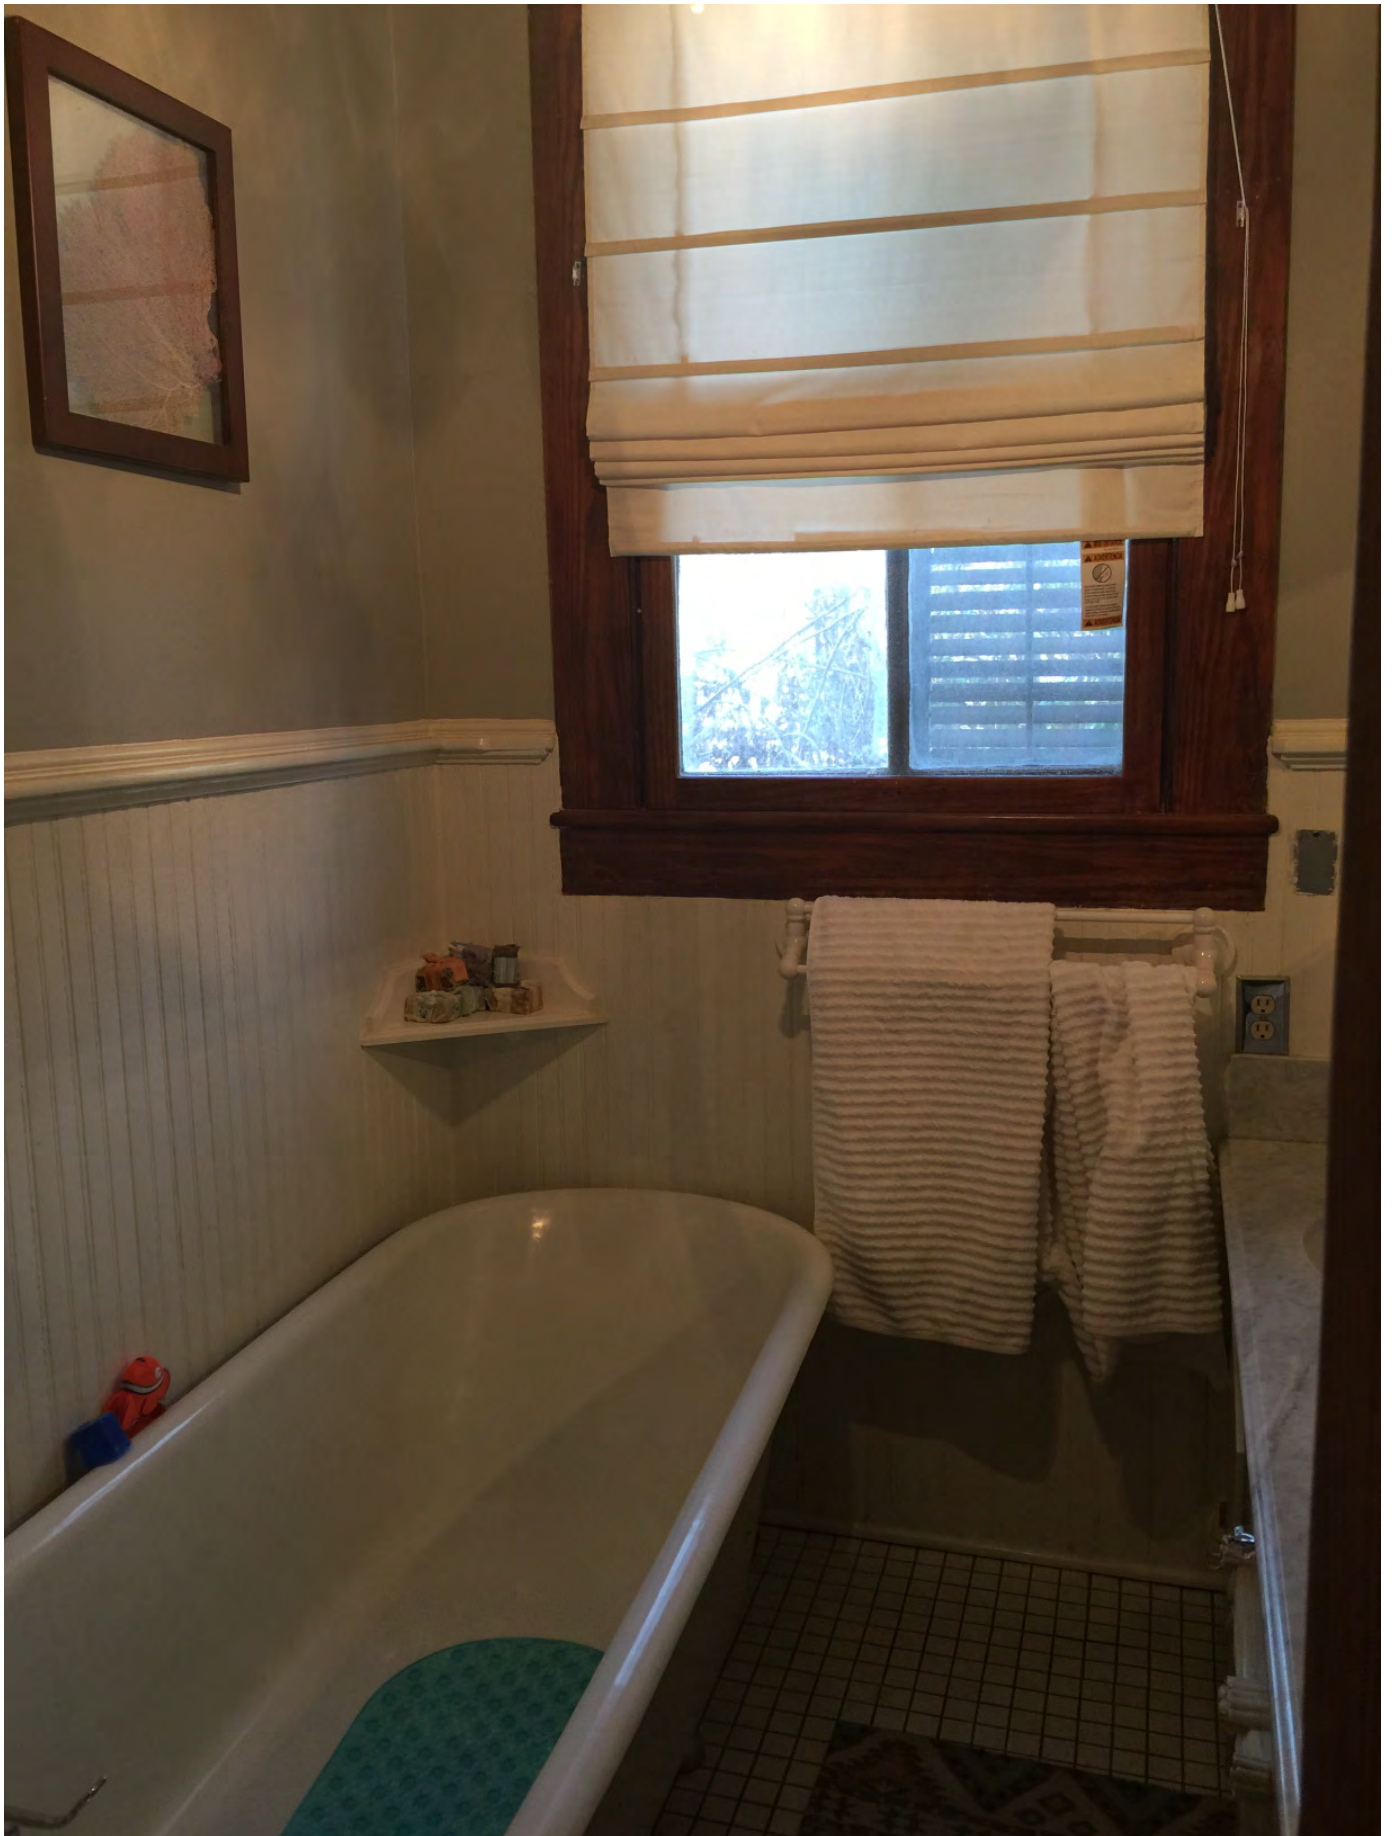
Pre-Remodel 2nd Floor Guest Bathroom B
to receive new flooring and paint, restored and repair fixtures

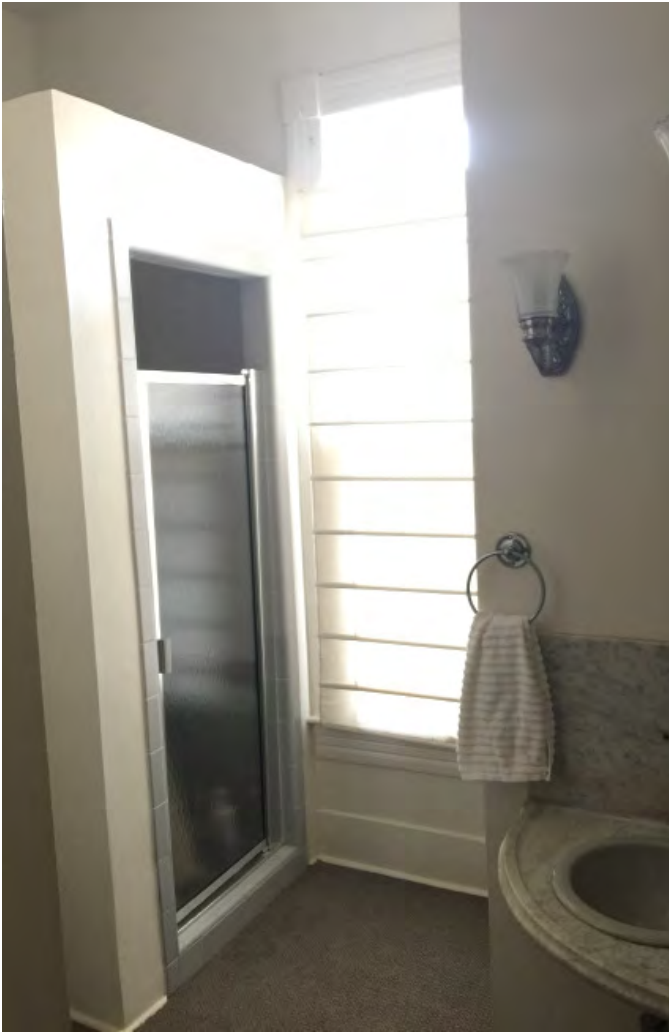
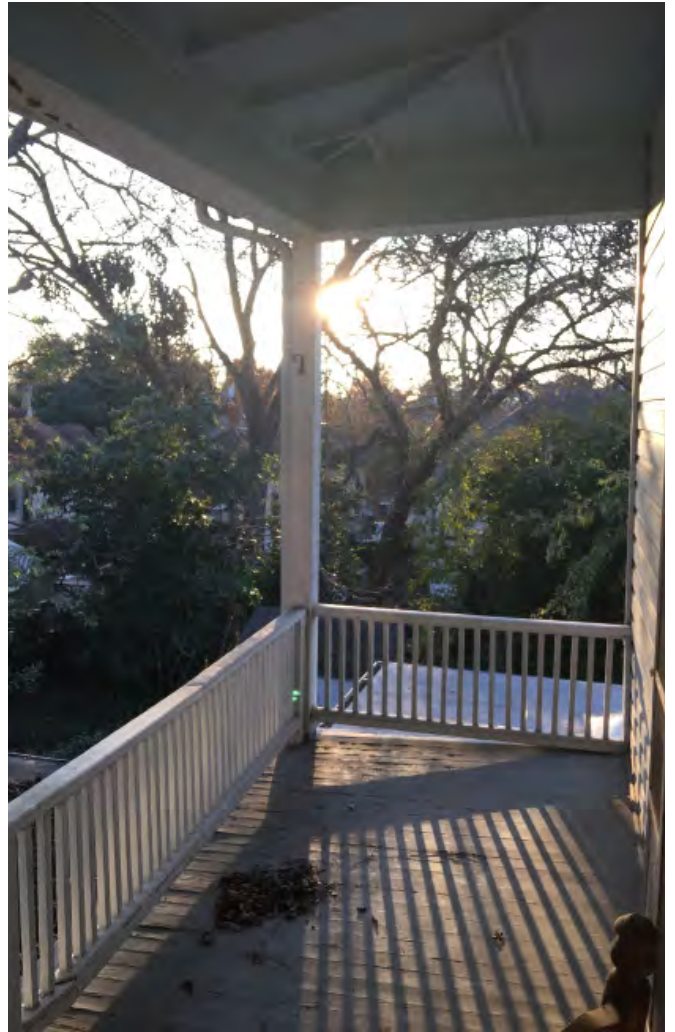
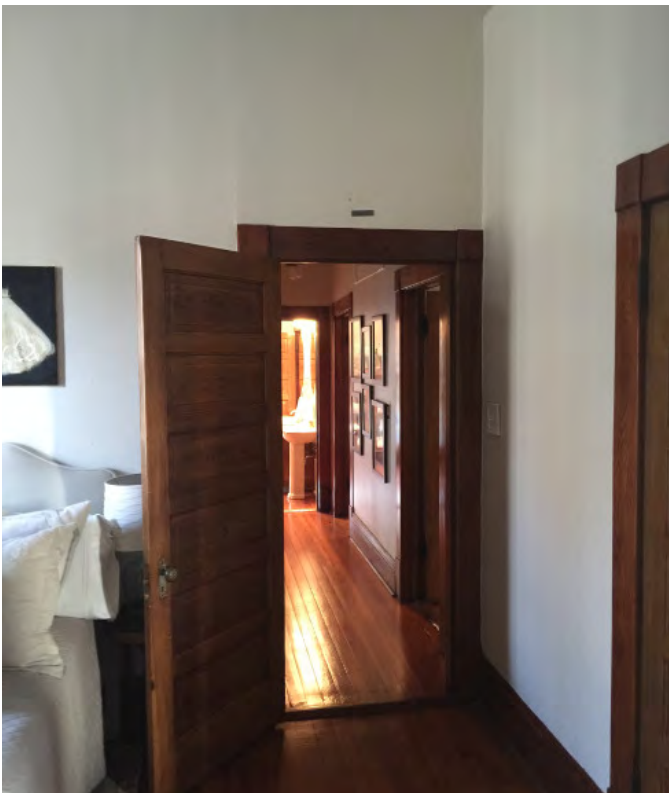
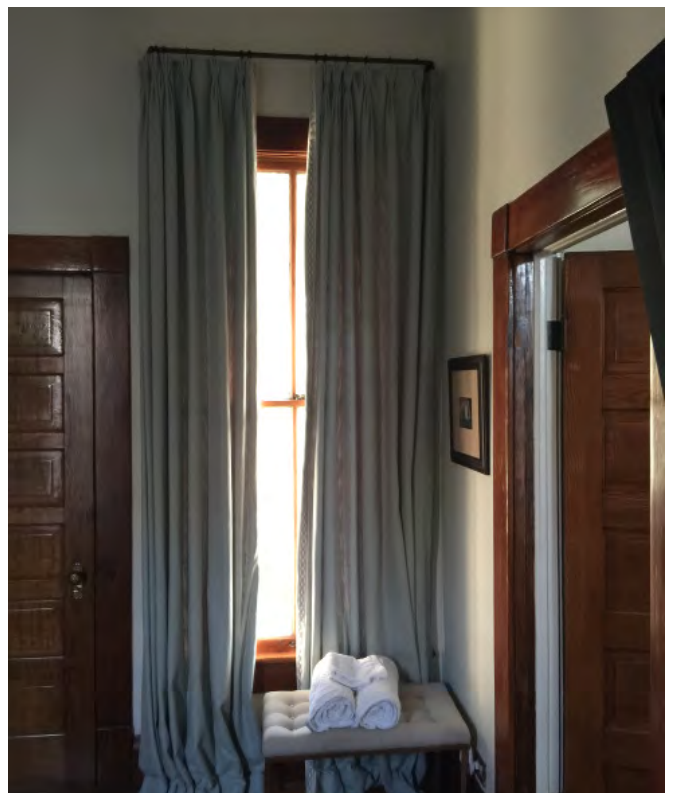
Pre-Remodel Master Suite & Balcony
New layout and all new finishes and fixtures, doors to be reused

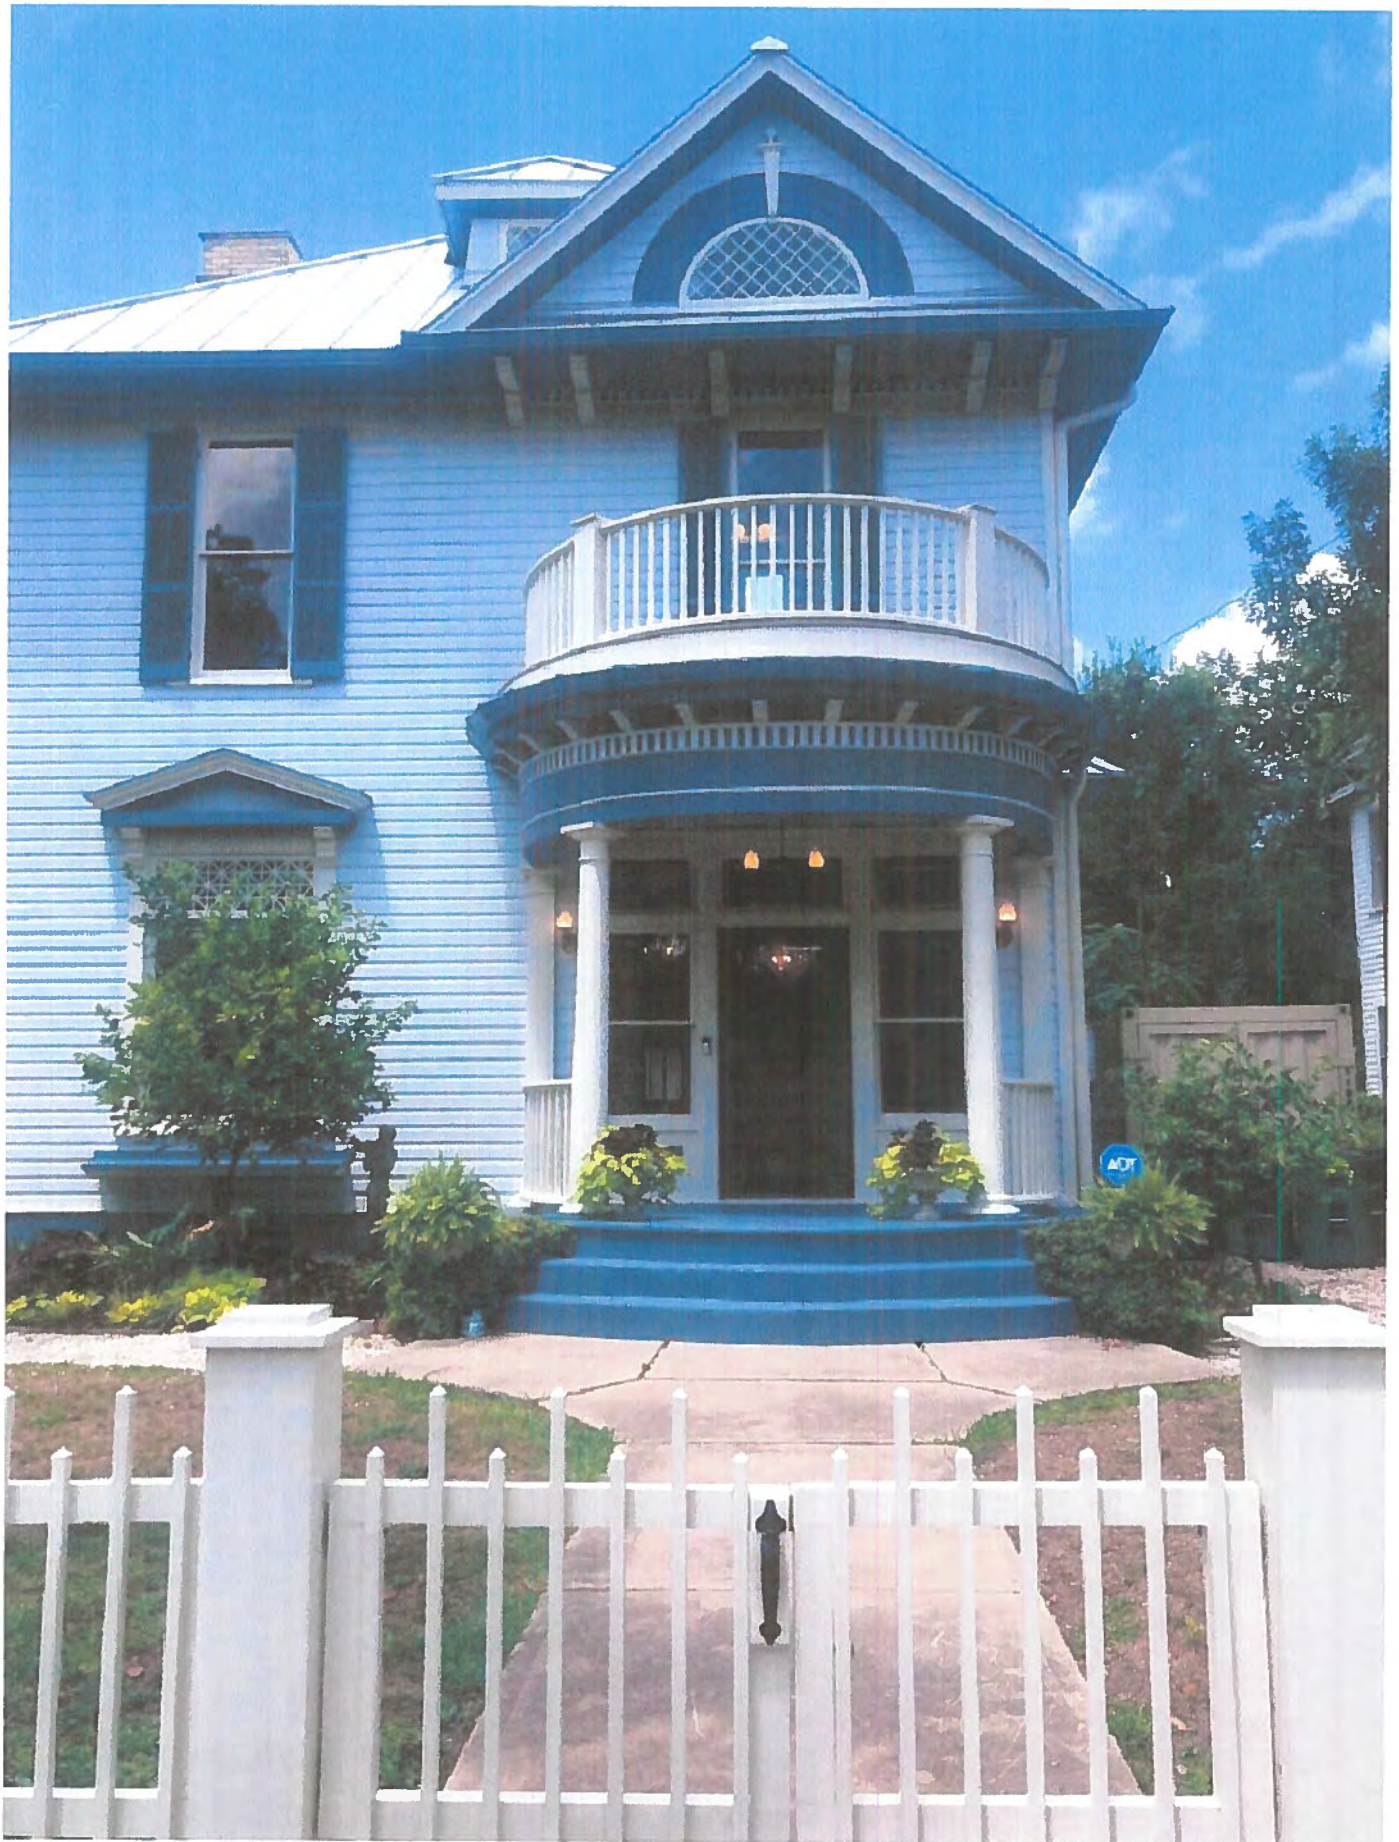
Exterior Front of House
New paint & maintenance

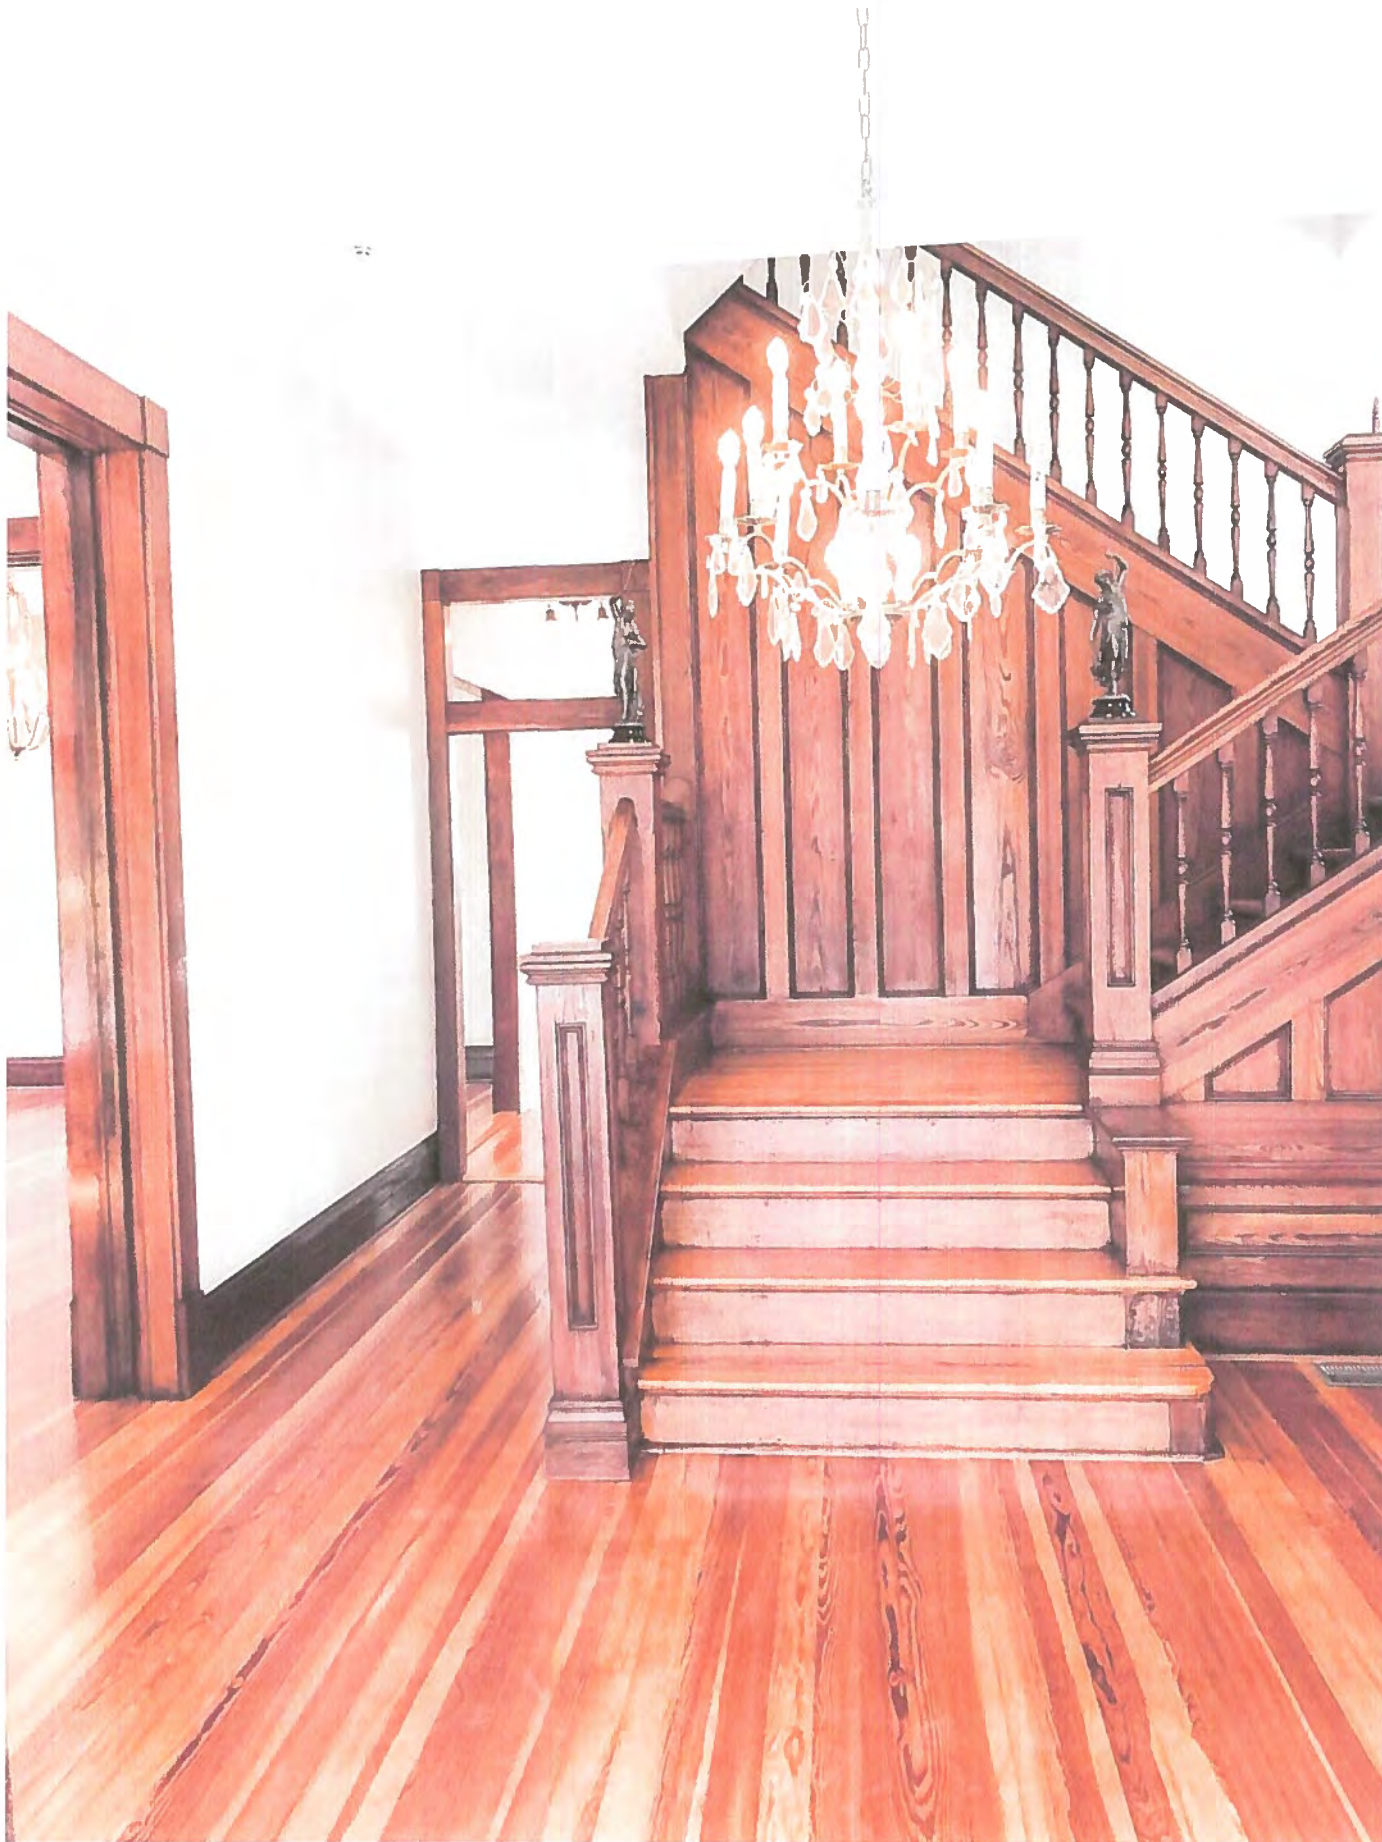
1st Floor Entrance

New paint, hallway wall and door removed, hall transom restored, furr downs removed & HVAC supply relocated to floor.

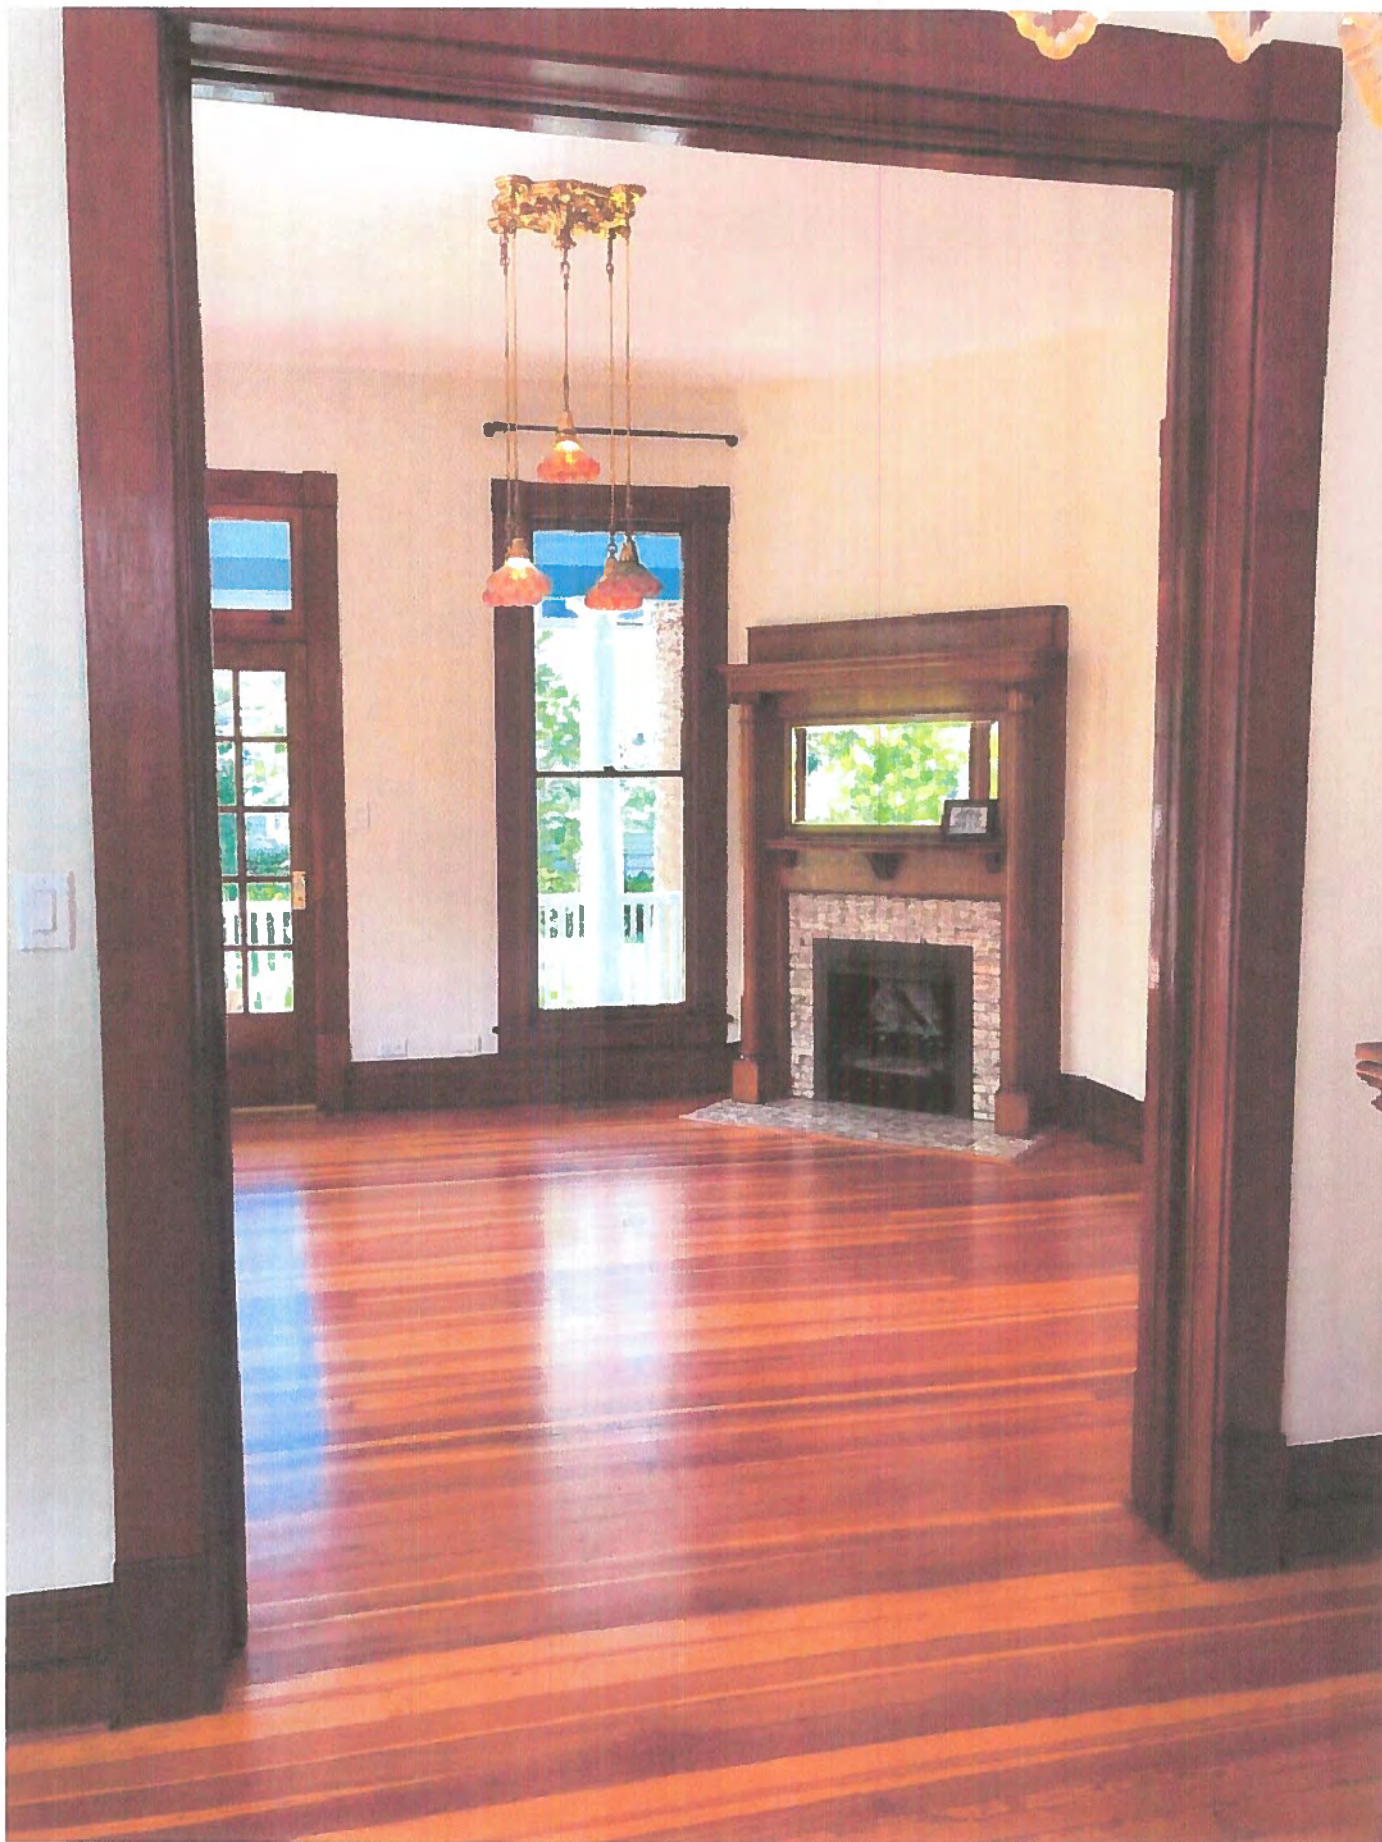
1st Floor Entrance & Parlor
New paint & furr downs removed & HVAC supply relocated to floor.
