HISTORIC AND DESIGN REVIEW COMMISSION

HDRC CASE NO: 2019-575
ADDRESS: 119 ADAMS ST
LEGAL DESCRIPTION: NCB 931 BLK LOT 17 AND 18
ZONING: RM-4,HS, H
CITY COUNCIL DIST.: 1
DISTRICT: King William Historic District
LANDMARK: Koehler House
APPLICANT: Nicole Corwin/Tatanka
OWNER: Jarod and Celeste Oliver
TYPE OF WORK: Historic Tax Verification
APPLICATION RECEIVED: September 24, 2019
60-DAY REVIEW: November 23, 2019
CASE MANAGER: Huy Pham
REQUEST:

The applicant is requesting Historic Tax Verification for the property at 119 Adams.

119 Adams

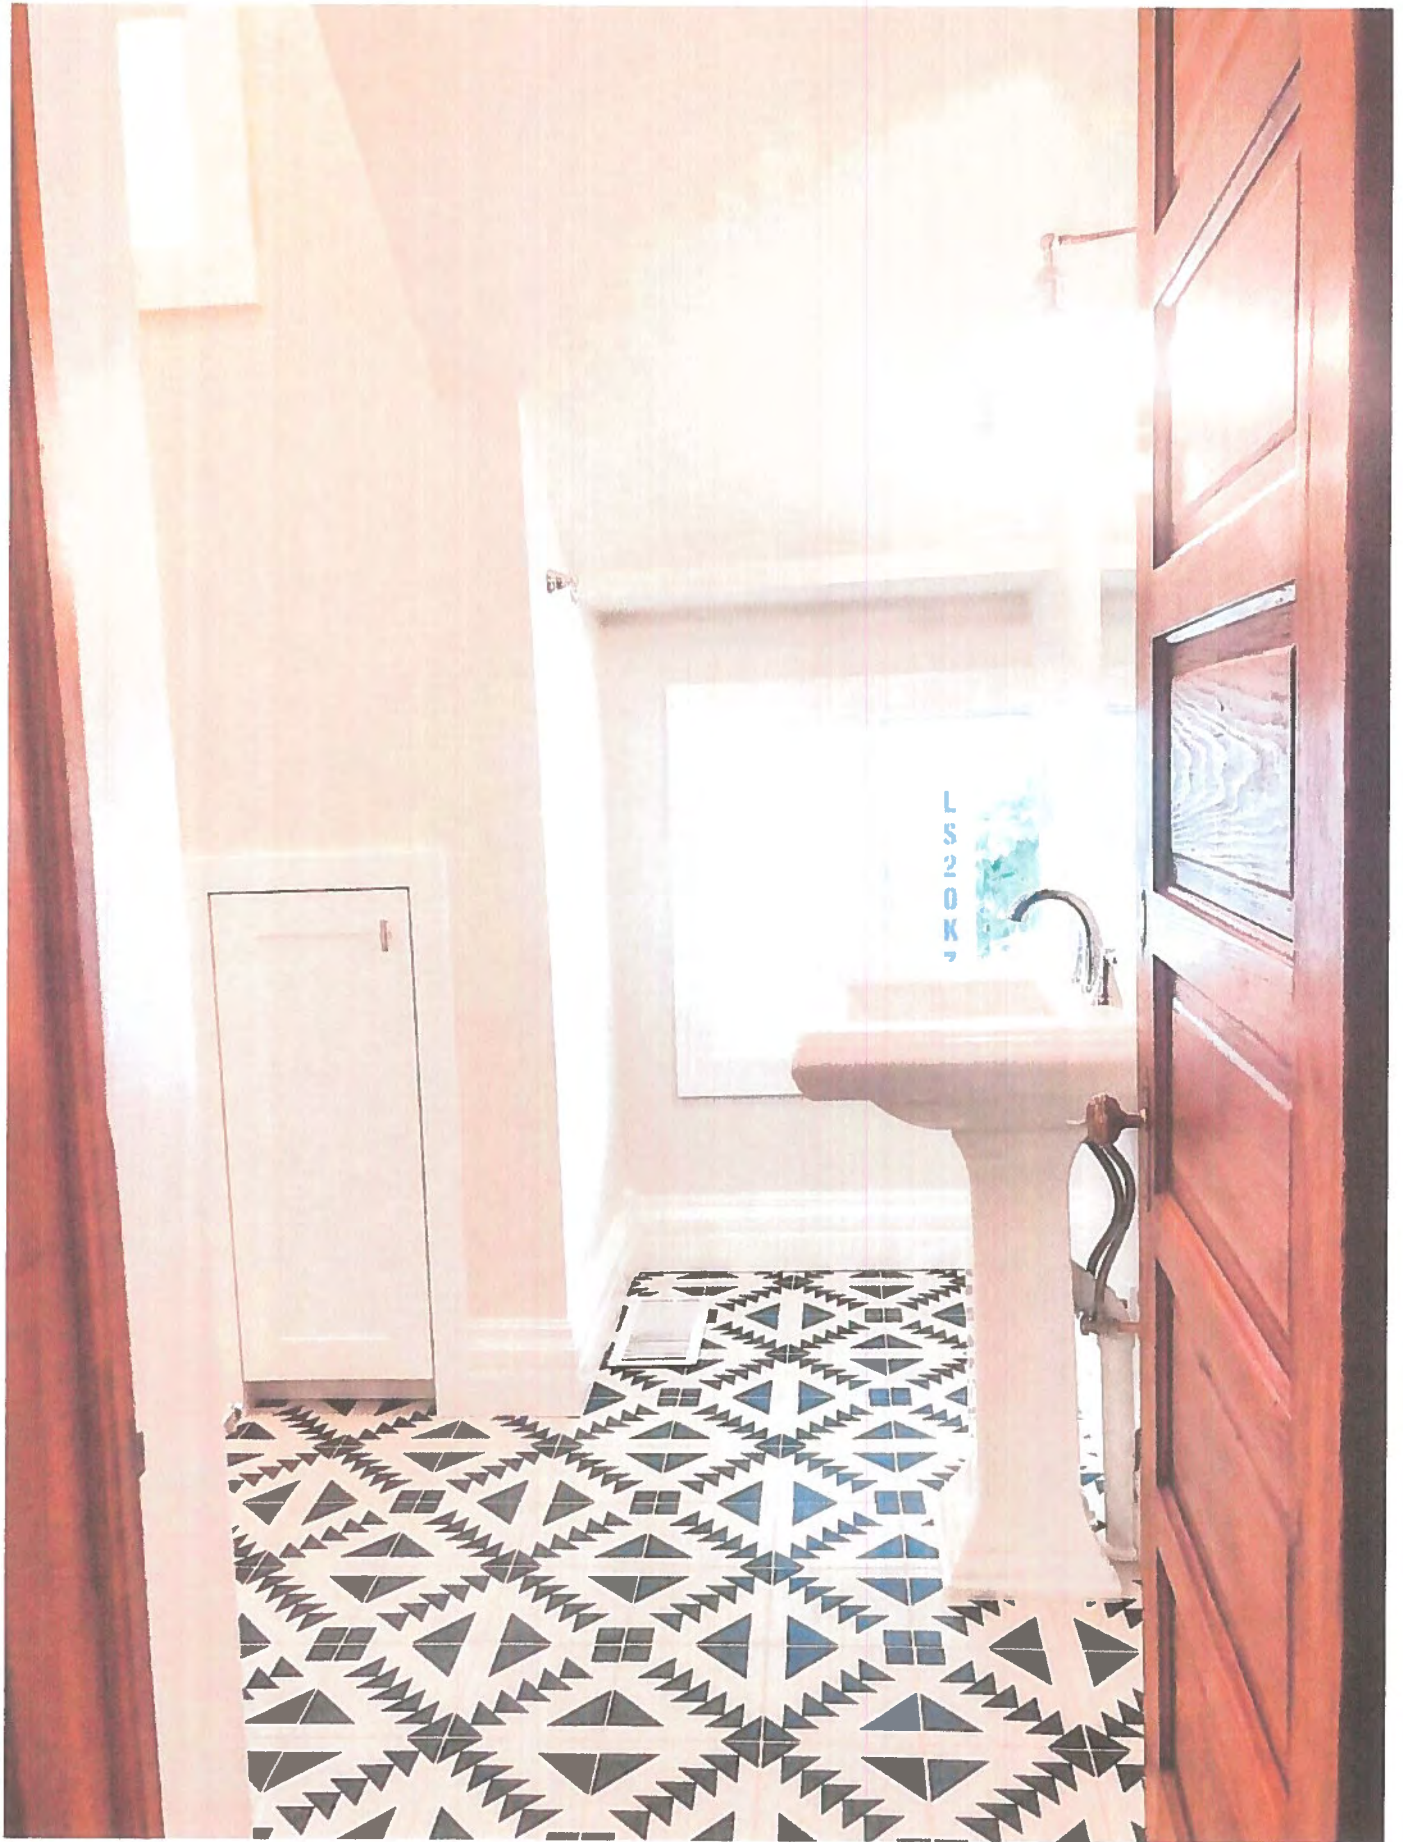
1st Powder Room

New Layout, all new fixtures and finishes, relocated door and restored existing window.

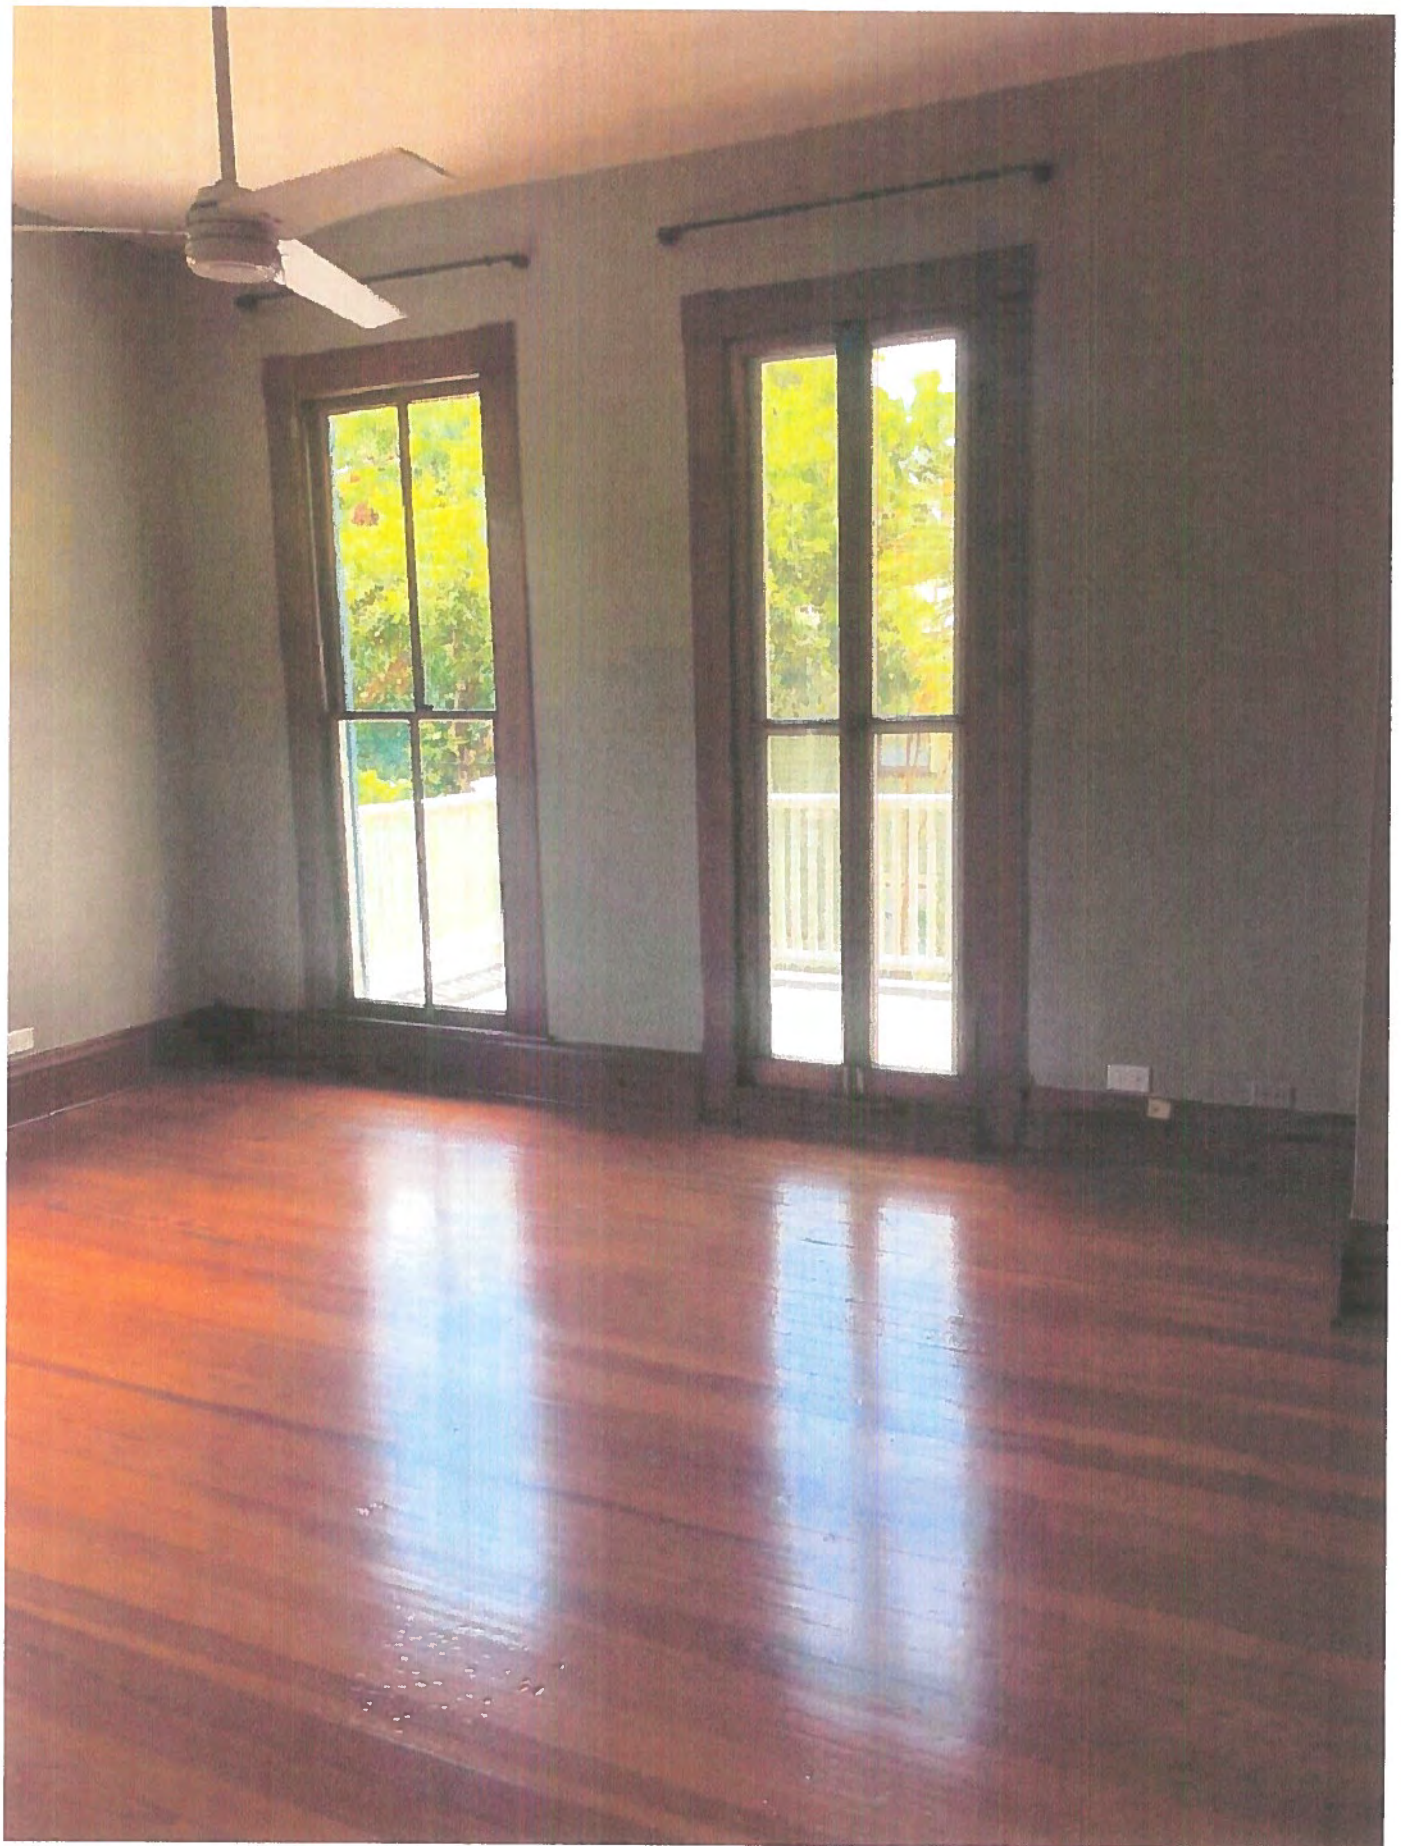
2nd Floor Guest Bedroom
New Paint, Window and Balcony Repair

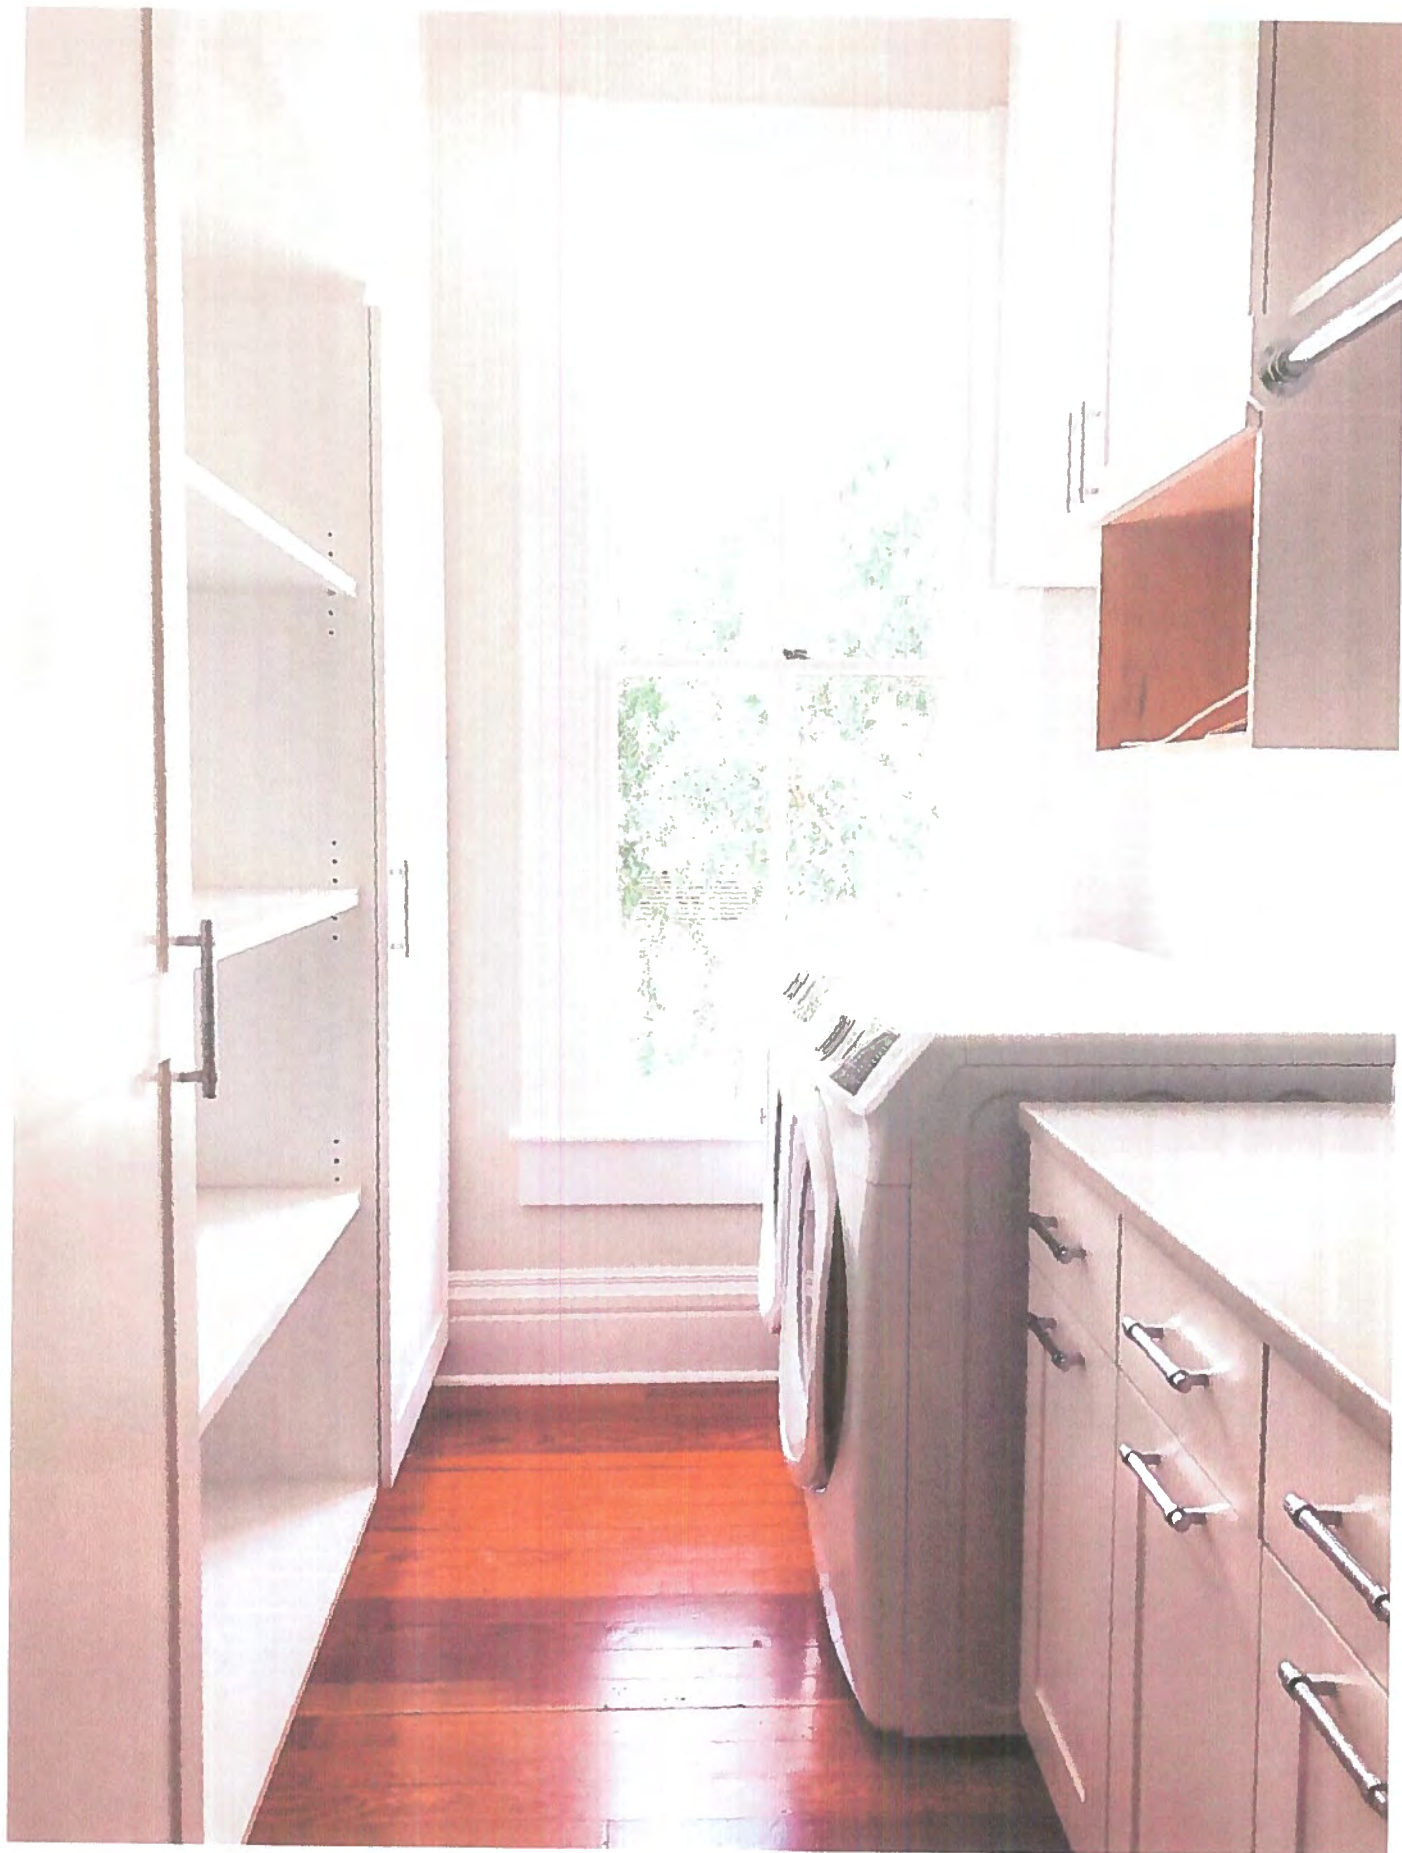
2nd Floor Laundry Room

New, previous laundry was in a closet on the 1st floor. All new fixtures and finishes. Original wood floor.

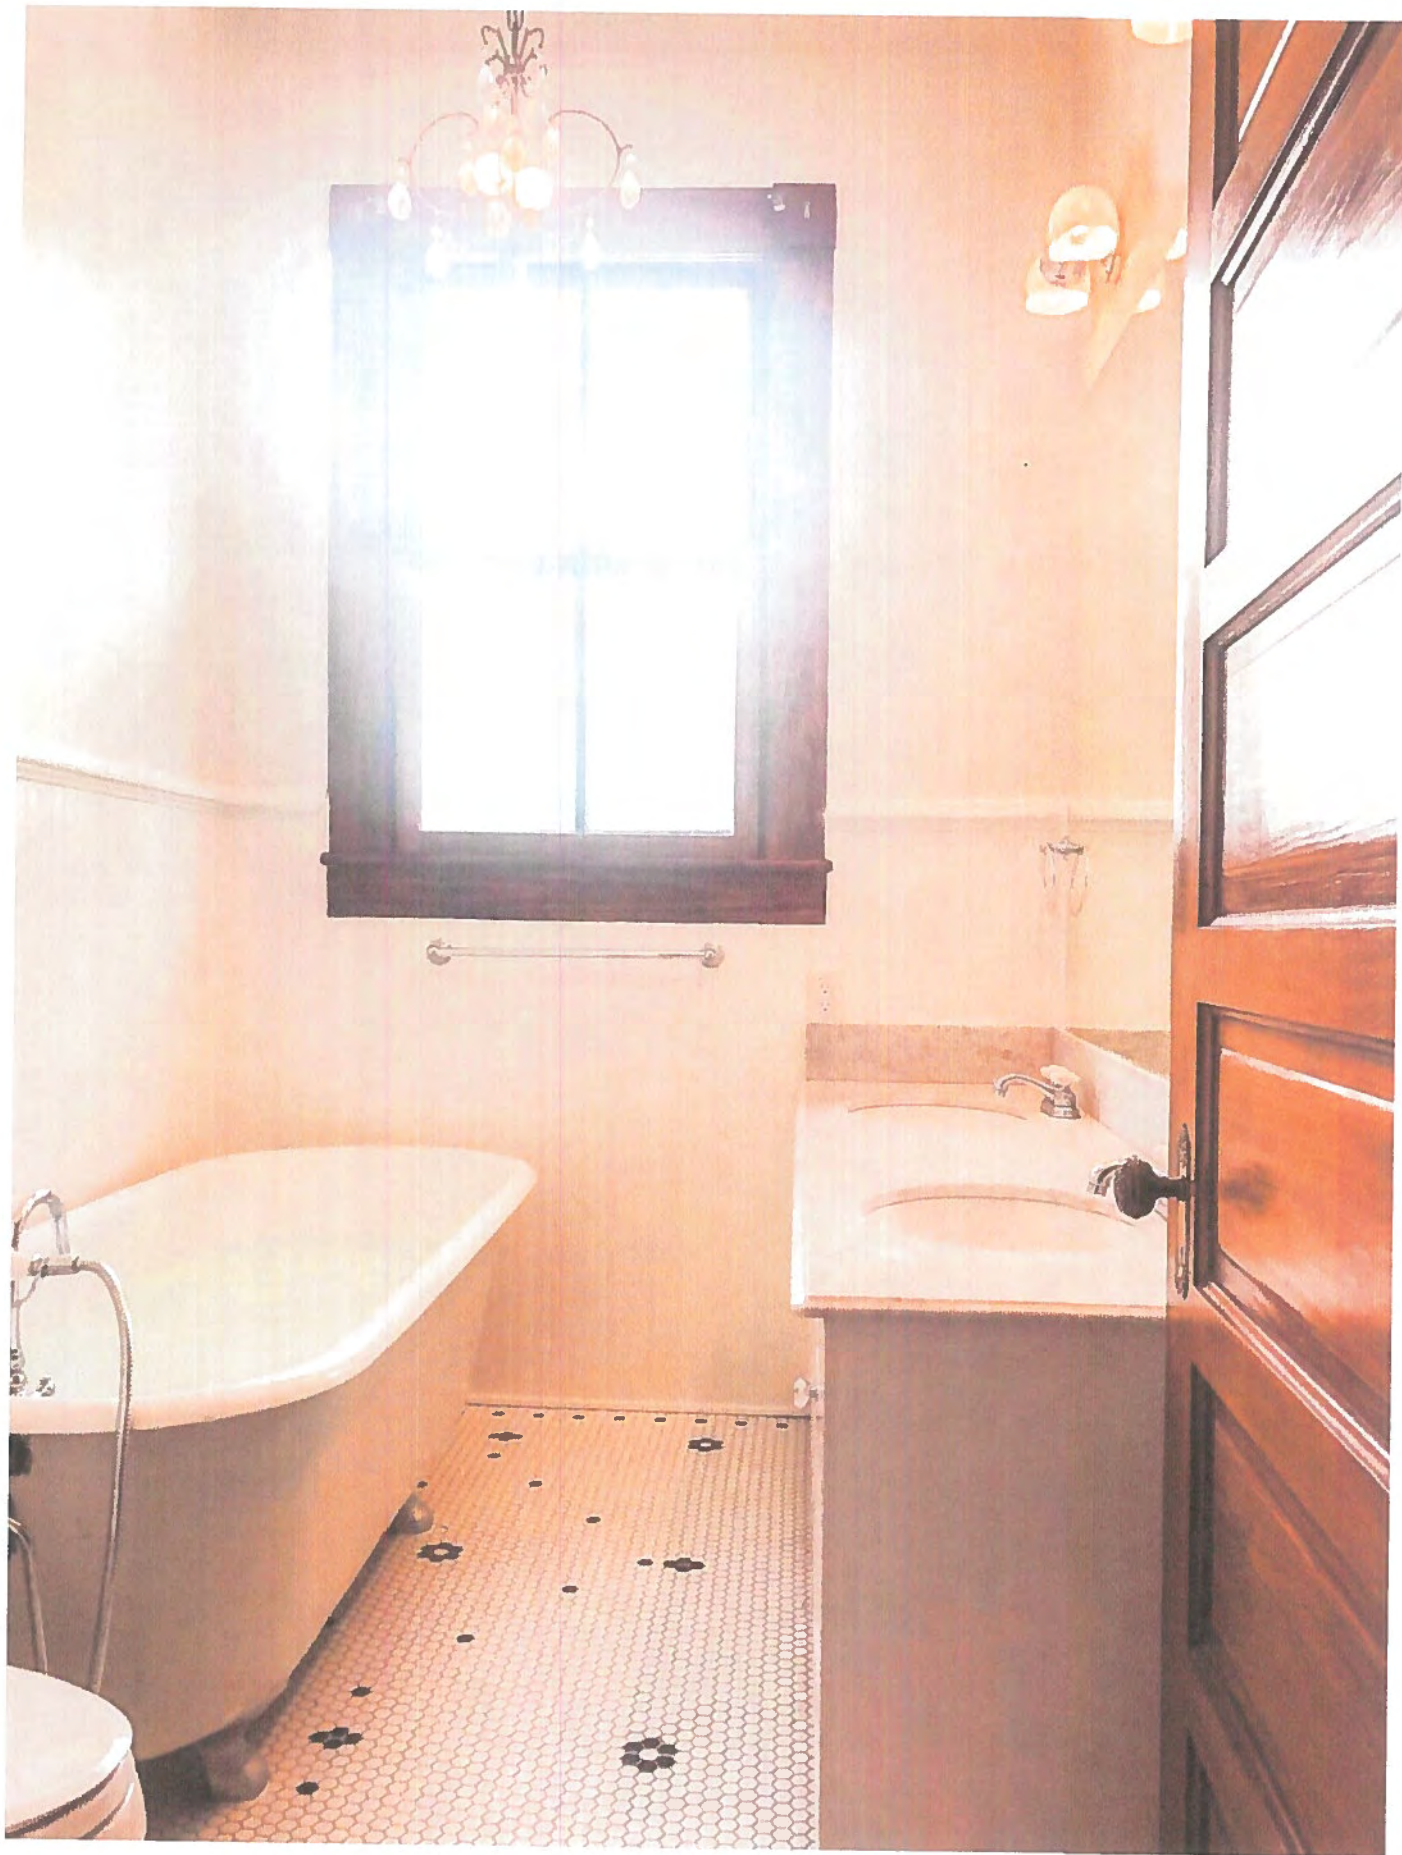
2nd Floor Guest Bathroom B
New flooring and paint, restored and repaired fixtures.

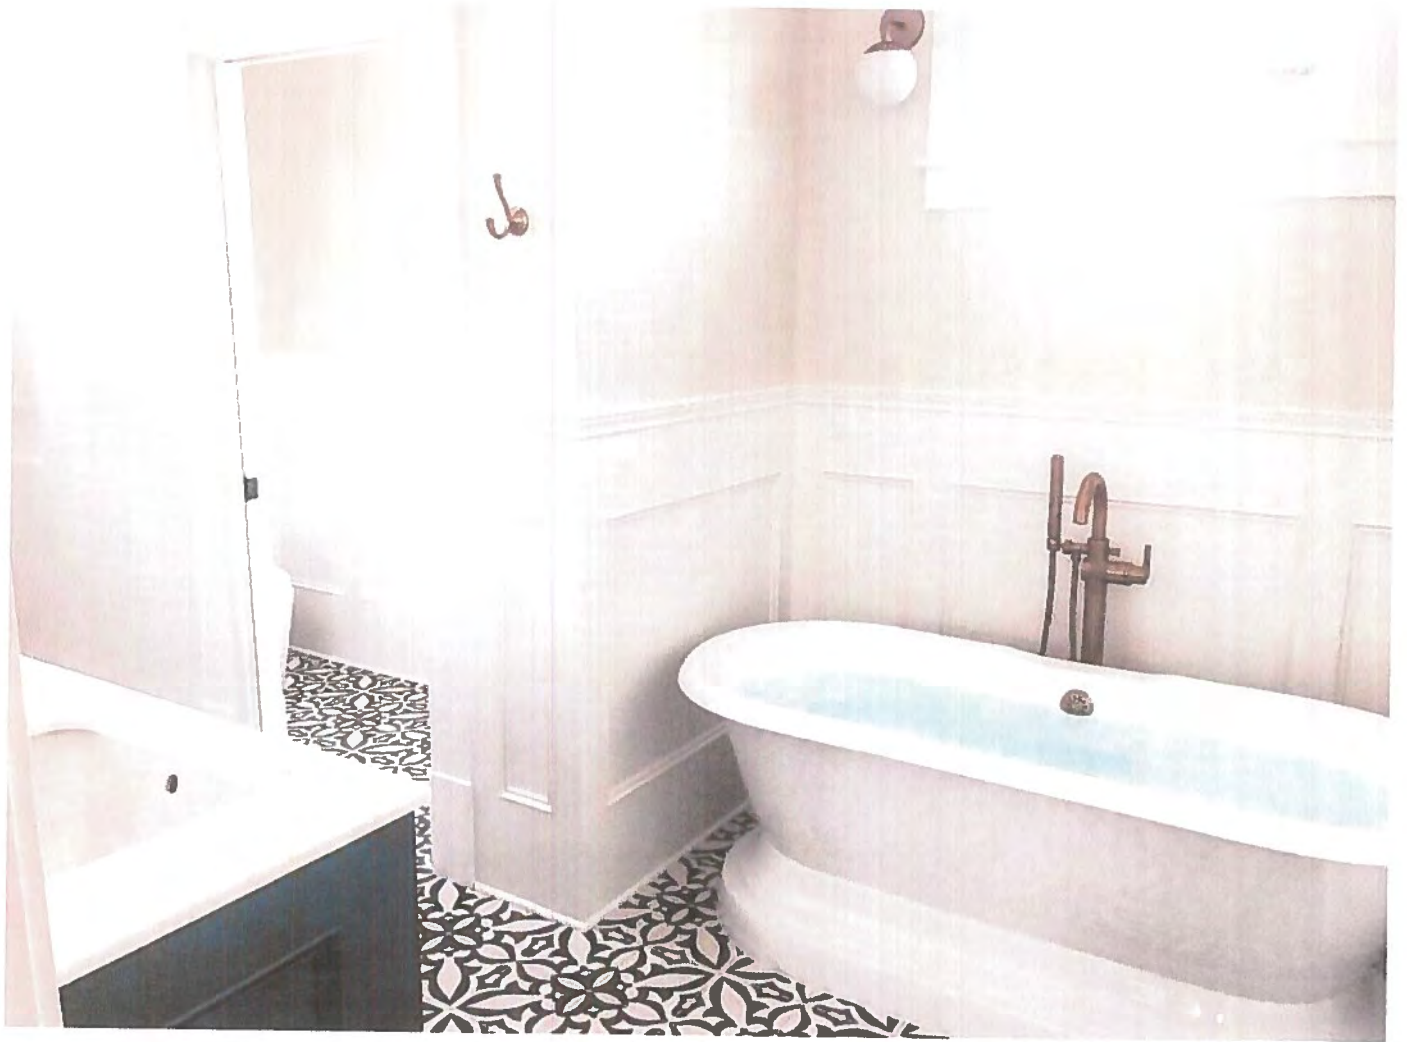
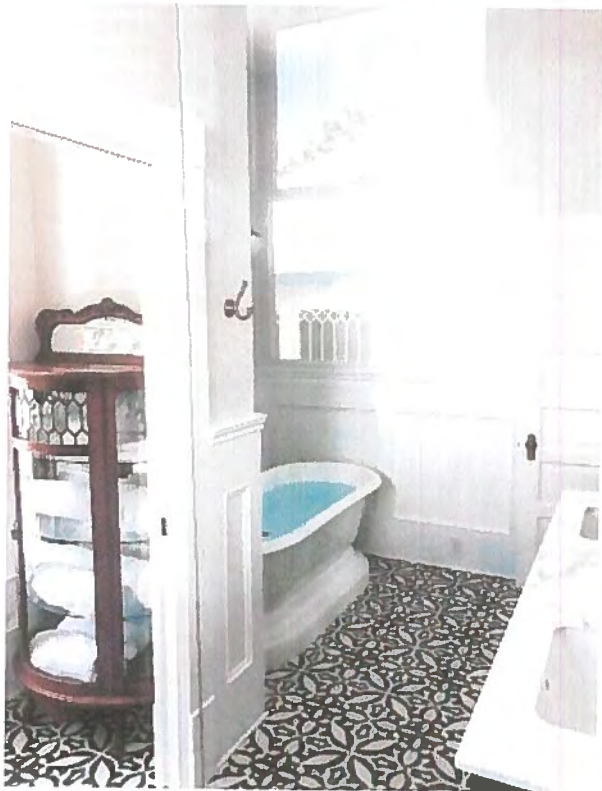
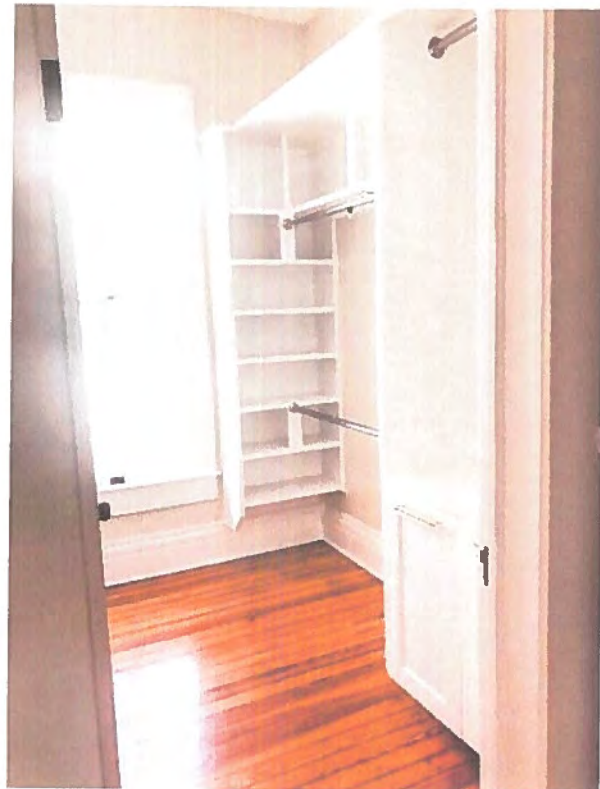
2nd Floor Master Bathroom & Closet
New layout and all new finishes and fixtures. Relocated historic leaded window above tub. Original flooring in closet.

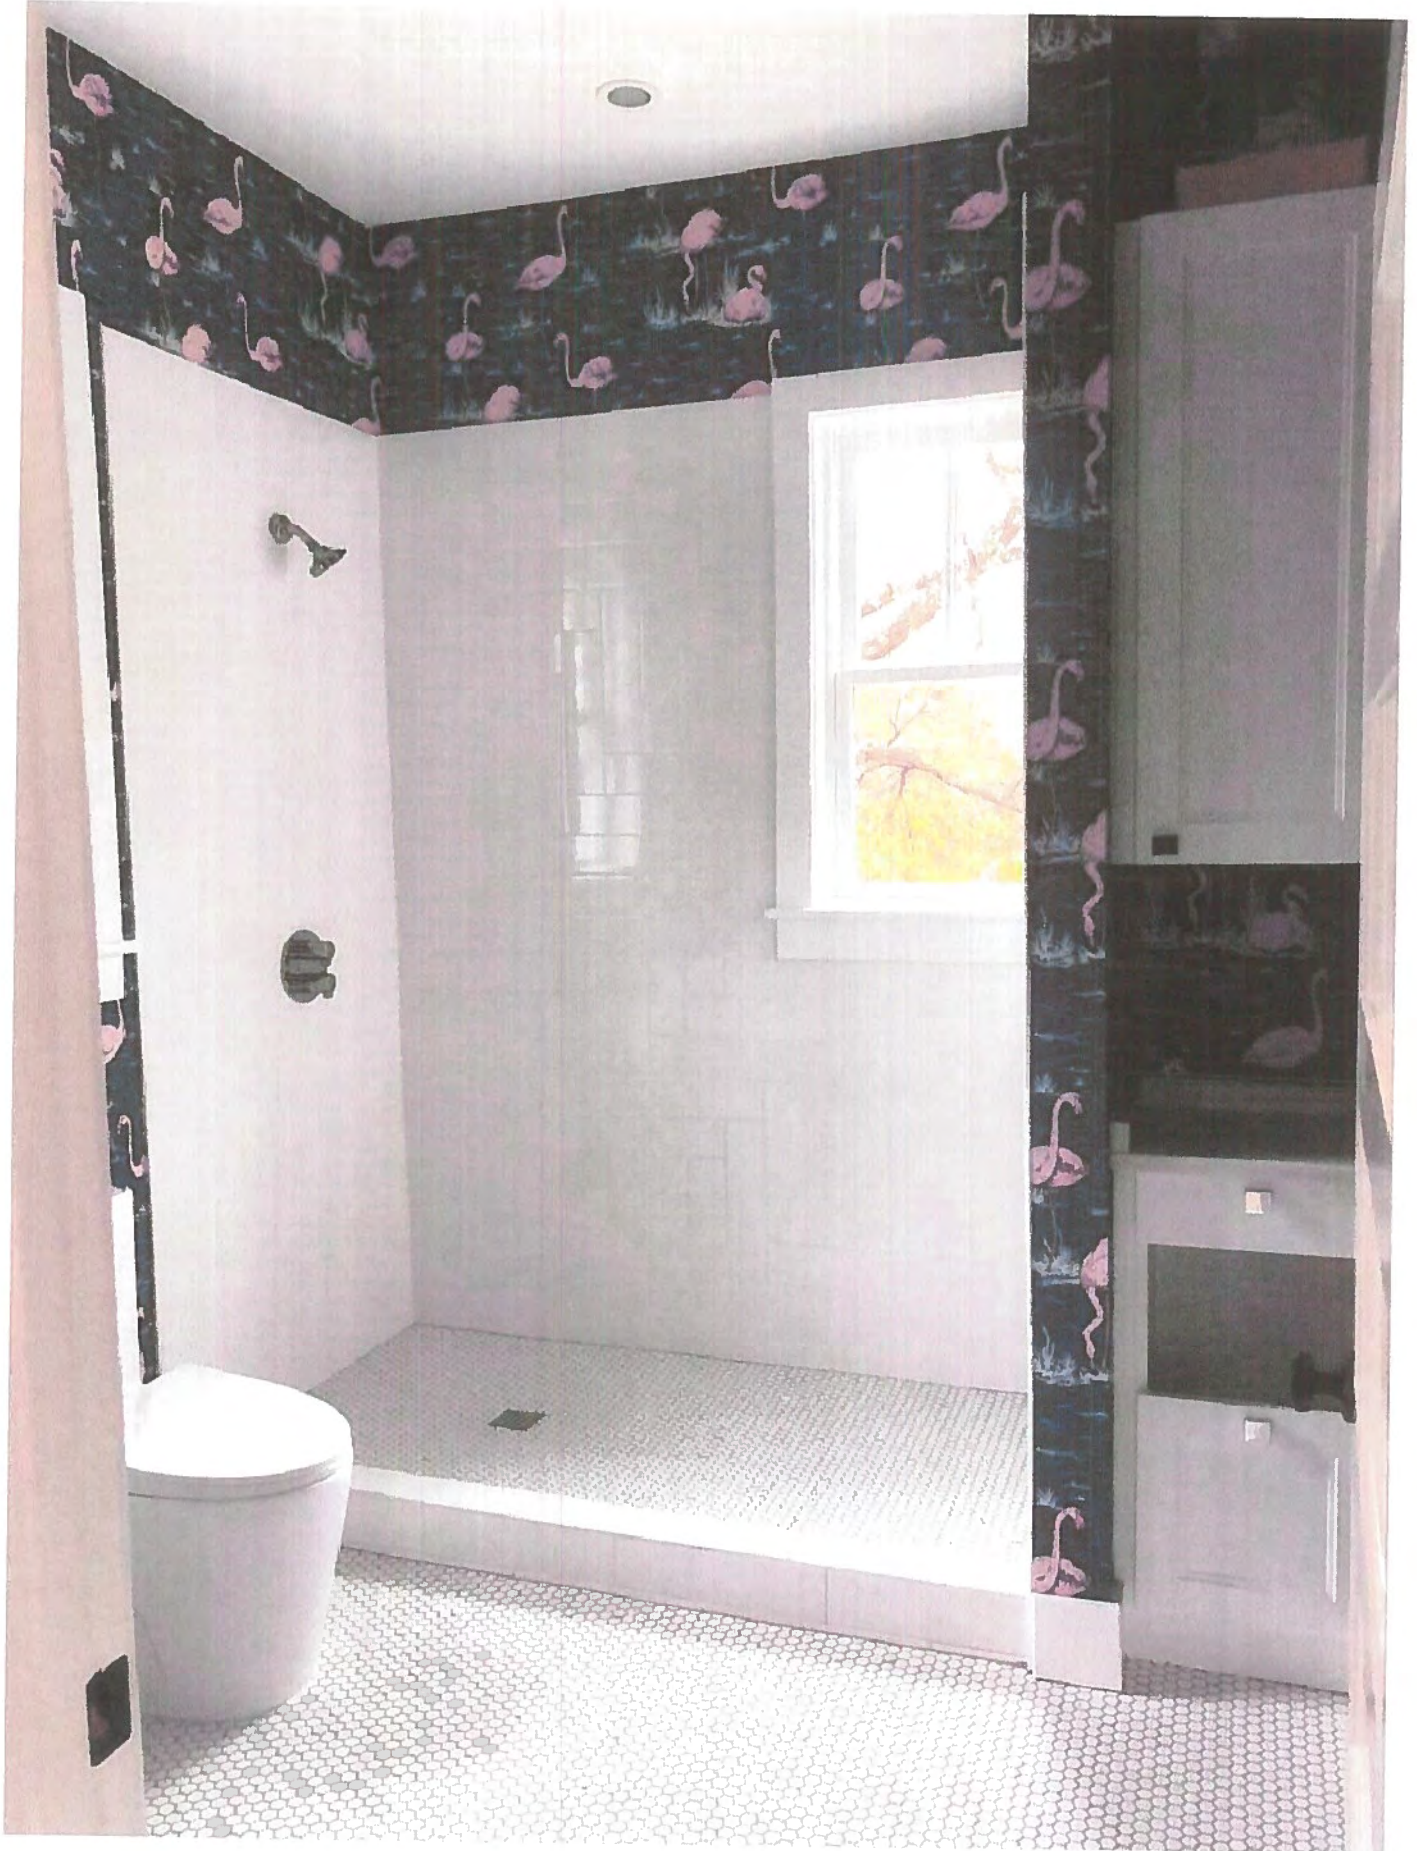
Accessory Dwelling Bathroom
New, Relocated Original Window

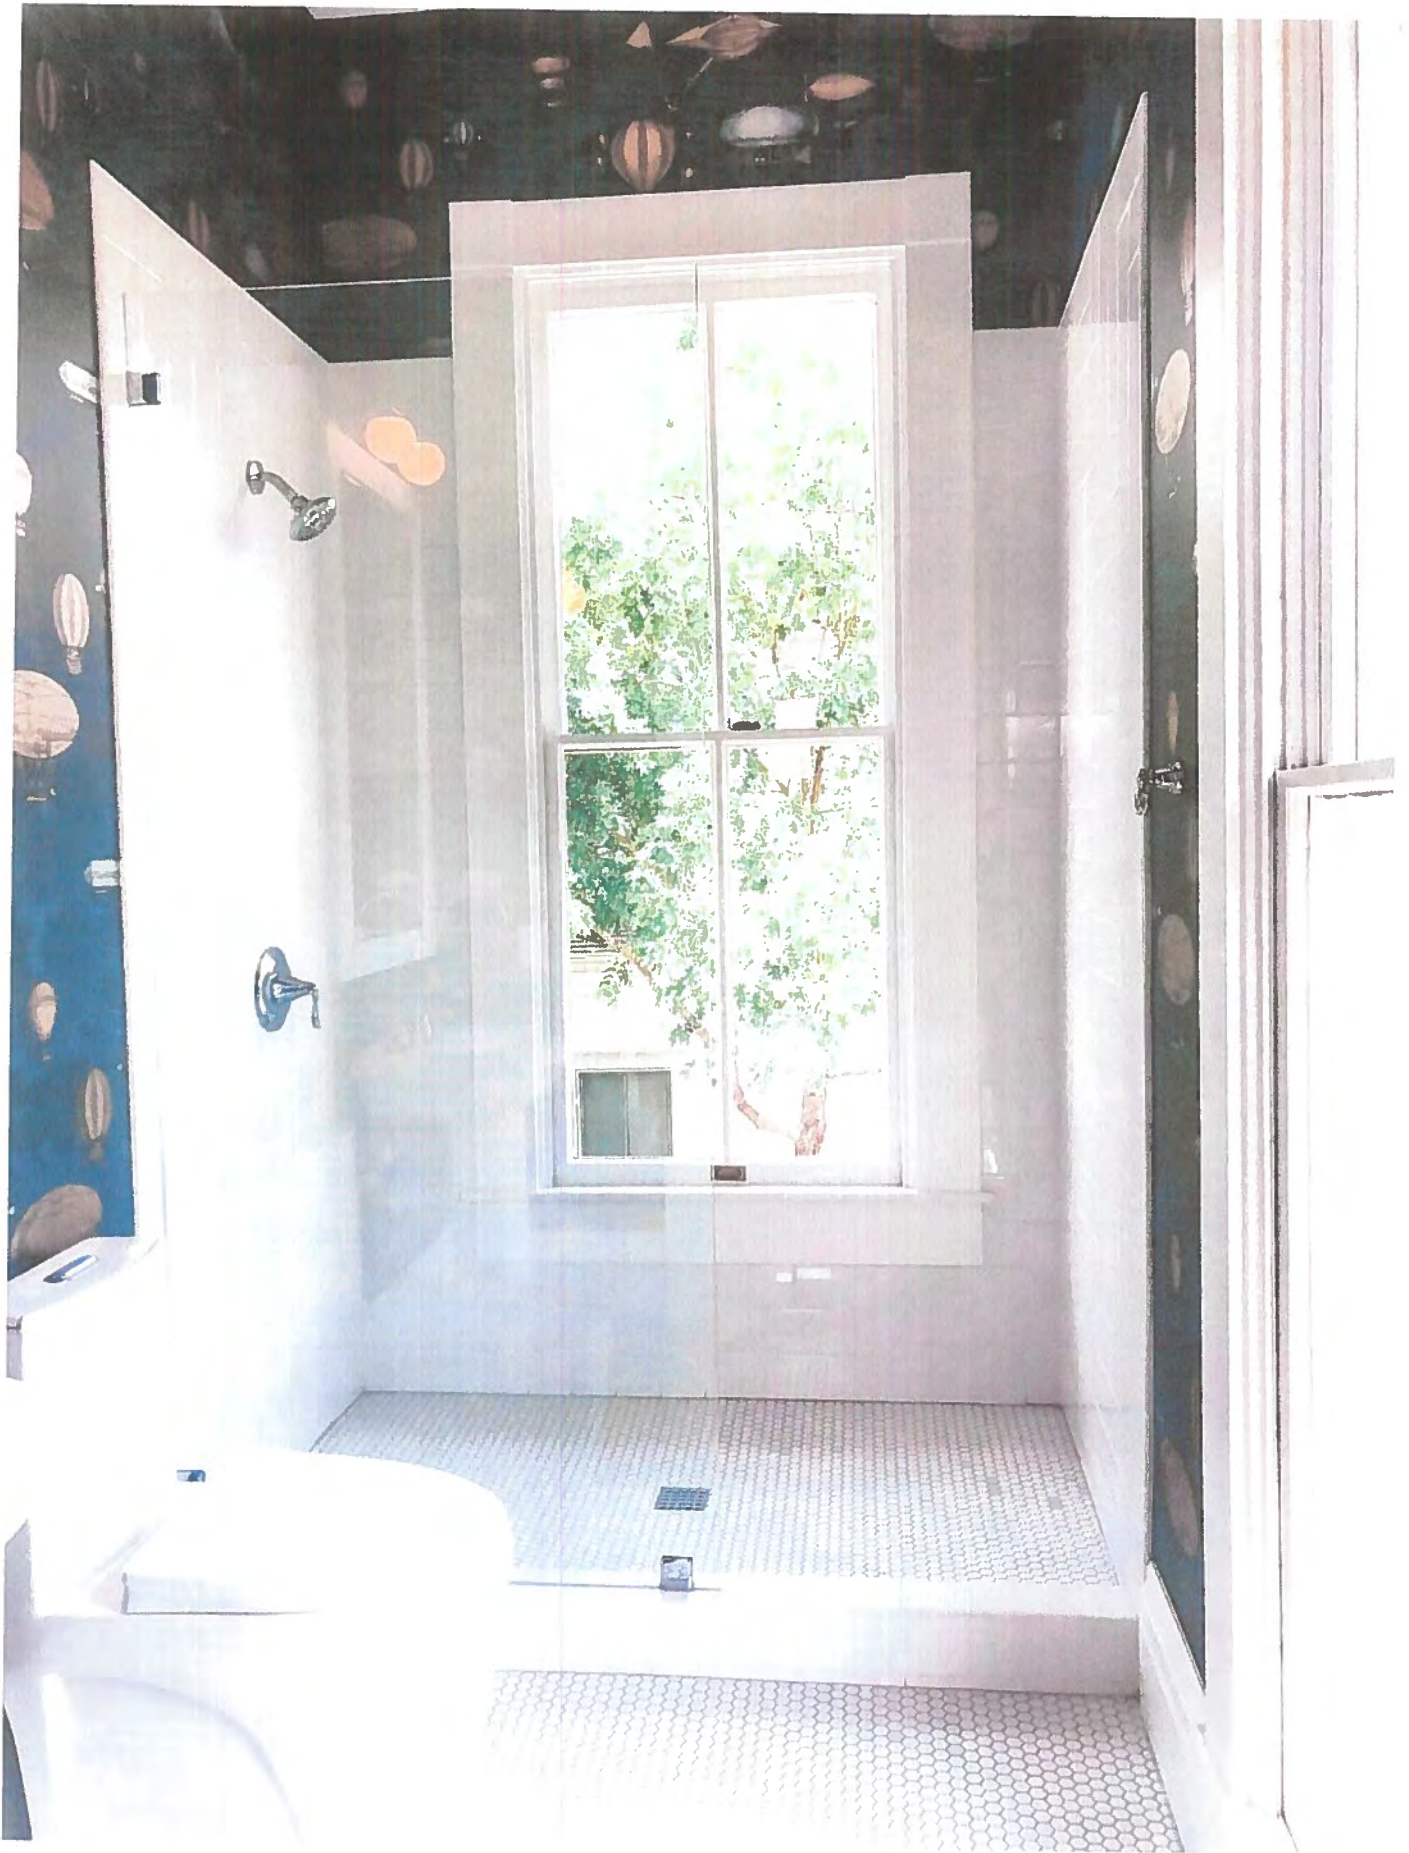
2nd Floor Guest Bathroom A
New layout and all new finishes and fixtures. Relocated original window to shower.
