HISTORIC AND DESIGN REVIEW COMMISSION

January 15, 2020

HDRC CASE NO: 2019-603
ADDRESS: 219 ADAMS ST
216 WICKES
218 WICKES
LEGAL DESCRIPTION: NCB 942 BLK 1 LOT 5
ZONING: RM-4, RM-4,HS
CITY COUNCIL DIST.: 1
DISTRICT: King William Historic District
LANDMARK: Le Laurin House
APPLICANT: Don Fry/RIVER CITY LOANS INC
OWNER: RIVER CITY LOANS INC
TYPE OF WORK: Demolition of primary structure addressed 216/218 Wickes with construction of a parking lot
APPLICATION RECEIVED: November 01, 2019
60-DAY REVIEW: December 31, 2019; 30 day decision period – January 30, 2019
CASE MANAGER: Stephanie Phillips
REQUEST:

1. Demolish the contributing primary structure addressed 216-218 Wickes.
2. Construct a rear parking pad to include spaces for six vehicles.

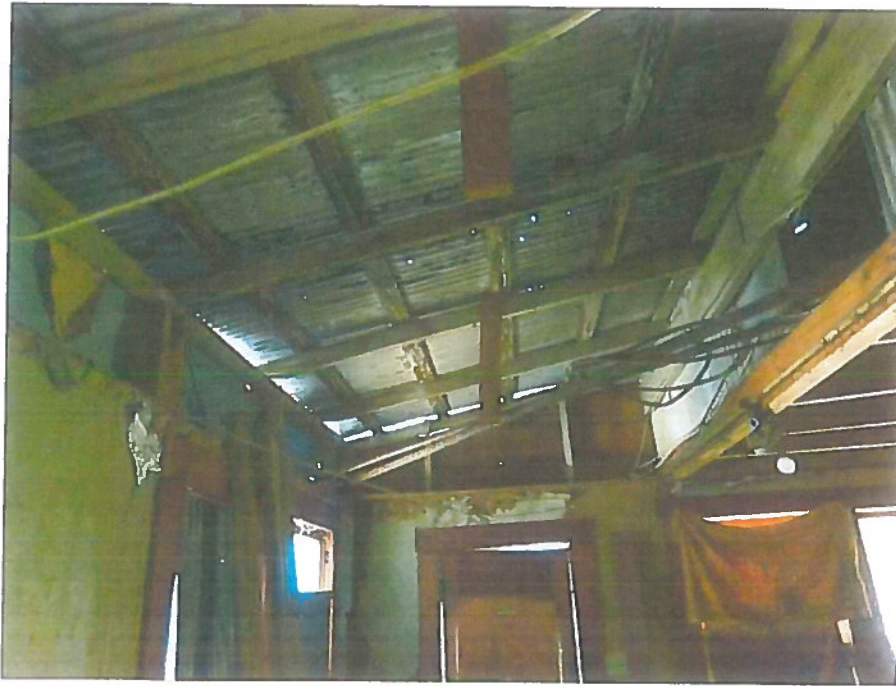
Fig. 1. Interior rafters, pinholes in corrugated roof.

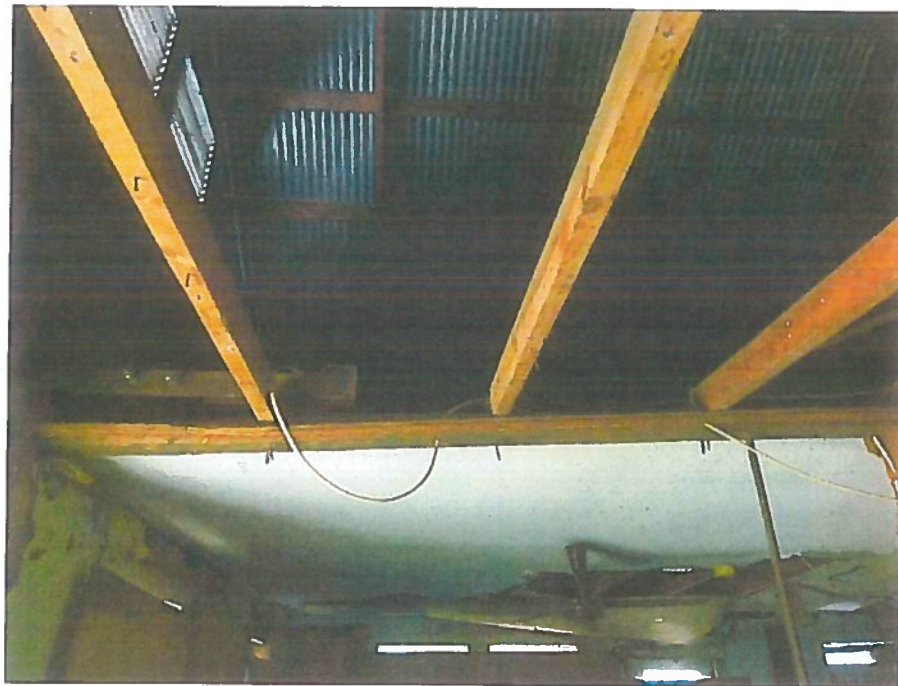
Fig 2: Ceiling joists resting on single top plate, at missing stud wall.

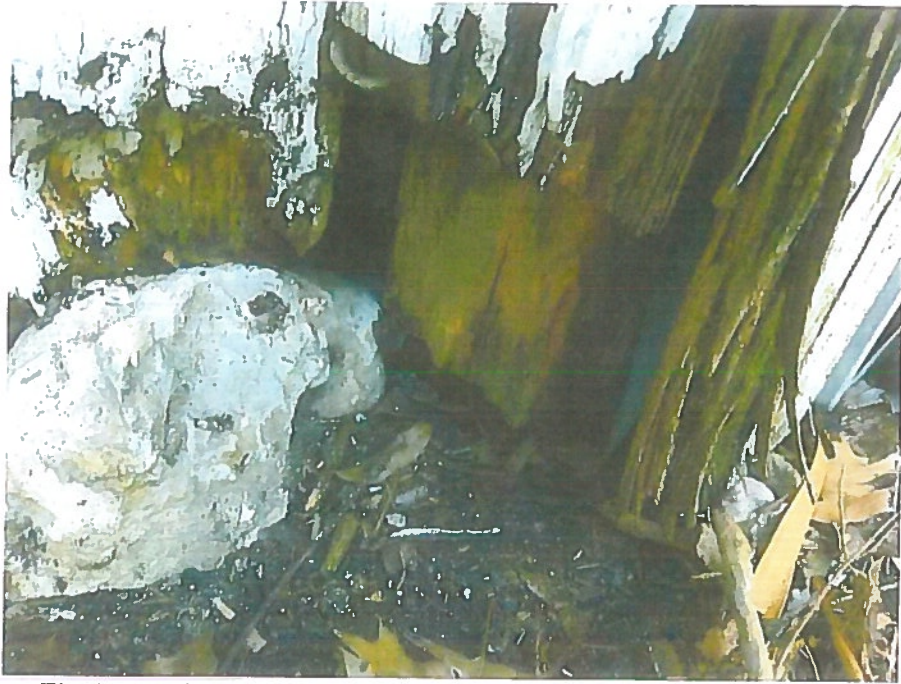
Fig. 3: Exterior post at side door deteriorated. No bottom plate or beam, concrete rubble used to shim gap.

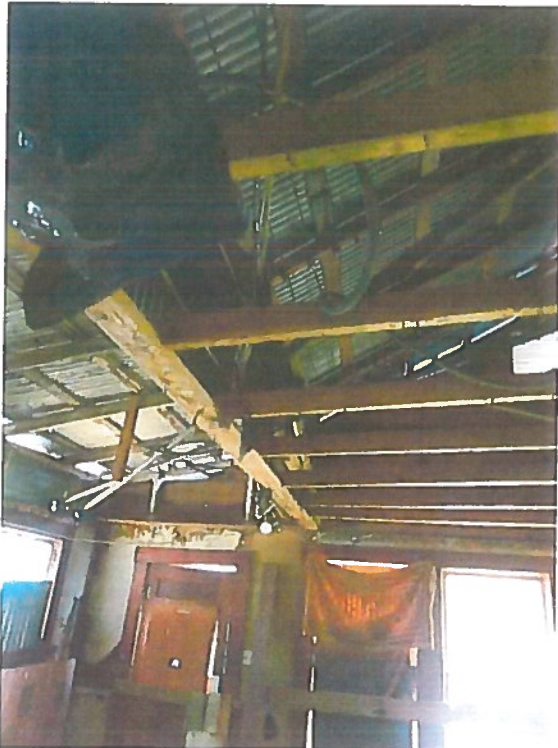
Fig. 4: Rafters and ceiling joists resting on top plate of another missing wall

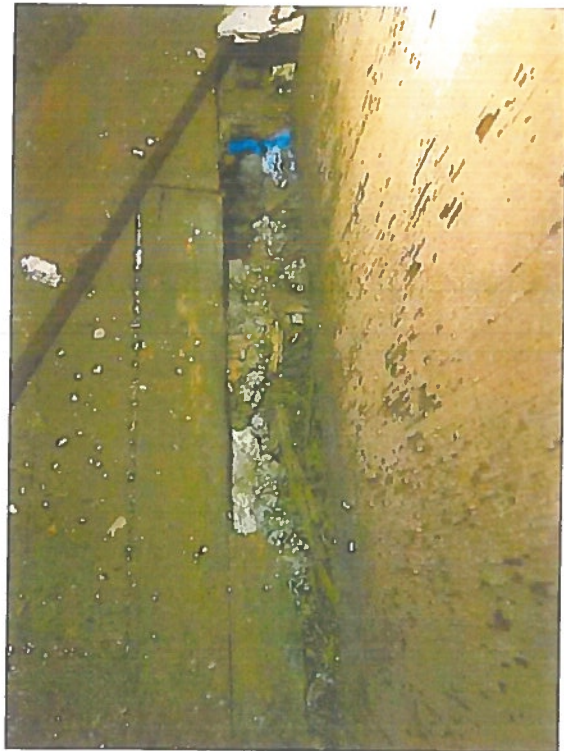
Fig. 5: Floor joists and beam disintegrated at exterior wall, sack concrete used as filler.

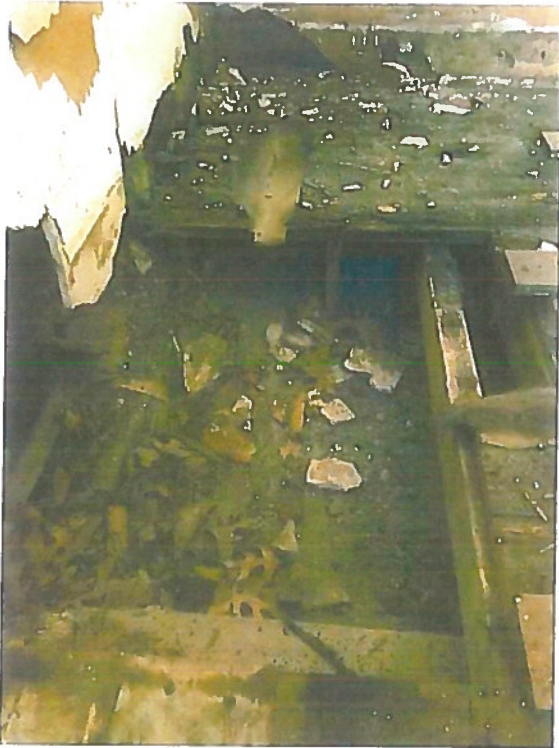
Fig. 6: Interior studs and floor deck deteriorated

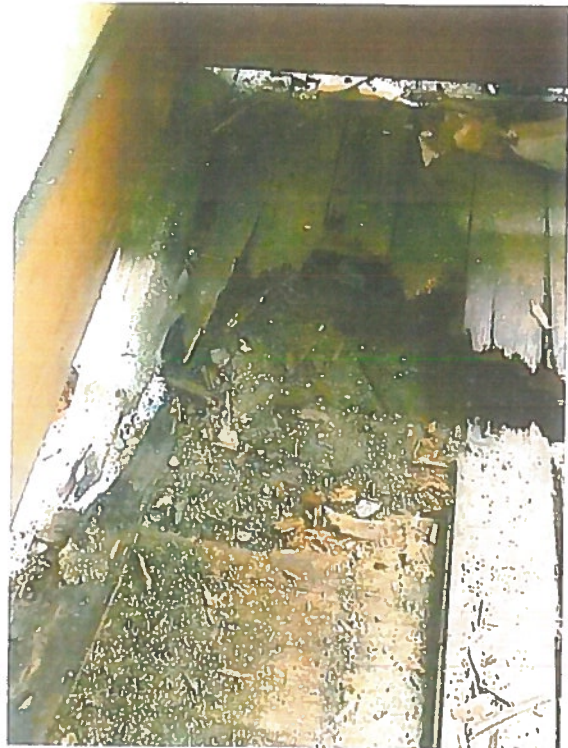
Fig 7: Floor deck disintegrated at exterior corner, no evidence of structural framing support

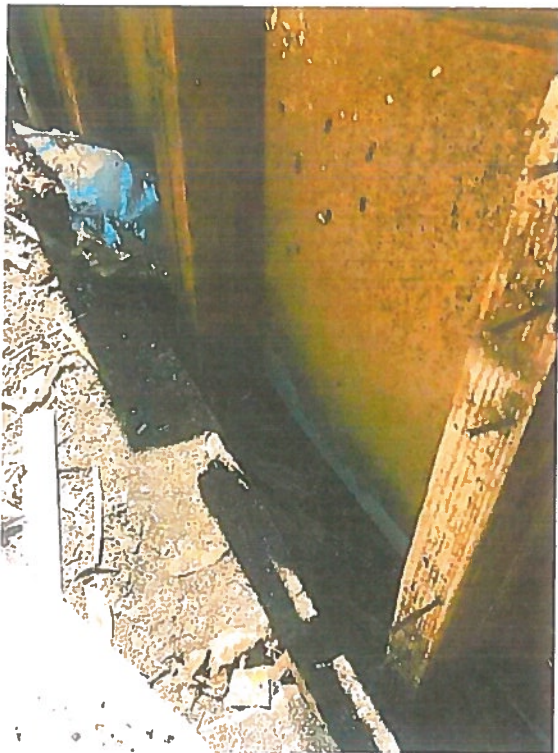
Fig 8: Exterior studs founded on soil below grade.

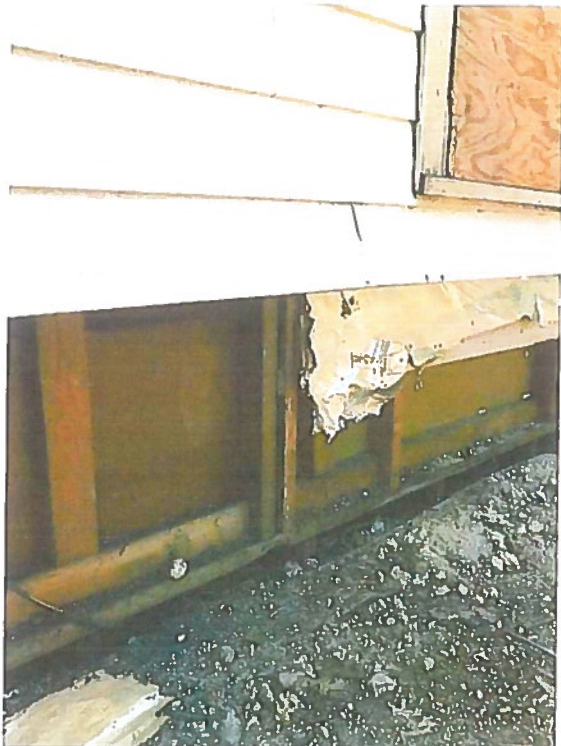
Fig. 9: Exterior joists resting on soil and below grade.

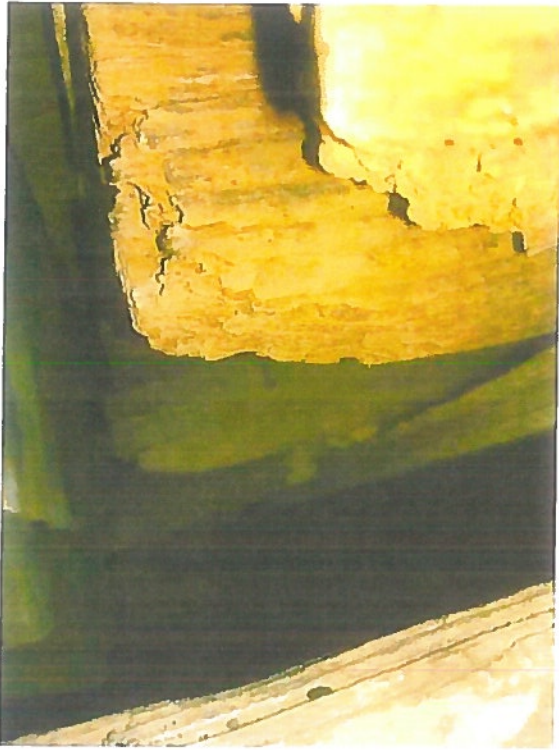
Fig 10: End of floor joist condition, separated from interior wall and beam.
