HISTORIC AND DESIGN REVIEW COMMISSION

May 01, 2020

HDRC CASE NO: 2020-122
ADDRESS: 533 E CARSON
LEGAL DESCRIPTION: NCB 993 BLK 3 LOT S 96.91 FT 7 (ARB 7C)
ZONING: MF-33, H
CITY COUNCIL DIST.: 2
DISTRICT: Government Hill Historic District
APPLICANT: Mary Jo Vargas/VARGAS MARY JOSEPHINE
OWNER: Mary Jo Vargas/VARGAS MARY JOSEPHINE
TYPE OF WORK: Siding and window replacement
APPLICATION RECEIVED: March 04, 2020
60-DAY REVIEW: May 03, 2020
CASE MANAGER: Huy Pham

533 E Carson

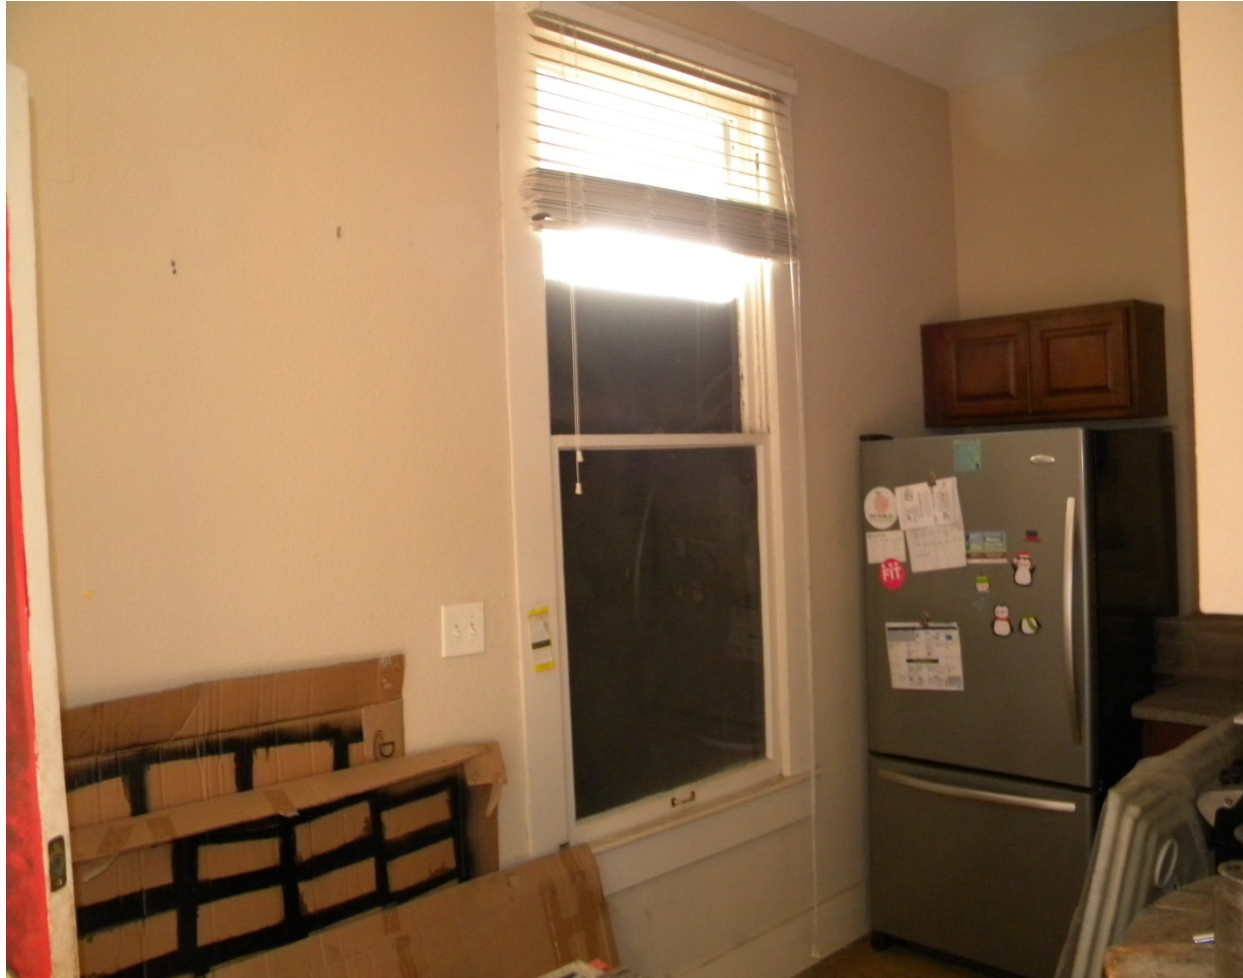
Unit I, Living Kitchen Window A

Faces front of property, requires lead paint remediation. If replaced, a 4 panel wood Pella window would be used.

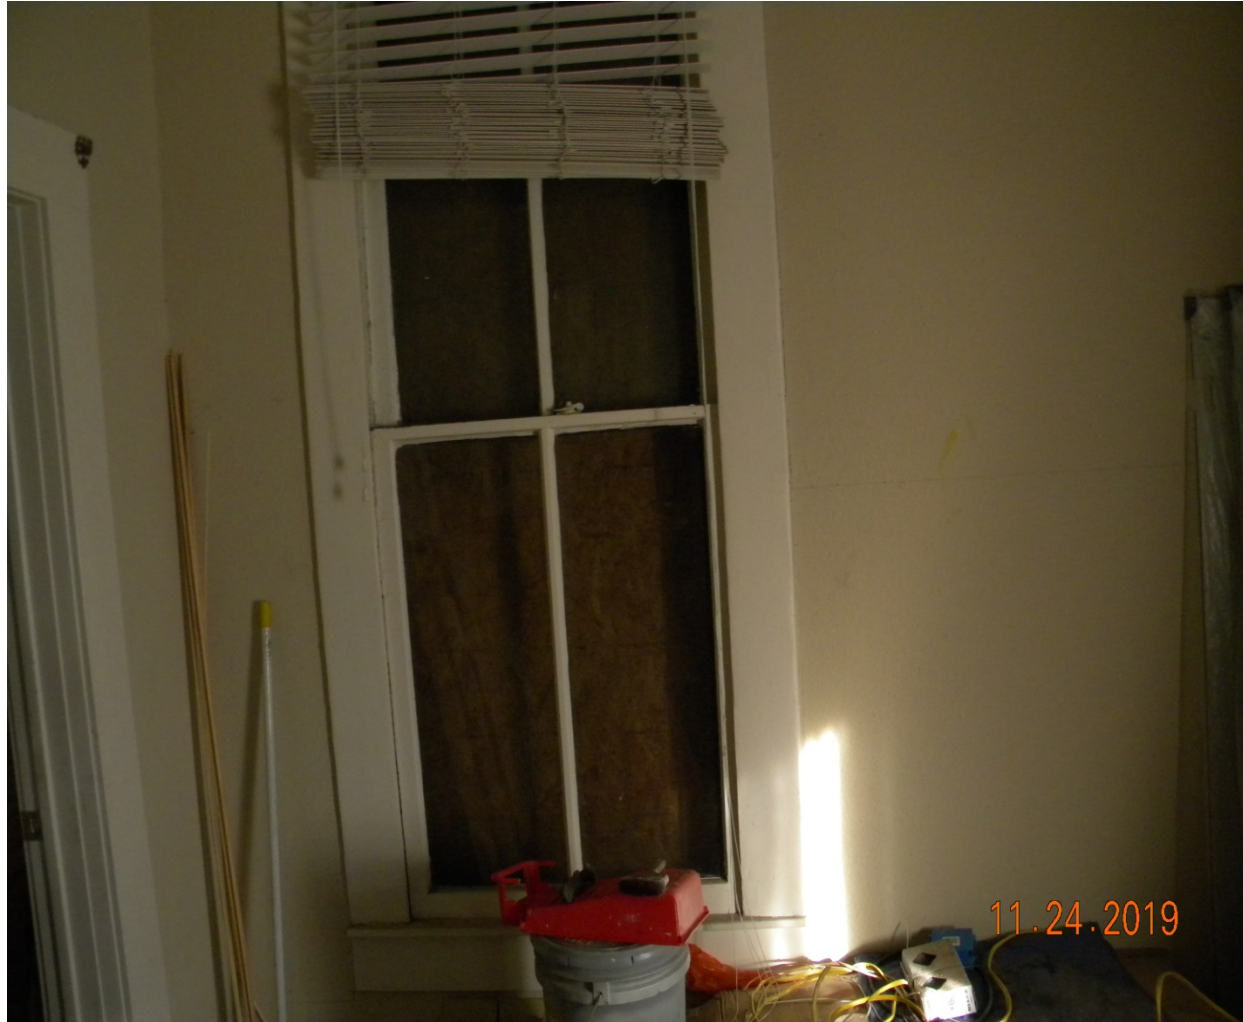
Unit I, Living Room, Window B

Requires lead
paint
remediation
and repairs.

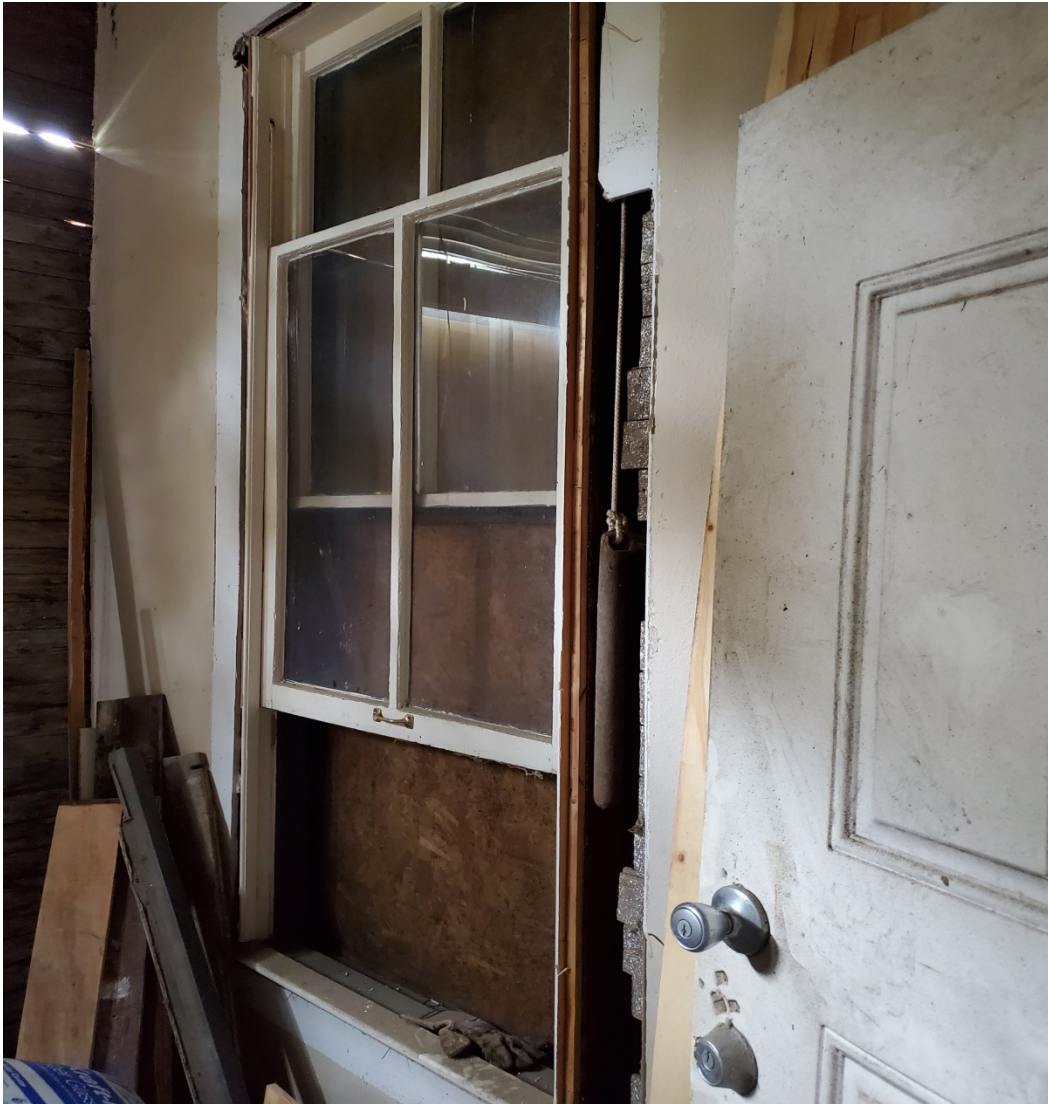
Unit I, Bedroom 1, Window C

Requires lead
paint
remediation
and repairs.

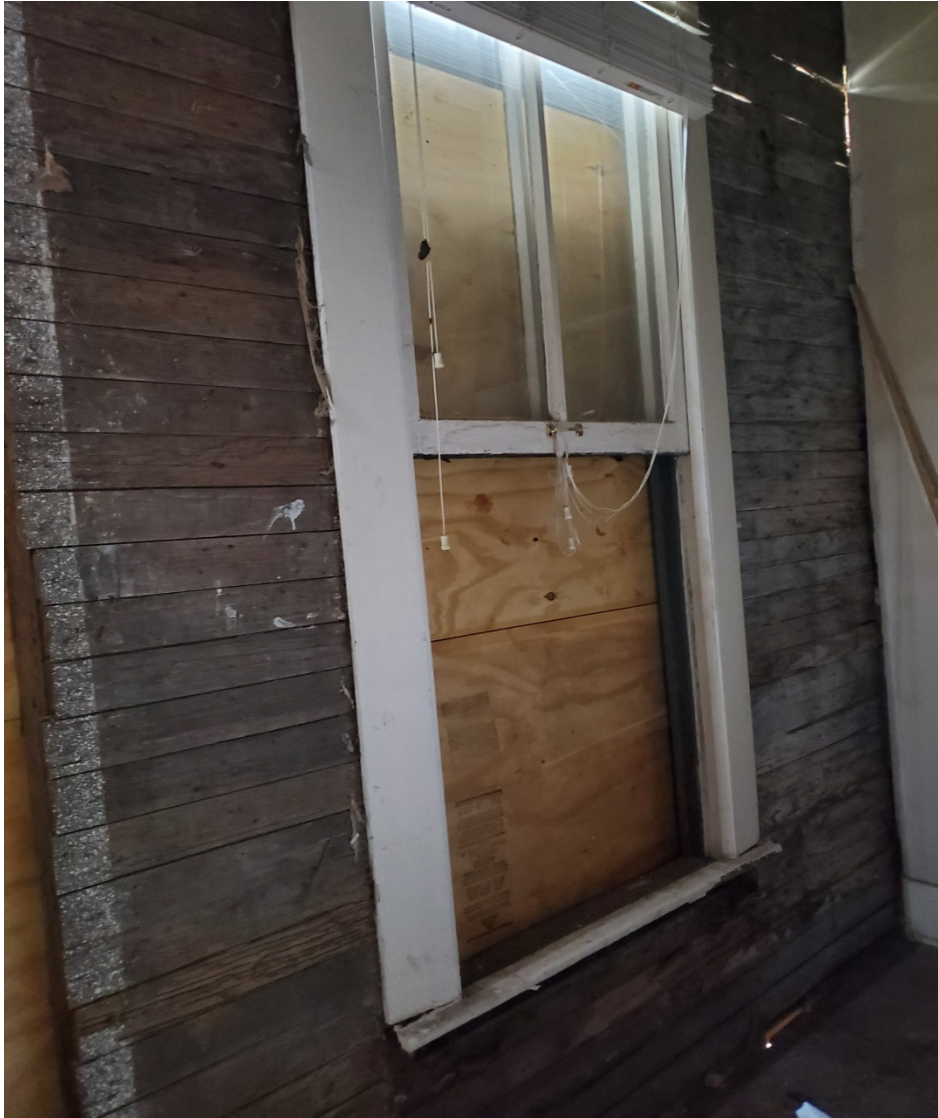
Unit I, Bedroom 1, Window D

Requires lead
paint
remediation
and repairs.

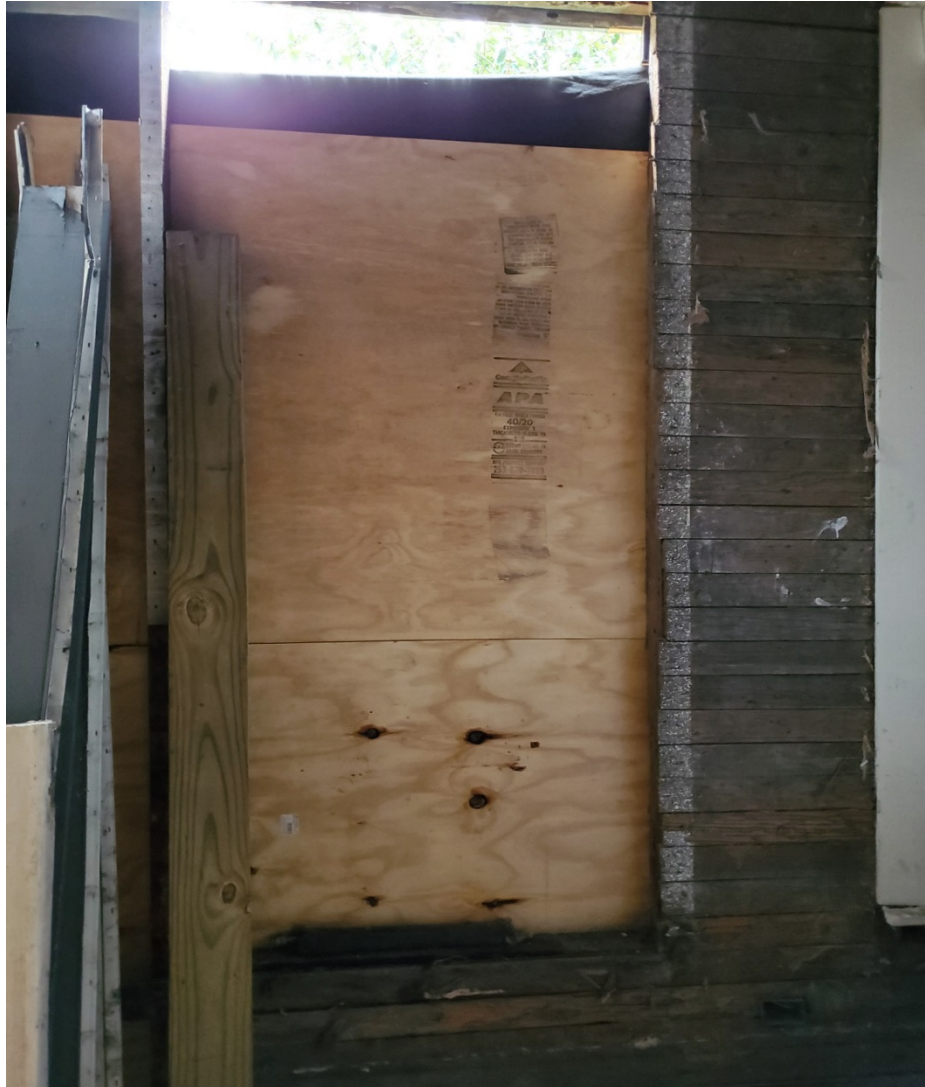
Unit I, Bedroom 1, Window E

Window burned
and damaged
during fire
suppression
activities.

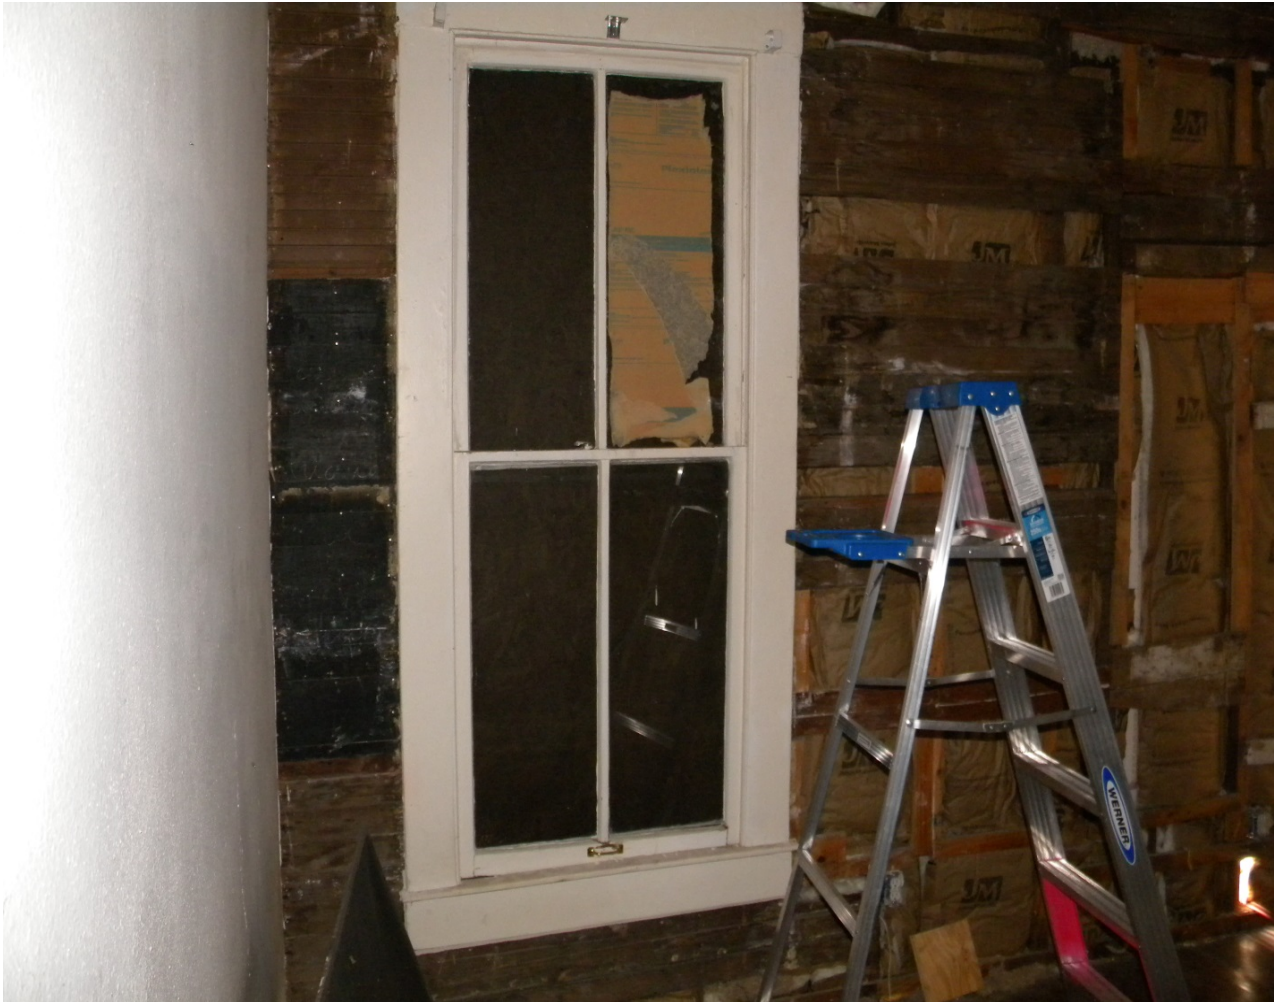
Unit I, Bedroom 2, Window F

Requires lead paint remediation and repairs. Next two slides provide closer view of window.

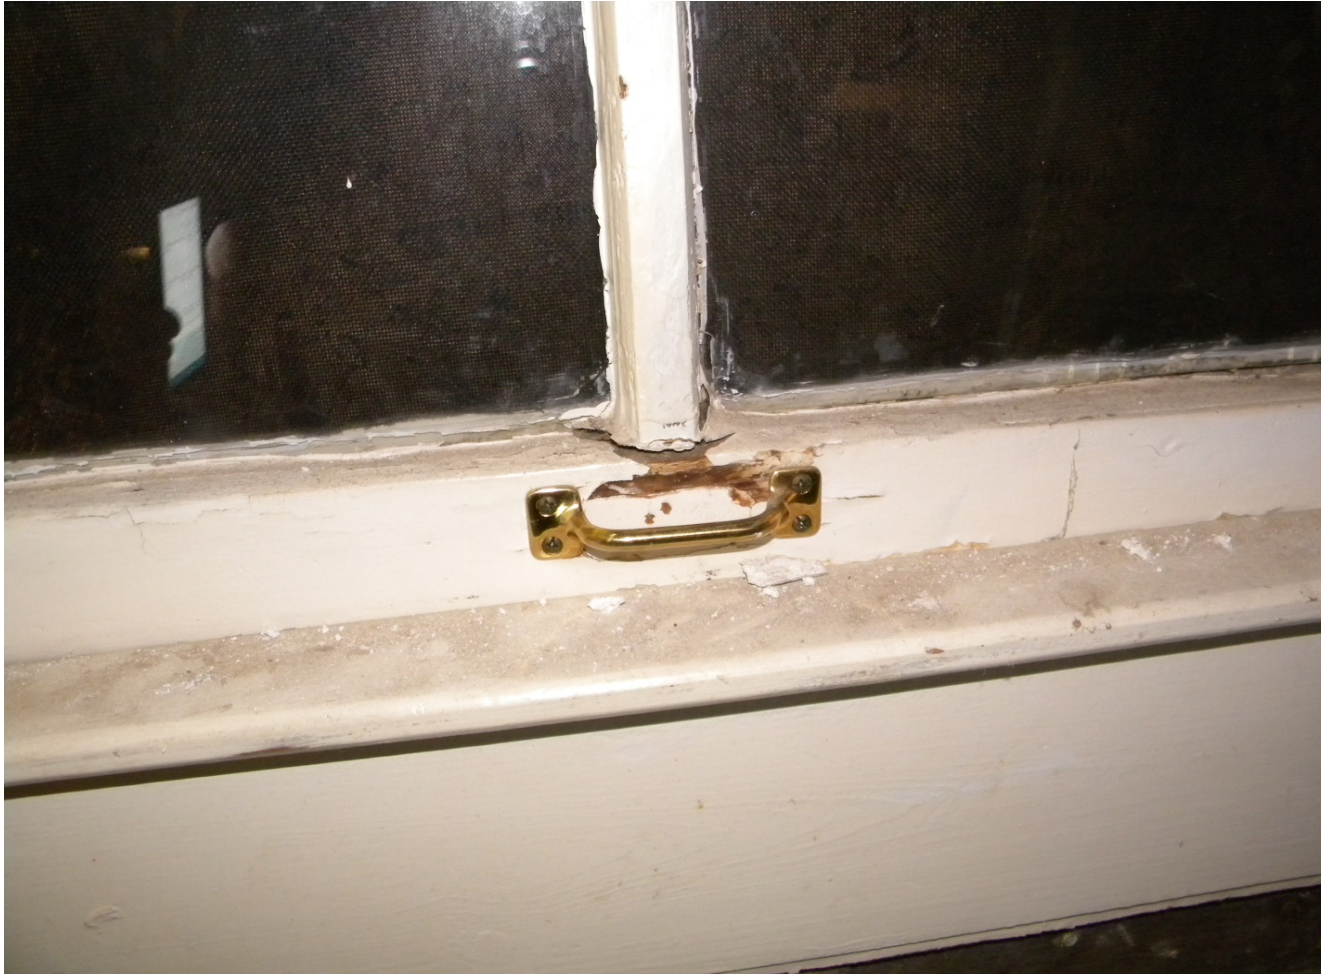
Unit I, Bedroom 2, Window F, cont.

Requires lead
paint
remediation
and repairs.

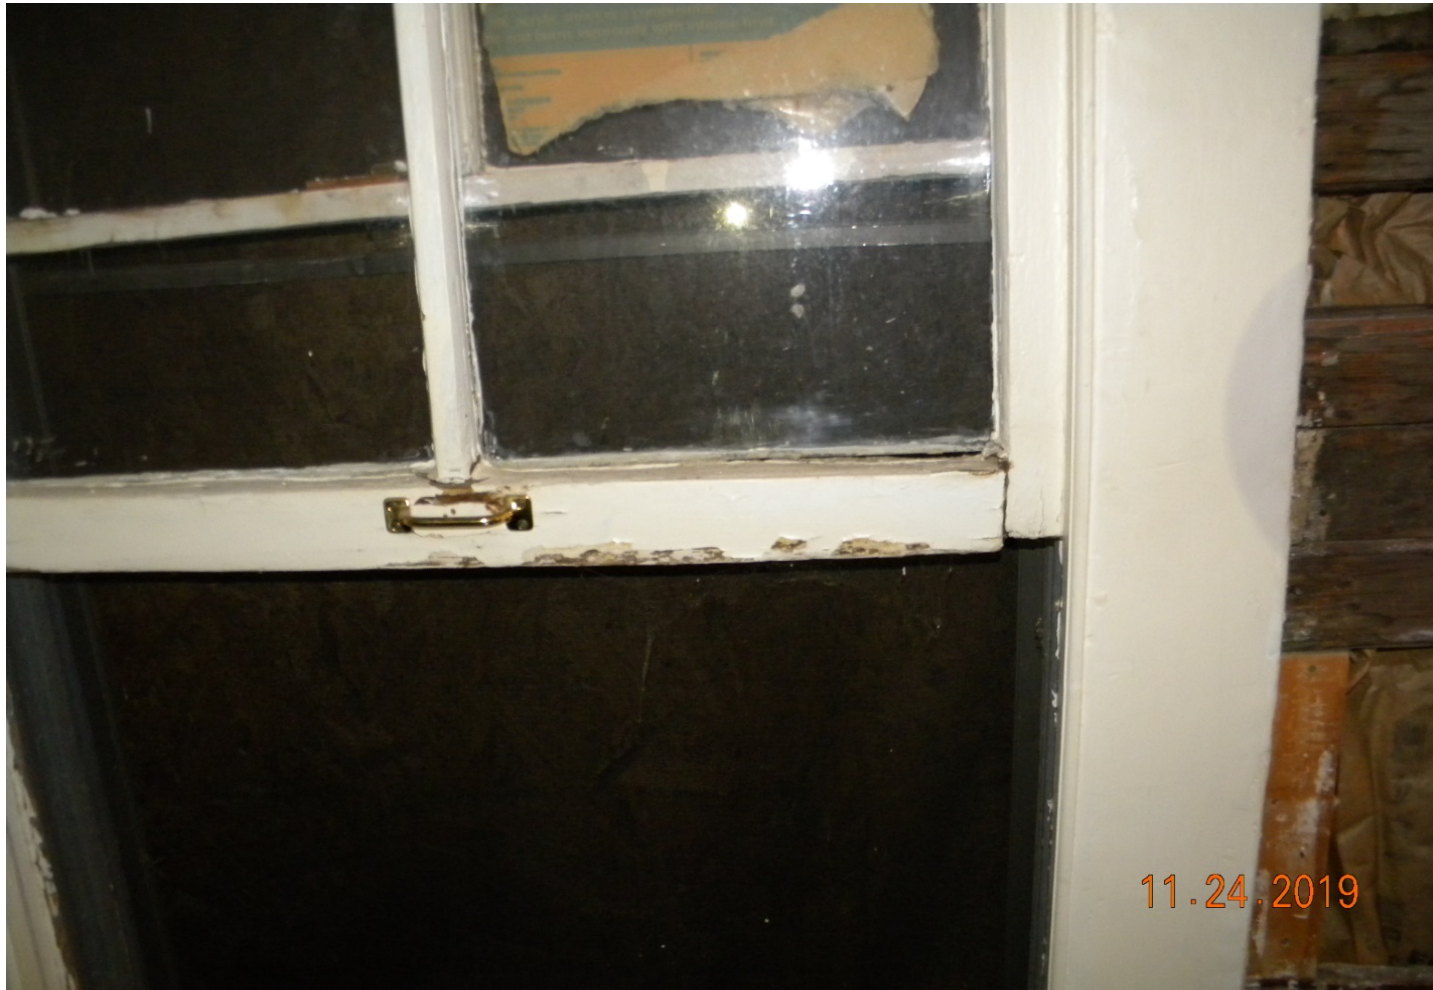
Unit I, Bedroom 2, Window F, cont.

Requires
lead paint
remediation
and repairs.

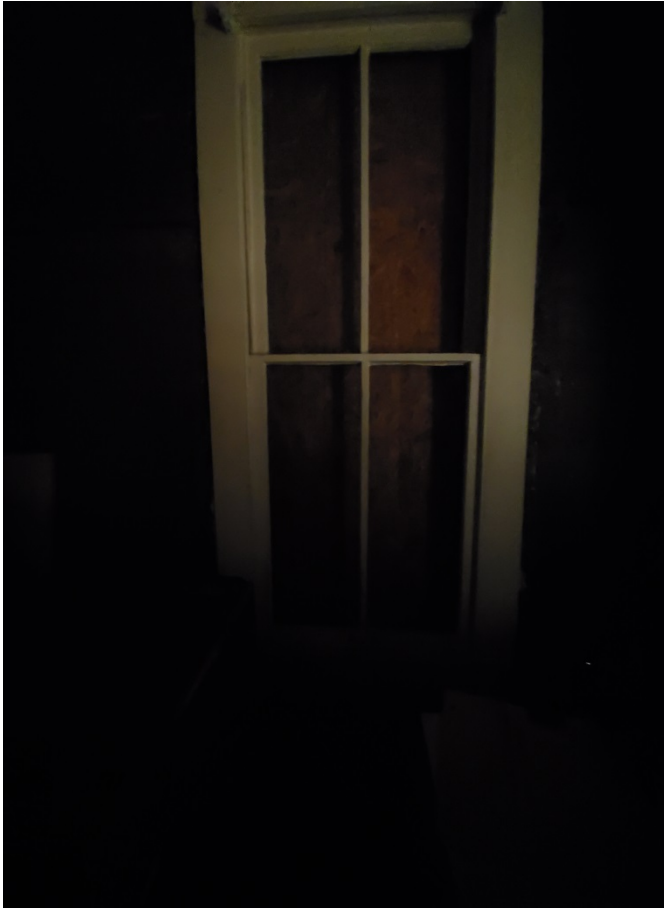
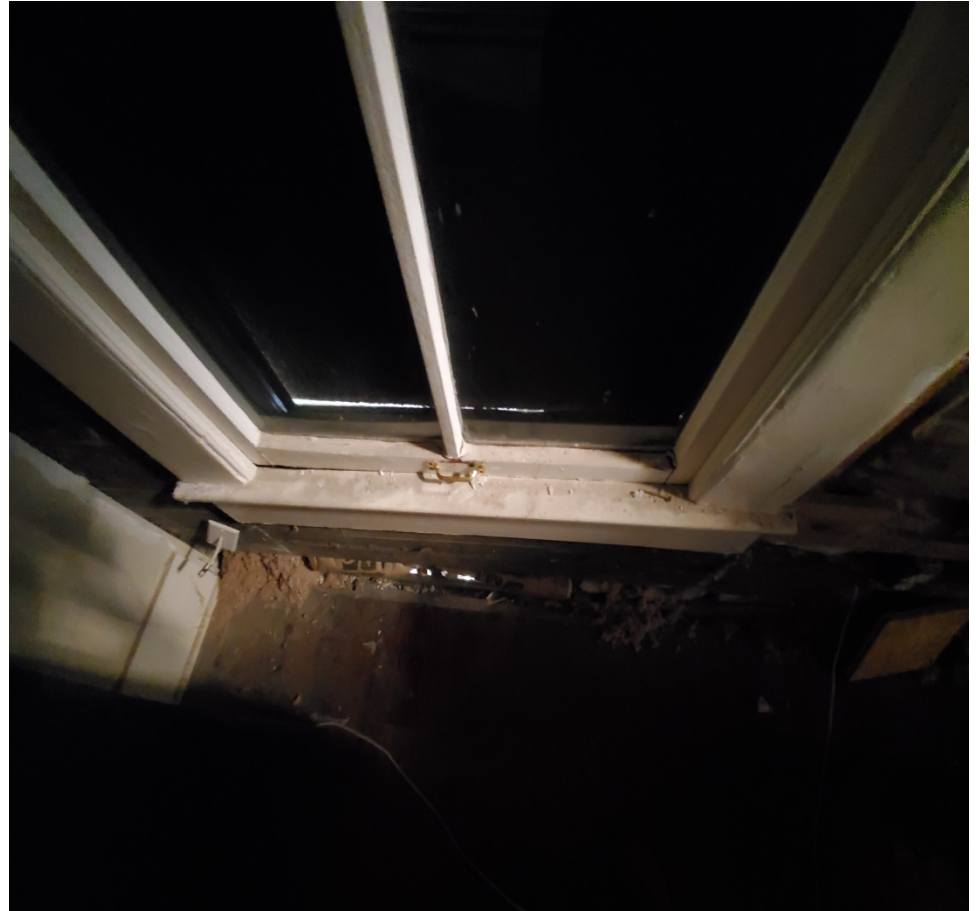
Unit II, Living Room, Window G

Requires lead paint remediation and repairs.

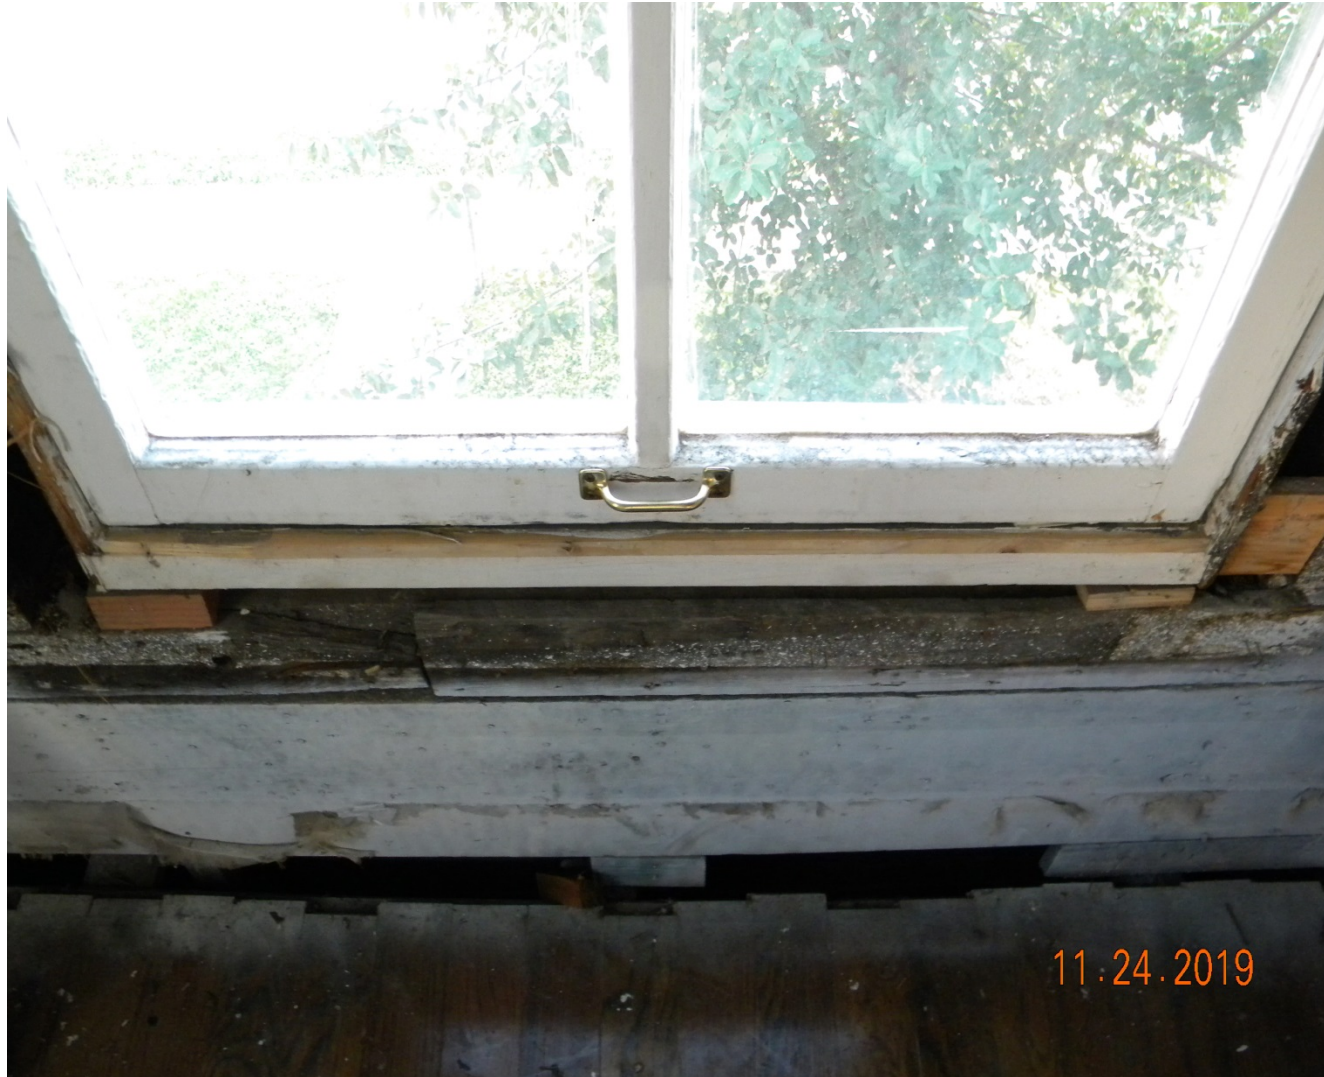
Unit III, Bedroom 1, Window H

Requires
lead paint
remediation
and repairs.

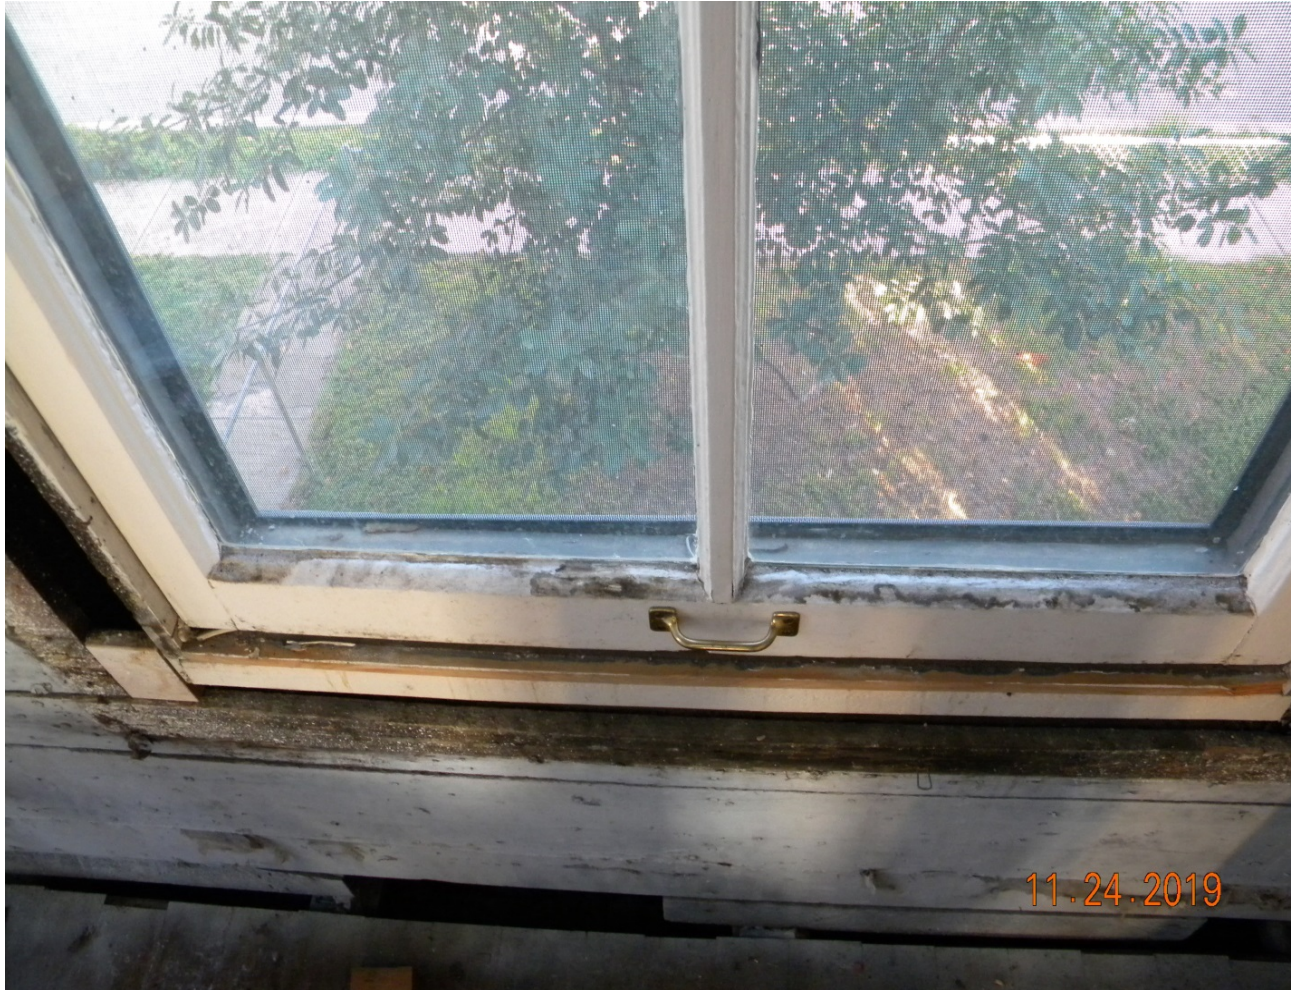
Unit III, Bedroom 1, Window I

Requires
lead paint
remediation
and repairs.

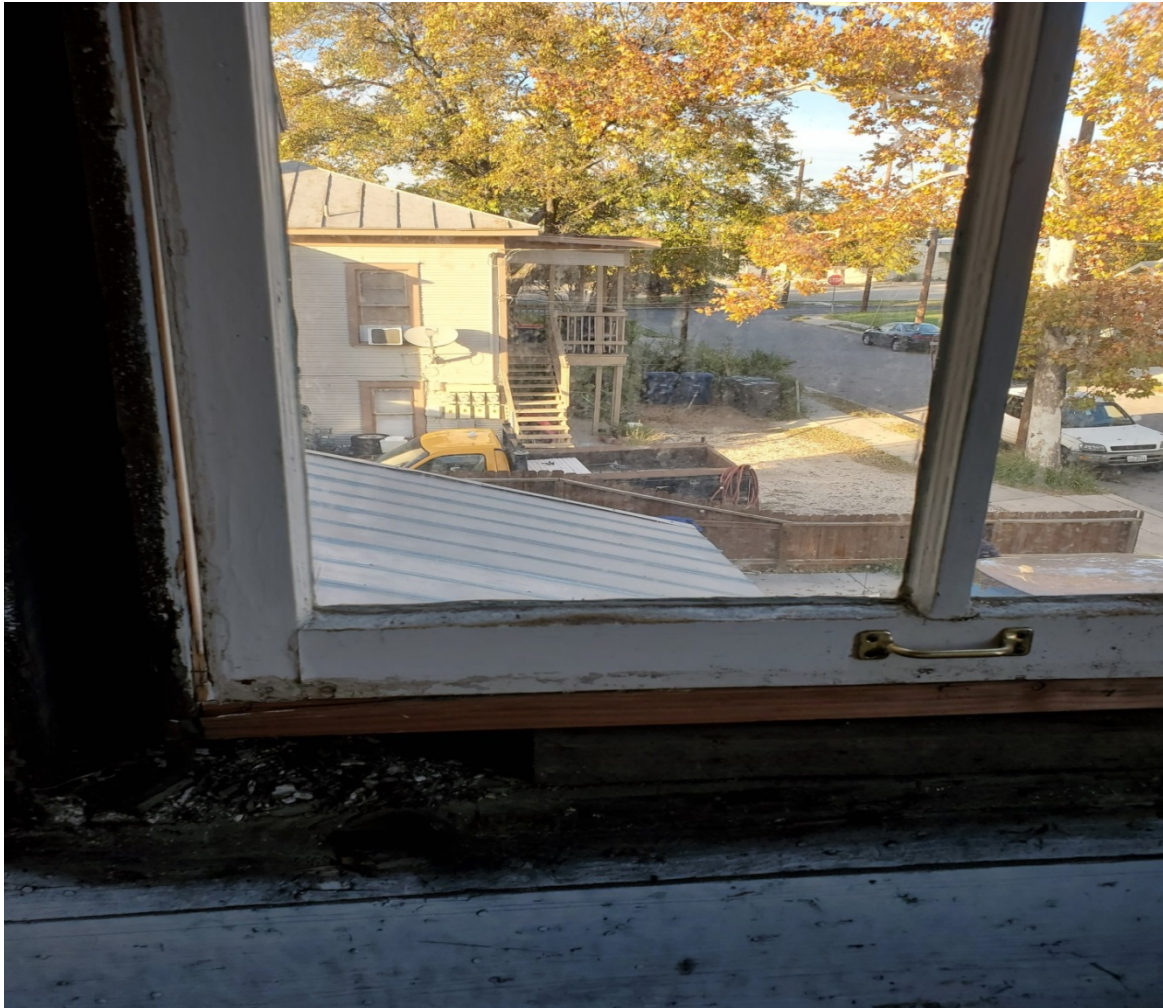
Unit III, Bedroom 1, Window J

Requires lead
paint
remediation
and repairs.

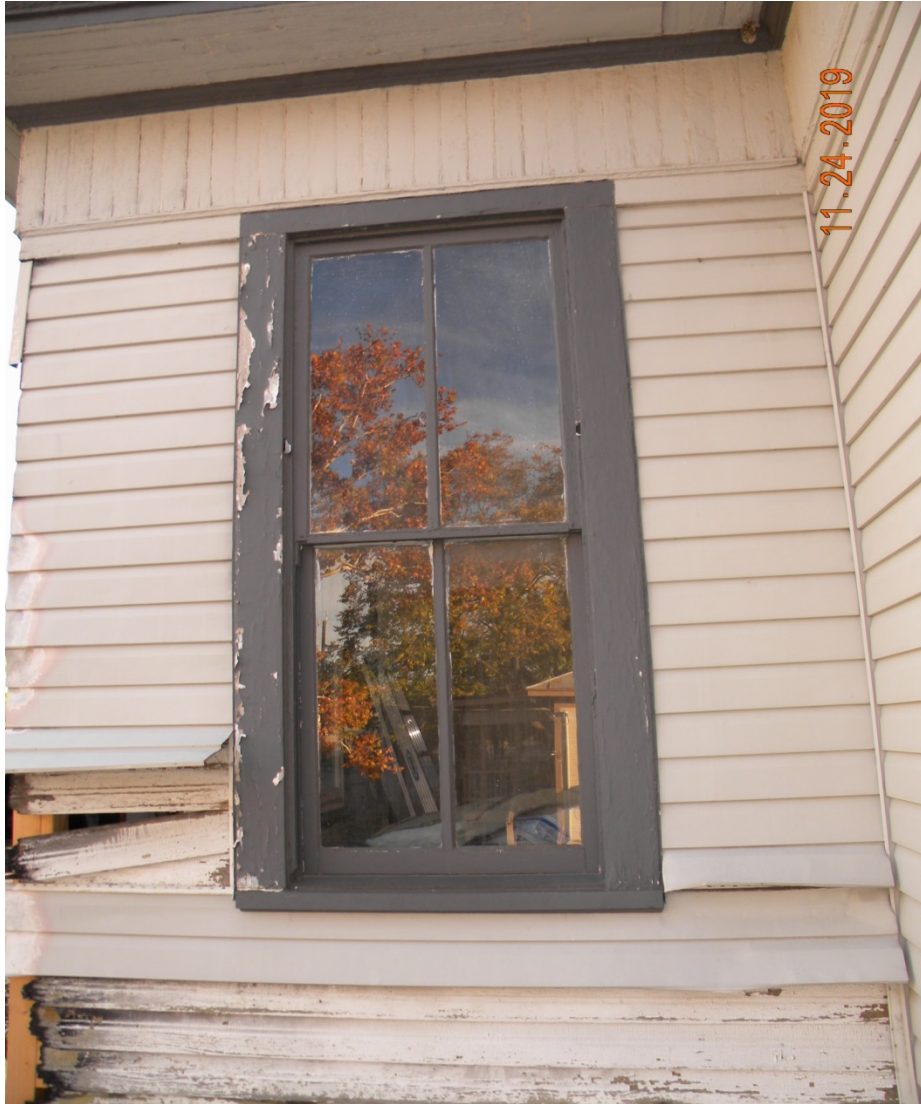
Unit III, Bedroom 1, Window J

Exterior window
requires lead paint
remediation and repairs.

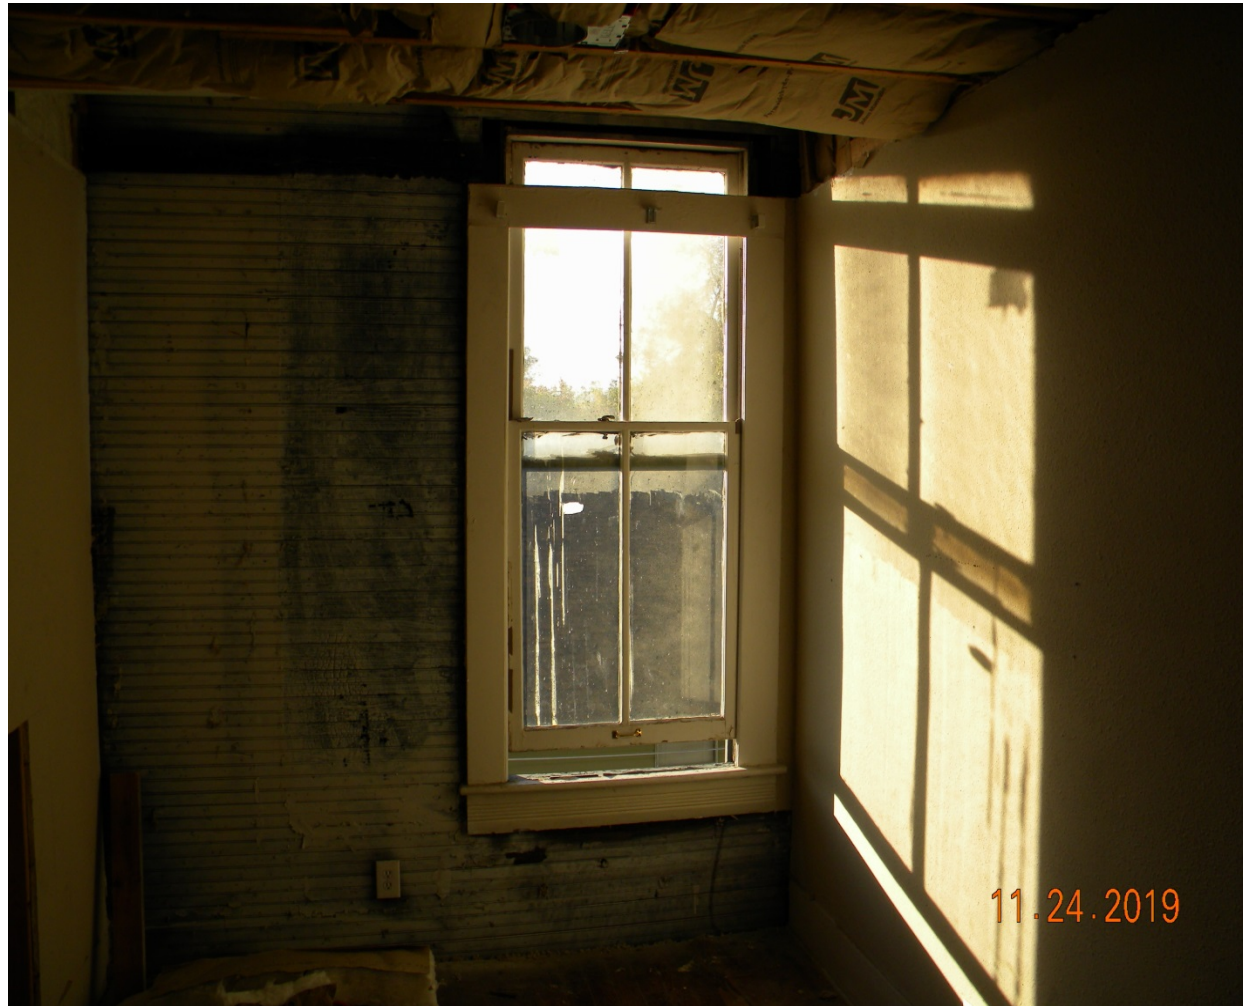
Unit III, Living Room Window K

Requires lead
paint
remediation
and repairs.

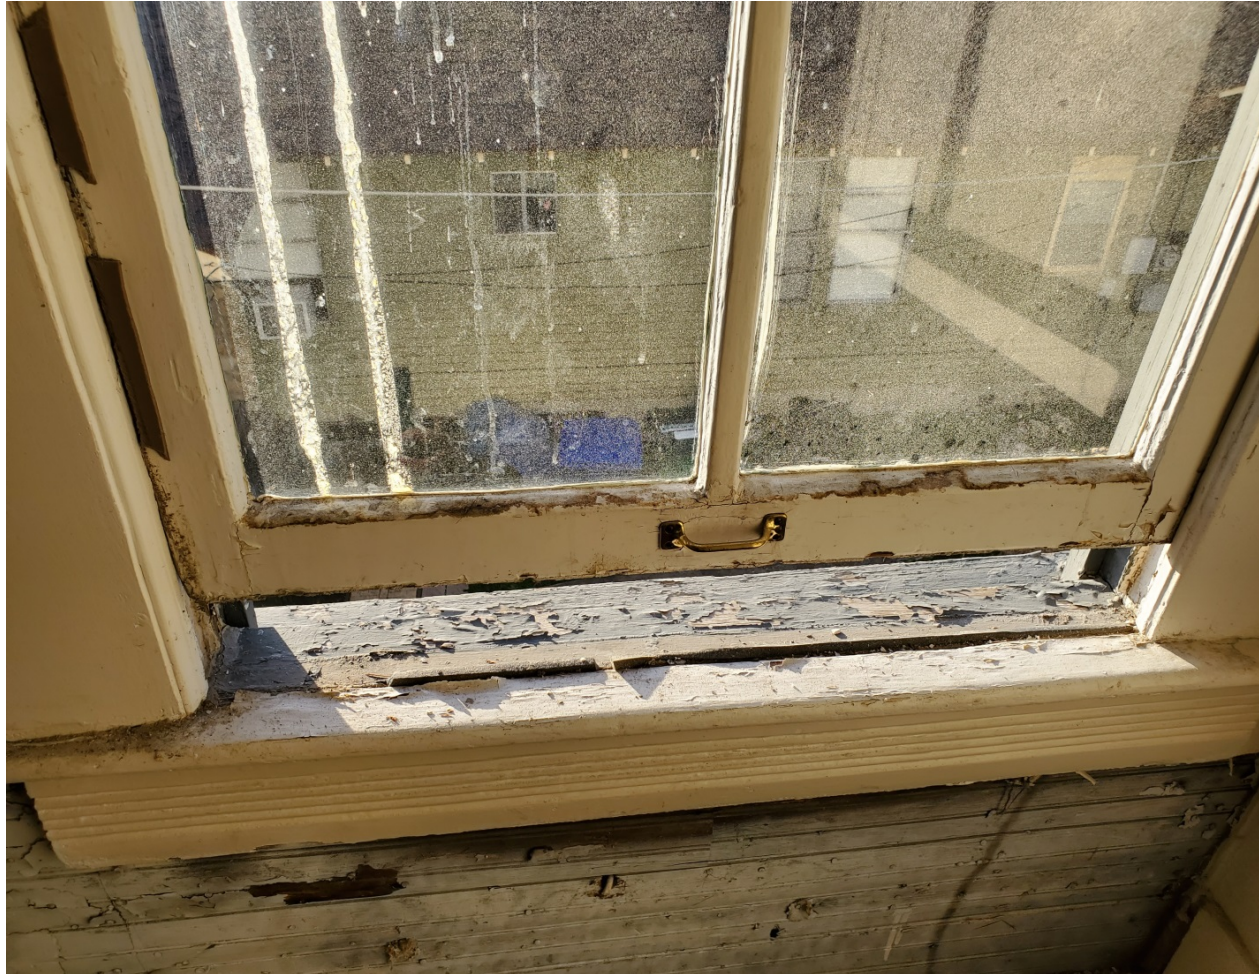
Unit III, Living Room Window K

Closer inspection of window shows flaking and use of foam strips to reduce air drafts.

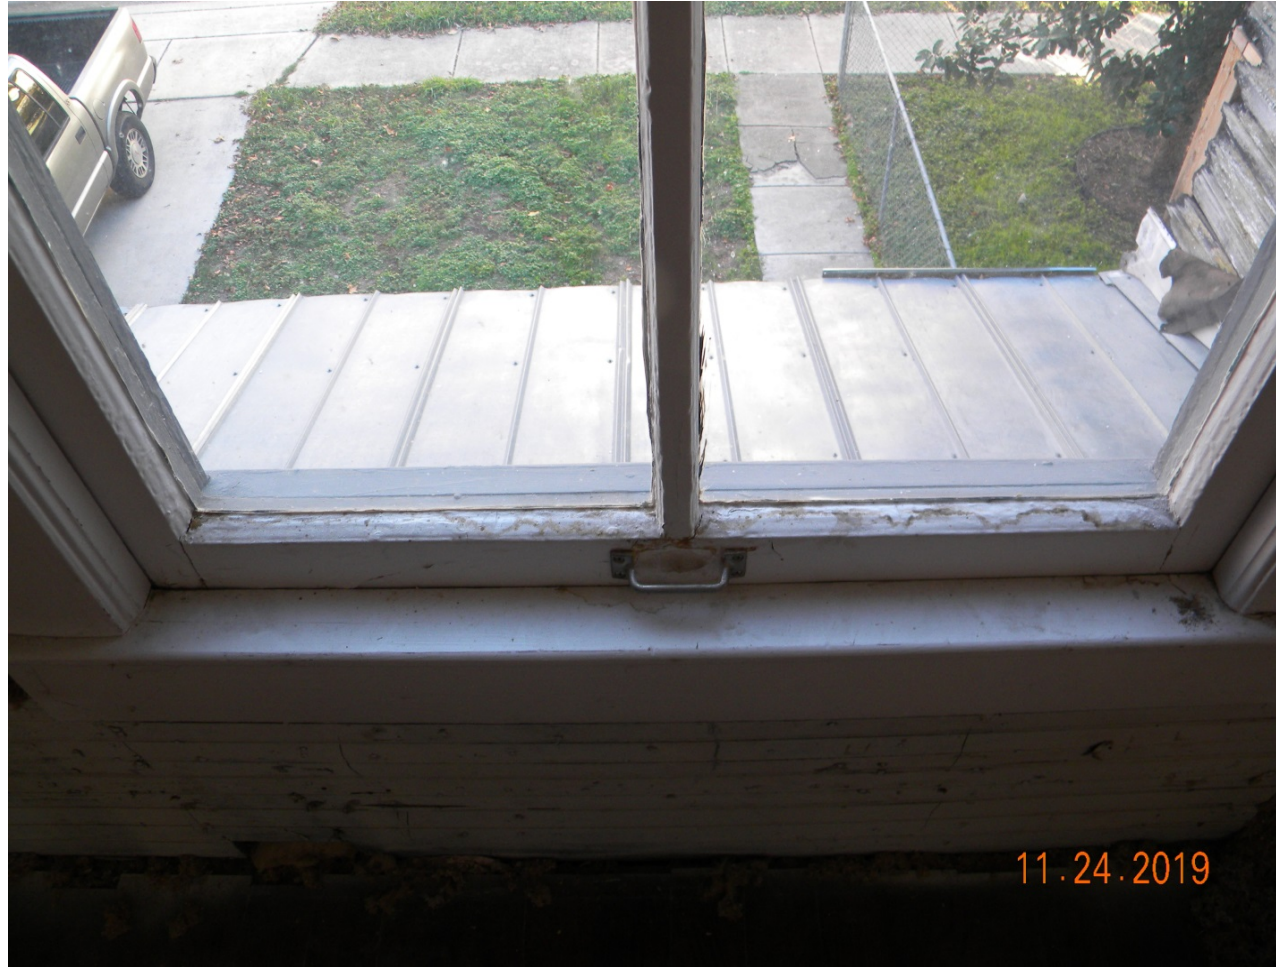
Unit IV, Living Room Window L

Requires lead
paint
remediation
and repairs.

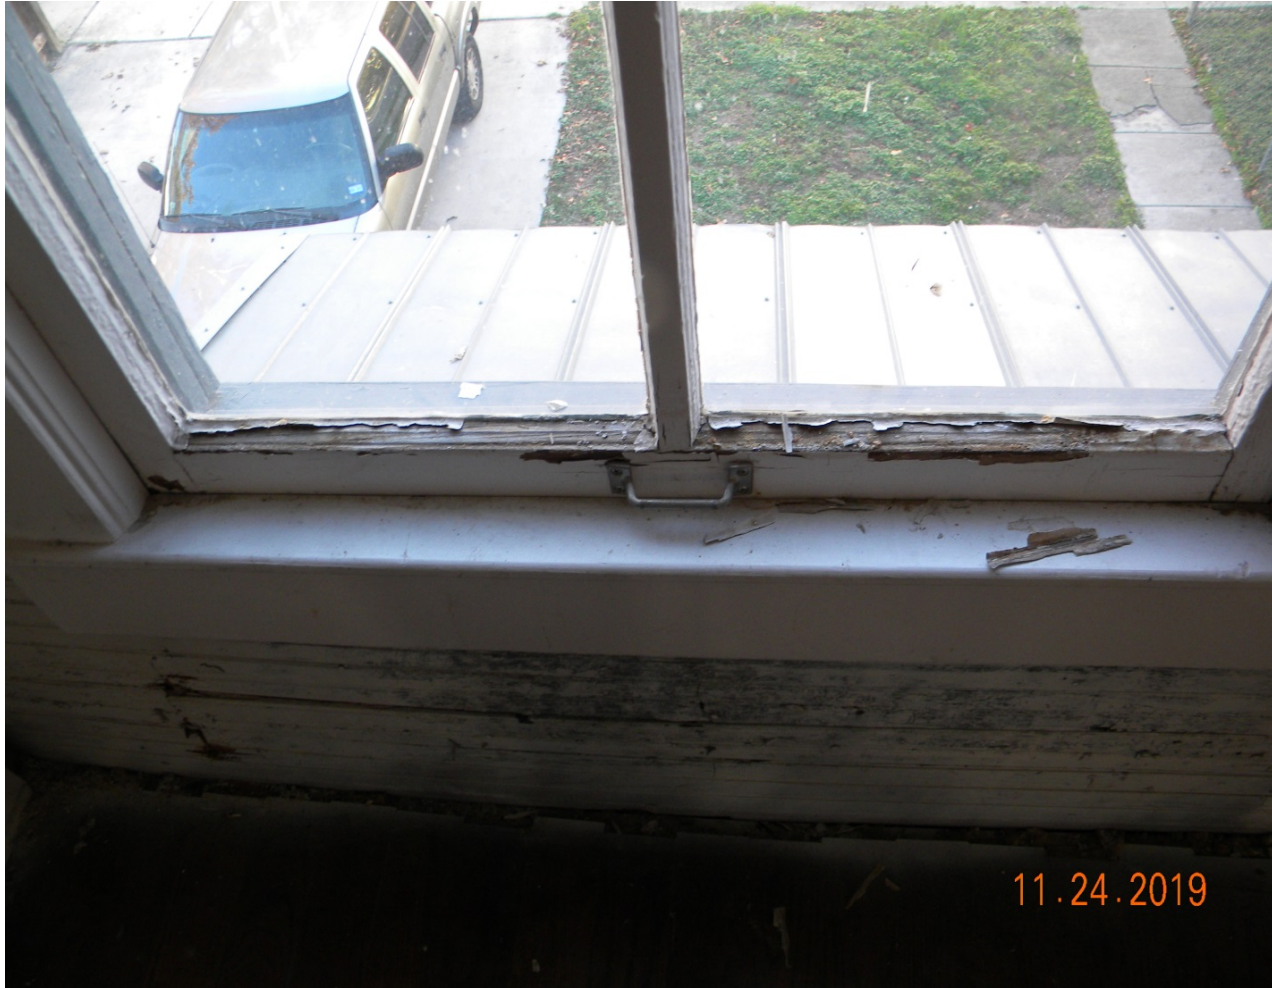
Unit IV, Living Room Window M

Requires
lead paint
remediation
and repairs.

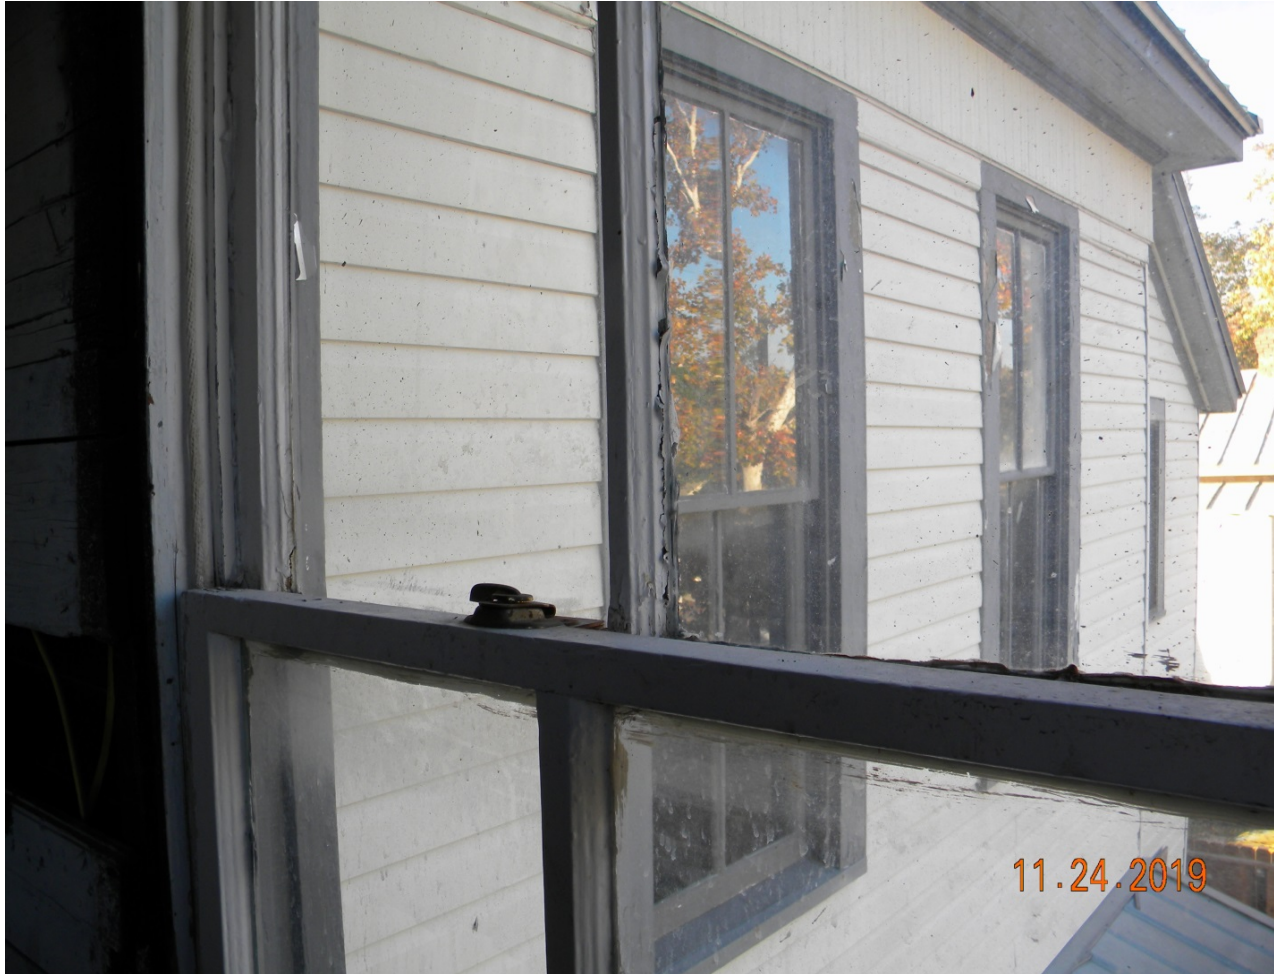
Unit IV, Living Room Windows

Exterior windows L and M, requires lead paint remediation and repairs.
