HISTORIC AND DESIGN REVIEW COMMISSION

May 01, 2020

HDRC CASE NO: 2020-122
ADDRESS: 533 E CARSON
LEGAL DESCRIPTION: NCB 993 BLK 3 LOT S 96.91 FT 7 (ARB 7C)
ZONING: MF-33, H
CITY COUNCIL DIST.: 2
DISTRICT: Government Hill Historic District
APPLICANT: Mary Jo Vargas/VARGAS MARY JOSEPHINE
OWNER: Mary Jo Vargas/VARGAS MARY JOSEPHINE
TYPE OF WORK: Siding and window replacement
APPLICATION RECEIVED: March 04, 2020
60-DAY REVIEW: May 03, 2020
CASE MANAGER: Huy Pham

533 E Carson

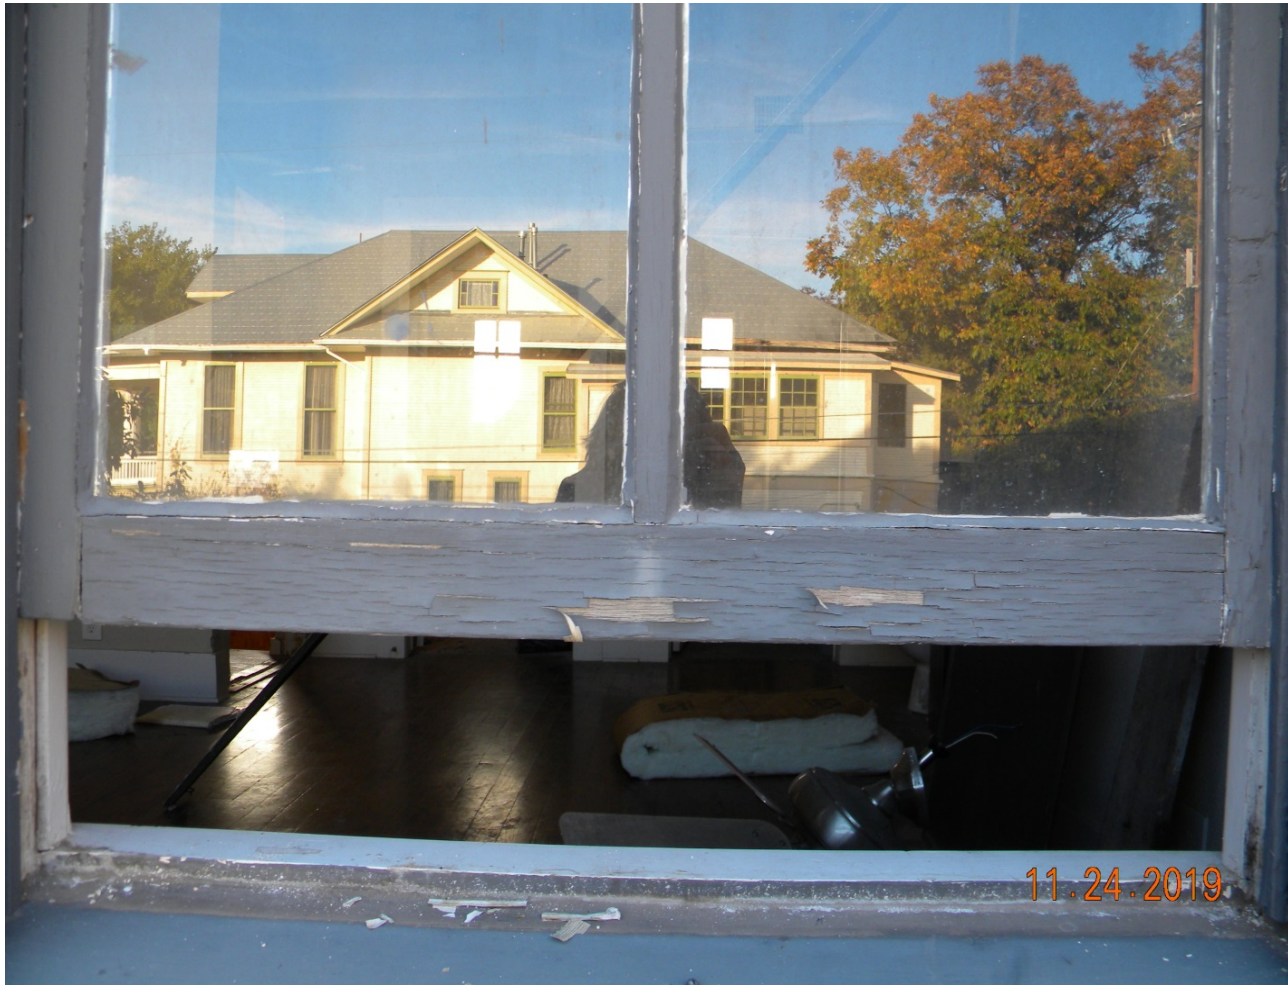
Unit IV, Living Room Window L

Exterior window, requires lead paint remediation and repairs.

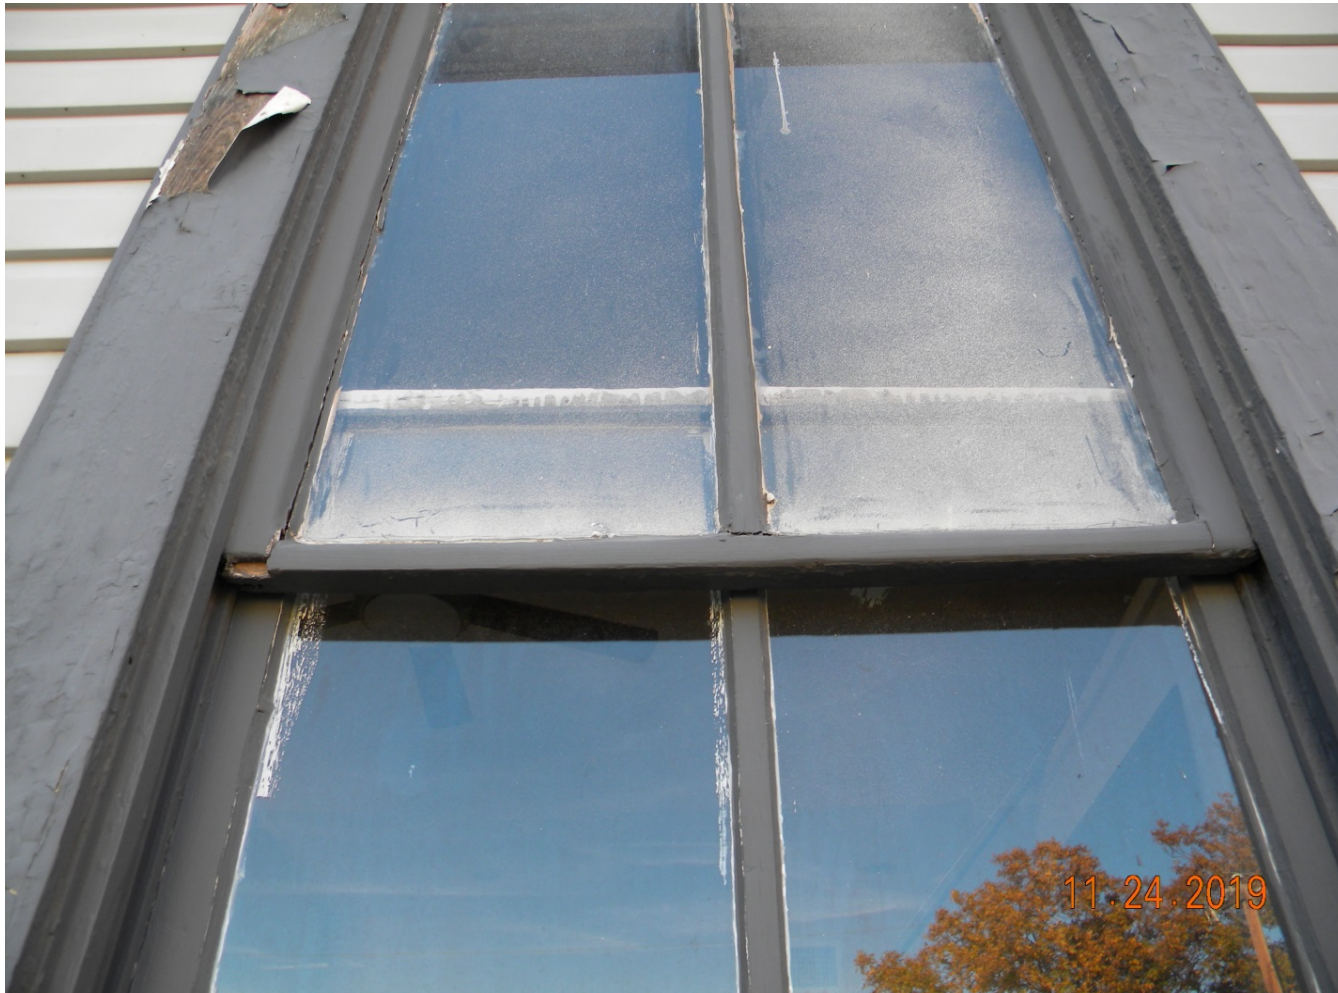
Unit IV, Living Room Window M

Exterior window requires lead paint remediation and repairs.

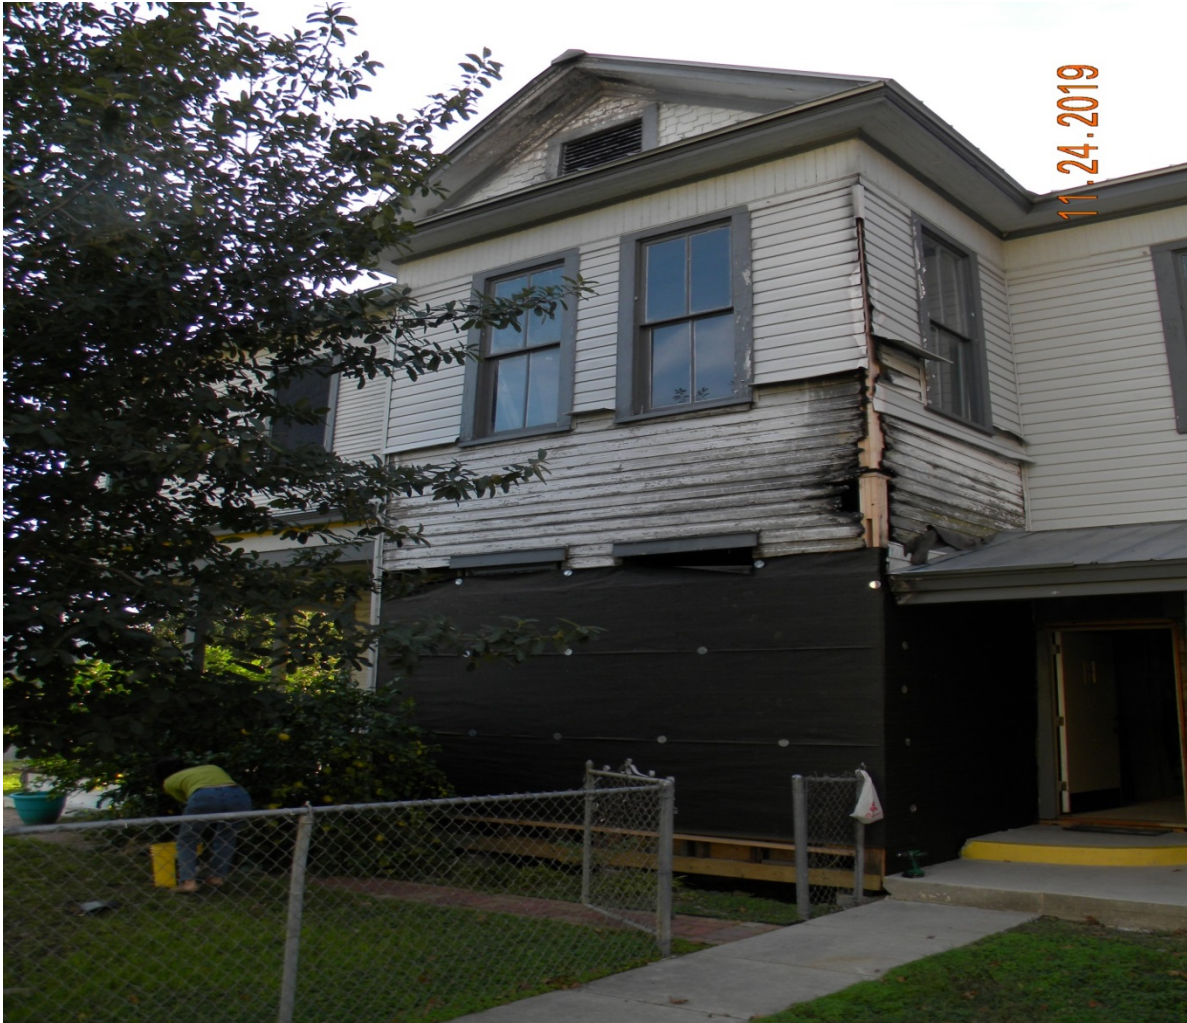
Exterior, East Side of Property

The extent of the fire damage is evident when the aluminum siding is peeled back. The east side of the property had aluminum, except for the second story portion above the porch. A picture of this area can be seen in the next slide.

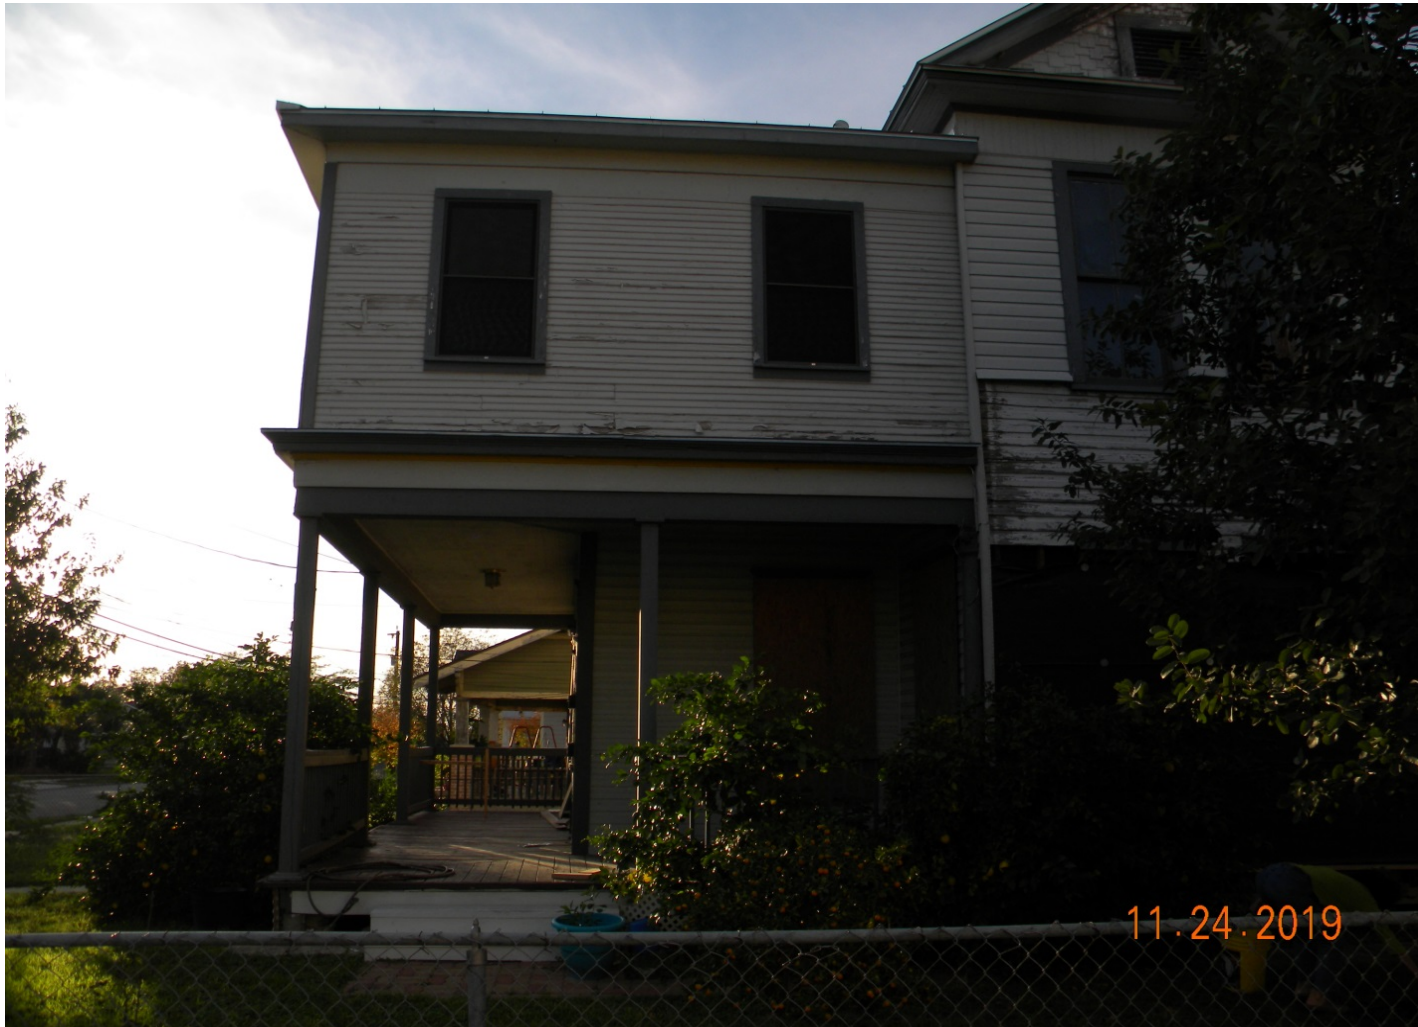
Exterior, East Side of Property

Upstairs area above the porch was enclosed using waterfall siding.

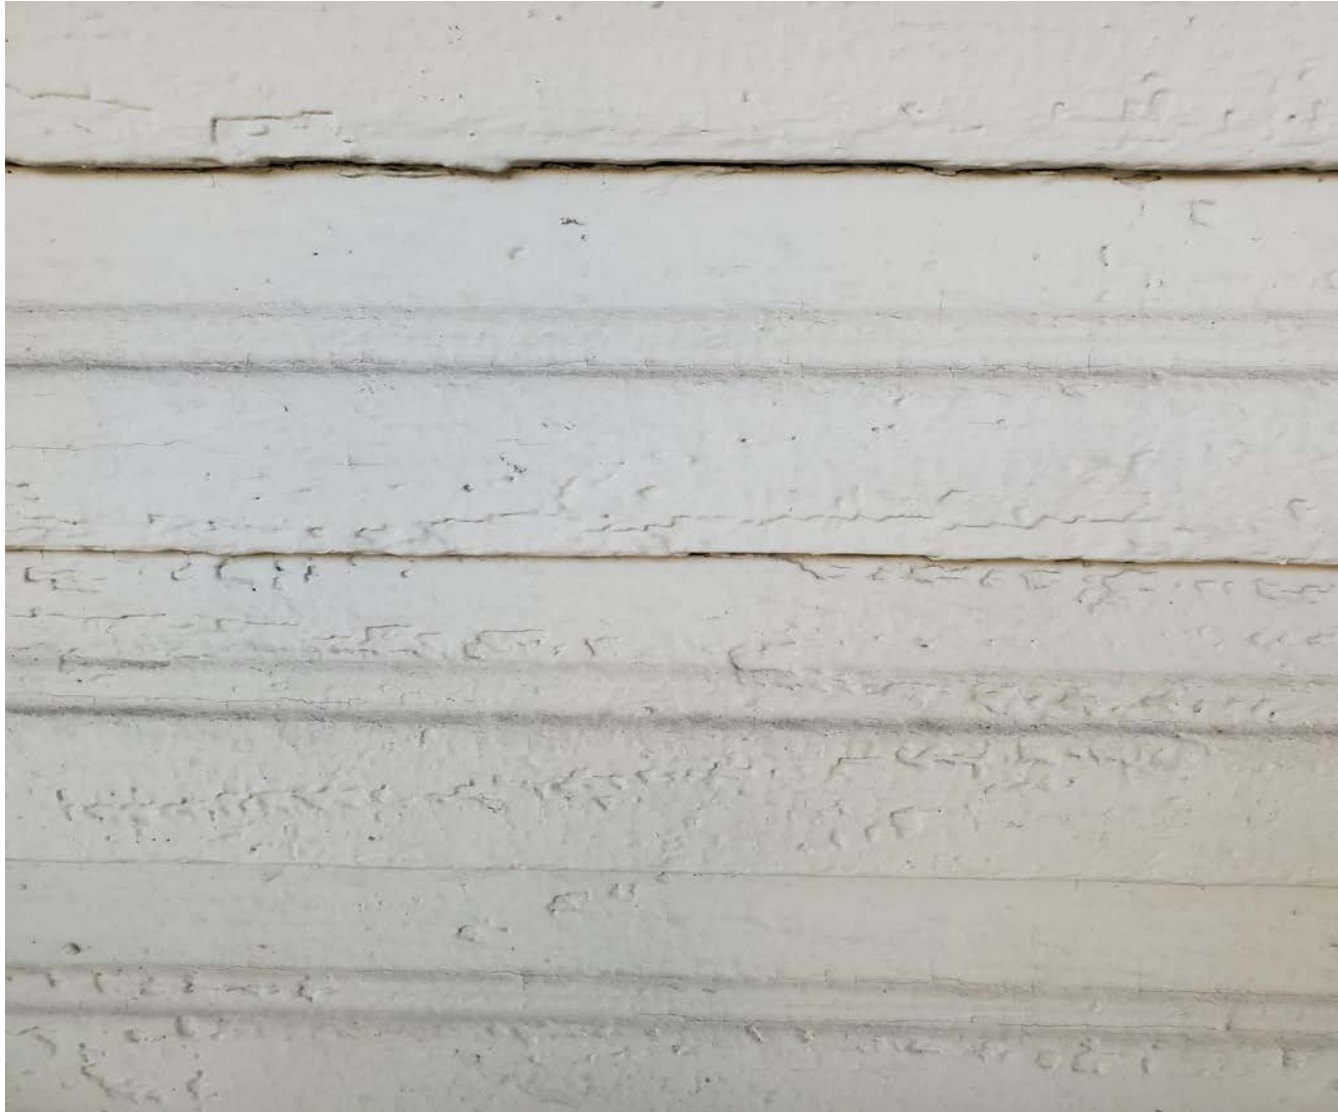
Picture of Original Siding

Original siding is located on the front of the property and requires lead paint remediation and repairs.

Staff does not recommend approval of items 1, 2, and 3 based on finding c. All existing wood siding should be restored in place, and any completely missing or fire damaged areas should feature wood lap siding that matches the historic profile.

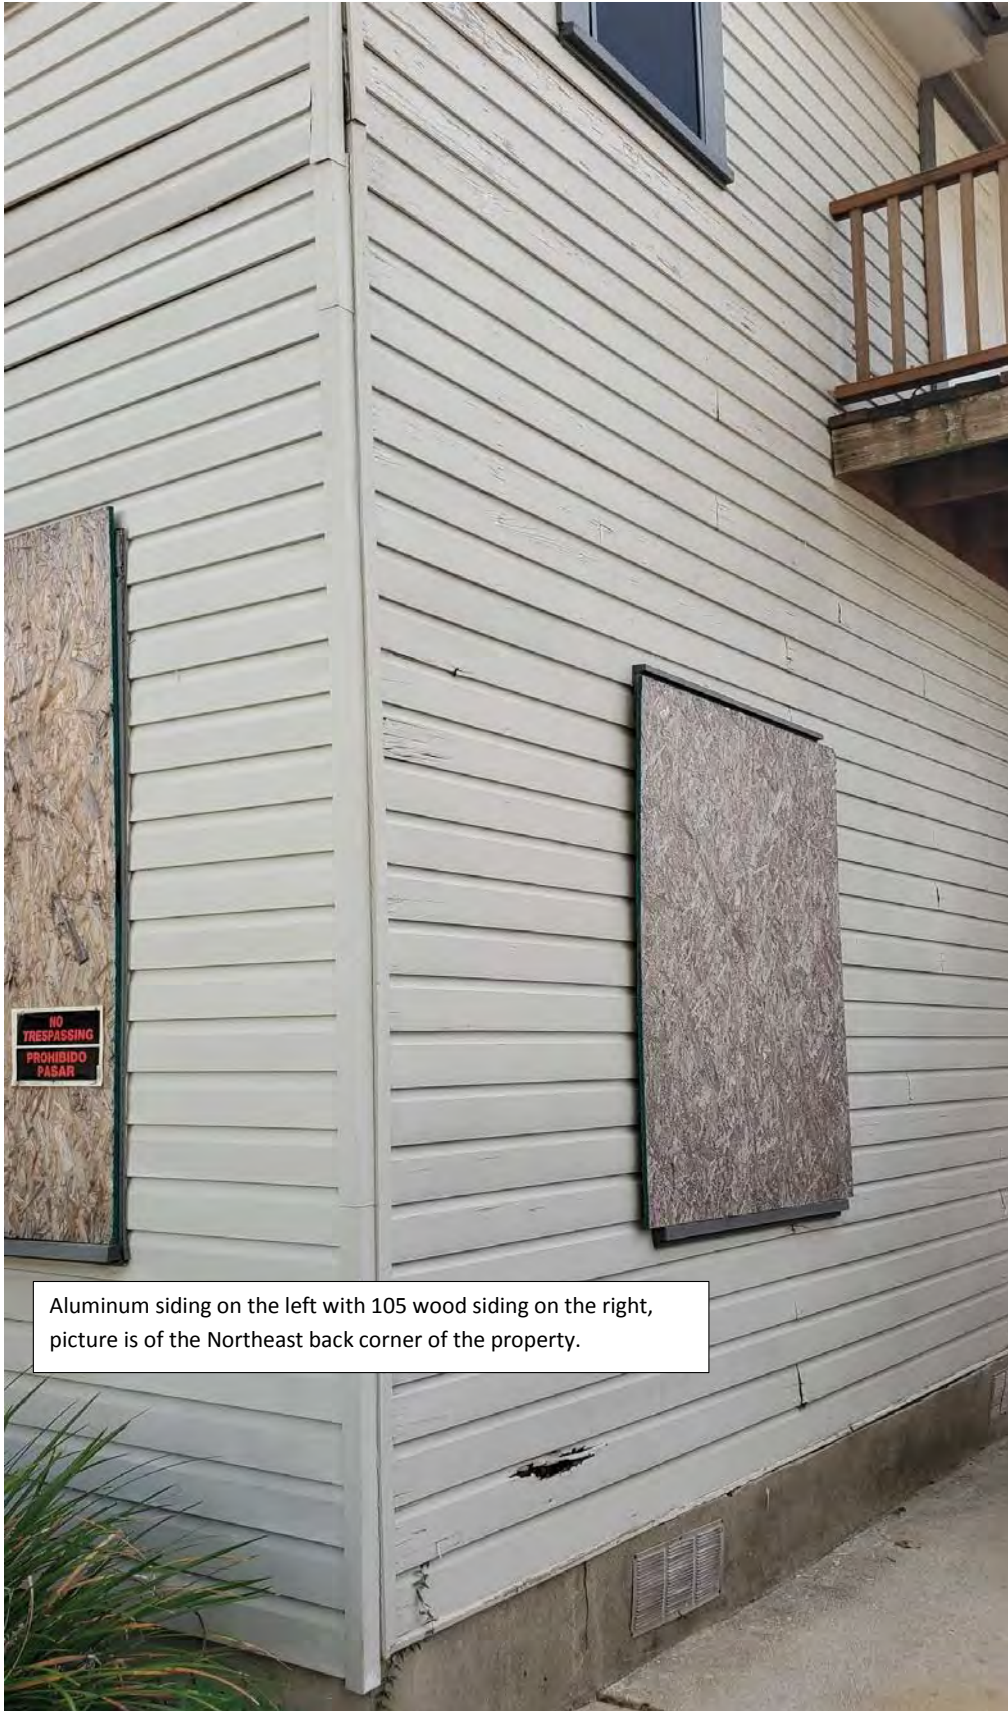
Aluminum siding on the left with 105 wood siding on the right, picture is of the Northeast back corner of the property.

Damage to aluminum siding does not appear to be extensive. Fire went through attic and out of gable.

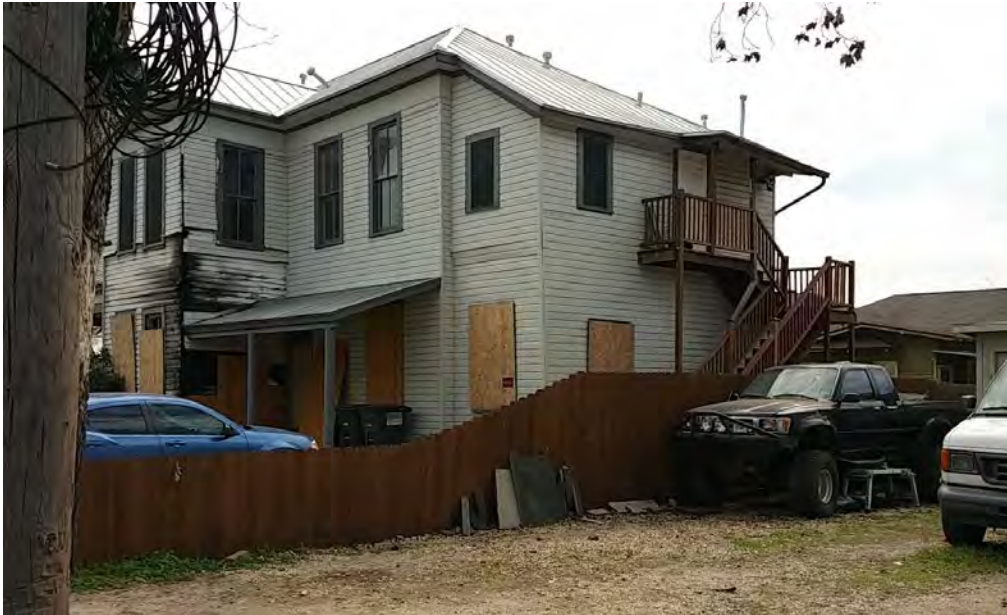
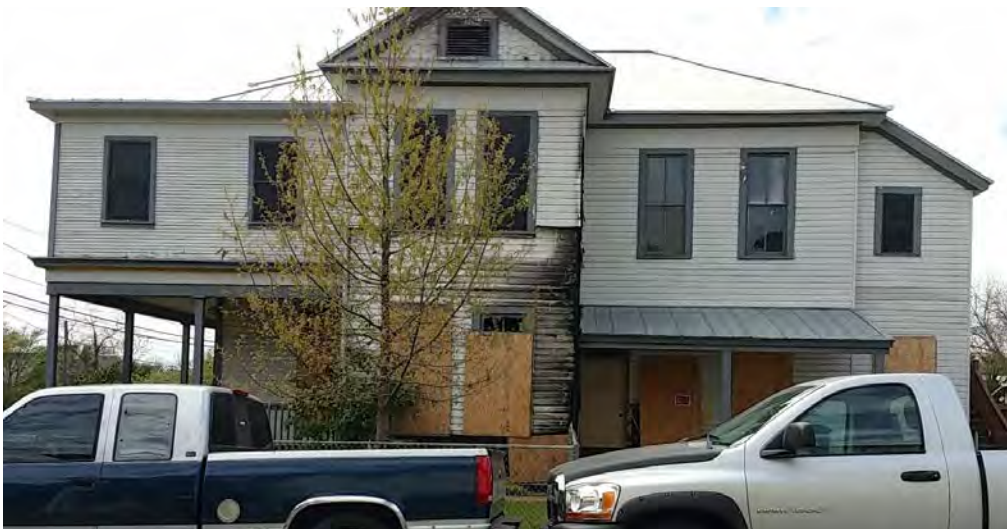
Above and below pictures shows how extensive the wood siding was fire damaged once the aluminum siding was removed.

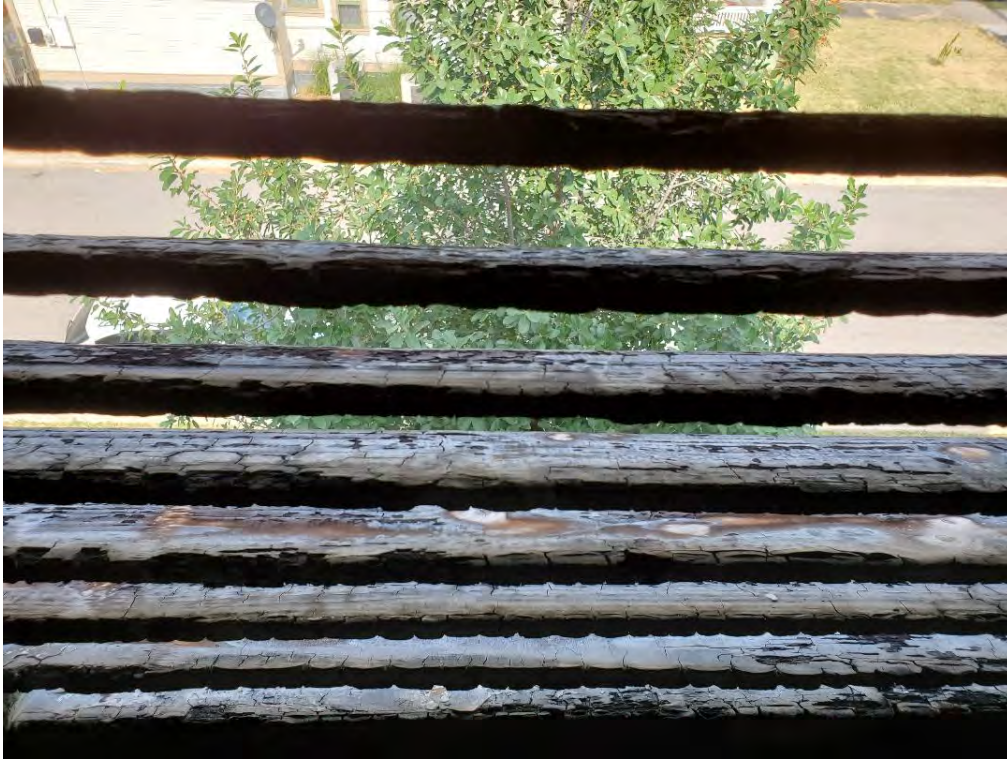
View from inside the attic looking through the gable on the east side of the property.

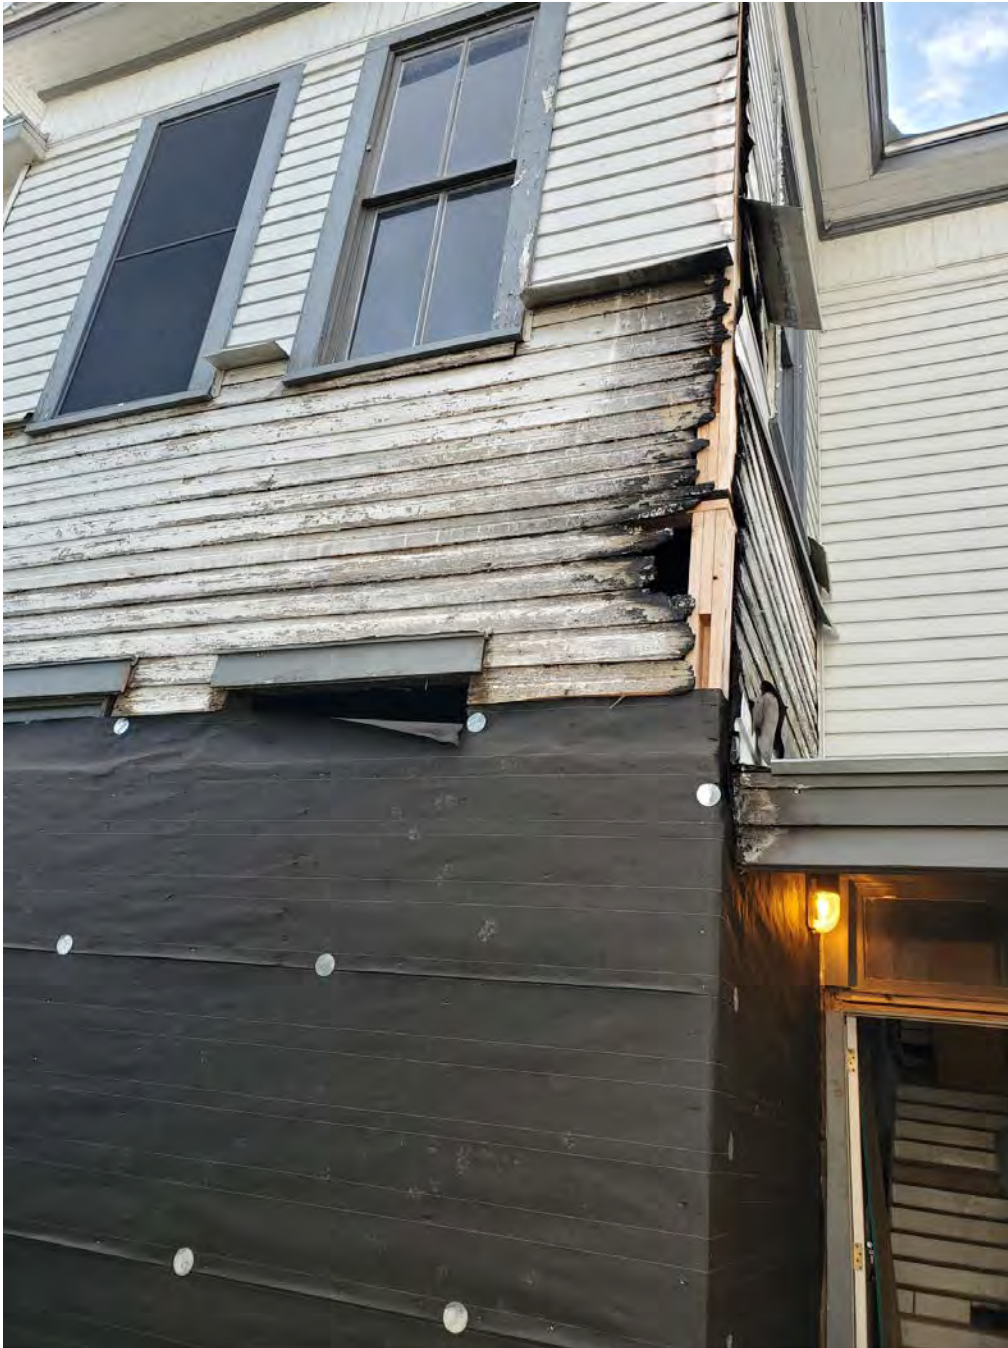
Fire damaged wall cavities that were removed.
