HISTORIC AND DESIGN REVIEW COMMISSION

HDRC CASE NO: 2020-575
ADDRESS: 732 N PINE ST
LEGAL DESCRIPTION: NCB 1659 BLK G LOT 1 AT 732 PINE N
ZONING: RM-6, H
CITY COUNCIL DIST.: 2
DISTRICT: Dignowity Hill Historic District
APPLICANT: John Perez/Castilla's Construction
OWNER: Adeel Riaz/MAJESTIC INVEST LLC
TYPE OF WORK: Demolition of accessory structure, rear porch enclosure
APPLICATION RECEIVED: December 18, 2020
60-DAY REVIEW: Not applicable due to City Council Emergency Orders
CASE MANAGER: Edward Hall
REQUEST:

**Mitigating Irreplaceable Loss by Reclaiming
from
Proposed Demolition of Detached Garage**

**By John Paul Perez
Project Manager Castilla's Construction**

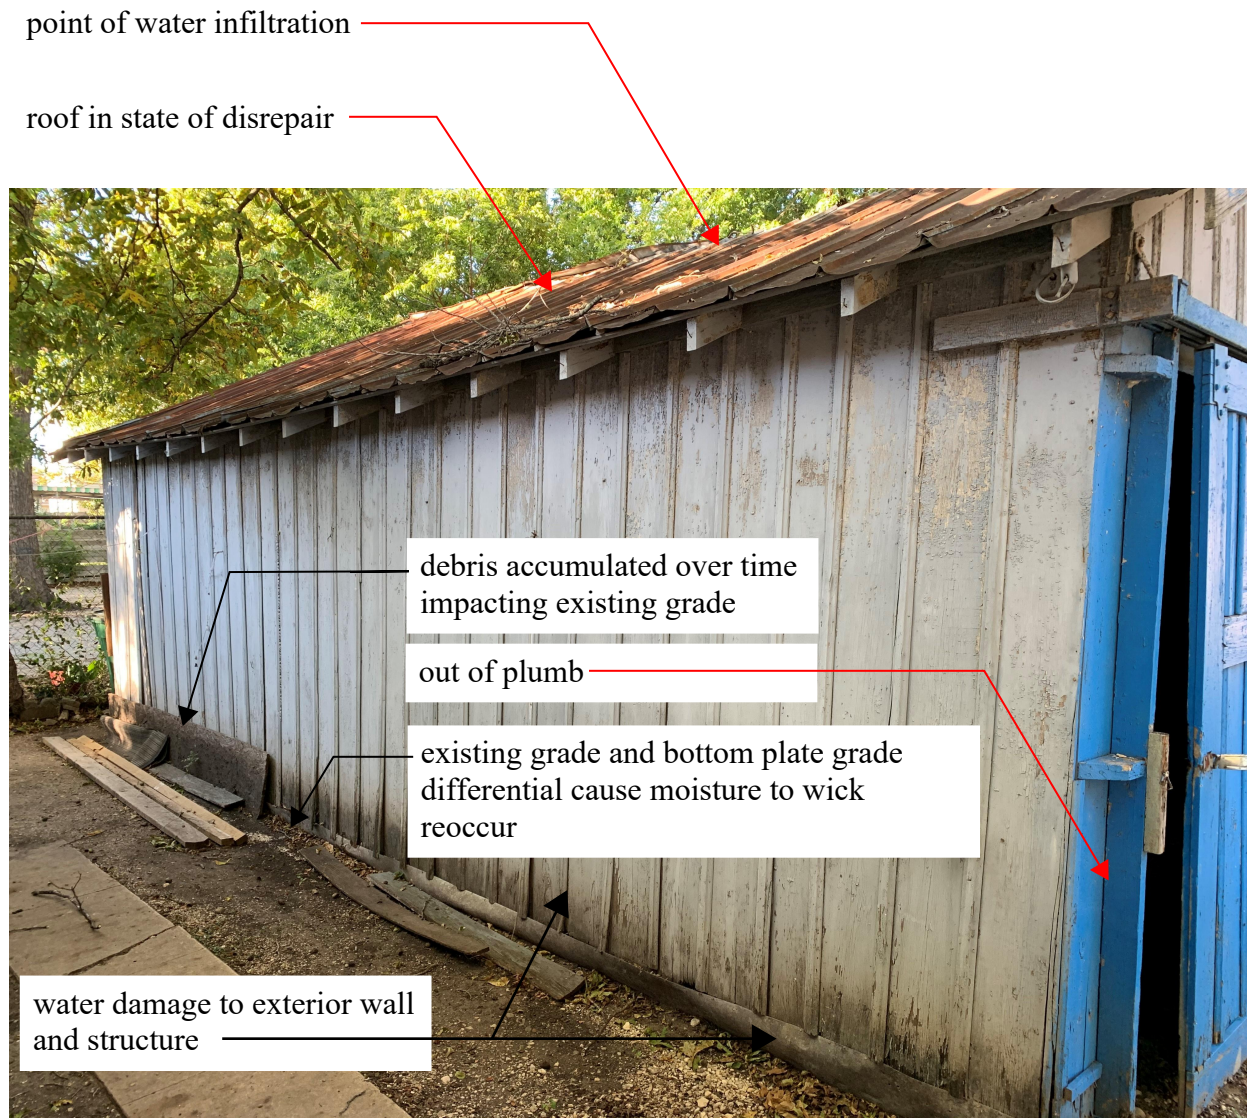
East Elevation

Water infiltration into the building. The water infiltration has weakened the existing roof framing structure and, in some areas, has attributed to structural failure of the roof framing causing a partial collapse.

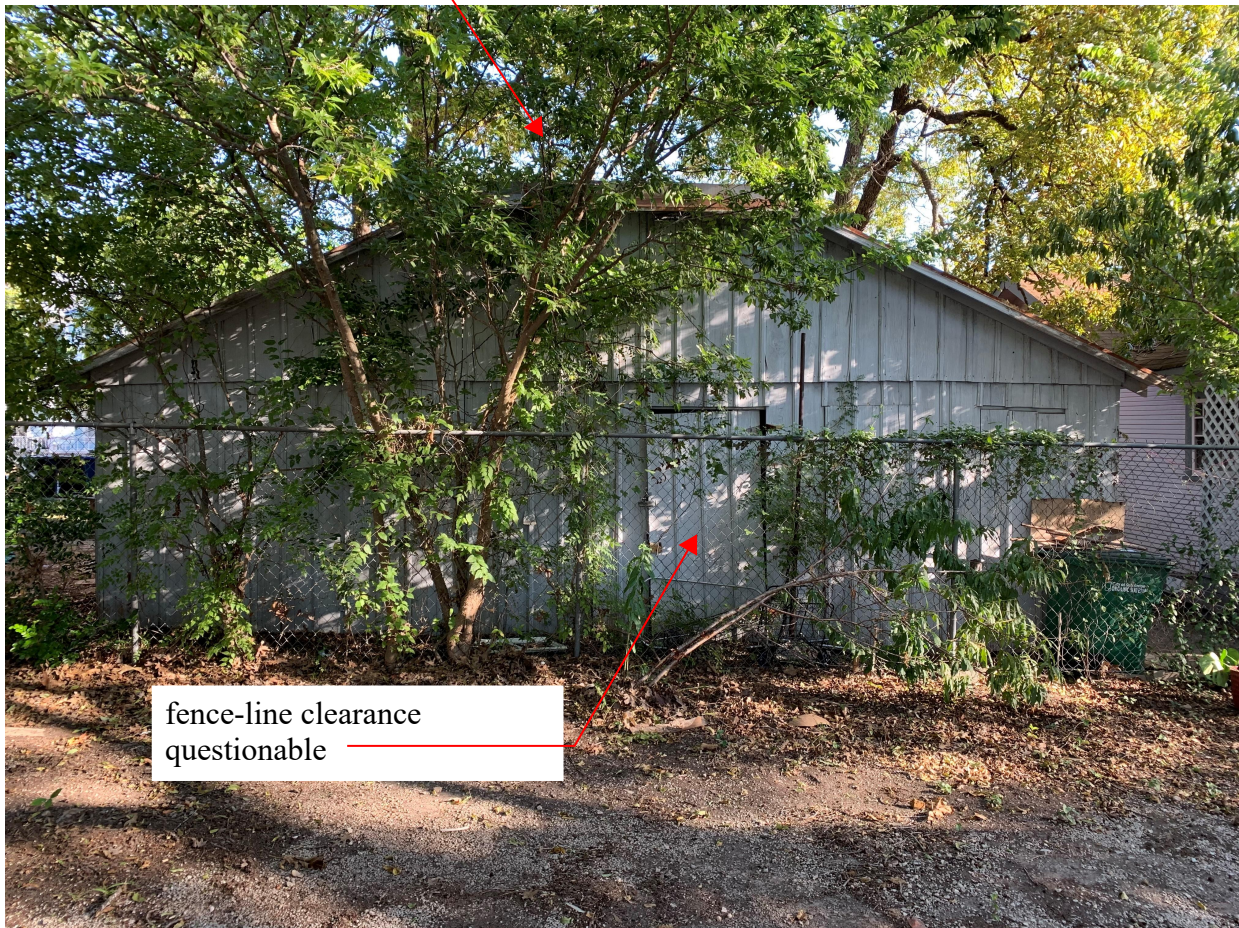
South Elevation

Overgrown vegetation and clearance between fence-line and exterior wall limited to work affectively.

overgrown vegetation

fence-line clearance
questionable

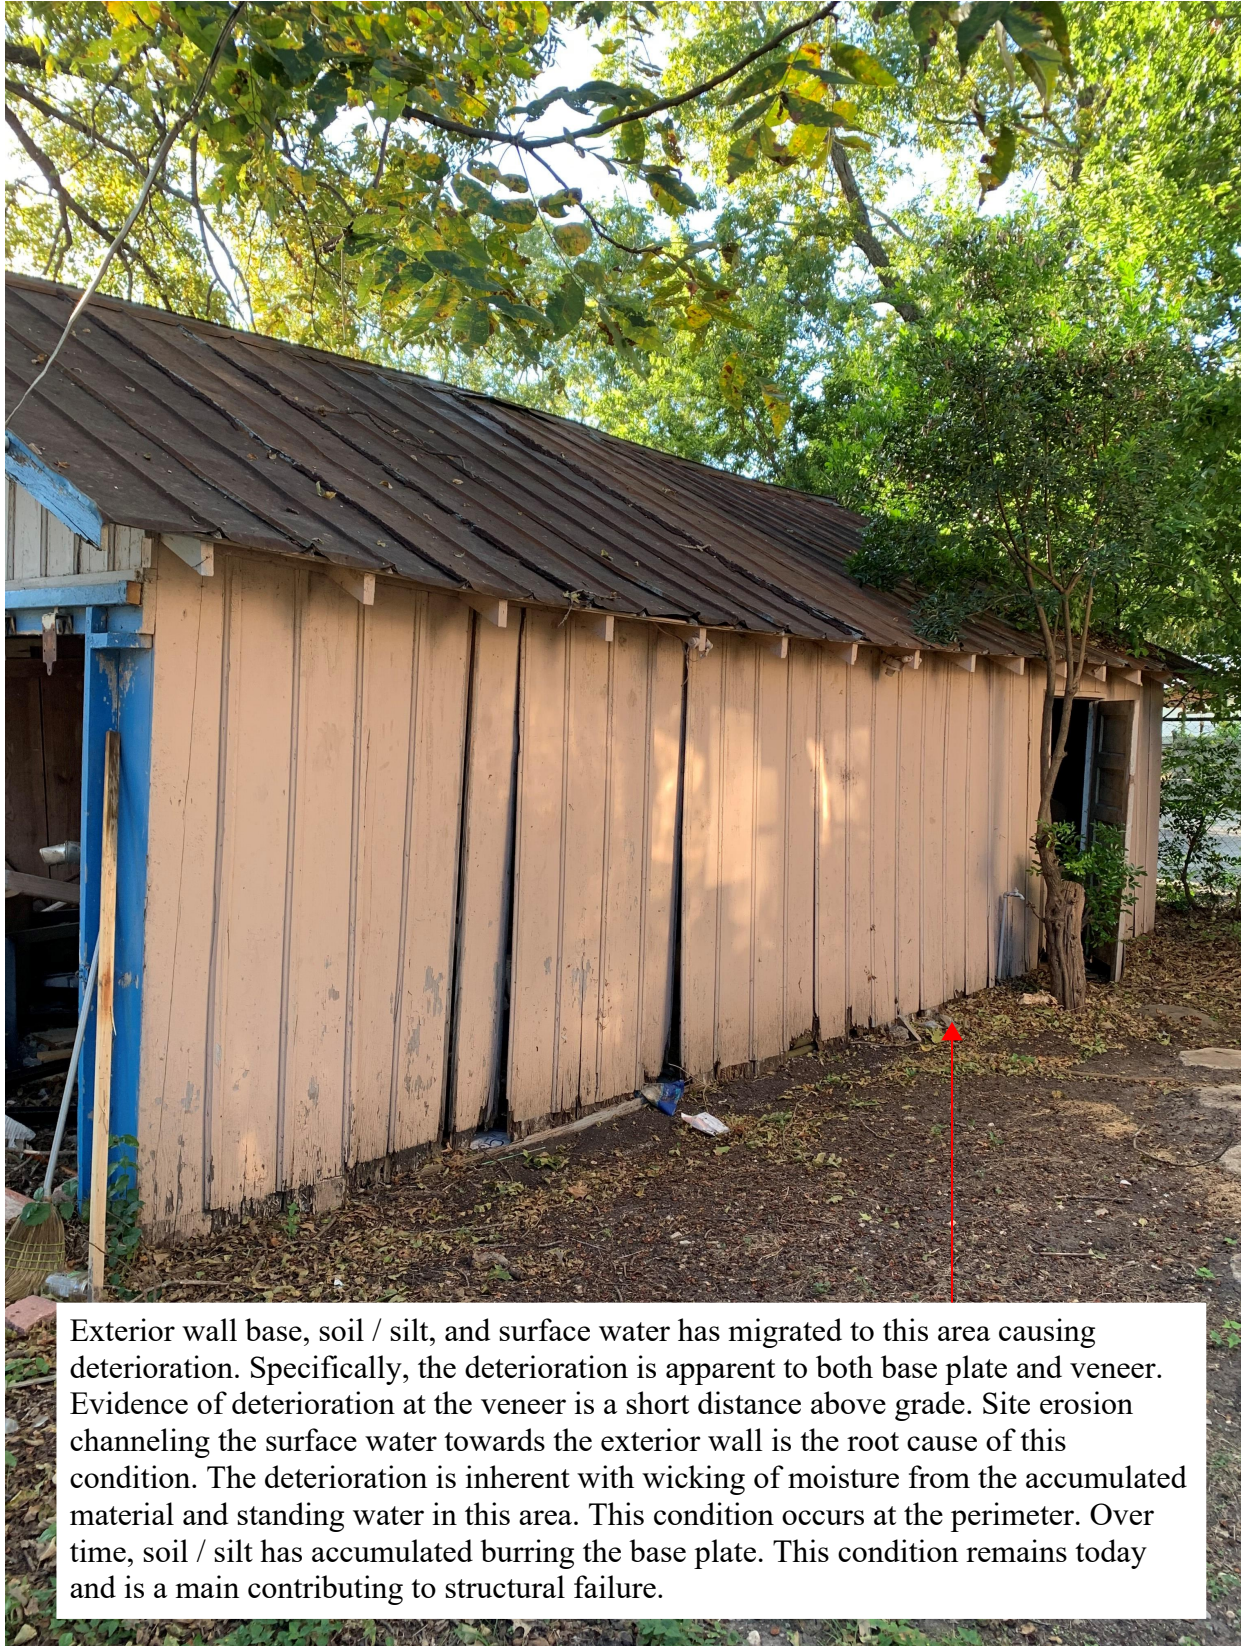
Exhibit E

Exterior wall base, soil / silt, and surface water has migrated to this area causing deterioration. Specifically, the deterioration is apparent to both base plate and veneer. Evidence of deterioration at the veneer is a short distance above grade. Site erosion channeling the surface water towards the exterior wall is the root cause of this condition. The deterioration is inherent with wicking of moisture from the accumulated material and standing water in this area. This condition occurs at the perimeter. Over time, soil / silt has accumulated burring the base plate. This condition remains today and is a main contributing to structural failure.

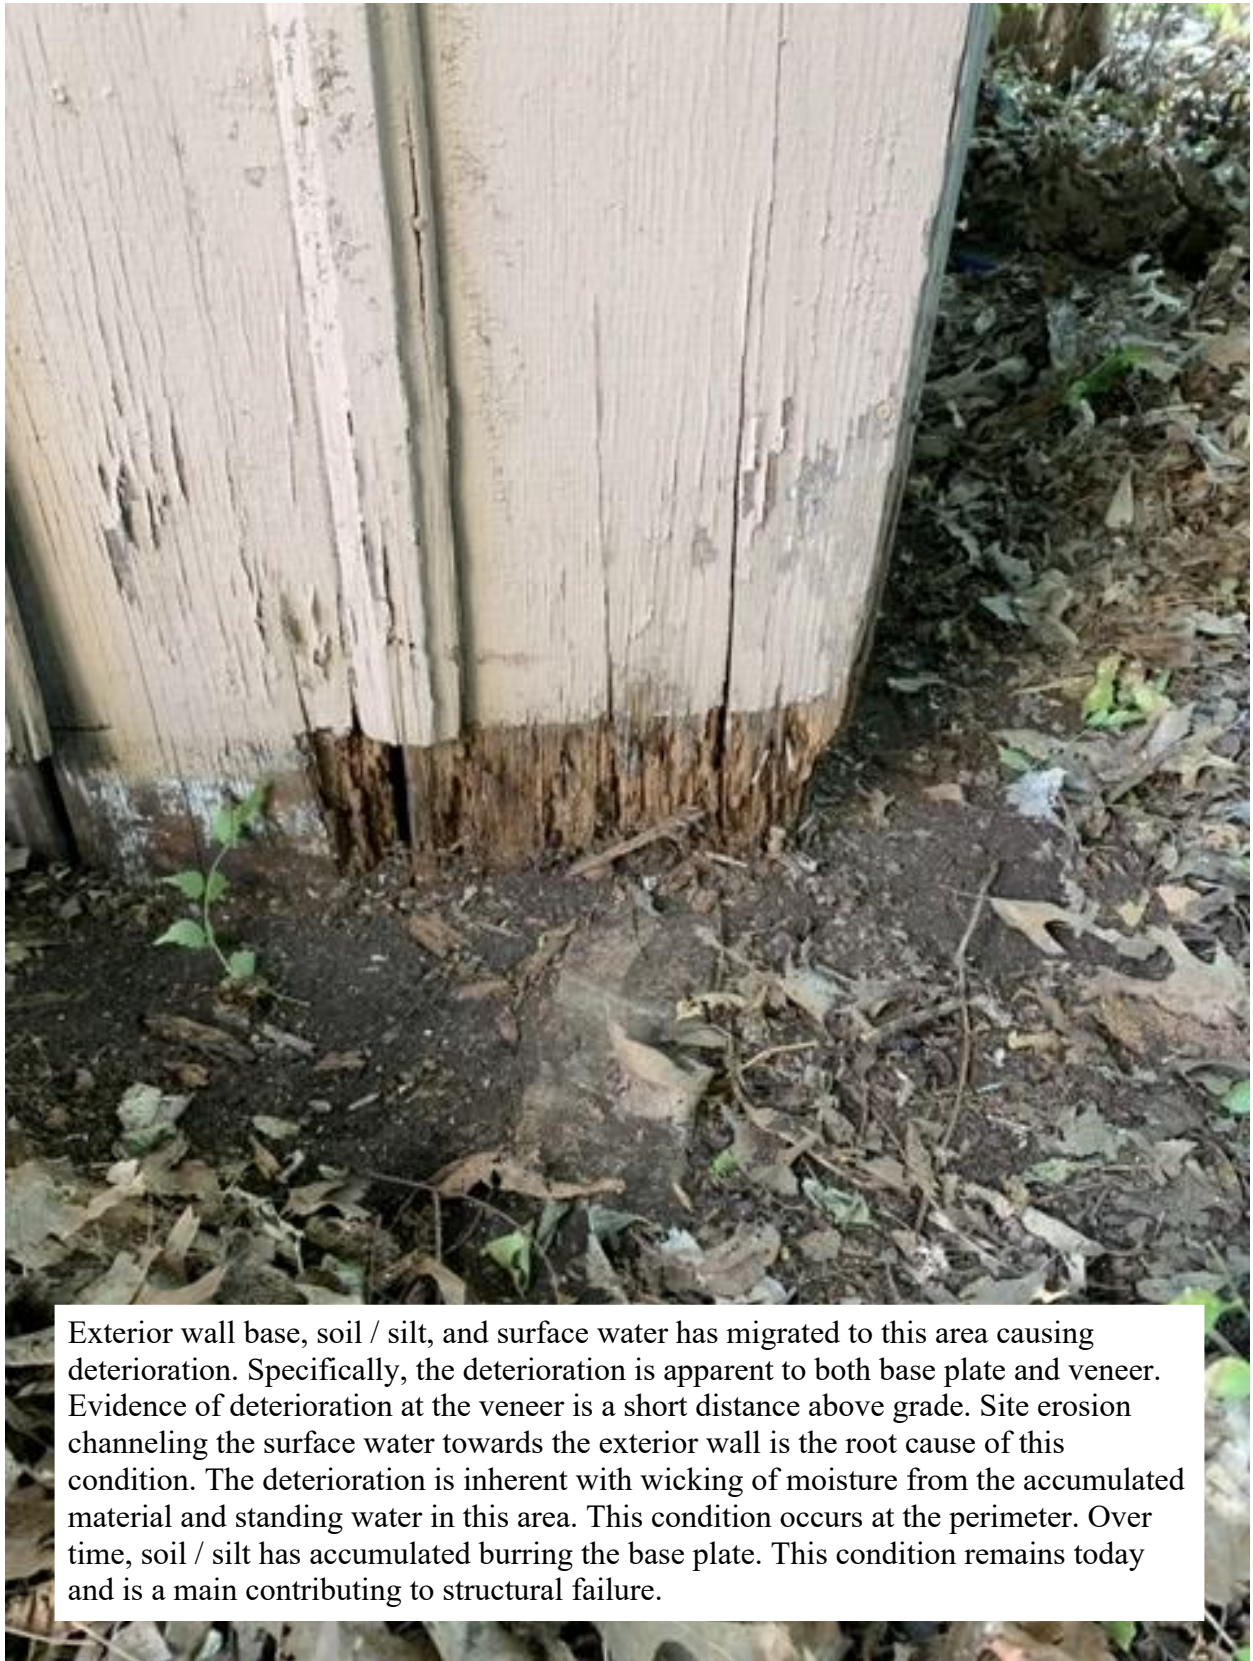
Exhibit H

Exterior wall base, soil / silt, and surface water has migrated to this area causing deterioration. Specifically, the deterioration is apparent to both base plate and veneer. Evidence of deterioration at the veneer is a short distance above grade. Site erosion channeling the surface water towards the exterior wall is the root cause of this condition. The deterioration is inherent with wicking of moisture from the accumulated material and standing water in this area. This condition occurs at the perimeter. Over time, soil / silt has accumulated burring the base plate. This condition remains today and is a main contributing to structural failure.

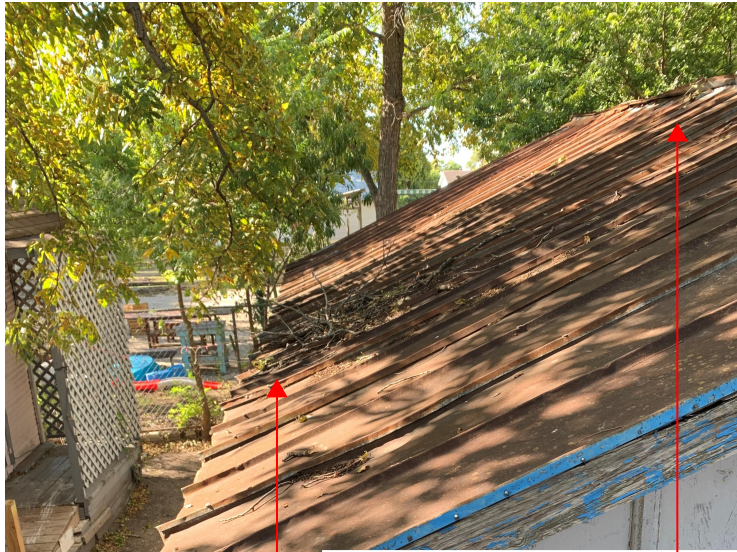
At the roof, disrepair is evident causing water infiltration into the building. The water infiltration has weakened the existing roof framing structure/deck and, in some areas, has attributed to structural failure of the roof framing causing a partial collapse.

Water infiltration into the building. The water infiltration has weakened the existing roof framing structure and, in some areas, has attributed to structural failure of the roof framing causing a partial collapse

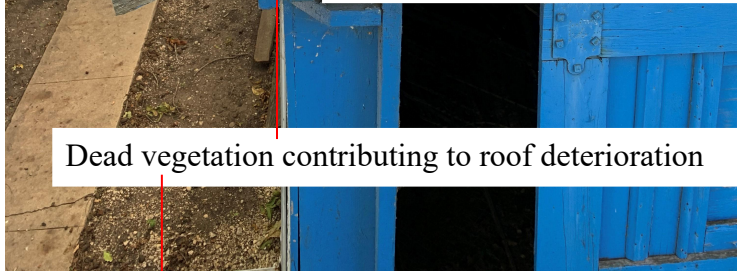
Dead vegetation contributing to roof deterioration

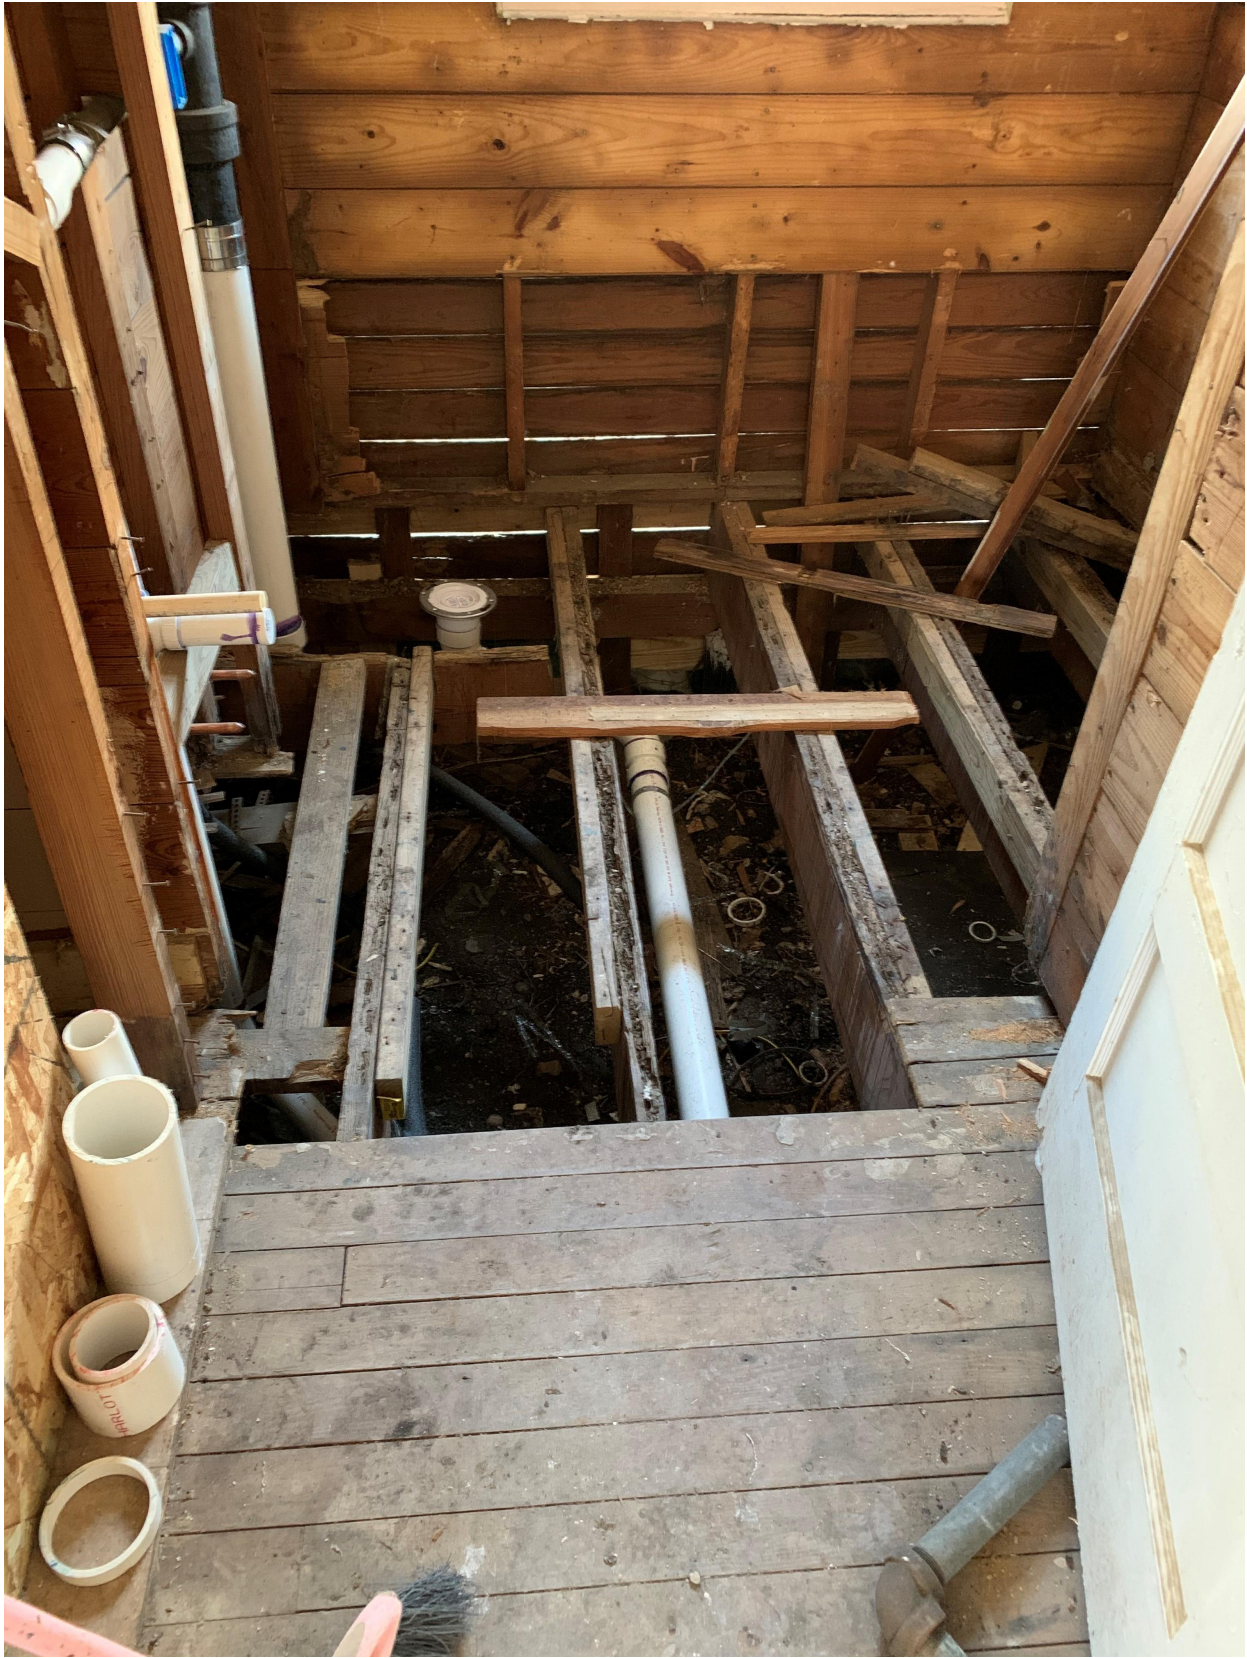
Interior Restroom Facility 912 Burnet

See attached photos of existing restrooms facilities that present a prime example to use reclaimed material. Reference Exhibit J & K.

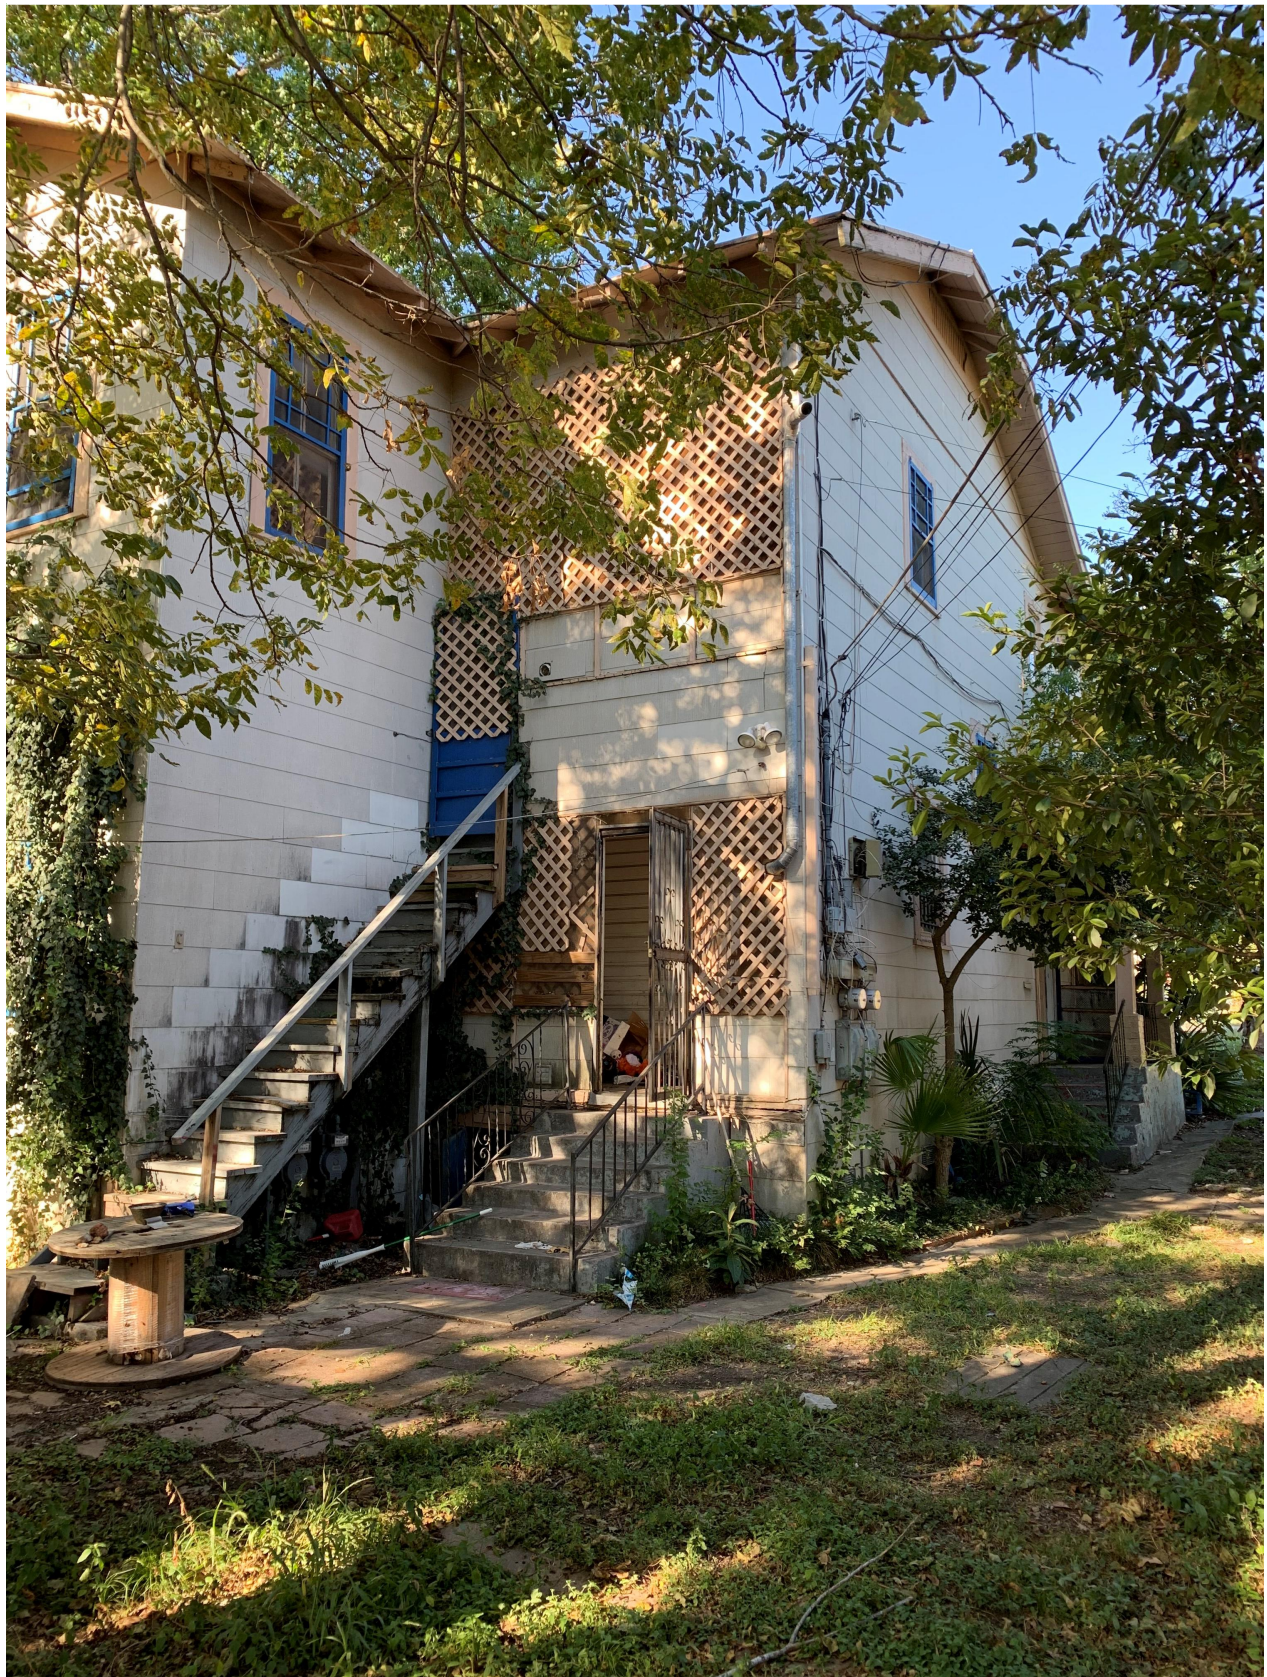
REAR PORCH - ORIGINAL CONDITION
732 N PINE ST

- g. REAR PORCH ENCLOSURE – The applicant has proposed to enclose an open air, rear porch at the rear (east facade) of the primary historic structure at 732 N Pine. The current porch has been informally enclosed with an open air lattice for an undetermined amount of time.

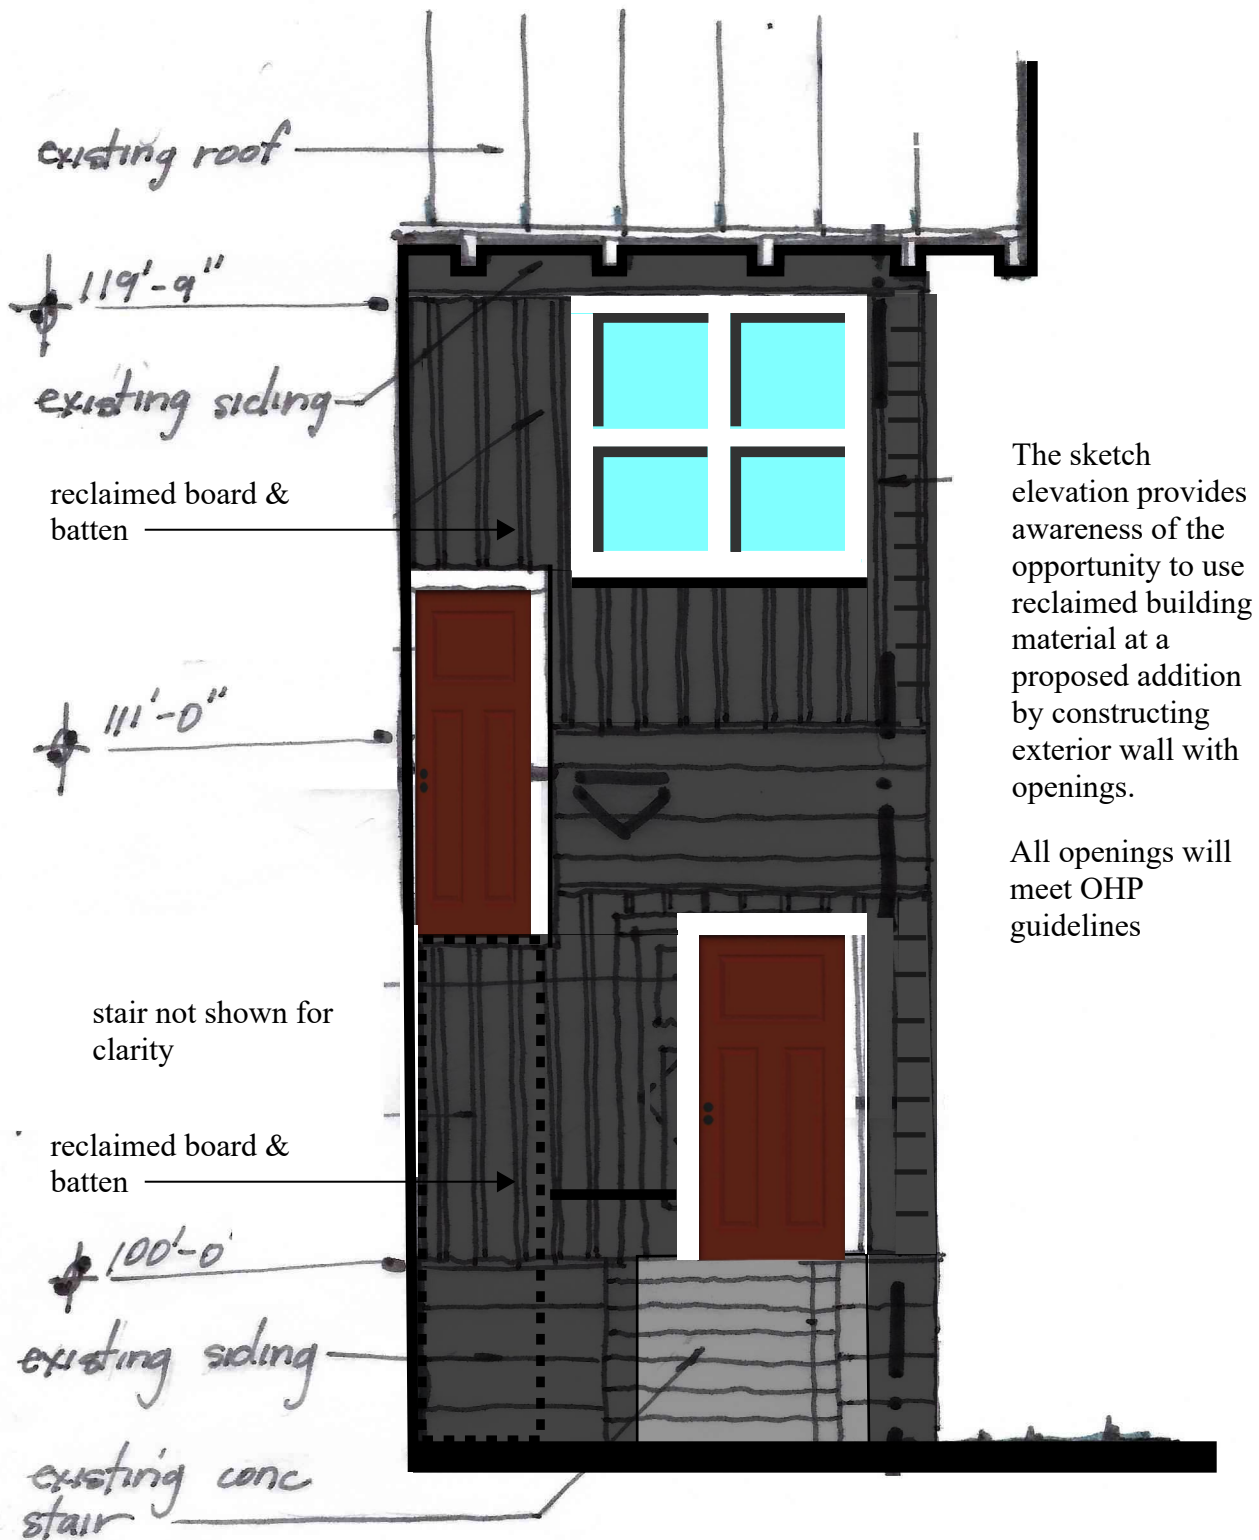
The sketch elevation provides awareness of the opportunity to use reclaimed building material at a proposed addition by constructing exterior wall with openings.

All openings will meet OHP guidelines
