HISTORIC AND DESIGN REVIEW COMMISSION

HDRC CASE NO: 2016-051
ADDRESS: 304 E TRAVIS ST
LEGAL DESCRIPTION: NCB 415 BLK 18 LOT A-7, A- 8, A-9, P-100, P-101 & P-102
ZONING: D HE
CITY COUNCIL DIST.: 1
LANDMARK: St Anthony Hotel
APPLICANT: Brandon Raney
OWNER: BCL St. Anthony ML, LP
TYPE OF WORK: Tax Verification
REQUEST:

St. Anthony Hotel
Scope Summary of Exterior Rehabilitation

ST. ANTHONY HOTEL RENOVATION
 PHOTO KEY PLAN - EXISTING 1ST FLOOR

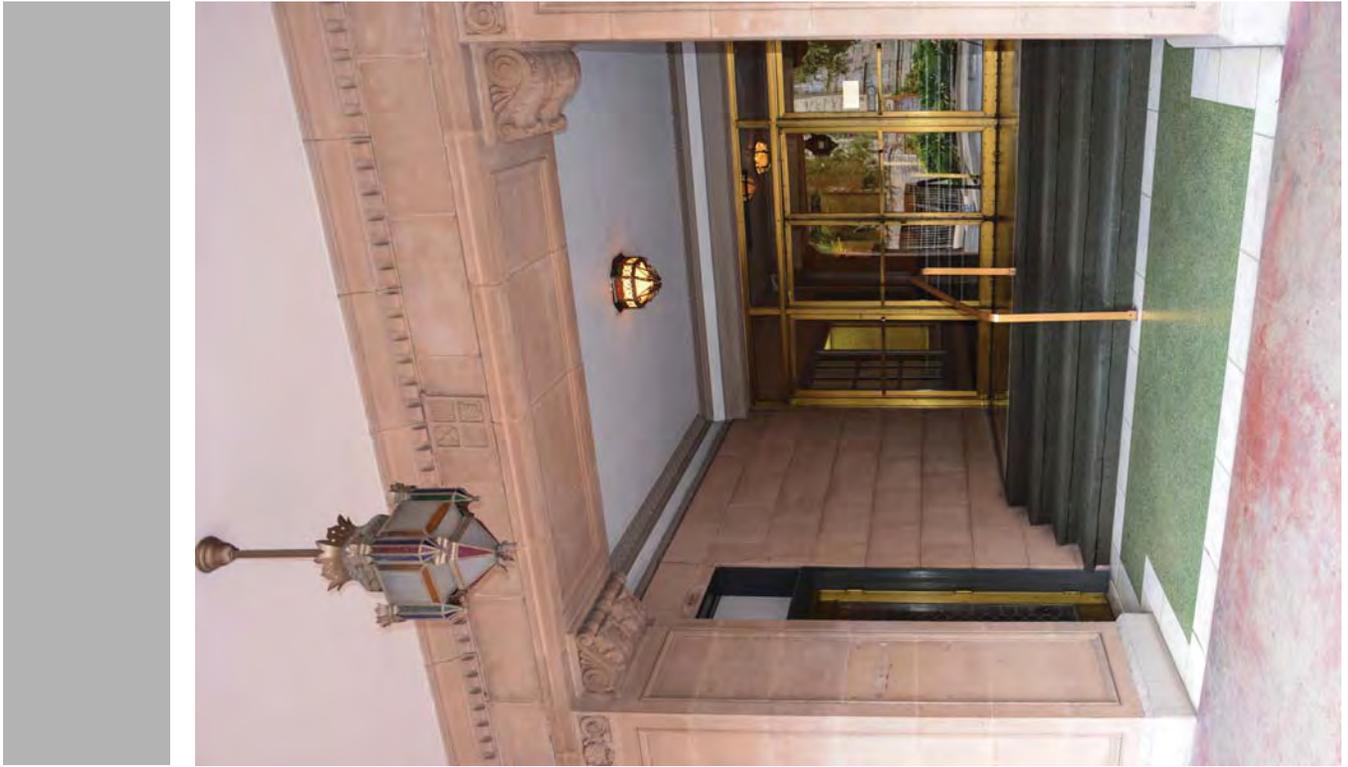
Name: Saint Anthony Hotel, 300 East Travis Street, San Antonio, Texas
View: Navarro Street entrance, looking east
Description: Non-historic door and glazing system to be replaced
Date: September 2012

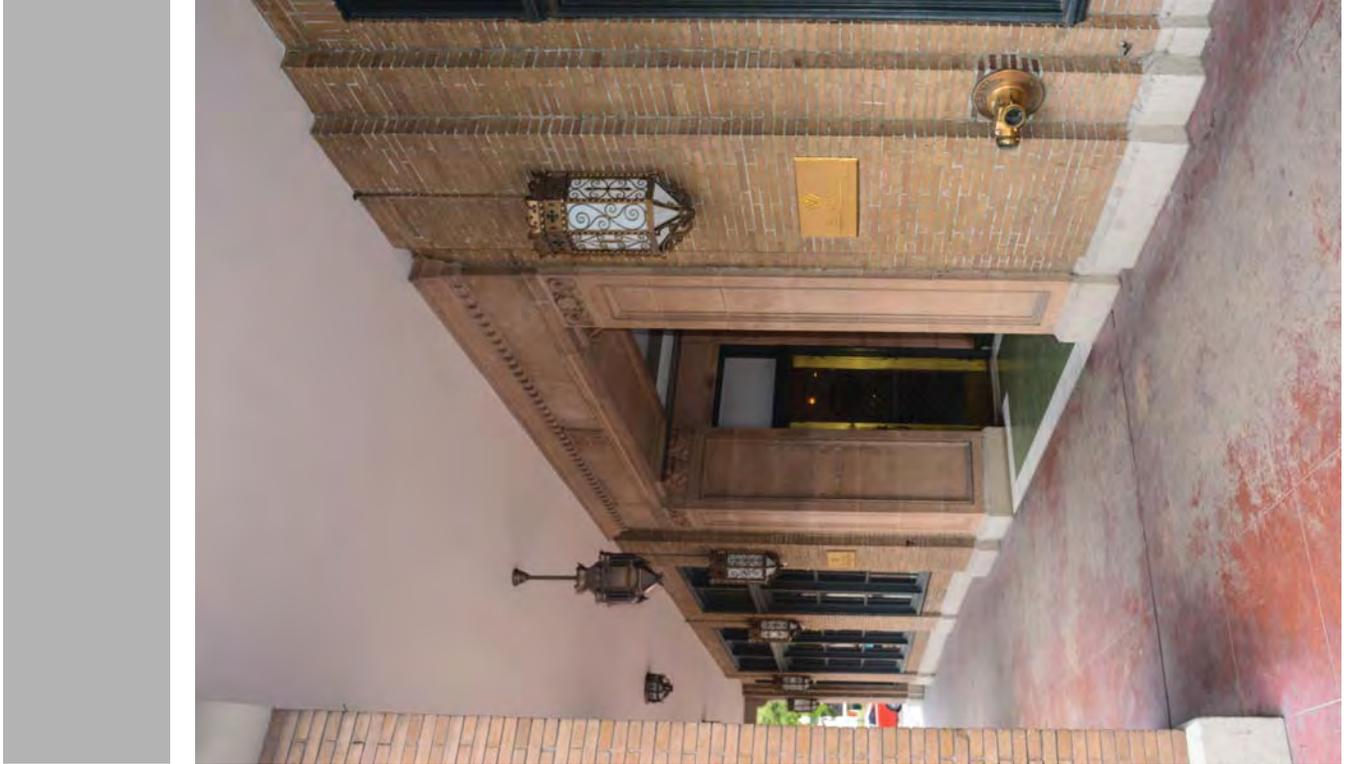
Name: Saint Anthony Hotel, 300 East Travis Street, San Antonio, Texas
View: Navarro Street entrance, looking northeast
Description: Cast stone and brick masonry requiring general cleaning and repair
Date: September 2012

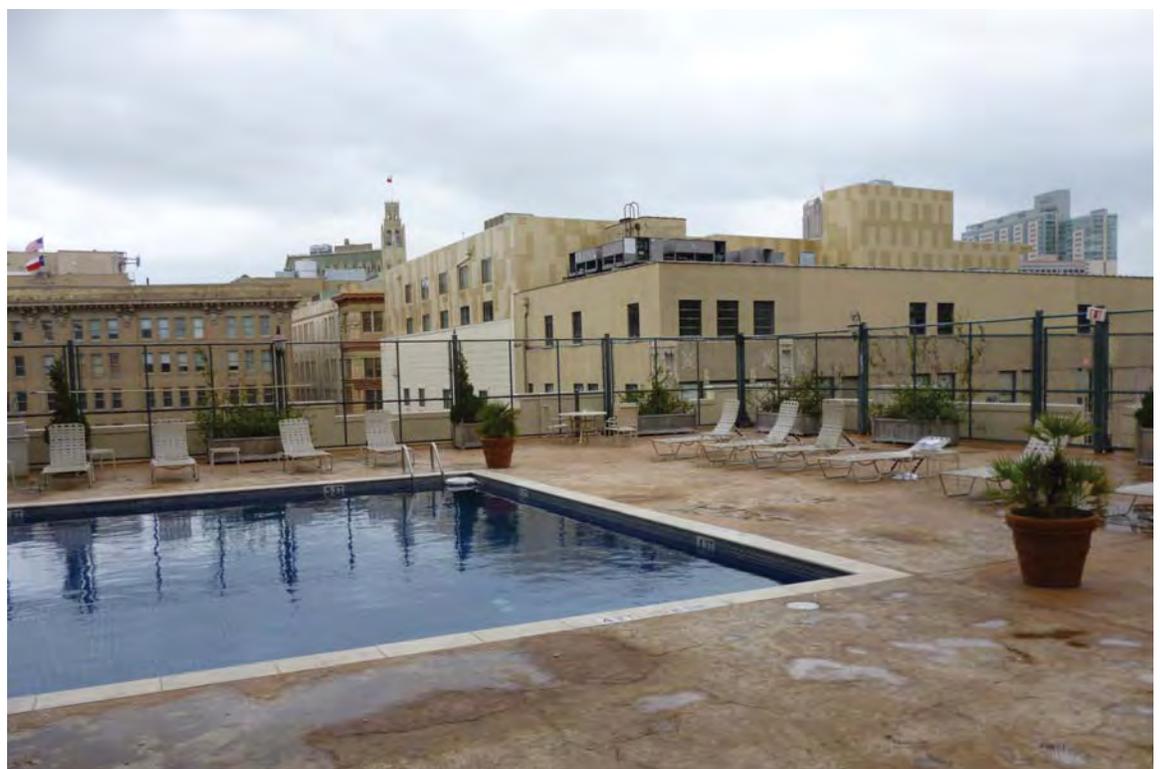
Name: Saint Anthony Hotel, 300 East Travis Street, San Antonio, Texas
View: Sixth floor pool terrace, looking east-southeast
Description: Cracked and spawling decking material & inappropriate fencing
Date: September 2012

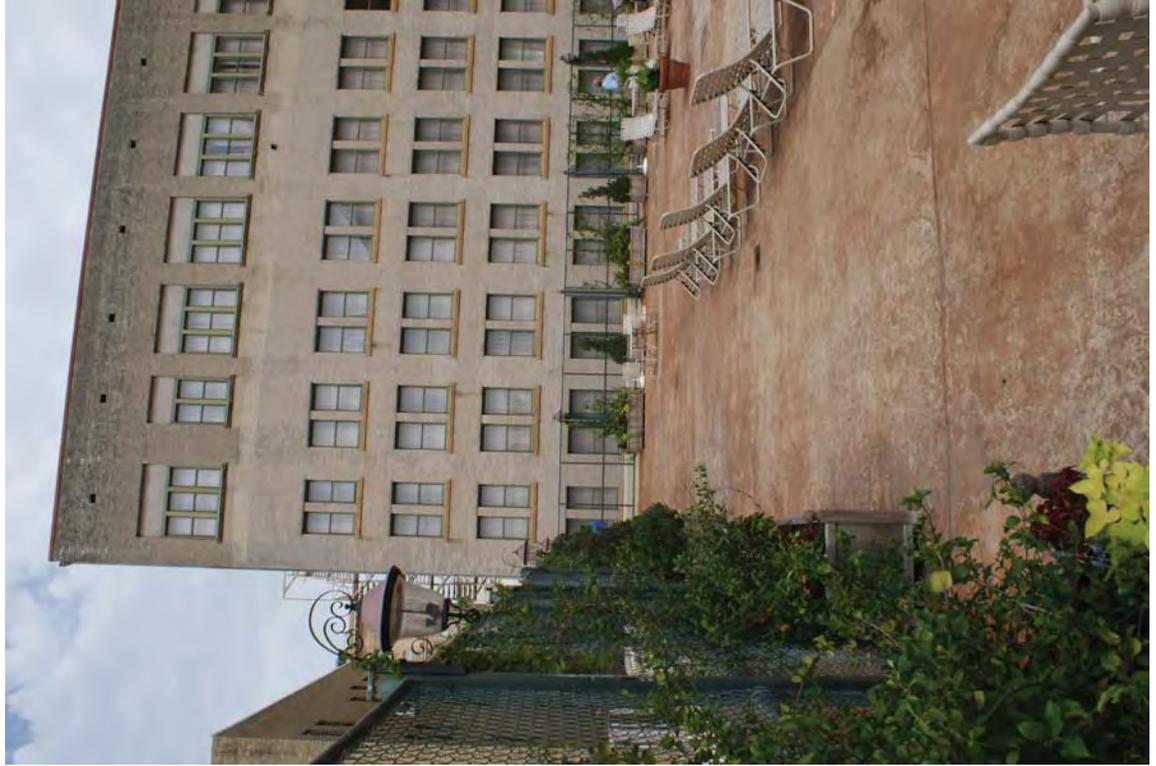
Name: Saint Anthony Hotel, 300 East Travis Street, San Antonio, Texas
View: Sixth floor pool terrace, looking west toward Tower 3
Description: Atmospheric and mineral stained masonry; inappropriate fencing
Date: September 2012

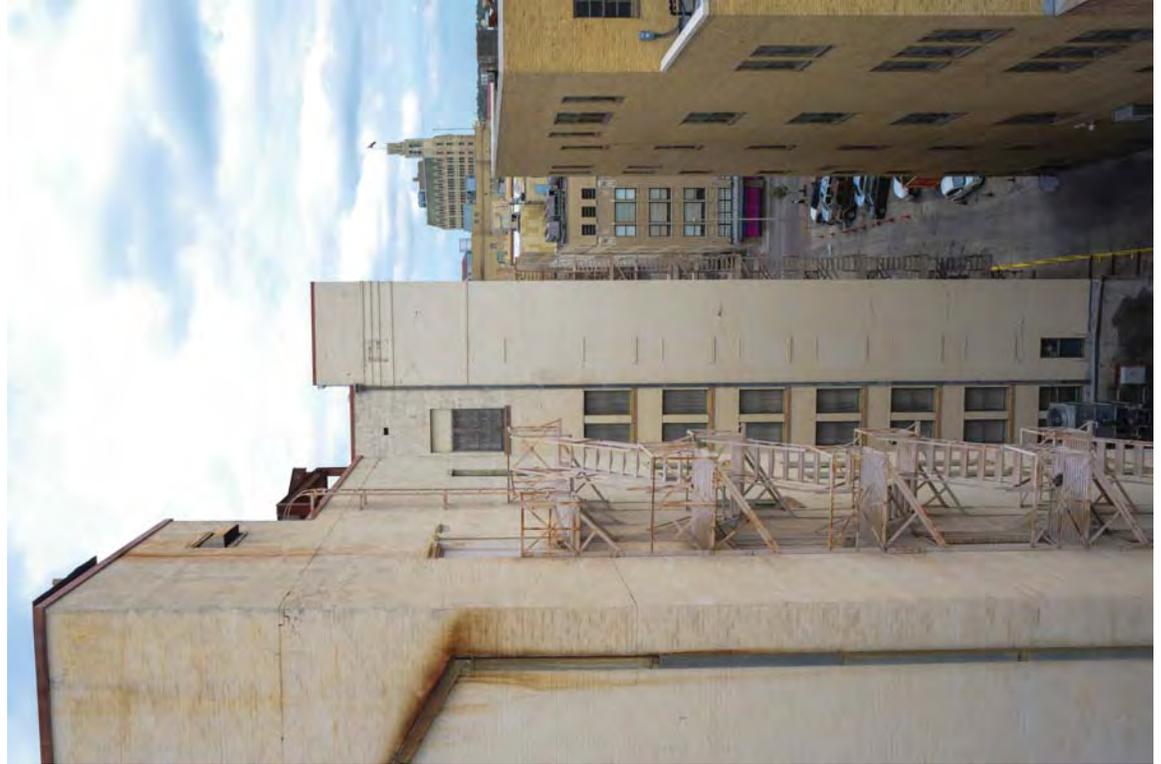
Name: Saint Anthony Hotel, 300 East Travis Street, San Antonio, Texas
View: Alley as seen from tenth floor Starlight Terrace, looking east
Description: Coated masonry with rust stains; Tower 2 fire escape
Date: September 2012

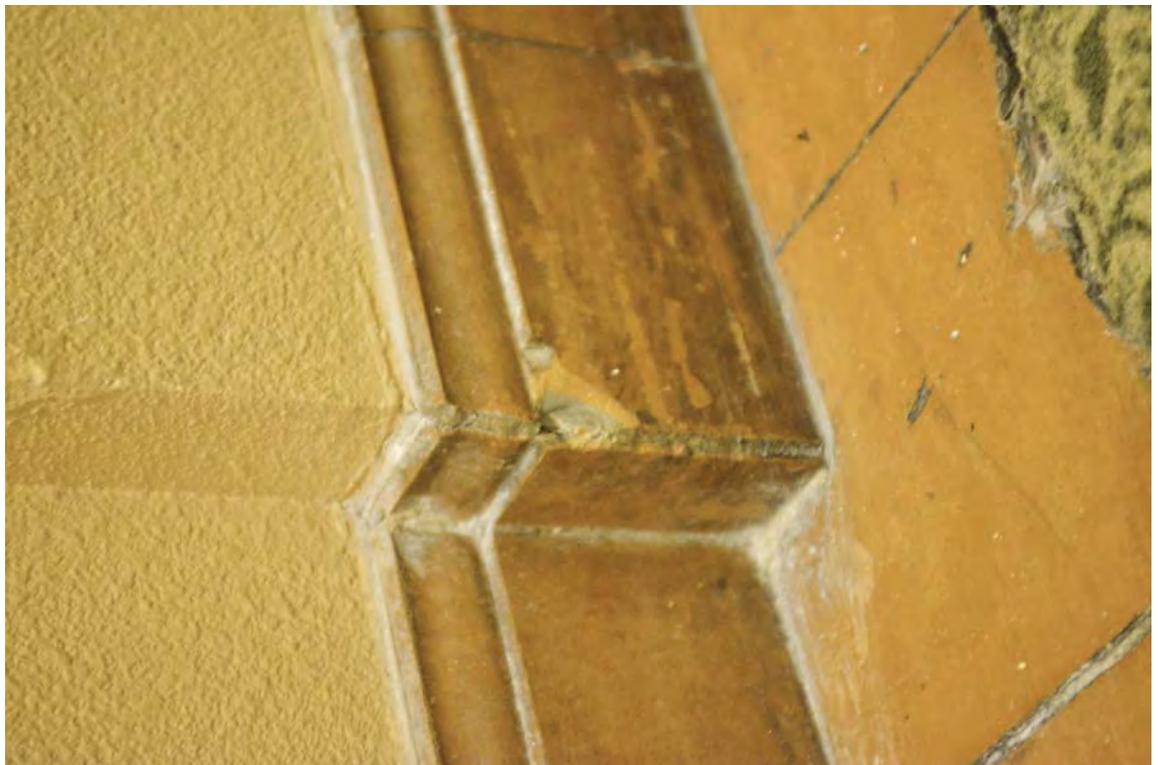
Name: Saint Anthony Hotel, 300 East Travis Street, San Antonio, Texas
View: Third floor corridor tile border and base detail
Description: Detail view of typical damage to tile base at projecting corners
Date: September 2012

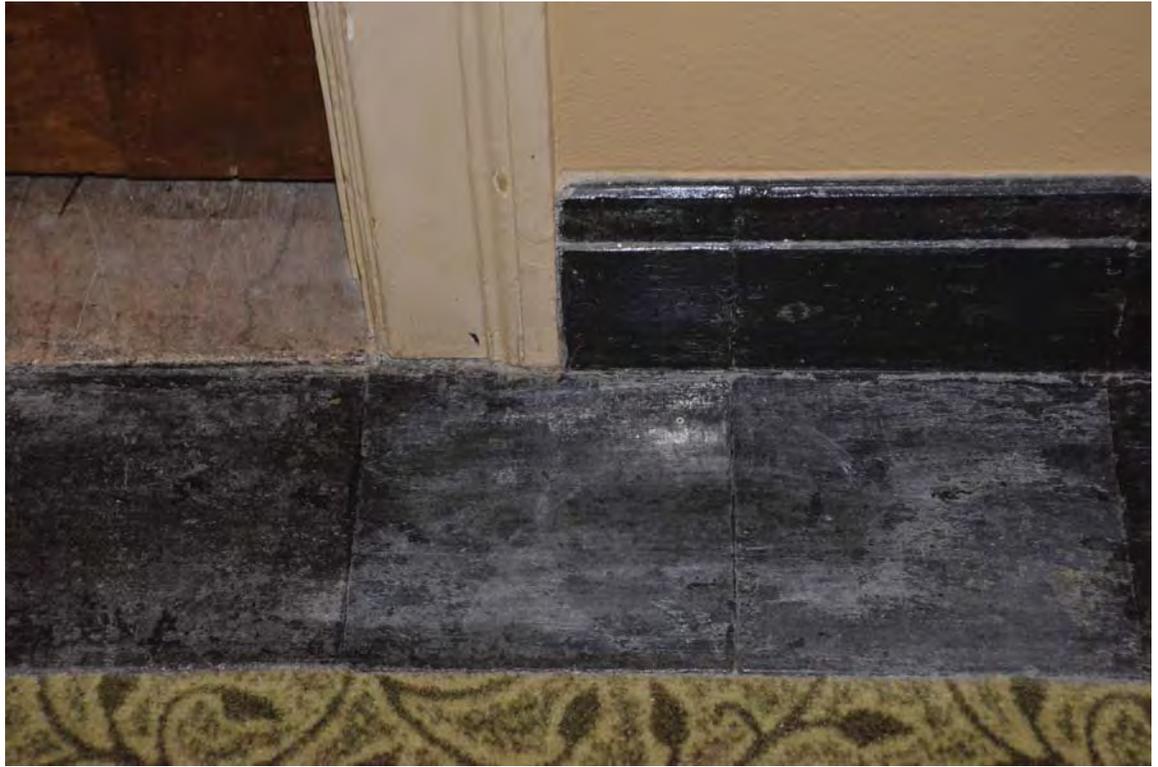
Name: Saint Anthony Hotel, 300 East Travis Street, San Antonio, Texas
View: Fourth and fifth floor corridor tile border and base detail
Description: Example of dirt, abrasion, wear and chemical staining to tile at door thresholds
Date: September 2012

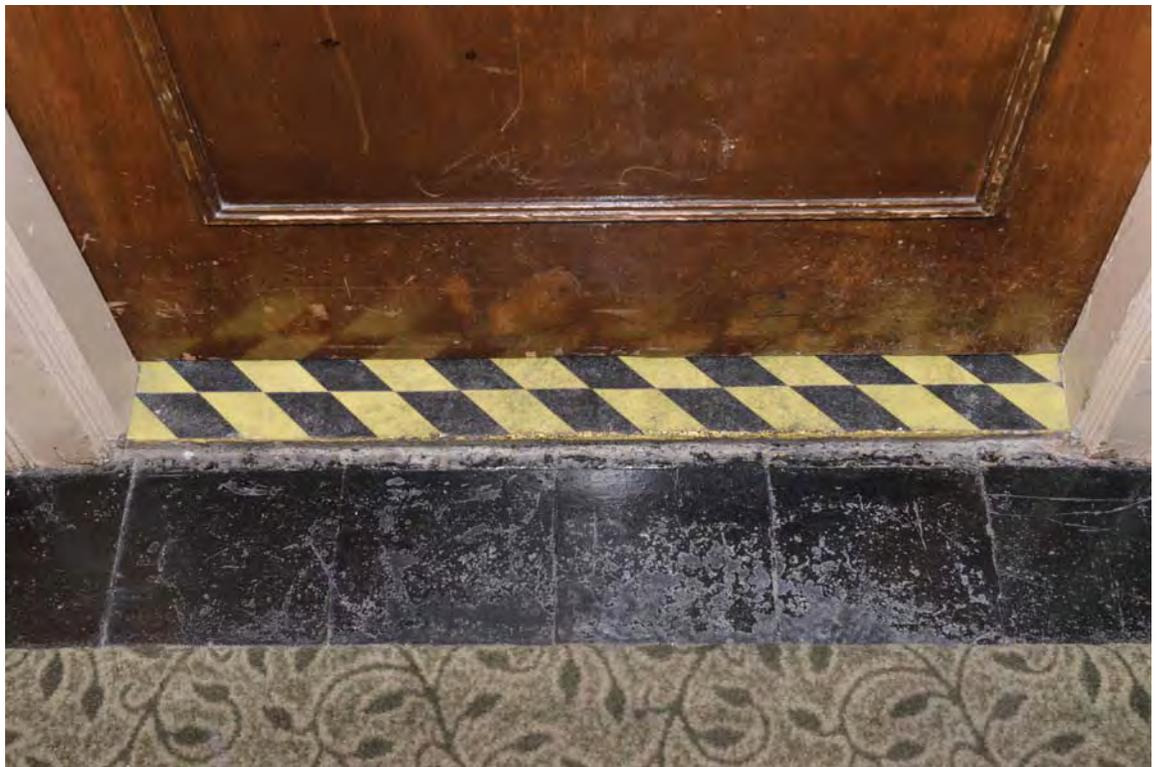
Name: Saint Anthony Hotel, 300 East Travis Street, San Antonio, Texas
View: Fourth and fifth floor corridor tile border and base detail
Description: Example of deep pitting, scratches, abrasion, & wear to tile at door thresholds
Date: September 2012
