HISTORIC AND DESIGN REVIEW COMMISSION

March 21, 2018

HDRC CASE NO: 2018-110
ADDRESS: 170 HERMINE BLVD NCB
LEGAL DESCRIPTION: 9007 BLK 13 LOT 5&6
ZONING: R-4 H
CITY COUNCIL DIST.: 1
DISTRICT: Olmos Park Terrace Historic District
APPLICANT: Robert Beldon
OWNER: Joseph Gamez
TYPE OF WORK: Construction of rear addition and deck, window replacement
APPLICATION RECEIVED: March 05, 2018
60-DAY REVIEW: May 04, 2018
REQUEST:

Investigation Report

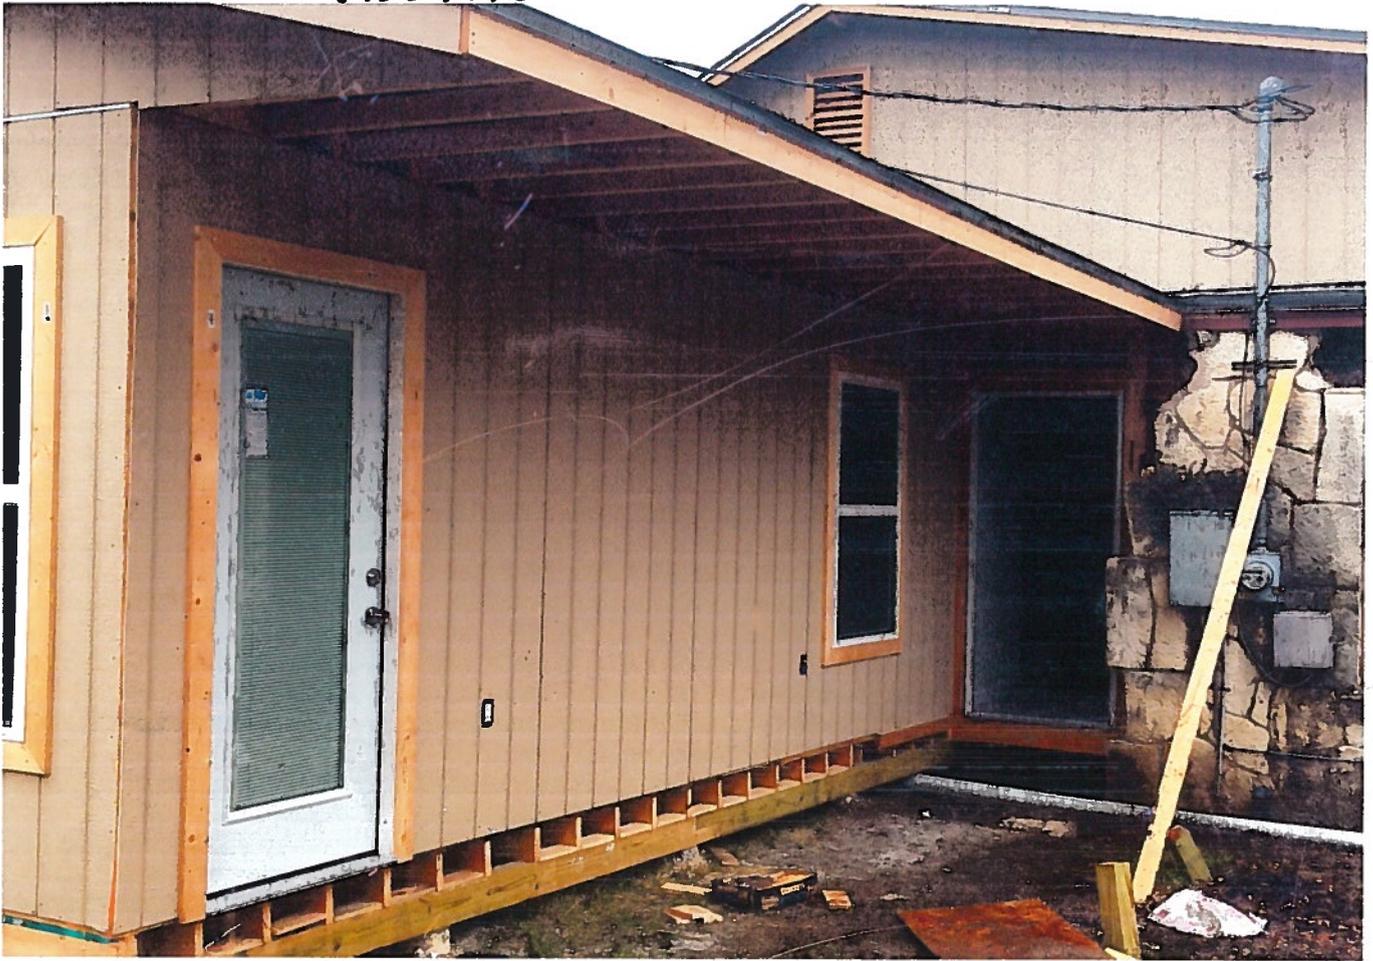
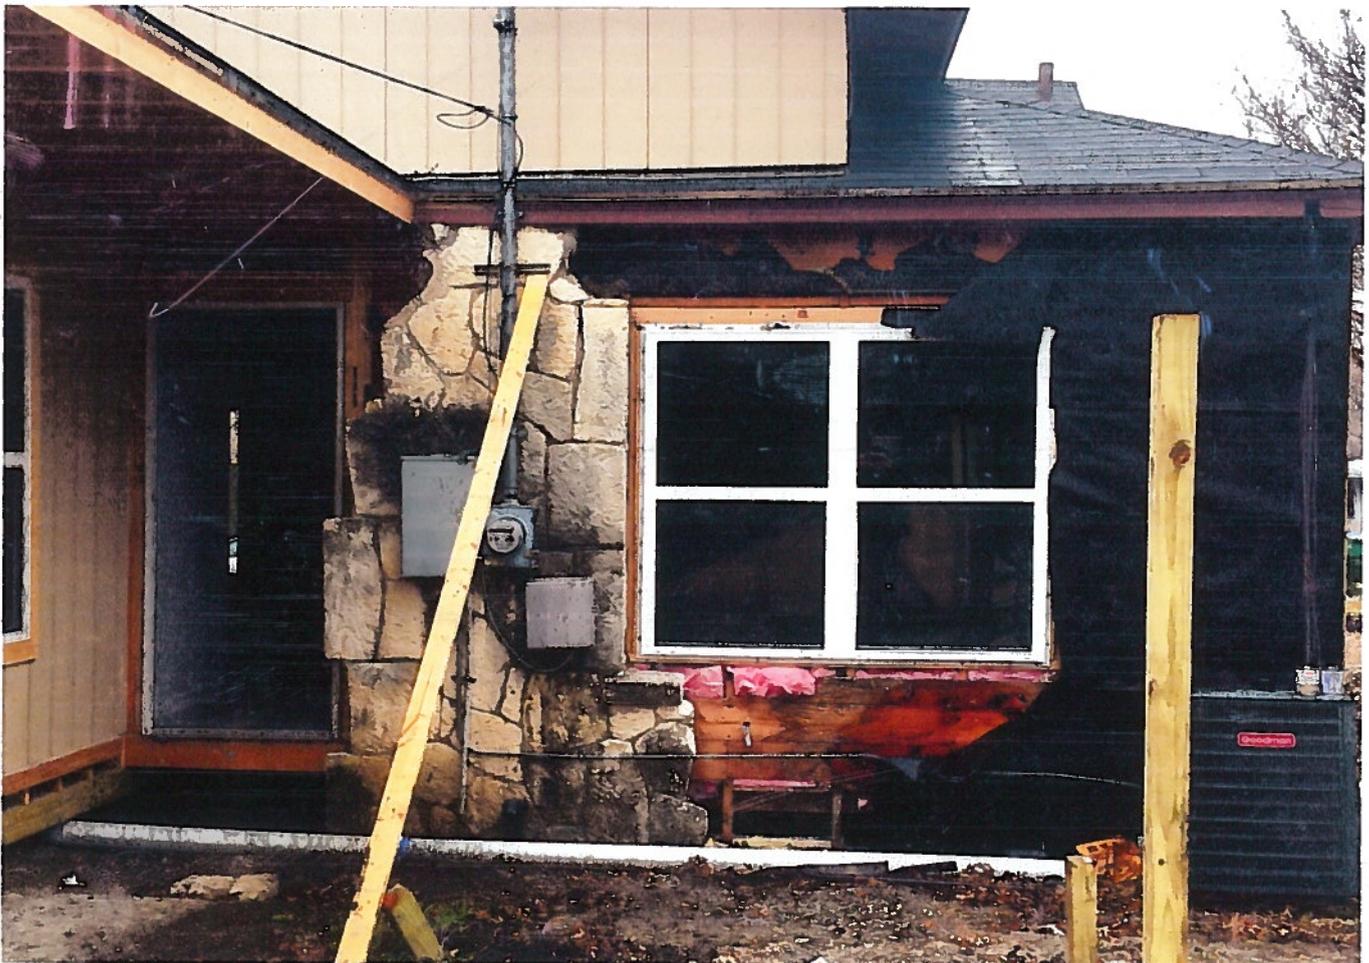
ADDITION

- c. **ADDITION** – The application has proposed to install a 480 addition at the rear of the property. The addition features a door and double-hung window on the east elevation and two double-hung windows on the south elevation. The addition features shingle roofing to match the existing structure and horizontal hardi siding which provides a clear visual distinction between the new and old (stone façade) forms. The addition also features a gable roof at a height that is subordinate to the existing primary structure. Staff finds the proposal consistent with the Guidelines for Additions 3.1. through 4.

- reinstall the three removed window openings with wood double-hung windows based on finding B.
2. Staff recommends approval of the rear addition as proposed based on finding C.
 3. Staff does not recommend approval of the rooftop addition as proposed based on finding D. Staff recommends the applicant submit a roof form that does not require the removal or covering of the existing hipped roof and/or feature a height that is subordinate to the primary gable of the historic structure.
 4. Staff recommends the approval to install a rear wood deck as proposed based on finding E.

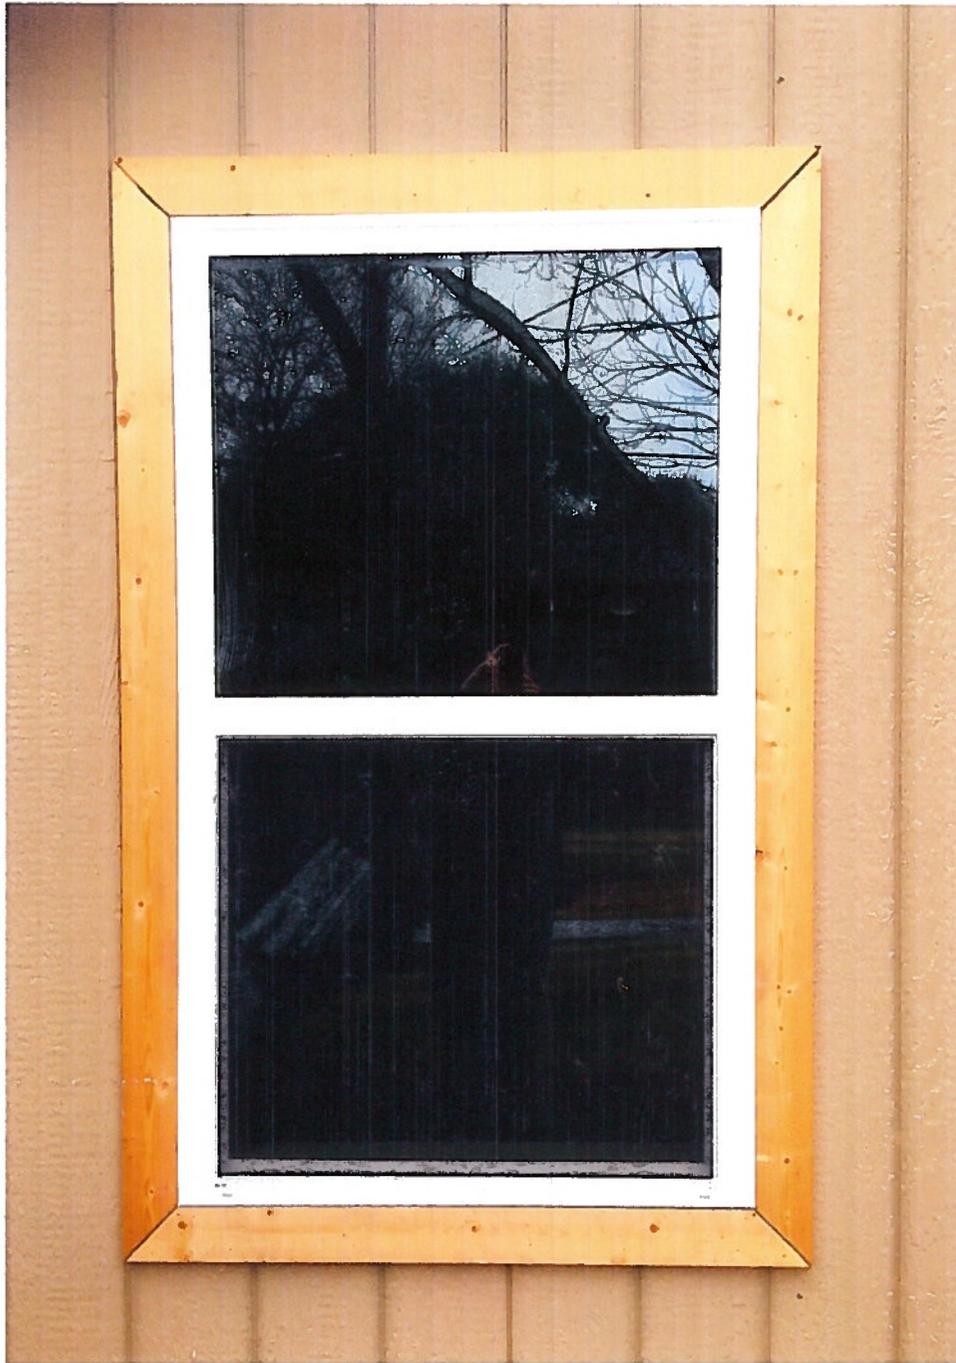
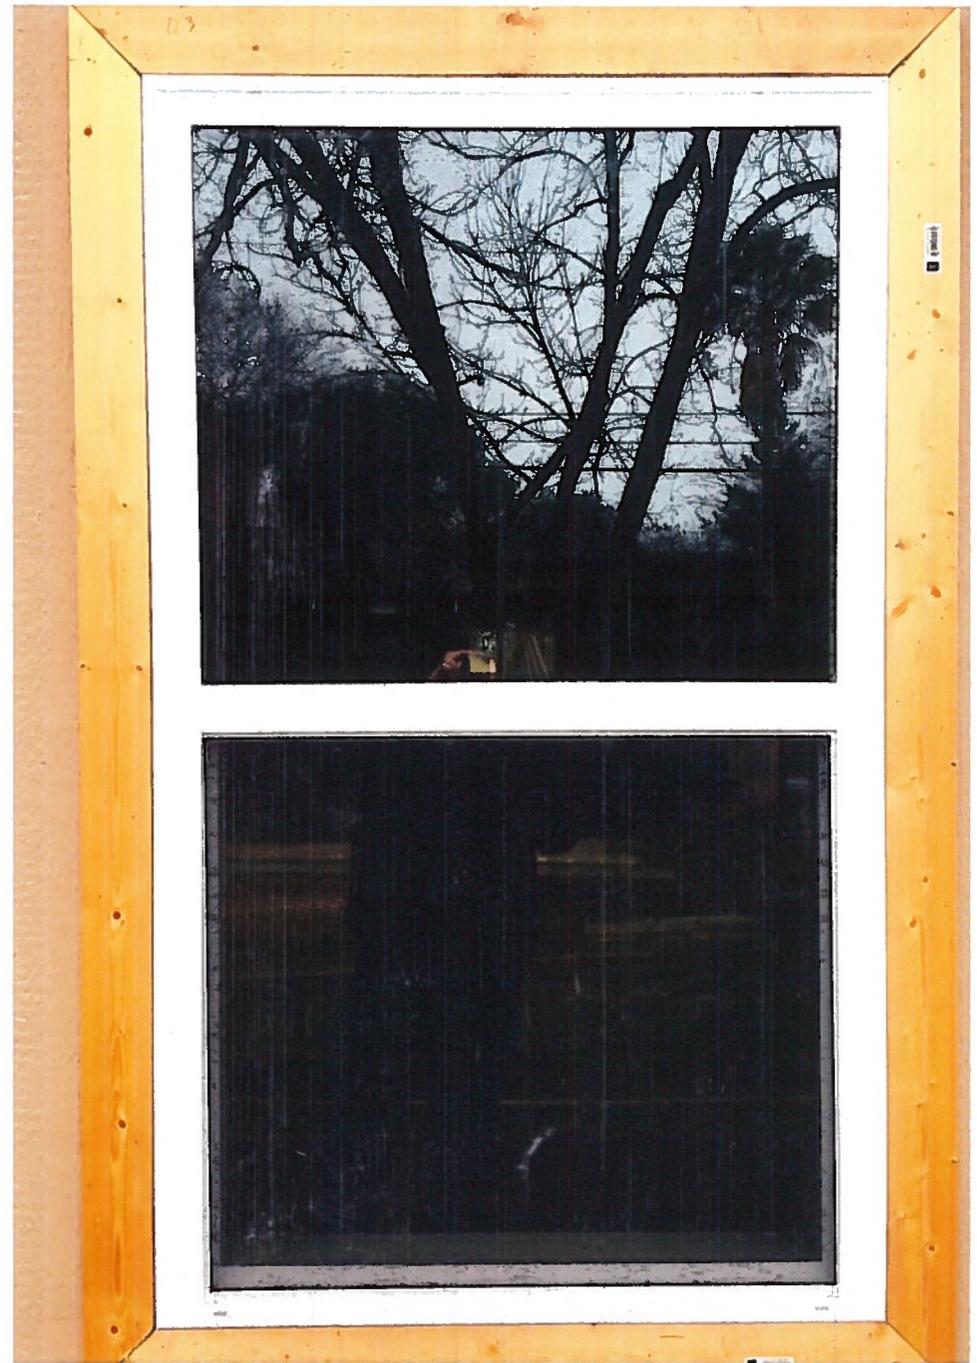
REAR VIEW

Date	02/02/2018
Time	12:04 PM (-6 GMT)
Present Staff	Huy Pham
Present Individuals	Homeowner, Contractor(s), Crew member(s)
Types of Work Observed	Exterior Maintenance and Alterations, Additions
Amount of Work Completed	75%
Description of work	Work was being performed on the rear side of the property (either fenestration changes or construction of an addition). Elevation adjacent to fence still featured Hardi siding instead of stone; window/openings have been removed.
Description of interaction	<p>Staff was placing the HDRC public notice sign as a contractor approached the front yard. Staff asked the contractor of staff could take photos of the rear side of the property to which the contractor allowed. When staff informed the contractors that the work on the rear addition has yet to be approved, one contractor called the owner (Joseph Gamez) to speak with staff.</p> <p>Mr. Gamez explained that he felt targeted by staff and that he was performing the work in compliance to which staff explained that the rear and side elevations have not been accounted for and that another stop work order will have to be issued. Mr. Gamez asked staff is remain on the site to speak with staff directly and to show staff other unapproved work by other owners/contractors. As Mr. Gamez showed up, staff explained that his comments should be reserved for his HDRC hearing on February 7, 2018. Staff was able to post a Notice of Investigation during the investigation.</p>

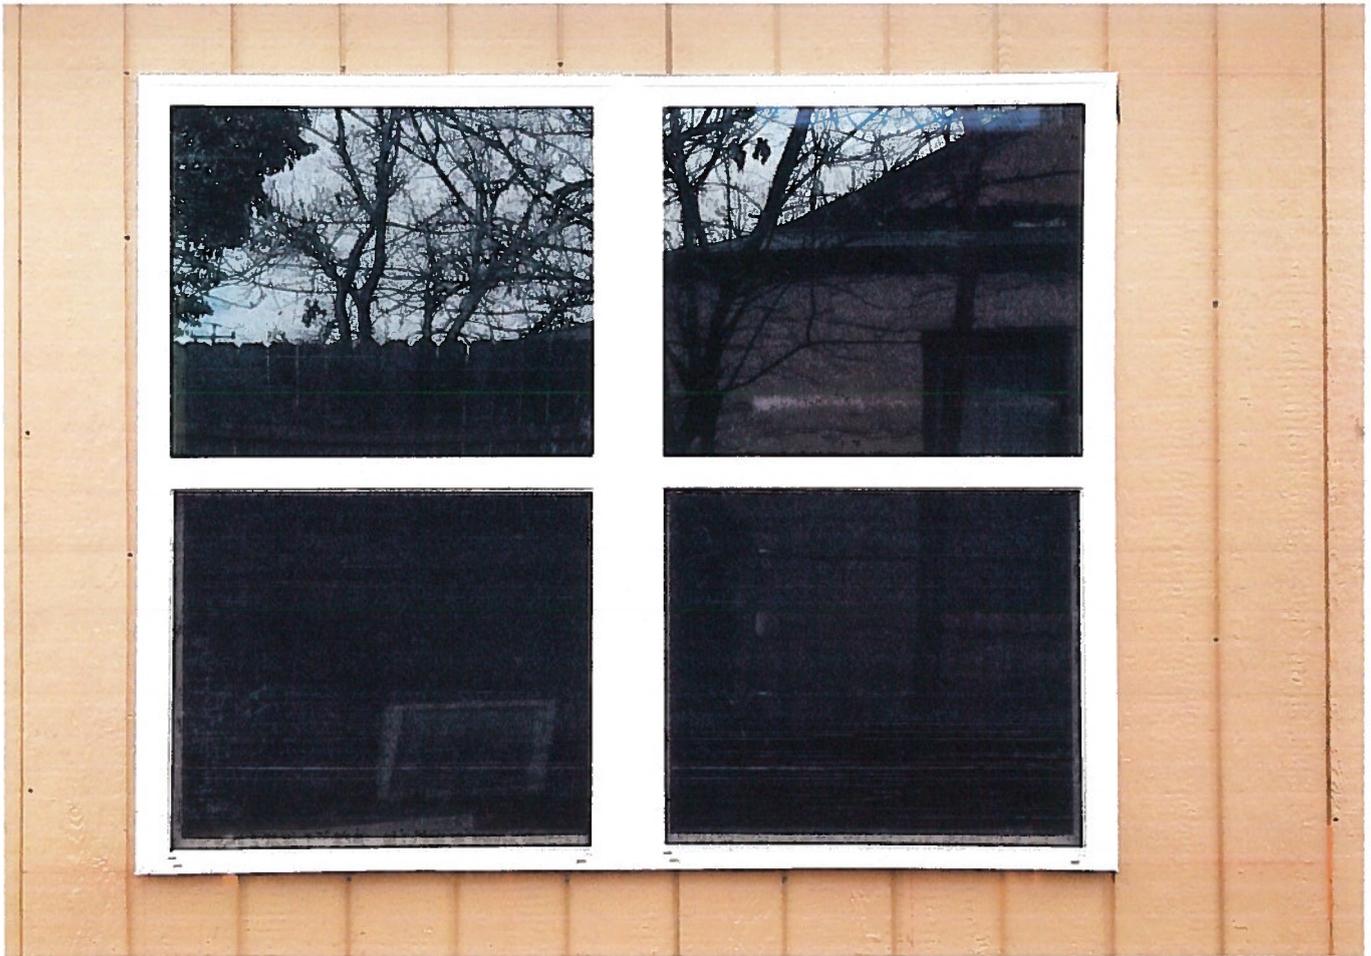
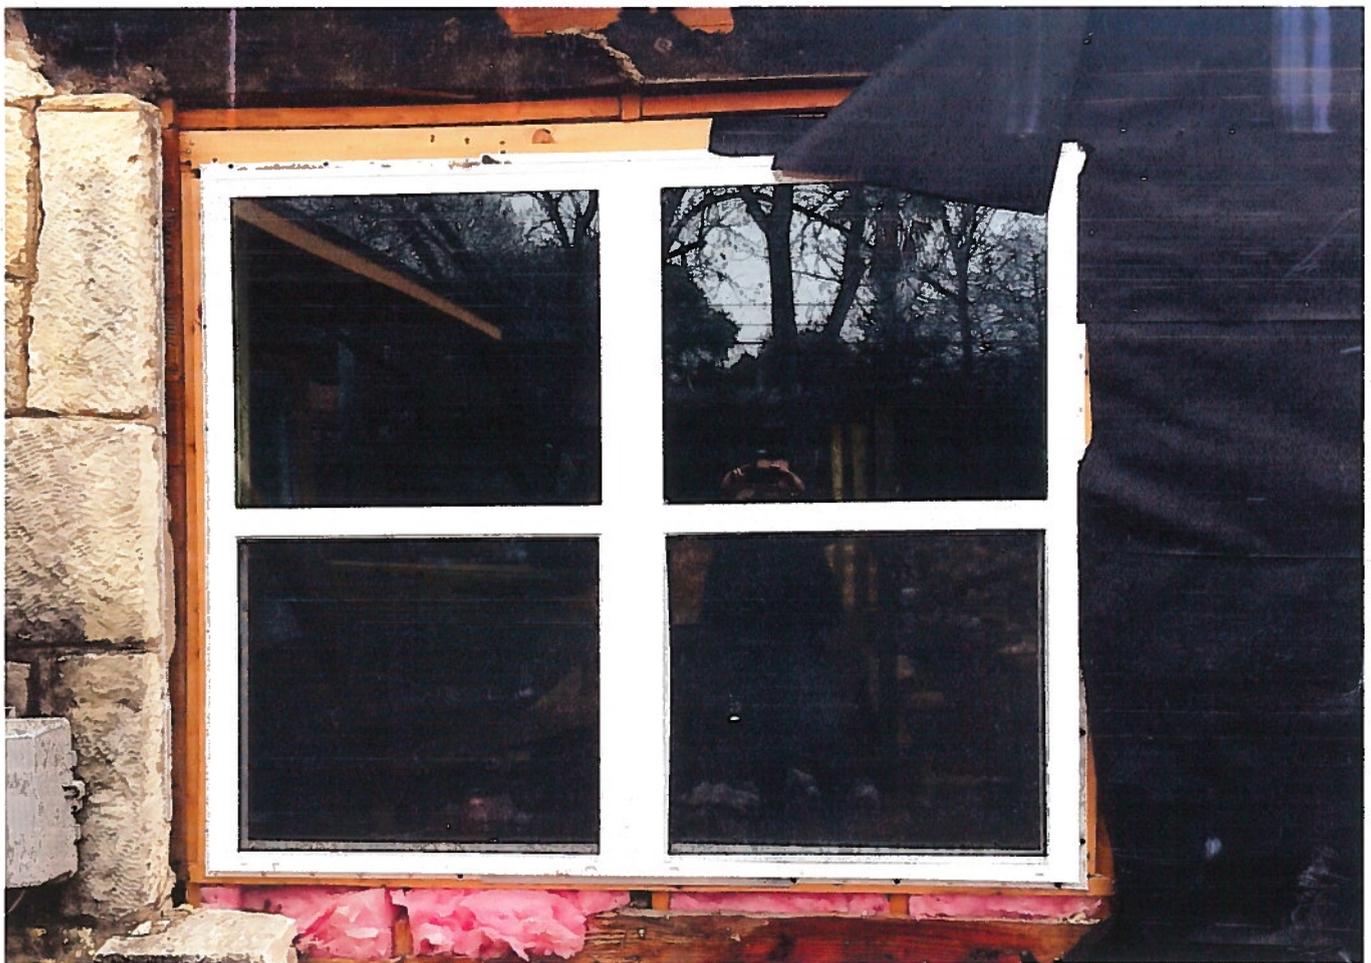
REAR WINDOWS ON ADDITION

- b. **WINDOWS** – The homeowner had replaced the original wood windows of the home with vinyl windows with wood trim, as well as removed three window openings on the side elevation. After the HDRC hearing on February 7, 2018 in which vinyl replacement of wood windows was denied, the homeowner through the applicant is requesting to install wood double-hung windows in all window openings as well as restore the three removed window opening on the side elevation. Per the Guidelines for Exterior Maintenance and Alterations 2.B. iv. new windows should match the historic or existing windows in terms of size, type, configuration, material, form, appearance, and detail when the original windows are deteriorated beyond repair. The proposed windows feature meeting rails that are no taller than 1.25” and stiles no wider than 2.25”. There should be a minimum of two inches in depth between the front face of the window trim and the front face of the top window sash. This must be accomplished by recessing the window sufficiently within the opening or with the installation of additional window trim to add thickness. Window trim must feature traditional dimensions and an architecturally appropriate sill detail. Window track components must be painted to match the window trim or concealed by a wood window screen set within the opening. Staff finds the proposed wood double-hung windows consistent with the Guidelines.

1. Staff recommends approval to replace the windows with the wood double-hung windows as proposed and to

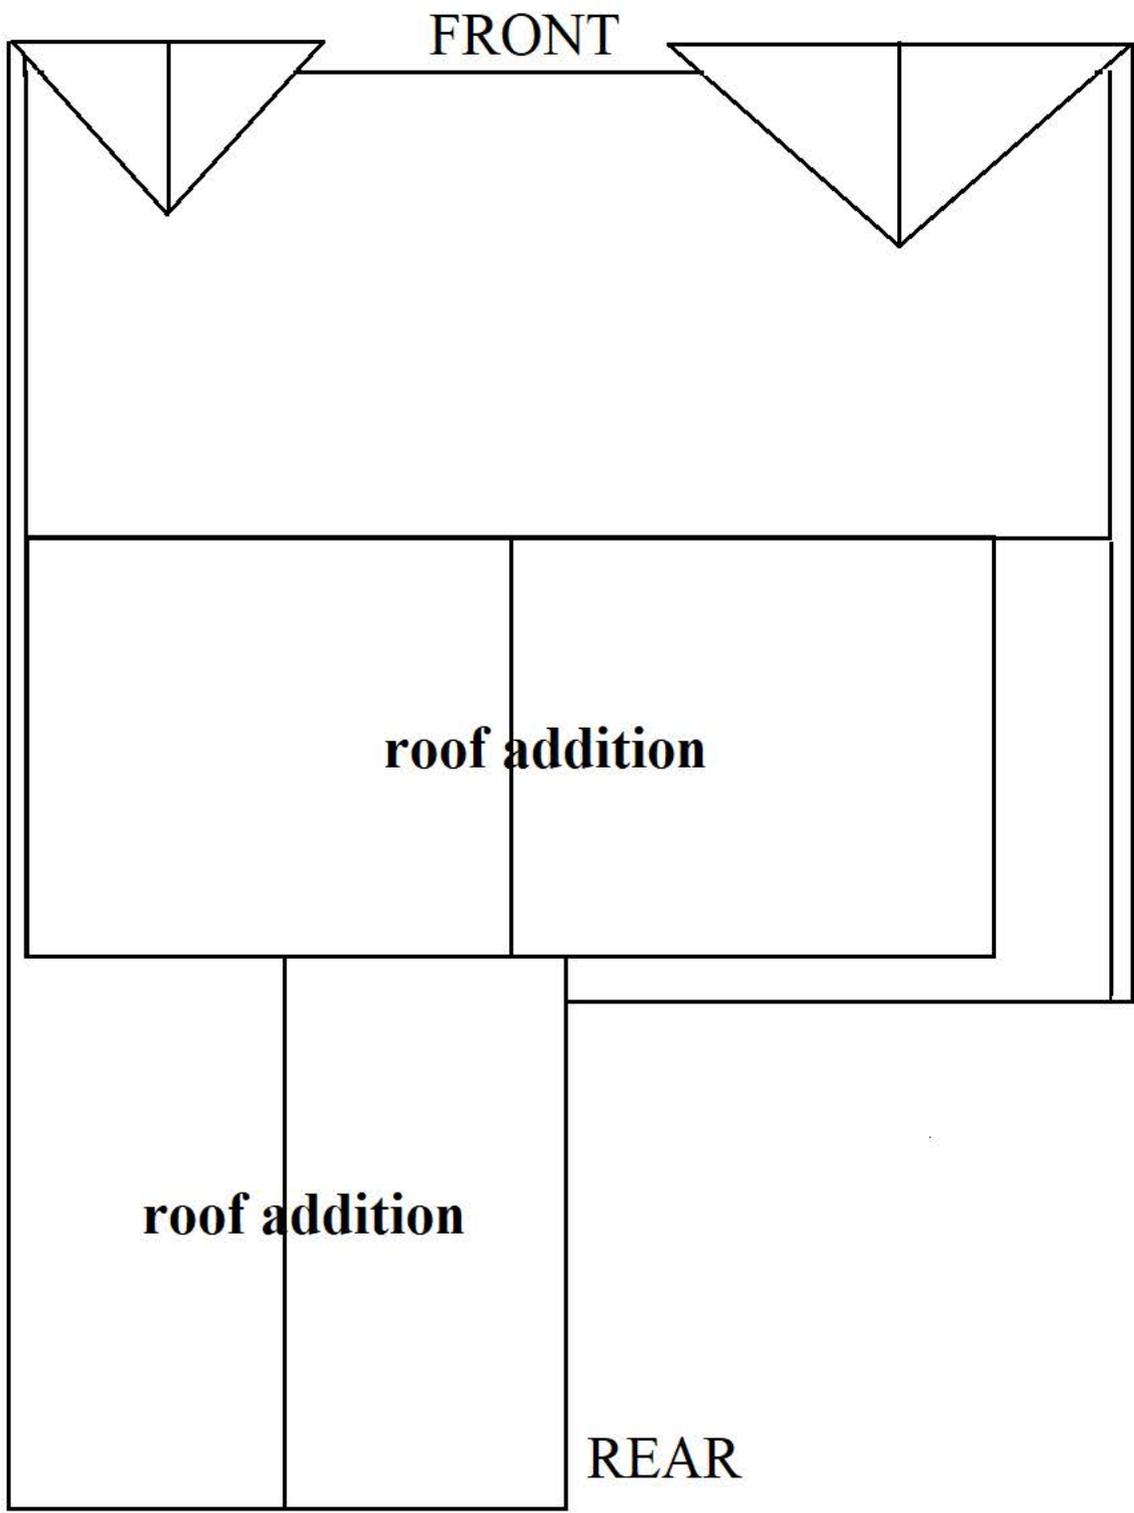
ROOF DRAWING

- d. **ROOF ADDITION** – The applicant has also propose to construct a new rear gable roof which would envelope the existing rear hipped roof. The new roof’s ridge would meet at the primary existing gable’s ridge in height. Per the Guidelines for Additions 3.1.B.ii, one should limit rooftop additions to rear facades to preserve the historic scale and form of the building from the street level and minimize visibility from the public right-of-way and full-floor second story additions that obscure the form of the original structure are not appropriate. Staff finds the new taller gable roof would obscure the original hipped roof form with a subordinate height to the primary gable roof.
