HISTORIC AND DESIGN REVIEW COMMISSION

December 06, 2017

HDRC CASE NO: 2017-612
ADDRESS: 517 E HOUSTON ST
LEGAL DESCRIPTION: NCB 422 BLK 26 W 26 FT OF 5 ARB A2
ZONING: D,HS
CITY COUNCIL DIST.: 1
DISTRICT: Alamo Plaza Historic District
LANDMARK: Rosenberg, Frank Building
OWNER: Michael Litofsky
TYPE OF WORK: remove plywood boards and install temporary plastic screens in storefront
APPLICATION RECEIVED: November 8, 2017
60-DAY REVIEW: January 7, 2018
REQUEST:

Investigation Report

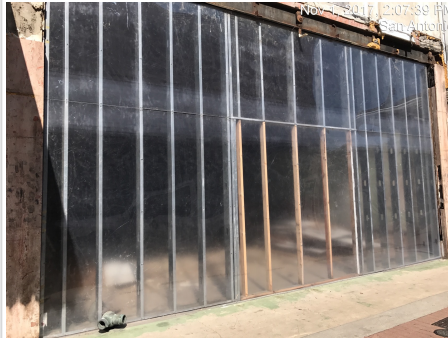
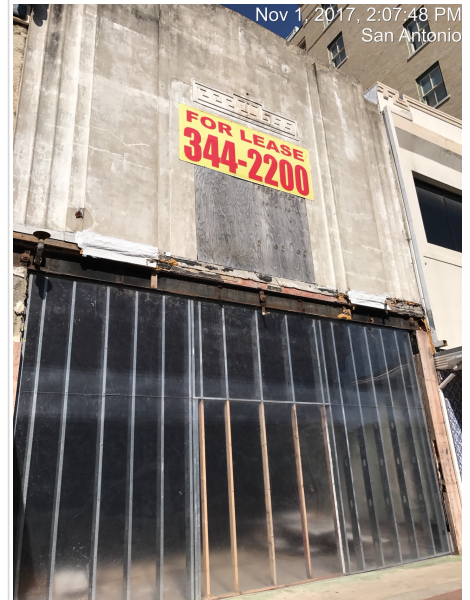
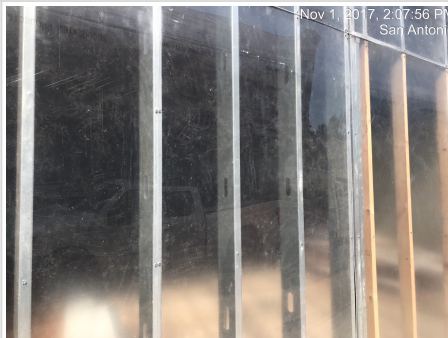
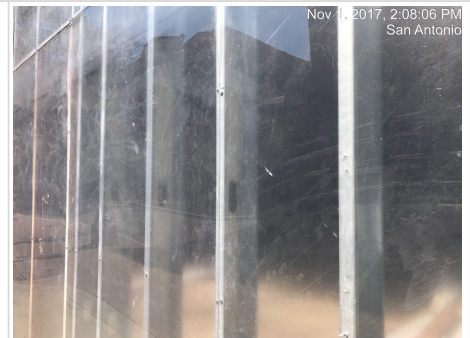
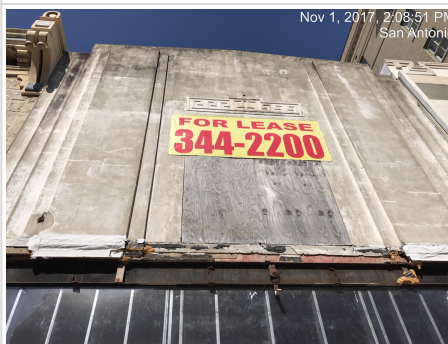
Photographs

- c. FAÇADE – The façade originally featured a recessed storefront with Art Deco architectural details. The original façade at the ground level was previously removed and replaced with gray painted plywood that mimicked the second floor profile down to the ground level. In November 2017, the plywood façade was replaced with SecureView Clearboarding in order to improve security and visibility into the site.

- d. CLEARBOARDING – The applicant has proposed to install plastic screens supported by wood studs. The specific product is called Clearboarding and is manufactured by SecureView. The applicant notes in the request that Clearboarding is a temporary installation material, but no plans for a long-term solution have been submitted at this time. According to the guidelines for commercial facades, new façade elements that alter the historic building character or materials are not recommended. Staff finds that the proposed material and configuration is not consistent with the guidelines and is not appropriate as a long-term solution for the treatment of the façade.

Date	11/01/2017
Time	02:23 PM (-5 GMT)
Present Staff	Huy Pham
Present Individuals	None
Types of Work Observed	Exterior Maintenance and Alterations
Amount of Work Completed	Completed
Description of work	Non-original plywood enclosure replaced with clear plastic.

Violation Type	No Certificate of Appropriateness (Code 35-451a)
OHP Action	posted "Notice of Violation", Other [see field notes]
Deadline to contact office	11/01/2017
Field Notes	Letter sent to owner 11/1/2017.

Staff does not recommend approval of the installation SecureView Clearboarding based on findings d as a long-term solution. Staff recommends that the Clearboarding be removed within 90 days and that applicant submit an updated plan with a timeline for a permanent solution that is consistent with the Historic Design Guidelines. The applicant may utilize the previously-approved storefront design as a reference.
