# HISTORIC AND DESIGN REVIEW COMMISSION

**HDRC CASE NO:** 2020-027  
**ADDRESS:** 1425 S FLORES ST  
**LEGAL DESCRIPTION:** NCB 1009 BLK LOT 40B  
**ZONING:** IDZ, H, RIO-7  
**CITY COUNCIL DIST.:** 1  
**LANDMARK:** Fest Block  
**APPLICANT:** Kris Feldmann/Creoarc, LLC  
**OWNER:** Jacob Harris/HB PROPERTIES I LLC  
**TYPE OF WORK:** Storefront restoration, cleaning  
**APPLICATION RECEIVED:** January 17, 2020  
**60-DAY REVIEW:** March 17, 2020  
**CASE MANAGER:** Edward Hall

# Fest Block

HDRC SUBMITTAL | 2020.1.17

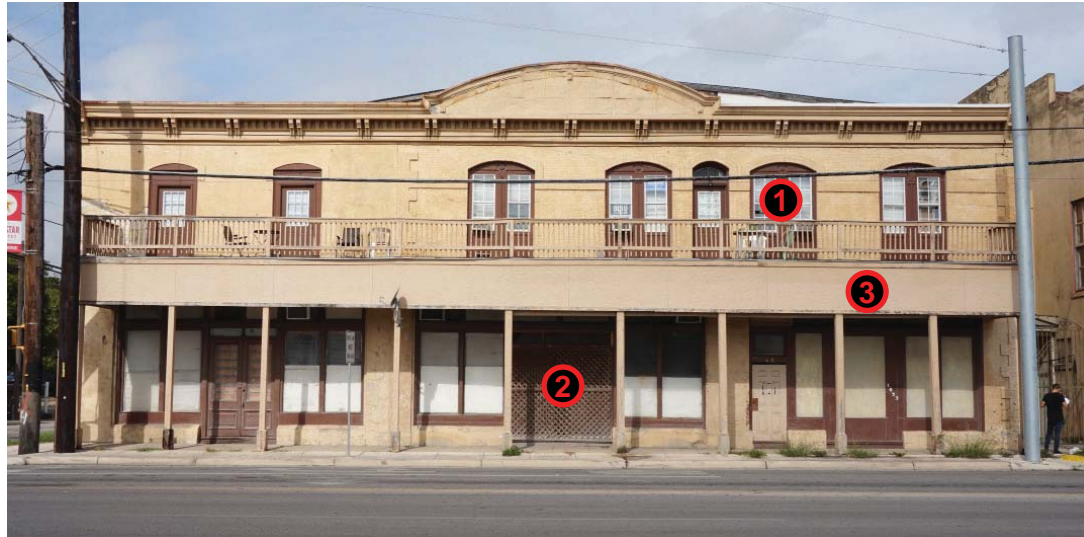
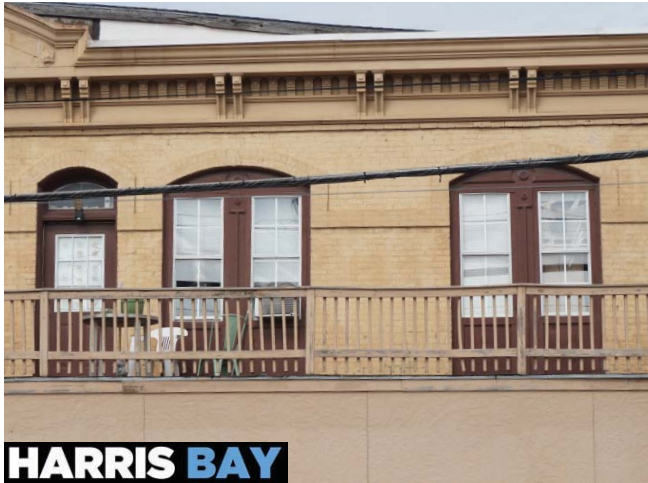
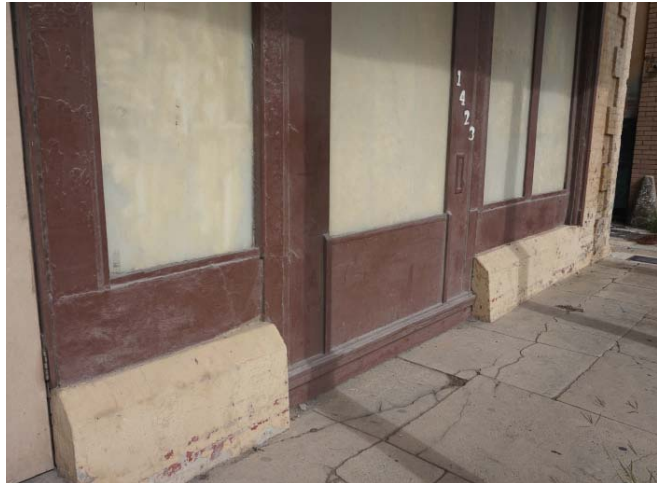
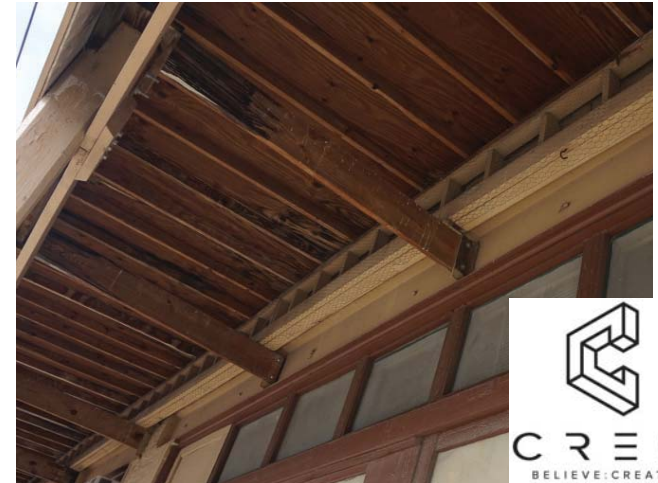
**EXISTING EXTERIOR CONDITIONS - EAST (S. FLORES ST.)**

**① DETERIORATING SINGLE PANE WOOD FRAMED WINDOWS - TO BE REPLACED (REF. WINDOW SPEC EXHIBIT)**

**② ORIGINAL STOREFRONTS TO BE RESTORED**

**③ EXISTING BALCONY TO BE CLEANED AND REPAIRED**

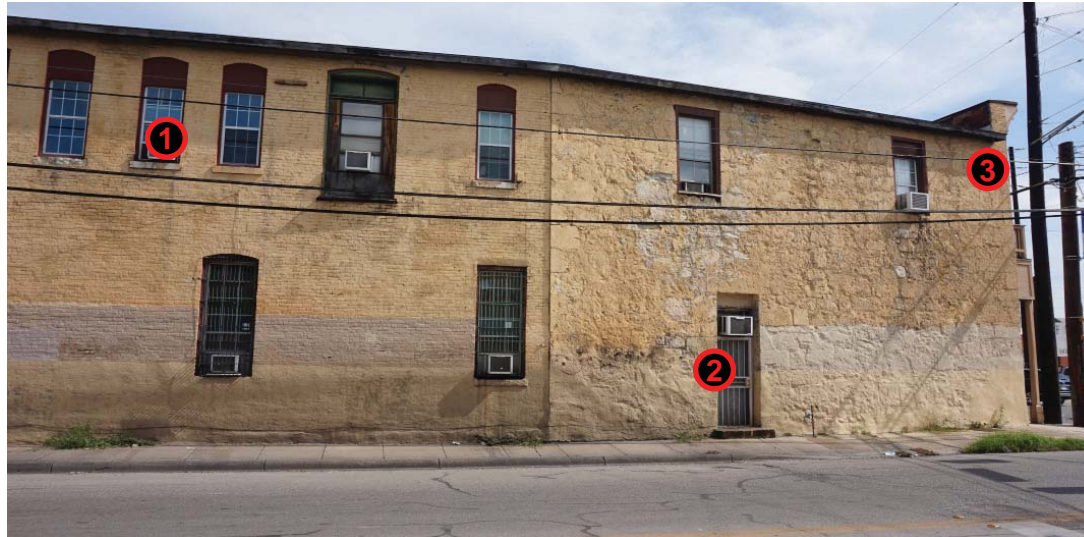
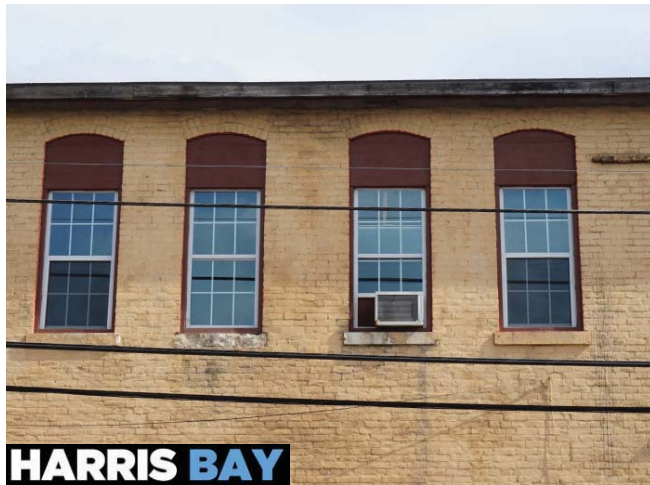
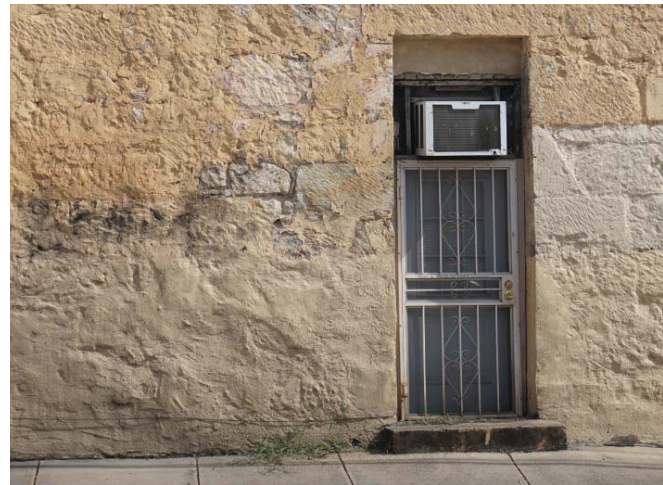
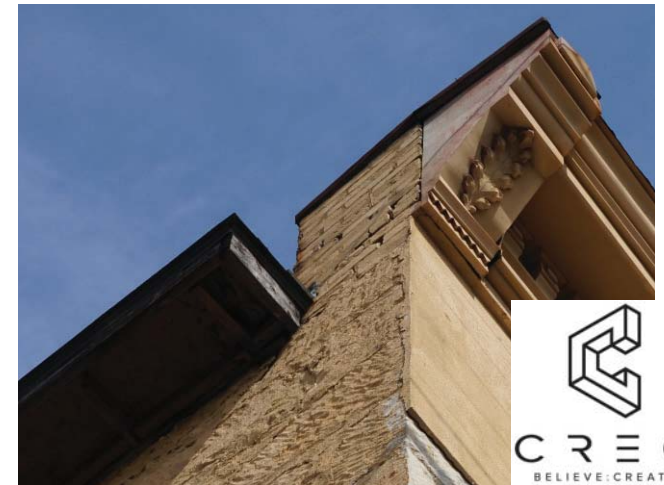
**EXISTING EXTERIOR CONDITIONS - SOUTH (CEVALLOS ST.)**

**① DETERIORATING SINGLE PANE WOOD FRAMED WINDOWS - TO BE REPLACED (REF. WINDOW SPEC EXHIBIT)**

**② ORIGINAL OPENINGS TO REMAIN. DETERIORATING NON-ORIGINAL WINDOWS AND DOORS TO BE REPLACED**

**③ EXISTING ROOF TO BE ASSESSED AND REPAIRED/REPLACED AS NEEDED. CORNICE TO REMAIN AND TO BE REPAIRED.**

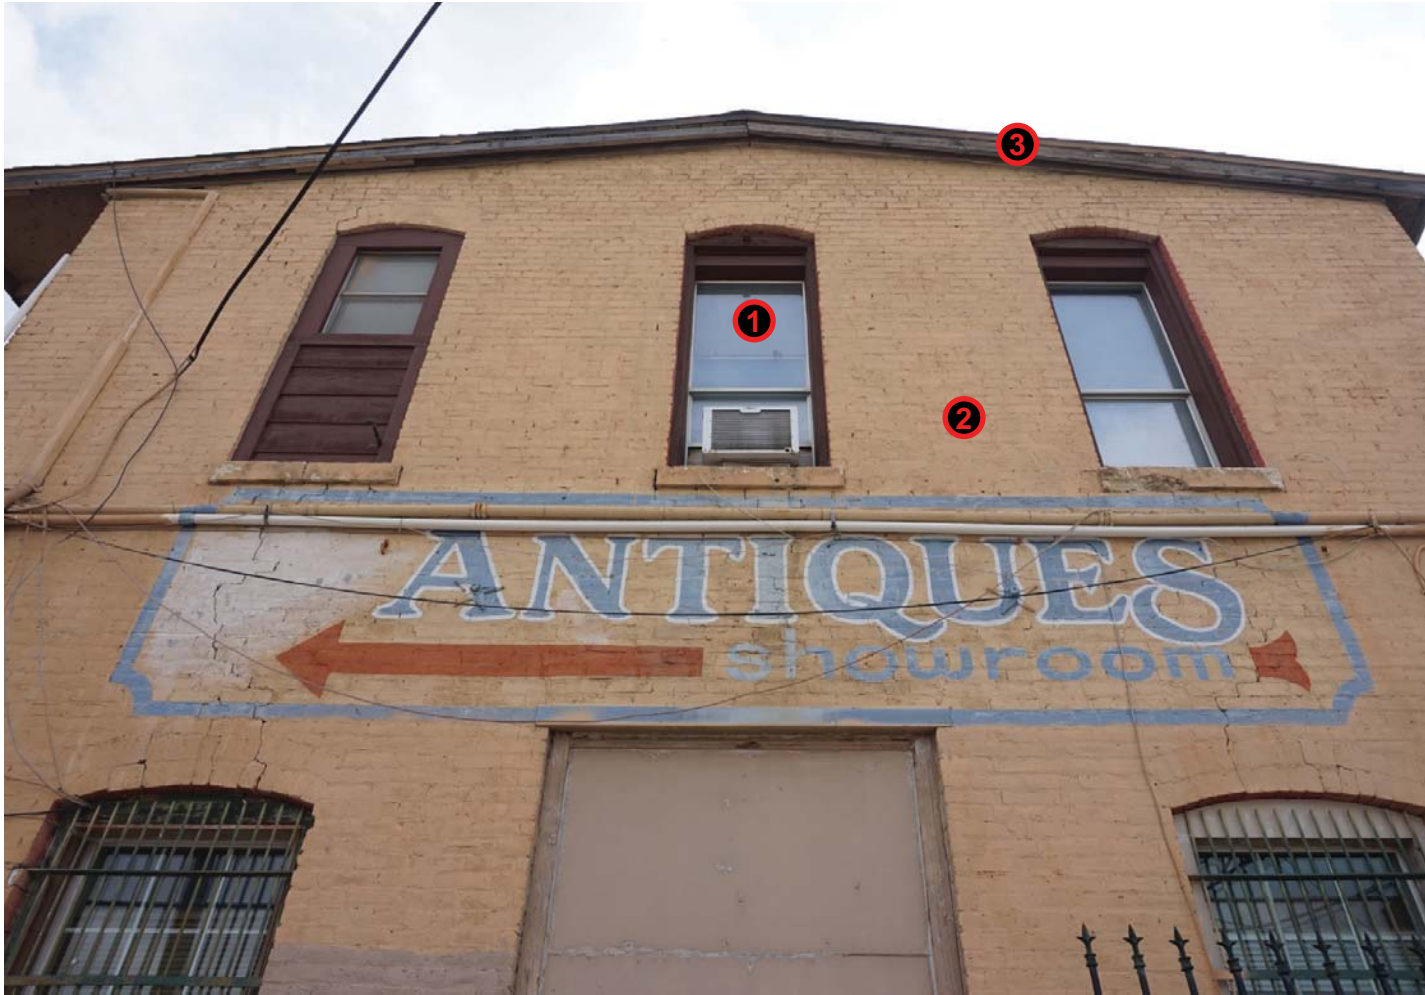
EXISTING EXTERIOR CONDITIONS - WEST (PARKING LOT)

- ① DETERIORATING SINGLE PANE WOOD FRAMED WINDOWS - TO BE REPLACED (REF. WINDOW SPEC EXHIBIT)
- ② CLEAN ORIGINAL BRICK FACADE AND REPAIR AS NEEDED
- ③ EXISTING ROOF TO BE ASSESSED AND REPAIRED/REPLACED AS NEEDED.

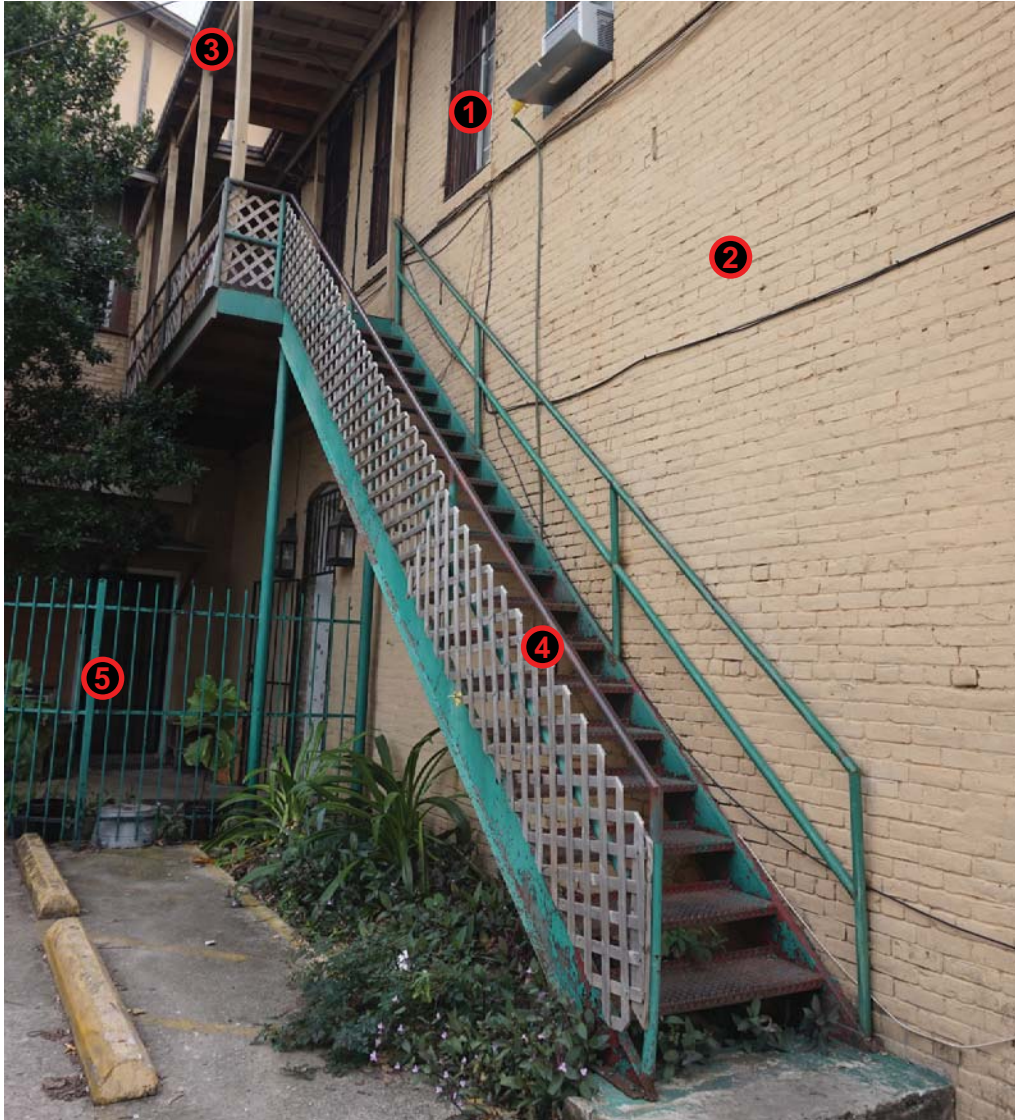
EXISTING EXTERIOR CONDITIONS - WEST (PARKING LOT)

- ① DETERIORATING SINGLE PANE WOOD FRAMED WINDOWS - TO BE REPLACED (REF. WINDOW SPEC EXHIBIT)
- ② CLEAN ORIGINAL BRICK FACADE AND REPAIR AS NEEDED
- ③ EXISTING ROOF TO BE ASSESSED AND REPAIRED/REPLACED AS NEEDED.
- ④ EXISTING STAIR TO REMAIN.
- ⑤ EXISTING METAL FENCE TO BE REMOVED

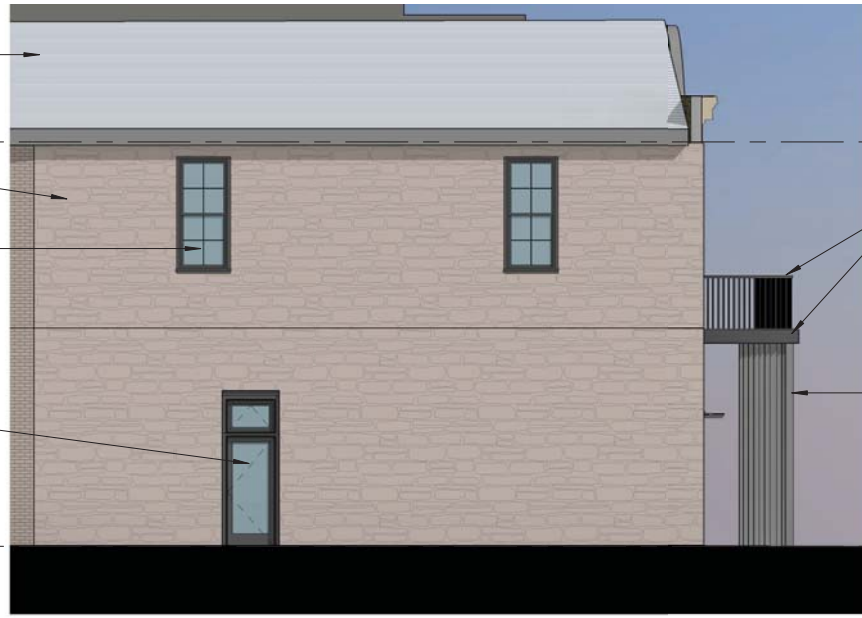
**PROPOSED ELEVATIONS - SOUTH**

REPAIR/REPLACE EXISTING  
DETERIORATED COMPOSITE  
SHINGLE ROOF

CLEAN ORIGINAL  
LIMESTONE FACADE.  
REPAIR AS NEEDED

ALL EXTERIOR WINDOWS  
TO BE REPLACED WITH  
NEW WOOD FRAMED  
ENERGY EFFICIENT  
WINDOWS. EXISTING  
OPENING TO REMAIN  
PAINT PNT02

REPLACE EXISTING  
DOORS WITH NEW  
ENERGY EFFICIENT  
WOOD FRAMED DOORS.  
PNT02

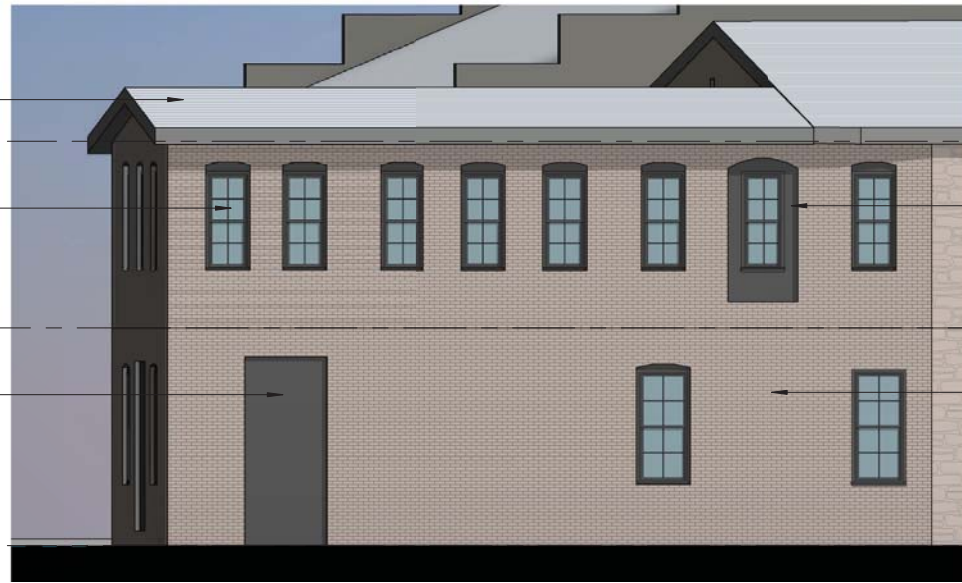
CLEAN AND REPAIR  
EXISTING  
CANOPY AND  
WOOD RAILING.  
PNT02

CLEAN AND REPAIR  
EXISTING STEEL  
COLUMNS. PNT02

REPAIR/REPLACE EXISTING  
DETERIORATED COMPOSITE  
SHINGLE ROOF

ALL EXTERIOR WINDOWS  
TO BE REPLACED WITH  
NEW WOOD FRAMED  
ENERGY EFFICIENT  
WINDOWS. EXISTING  
OPENING TO REMAIN  
PAINT PNT02

CLEAN AND REPAIR  
EXISTING  
WOOD INFILL WALLS.  
EXISTING OPENINGS TO  
REMAIN. PNT02

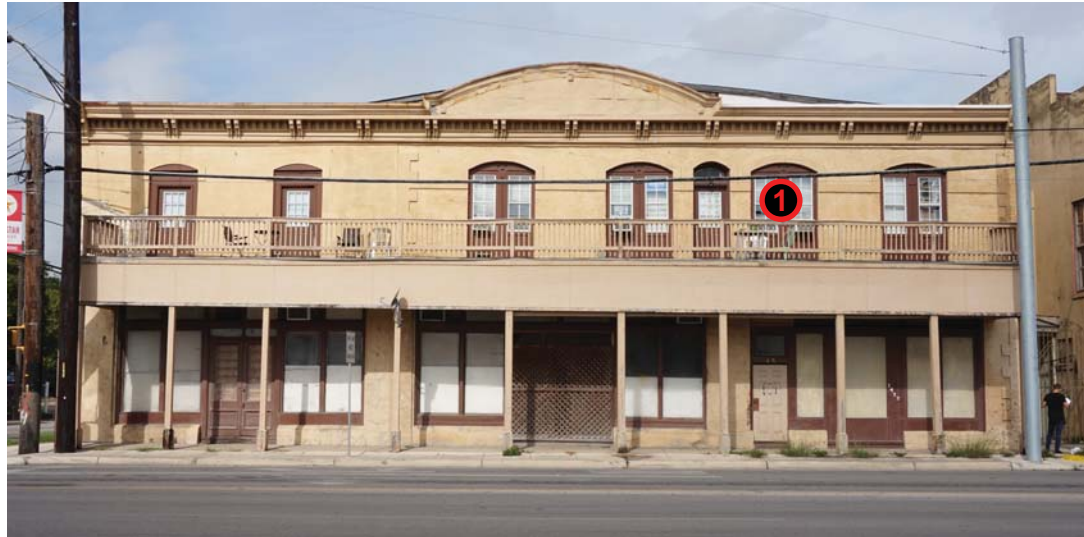
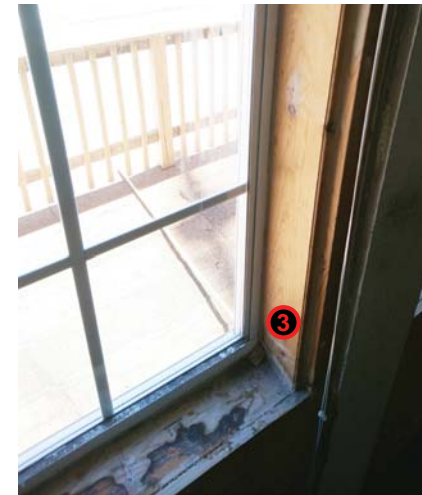
**EXISTING EXTERIOR CONDITIONS - EAST (S. FLORES ST.)**

**① EXISTING NON-ORIGINAL WINDOW. NON-ORIGINAL WINDOWS ARE INSTALLED THROUGHOUT THE ENTIRE BUILDING**

**② EXISTING NON-ORIGINAL WINDOW. VIEW FROM INSIDE. NON-ORIGINAL WINDOWS FRAMED INSIDE ORIGINAL OPENING**

**③ EXISTING NON-ORIGINAL WINDOW. CLOSER VIEW FROM INSIDE OF NON-ORIGINAL WOOD SASH**

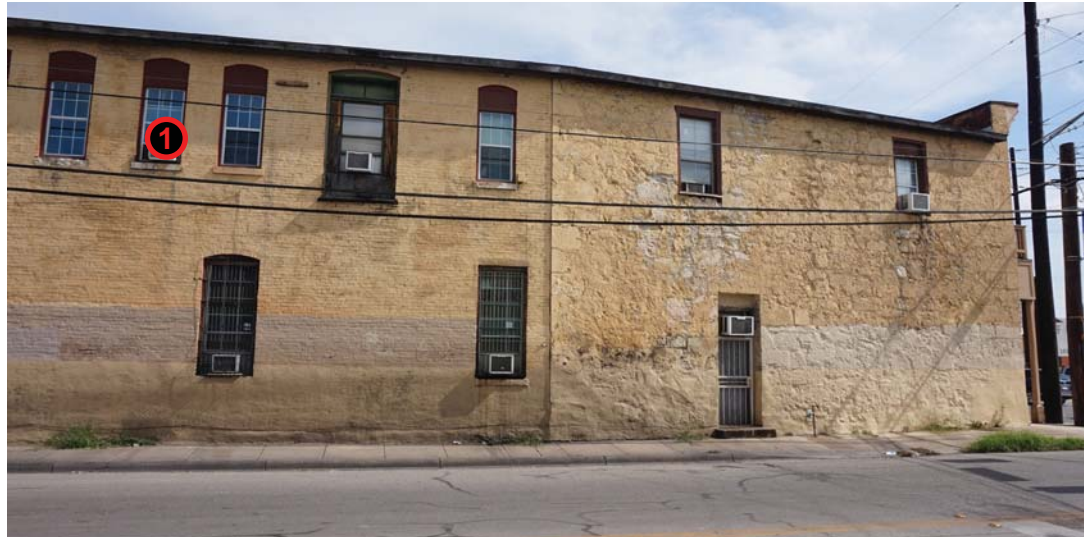
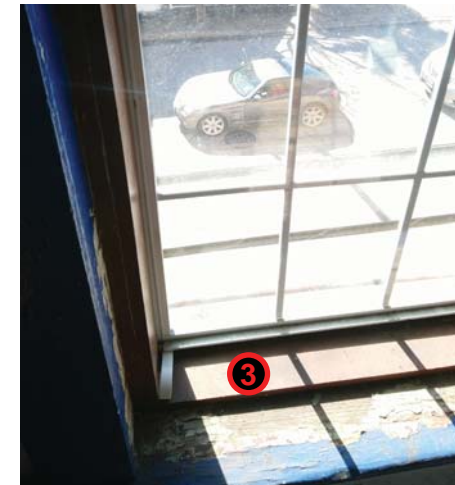
**EXISTING EXTERIOR CONDITIONS - SOUTH (CEVALLOS ST.)**

**① EXISTING NON-ORIGINAL WINDOW. NON-ORIGINAL WINDOWS ARE INSTALLED THROUGHOUT THE ENTIRE BUILDING**

**② EXISTING NON-ORIGINAL WINDOW. VIEW FROM INSIDE. NON-ORIGINAL WINDOWS FRAMED INSIDE ORIGINAL OPENING**

**③ EXISTING NON-ORIGINAL WINDOW. CLOSER VIEW FROM INSIDE OF NON-ORIGINAL WOOD SASH**

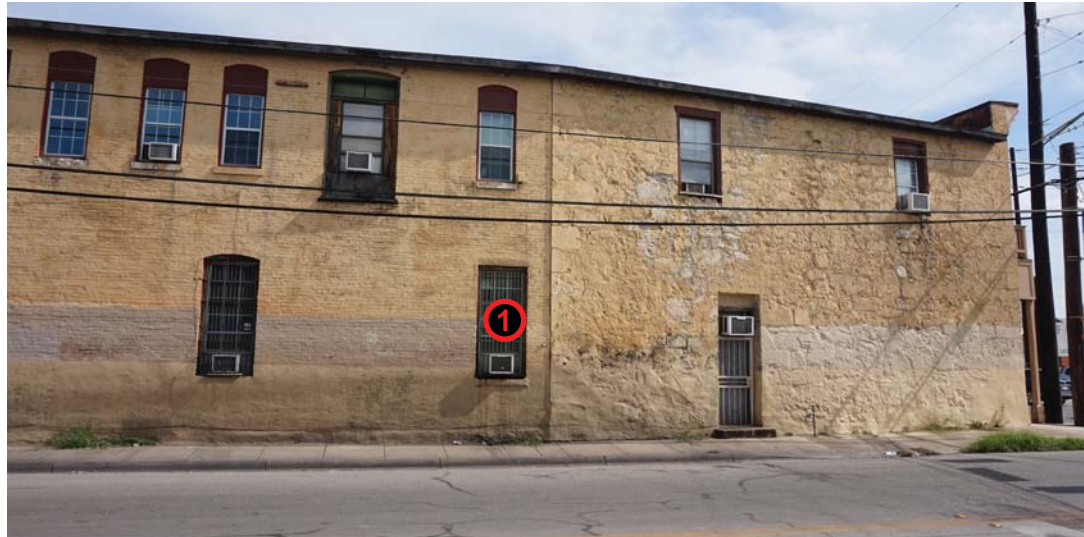
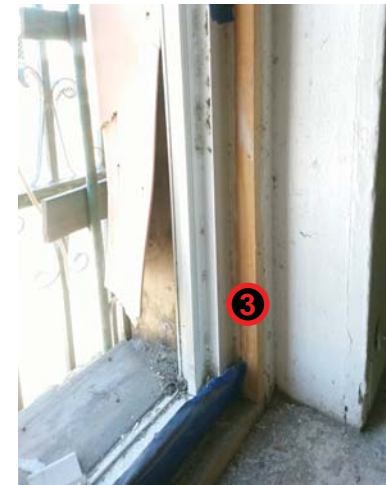
**EXISTING EXTERIOR CONDITIONS - SOUTH (CEVALLOS ST.)**

**1** EXISTING NON-ORIGINAL WINDOW. NON-ORIGINAL WINDOWS ARE INSTALLED THROUGHOUT THE ENTIRE BUILDING

**2** EXISTING NON-ORIGINAL WINDOW. VIEW FROM INSIDE. NON-ORIGINAL WINDOWS FRAMED INSIDE ORIGINAL OPENING

**3** EXISTING NON-ORIGINAL WINDOW. CLOSER VIEW FROM INSIDE OF NON-ORIGINAL WOOD SASH

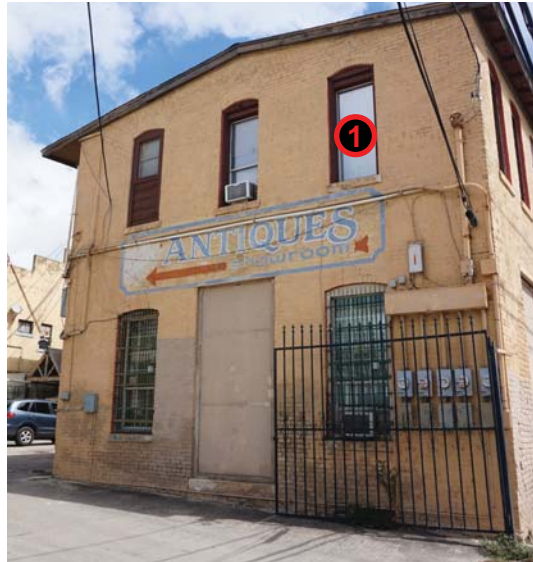
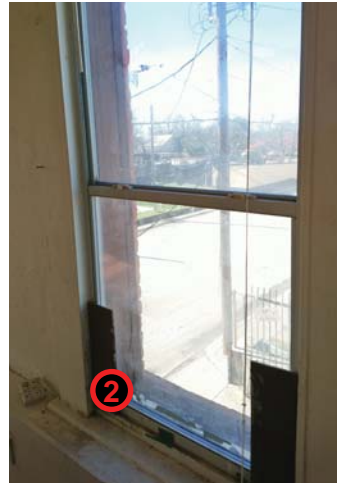
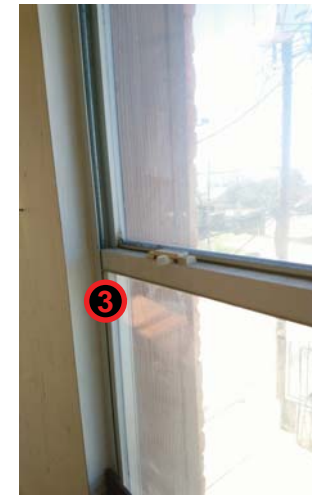
**EXISTING EXTERIOR CONDITIONS - SOUTH (CEVALLOS ST.)**

**1** EXISTING NON-ORIGINAL WINDOW. NON-ORIGINAL WINDOWS ARE INSTALLED THROUGHOUT THE ENTIRE BUILDING

**2** EXISTING NON-ORIGINAL WINDOW. VIEW FROM INSIDE. NON-ORIGINAL WINDOWS FRAMED INSIDE ORIGINAL OPENING

**3** EXISTING NON-ORIGINAL WINDOW. CLOSER VIEW FROM INSIDE OF NON-ORIGINAL WOOD SASH

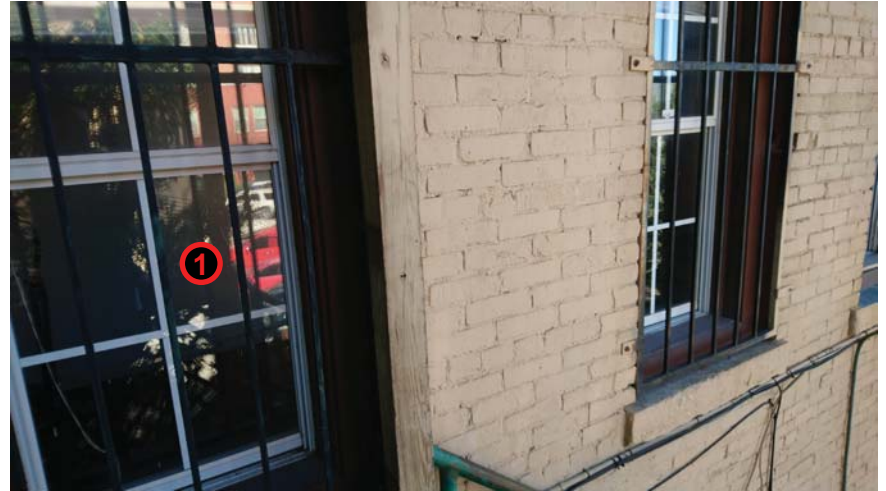
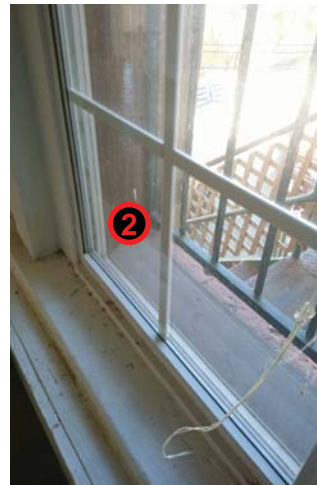
**EXISTING EXTERIOR CONDITIONS - SOUTH (CEVALLOS ST.)**

- 1** EXISTING NON-ORIGINAL WINDOW. NON-ORIGINAL WINDOWS ARE INSTALLED THROUGHOUT THE ENTIRE BUILDING

- 2** EXISTING NON-ORIGINAL WINDOW. CLOSER VIEW FROM INSIDE OF NON-ORIGINAL WOOD SASH

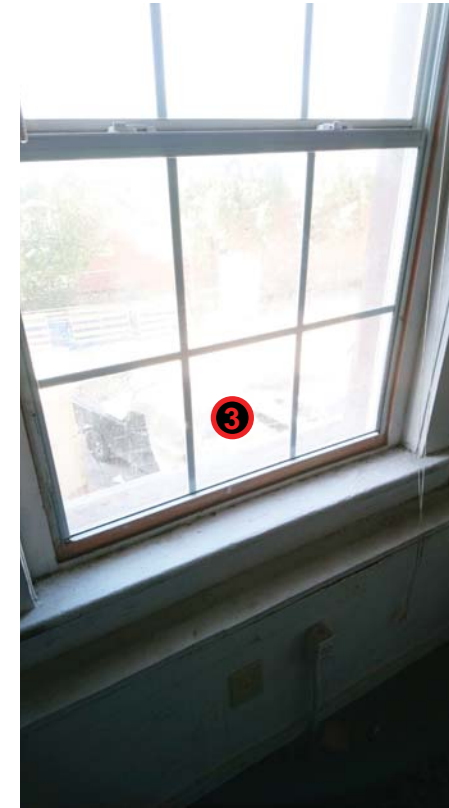
**EXISTING EXTERIOR CONDITIONS - WEST (PARKING LOT)**

**1** EXISTING NON-ORIGINAL WINDOW.  
NON-ORIGINAL WINDOWS ARE INSTALLED  
THROUGHOUT THE ENTIRE BUILDING

**3** EXISTING NON-ORIGINAL WINDOW.  
CLOSER VIEW FROM INSIDE OF  
NON-ORIGINAL WOOD SASH

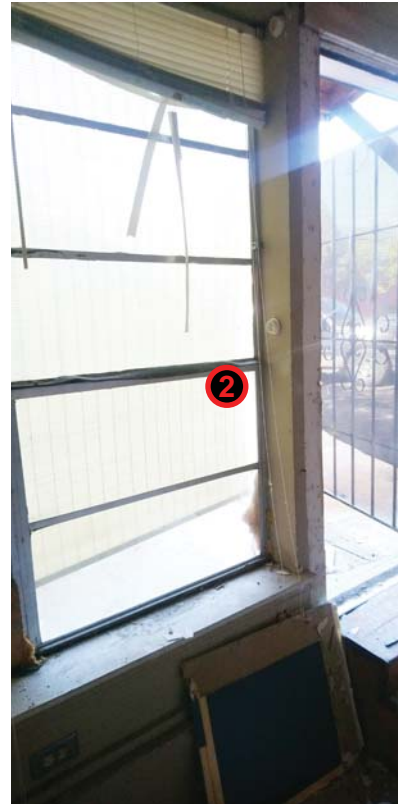
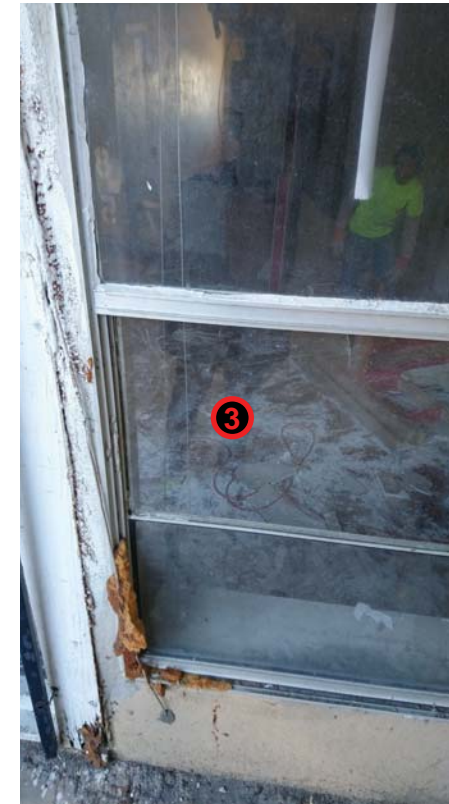
**EXISTING EXTERIOR CONDITIONS - WEST (PARKING LOT)**

**1** EXISTING NON-ORIGINAL WINDOW.  
NON-ORIGINAL WINDOWS ARE INSTALLED  
THROUGHOUT THE ENTIRE BUILDING

**2** EXISTING NON-ORIGINAL  
WINDOW.  
VIEW FROM INSIDE.  
NON-ORIGINAL WINDOWS  
FRAMED INSIDE ORIGINAL  
OPENING

**3** EXISTING NON-ORIGINAL WINDOW.  
CLOSER VIEW FROM EXTERIOR OF  
NON-ORIGINAL WINDOW
