HISTORIC AND DESIGN REVIEW COMMISSION

April 03, 2019

HDRC CASE NO: 2019-154
ADDRESS: 908 E CROCKETT ST
LEGAL DESCRIPTION: NCB 583 BLK 8 LOT 7
ZONING: RM-4, H
CITY COUNCIL DIST.: 2
DISTRICT: Dignowity Hill Historic District
APPLICANT: Hayley Olliverre
OWNER: Dorian Shillingford
APPLICATION RECEIVED: March 18, 2019
60-DAY REVIEW: May 17, 2019
CASE MANAGER: Huy Pham

The applicant is requesting a Certificate of Appropriateness to amend an administrative approval of porch modifications to feature Craftsman-inspired forms including a gable roof and two additional columns on a non-Craftsman and non-contributing structure.

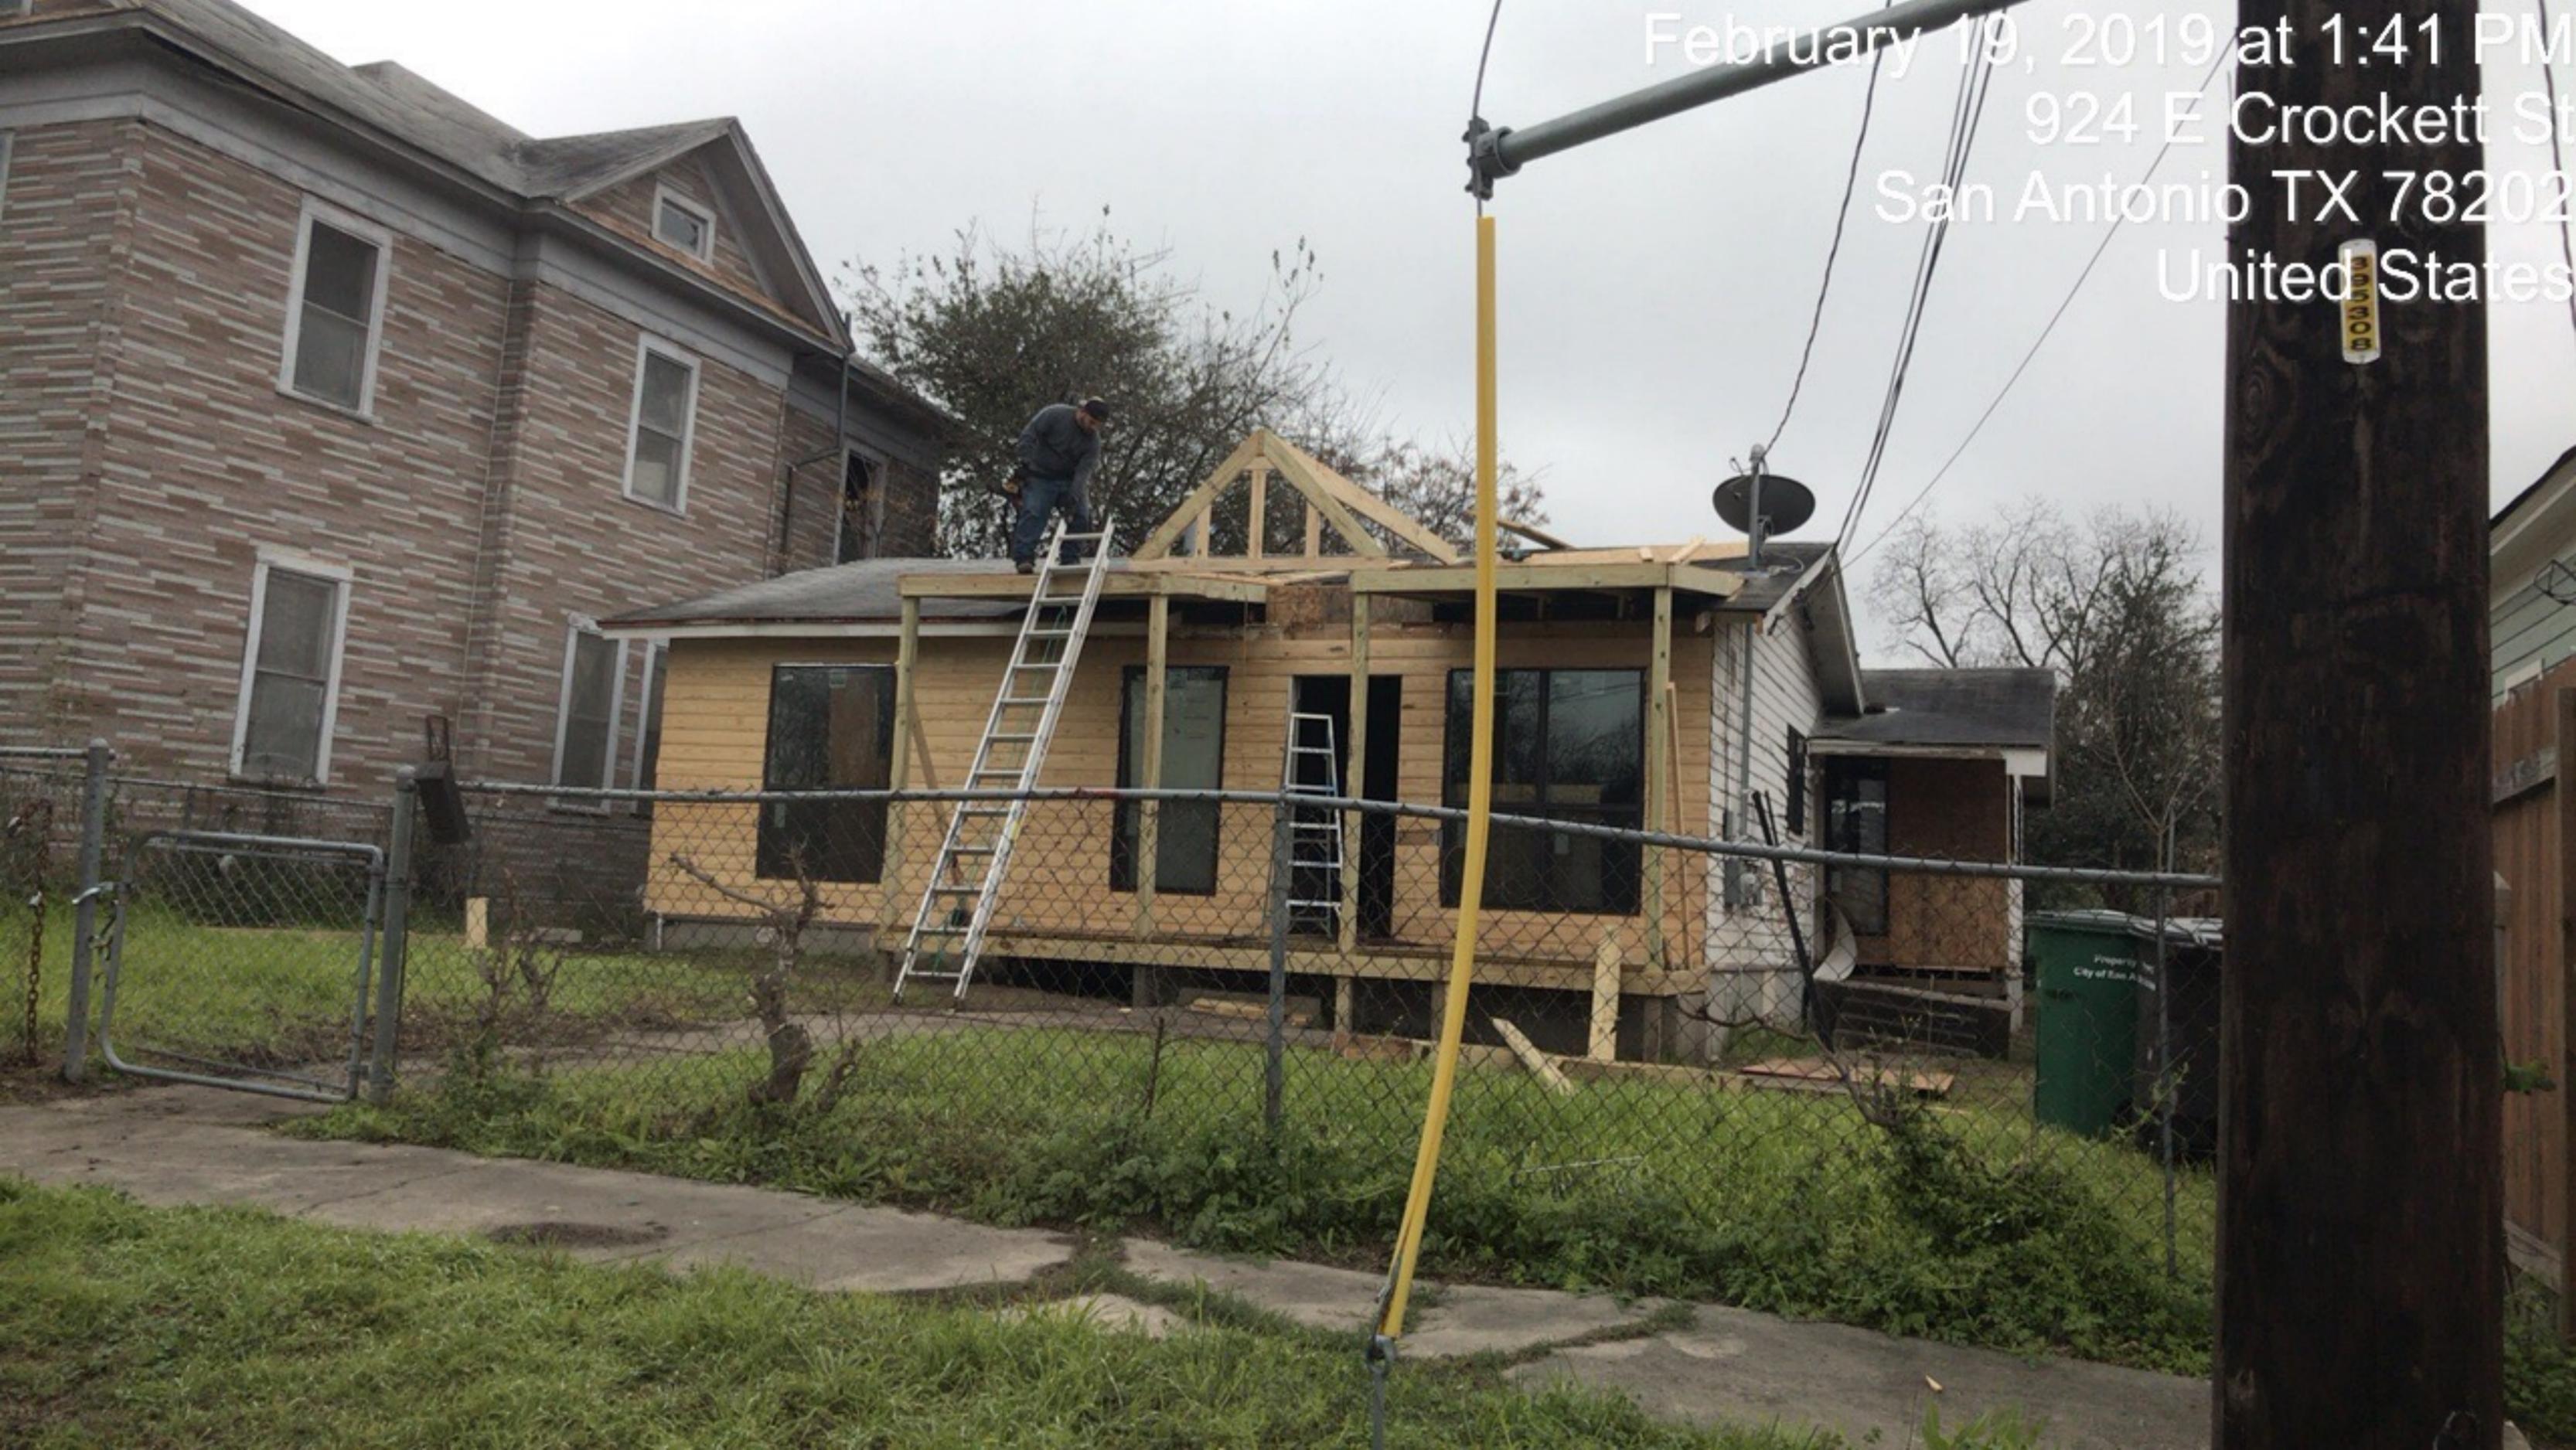
February 19, 2019 at 1:41 PM
924 E Crockett St
San Antonio TX 78202
United States

- c. VIOLATION – On a site visit conducted on February 19, 2019, staff found that the porch modifications did not match the plans submitted at the time of approval, most notably the inclusion of a porch gable. The owner/applicant explained to staff that they had modified their design from a shed roof to a gable-on-shed with other Craftsman-inspired elements. They were cooperative to submit a request on March 18, 2019, to be heard at the next available hearing.

Staff does not recommend approval based on findings b through d. Staff recommends that the applicant complies with the administrative approval by restoring the existing shed roof and replacement of the wrought iron columns with square wood columns and other updated but simplified details. The front facing porch gable and two additional columns should be removed.

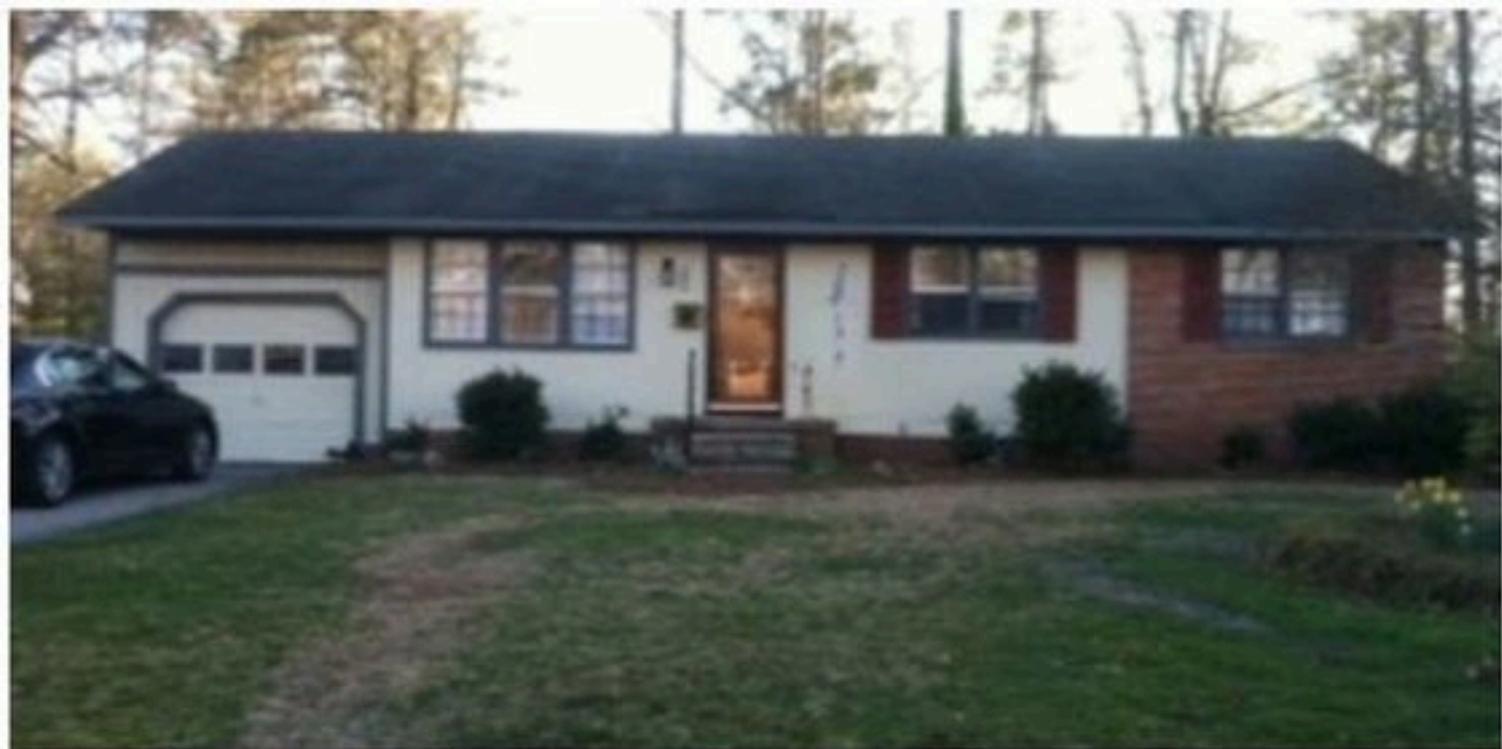
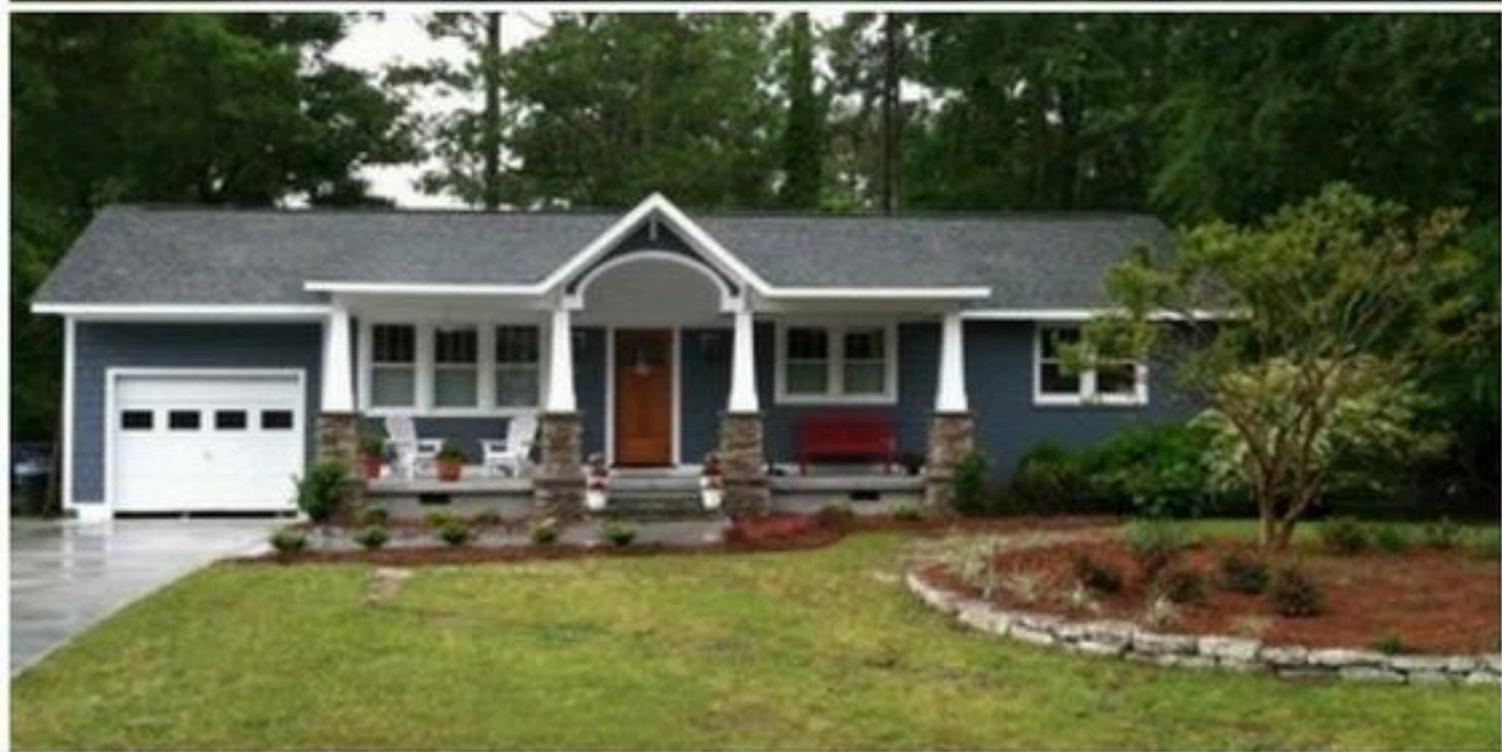
908 E Crockett

- d. PORCH – The applicant is requesting to modify the front porch to feature a centered gable on the shed roof over the front gable and to include four (4) square columns instead of two (2) replaced existing columns. Per the Guidelines for Exterior Maintenance and Alterations 2.B.iv, new elements and details should not be added to create a false historic appearance and 2.B.iii., the design of replacement porches should be compatible in scale, massing, and details. Staff finds that the proposed design would create both false and inaccurate historicism by utilizing Craftsman forms and details on a simple non-Craftsman, non-contributing structure. Staff finds that the faux Craftsman-inspired porch modifications in addition to the large front façade aluminum windows and the front yard cattle panel fencing would be a departure and distraction to the contributing structures on E Crockett and the Dignowity Hill Historic District. Staff finds that the applicant should comply with the administrative approval by restoring the existing shed roof and replacement of the wrought iron columns with square wood columns and other updated but simplified details.

Revised proposed Front Facade
4 columns. Raised roof line as before
with gable centered over front door.

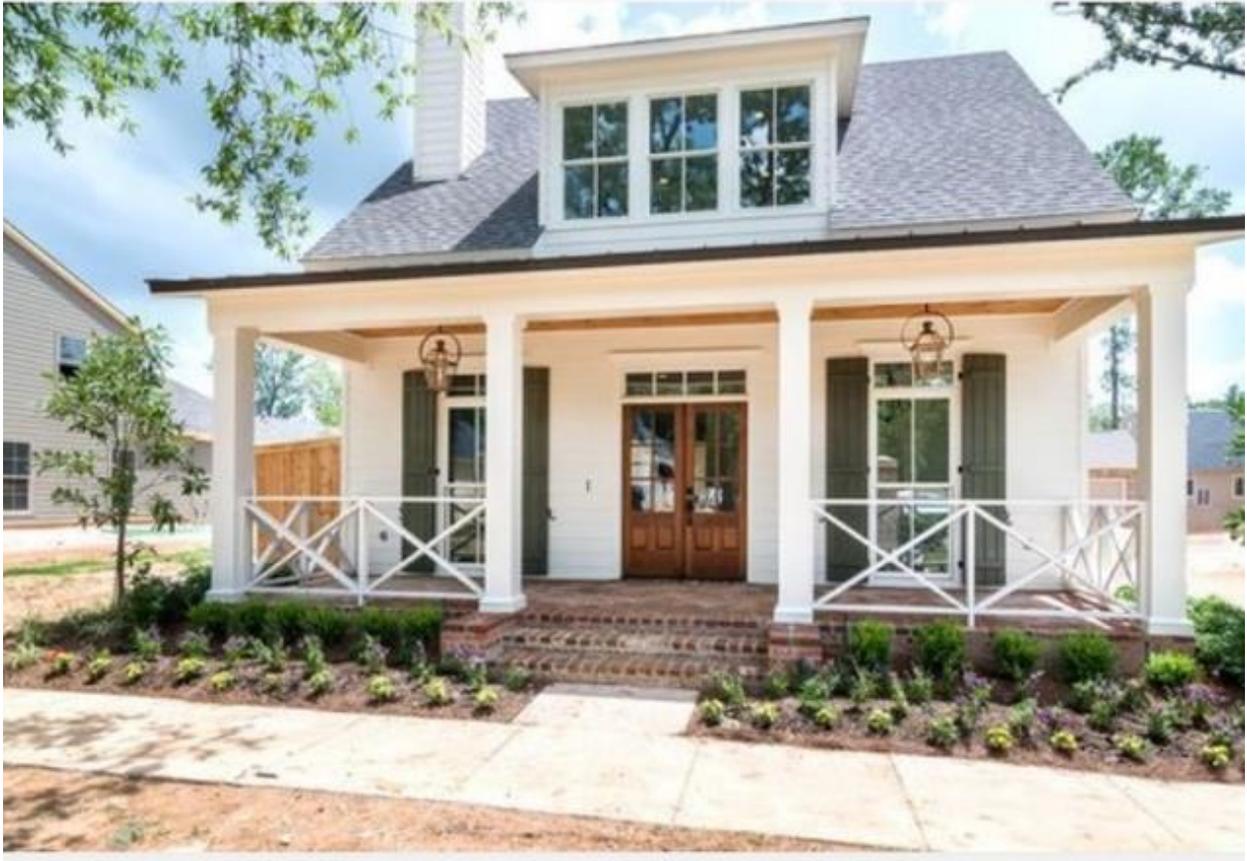
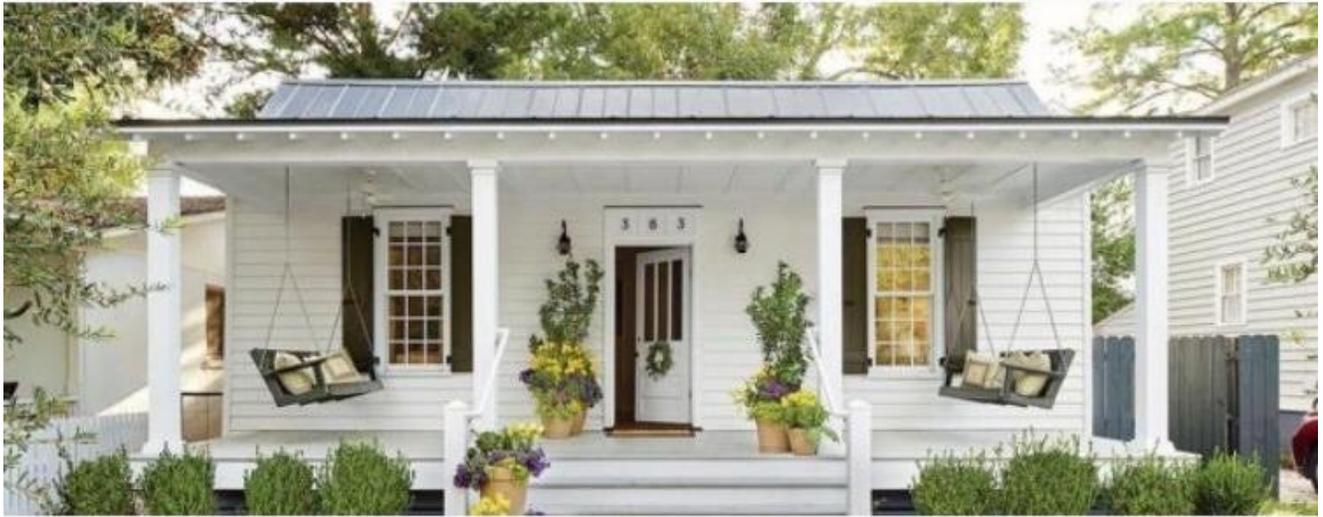
908 E Crockett
Proposed Front Facade

2 new wood columns,
see sample picture.

To highlight entrance,
create new raised roof line
over
porch extend over existing middle window

windows
matching in
height,
for pleasing lines

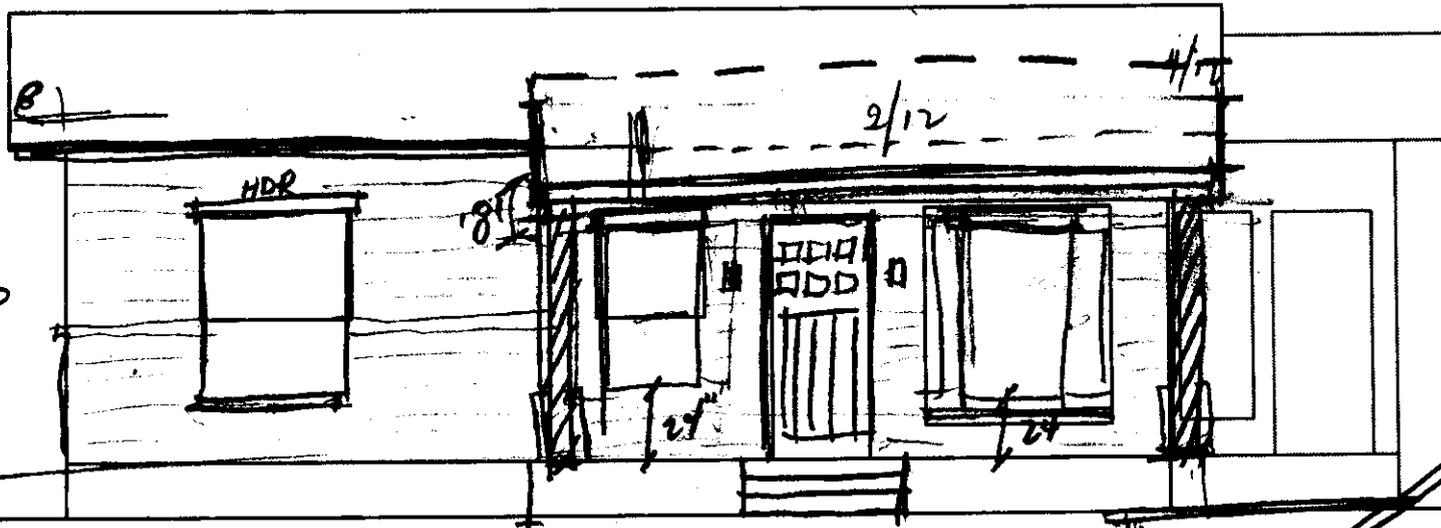
continue
siding
on front
facade

extend porch
to middle window
- wooden porch floor
open to suggestions
on preference
4" floor boards or
2x4 decking boards.

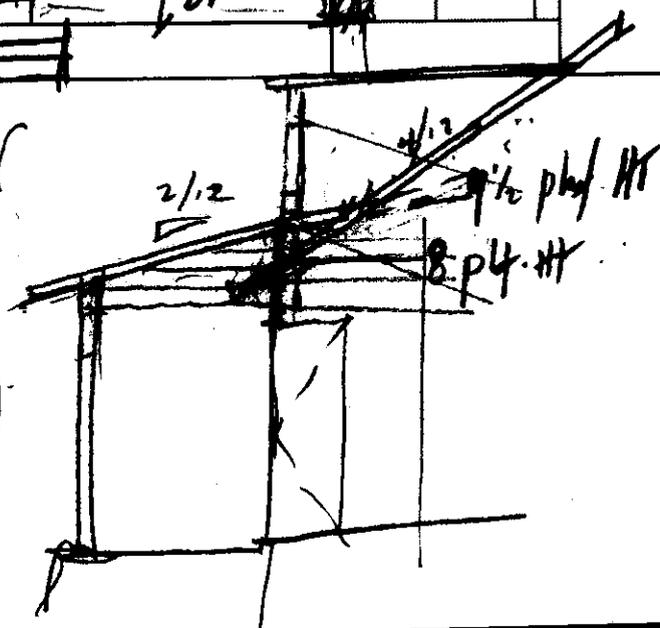
side
view
of porch
showing
new roof
line.
