# HISTORIC AND DESIGN REVIEW COMMISSION

August 15, 2018

**HDRC CASE NO:** 2018-328  
**ADDRESS:** 230 ADAMS ST  
**LEGAL DESCRIPTION:** NCB 943 BLK 1 LOT SW 100 FT OF 16  
**ZONING:** RM-4 CD  
**CITY COUNCIL DIST.:** 1  
**DISTRICT:** King William Historic District  
**APPLICANT:** Genevie Ramirez/Build Modern  
**OWNER:** David Roberson/Build Modern  
**TYPE OF WORK:** Exterior modifications, window replacement, porch modifications, construction of a rear addition and fencing  
**APPLICATION RECEIVED:** August 09, 2018  
**60-DAY REVIEW:**  
**REQUEST:**

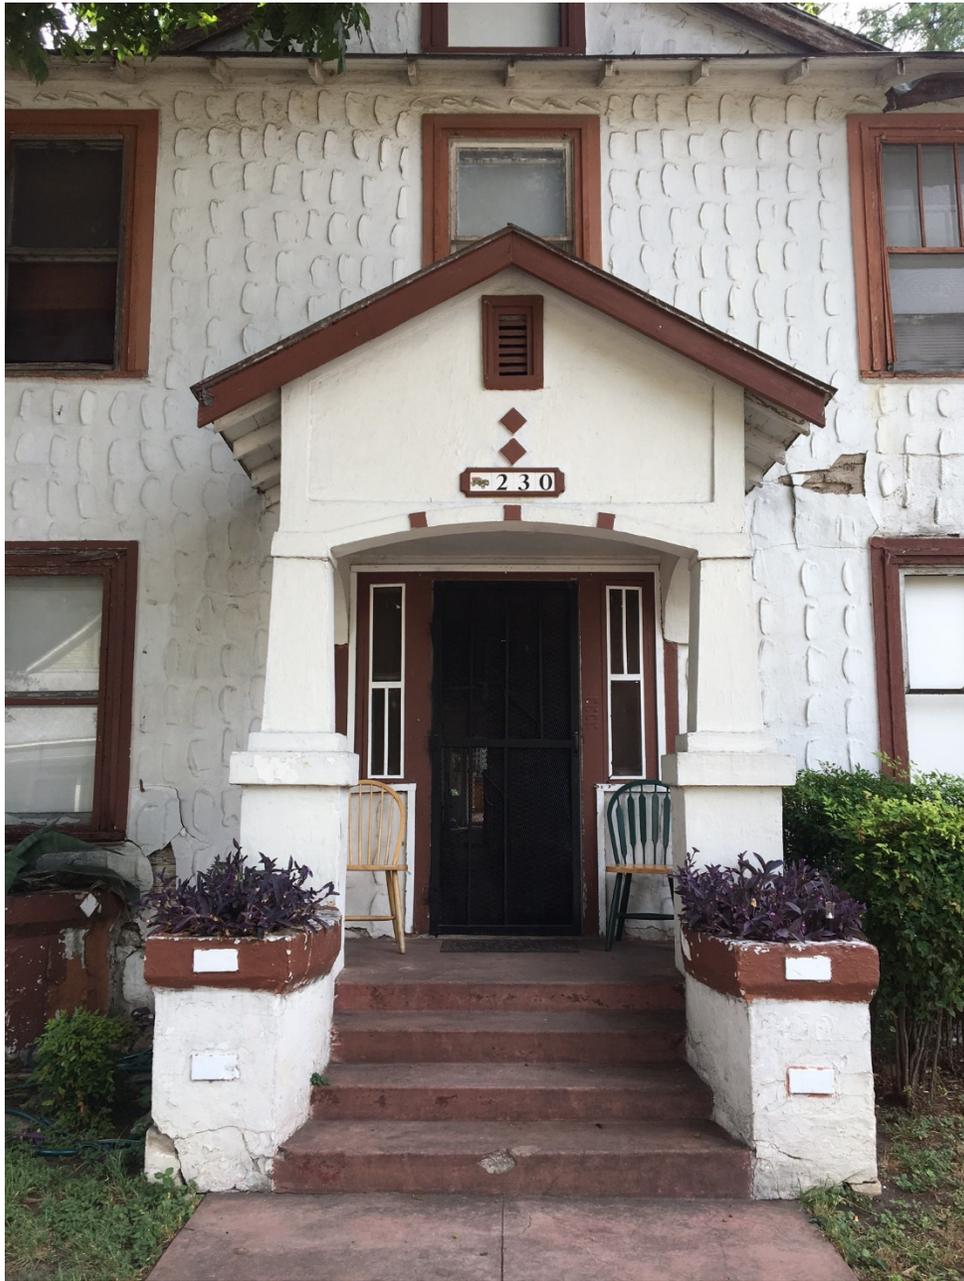
EXISTING PORCH TO REMAIN

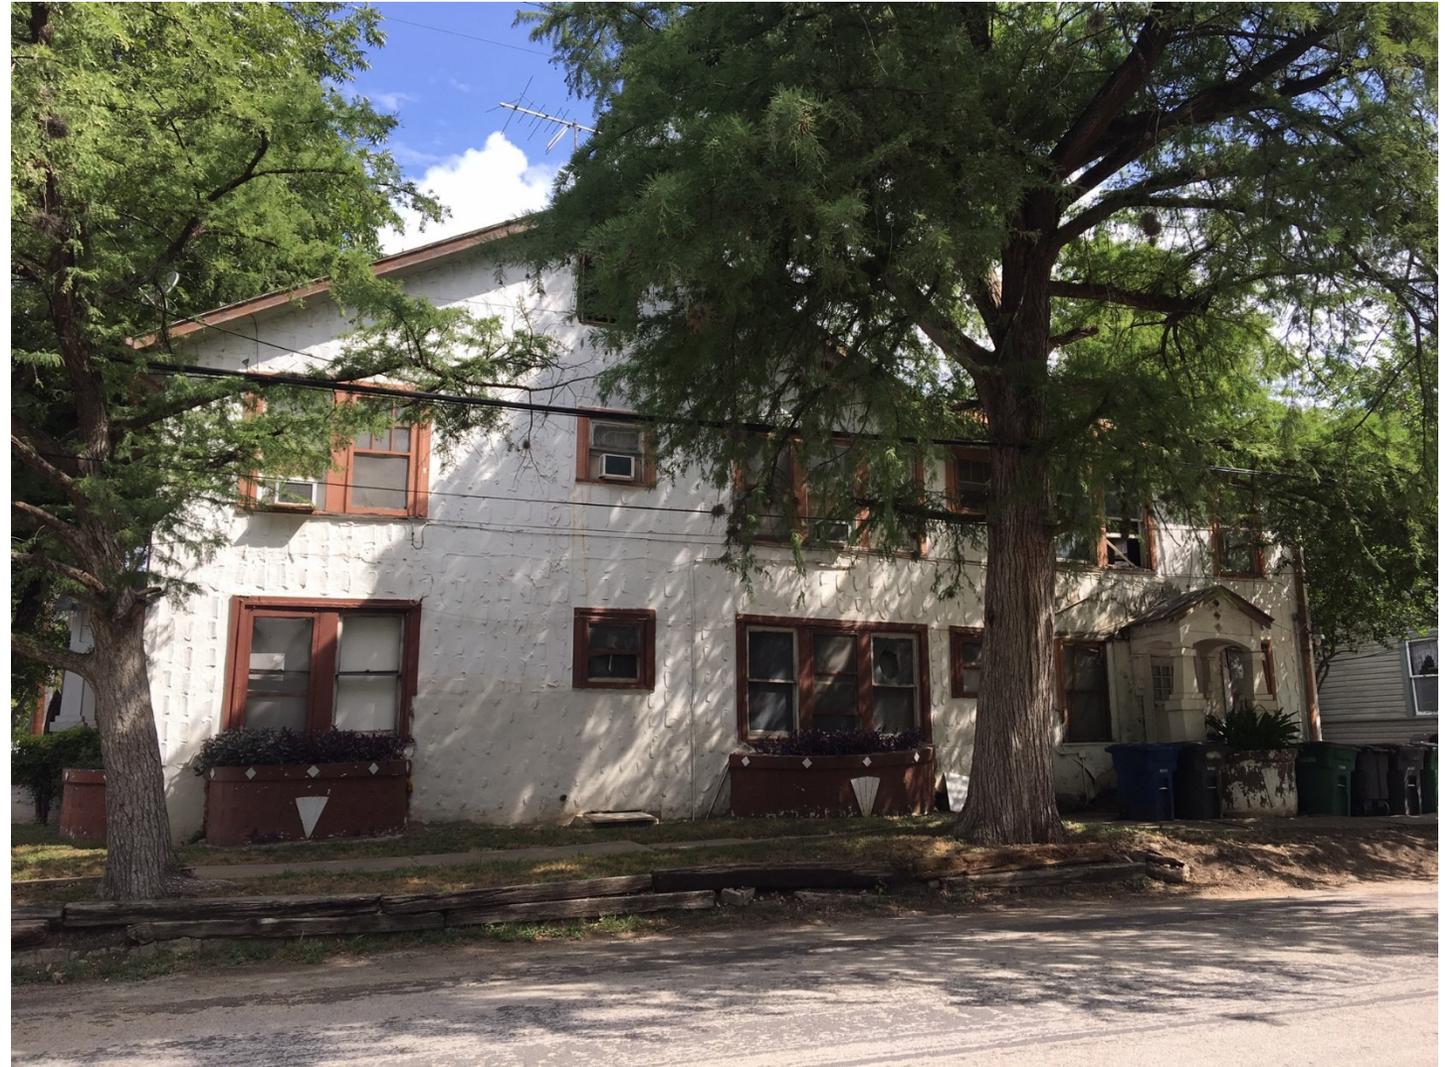
SIDE PORCH TO REMAIN

WOOD SIDING  
EXPOSURE AT  
SECOND LEVEL

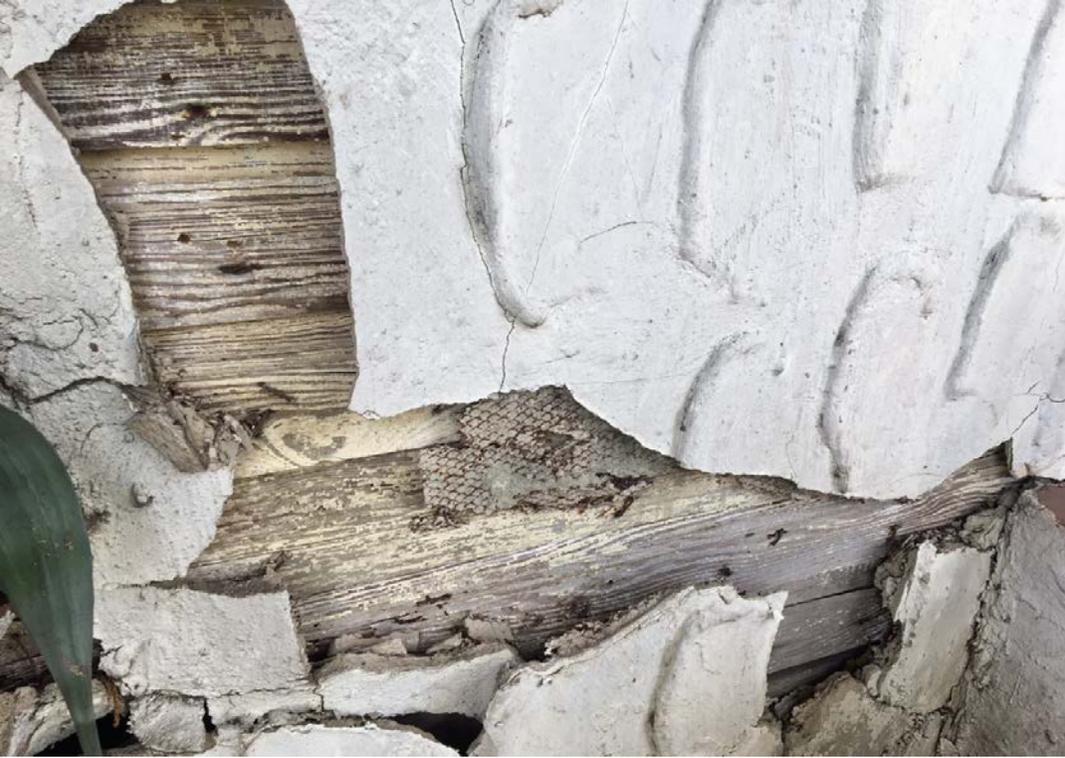
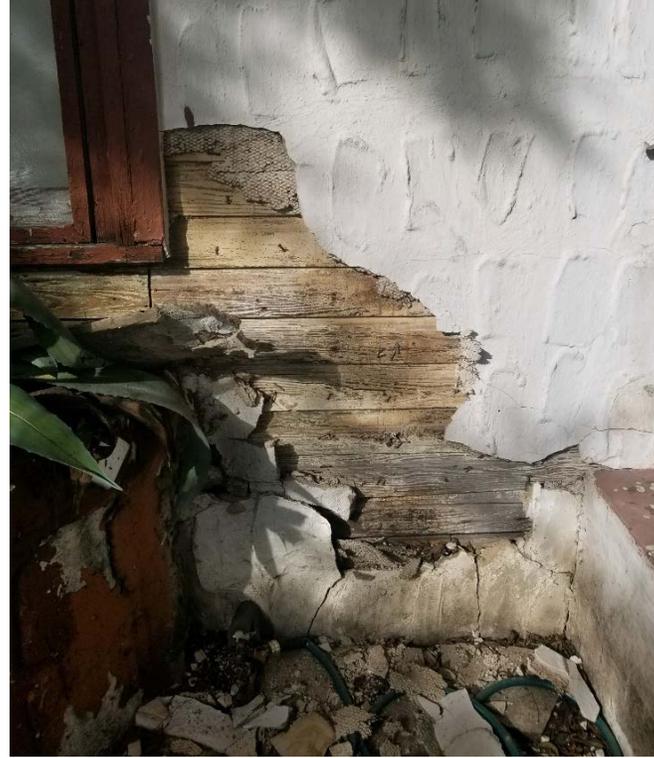
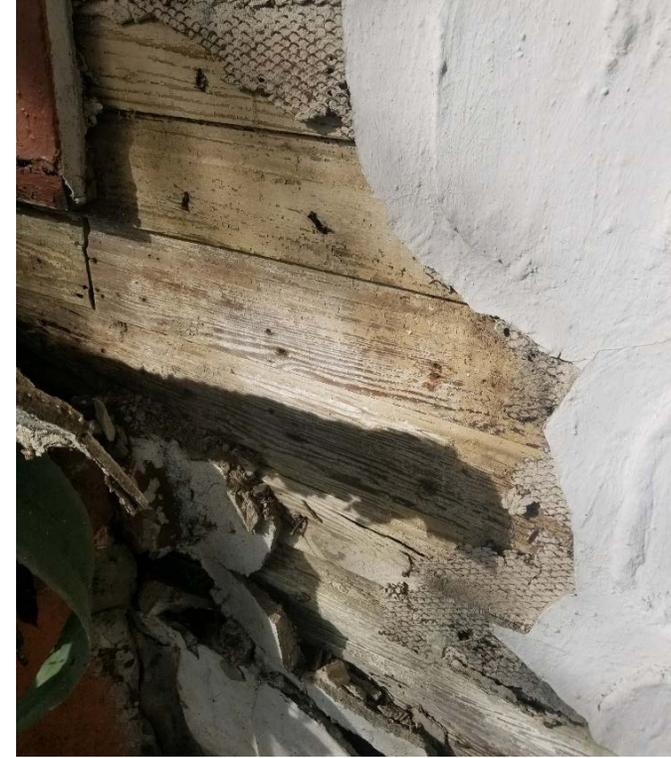
## WOOD SIDING BEHIND STUCCO/PLASTER

- STRUCTURE WAS NOT DESIGNED FOR STUCCO CAUSING IT TO CRACK
- STUCCO IS NOT ORIGINAL TO THE HOME

- REMOVE STUCCO/PLASTER
- RESTORE EXISTING WOOD SIDING OR REPLACE DAMAGED WOOD SIDING:
