## HISTORIC AND DESIGN REVIEW COMMISSION

October 03, 2018

**HDRC CASE NO:** 2018-486  
**ADDRESS:** 1018 BURNET ST  
**LEGAL DESCRIPTION:** NCB 1660 BLK 1 LOT 5  
**ZONING:** R-6, H  
**CITY COUNCIL DIST.:** 2  
**DISTRICT:** Dignowity Hill Historic District  
**APPLICANT:** Cory Johnson  
**OWNER:** Nicole Johnson  
**TYPE OF WORK:** Rear addition, replacement of windows, door, and columns, wood element repairs  
**APPLICATION RECEIVED:** September 17, 2018  
**60-DAY REVIEW:** November 16, 2018  
**REQUEST:**

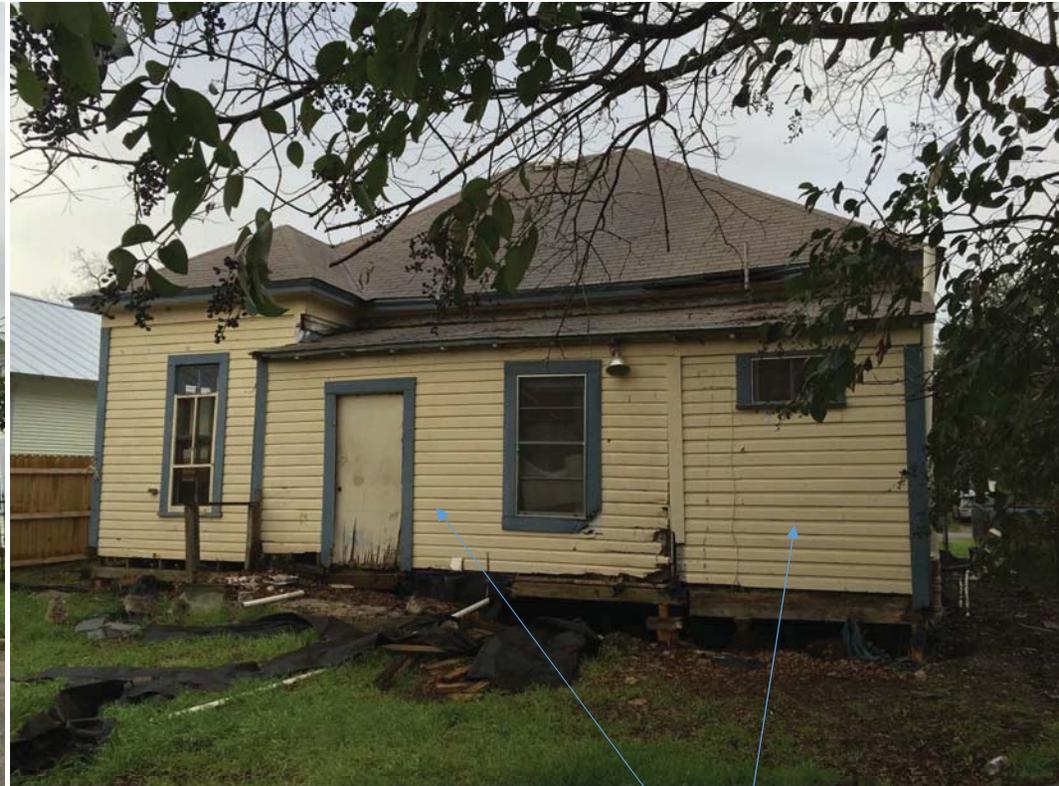
EXISTING REAR FACADE

NON-HISTORIC ADDITION TO BE REMOVED
