HISTORIC AND DESIGN REVIEW COMMISSION

October 07, 2020

HDRC CASE NO: 2020-431
ADDRESS: 109 CANAL ST
LEGAL DESCRIPTION: NCB 924 BLK 5 LOT S 43 FT OF 7 & S 46 FT OF E 12 FT OF 6
ZONING: RM-4, H
CITY COUNCIL DIST.: 1
DISTRICT: Lavaca Historic District
APPLICANT: Martin Lopez/LOPEZ MARTIN & MARIA
OWNER: Martin Lopez/LOPEZ MARTIN & MARIA
TYPE OF WORK: Window replacement
APPLICATION RECEIVED: September 15, 2020
60-DAY REVIEW: Not applicable due to City Council Emergency Orders
CASE MANAGER: Huy Pham

Investigation Report

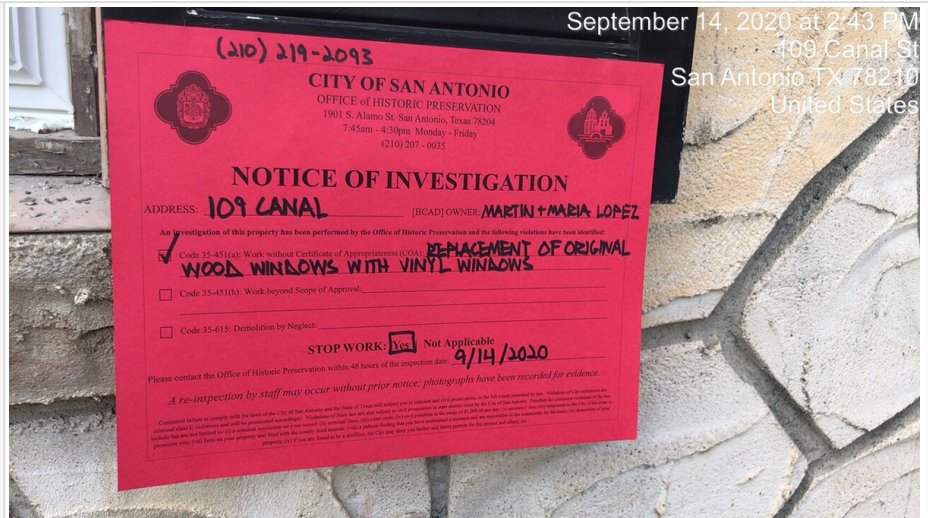
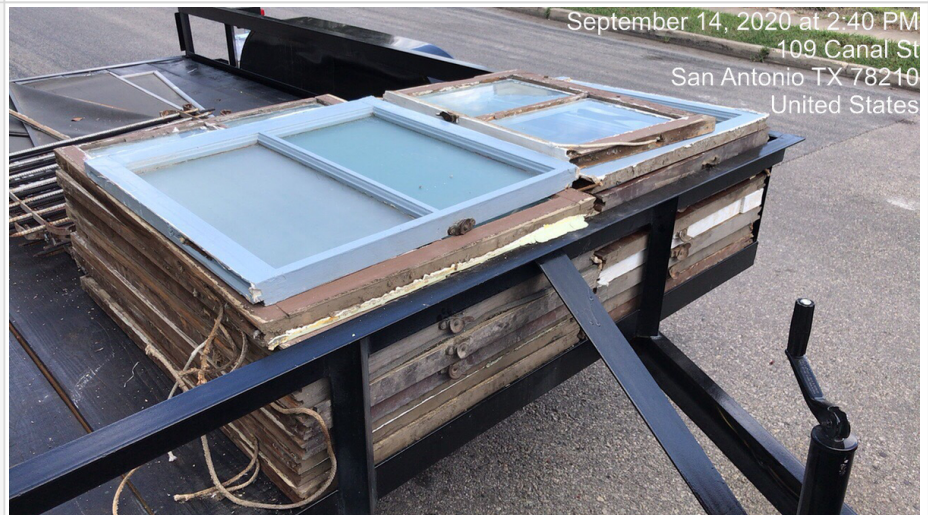
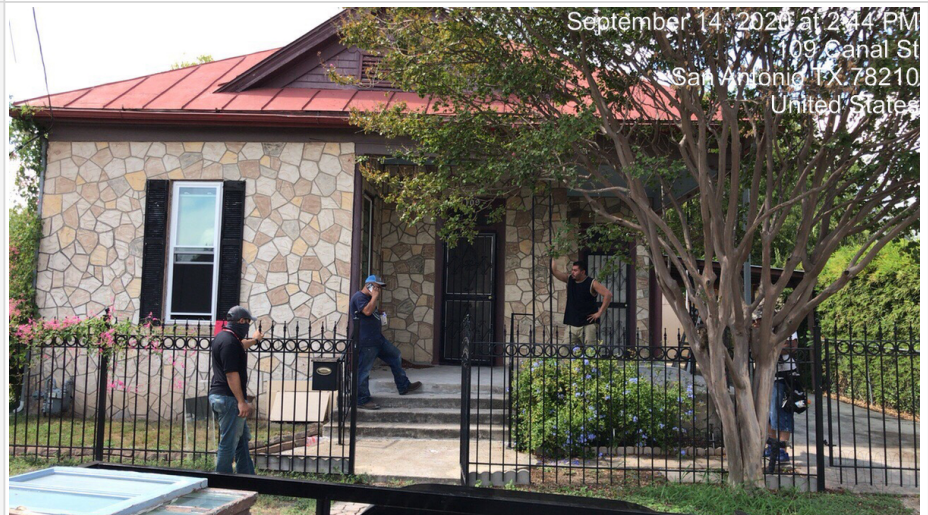
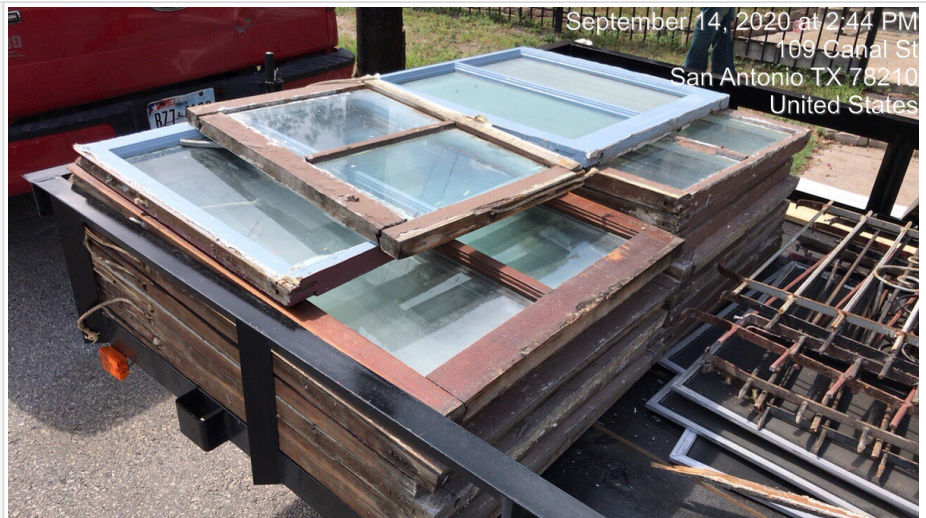
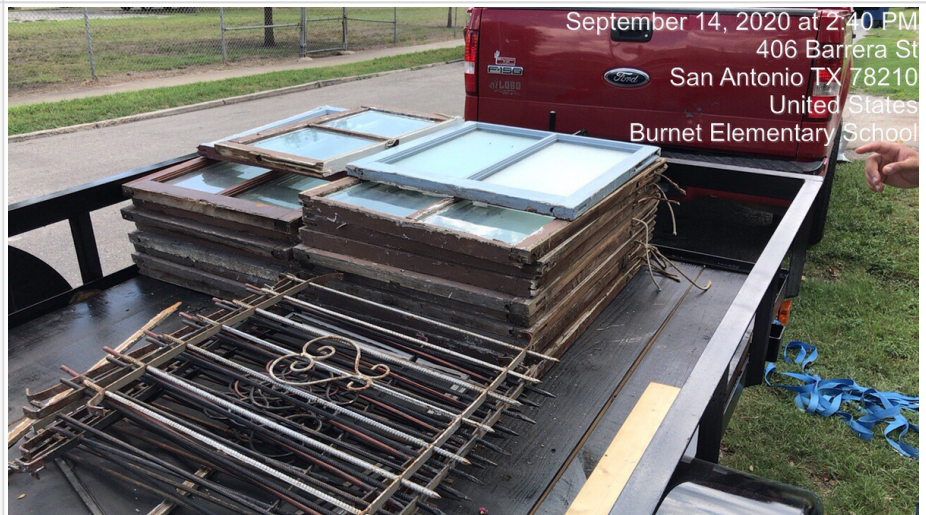
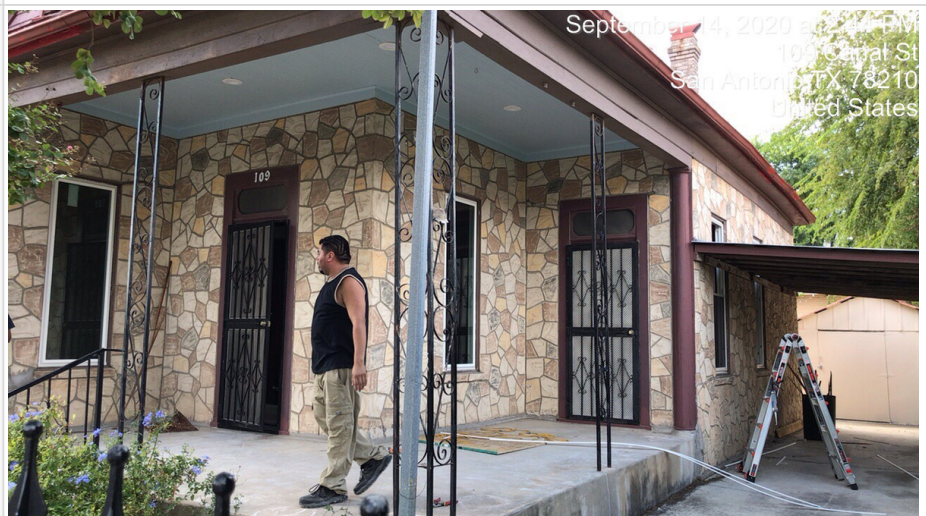
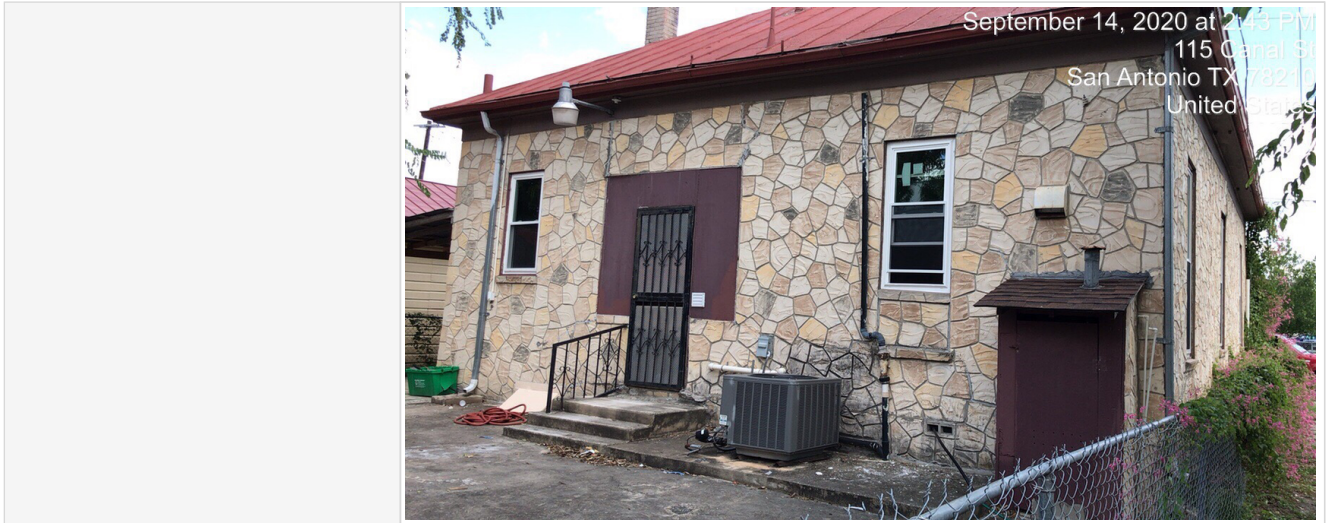
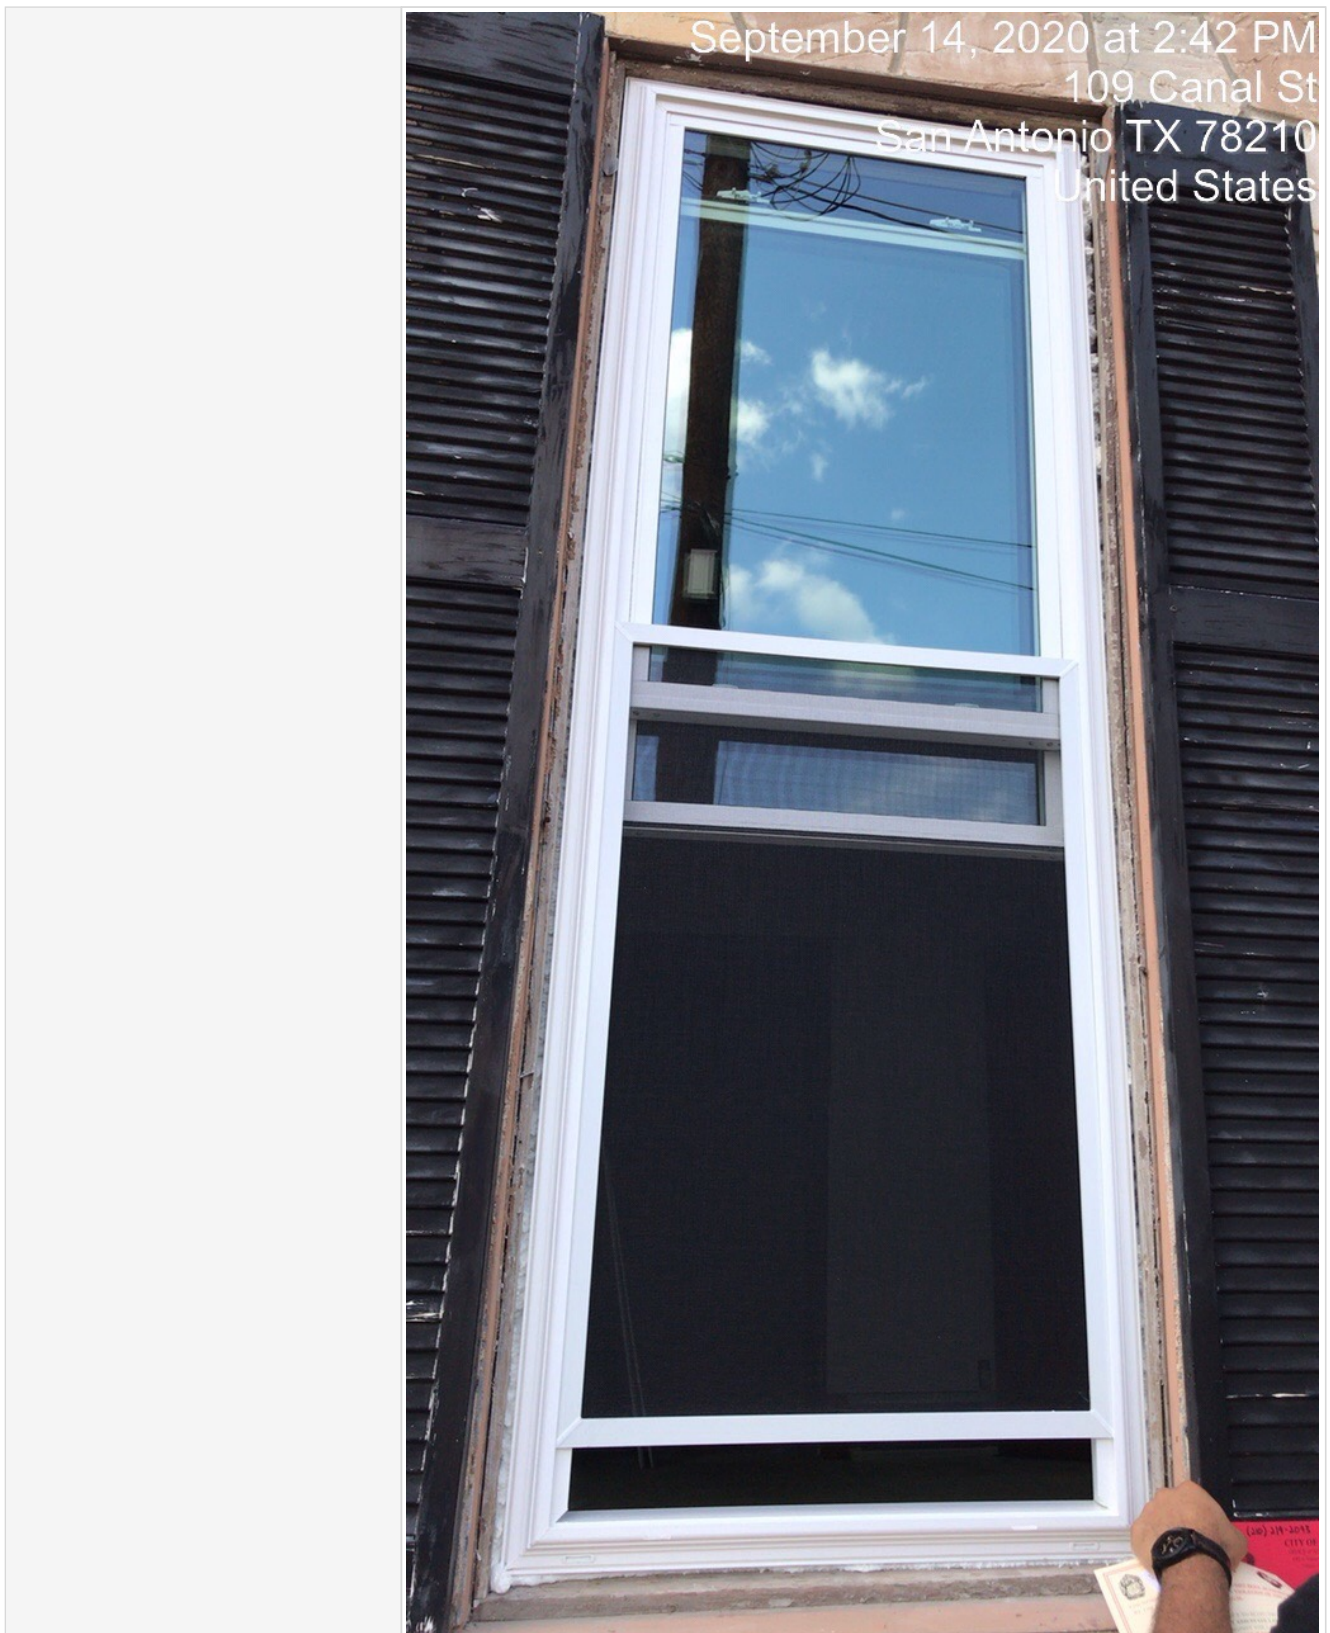
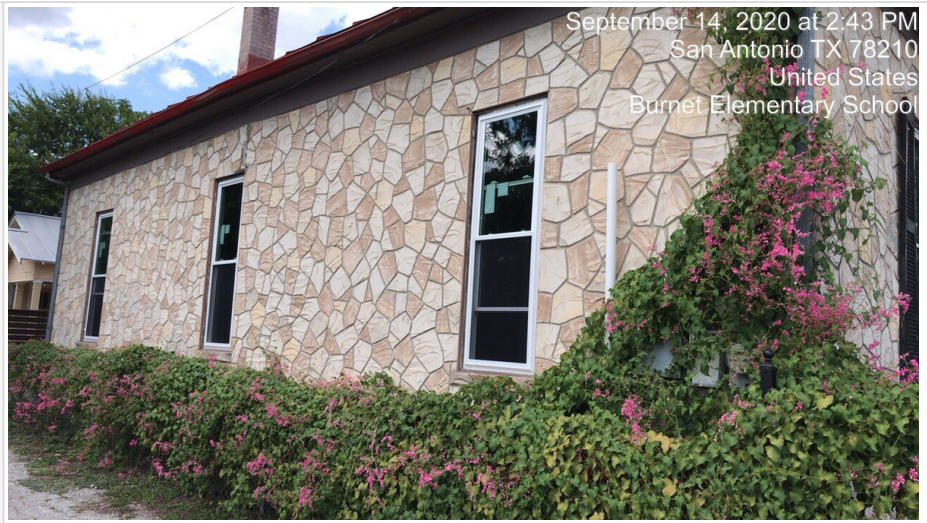
Photographs

- b. COMPLIANCE -On a site visit conducted on September 14, 2020, staff found that the property at 109 Canal was subjected to window replacement prior to approval. Staff advised the contractors on-site to store and not discard any of the wood windows prior to a commission action. The contractors and applicant were cooperative with the Stop Work Order and submitted an application on September 15, 2020, to be heard at the next Historic and Design Review Commission hearing.

Date	09/14/2020
Time	02:45 PM (-5 GMT)
Context	citizen report
Present Staff	Huy Pham, Edward Hall
Present Individuals	Contractor(s)
Contractor/Realtor Companies	Champion Window (unassociated subcontractors)
Types of Work Observed	Exterior Maintenance and Alterations
Amount of Work Completed	Completed
Description of work	Replacement of up to 10 wood windows with sashes visible on site.
Description of interaction	Subcontractors were cooperative to the Stop Work Order and committed to storing the windows inside until the homeowner/project manager submits an application.

Staff does not recommend approval of window replacement based on findings b through c. The removed, wood windows should be repaired and reinstalled.
