HISTORIC AND DESIGN REVIEW COMMISSION

HDRC CASE NO: 2018-402
ADDRESS: 209 MADISON ST
LEGAL DESCRIPTION: NCB 740 BLK 3 LOT 13 & SW 25.075FT OF 12
ZONING: RM-4,HE
CITY COUNCIL DIST.: 1
DISTRICT: King William Historic District
LANDMARK: Greabner-Giles House
APPLICANT: Elisa Madrid
OWNER: Elisa Madrid
TYPE OF WORK: Enclose second-floor balcony
APPLICATION RECEIVED: July 23, 2018
60-DAY REVIEW: September 22, 2018

RE: HDRC Case No. 2018-320 or other number as may have been assigned
Certificate of Appropriateness for:
Enclosure of Small Second Level Porch:
209 Madison Street
San Antonio, TX 78204

ENGINEER INSPECTION REPORT

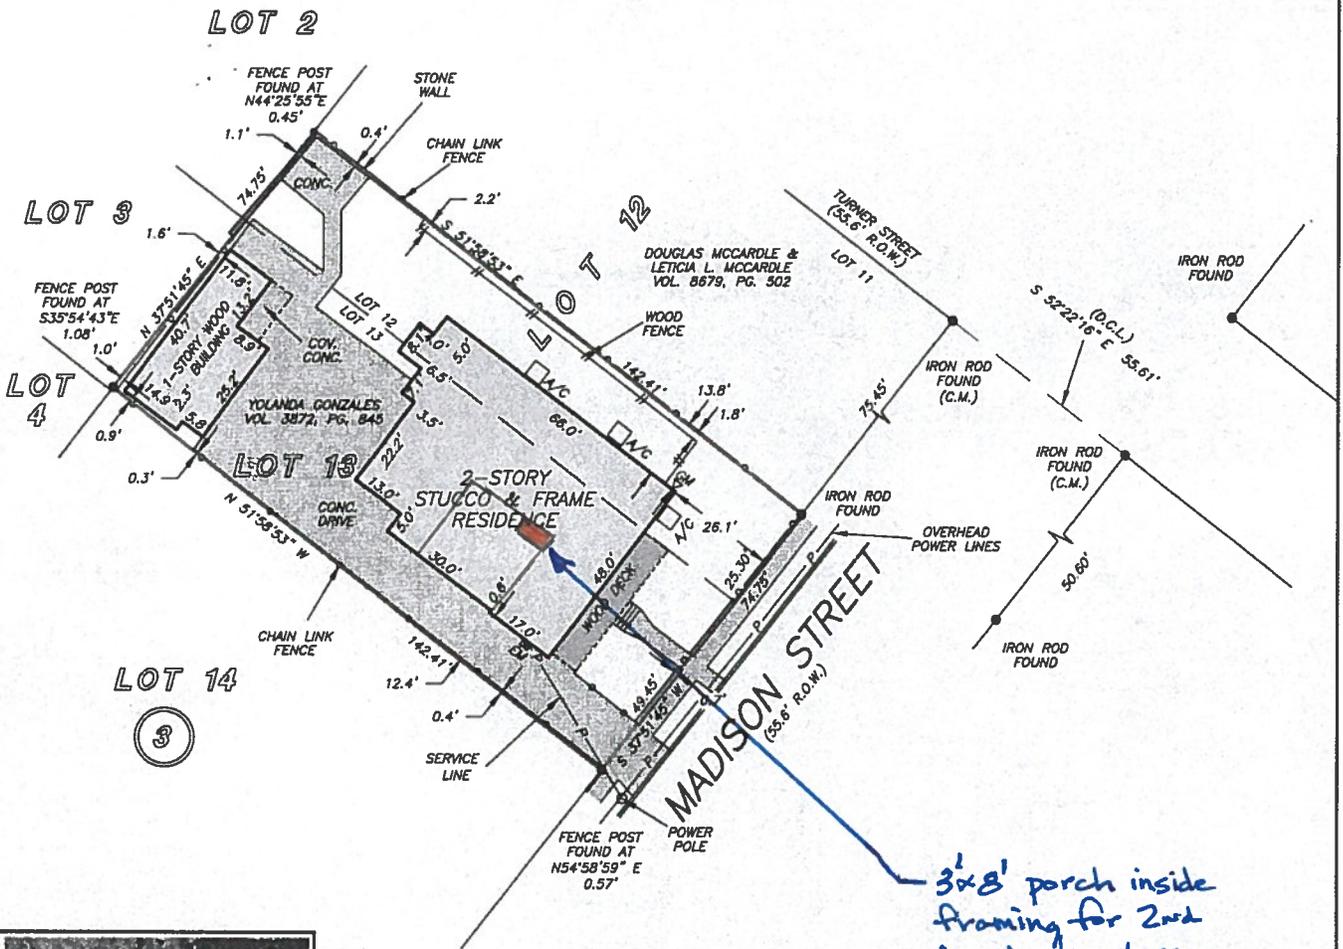
EXHIBIT B

2. We have also attached the Survey of the current configuration, noted as **Exhibit B**. This survey has marked the location of the small porch near the center of the current existing structure.

3'x8' porch inside framing for 2nd level structure. Convert to waterproof and enclose with siding to match historical siding existing.

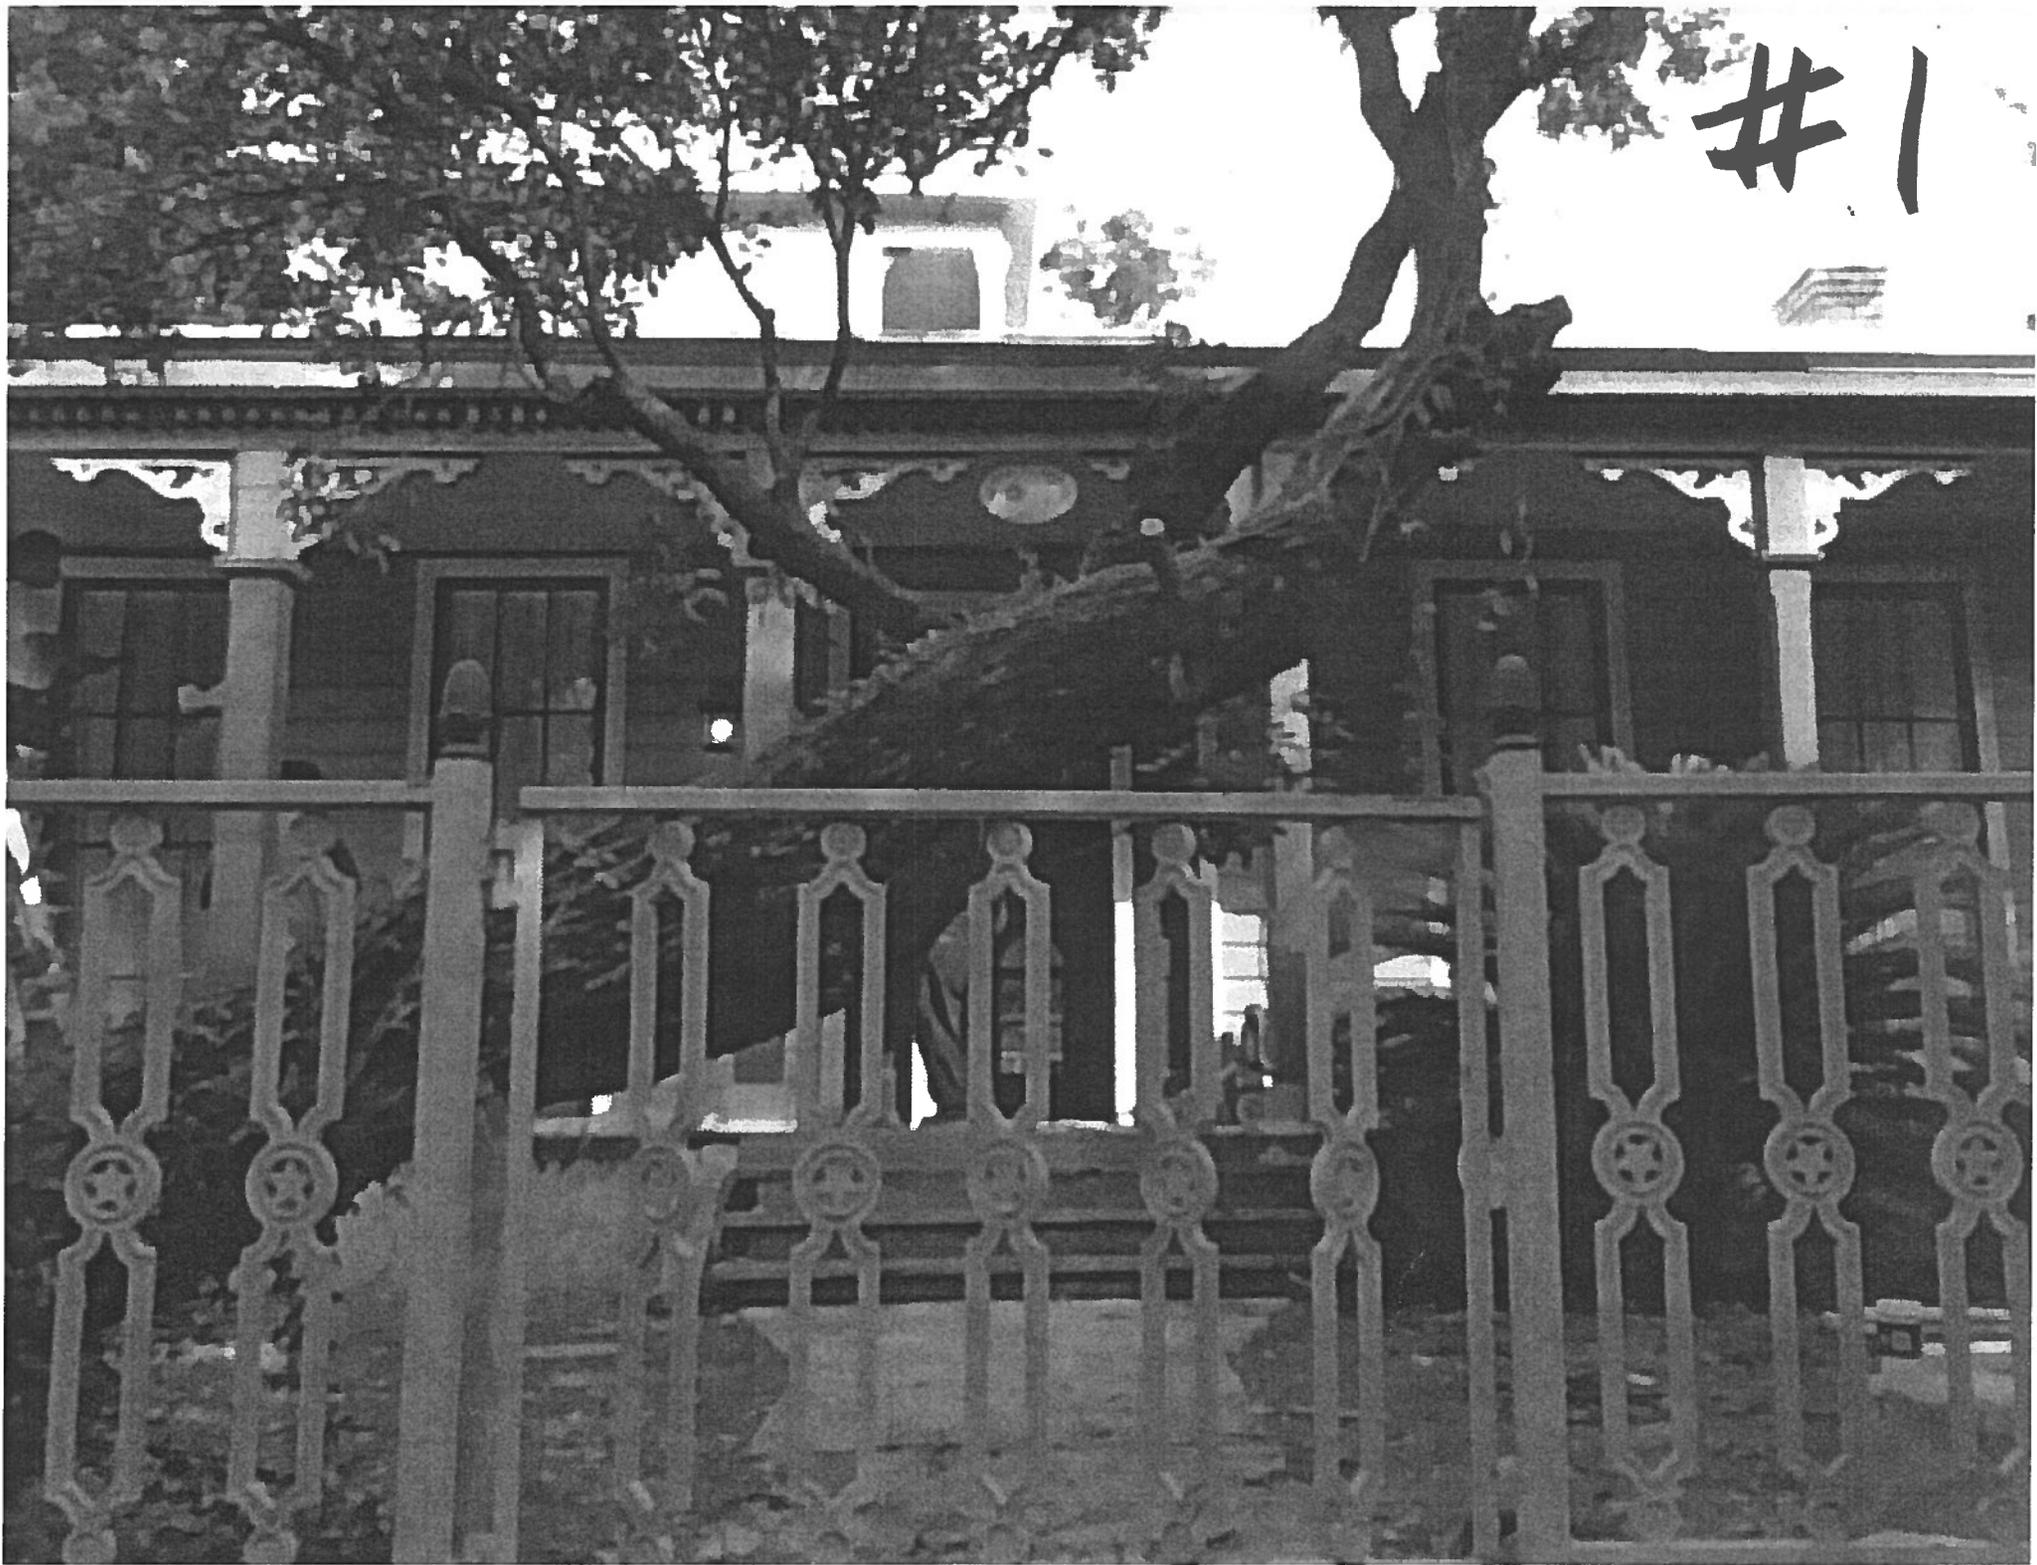
3. The original wood structure was built with the small observation porch located at the right front corner of the second level. That room was a bedroom but lacked a closet, as did bedrooms in most homes of this vintage. The exterior front elevation is shown in **Photos #1 and 2**.

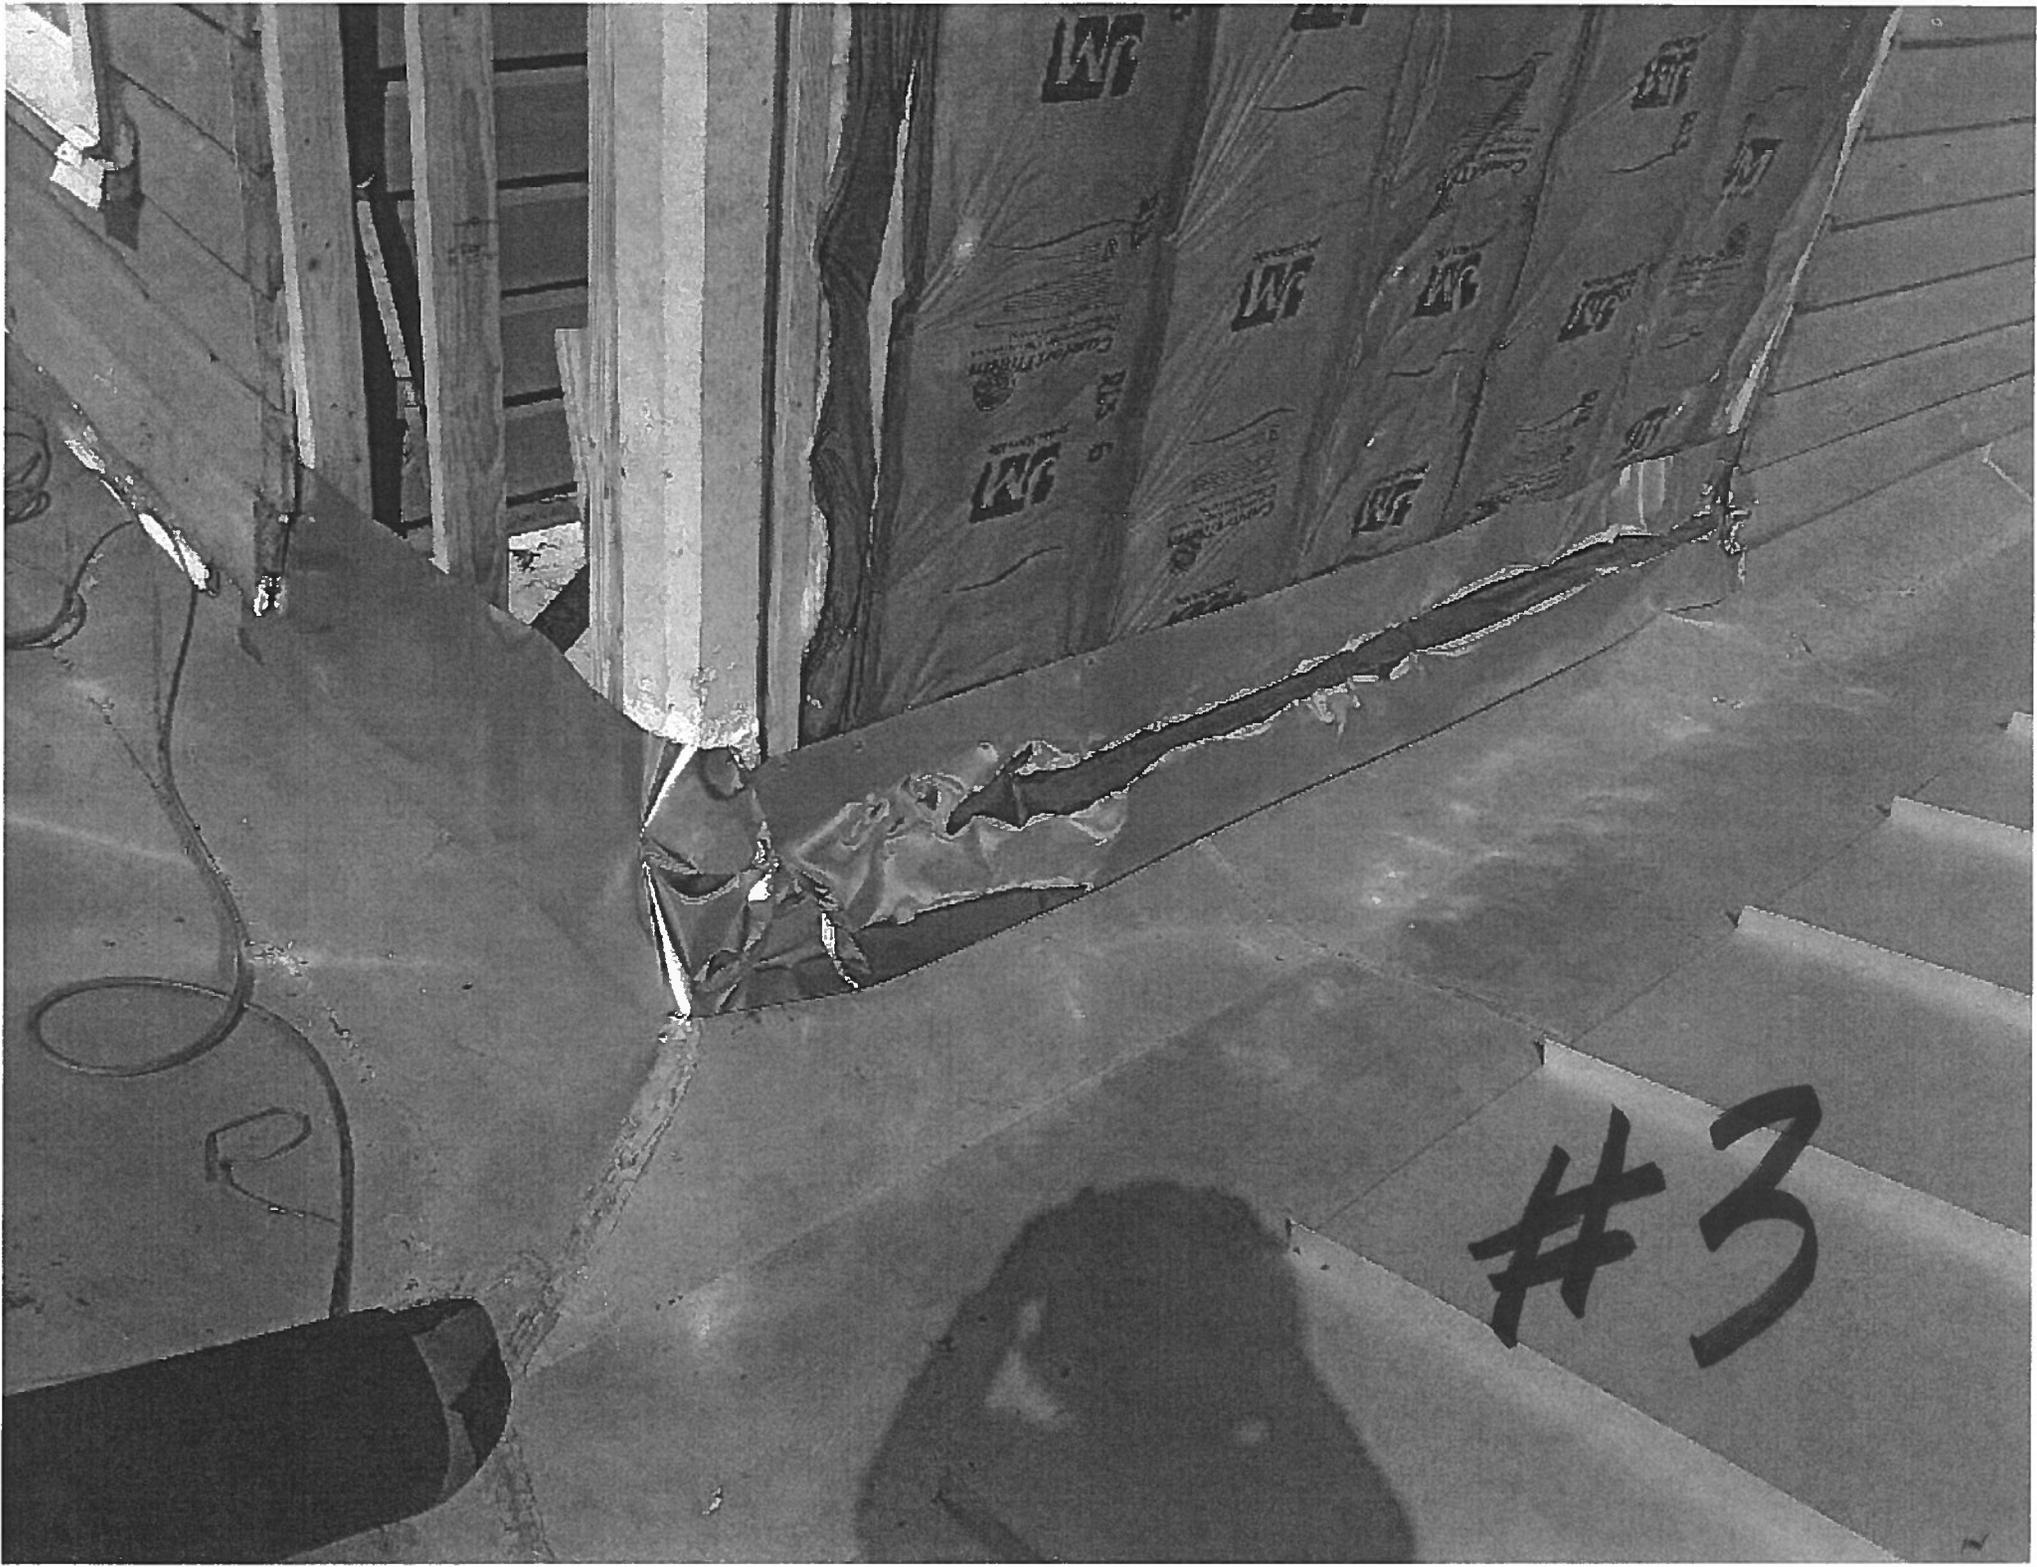
#3

4. At the time of my inspection, I reviewed the roofing work in progress and show the new waterproofing at the exterior perimeter of the front right 2nd level corner of the home. That condition is shown in attached **Photo #3**. Note that the existing siding is a lap siding and the enclosure was in place for the waterproofing of this corner of the home structure.

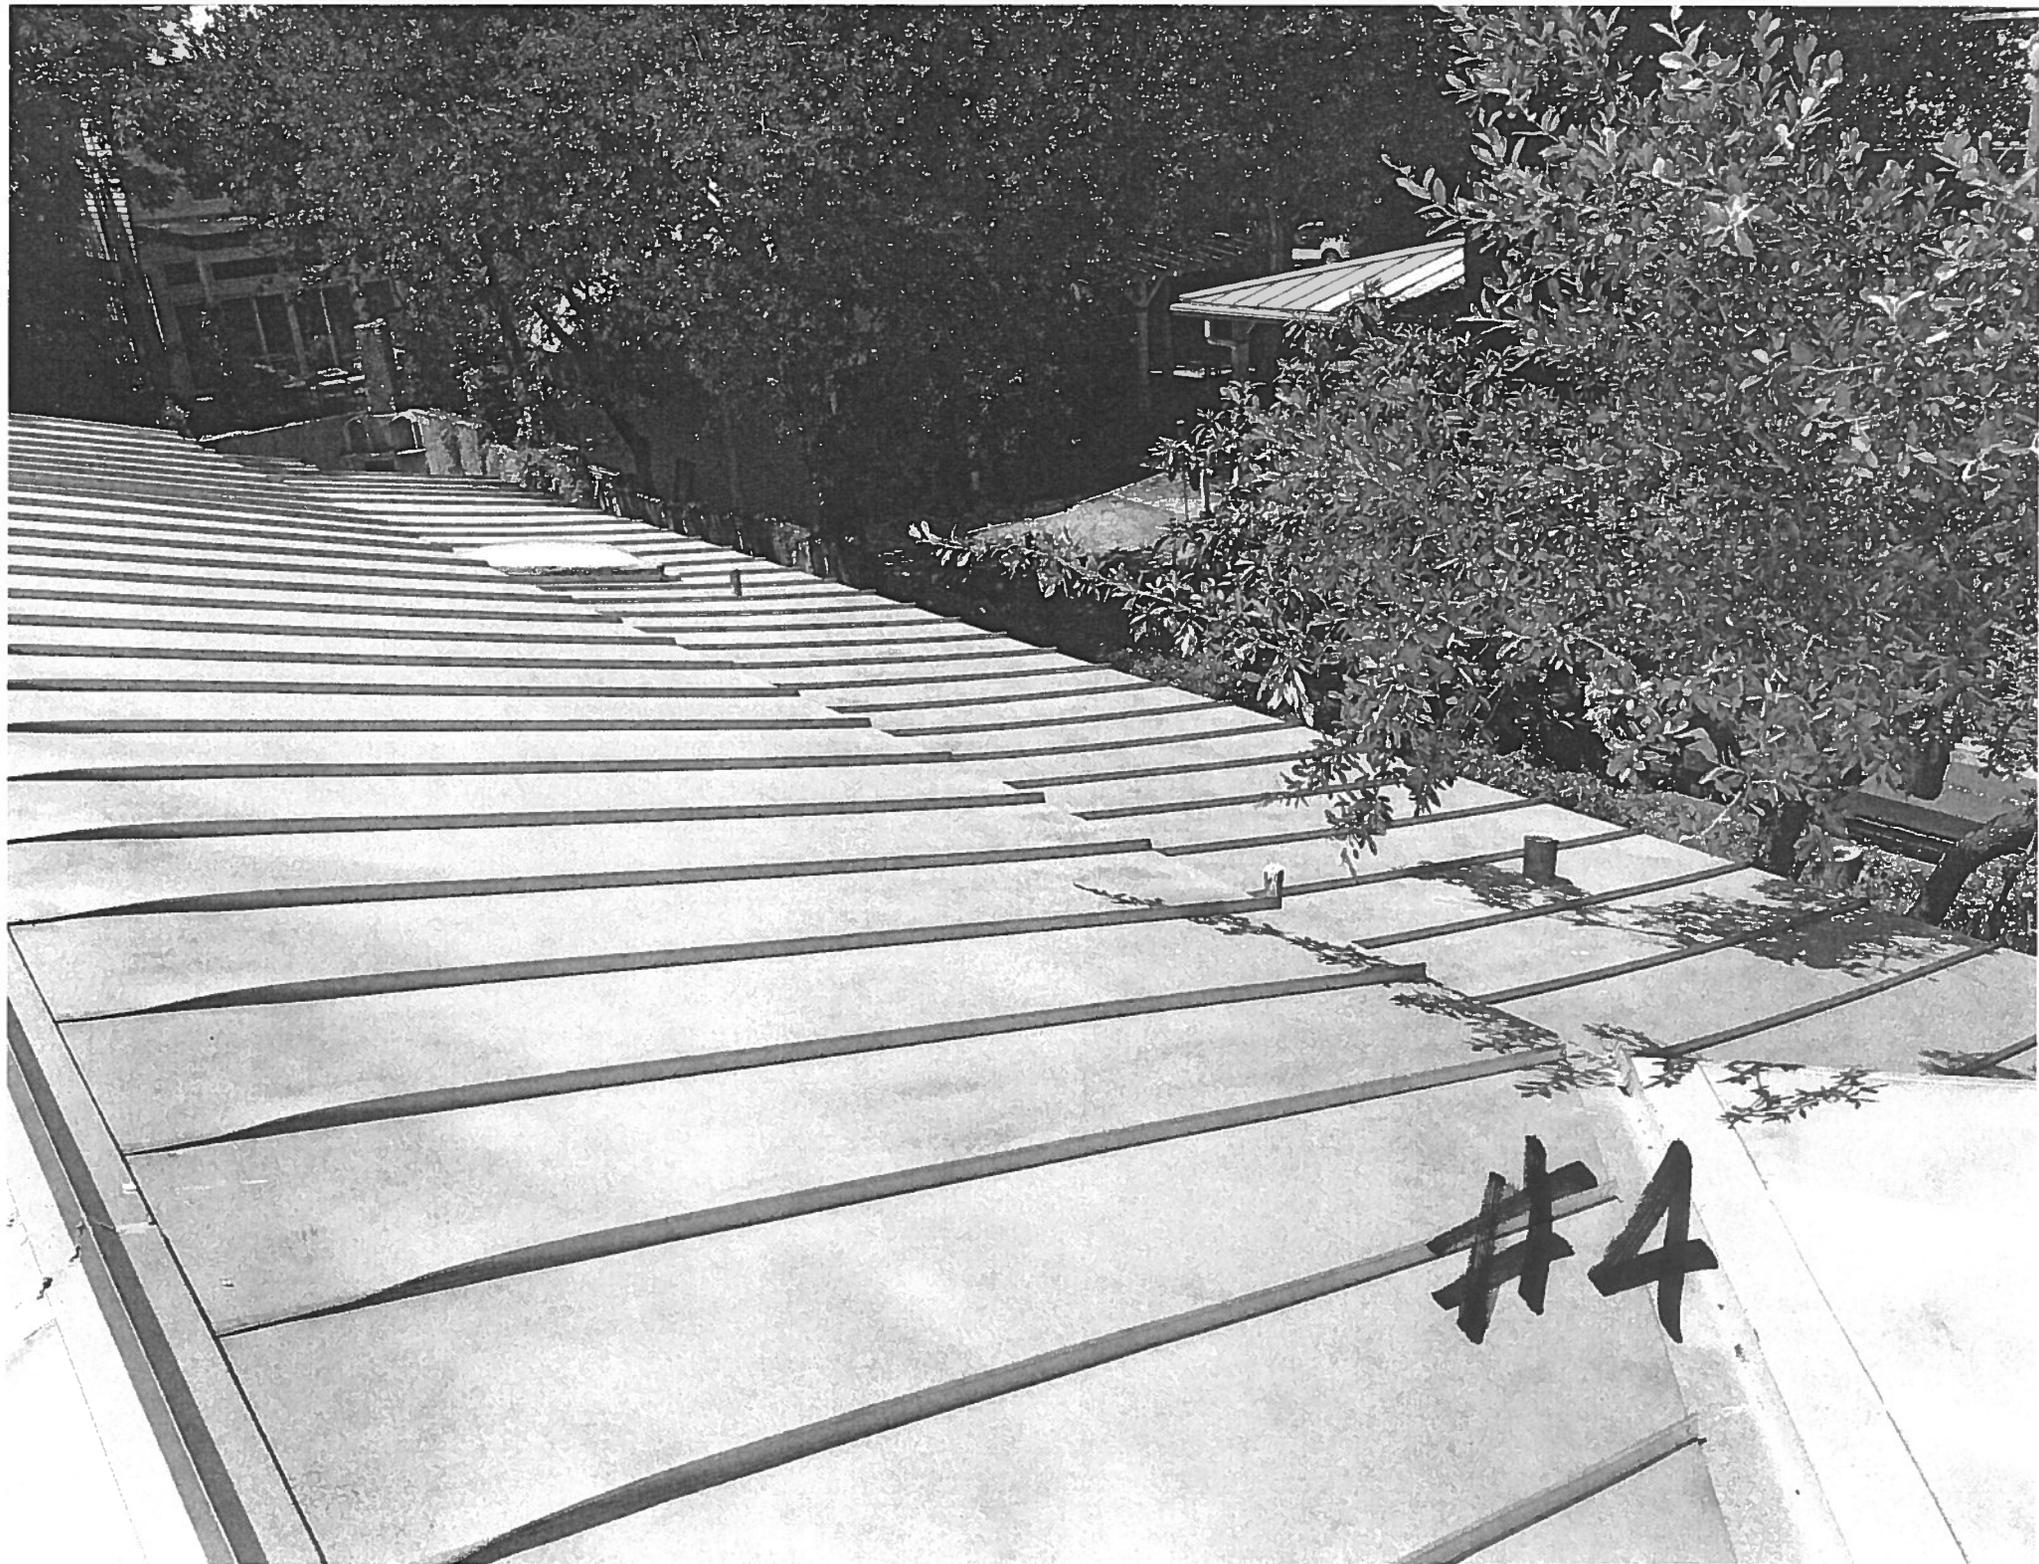
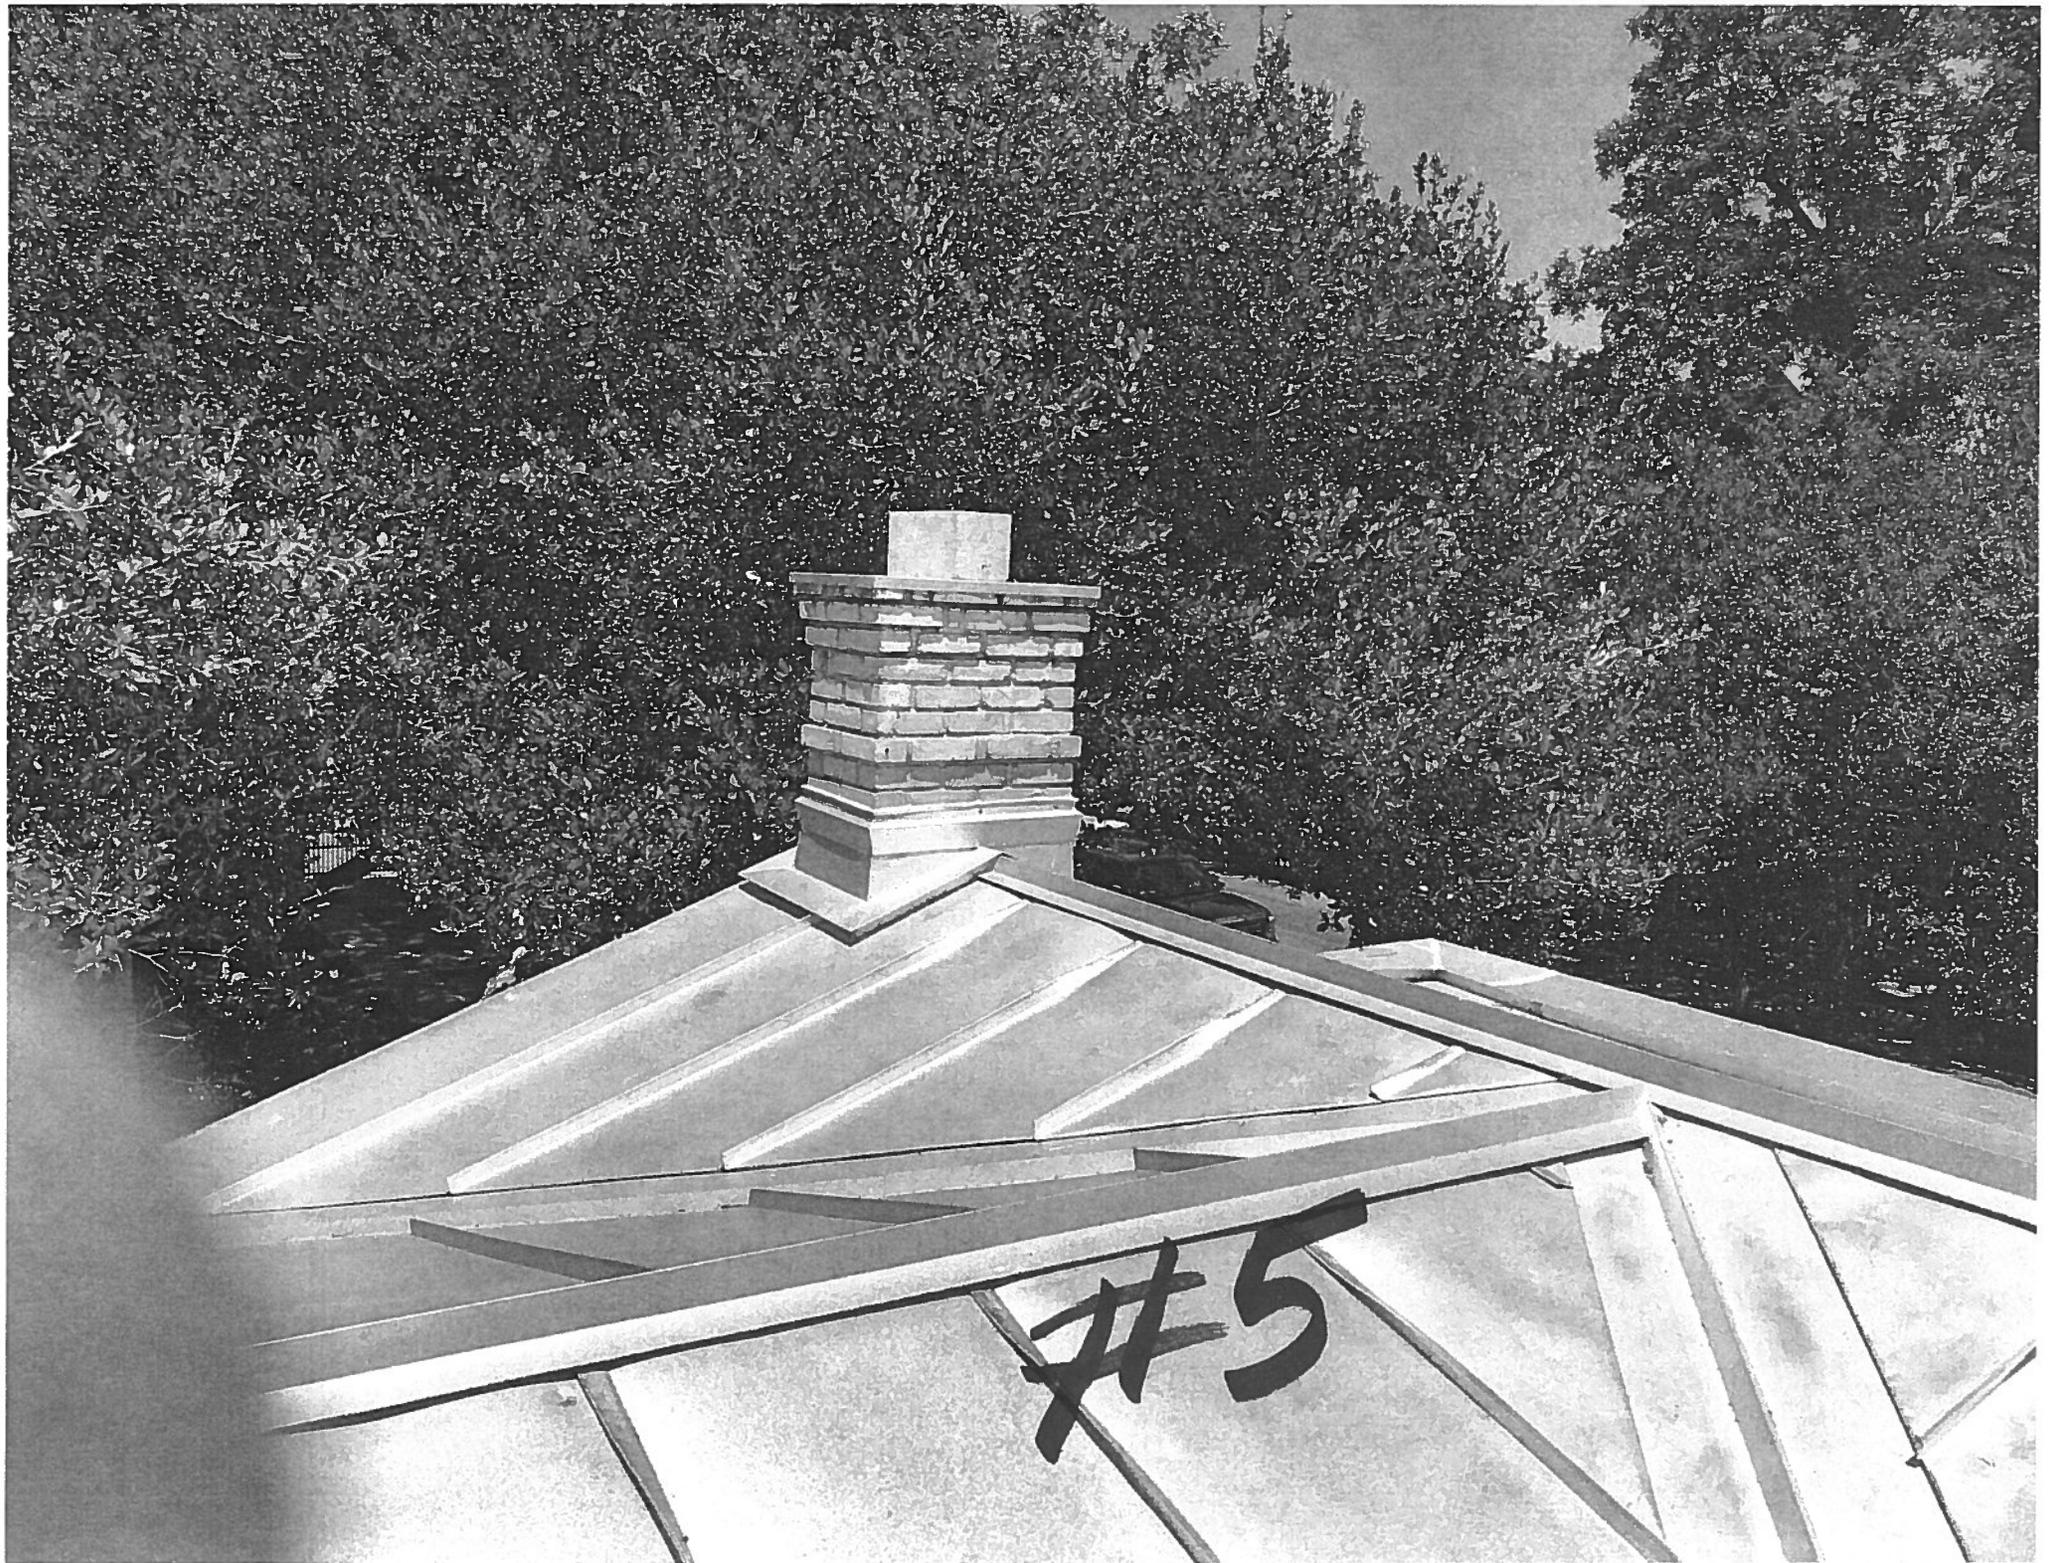
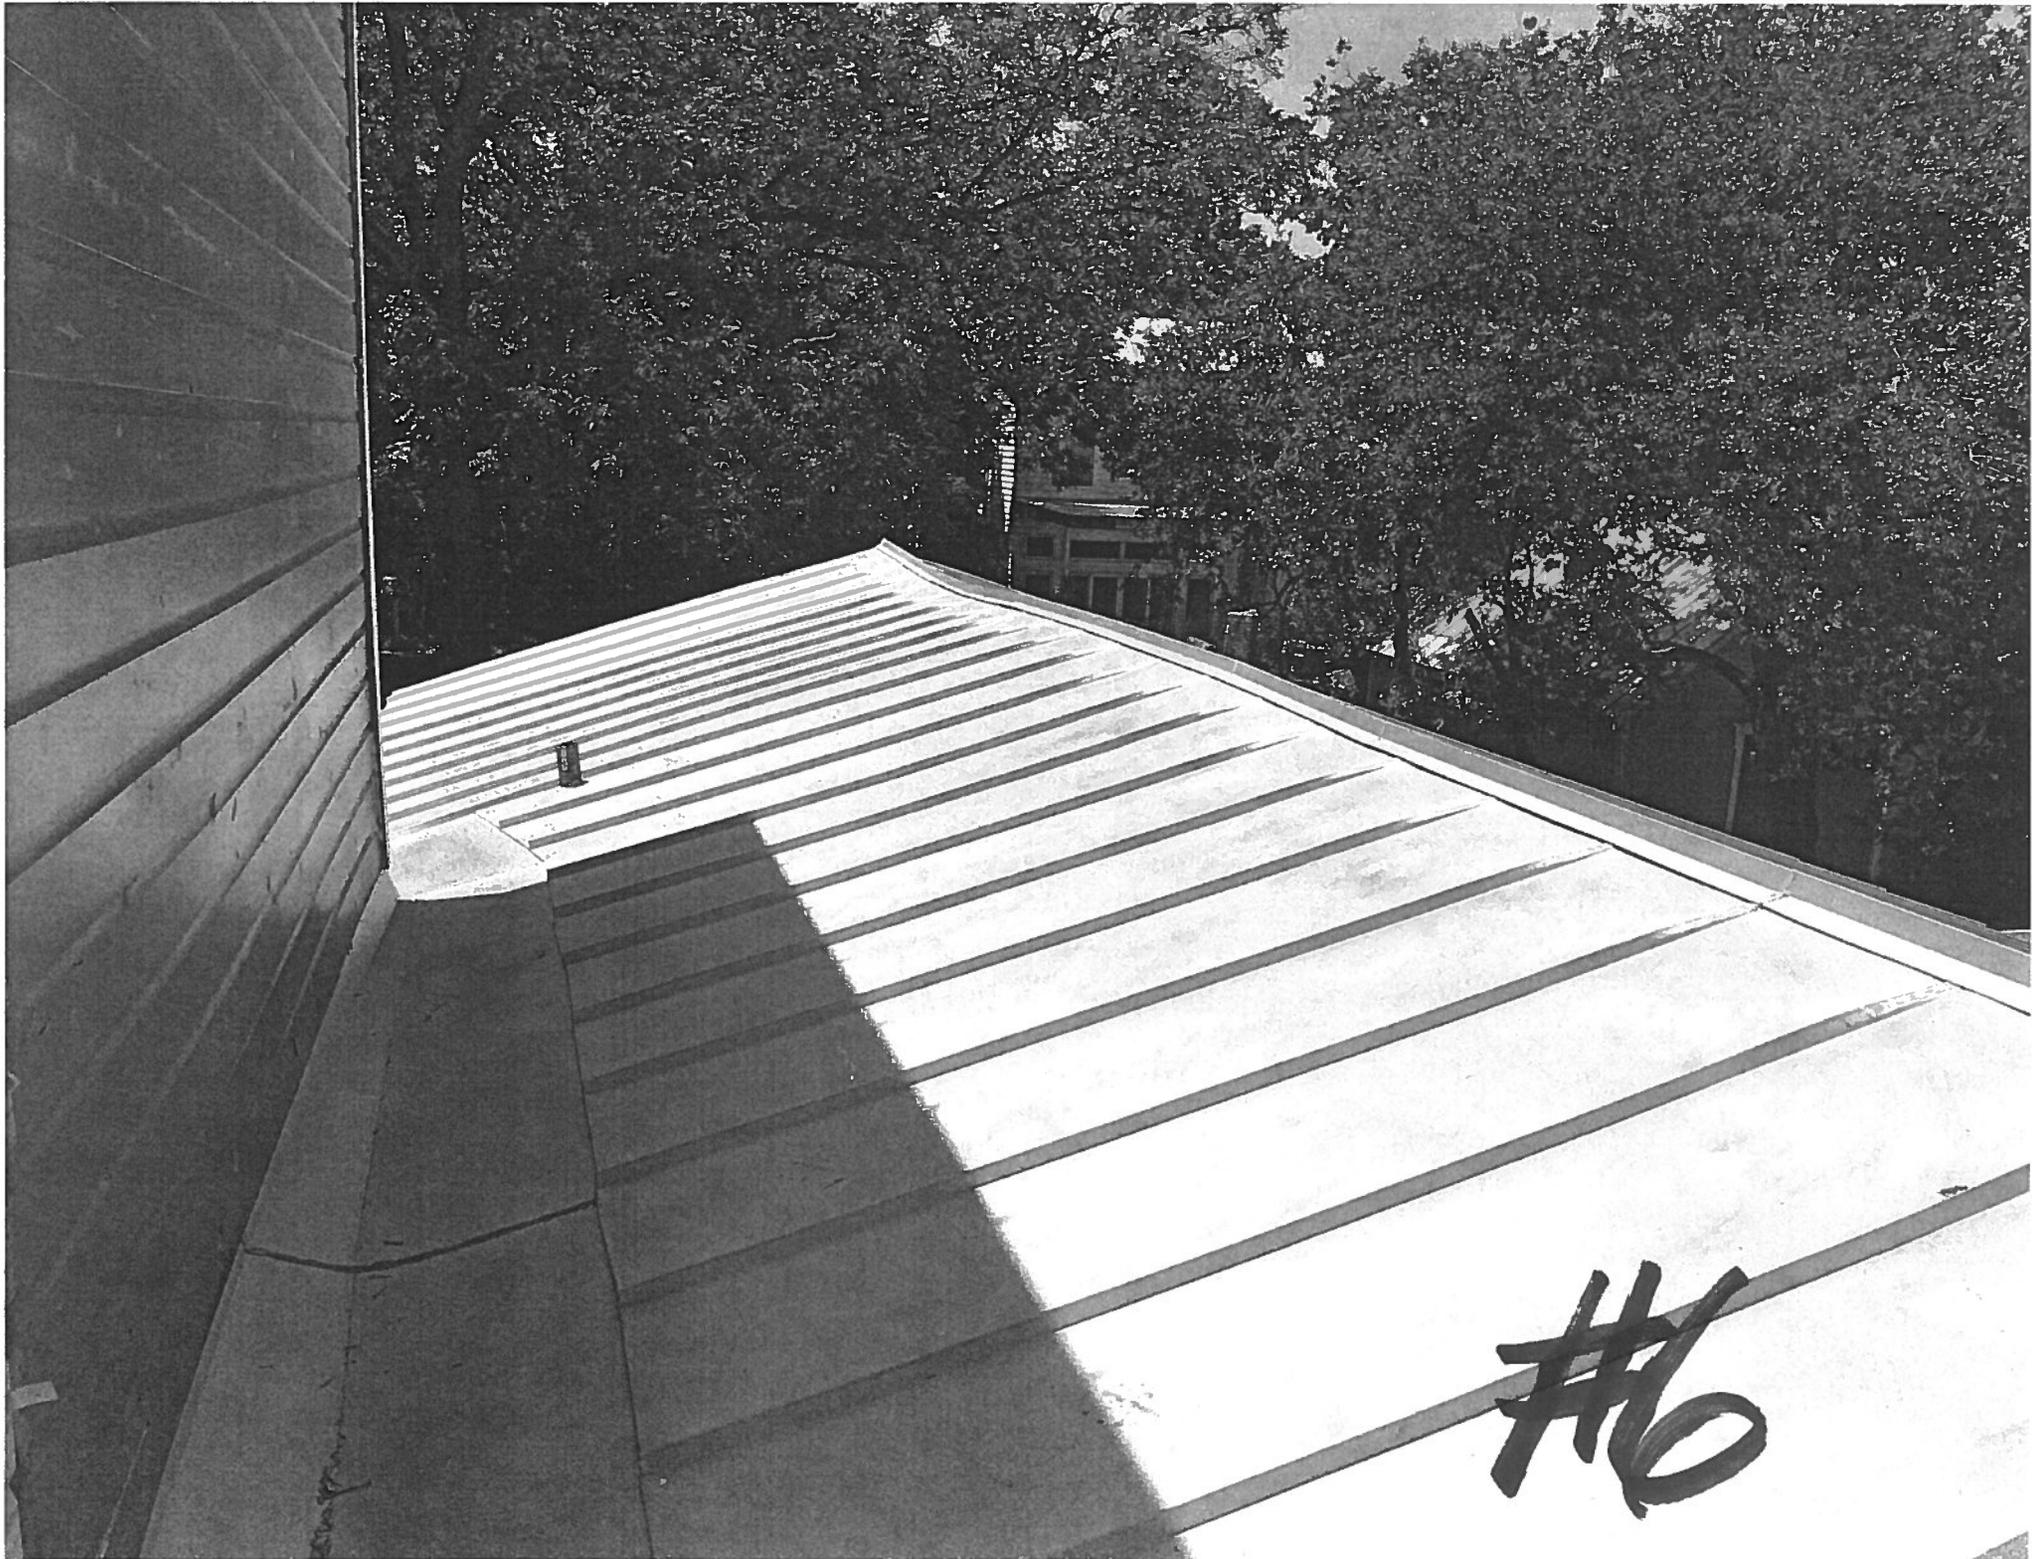
5. Several photos of the existing new roofing taken from the front right corner of the 2nd level show that the original small observation porch no longer is a useful vantage point except to allow dangerous access to the roof. The roof slopes downward toward the sides of the second level and the porch waterproofing was compromised during several recent high rainfall periods. See attached **Photos #4, 5, and 6**.
