HISTORIC AND DESIGN REVIEW COMMISSION

HDRC CASE NO: 2018-402
ADDRESS: 209 MADISON ST
LEGAL DESCRIPTION: NCB 740 BLK 3 LOT 13 & SW 25.075FT OF 12
ZONING: RM-4,HE
CITY COUNCIL DIST.: 1
DISTRICT: King William Historic District
LANDMARK: Greabner-Giles House
APPLICANT: Elisa Madrid
OWNER: Elisa Madrid
TYPE OF WORK: Enclose second-floor balcony
APPLICATION RECEIVED: July 23, 2018
60-DAY REVIEW: September 22, 2018

RE: HDRC Case No. 2018-320 or other number as may have been assigned
Certificate of Appropriateness for:
Enclosure of Small Second Level Porch:
209 Madison Street
San Antonio, TX 78204

ENGINEER INSPECTION REPORT

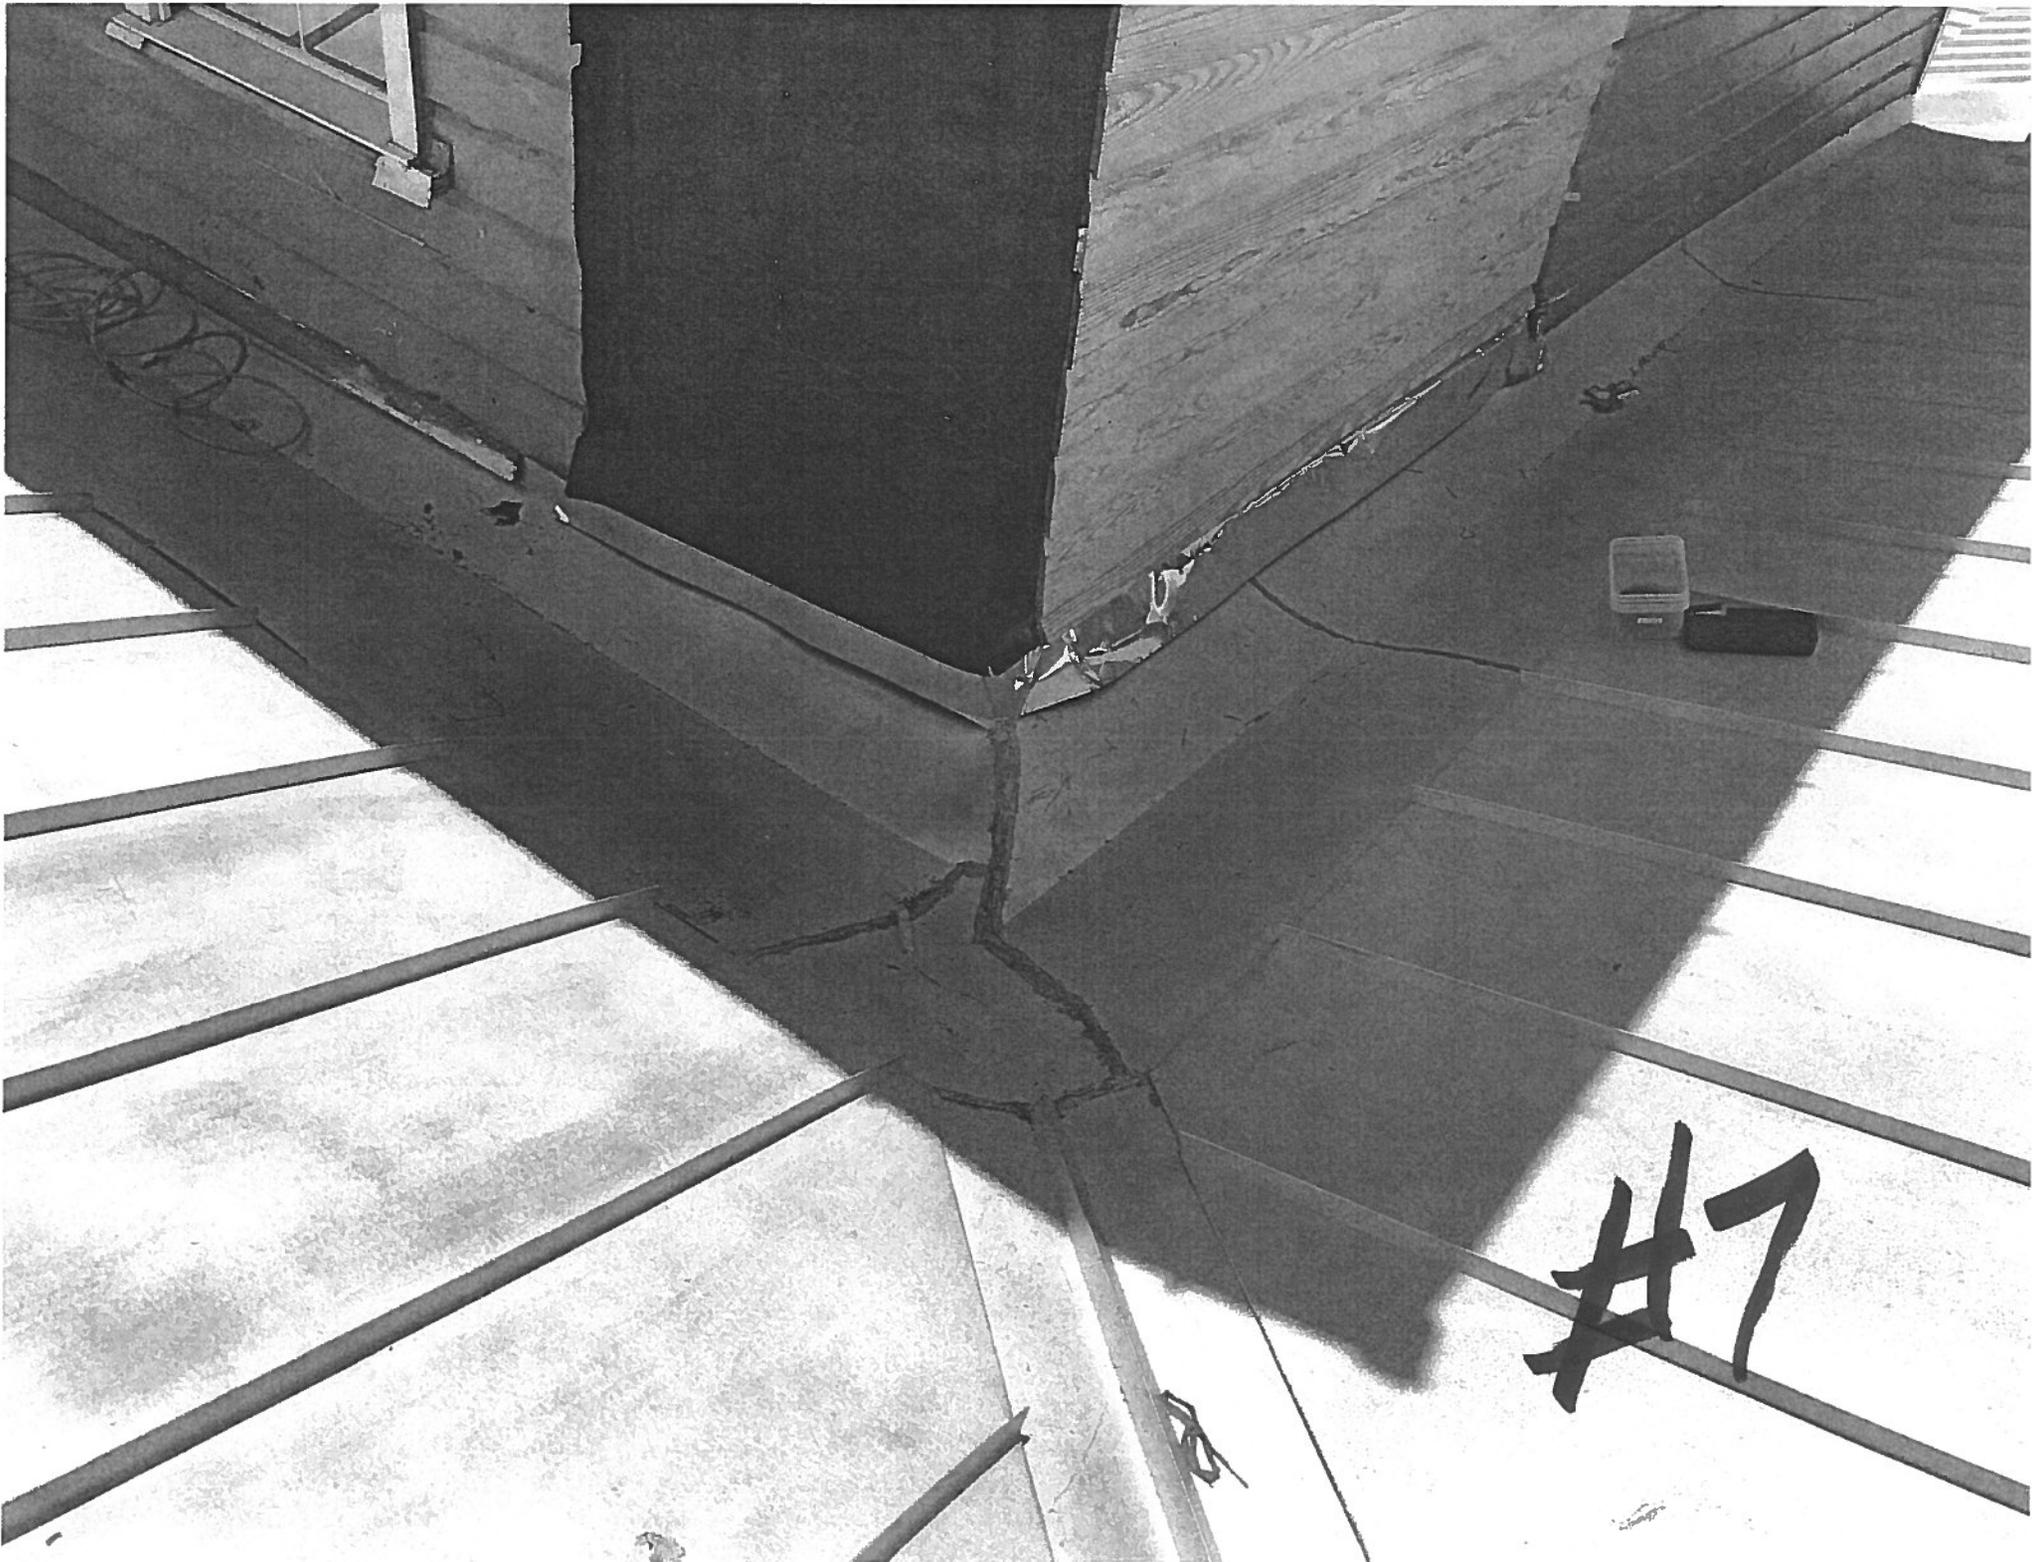
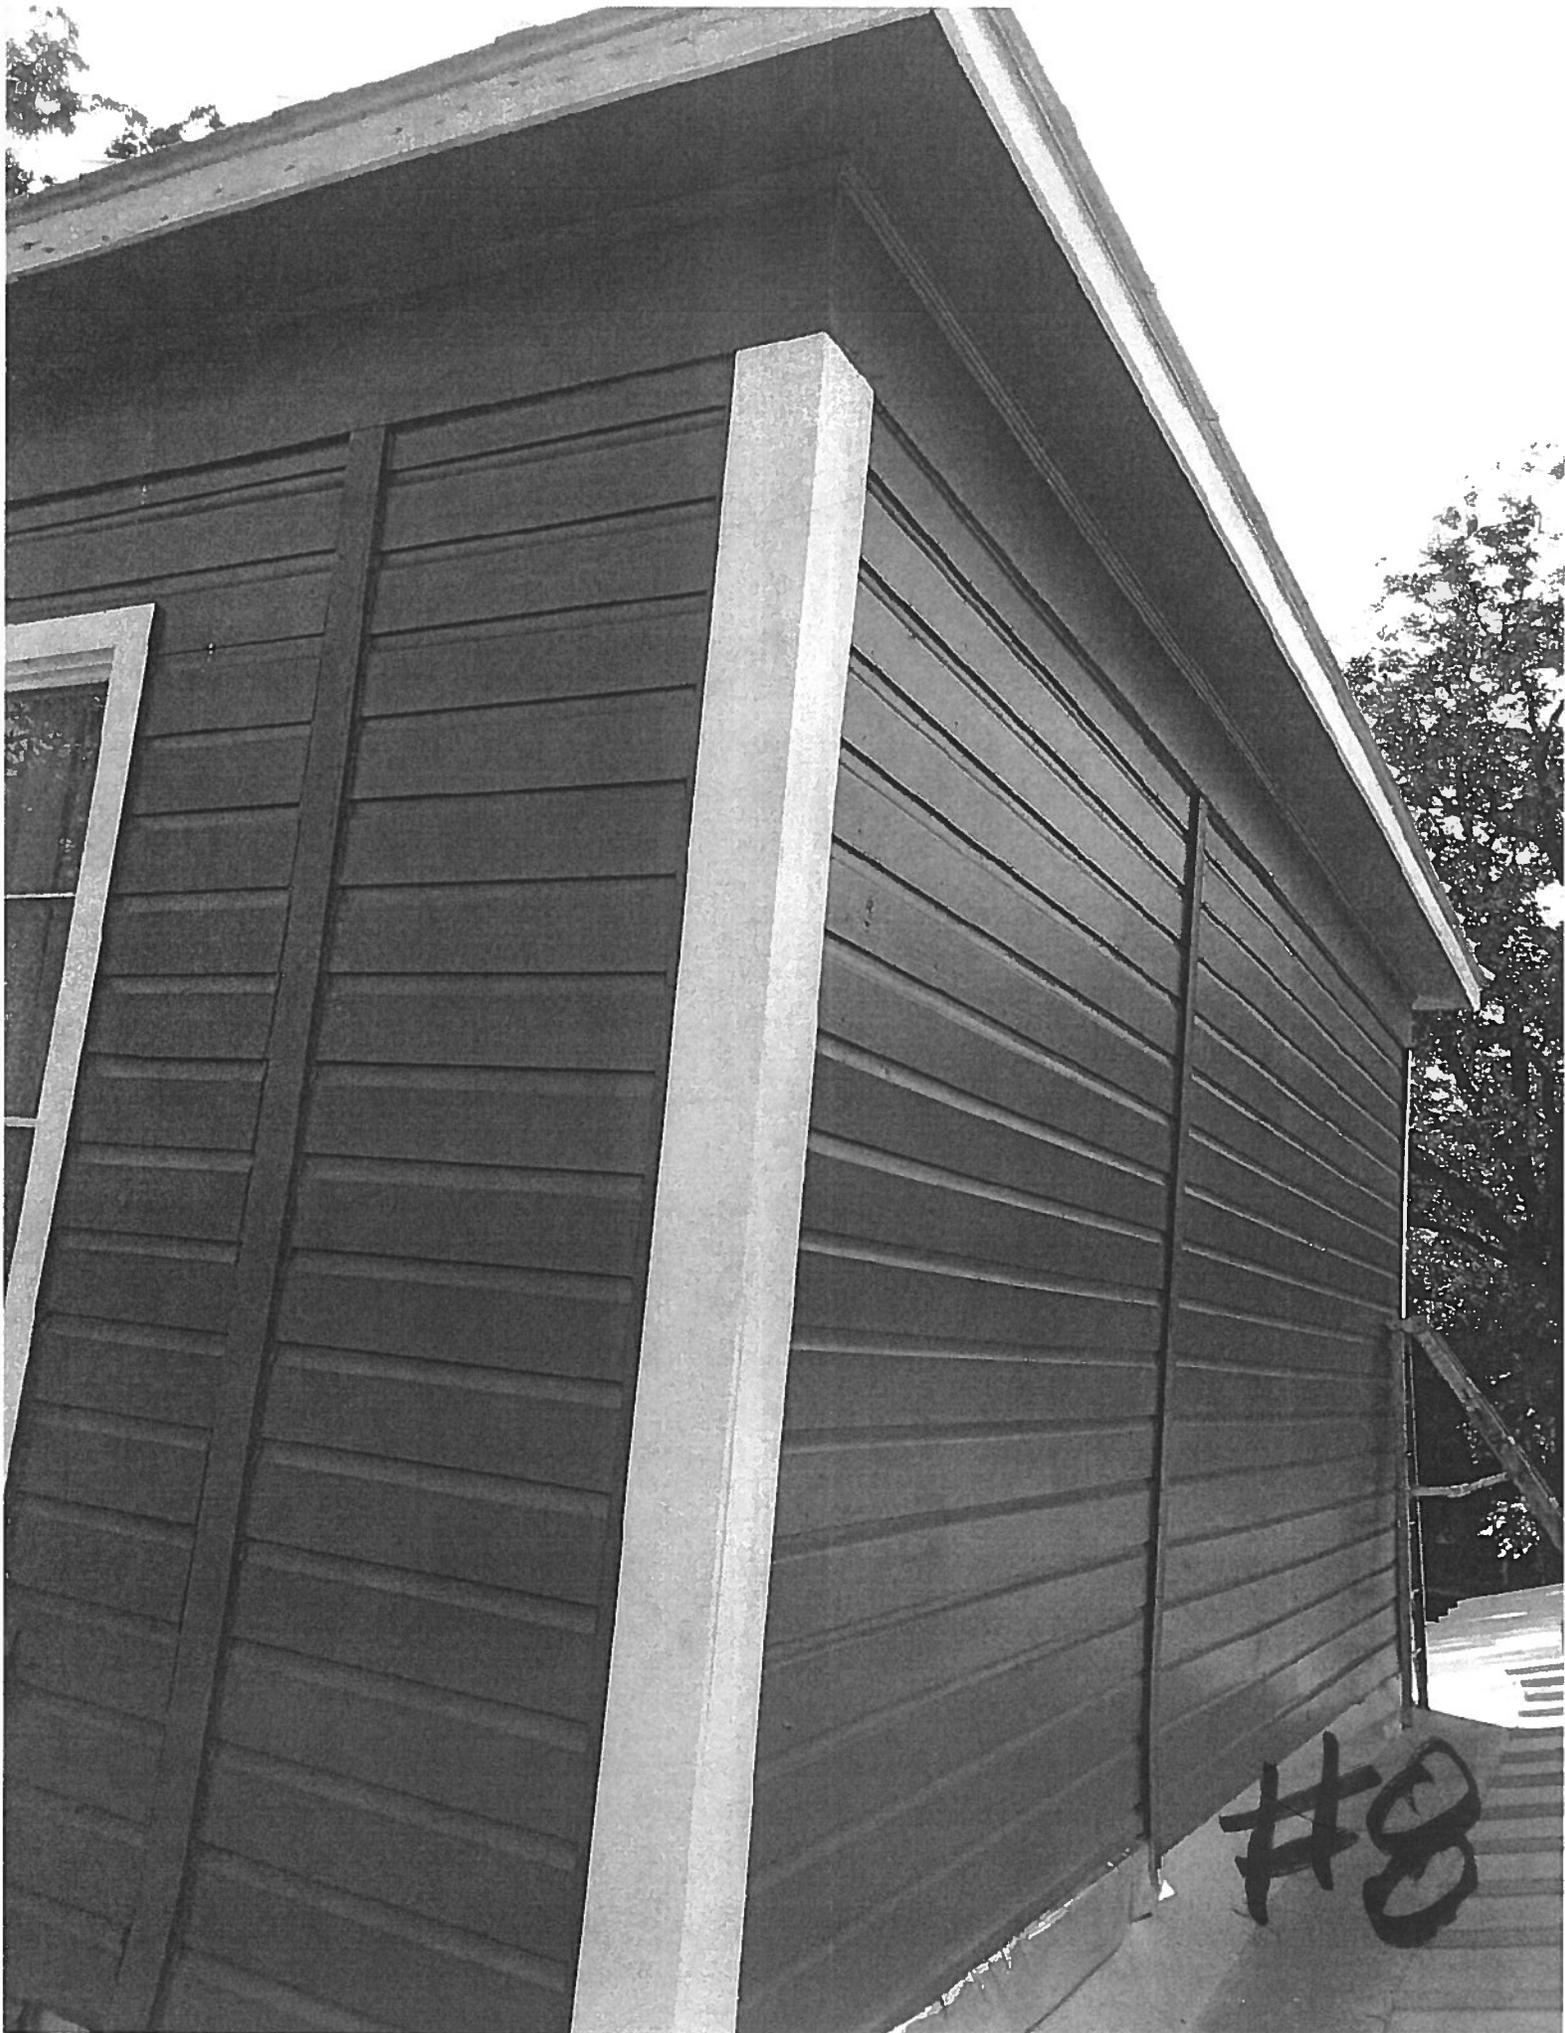
6. The existing porch open area was enclosed, waterproofed and siding was installed to complete the waterproofing of this area of the structure. The siding was lap siding to match the existing home exterior siding. See attached **Photos #7 and 8**.

It is my opinion that the proper solution to the waterproofing problem was achieved by removing the damaged waterproofing around the perimeter of the small second level porch. The enclosure was properly waterproofed and the siding installed was matched to the existing siding in place on the front and side walls of the second level of the home. The area of the porch was made into a closet for the bedroom and meets the requirements of the 2015 International Residential Code. We recommend approval of the enclosure and waterproofing of this small porch.
