HISTORIC AND DESIGN REVIEW COMMISSION

HDRC CASE NO: 2016-097
ADDRESS: 3700 N ST MARYS
ZONING: R6 HS RIO-1
CITY COUNCIL DIST.: 2
LANDMARK: Brackenridge Park
APPLICANT: Stan Albus/Rialto Studio, Inc
OWNER: City of San Antonio Parks and Recreation Department
TYPE OF WORK: Repair and maintenance to park entrance monuments, sculptures and restroom buildings

Re: **Brackenridge Park 2012 Bond Package**

The referenced project is being submitted for **Conceptual Approval** of repair and renovation of specific Park Features: Park Entry Monuments, Dionico Rodriguez Sculptures, and North St. Marys Street Public Restroom Buildings

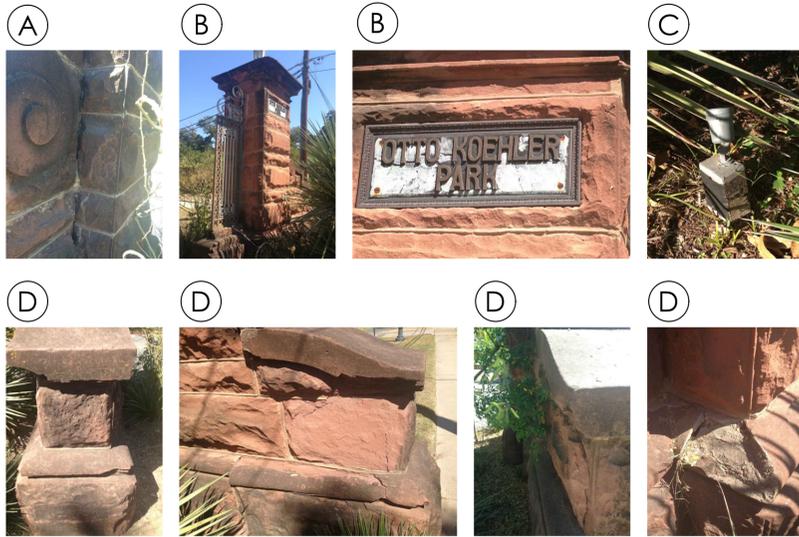
1 ST. MARYS ST. @ ZOO ENTRANCE

Roof and lighting repair are included in the proposed work, as is masonry cleaning and repair, metalwork cleaning and refurbishment, and replacement of landscape with plants common to the period of construction. Specifically, in addition to the above, proposed repair of the red sandstone masonry of the St Marys monuments will be similar to recent work at the Bexar County Courthouse. Masonry repair of the Tuleta and Avenue B limestone monuments will involve straightening and shoring of the walls, bridging of vertical separations, and replacement of damaged or missing stone components. Past repair in the form of surface plastering of the limestone at the Avenue B location is believed to have contributed to the extensive spalling evident there. Mildew and lichen growth on all monuments is believed to be trapping moisture which aids weathering. Incorrect masonry technique is also believed to be contributing to weathering. In some cases, the lay of stone components is vertical, exposing the grain of the material to rain and moisture ingress.

GENERAL RESTORATION NEEDED:

- (A) GROUT REPOINTING
- (B) METAL WORK REFINISH
- (C) LIGHTING REPAIR / REPLACE
- (D) STONE REPAIR / REPLACE

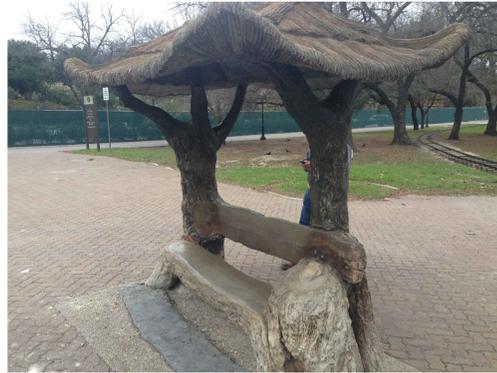
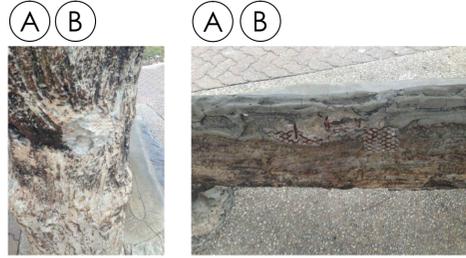
1 PALAPA BENCH

Constructed in the faux bois style after the artist came to San Antonio in 1920, Brackenridge Park contains four of Mr. Rodriguez's pieces, most notably the Upper Labor Acequia Bridge near Hildebrand Avenue. Other pieces include the Palapa Bench at the Zoo entrance, the Palapa Table and Benches (considered a single piece) in the Koehler Park Section, and the Hollow Tree Bench in the Wilderness Section of Brackenridge Park. All sculptures have been repaired to some degree in the past and all show signs of continued weather-related damage to construction material and aging of the original finish.

GENERAL RESTORATION NEEDED:

- (A) COSMETIC REPAIRS
- (B) VENEER FINISH REFRESHING

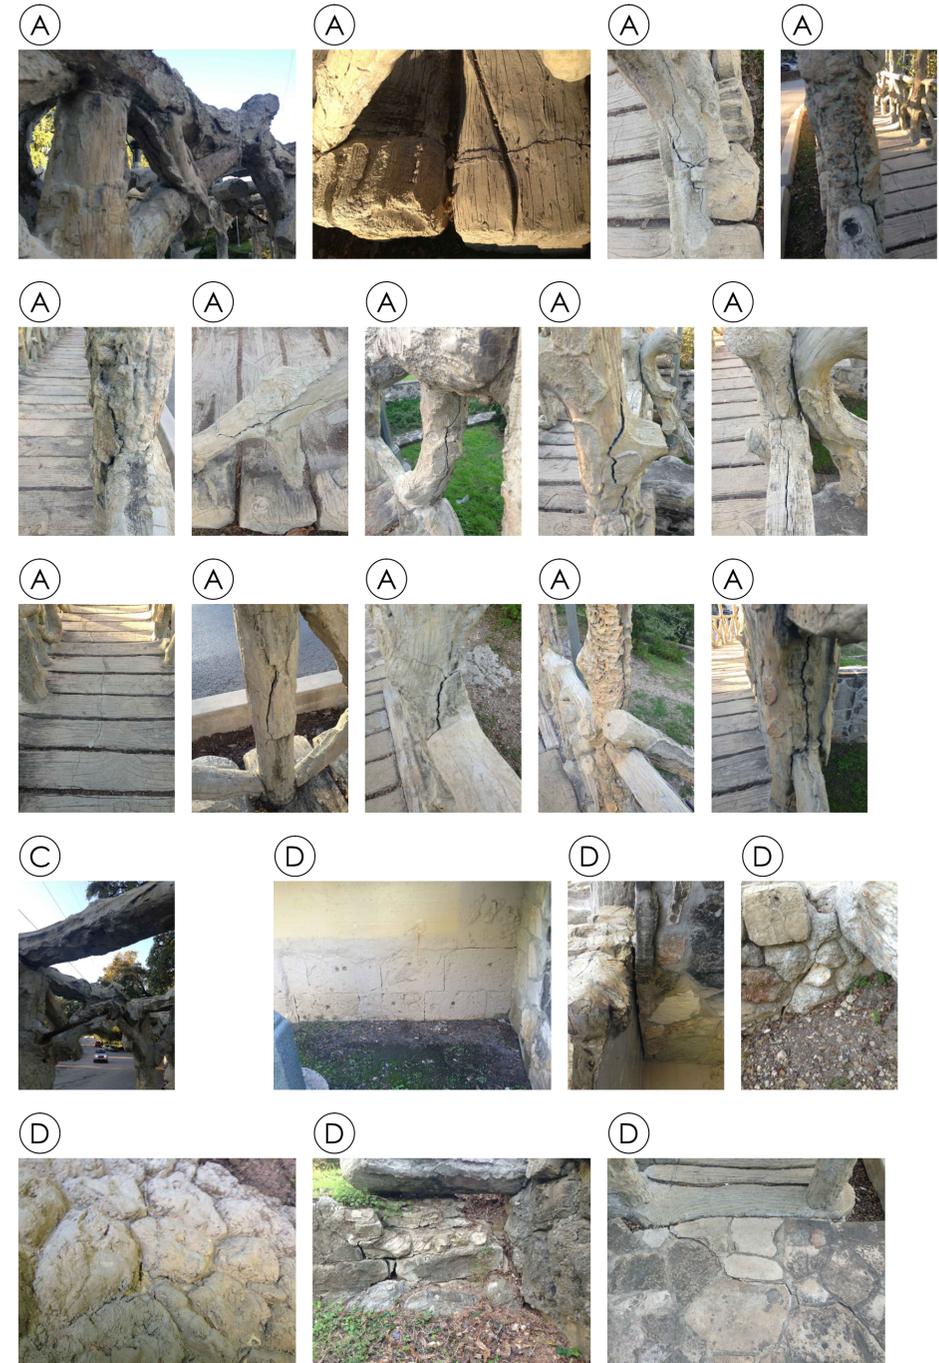
4 BRIDGE

The Bridge, considered the best example of its kind in San Antonio and previously repaired in the 1960's and again in 2003, suffers extensively from splitting and cracking as moisture intrusion swells the masonry and rusts the internal steel reinforcement. Past work in the 60's in the form of cement build-up and finish repair of sculpture components and structural straightening and repair in 2003 have proven successful in halting degradation of those components. The Bridge appears structurally sound at present and similar repair of cracking and finish is proposed. The Bench Table and Hollow Tree exhibit to a lesser degree similar cracking and loss of original masonry and proposed repairs will be in line with Bridge repair. Previous repair of the Palapa Table was not consistent in the faux bois style and will be removed or overlaid and refinished. Components of all pieces appear to be intact except for one limb section of the bridge where only the steel remains.

GENERAL RESTORATION NEEDED:

- (A) COSMETIC REPAIRS
- (B) VENEER FINISH REFRESHING
- (C) MINOR STRUCTURAL REPAIRS
- (D) MAJOR STRUCTURAL REPAIRS

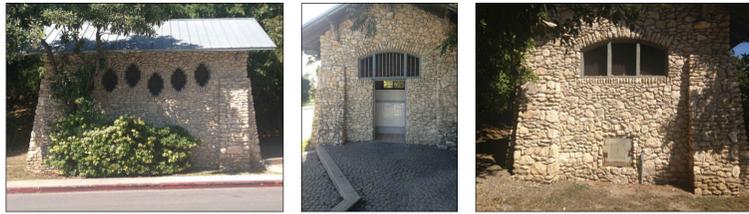
1 EXISTING EXTERIOR ELEVATIONS

Believed to be structurally sound both buildings are in need of repair, both exhibit material and design aspects which do not comply with Texas Accessibility Standards, and both buildings bear evidence of past remodel of both interior and exterior. Proposed work includes interior renovation in compliance with accessibility standards, roof and fixtures replacement, and minor cosmetic upgrades to identify with other structures in the park.

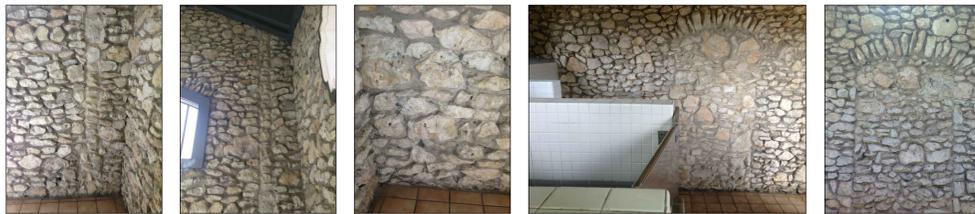
3 EVIDENCE OF PAST REMODEL

As clay tile is believed to be the original roofing, this will be the material of choice, subject to an engineering study of the supporting structure and budgetary allowance. Stone masonry of both interior and exterior bears evidence of past usage patterns that differs from the present. Proposed floor plans will enable compliance with 2012 Texas Accessibility Standards without loss of the current fixture inventory and without altering the exterior facade. Surface approach upgrades to both buildings are similarly necessary to conform to TAS. Landscape upgrades will include plants common to the period of construction.

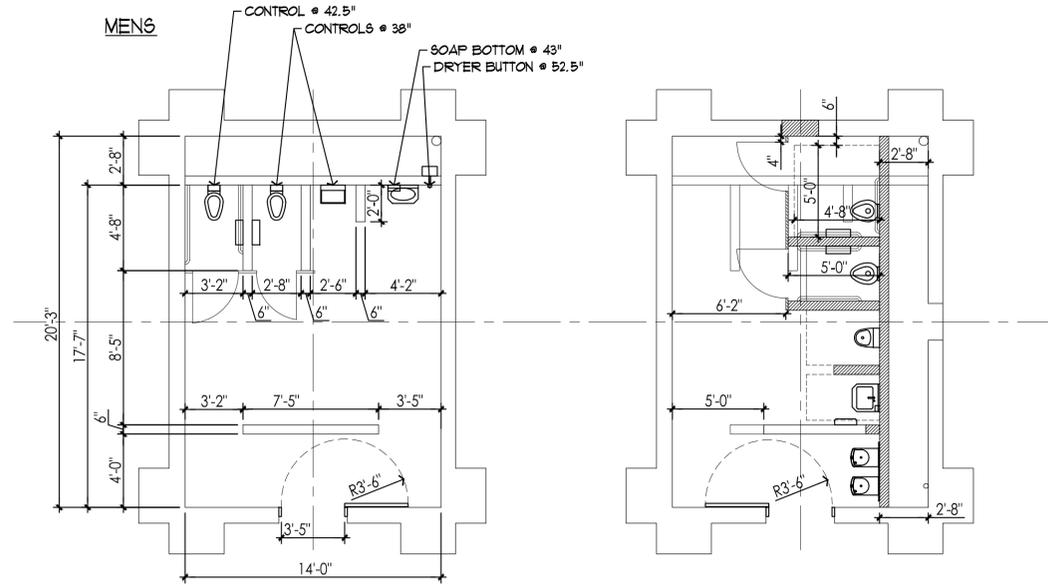
- EXISTING CONDITION:
- WATER CLOSET AND URINAL SPACES ARE NOT COMPLIANT
 - HEIGHTS OF CONTROLS ARE NOT COMPLIANT
 - SINK IS NOT COMPLIANT
 - OTHER ACCESSORIES NOT COMPLIANT
 - EXIT LANDING MAY NOT BE COMPLIANT

- OPTION 3:
- GUT COMPLETE INTERIOR, CLOSE CHASE ACCESS
 - CREATE NEW PLUMBING CHASE WITH IMPROVED ACCESS
 - MODIFY ENTRANCE
 - INSTALL NEW FIXTURES THROUGHOUT
 - ADDRESS PAYING ISSUES
 - ALLOWS SPACE FOR DRINKING FOUNTAIN

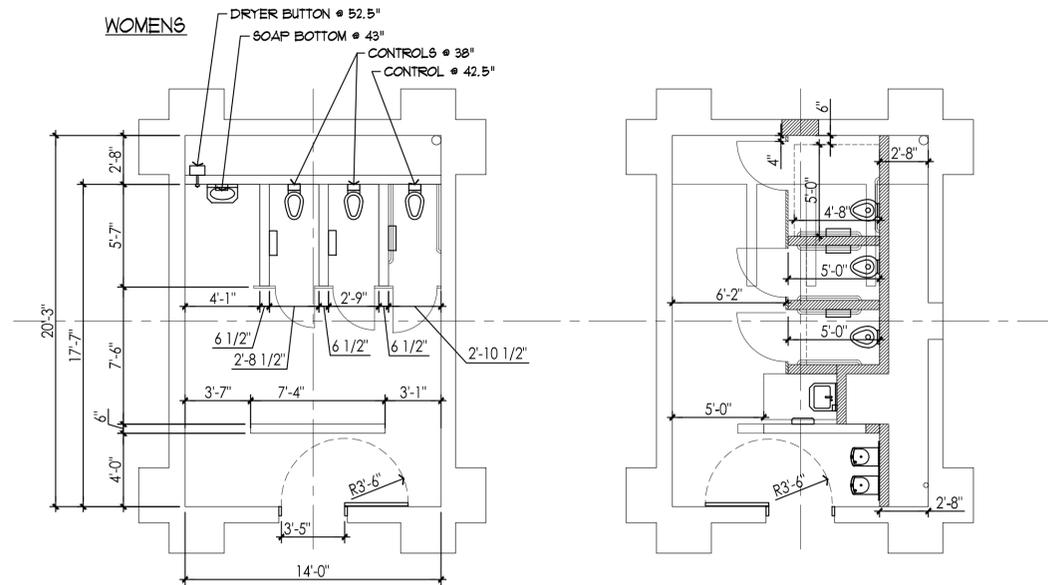
- EXISTING CONDITION:
- WATER CLOSET SPACES ARE NOT COMPLIANT
 - HEIGHTS OF CONTROLS ARE NOT COMPLIANT
 - SINK IS NOT COMPLIANT
 - OTHER ACCESSORIES NOT COMPLIANT

- OPTION 3:
- SIMILAR TO MEN'S
