Re: Variance Request to UDC Section §35-523(h) for a 1.785-Acre Tract of Land Located at Schaeffeld Road and Loop 1604 (the "Subject Property;" *see Exhibit "1"*); *Our File No. 9844.002/ COSA AP No. PM2235762*

Tree Assessment – Shaenfield Road at Loop 1604

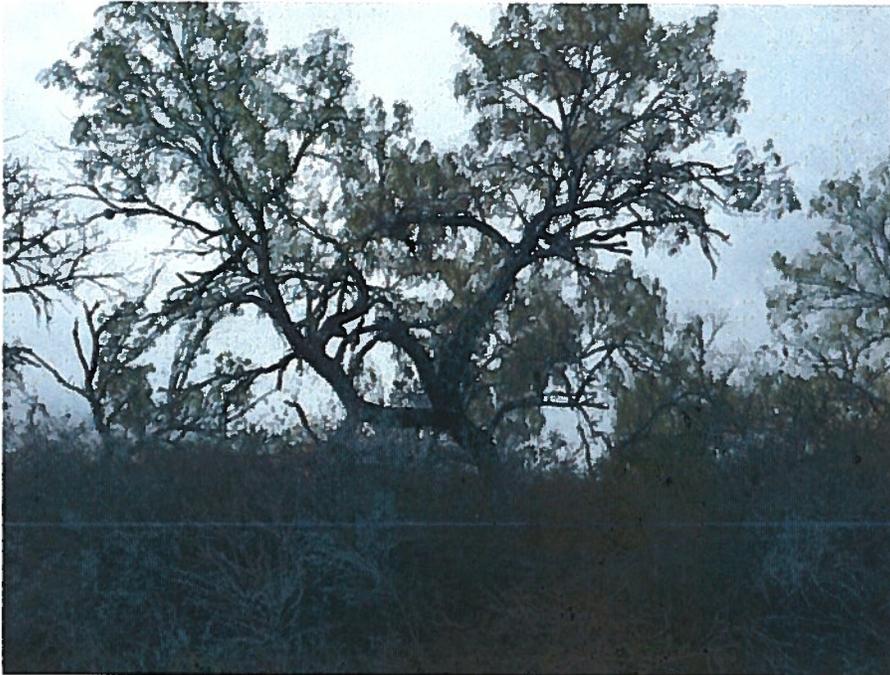
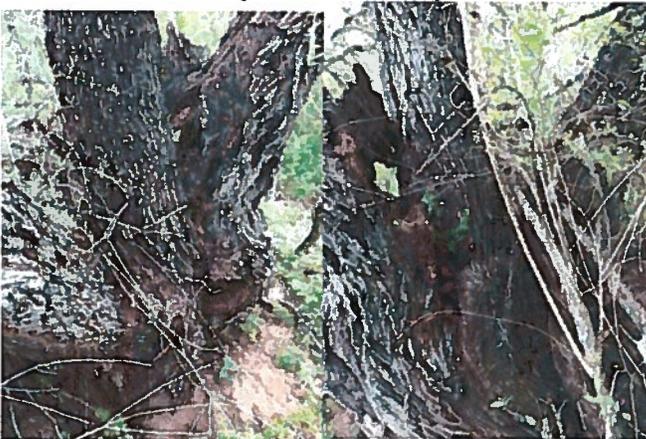
Tree #105 Trunk (front and back)

Tree #105

One live trunk	13"	13"
One ½ live trunk	12"/2	6"
Two dead trunks	0"	0"
Total Caliper		19"

I would request that this tree be deemed diseased and damaged based on the condition of the main trunk (see photo below).

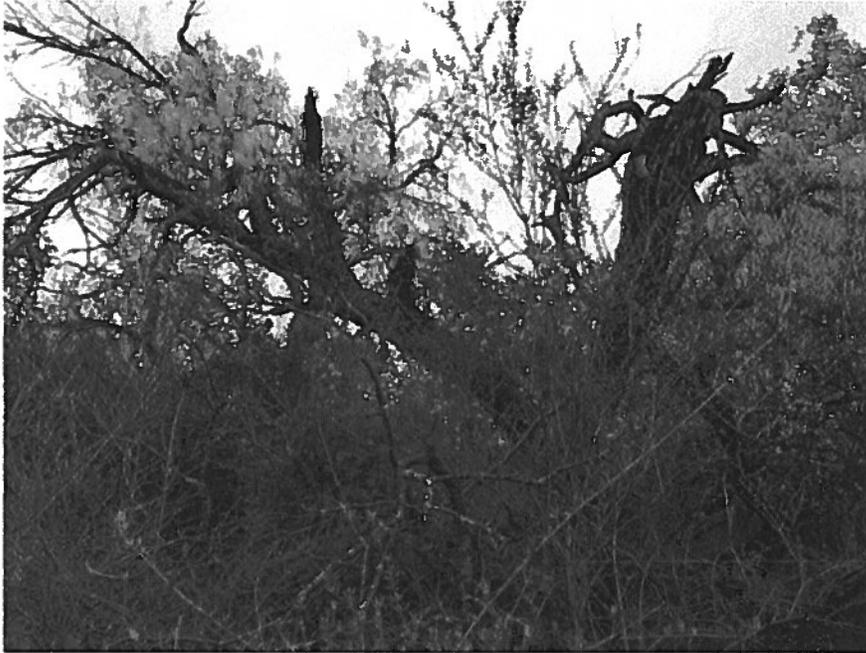
Tree #103

One live trunk	17"	17"
One dead trunk	0"	0"
Total Caliper		17"

I would request that this tree be deemed diseased and damaged based on the condition of the main trunk (see photo below).
