## HISTORIC AND DESIGN REVIEW COMMISSION

**HDRC CASE NO:** 2021-213  
**ADDRESS:** 222 BEAUREGARD  
**LEGAL DESCRIPTION:** NCB 743 BLK 2 LOT 1 MASTERFILE & COMMON ELEMENT -MADISON CONDOMINIUMS  
**ZONING:** RM-4, H  
**CITY COUNCIL DIST.:** 1  
**DISTRICT:** King William Historic District  
**APPLICANT:** Lyndsay Thorn/Thorn Architects, PLLC  
**OWNER:** Sean Moore (Wife: Blythe Evans)/MADISON CONDOMINIUM OWNERS ASSOCIATION INC  
**TYPE OF WORK:** Window sash replacement  
**APPLICATION RECEIVED:** April 23, 2021  
**60-DAY REVIEW:** Not applicable due to City Council Emergency Orders  
**CASE MANAGER:** Huy Pham  
**REQUEST:**

The applicant is requesting a Certificate of Appropriateness for approval to replace non-original window windows with new aluminum-clad wood windows matching historic specifications (Pella Reserve Traditional Series)

MOORE-EVANS RESIDENCE, UNIT 2  
222 Beauregard San Antonio Texas 78209

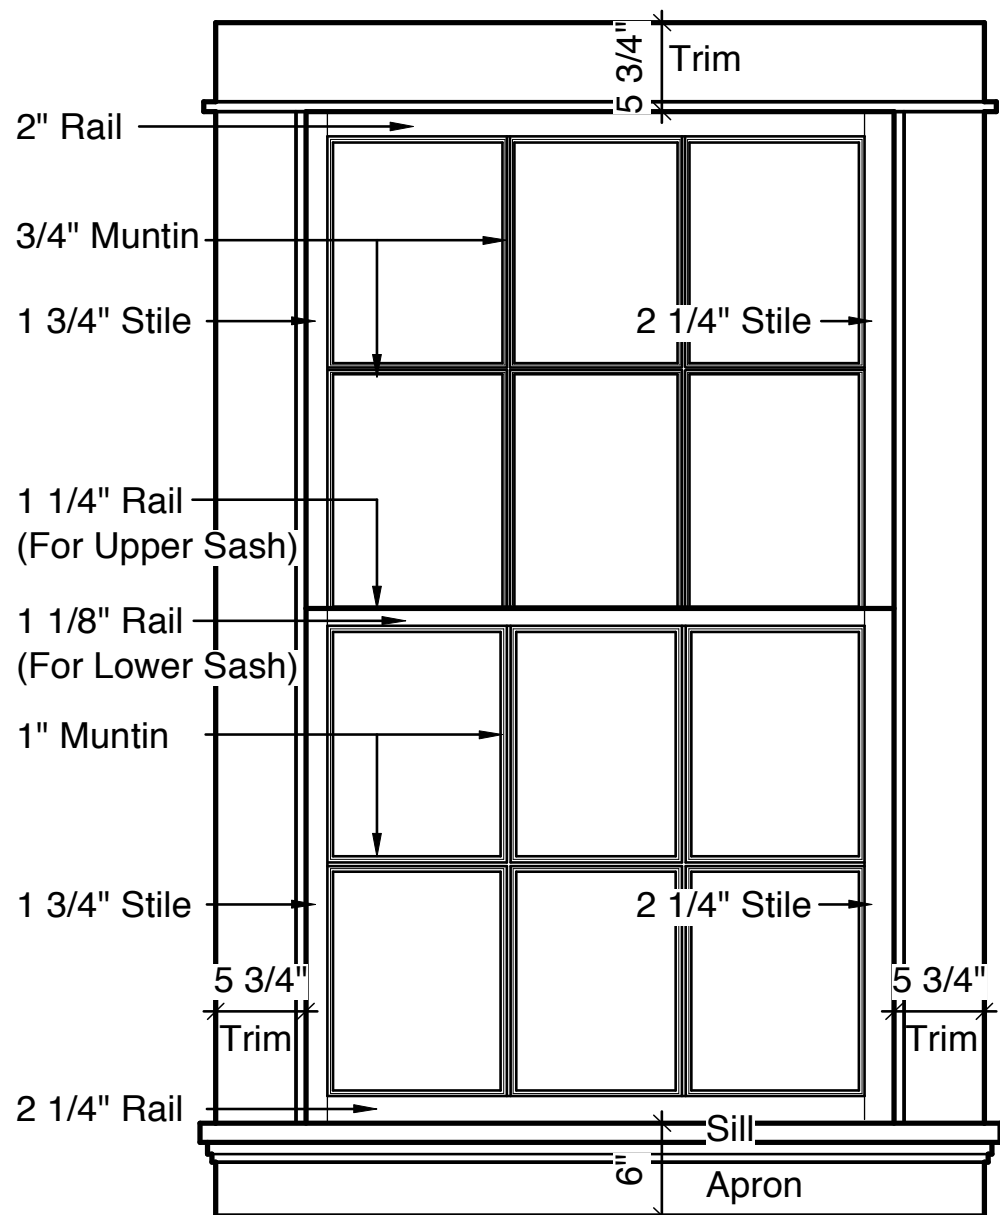
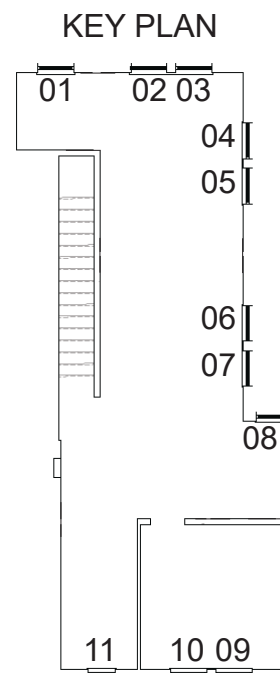
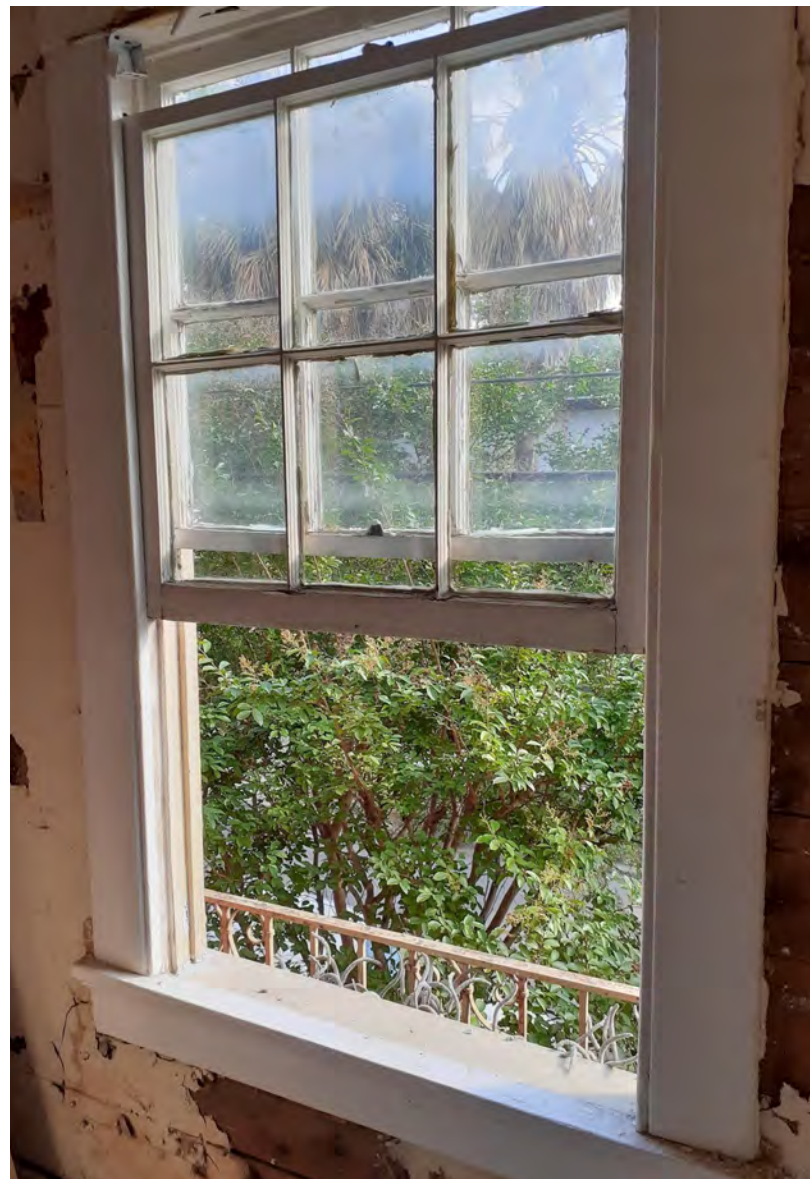
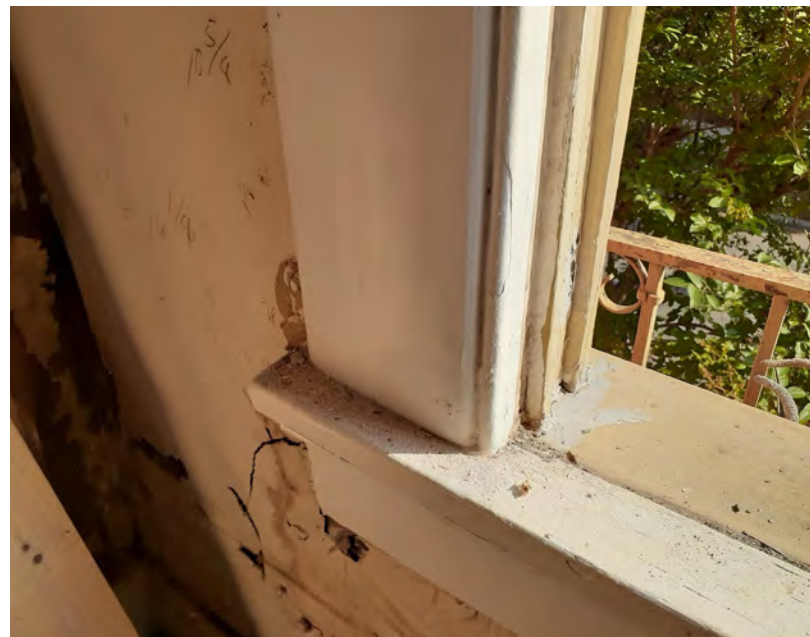
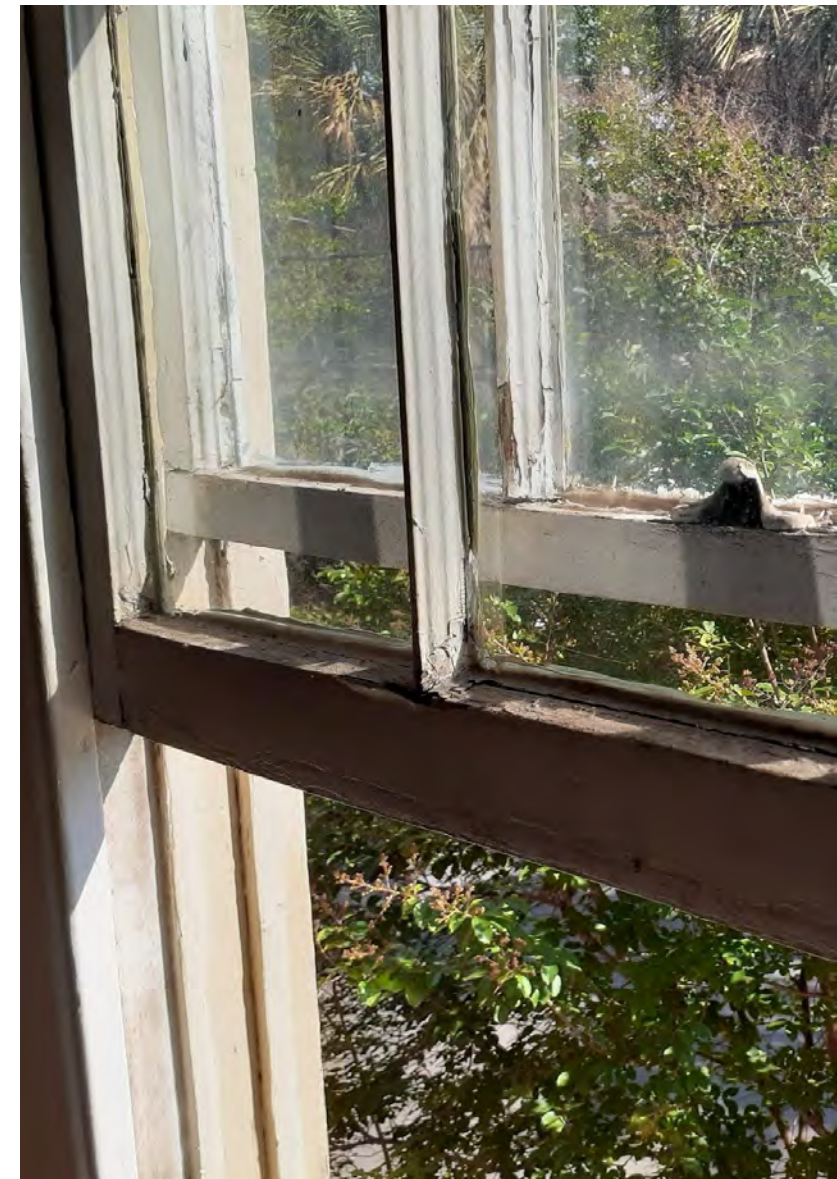
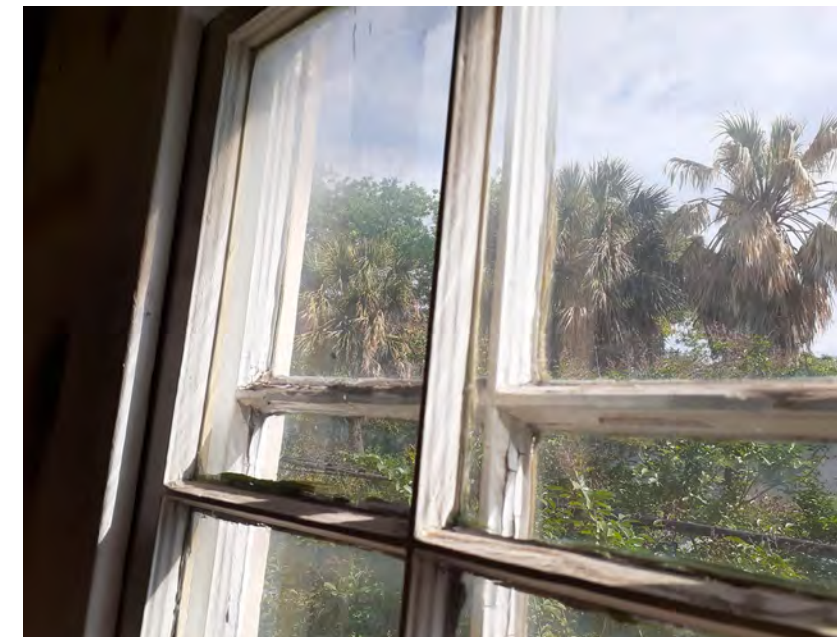
## 01 | FRONT CLOSET WINDOW

Notes: This does not appear to be a full "Original Window"

This window has had individual parts replaced over the years as can be

dimensions; as well as whole Sashes have been replaced. Note, upper Sash has 3/4" Muntins and lower Sash has 1" Muntins.

over water damaged wood, typical.

been measured and observed within this window.

Window glass appears to be a standard glass, not milk,

Rehabilitation of the existing window sashes only, does not address the condition of the window frame or preventative measures for future water

Window Trim+Sill to be preserved were possible and

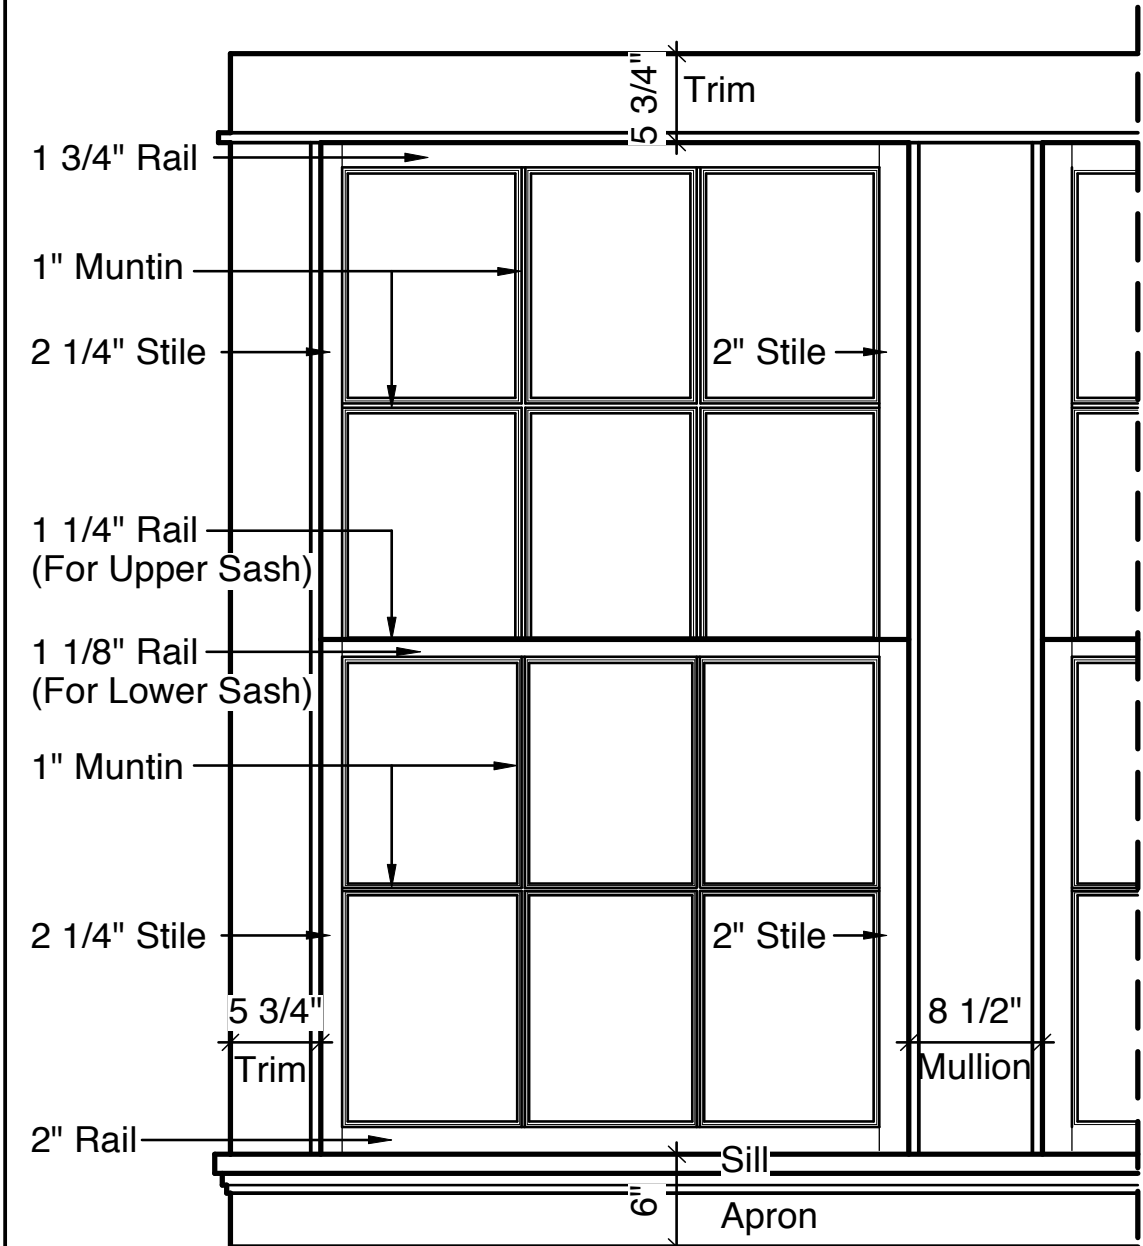
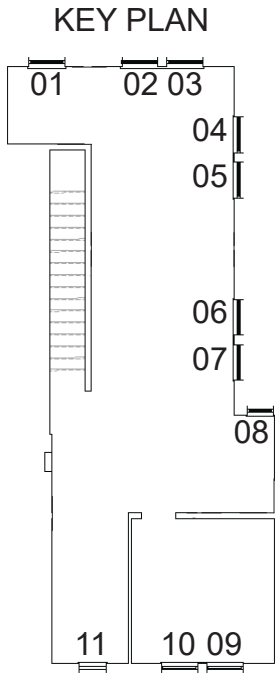
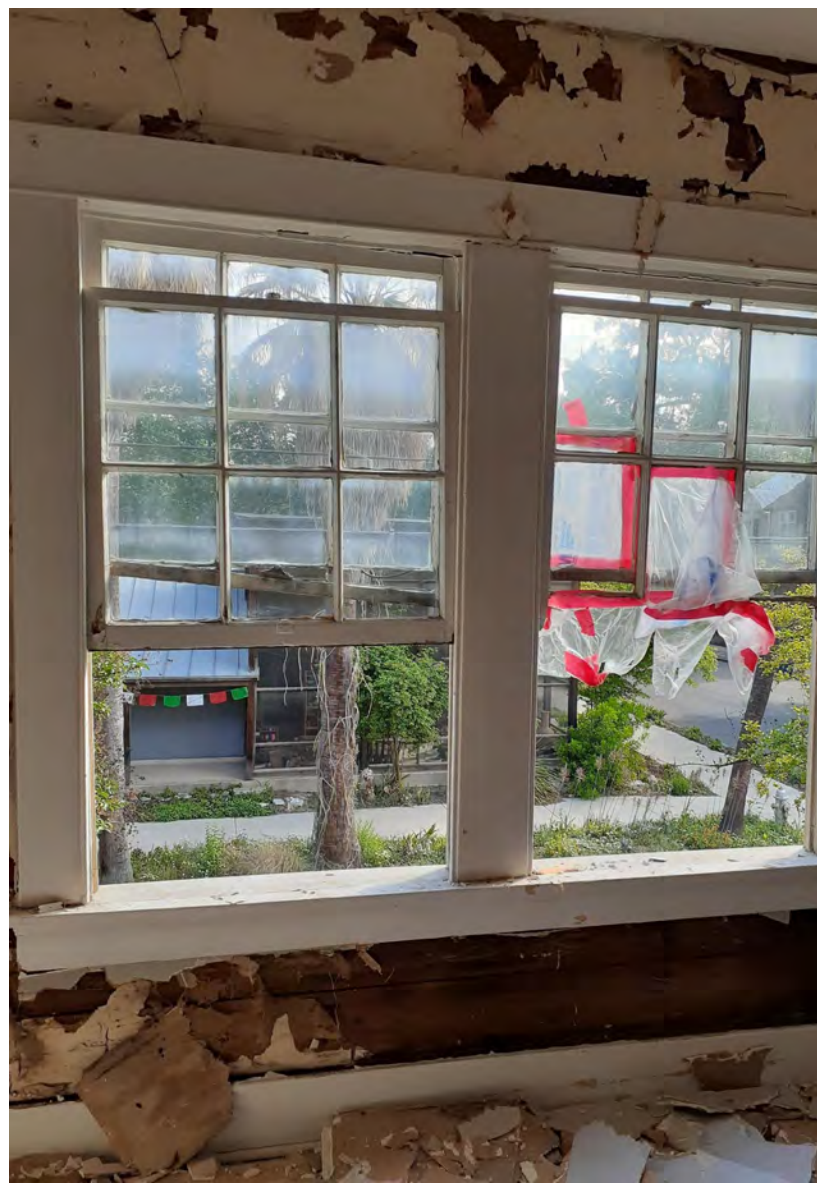
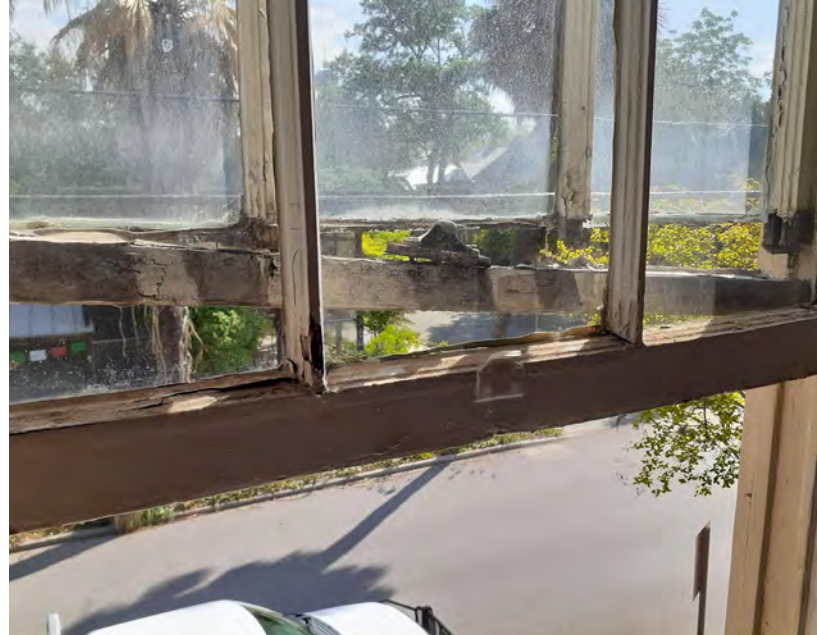
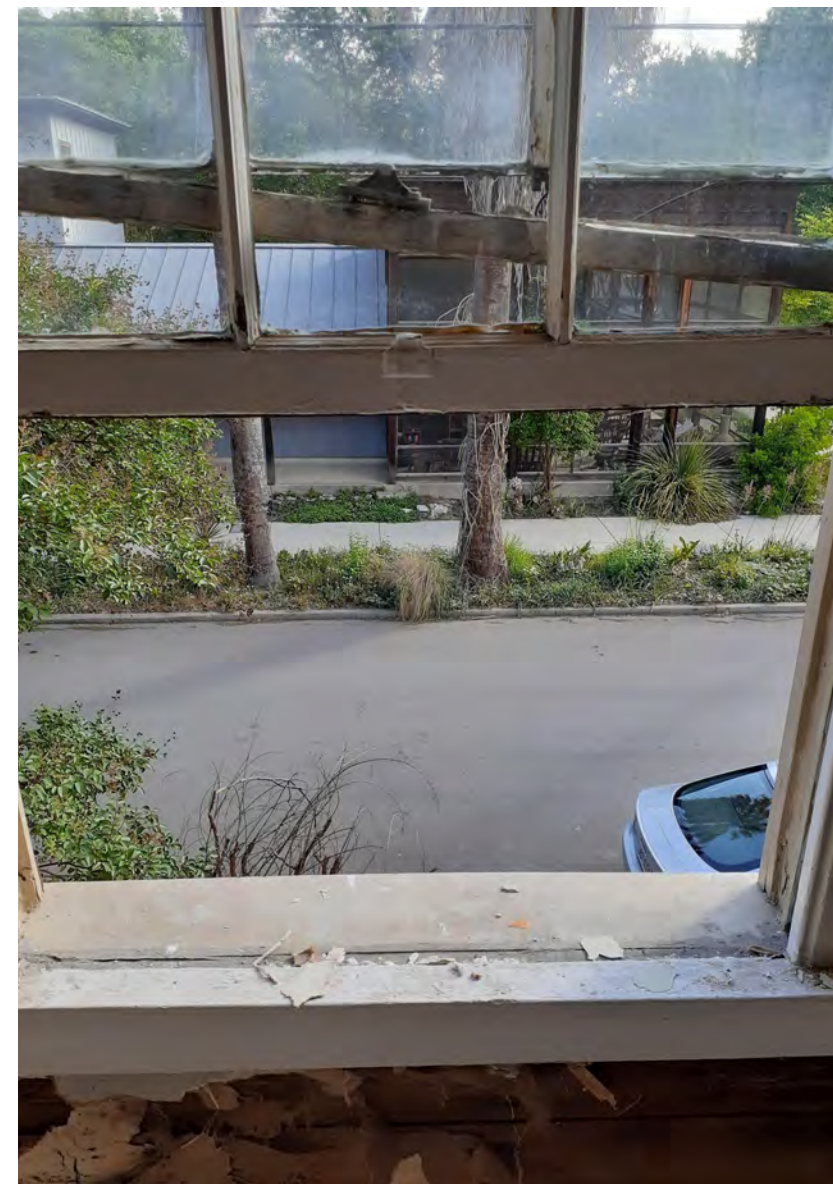
02 | LIVING ROOM WINDOW  
Facing Beauregard

Notes: This does not appear to be a full “Original Window”

This window has had individual parts replaced over the years as can be dimensions; as well as whole Sashes have been replaced. Note, upper Sash has 3/4” Muntins and lower Sash has 1” Muntins.

Overall Window 2: Multiple layers of paint and caulk over water damaged wood, typical.

Window glass appears to be a standard glass, not milk,

Rehabilitation of the existing window sashes only, does not address the condition of the window frame or preventative measures for future water

Window Trim+Sill to be preserved were possible and

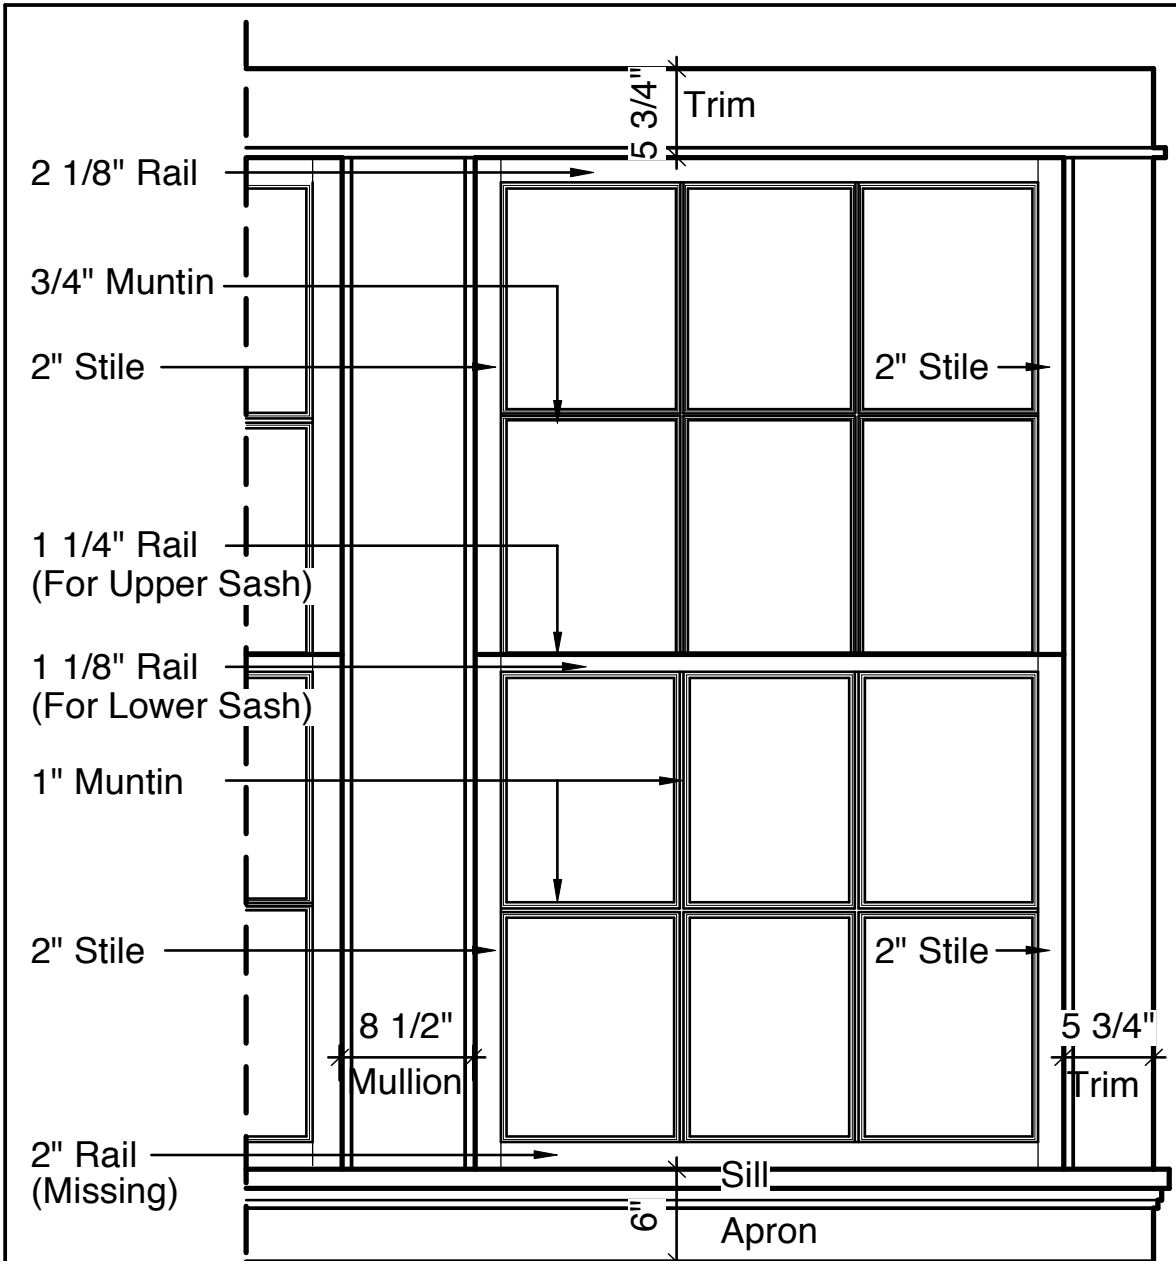
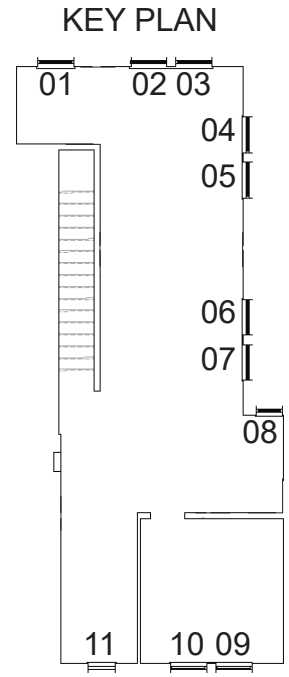
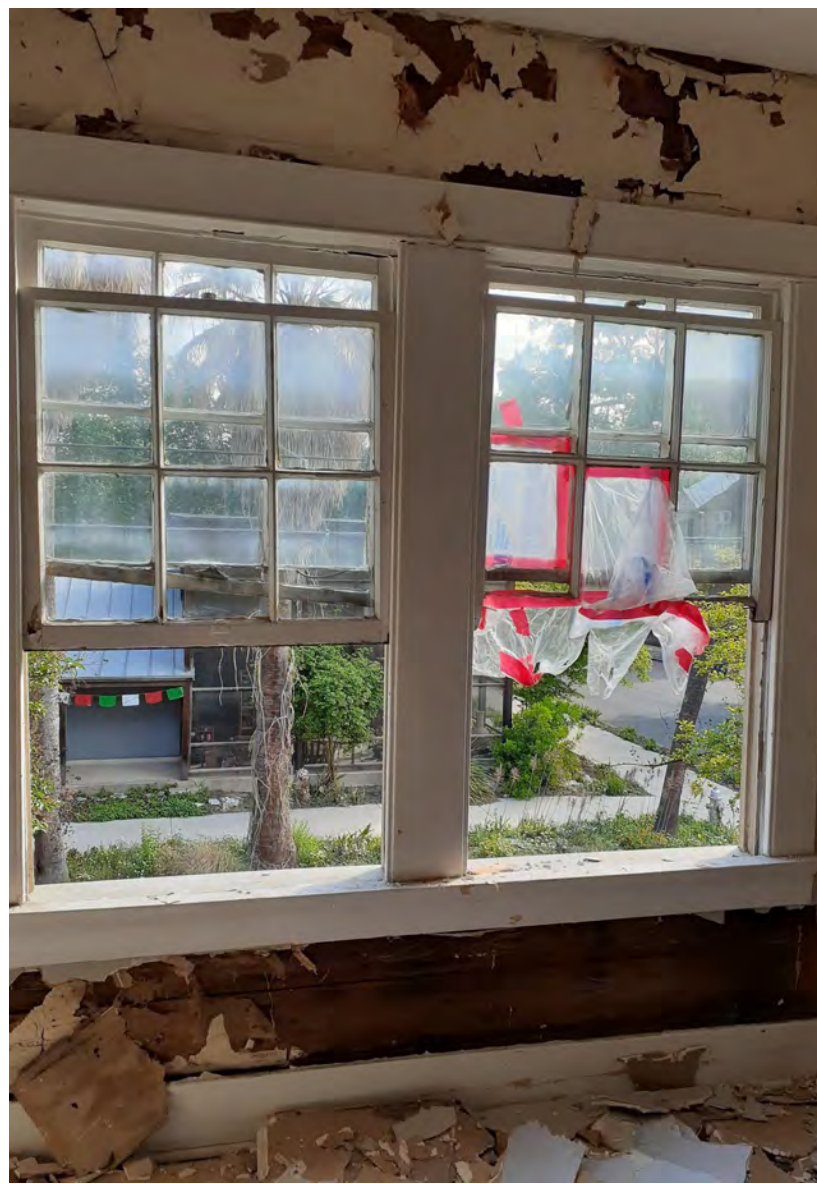
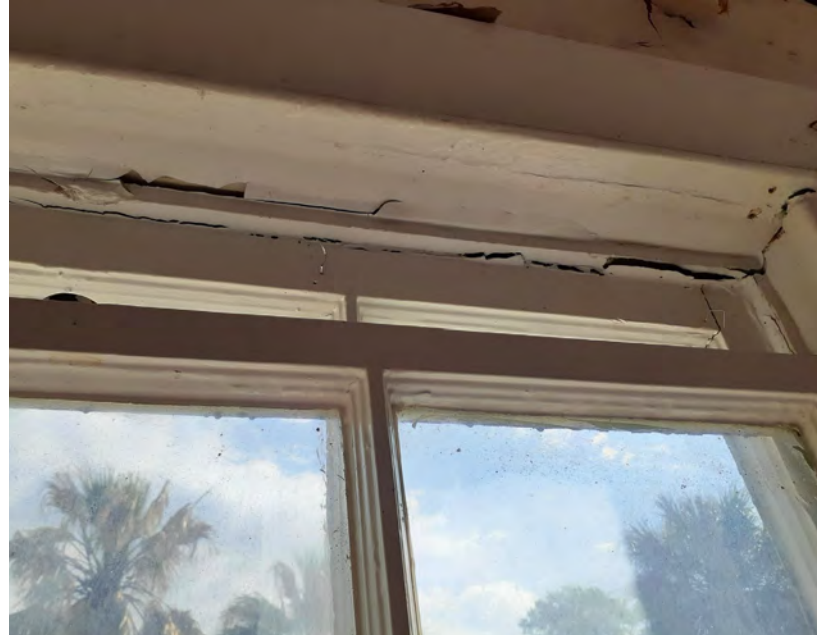
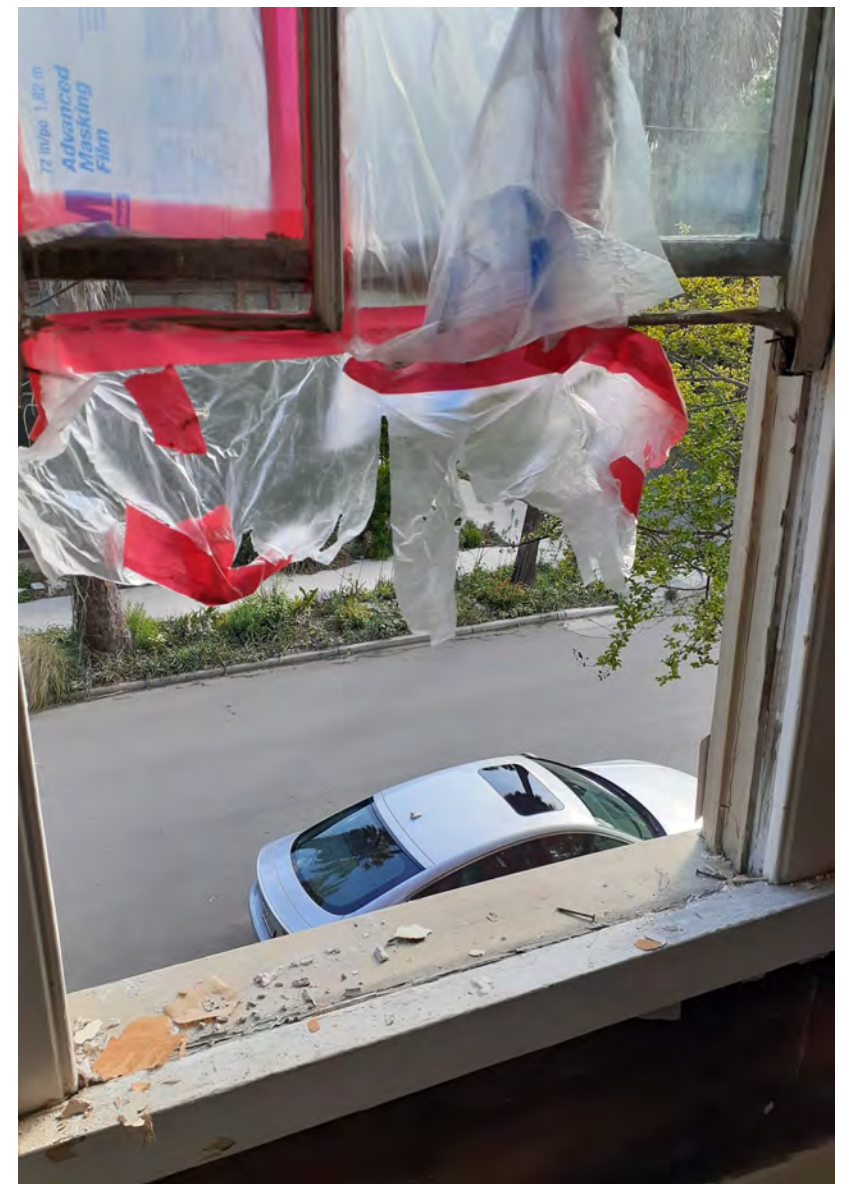
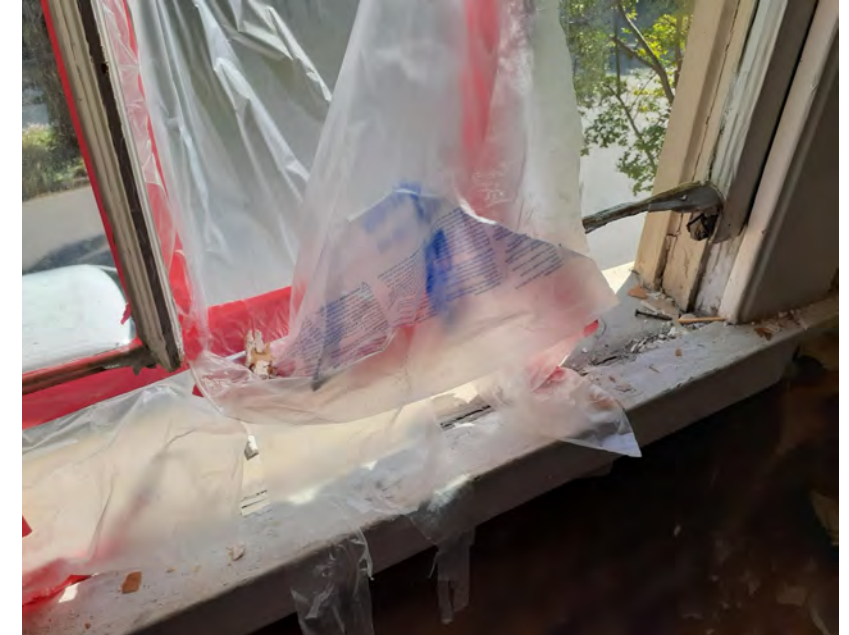
03 | LIVING ROOM WINDOW  
Facing Beauregard

Notes: This does not appear to be a full "Original Window"

This window has had individual parts replaced over the years as can be dimensions; as well as whole Sashes have been replaced. Note, upper Sash has 3/4" Muntins and lower Sash has 1" Muntins.

Overall Window 3: Multiple layers of paint and caulk over water damaged wood, typical.

lower Sash Rail and damage to side Stiles and Muntin.

Rehabilitation of the existing window sashes only, does not address the condition of the window frame or preventative measures for future water

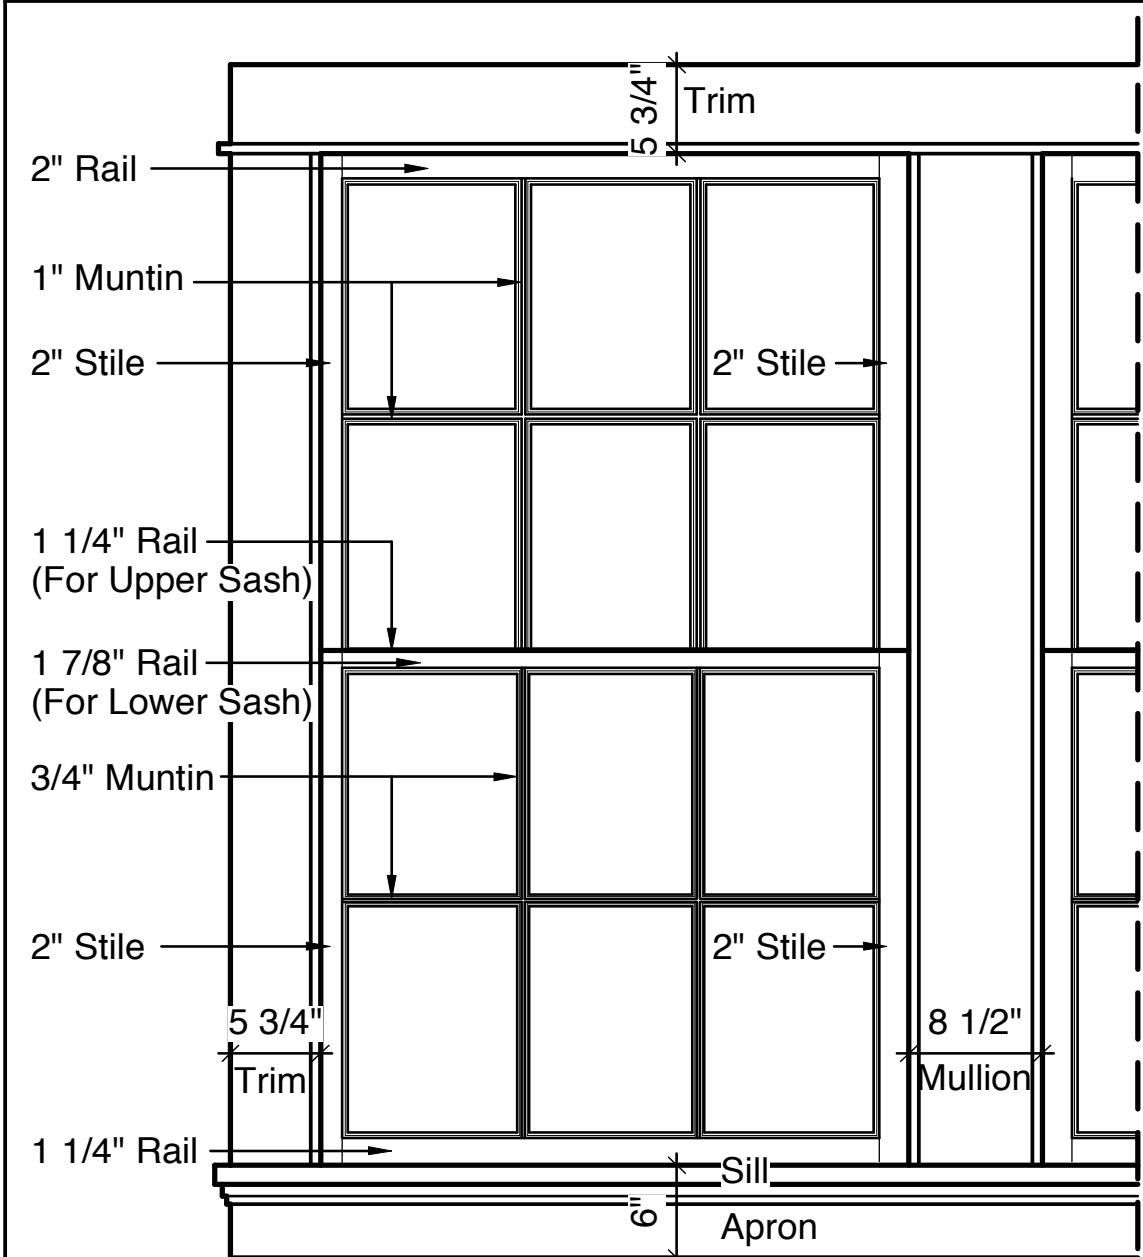
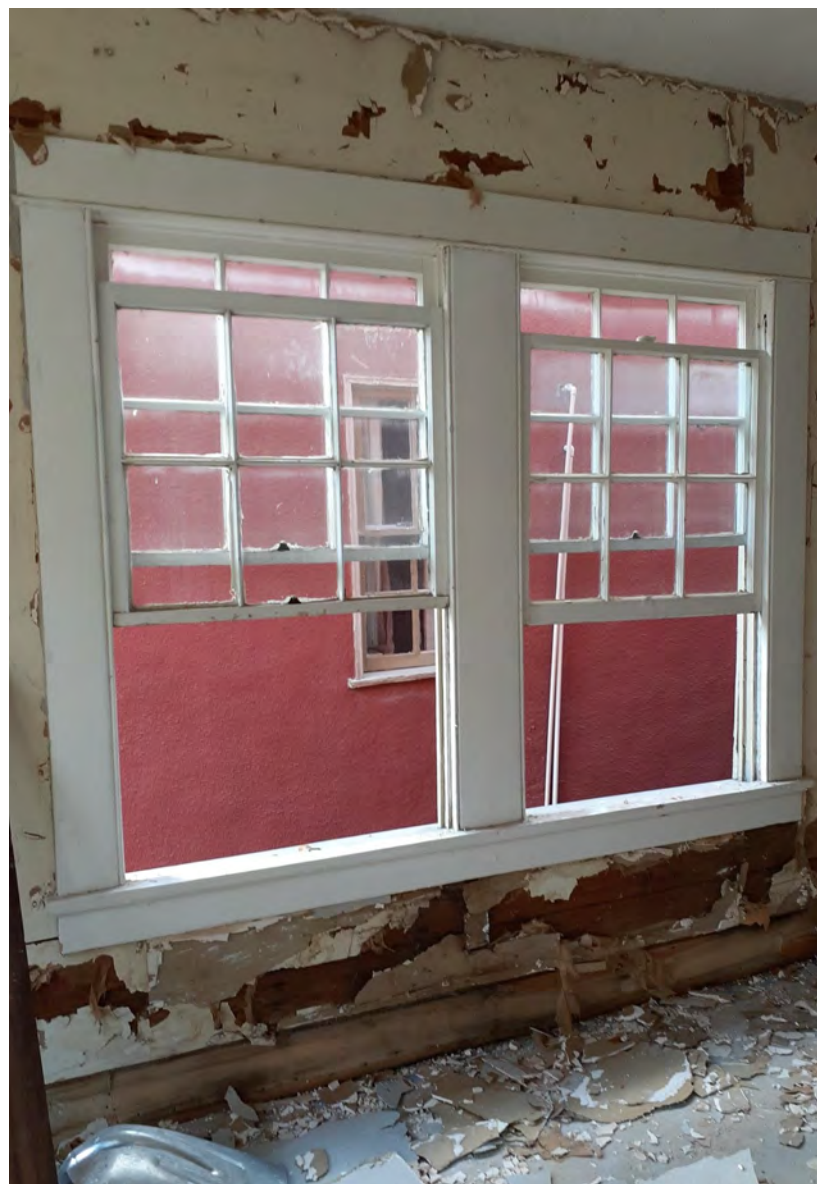
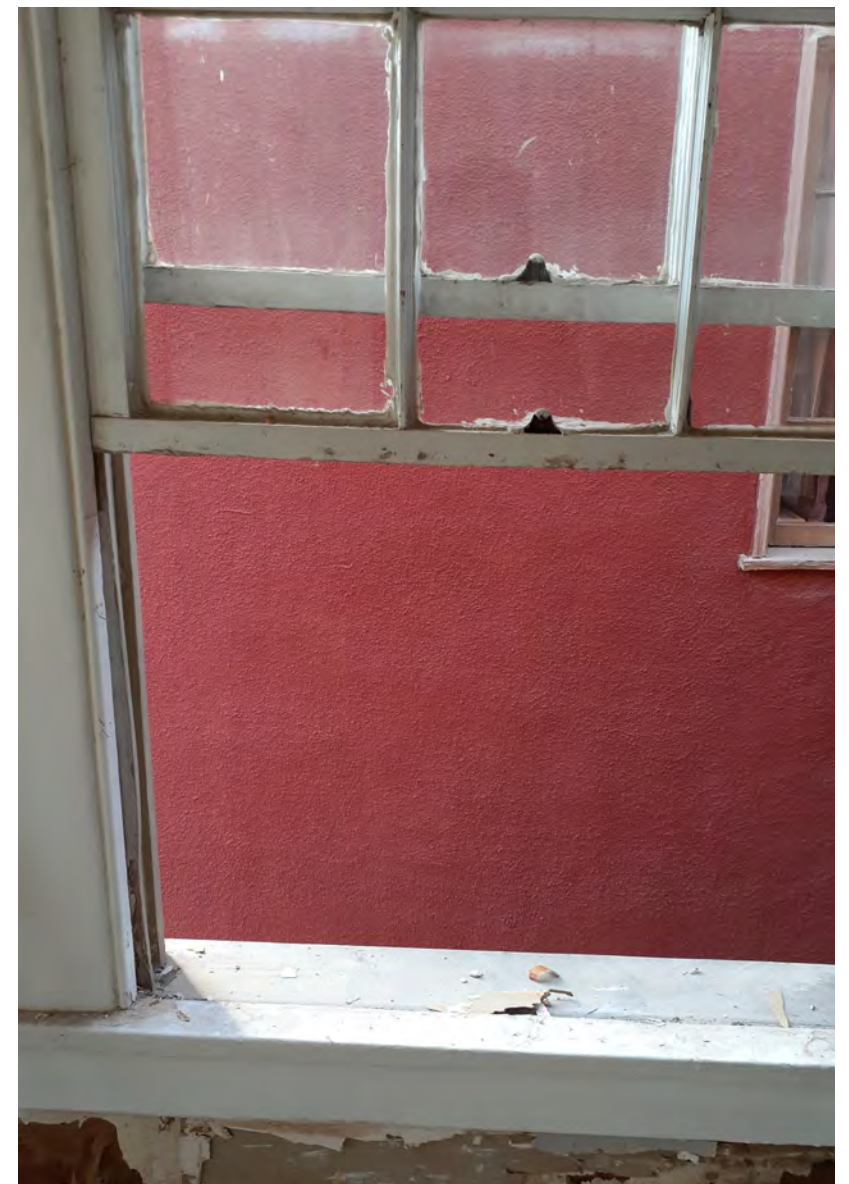
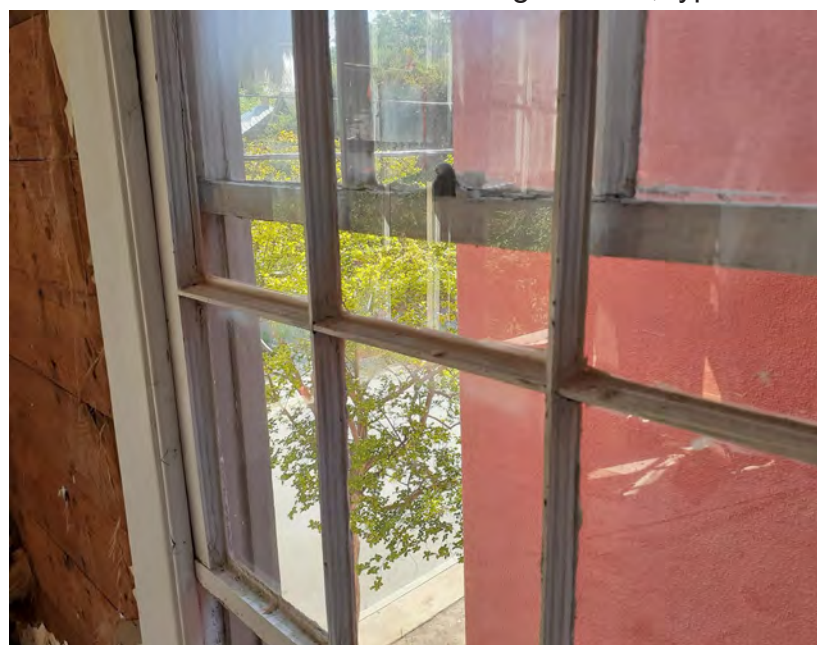
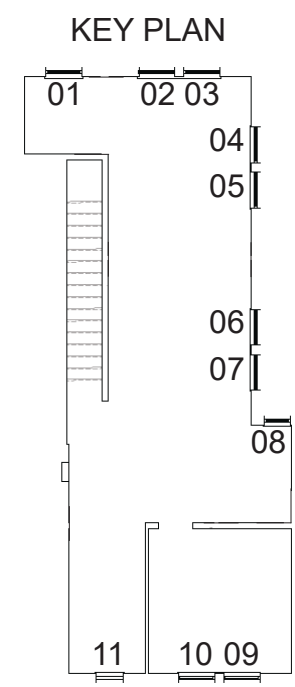
04 | LIVING ROOM WINDOW  
Facing Courtyard

over water damaged wood, typical.

been measured and observed within this window.

Window glass appears to be a standard glass, not milk,

Notes: This does not appear to be a full "Original Window"

This window has had individual parts replaced over the years as can be dimensions; as well as whole Sashes have been replaced. Note, upper Sash has 3/4" Muntins and lower Sash has 1" Muntins.

Window Trim+Sill to be preserved were possible and

Rehabilitation of the existing window sashes only, does not address the condition of the window frame or preventative measures for future water

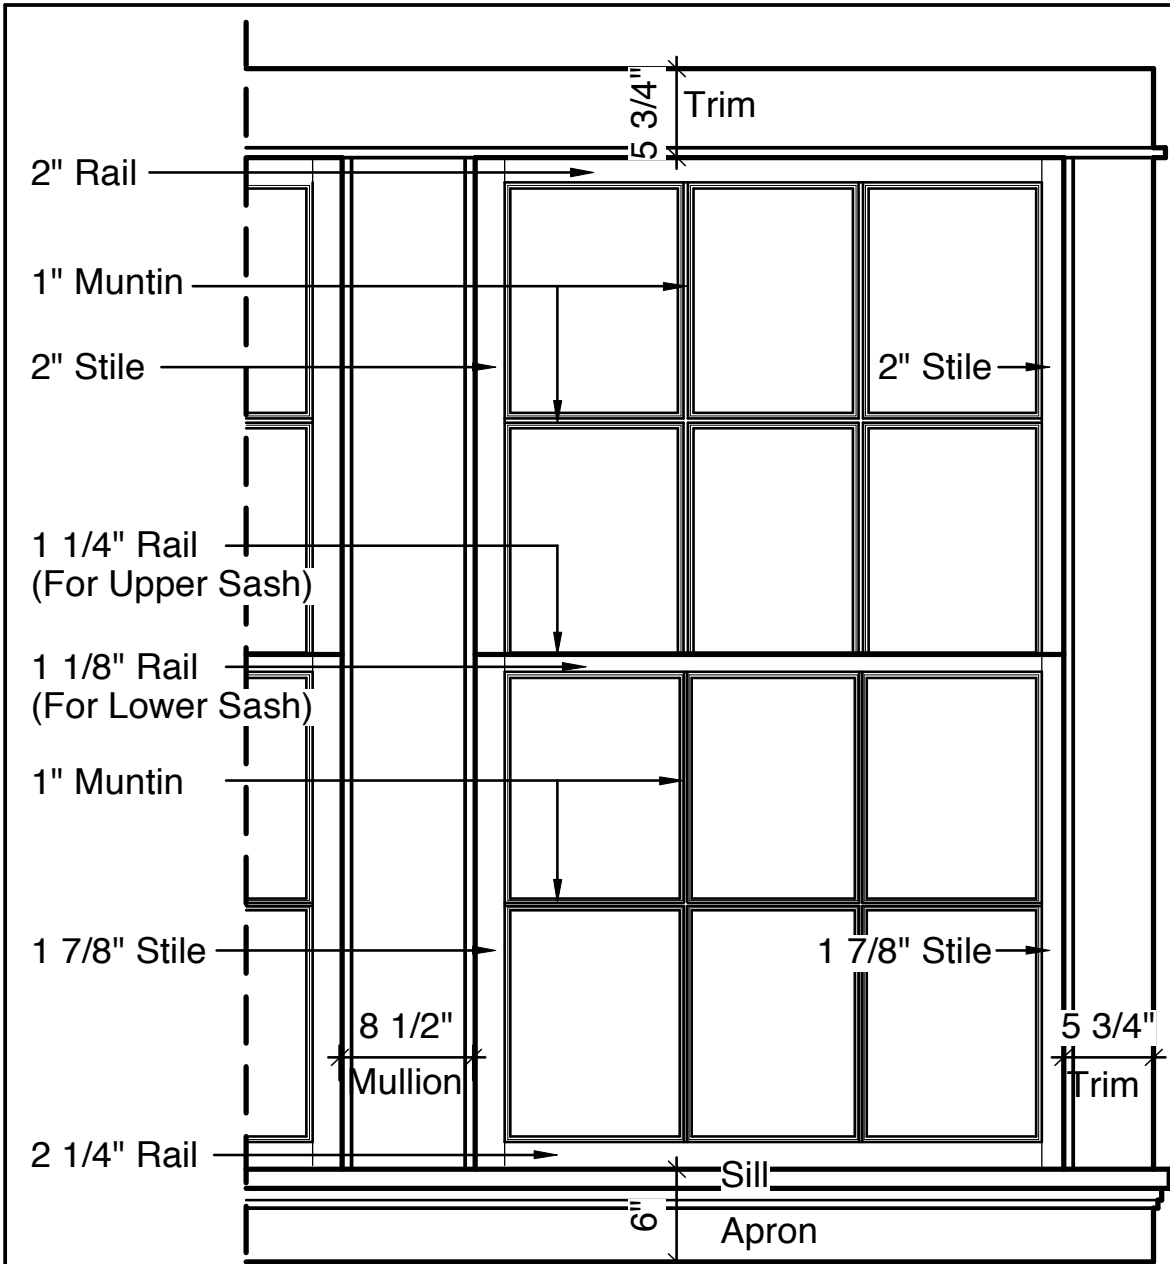
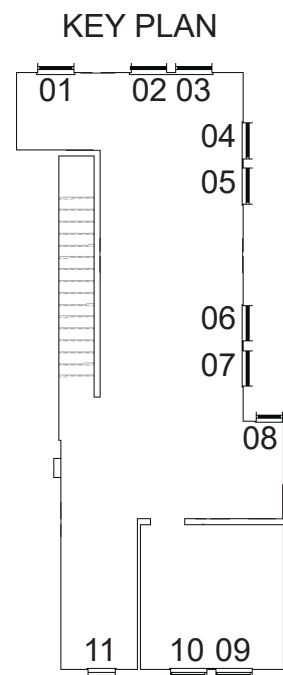
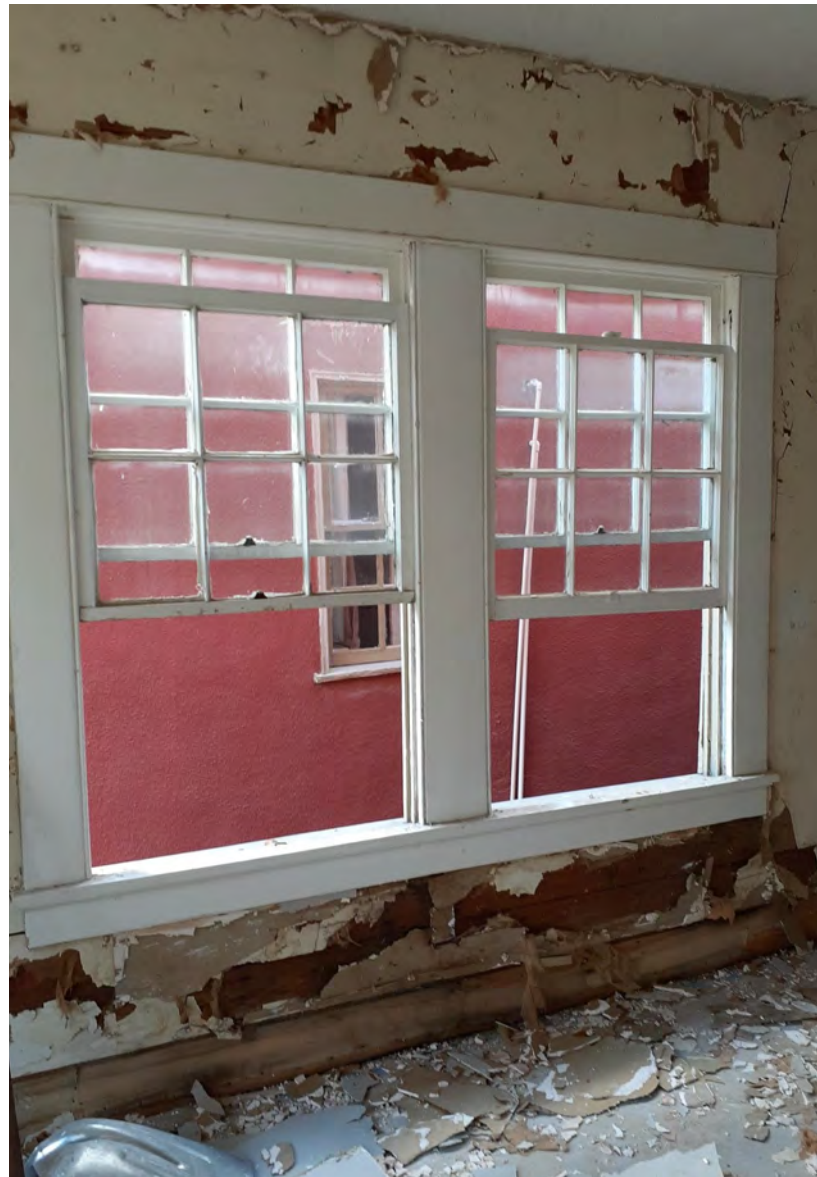
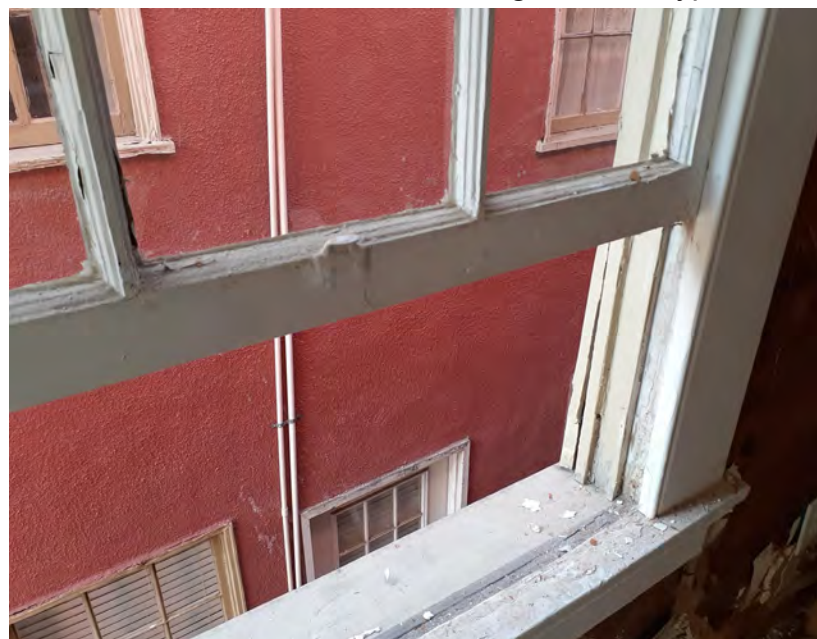
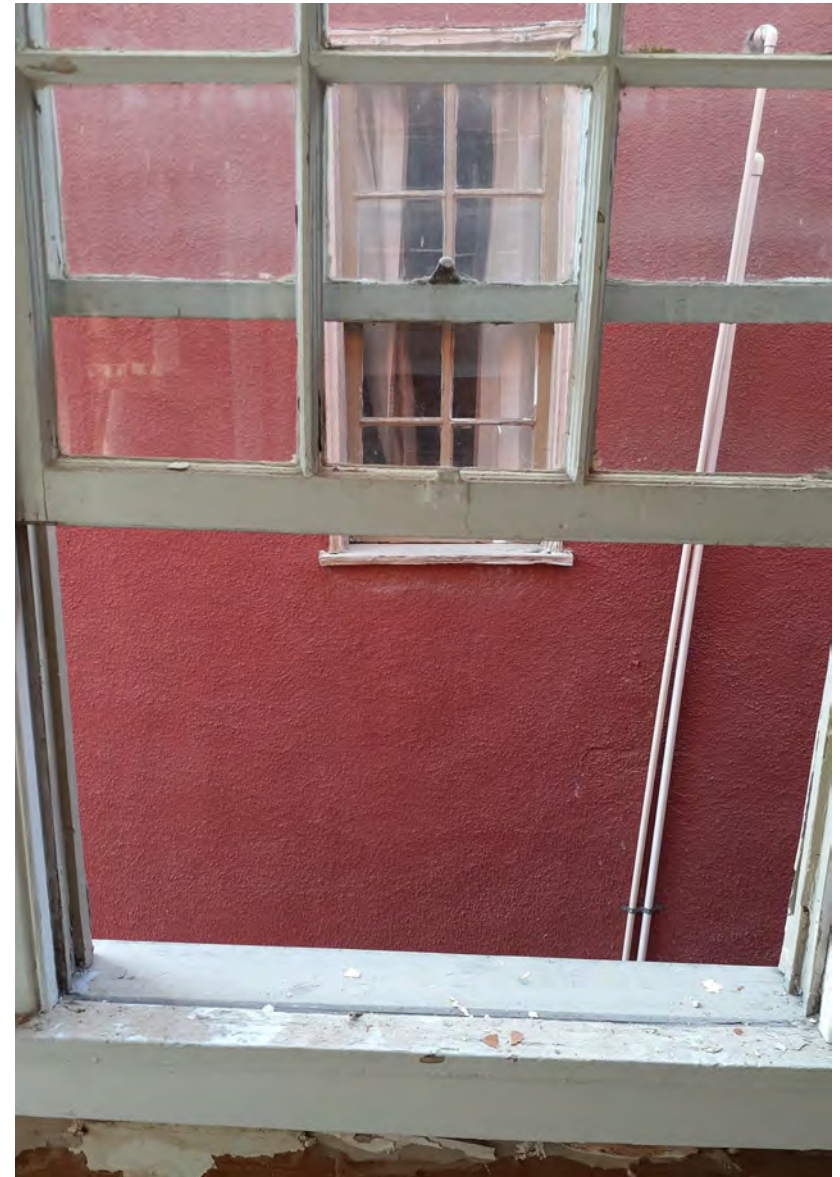
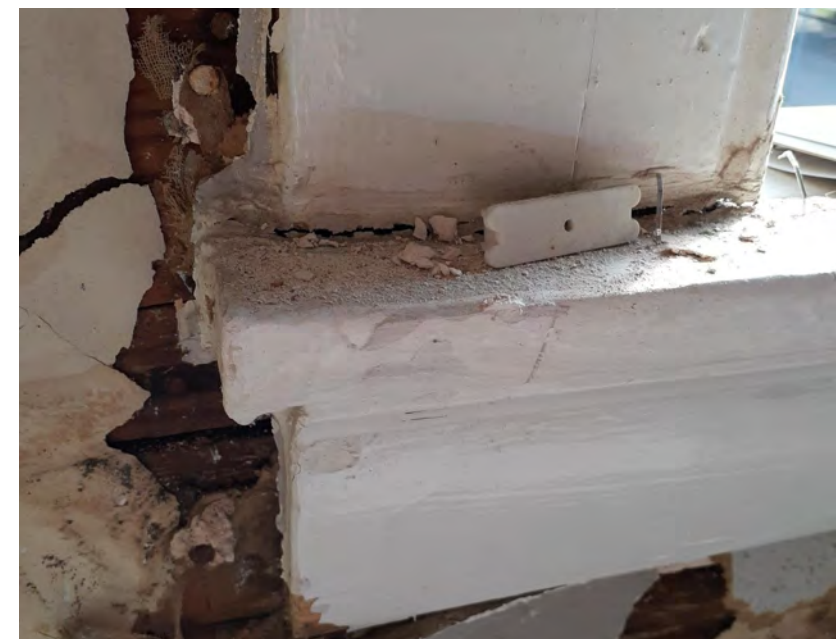
**05** | **LIVING ROOM WINDOW**  
Facing Beauregard

Notes: This does not appear to be a full “Original Window”

This window has had individual parts replaced over the years as can be dimensions; as well as whole Sashes have been replaced. Note, upper Sash has 3/4” Muntins and lower Sash has 1” Muntins.

over water damaged wood, typical.

Window glass appears to be a standard glass, not milk,

been measured and observed within this window.

Rehabilitation of the existing window sashes only, does not address the condition of the window frame or preventative measures for future water

Window Trim+Sill to be preserved were possible and
