## HISTORIC AND DESIGN REVIEW COMMISSION

**HDRC CASE NO:** 2021-213  
**ADDRESS:** 222 BEAUREGARD  
**LEGAL DESCRIPTION:** NCB 743 BLK 2 LOT 1 MASTERFILE & COMMON ELEMENT -MADISON CONDOMINIUMS  
**ZONING:** RM-4, H  
**CITY COUNCIL DIST.:** 1  
**DISTRICT:** King William Historic District  
**APPLICANT:** Lyndsay Thorn/Thorn Architects, PLLC  
**OWNER:** Sean Moore (Wife: Blythe Evans)/MADISON CONDOMINIUM OWNERS ASSOCIATION INC  
**TYPE OF WORK:** Window sash replacement  
**APPLICATION RECEIVED:** April 23, 2021  
**60-DAY REVIEW:** Not applicable due to City Council Emergency Orders  
**CASE MANAGER:** Huy Pham  
**REQUEST:**

The applicant is requesting a Certificate of Appropriateness for approval to replace non-original window windows with new aluminum-clad wood windows matching historic specifications (Pella Reserve Traditional Series)

MOORE-EVANS RESIDENCE, UNIT 2  
222 Beauregard San Antonio Texas 78209

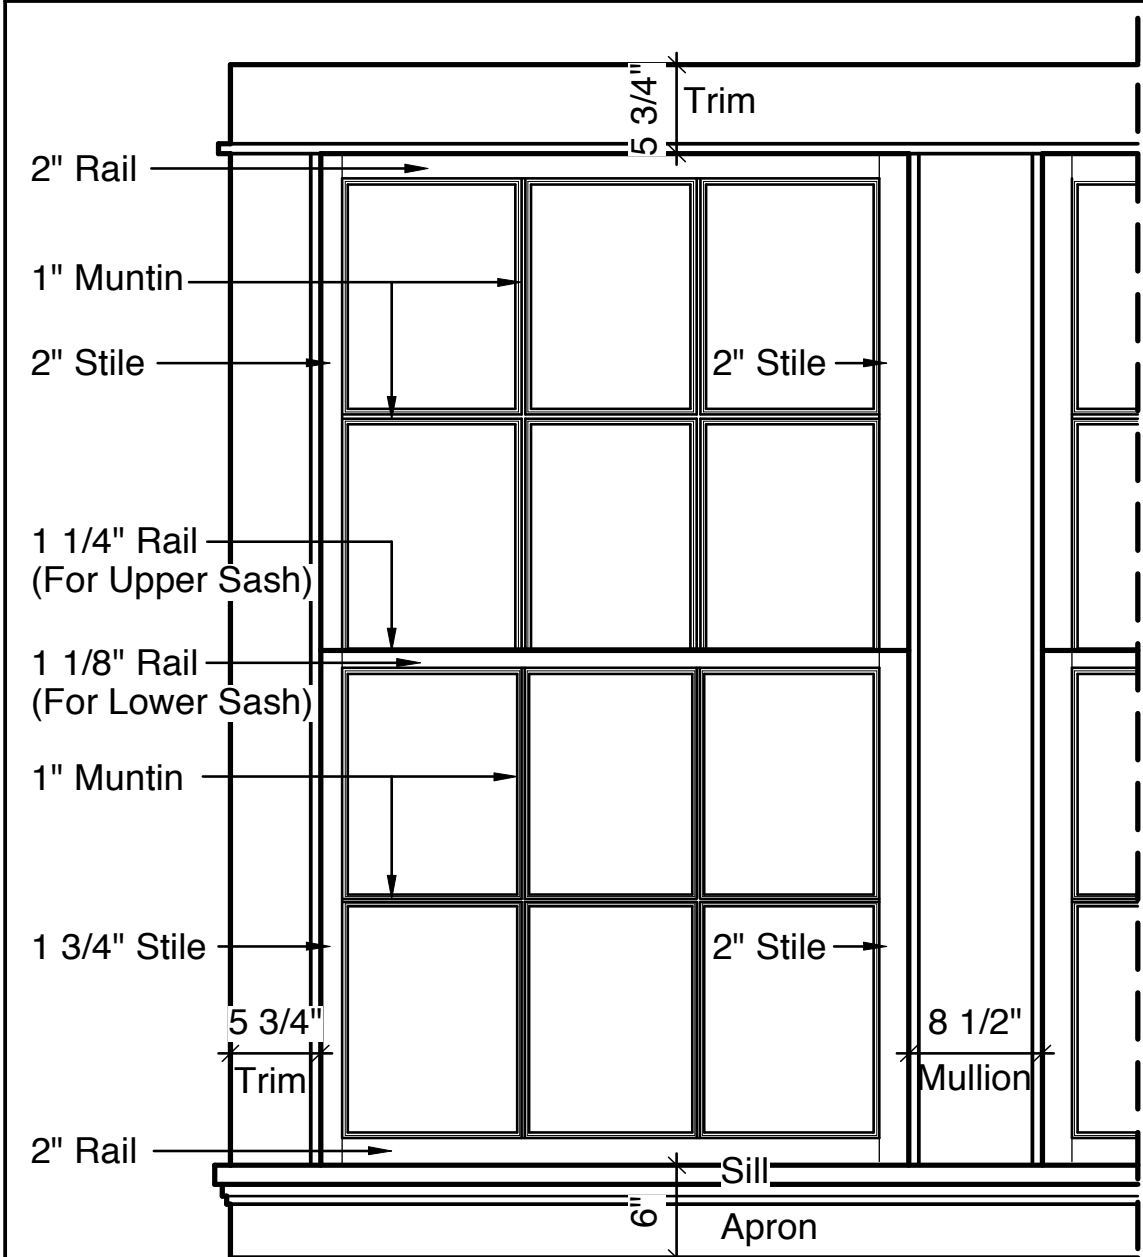
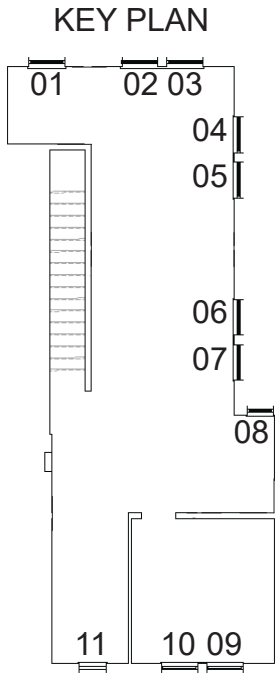
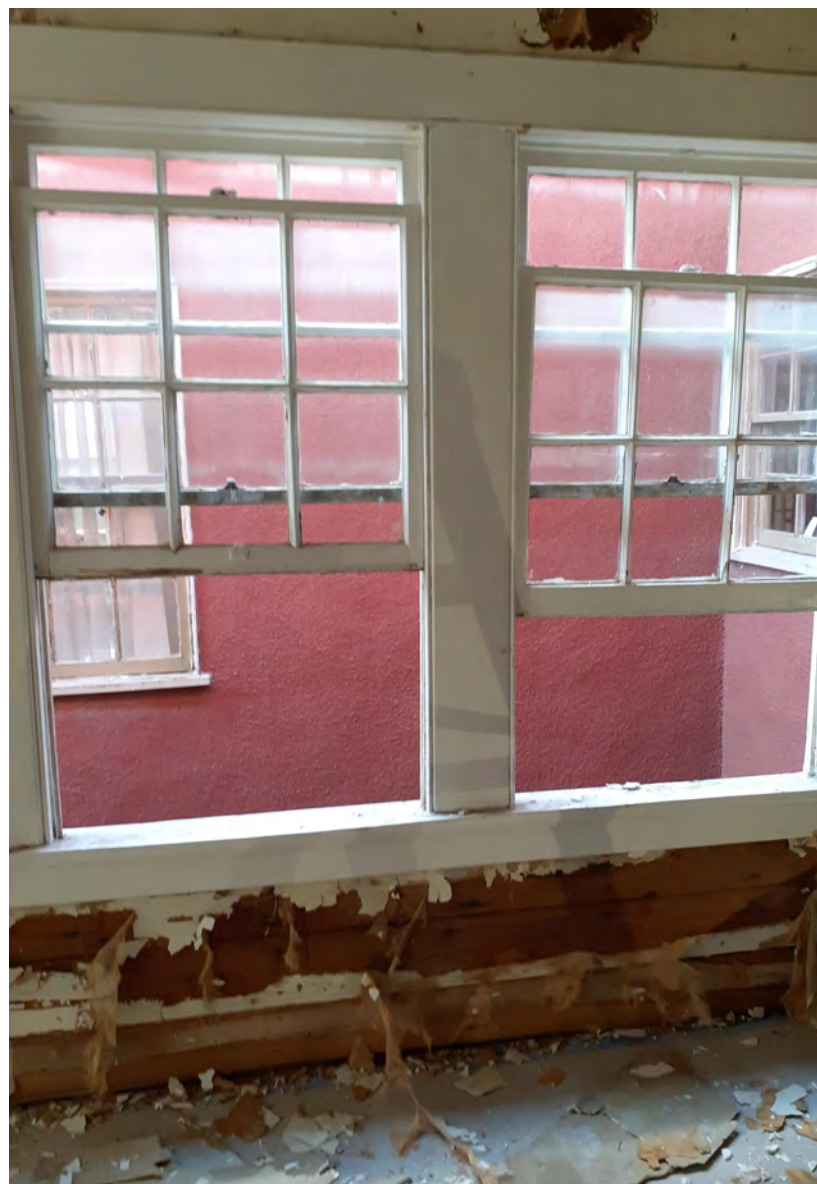
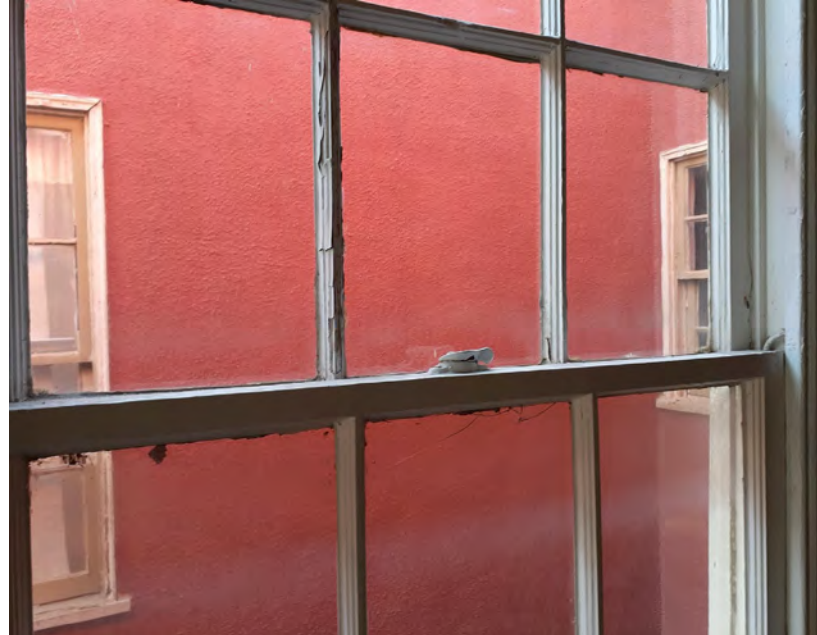
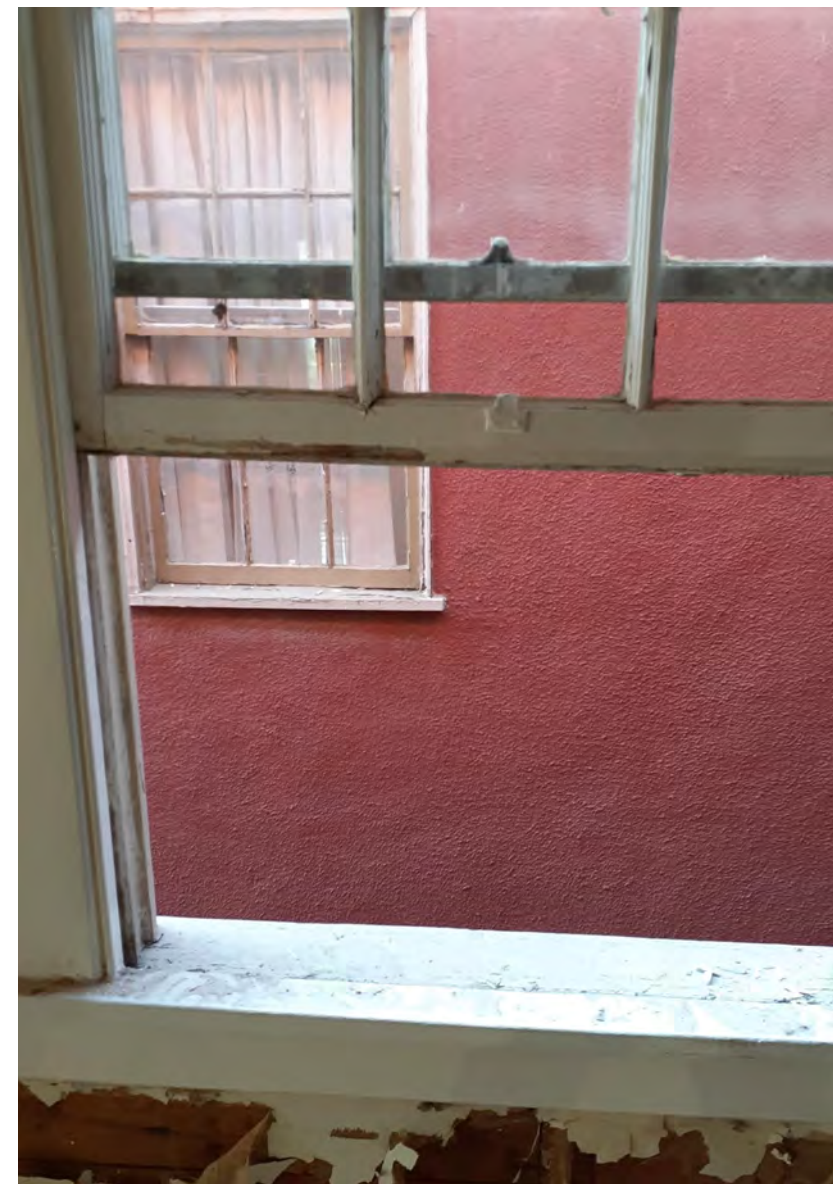
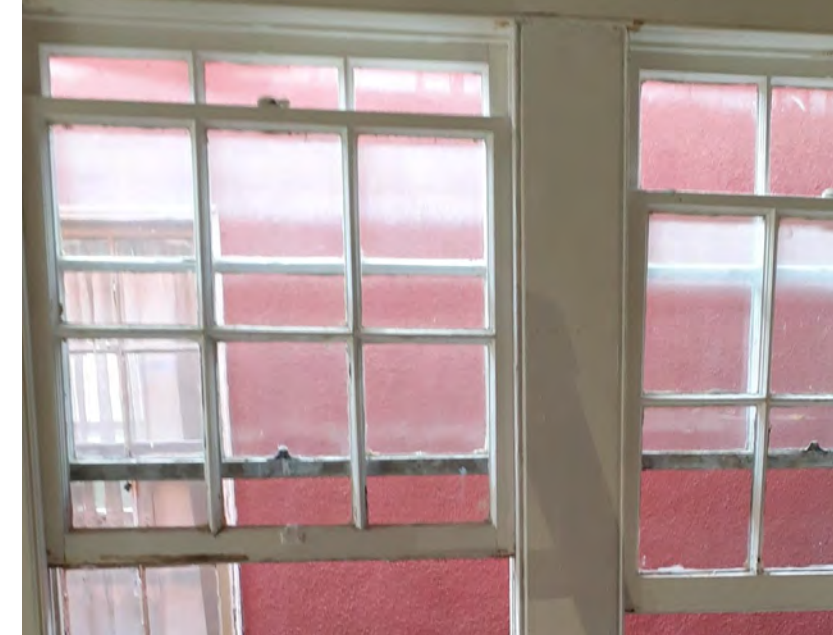
06 | LIVING ROOM WINDOW  
Facing Courtyard

Notes: This does not appear to be a full "Original Window"

This window has had individual parts replaced over the years as can be dimensions; as well as whole Sashes have been replaced. Note, upper Sash has 3/4" Muntins and lower Sash has 1" Muntins.

over water damaged wood, typical.

Window glass appears to be a standard glass, not milk,

been measured and observed within this window.

Rehabilitation of the existing window sashes only, does not address the condition of the window frame or preventative measures for future water

Window Trim+Sill to be preserved were possible and

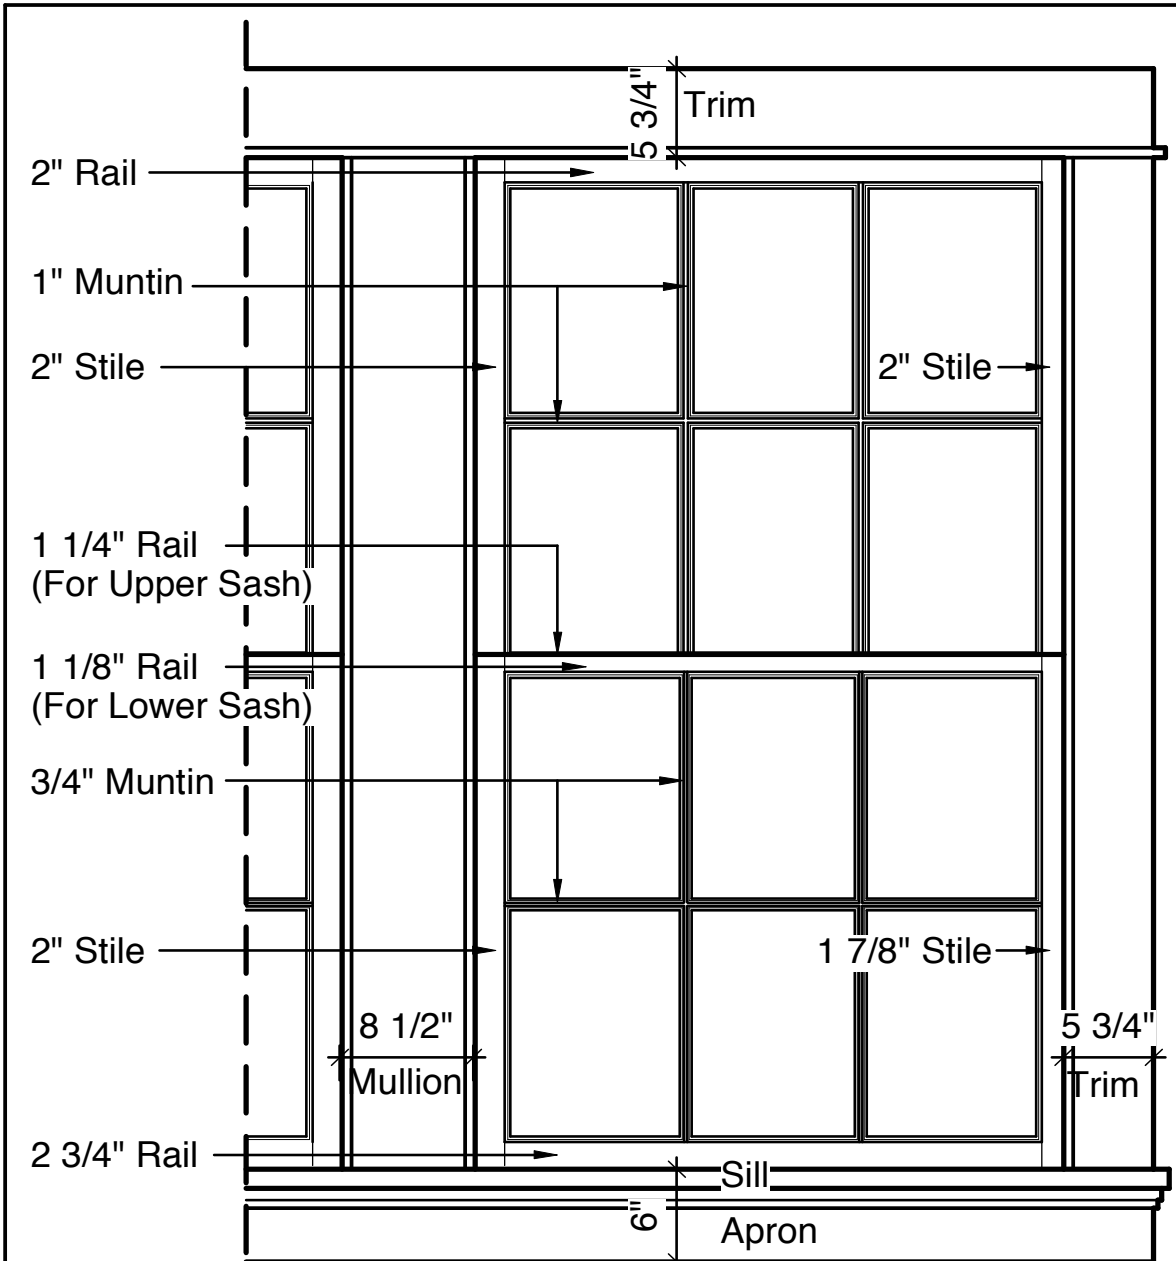
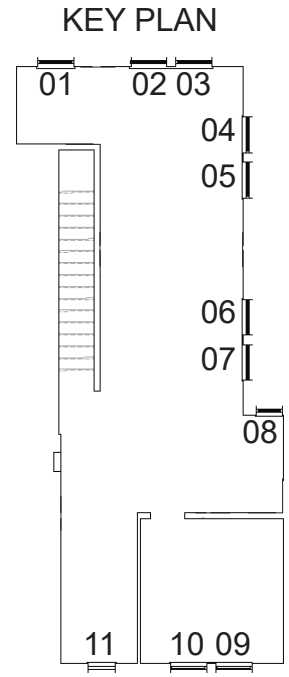
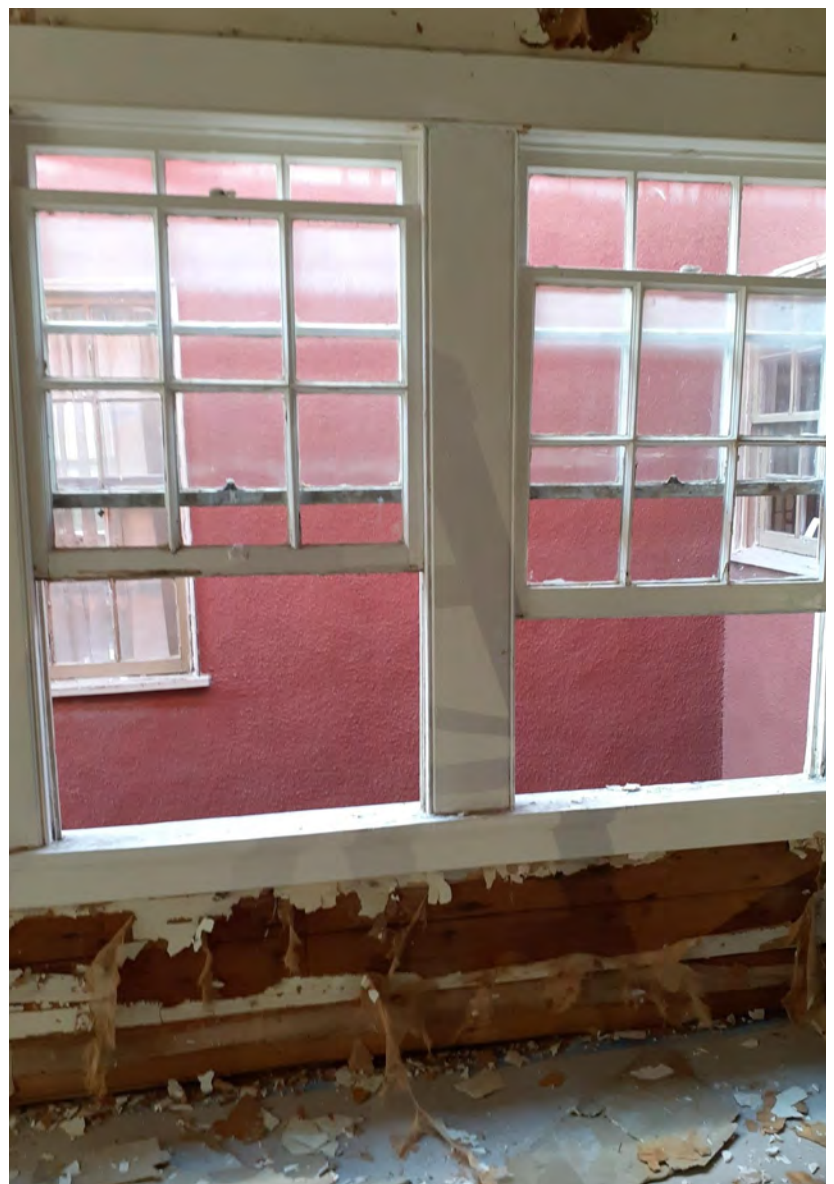
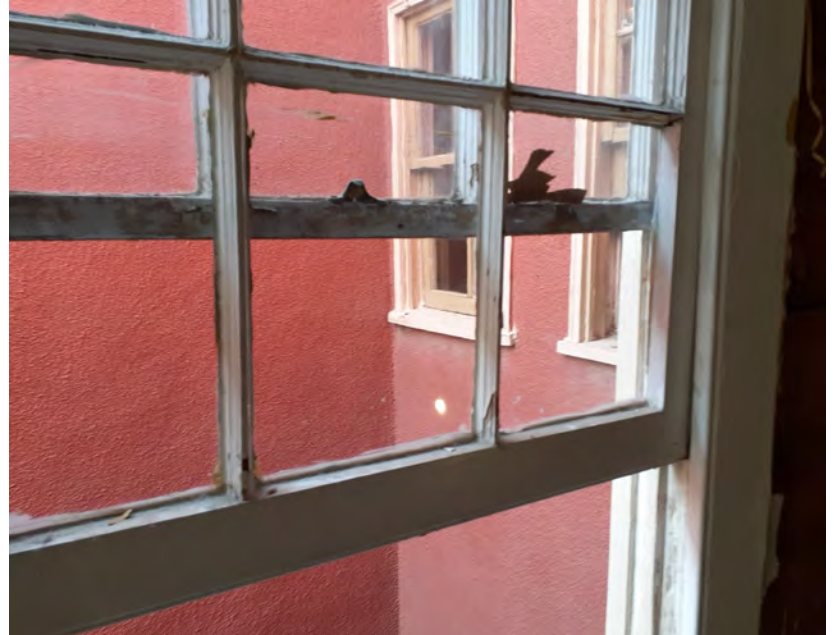
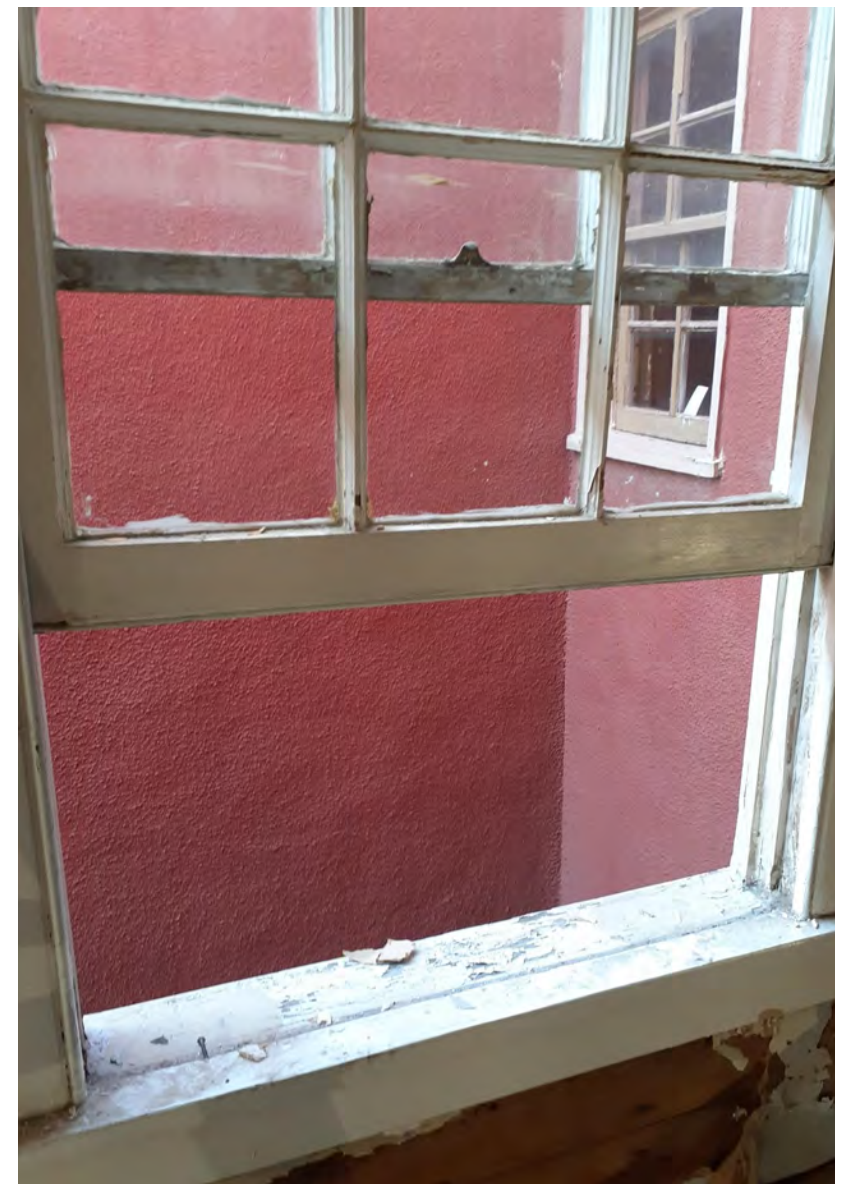
**07** | LIVING ROOM WINDOW  
Facing Courtyard

This window has had individual parts replaced over the years as can be seen by as well as whole Sashes have been replaced. Note, upper Sash has 3/4" Muntins and lower Sash has 1" Muntins.

Overall Window 7: Multiple layers of paint and caulk over water damaged wood, typical.

Window glass appears to be a standard glass, not milk,

Window does not stay open for long, it slowly lowers on its own.

Notes: We would like to provide a full frame replacement to closely match this "Original Window" in dimensions.

Rehabilitation of the existing window sashes only, does not address the condition of the window frame or preventative

Window Trim+Sill to be preserved were possible and

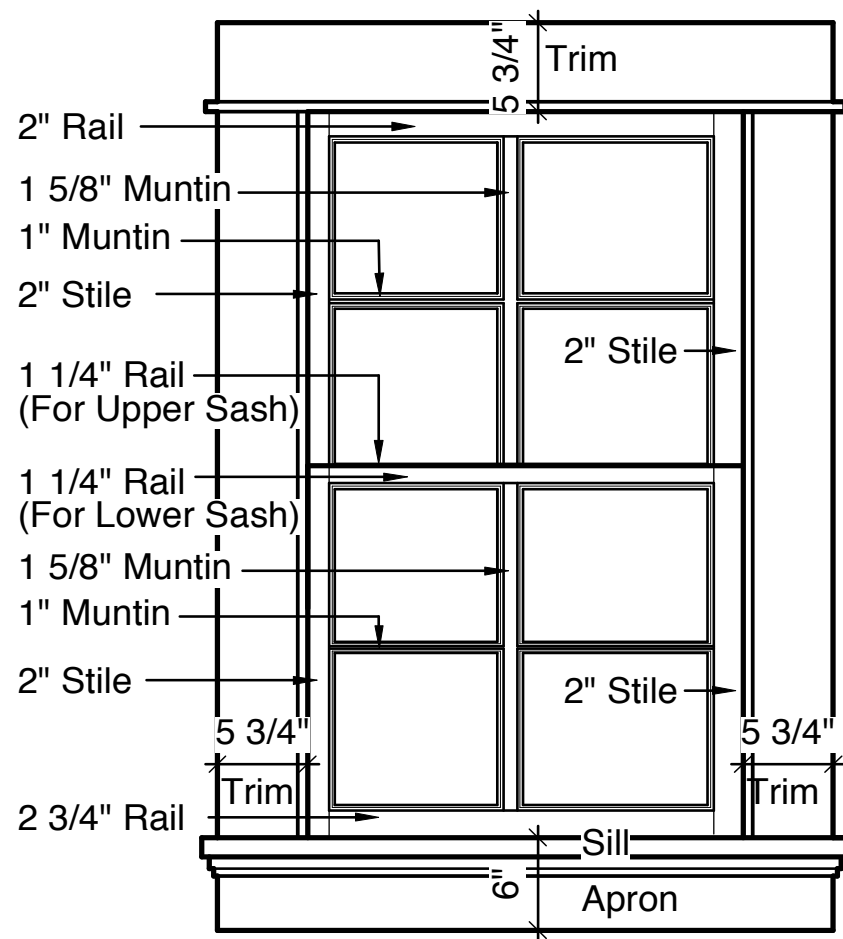
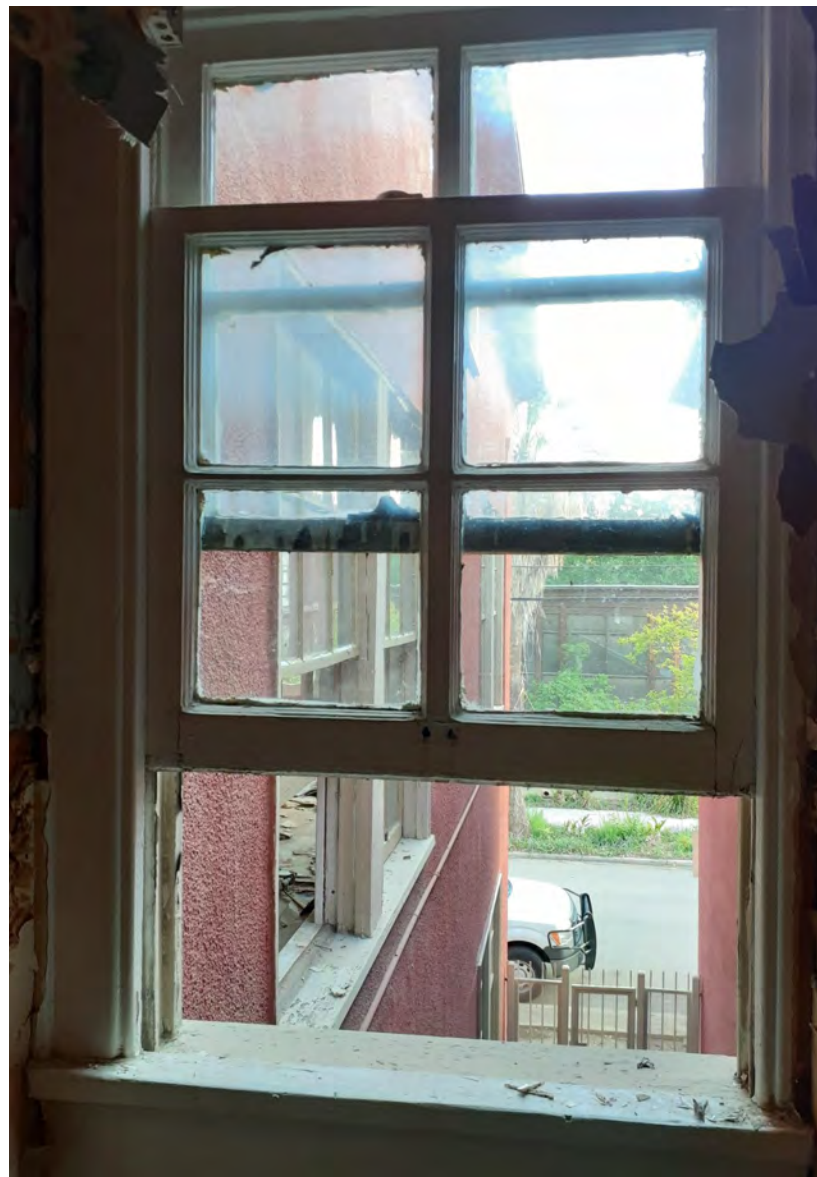
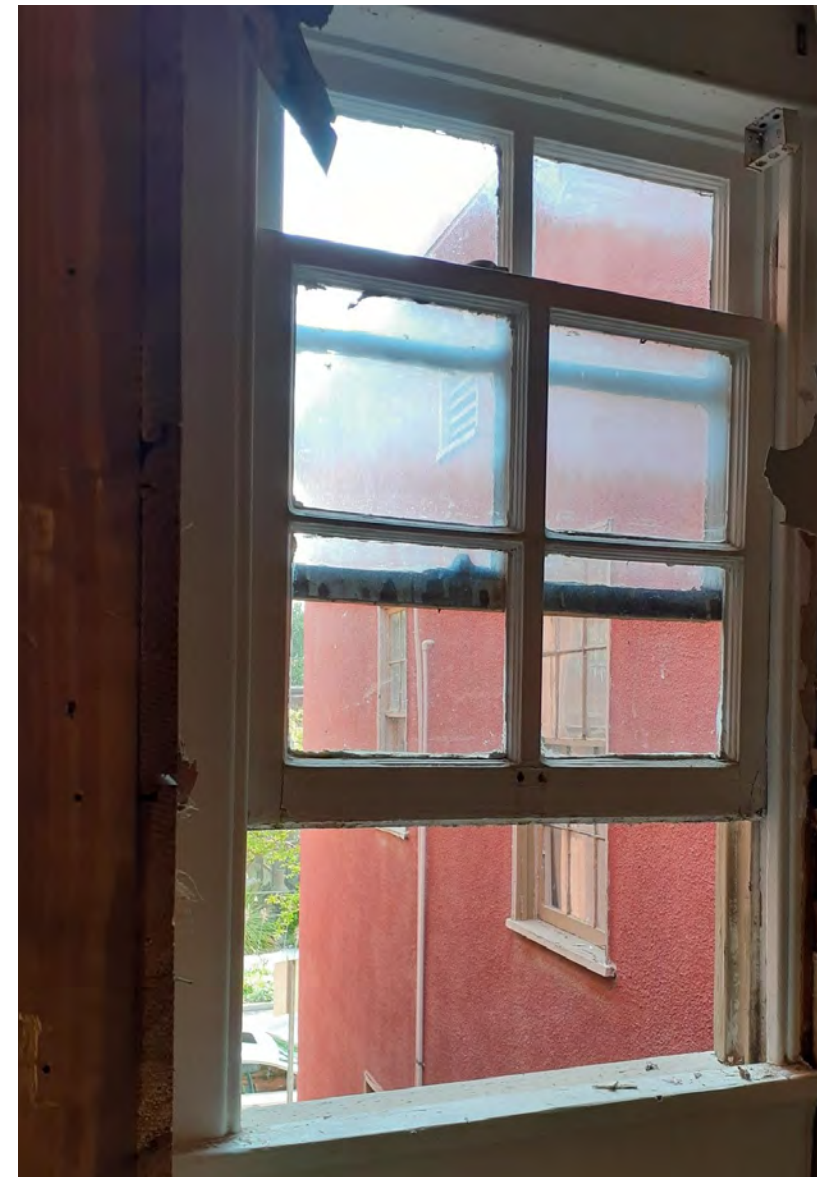
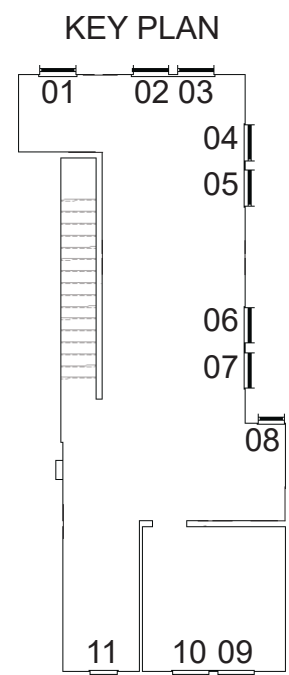
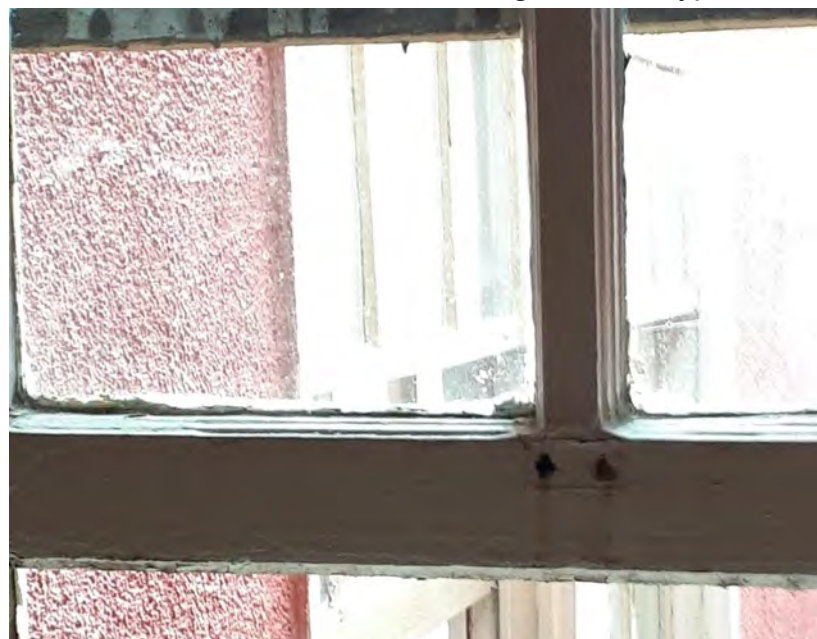
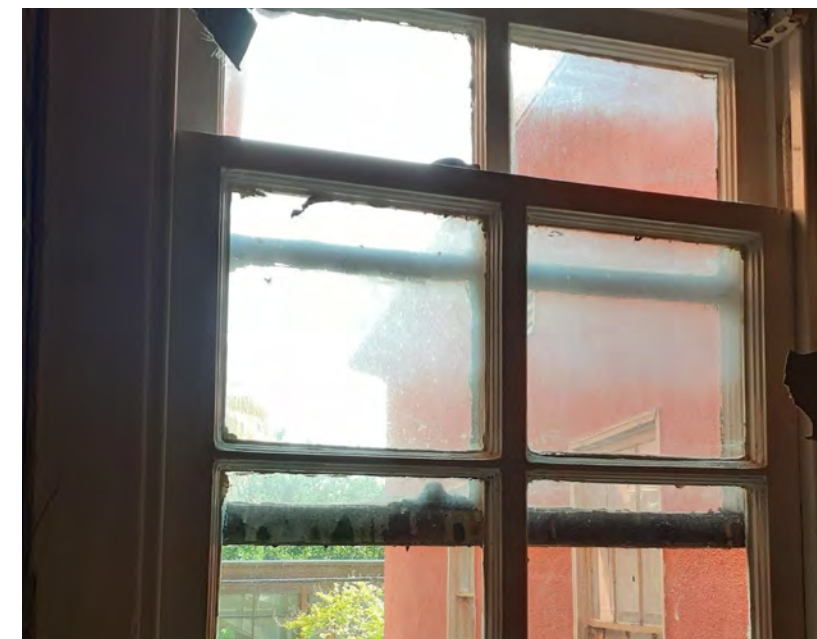
08 | BATHROOM WINDOW  
Facing Courtyard

Notes: We believe this window is the closest to an "Original Window" in dimensions.

This window has had individual parts replaced over the years as can be seen

sions; as well as whole Sashes have been replaced. Note, upper Sash has 3/4 inch Muntins and lower Sash has 1 inch Muntins.

over water damaged wood, typical.

Window glass appears to be a standard glass, not milk,

been measured and observed within this window.

Window has a wider center muntin than all other windows we believe this is the "Original"

Rehabilitation of the existing window sashes only, does not address the condition of the window frame or preventative

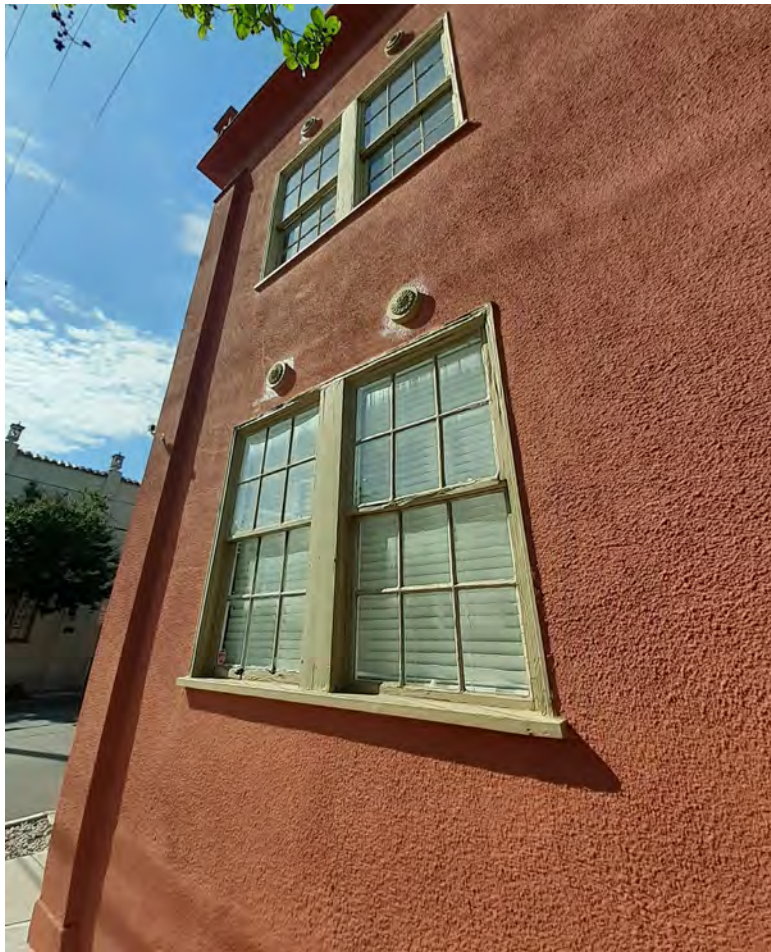
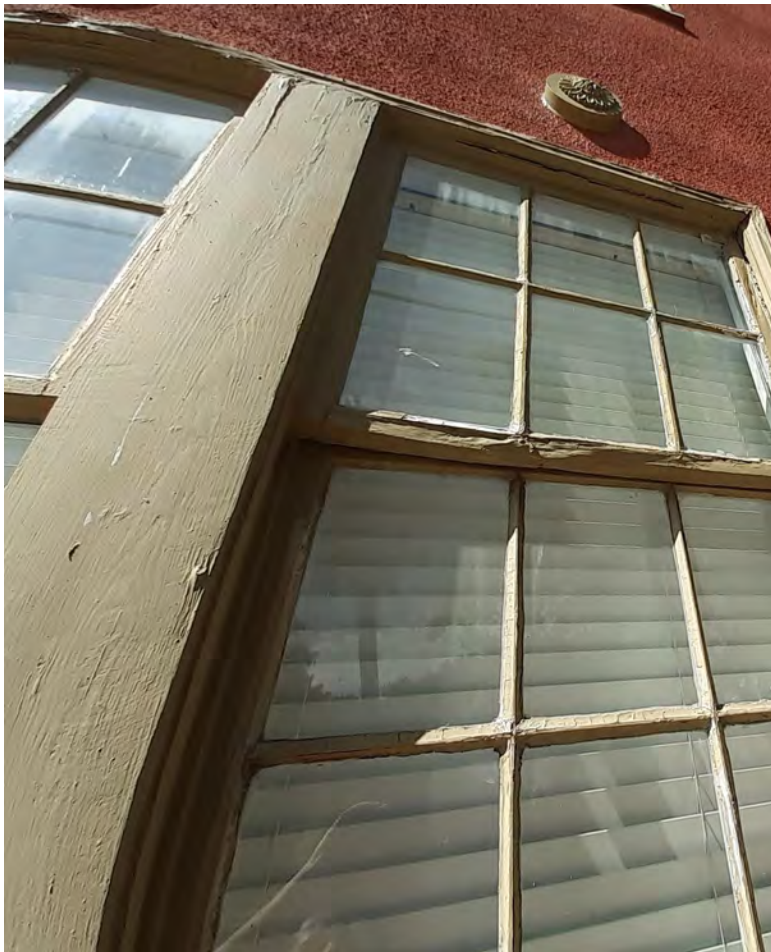
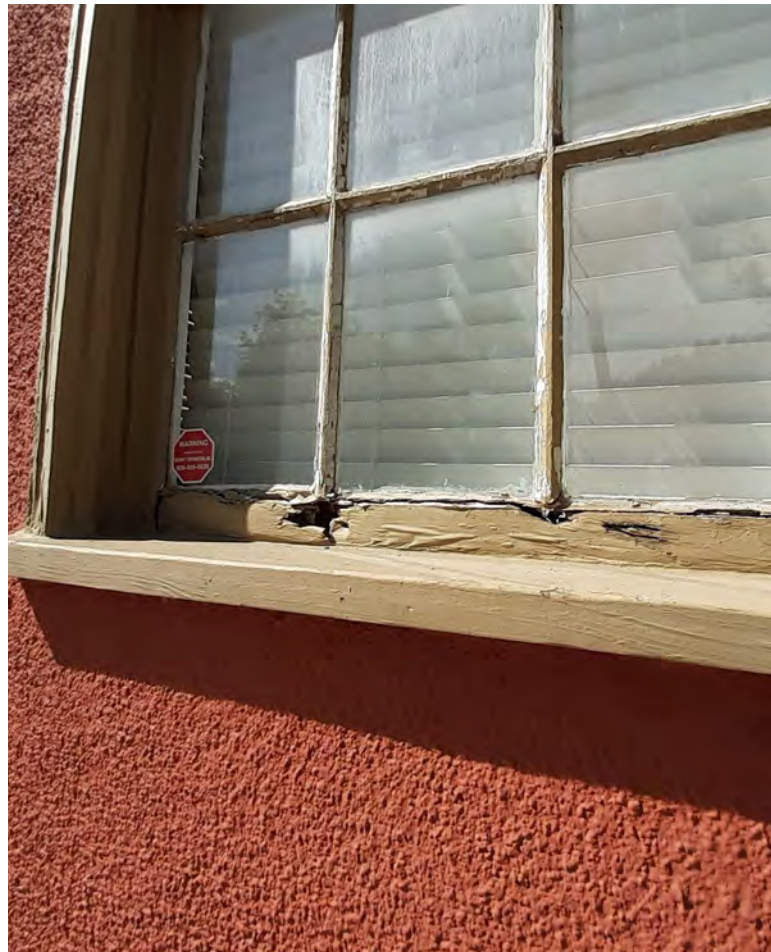
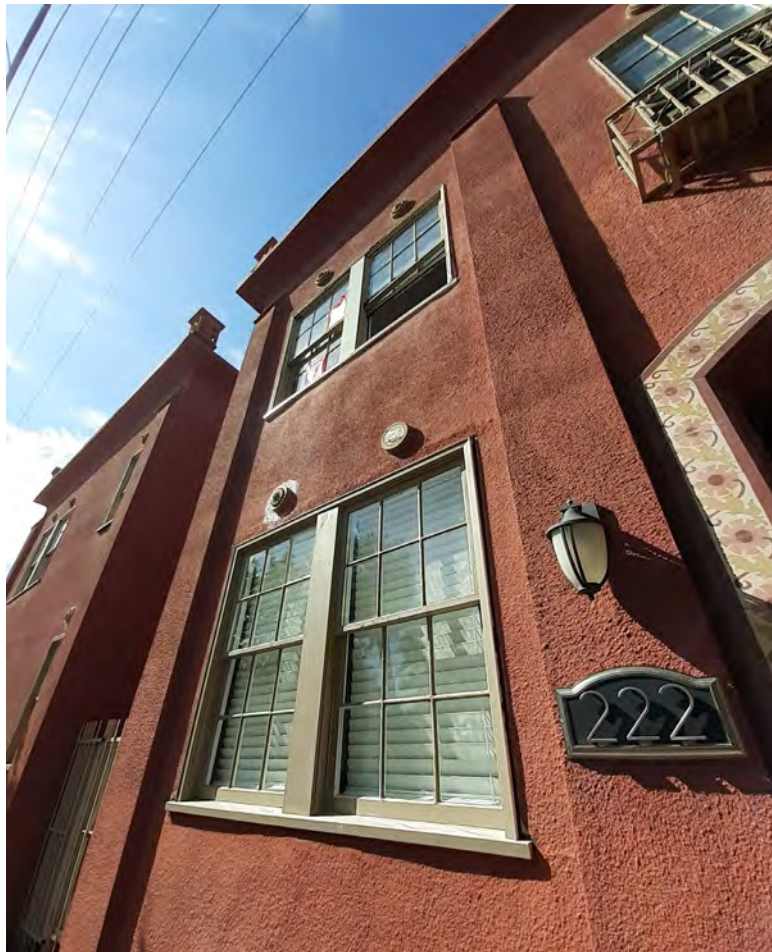
Images of the windows starting at the corner of Beauregard St and Madison. As can be seen, many of the windows have not been maintained properly over the years. - co in many areas. The Residence renovation is in Unit 2; 2nd Floor Apartment (directly above thee 222 plaque. Window 2, with missing Rail overlooks this sidewalk.

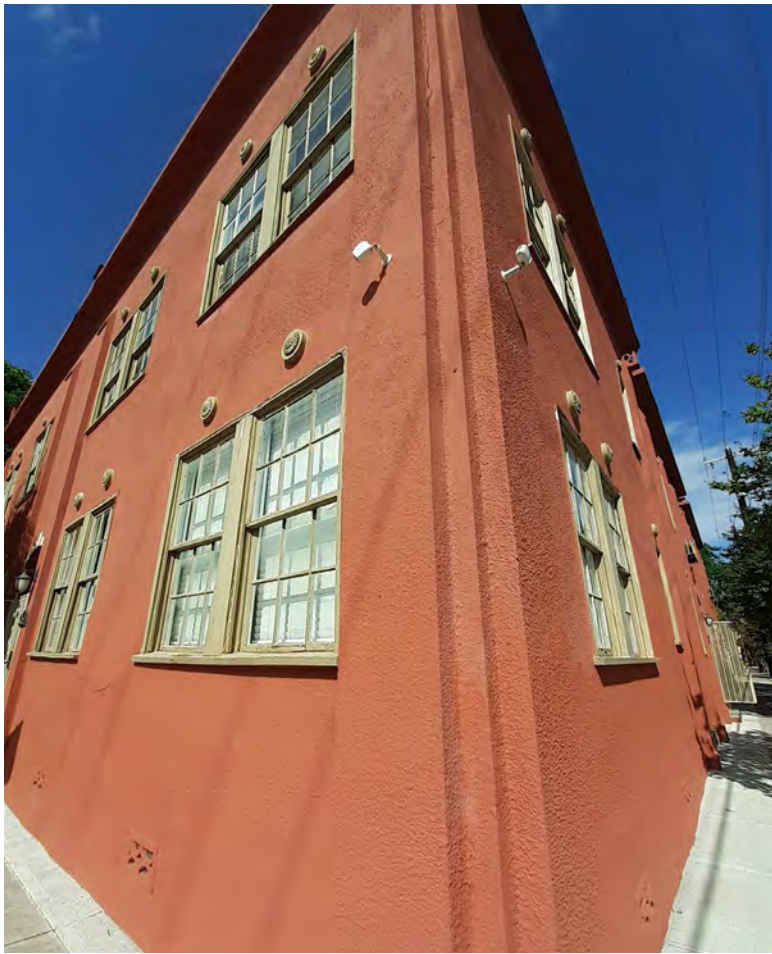
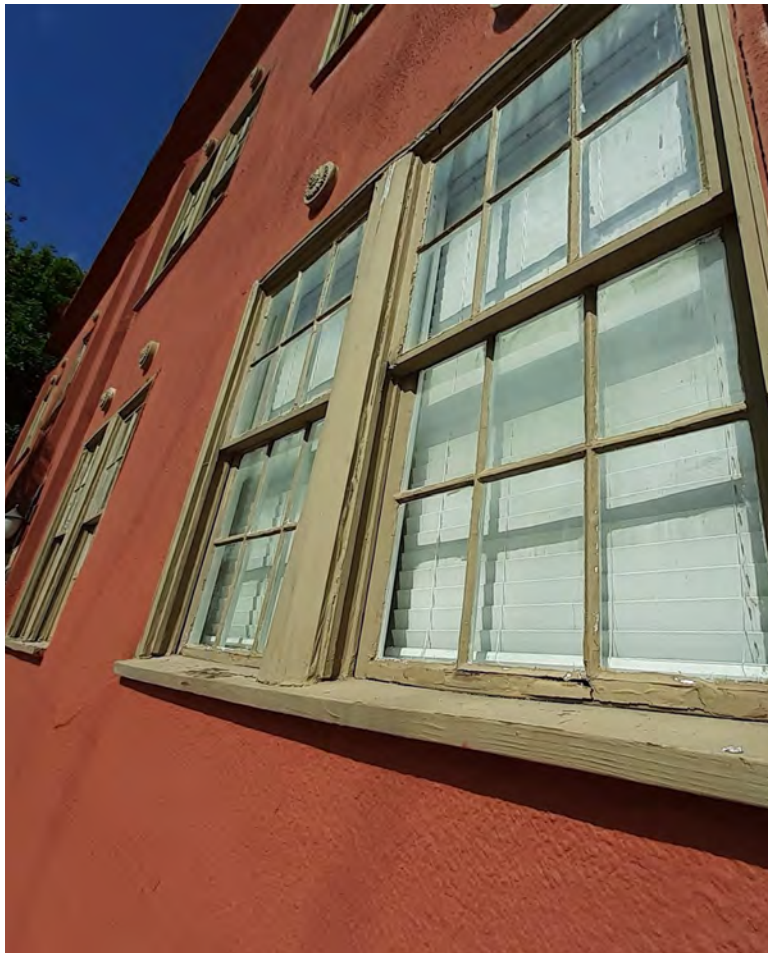
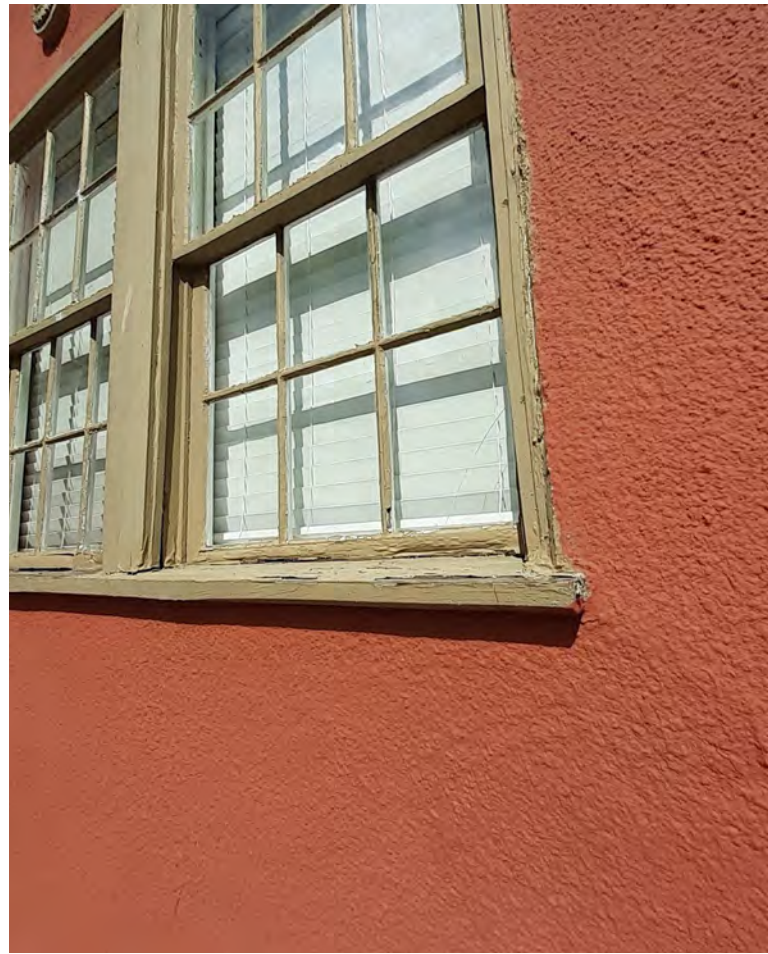
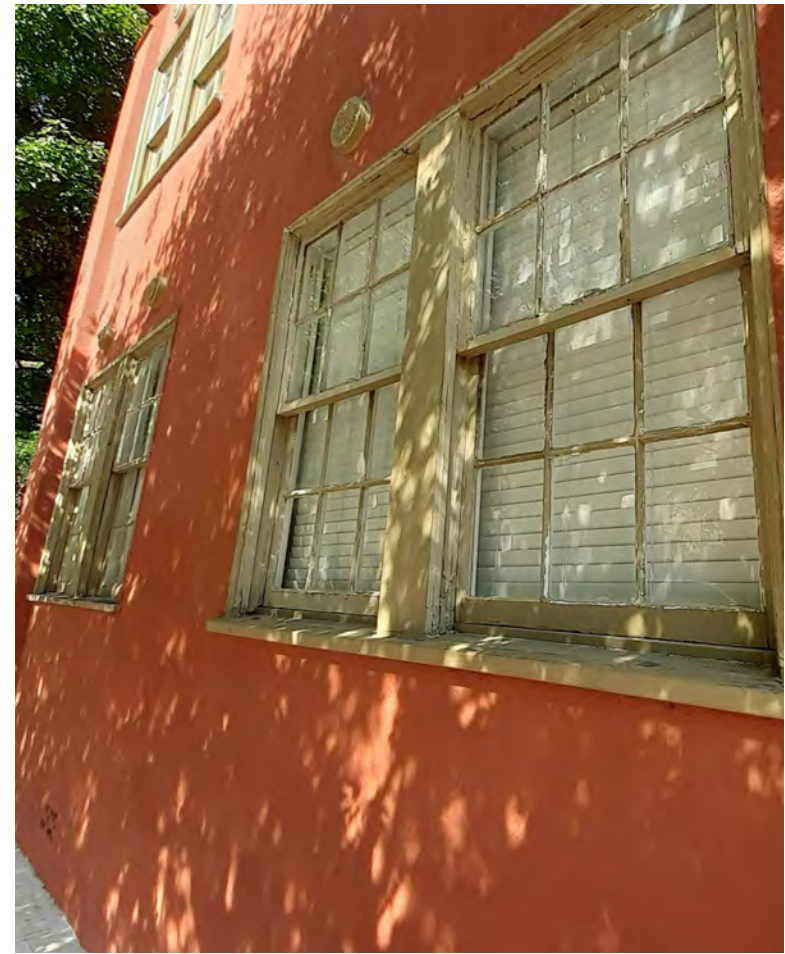
Images of the windows starting at the corner of Beauregard St and Madison; while walking down Madion Street.

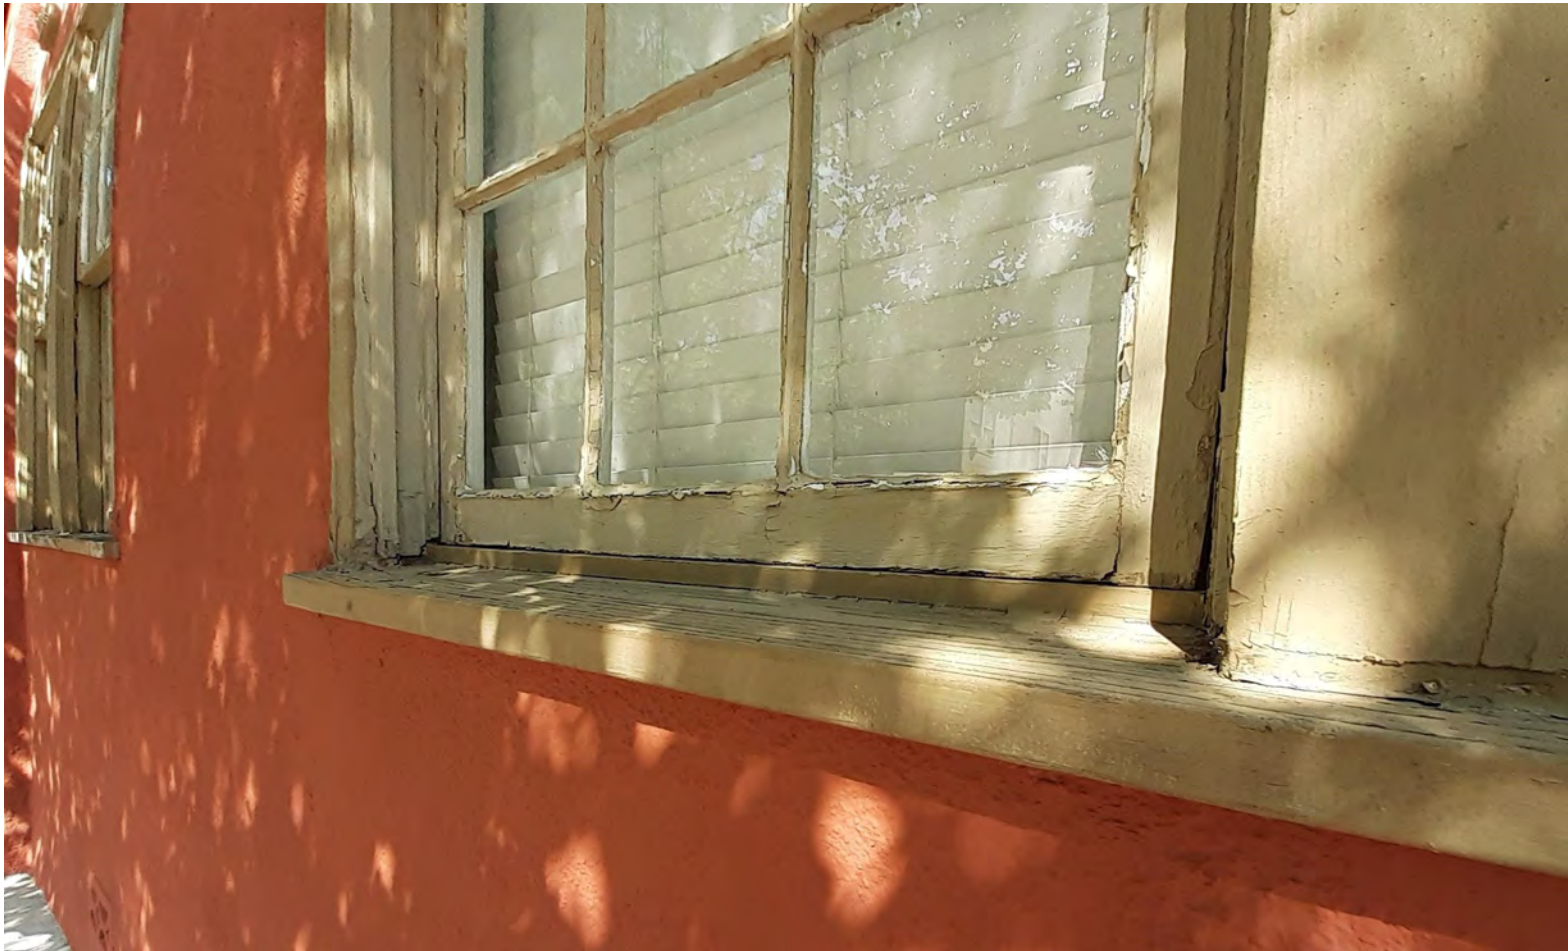
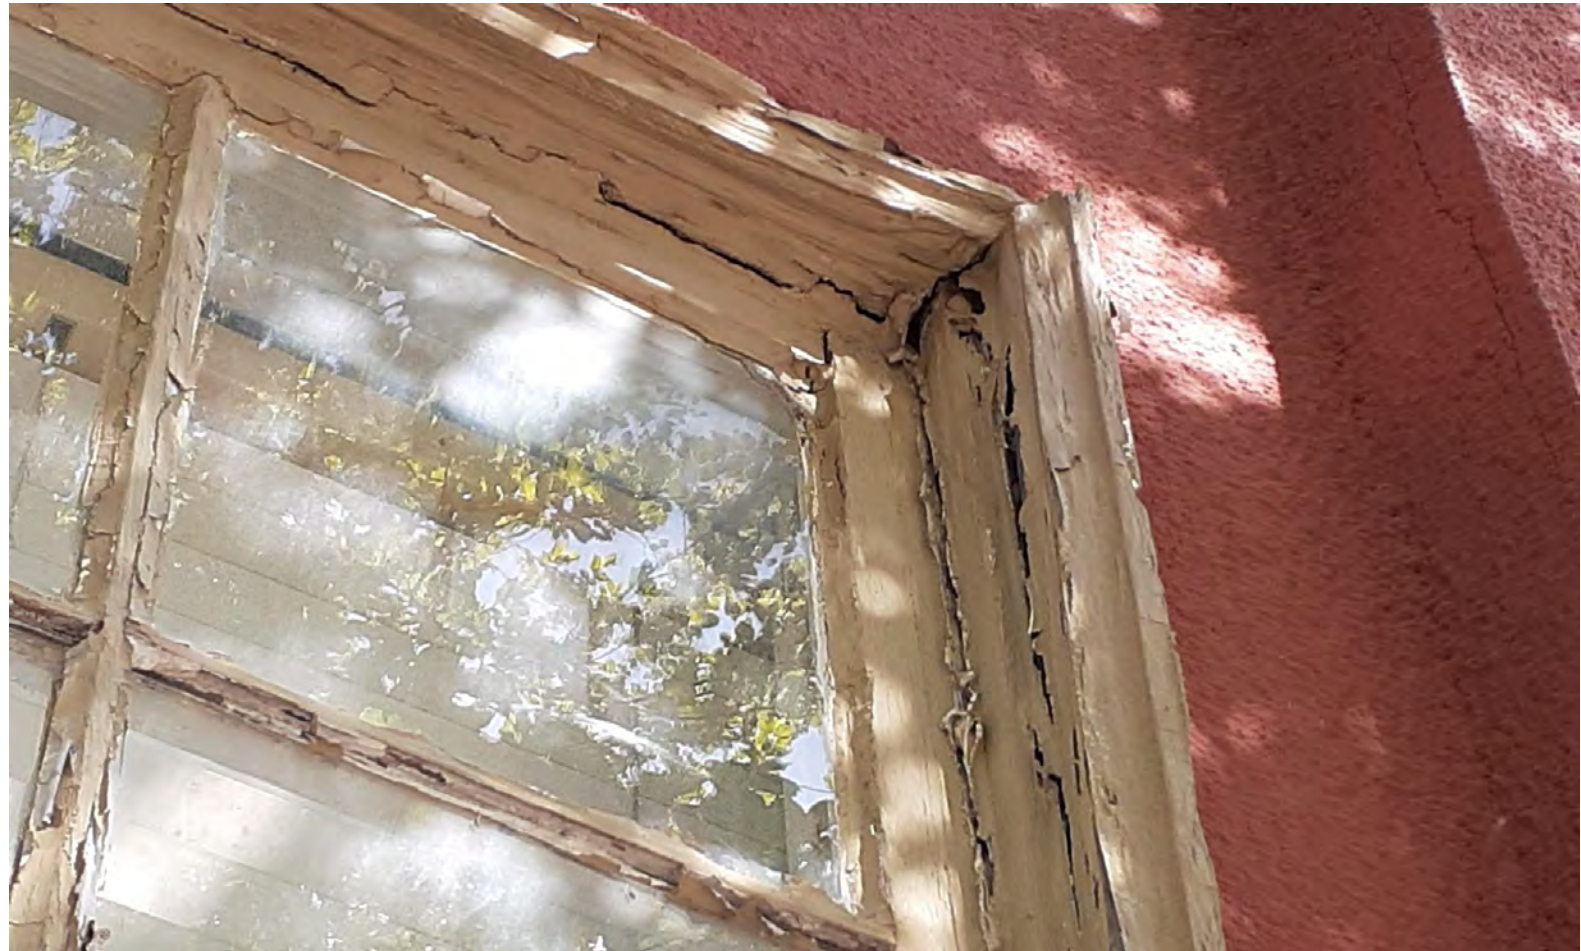
Typical Window condition, extensive water damage and aging has occurred.
