HISTORIC AND DESIGN REVIEW COMMISSION

March 06, 2019

HDRC CASE NO: 2019-074
ADDRESS: 413 CLUB DR
LEGAL DESCRIPTION: NCB 7014 BLK LOT W 35 FT OF 4 & E 16.5 FT OF 5
ZONING: RM-4, H
CITY COUNCIL DIST.: 7
DISTRICT: Monticello Park Historic District
APPLICANT: Ramiro Reyes
OWNER: Ramiro Reyes
TYPE OF WORK: Window replacement, exterior painting
APPLICATION RECEIVED: February 14, 2019
60-DAY REVIEW: April 13, 2019

Investigation Report

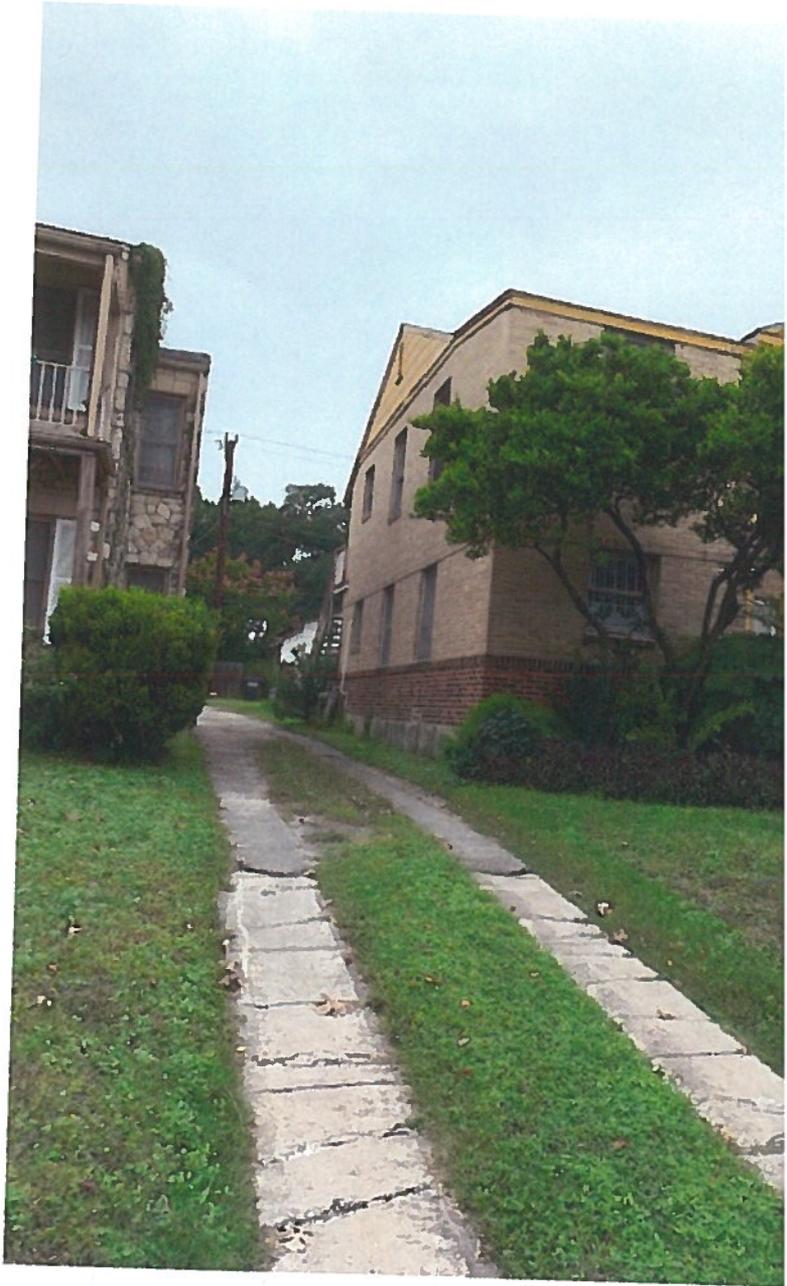
Old windows Left
Pre-Window Installation

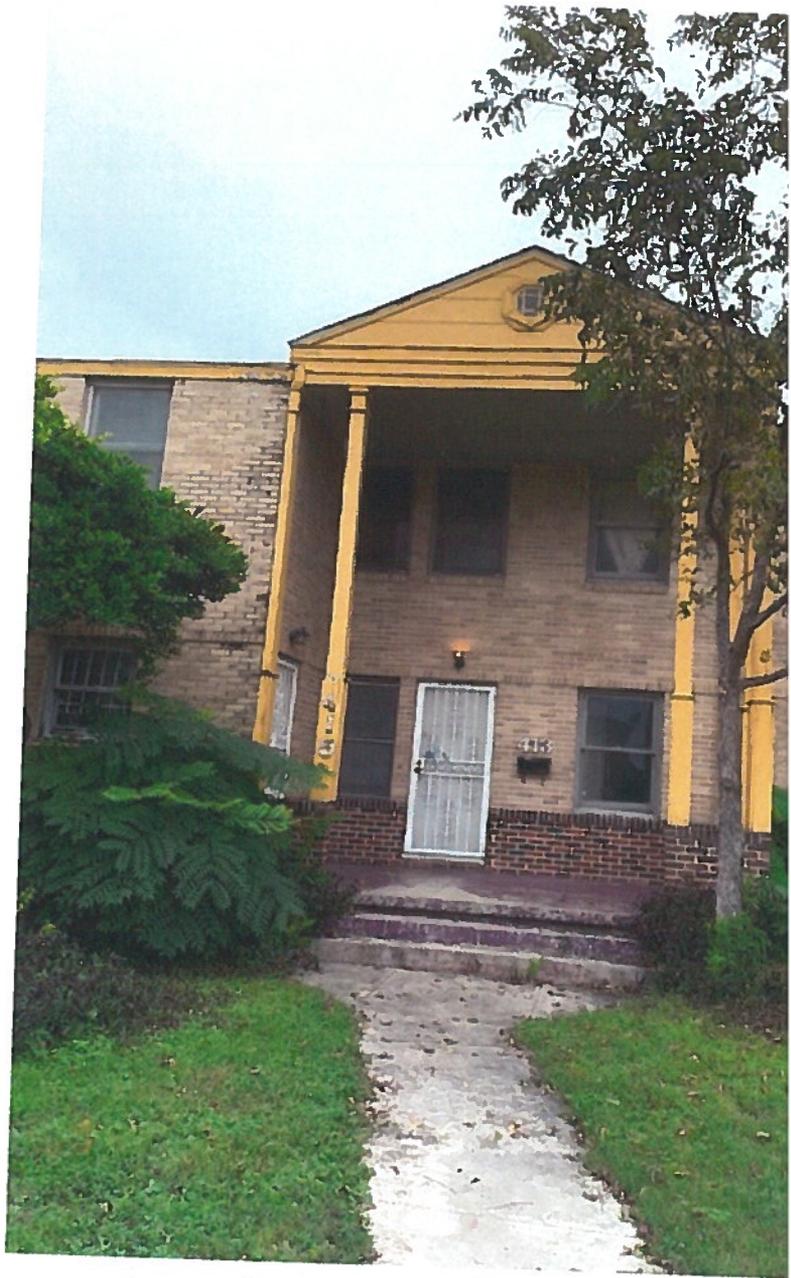
old windows Front

Pre-window Installation

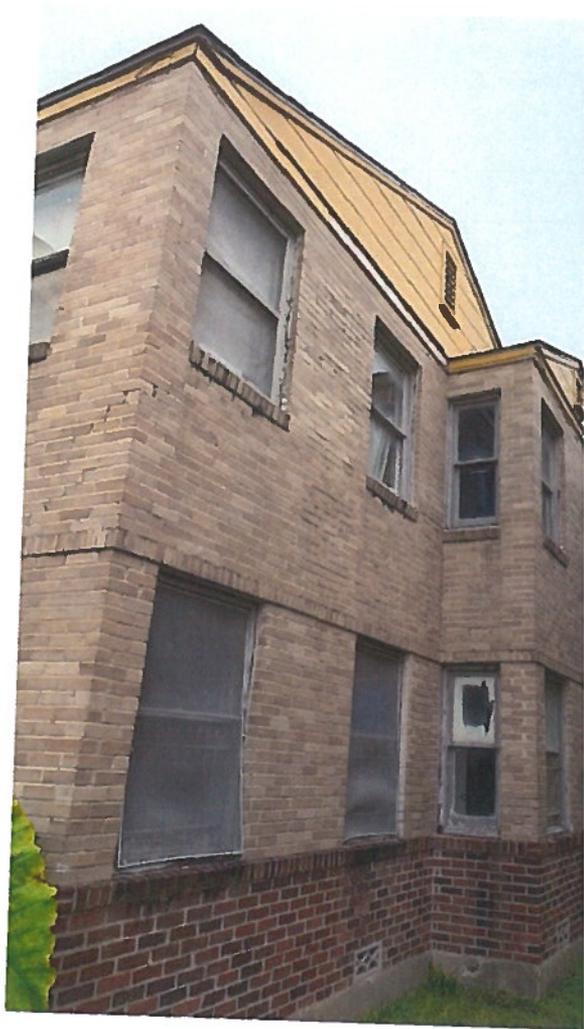
old windows

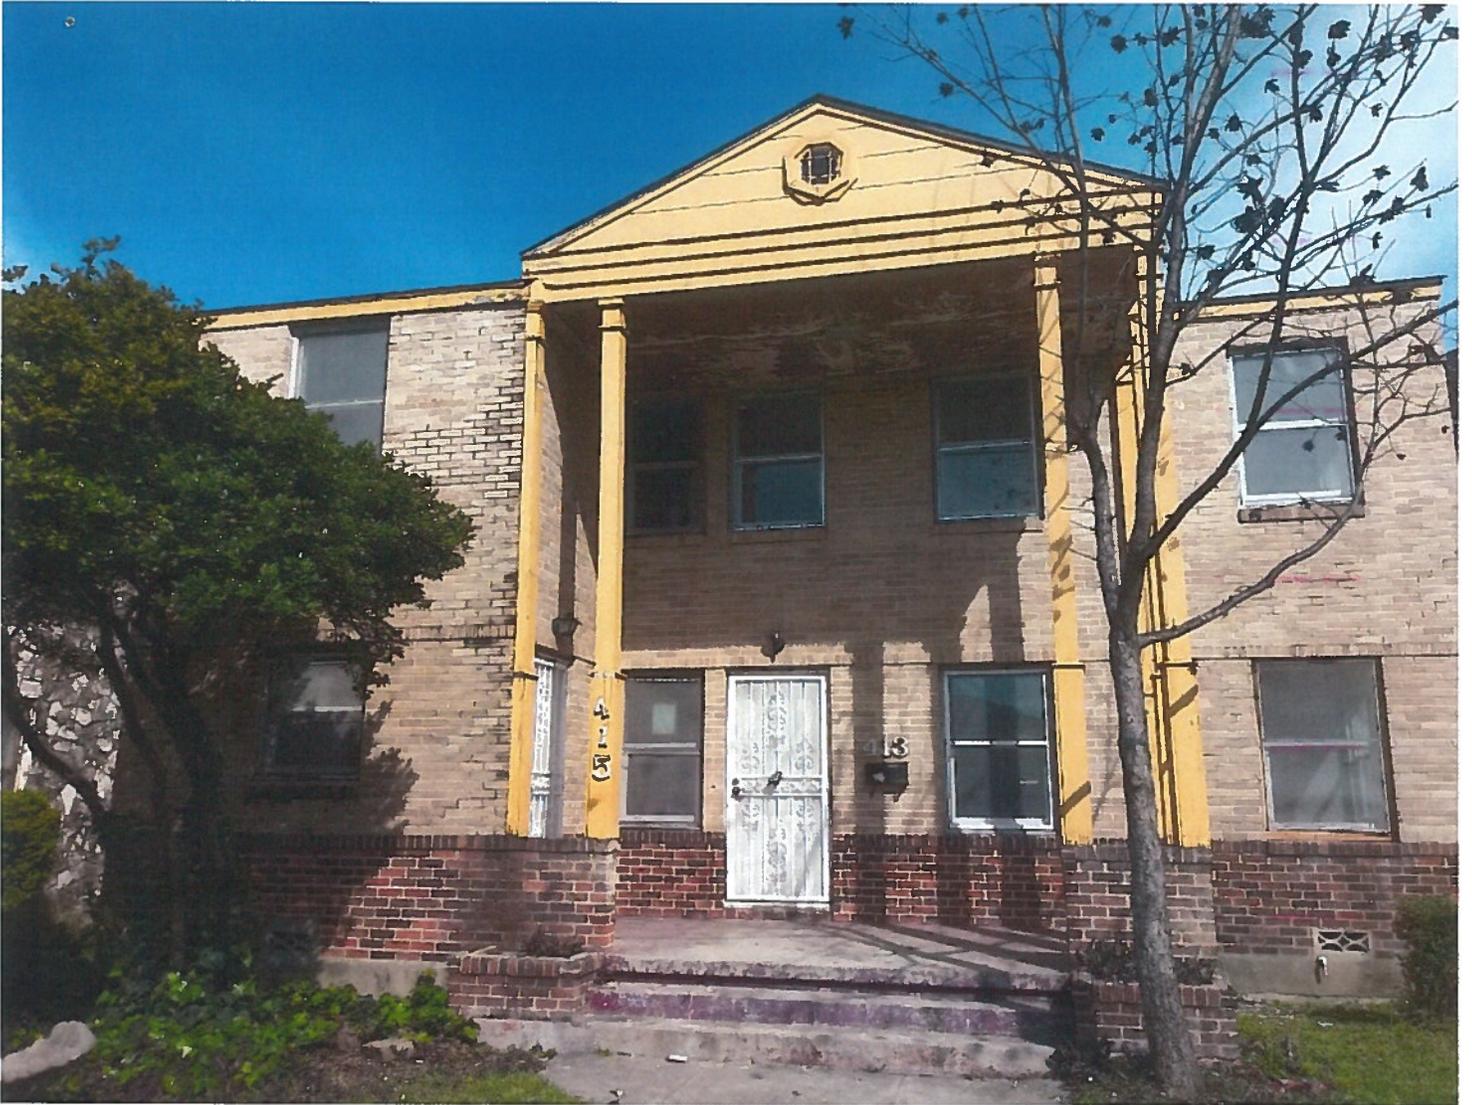
New windows Front side

Post-Window Installation

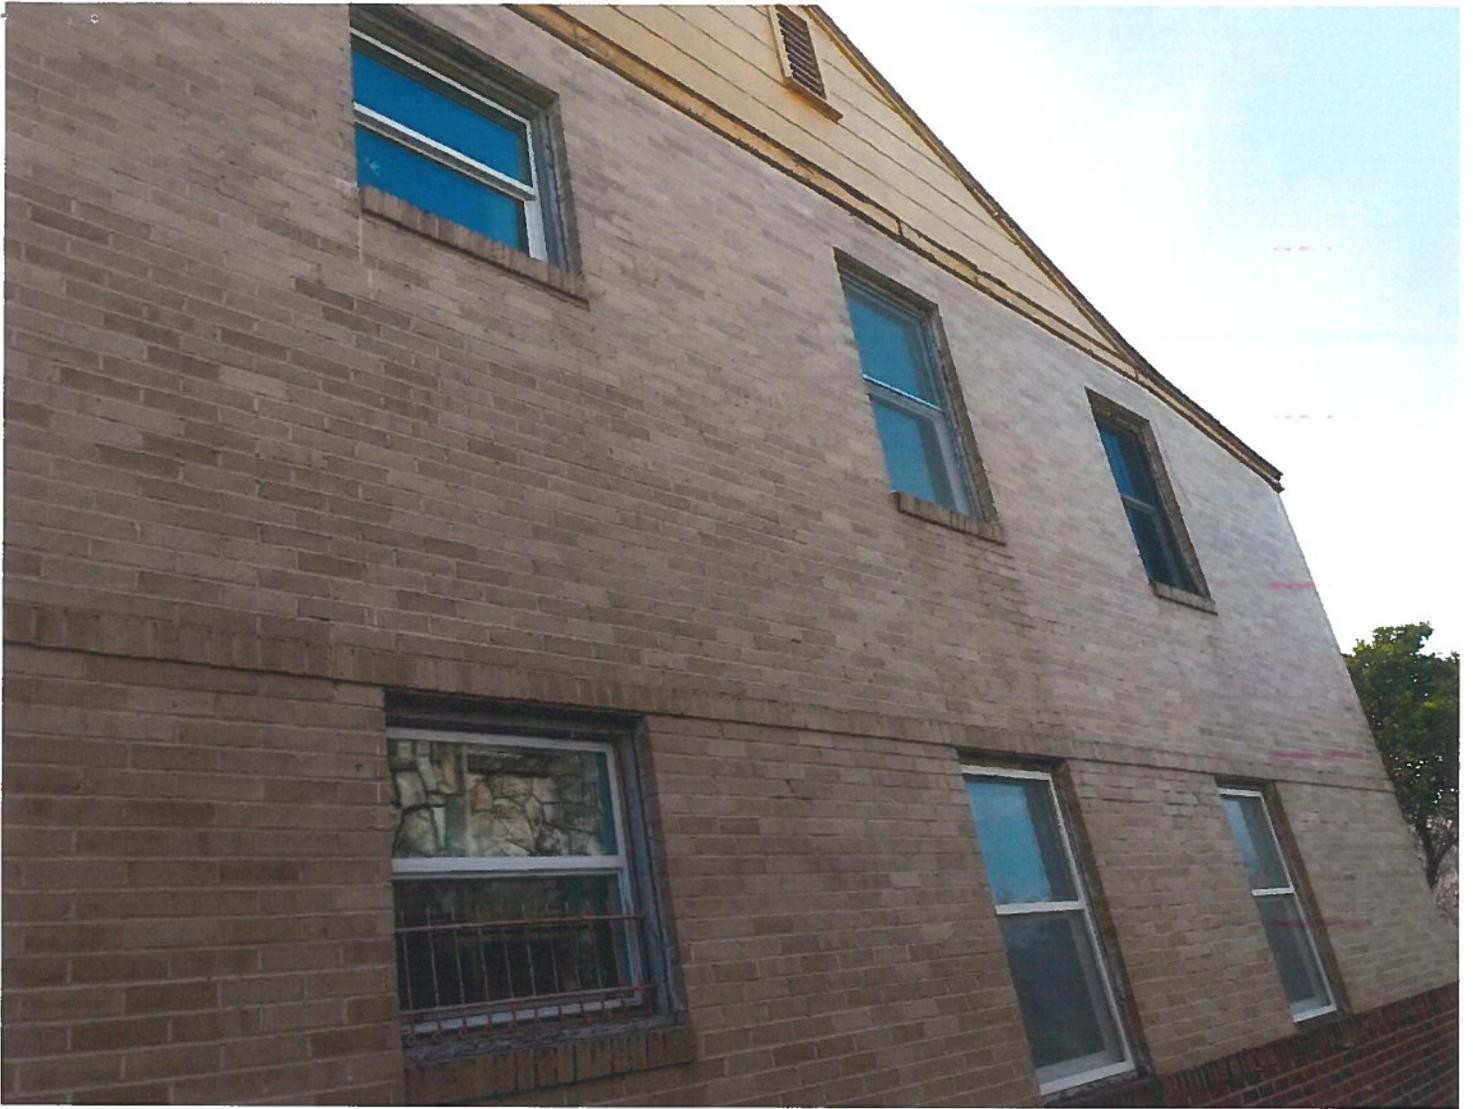
New windows left side

Post - window installation

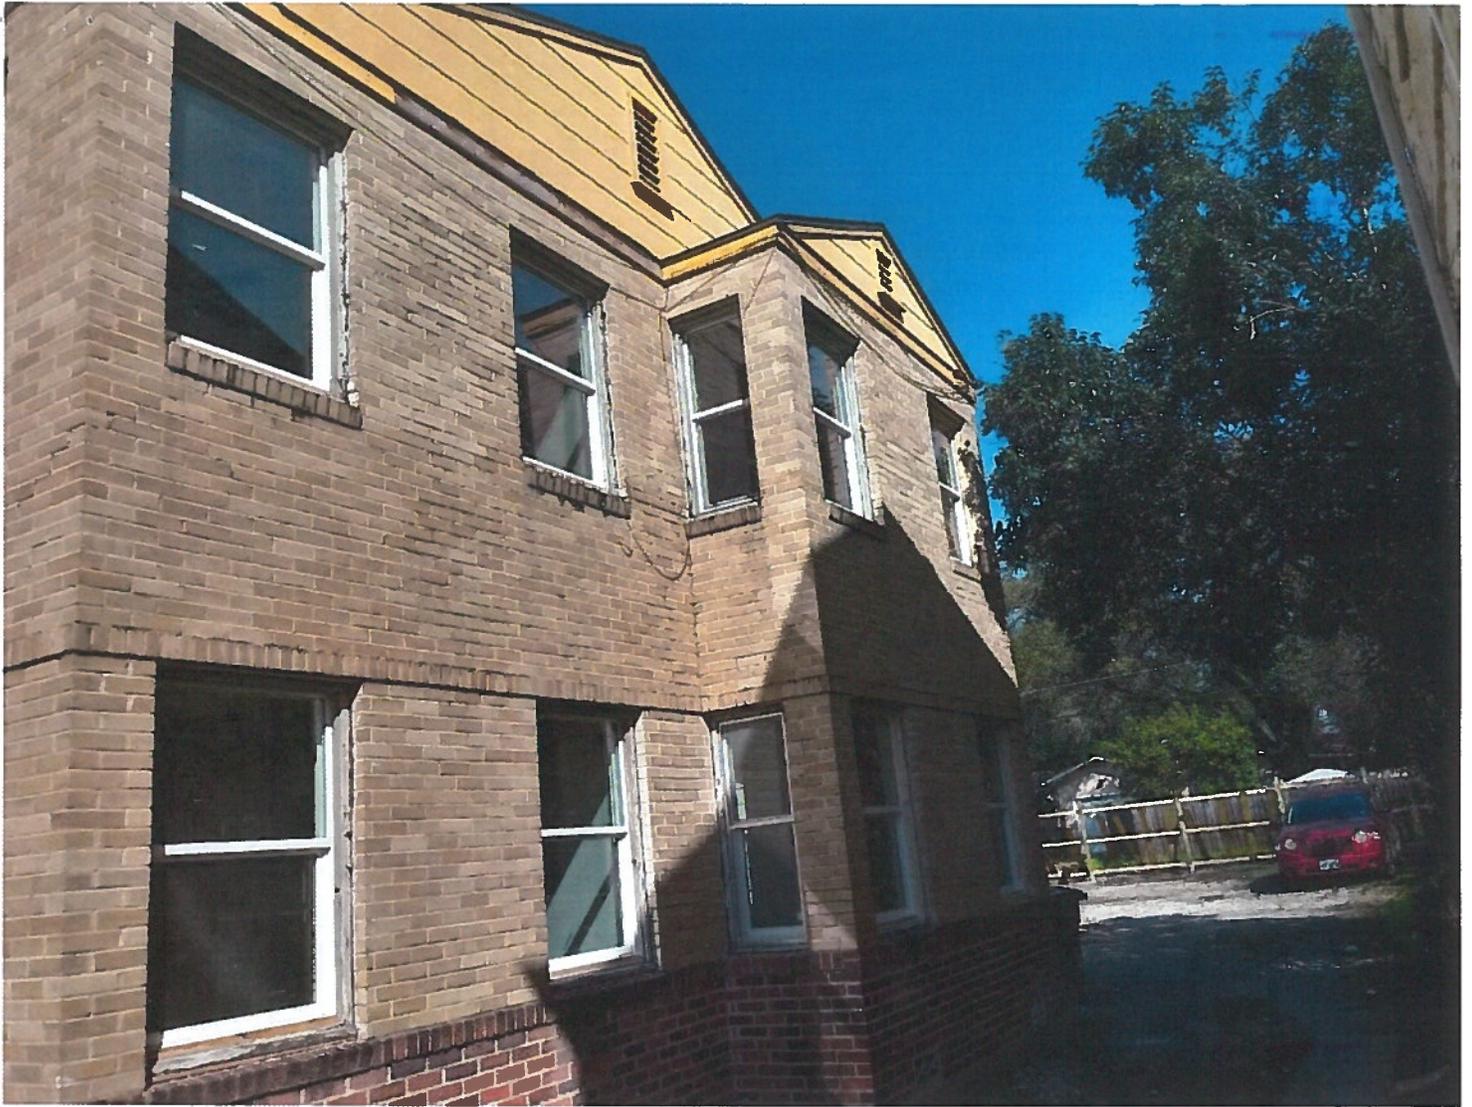
New windows Right side

post window installation

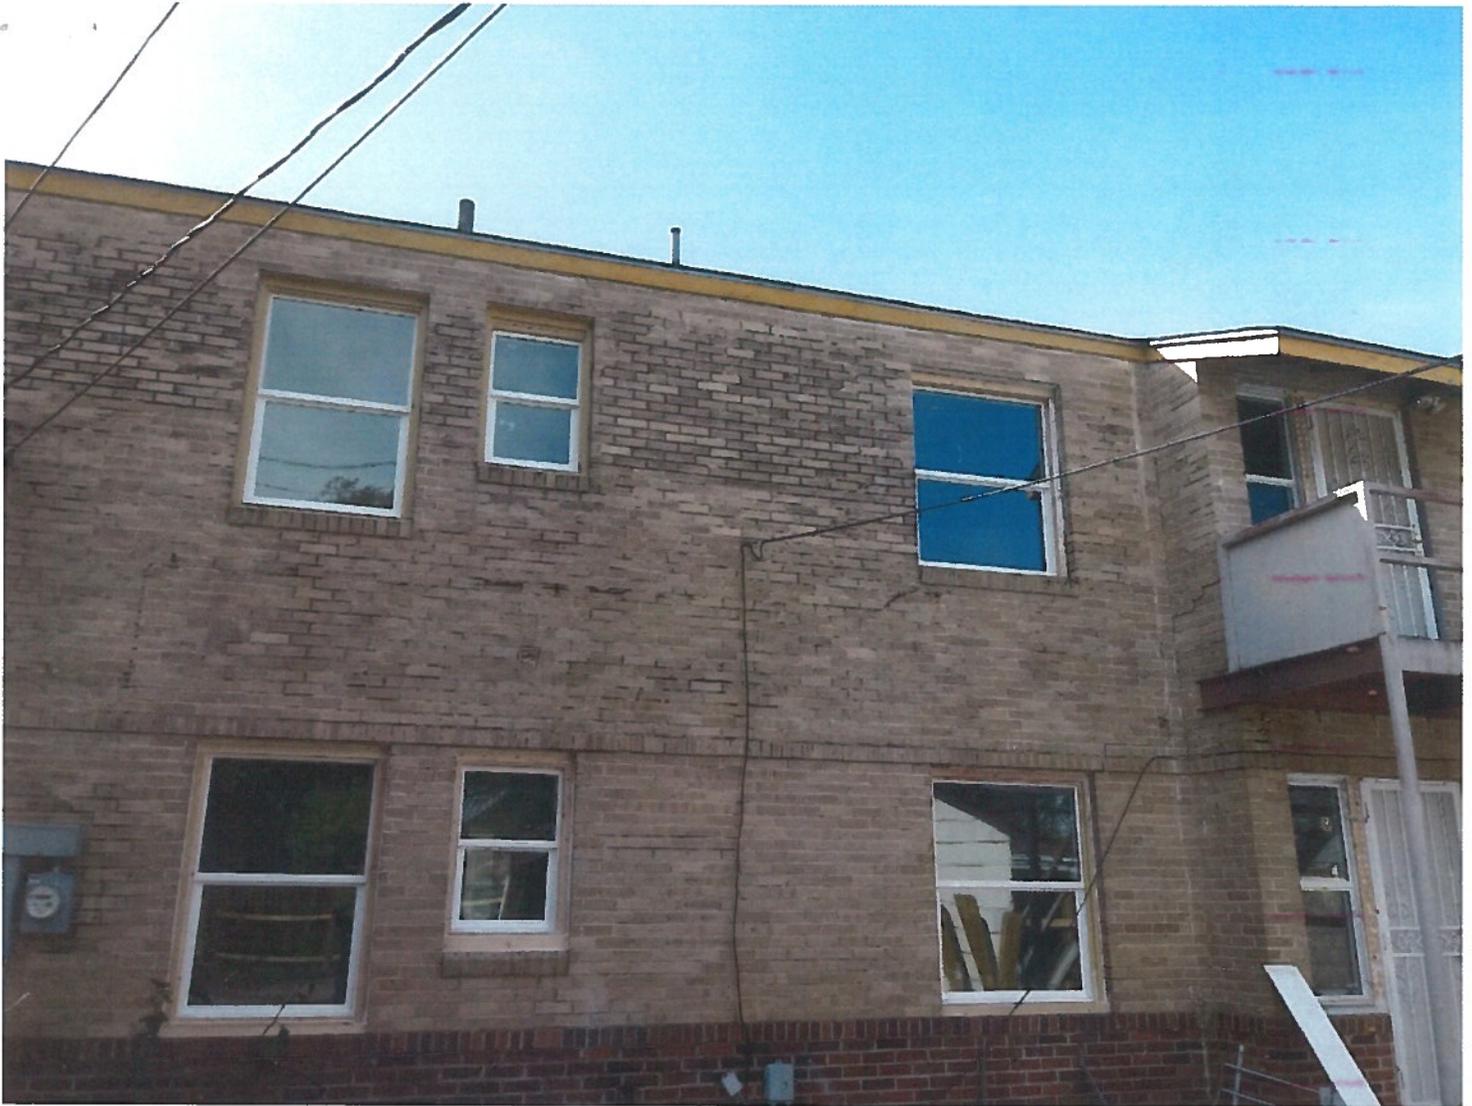
New windows back side

Post window installation

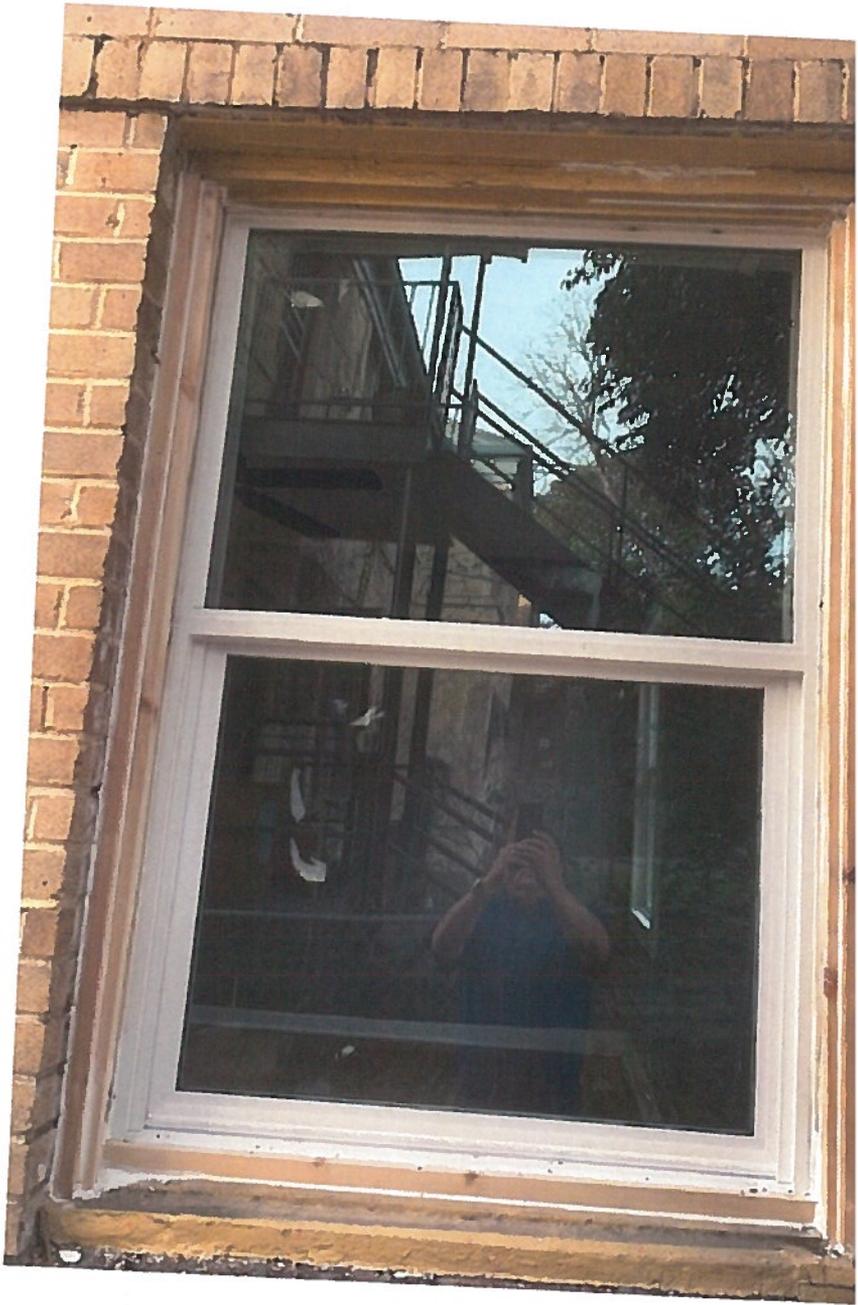
New windows

New windows w/ woodsc

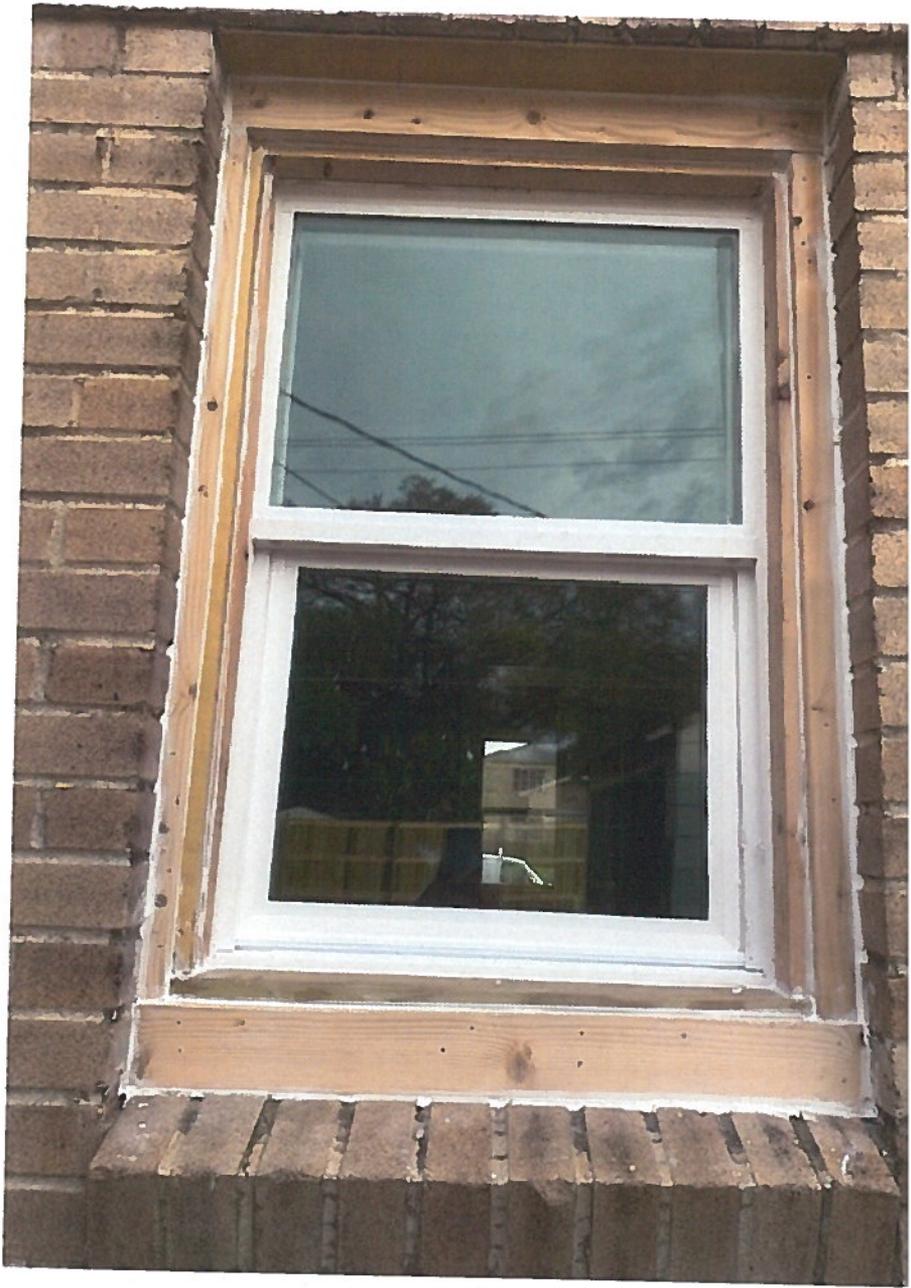
New windows w/ New trim

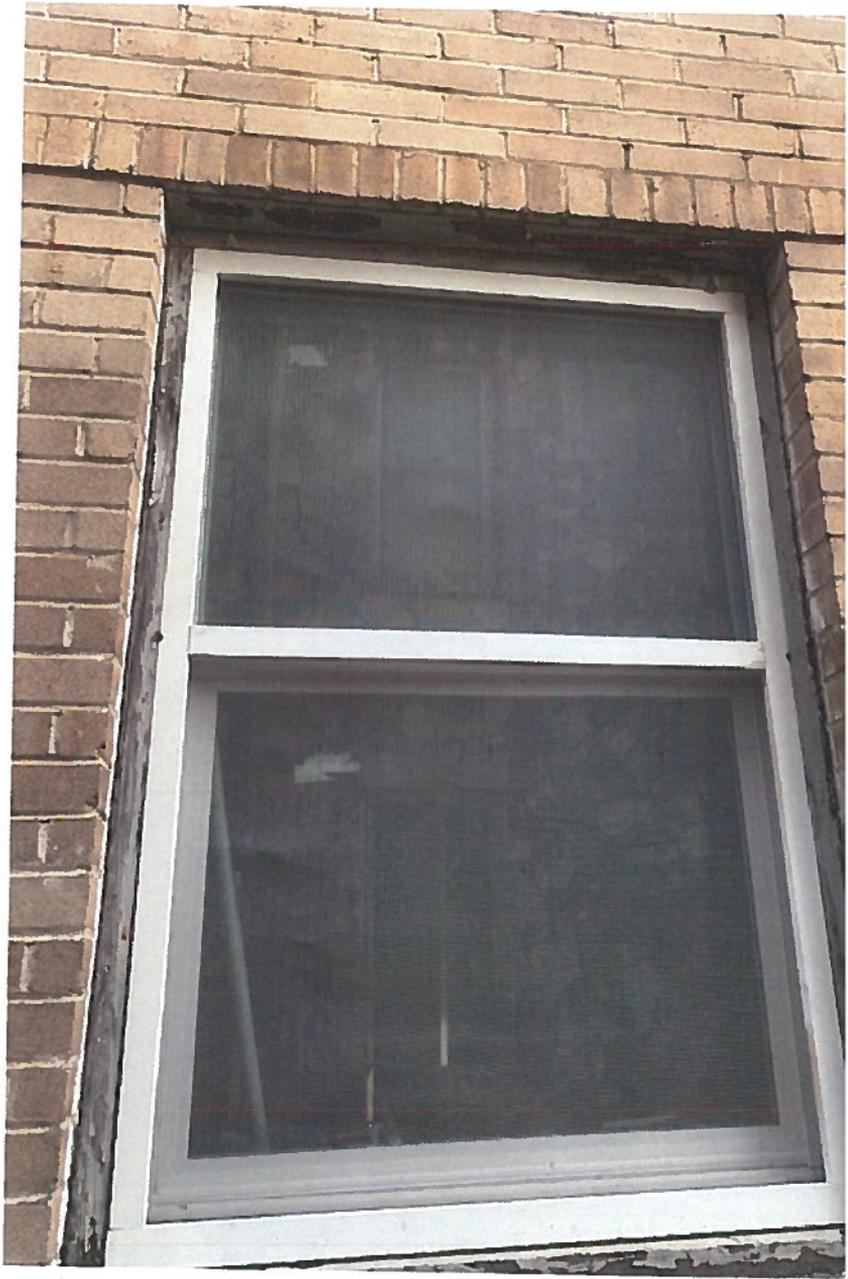
New windows
with wood screens

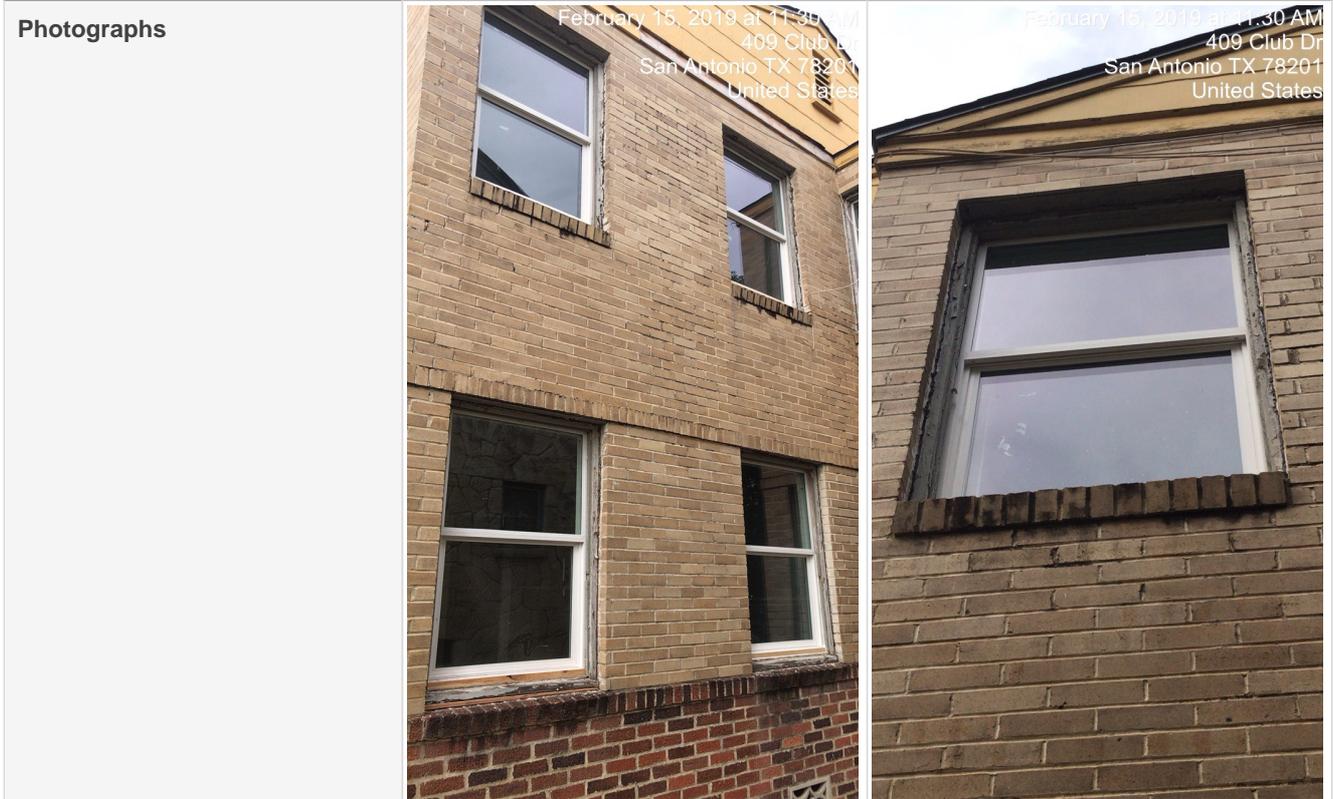
Date	02/15/2019
Time	11:34 AM (-6 GMT)
Context	follow-up, citizen report
Present Staff	Huy Pham, Other
Present Individuals	Crew member(s)
Types of Work Observed	Exterior Maintenance and Alterations
Amount of Work Completed	75%
Description of work	Windows have been replaced with vinyl windows; some are covered with wood or aluminum screens. Some work was occurring on the rear accessory structure and interior of the property.
Description of interaction	Two crew members were on site who spoke Spanish. Staff provided a stop work order with Spanish translation and posted a Notice of Investigation on the front facade.
