HISTORIC AND DESIGN REVIEW COMMISSION

September 19, 2018

HDRC CASE NO: 2018-459
ADDRESS: 1939 W GRAMERCY PLACE
LEGAL DESCRIPTION: NCB 1931 BLK 38 LOT 10
ZONING: R-6, H
CITY COUNCIL DIST.: 7
DISTRICT: Monticello Park Historic District
APPLICANT: Bruce Graham
OWNER: Bruce Graham
TYPE OF WORK: Window replacement
APPLICATION RECEIVED: August 29, 2018
60-DAY REVIEW: October 28, 2018
REQUEST:

The applicant is requesting a Certificate of Appropriateness for approval to replace twelve (12) wood windows with vinyl windows.

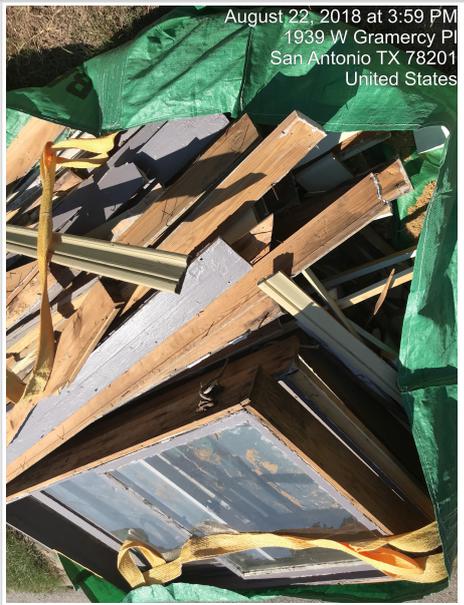
<p>August 22, 2018 at 3:59 PM 1939 W Gramercy Pl San Antonio TX 78201 United States</p>

Date	08/22/2018
Time	04:03 PM (-5 GMT)
Context	drive-by
Present Staff	Huy Pham
Present Individuals	None
Types of Work Observed	Exterior Maintenance and Alterations
Amount of Work Completed	Completed
Description of work	Removal of wood windows and installation of vinyl windows and dark mesh window screens. Some wood windows are still on site as of 4pm August 22, 2018.
