# HISTORIC AND DESIGN REVIEW COMMISSION

December 02, 2020

<b>HDRC CASE NO:</b>	<b>2020-505</b>
<b>ADDRESS:</b>	120 CALLAGHAN AVE
<b>LEGAL DESCRIPTION:</b>	NCB 719 BLK 1 LOT N 1-2 OF 5
<b>ZONING:</b>	RM-4,H
<b>CITY COUNCIL DIST.:</b>	1
<b>DISTRICT:</b>	Lavaca Historic District
<b>APPLICANT:</b>	Jim Ferrell/FT Builder Sevices
<b>OWNER:</b>	MENDIOLA MARIO J
<b>TYPE OF WORK:</b>	Window replacement
<b>APPLICATION RECEIVED:</b>	October 29, 2020
<b>60-DAY REVIEW:</b>	Not applicable due to City Council Emergency Orders
<b>CASE MANAGER:</b>	Stephanie Phillips

## Investigation Report

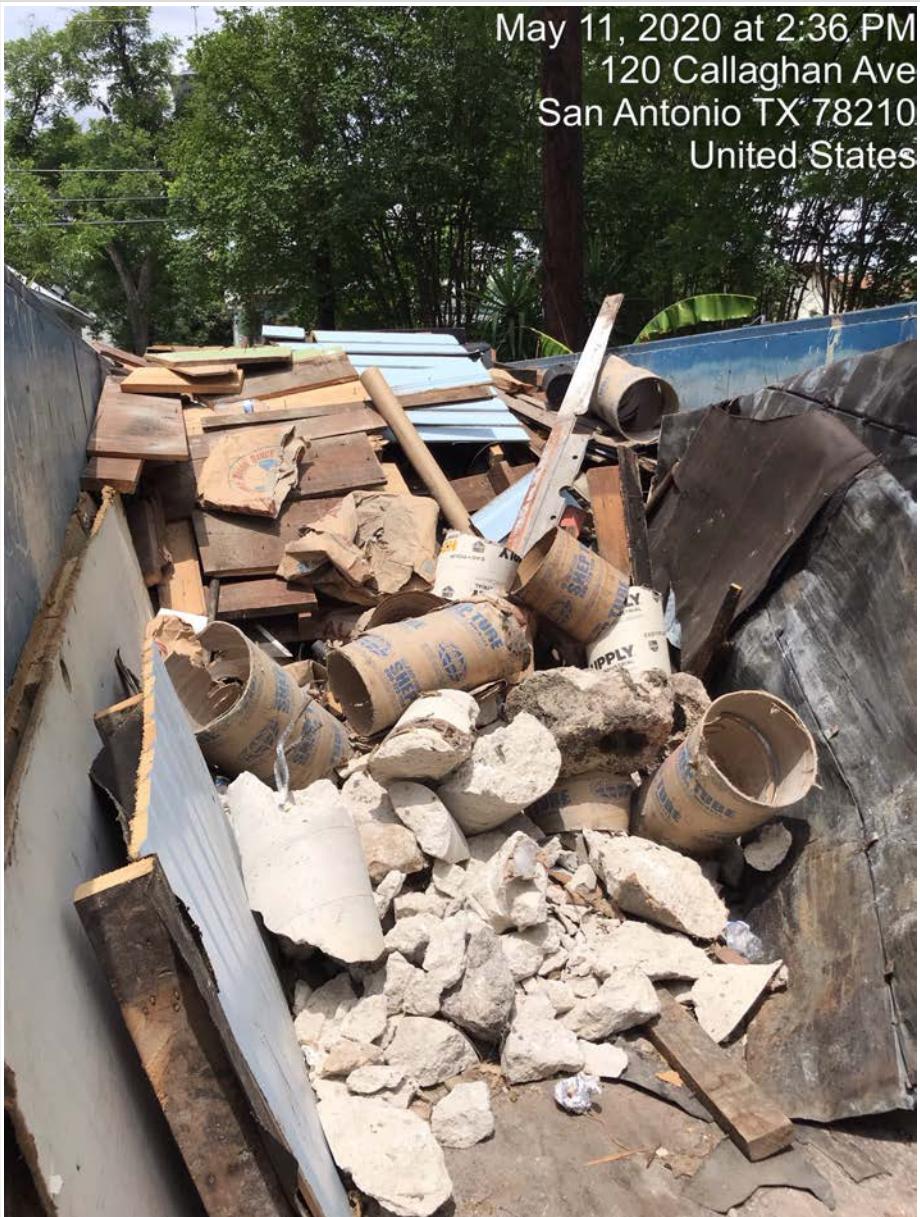
May 11, 2020 at 2:36 PM  
120 Callaghan Ave  
San Antonio TX 78210  
United States

Date	05/11/2020
Time	02:43 PM (-5 GMT)
Context	citizen report
Present Staff	Huy Pham, Edward Hall
Present Individuals	Other
Types of Work Observed	Exterior Maintenance and Alterations, Demolition
Amount of Work Completed	75%
Description of work	Demolition of historic facades and materials beyond the scope of approval for construction of a rear addition
