# HISTORIC AND DESIGN REVIEW COMMISSION

**HDRC CASE NO:** 2019-755

**ADDRESS:** 4101 SWANS LANDING

**LANDMARK:** Perrin House

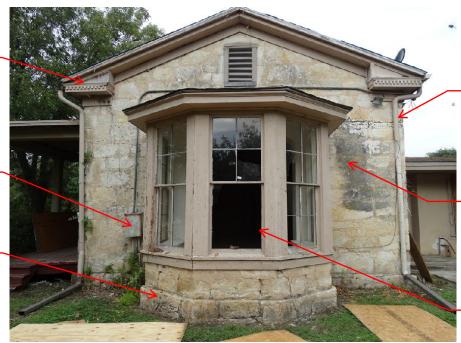
EXISTING ELECTRICAL TO BE REMOVED

DAMAGED MASONRY TO BE REPOINTED

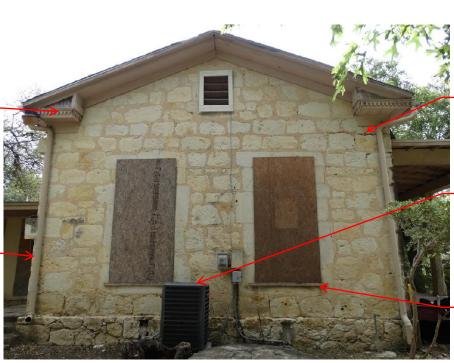
EXISTING GUTTERS AND DOWNPOUTS TO BE REMOVED AND REPLACED

MASONRY STAINS -TO BE REMOVED

EXISTING BOX RETURNS TO BE REMOVED AND REPLACED BY RAKE TRIM

EXISTING
GUTTERS AND
DOWNPOUTS TO
BE REMOVED
AND REPLACED

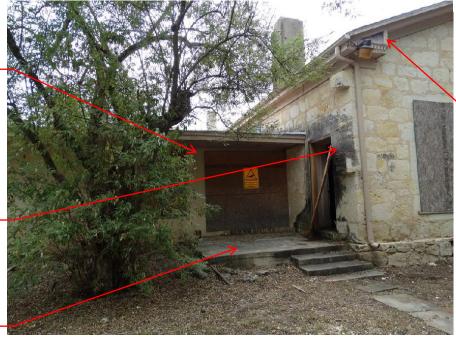
PARTIAL NORTH FACADE

DAMAGED MASONRY
TO BE REPOINTED

EXISTING MECHANICAL EQUIPMENT TO BE REMOVED

MASONRY STAINING TO BE REMOVED

1960'S ADDITION TO BE REMOVED. NEW ADDITION WILL NOT BE VISIBLE FROM STREET VIEW

EXISTING BOX RETURNS TO BE REMOVED AND REPLACED BY RAKE TRIM

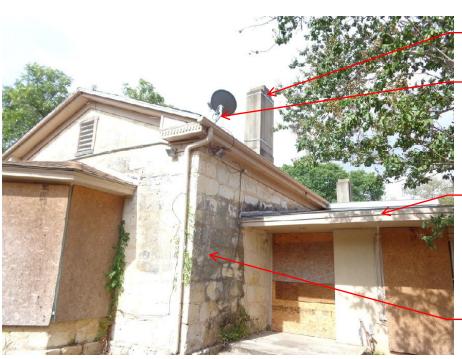
CHIMNEY TO REMAIN

SATELLITE DISH TO BE REMOVED

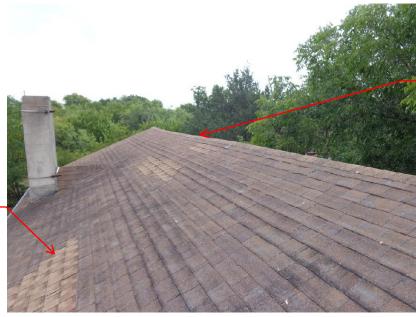
PARTIAL NORTH FACADE

SAGGING ROOF TO BE REPLACED BY METAL SEAMLESS ROOF

EXISTING
SHINGLES TO BE
REMOVE AND
REPLACED BY
SEAMLESS METAL
ROOF

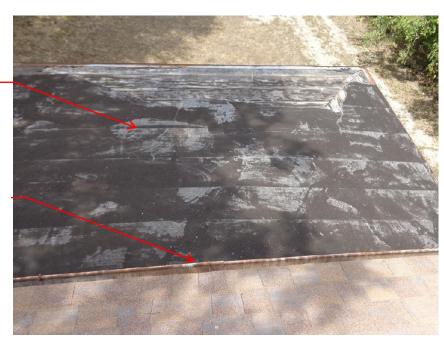
EXISTING
ROOFING TO BE
REMOVED AND
REPLACED BY
METAL
SEAMLESS ROOF

EXISTING GUTTERS TO BE REMOVED AND REPLACED.
