HISTORIC AND DESIGN REVIEW COMMISSION

September 06, 2017

HDRC CASE NO: 2017-436
ADDRESS: 106 GRAMERCY PL E
LEGAL DESCRIPTION: NCB 6381 BLK 1 LOT 21, 22 & 23
ZONING: R-5 H
CITY COUNCIL DIST.: 1
DISTRICT: Monte Vista Historic District
APPLICANT: Damon and Julie VanZandt
OWNER: Damon and Julie VanZandt
TYPE OF WORK: Historic Tax Certification

The applicant is requesting Historic Tax Certification for the property at 106 E Gramercy Pl.

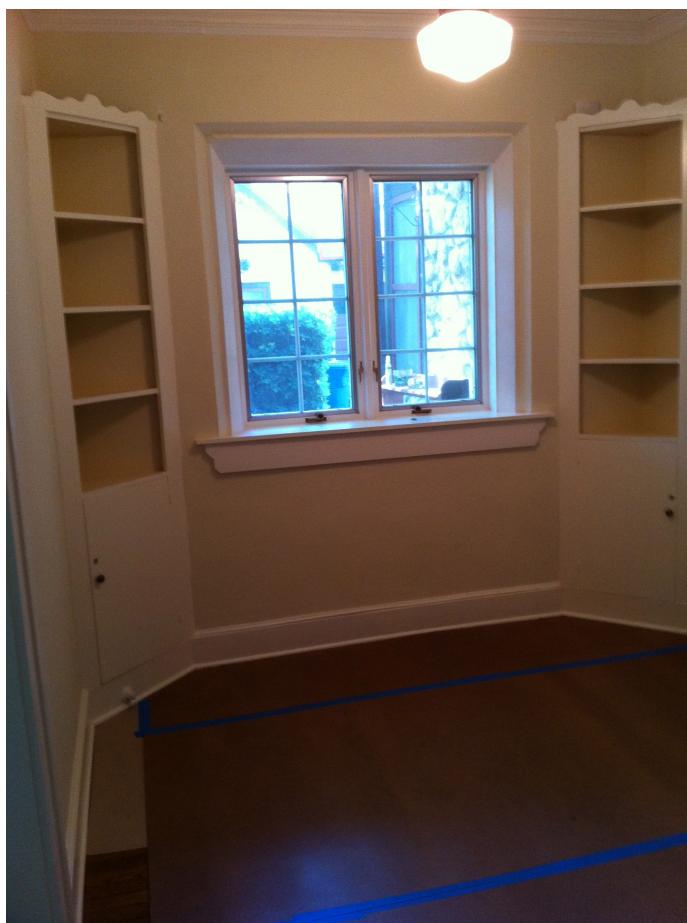
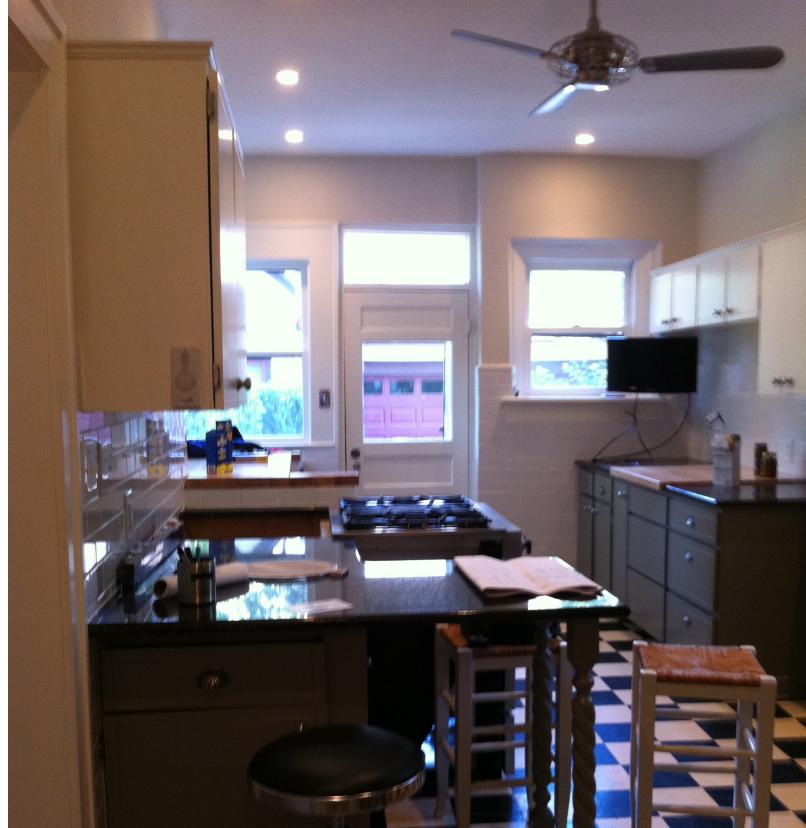
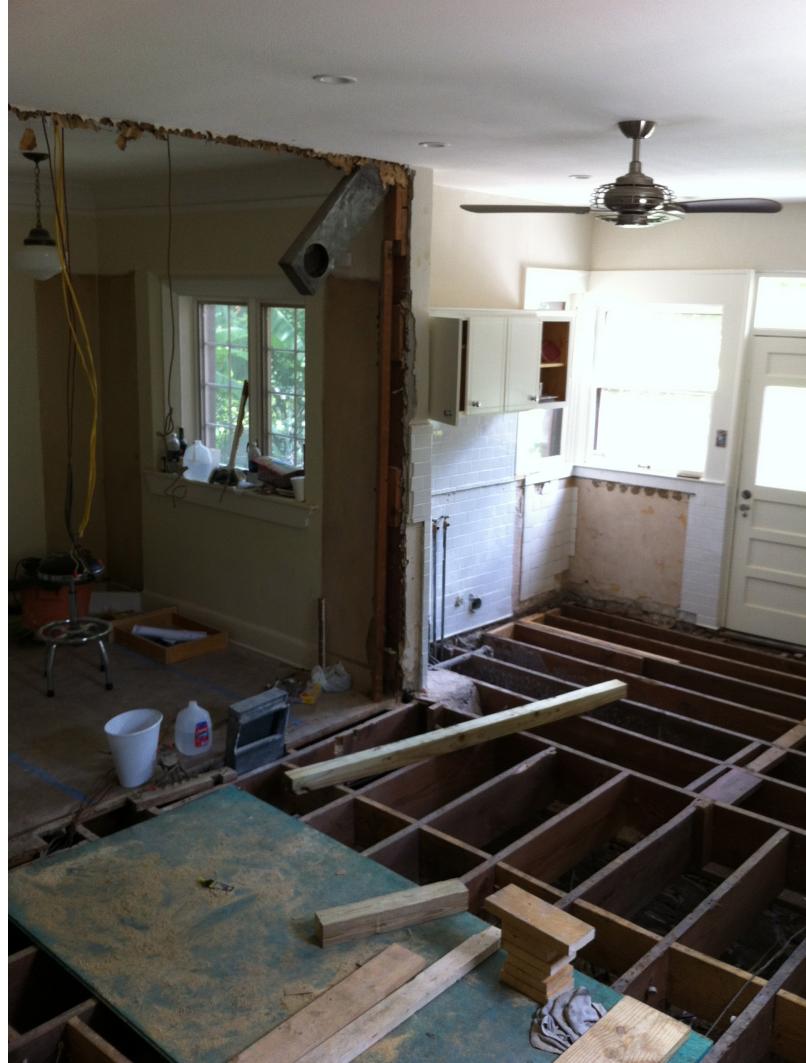
Shotgun style kitchen was combined with separate breakfast room below.

One interior wall was removed

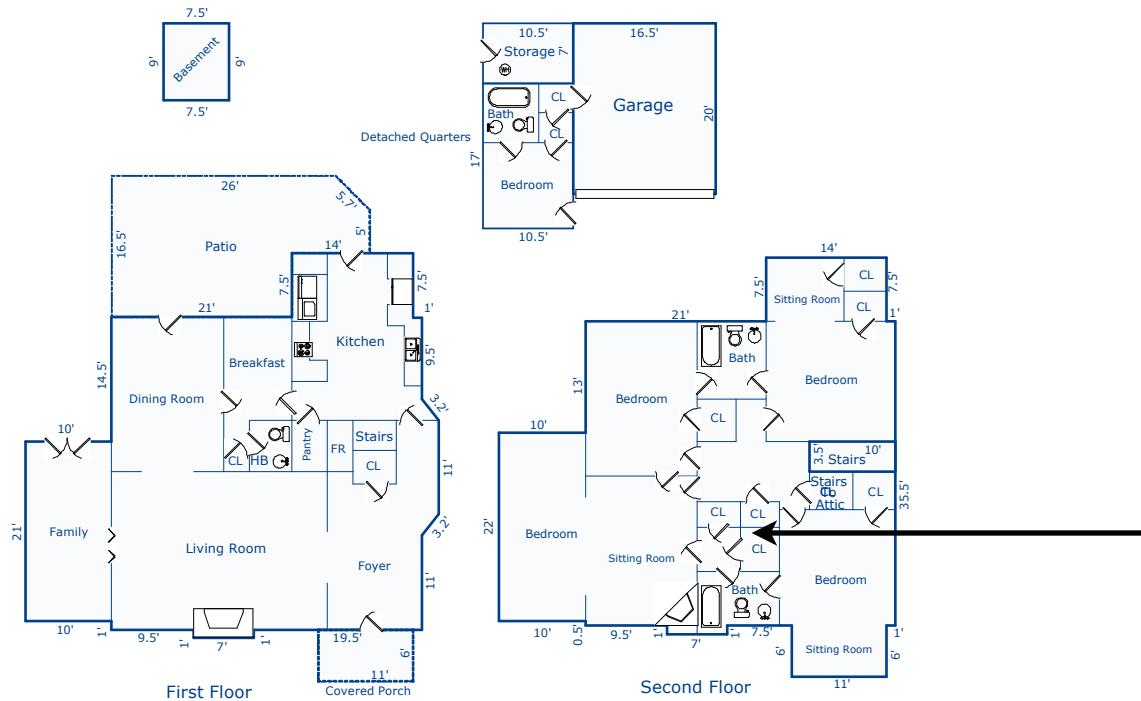
A third bath was added on 2nd floor closet space area.

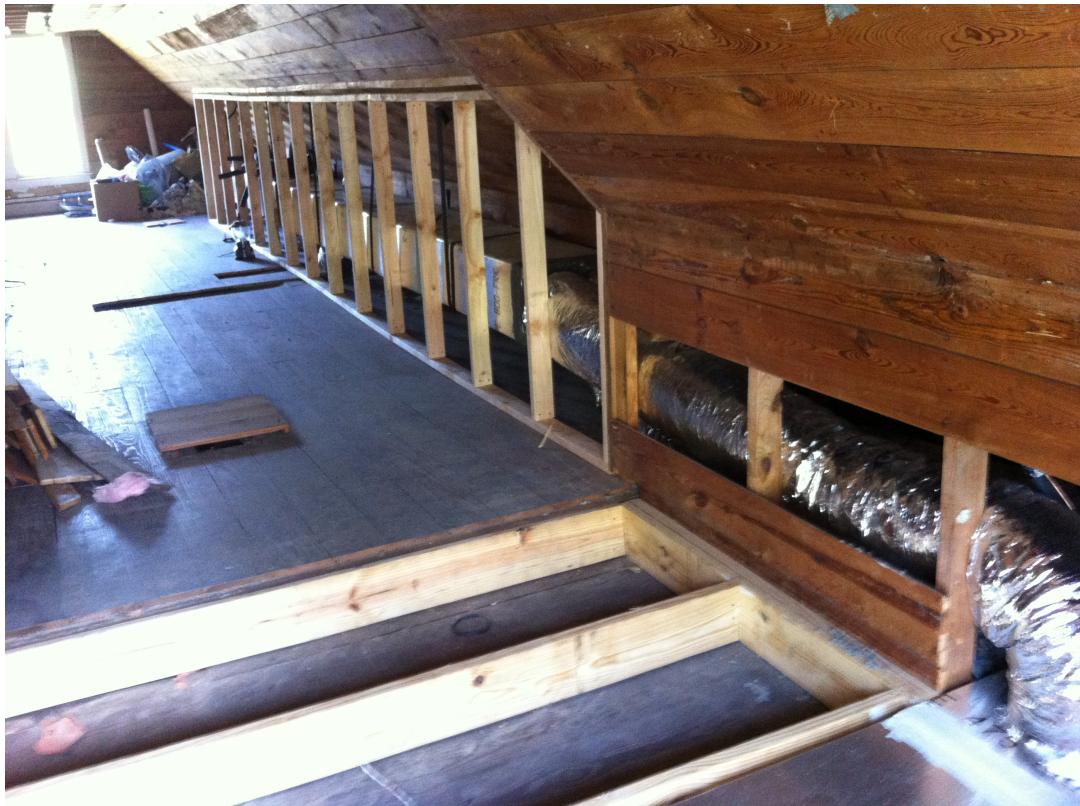
3rd floor HVAC system running down center of attic was removed and replaced with multiple systems tucked in the rafters serving separate zones in the home.

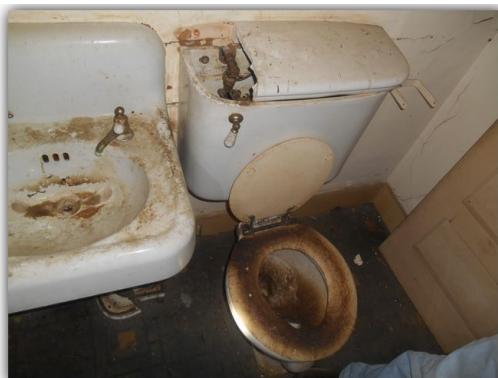
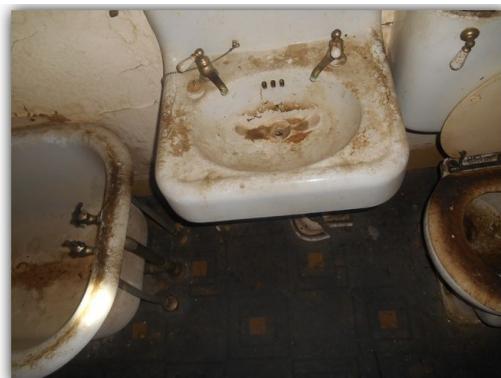
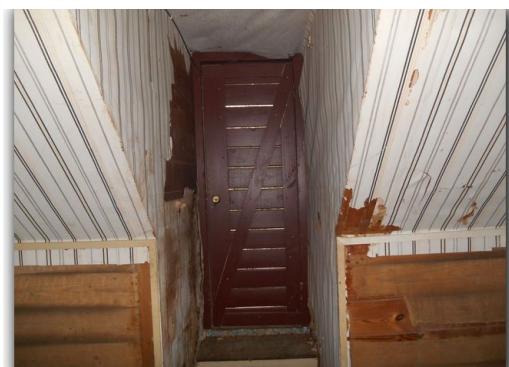
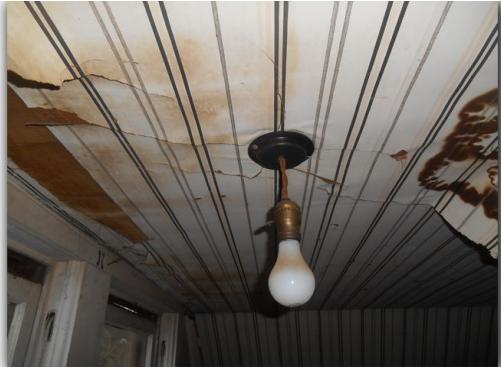
Third Floor Bath.
